# Assessment of Estuarine Water and Sediment Quality at Cape Hatteras National Seashore and Cape Lookout National Seashore *2021 Data Summary*

Natural Resource Data Series NPS/SECN/NRDS—2022/1373

Eric N. Starkey, Daniel McCay, Christopher S. Cooper and Mark Hynds

October 2022

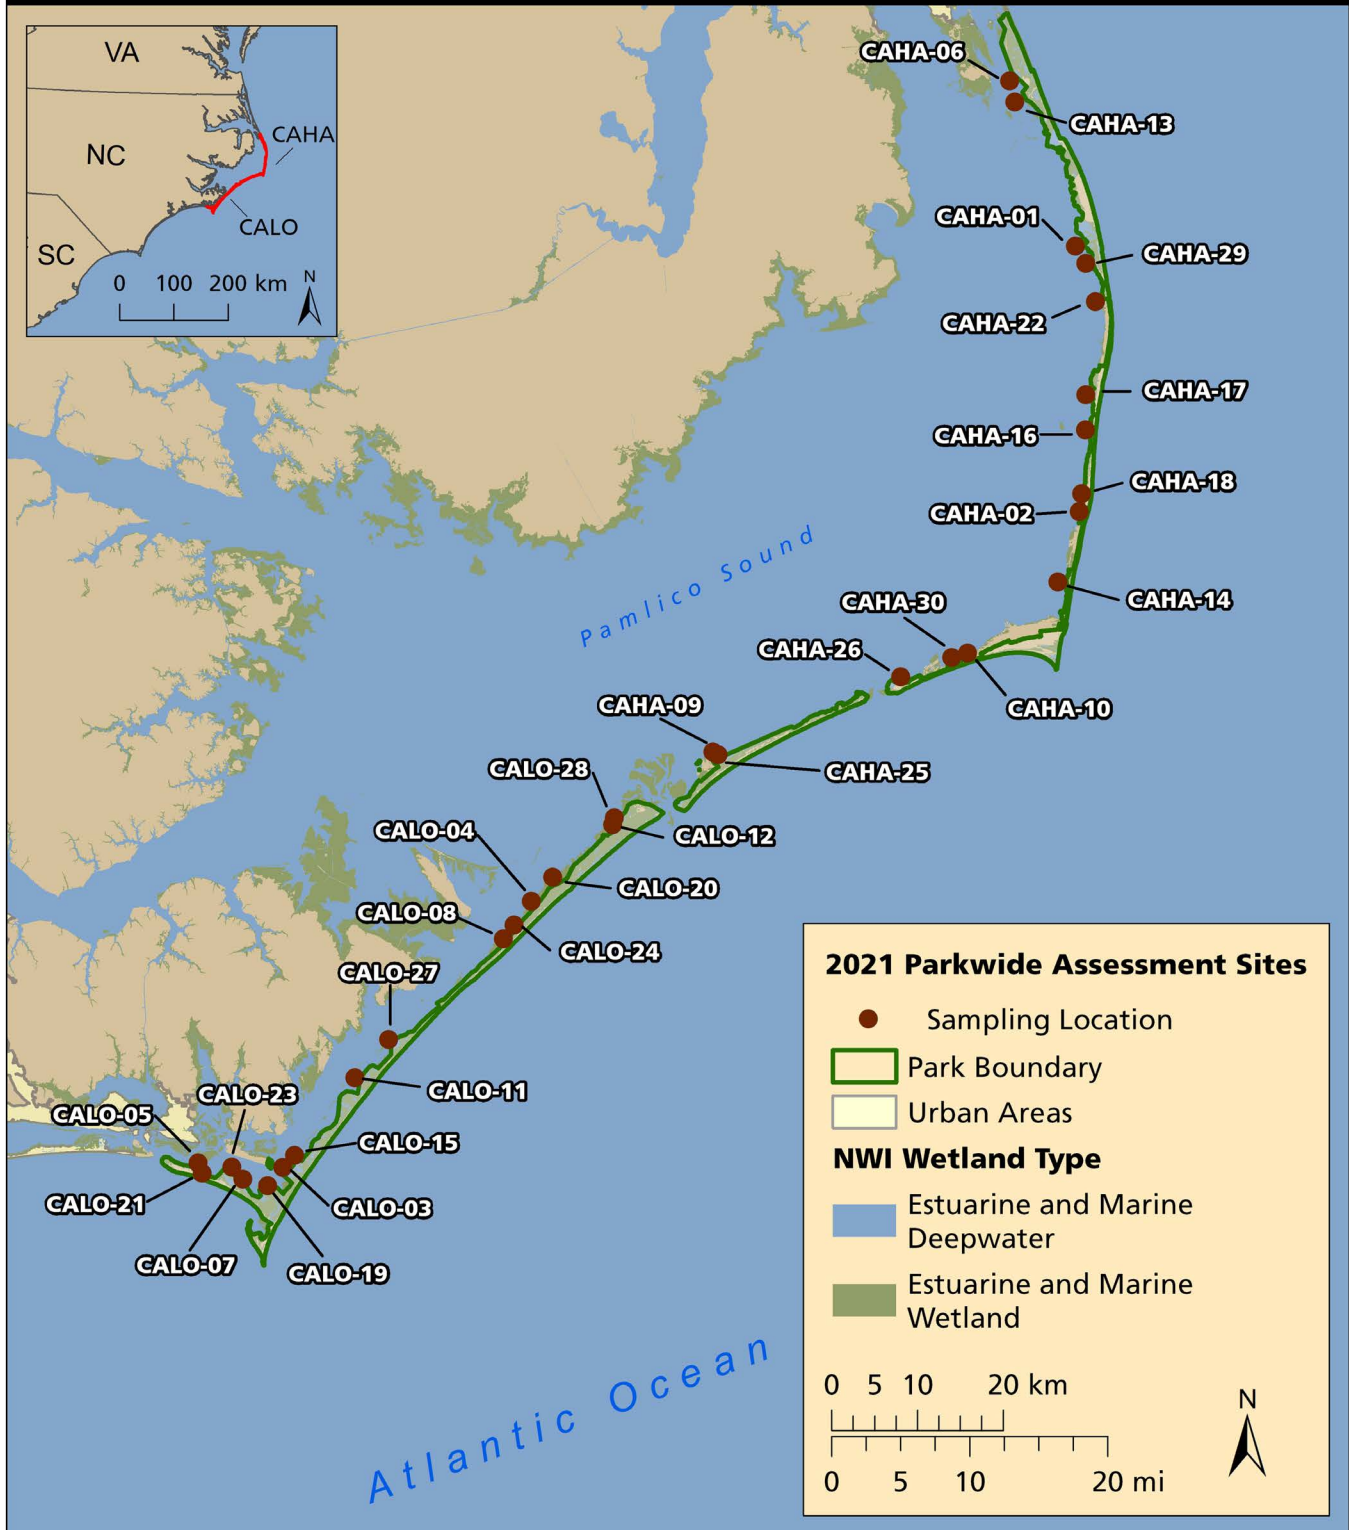
**Figure 3.** Map showing the location of coastal assessment sites sampled in July 2021 at Cape Hatteras and Cape Lookout National Seashores. See Table 1 for more information about each site.

In 2021, 30 sites in Pamlico, Core and Back Sounds were randomly selected for monitoring following methods developed by the EPA (Table 1, Figure 3; Stevens 1997; Stevens and Olsen 1999; Stevens and Olsen 2004). A pool of alternate sites was selected in case any of the original sites were not accessible. This method of randomly selecting spatially-balanced sites provides managers with a statistically valid estimate of the overall conditions of the assessed resource within or around the park.
