# Water Quality Monitoring for Theodore Roosevelt National Park

## *2019 Data Report*

Natural Resource Data Series NPS/THRO/NRDS—2022/1375

Anine T. Rosse, Myles J. Cramer

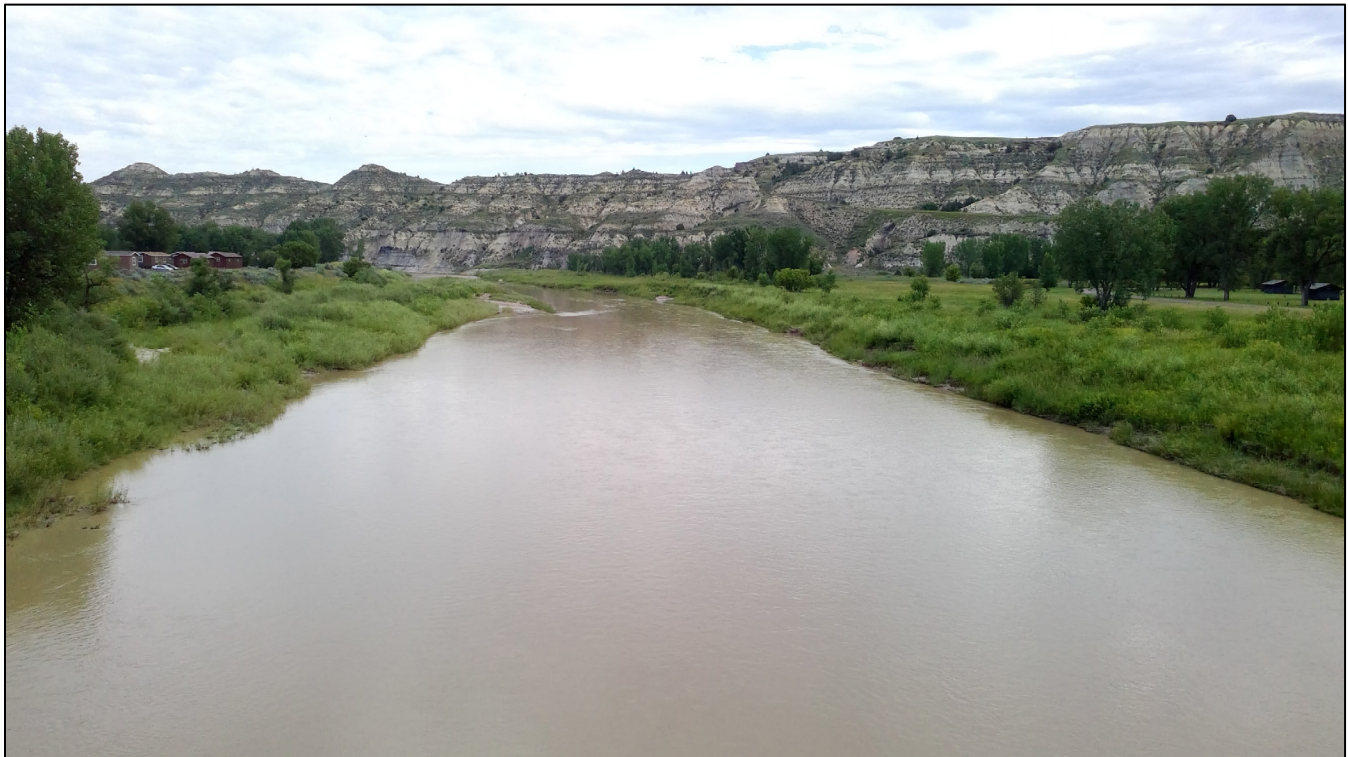
**ON THE COVER**

Photograph of Little Missouri River near Medora, ND, at Theodore Roosevelt National Park, July 2019.  
Photograph by USGS, station 06336000.

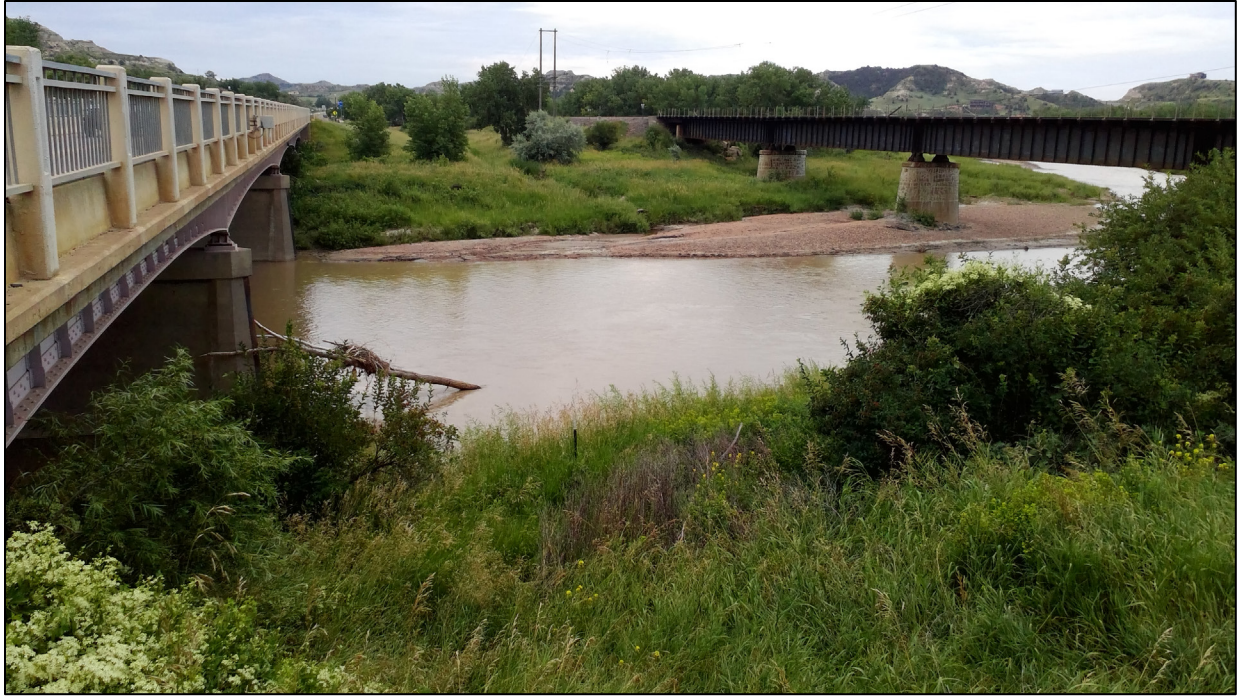
Photograph of USGS Dakota Water Science Center water quality sonde location in the Little Missouri River near Medora, ND.  
Photograph by USGS, station 06336000.

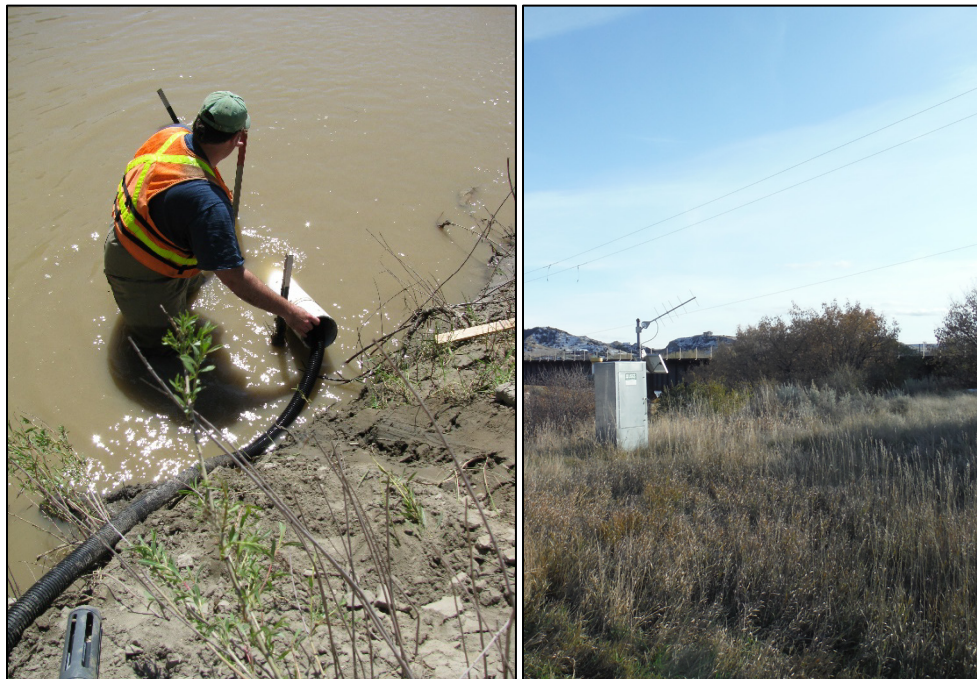
**Figure 3.** A sonde device is used to measure water quality in the Little Missouri River at Theodore Roosevelt National Park and it is installed within a pipe for protection (left panel). The United States Geological Survey Little Missouri gaging station (06336000) is set up for real-time data transmission via satellite (right panel). Photographs courtesy of USGS, station 06336000.

In 2019, NGPN continued to partner with the USGS North Dakota Water Science Center to have USGS staff collect water quality and streamflow data at THRO. The USGS deployed a continuous, multi-parameter sonde at the Little Missouri River Gaging Station (06336000) near Medora, ND, on April 17, 2019, (Figure 3) and visited the gaging station every three to four weeks for equipment maintenance (Table 2). The sonde instrument recorded dissolved oxygen (DO), pH, specific conductivity, and water temperature every 15 minutes, while the gage simultaneously measured stream stage (gage height; measured in feet) and discharge, a measure of streamflow.

During each site visit, USGS staff conducted a site inspection and a side-by-side comparison between the in-the-water sonde and an independent field sonde. They serviced and calibrated the sensors as needed. Calibration included pre- and post-calibration checks to quantify fouling errors and equipment drift; this data is critical to the correction and grading of the final data. On November 4, 2019, the USGS removed the multi-parameter sonde from the Little Missouri River.

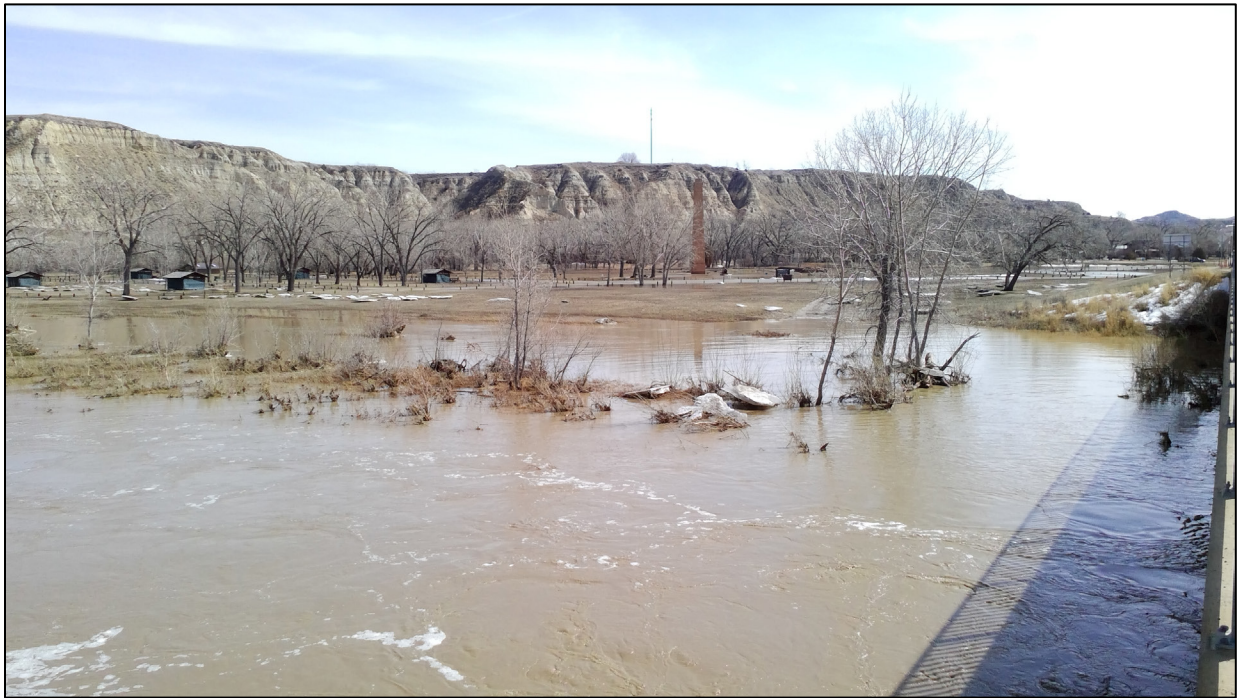
**Figure 4.** Little Missouri River at USGS gaging station 06336000 March 26, 2019, just one day after peak recorded flow of 27,600 cfs.

The water quality monitoring season (ice-free) on the Little Missouri River at THRO lasted from April 17 to November 4, 2019. River discharge peaked in March before the monitoring season began. Subsequent smaller peaks occurred in May, July, and September. The maximum recorded daily discharge prior to the monitoring season was recorded on March 25, 2019 at 27,600 cubic feet per second (cfs). During the monitoring season, peak discharge was recorded at 9,410 cfs.
