# Stream Channel Monitoring for Wind Cave National Park

## *2021 Data Report*

Natural Resource Data Series NPS/WICA/NRDS—2023/1386

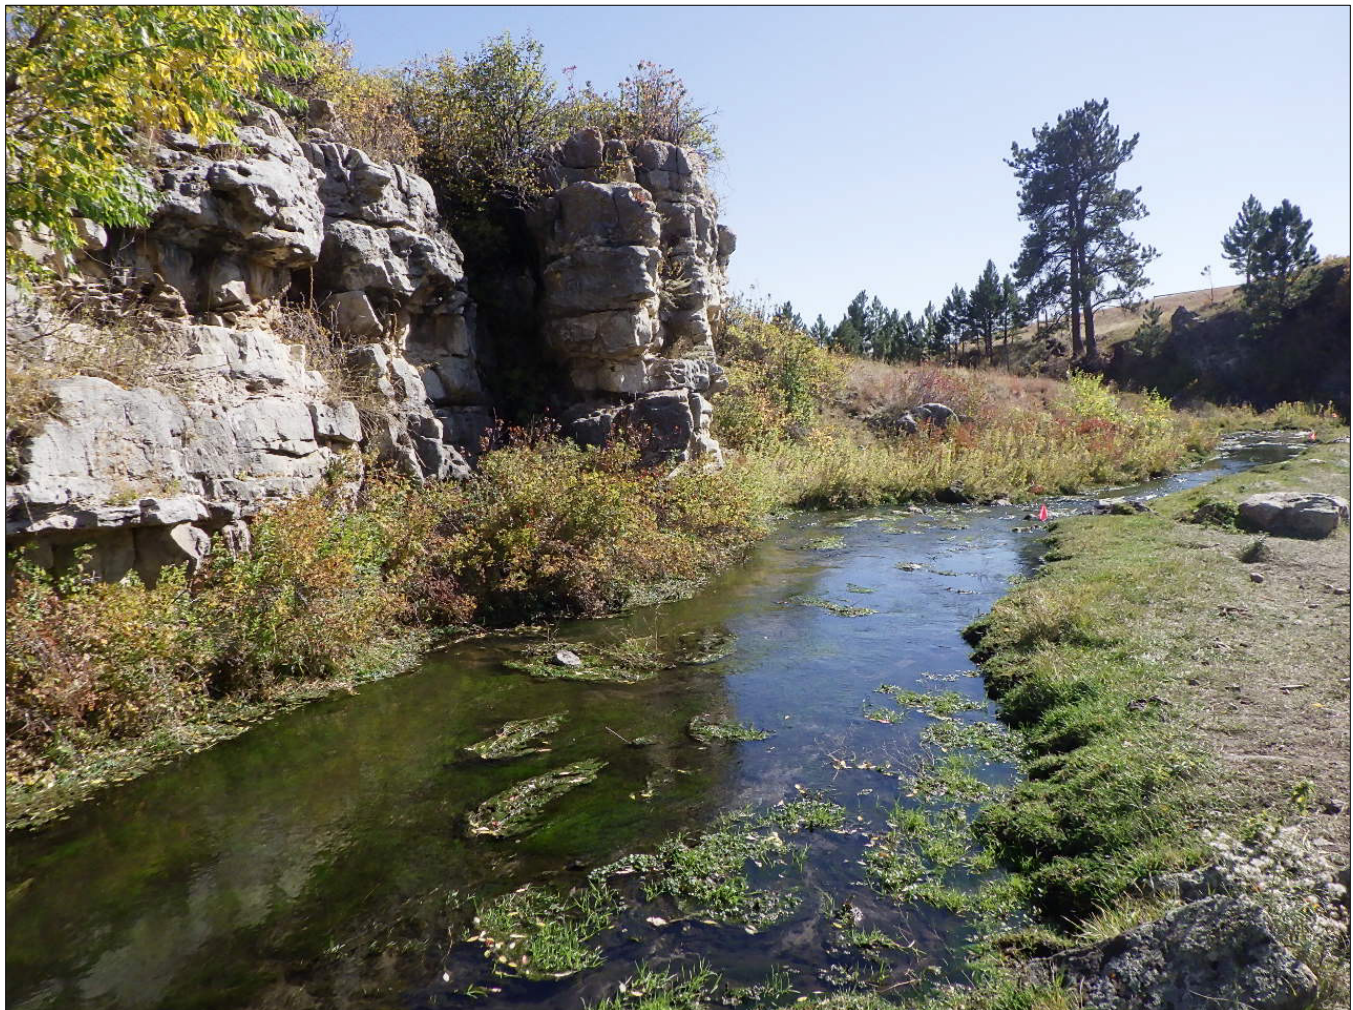
**ON THIS PAGE**

Cross section of WICA SCM 001 at Wind Cave National Park, South Dakota, in September 2021.  
Photograph courtesy of NGPN, National Park Service.

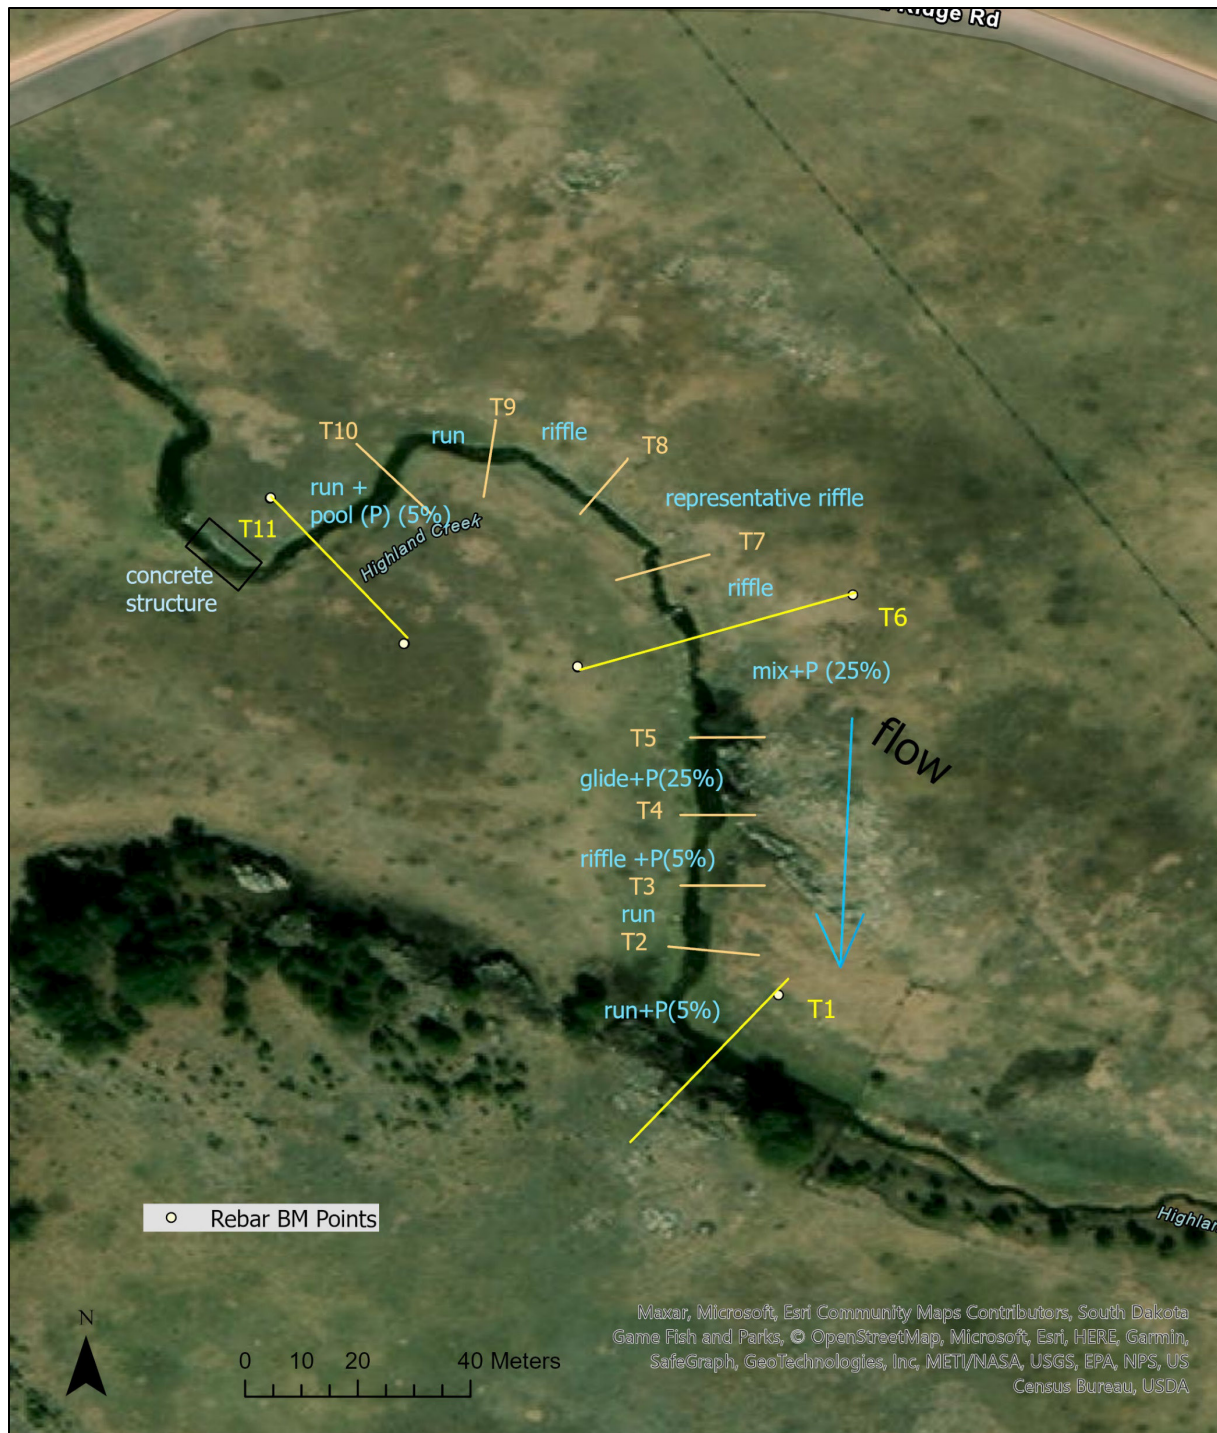
**Figure 2.** Layout of sampled reach of WICA stream channel monitoring site WICA SCM 001. Transects number 1-11 running from down to upstream. The dominant geomorphic channel unit is noted between each reach.

The NGPN crew performed stream channel measurements in September 2021. Discharge, photos, geomorphic channel units (pool, riffle, run, etc), representative pebble count at the riffle between transect 7-8, canopy cover, large woody debris, bank and bed sediment, channel- and bank-full heights and angles were taken. Vegetative bank cover and other cover measurements were taken in a one-meter strip up to the channel-full height. Figure 2 shows the layout of the reach. The concrete structure (weir) just upstream of the reach was built in the 1960s and was used for pumping water from the stream for fires. The placement likely affects flow dynamics; the stream is much narrower below the structure as evident in Figure 2. The longer yellow lines at T1, T6, and T11 show the permanently marked detailed transects where the total station was used.

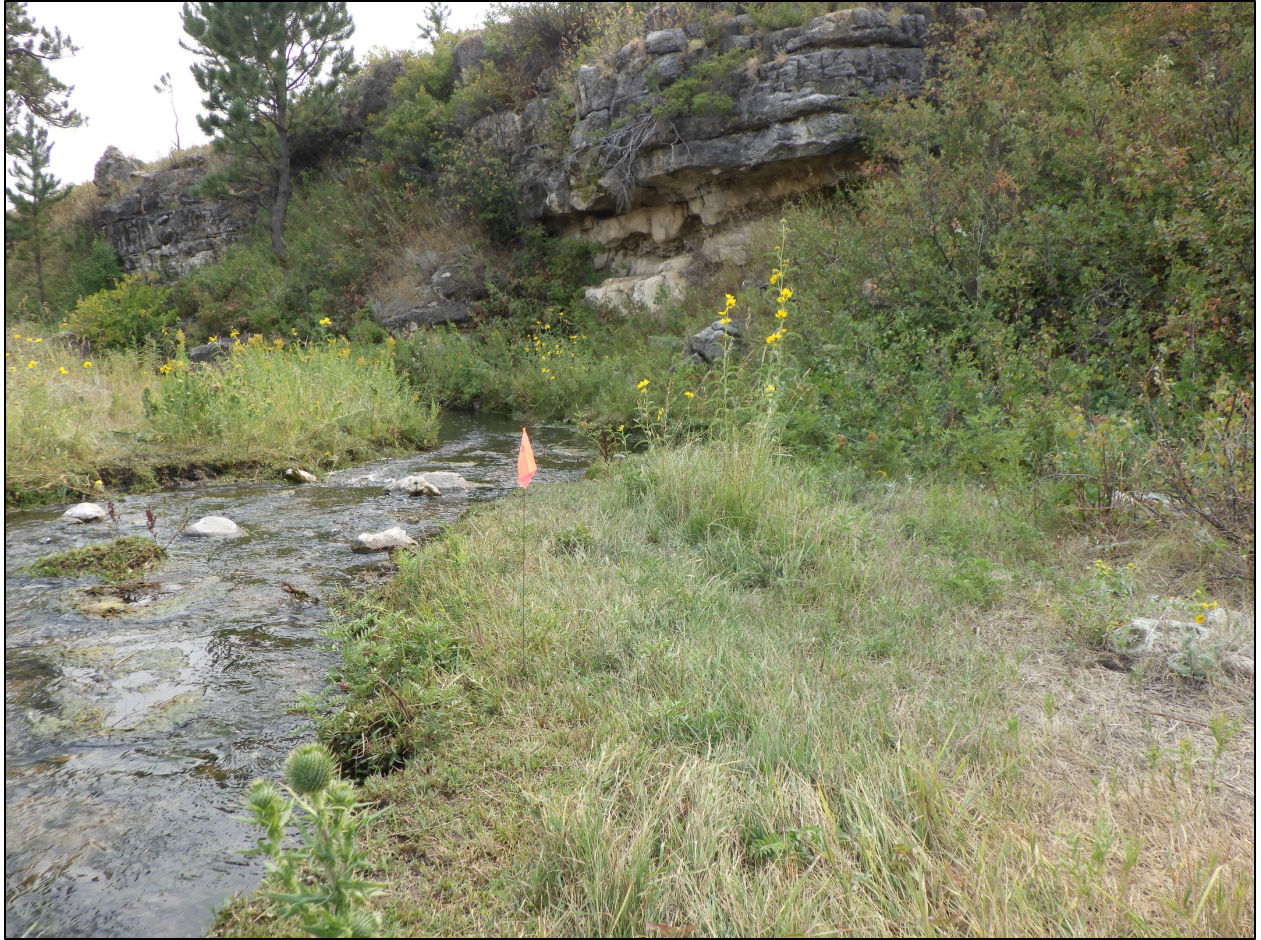
**Figure 4.** View of T1 from the flag at T2 showing steep limestone cliff impeding access of T1 transect and constraining the channel.

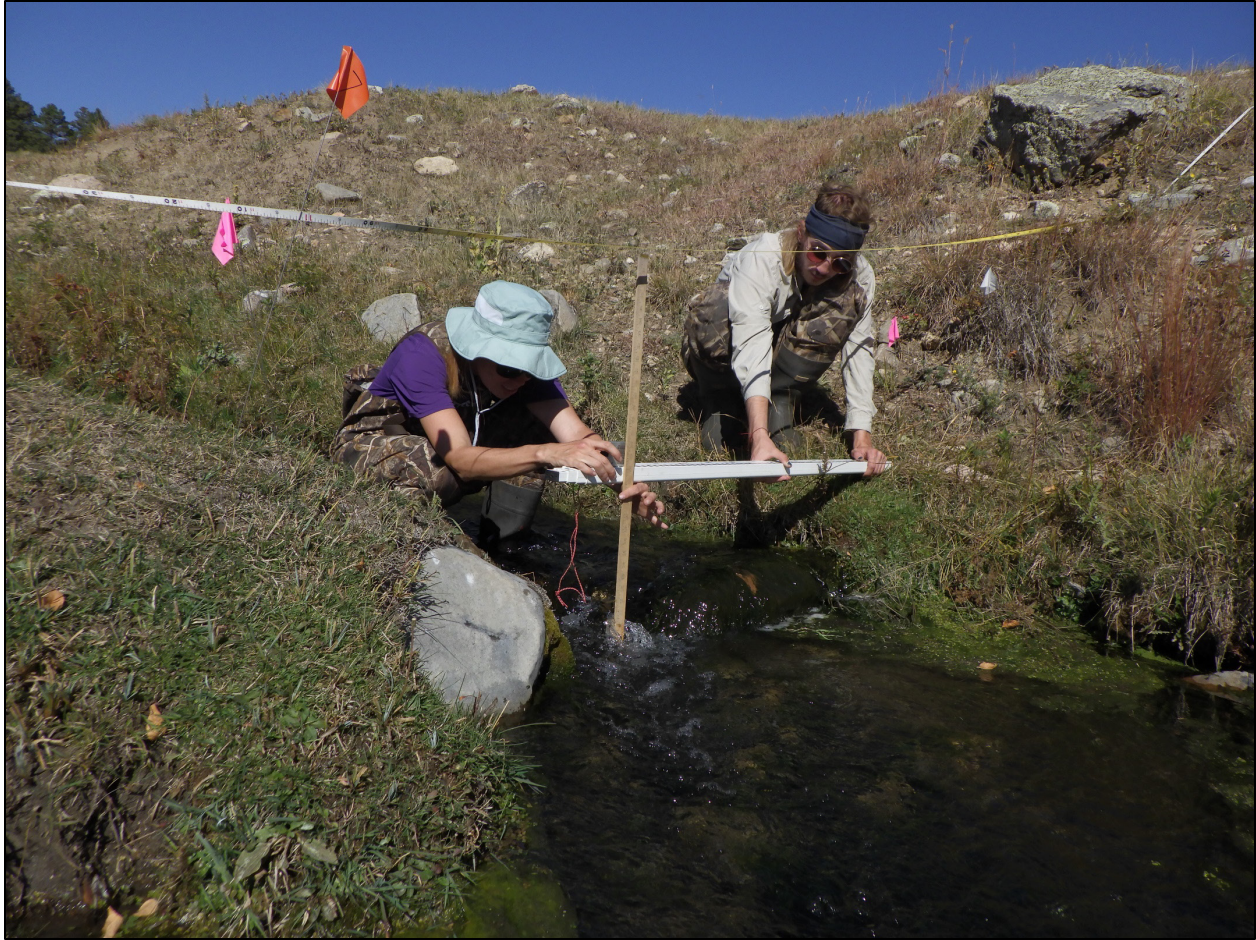
**Figure 7.** NGPN crew takes bank-full measurements at Transect 7.

Figure 7 shows crew taking bank-full measurements at Transect 7.

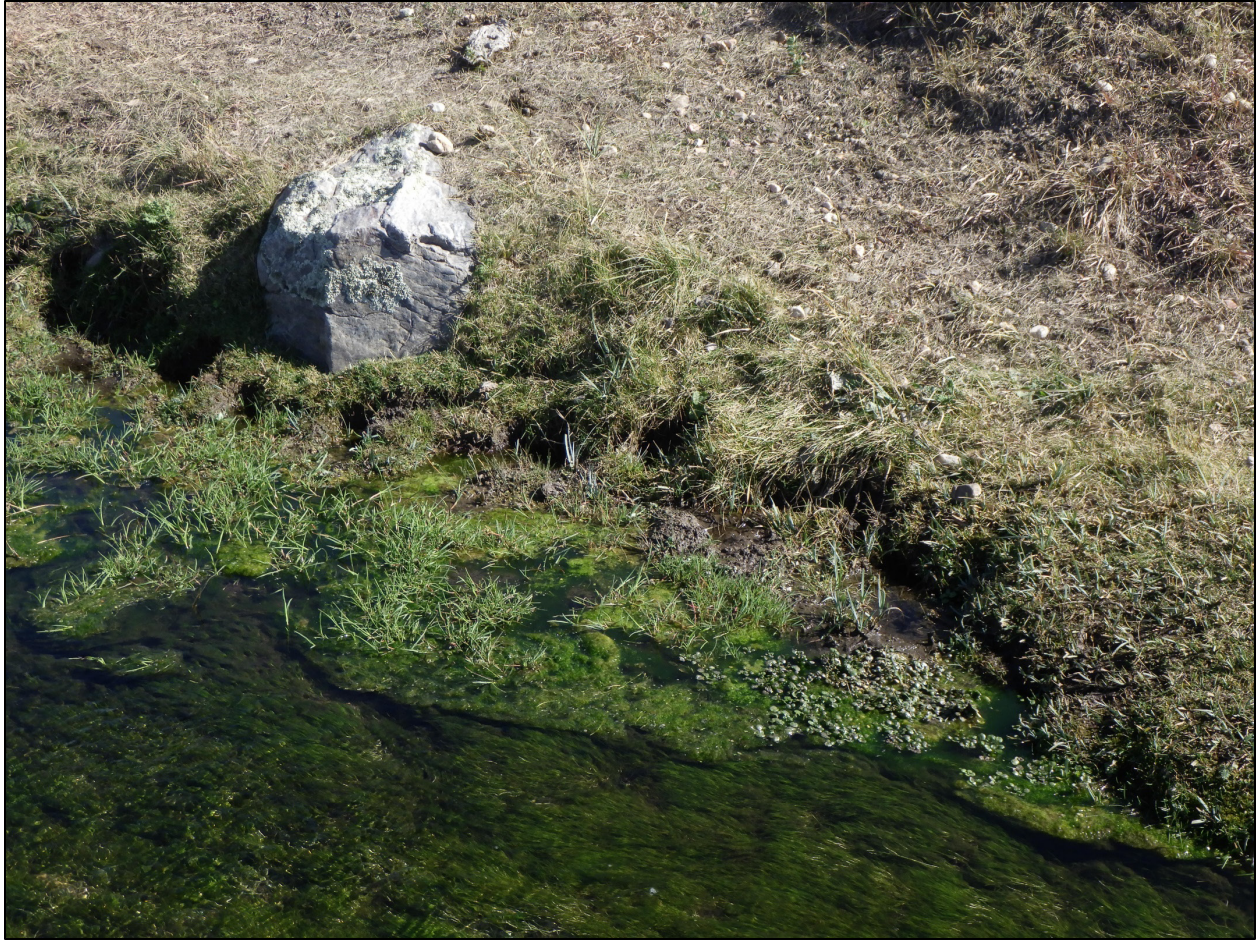
As seen in Figure 8, not only is animal trampling ubiquitous along the banks, but macrophyte and periphyton growth was quite heavy on much of the stream.

**Figure 8.** Animal trampling along bank with macrophyte growth evident in the stream.

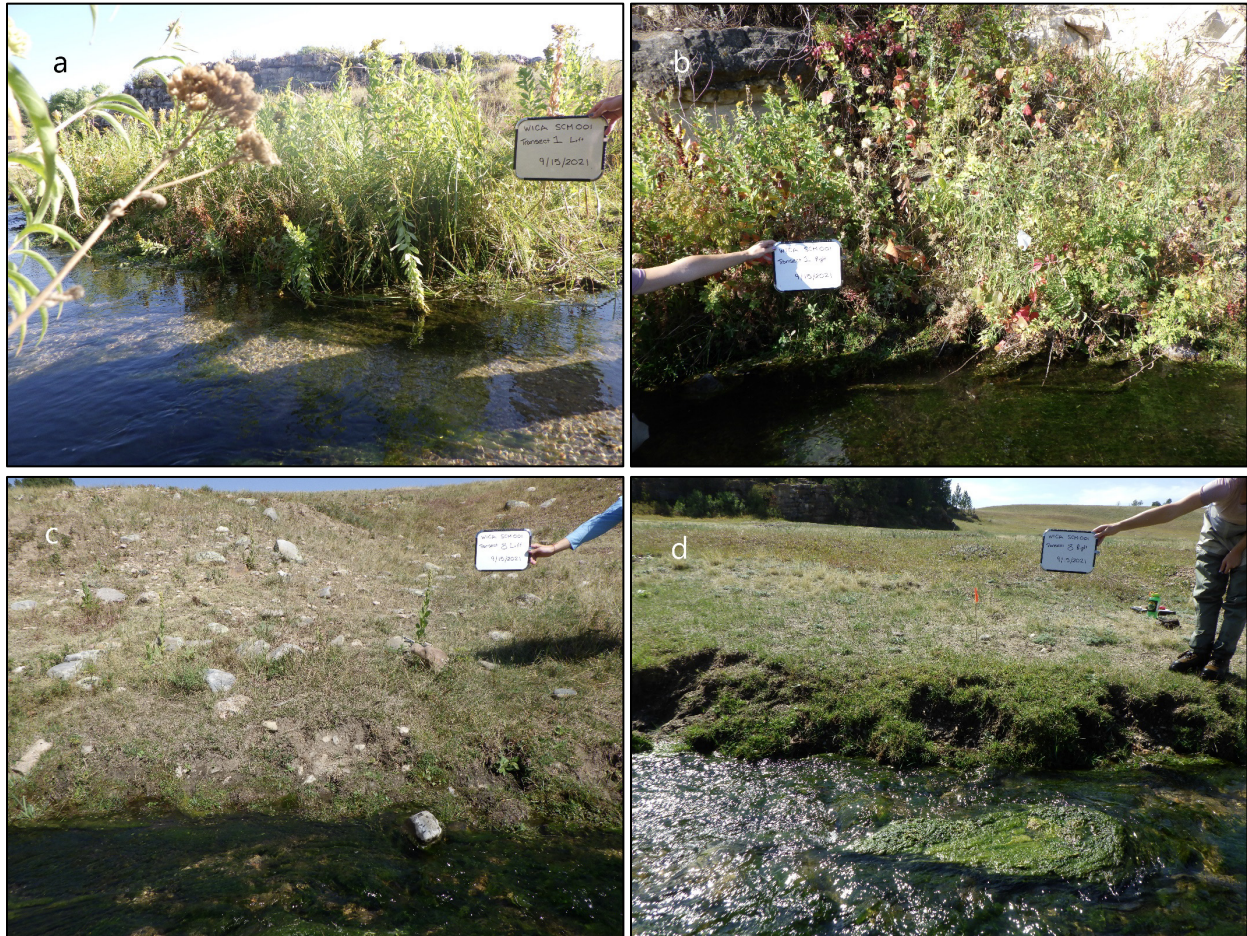
Transect 8 was the worst scoring transect overall for stability, while Transect 1 was the best. Pictures comparing the two transects' banks are below (Figure 9). Transect 8 occurs in a narrow, straight stretch of channel while Transect 1 is located on a bend.

**Figure 9.** Transect 1 shows little erosion and has bank stability of score of 8.5 on the left bank (a) and 7.5 on the right bank (b). Transect 8 shows high areas of erosion and has bank stability of score of 13.5 on the left bank (c) and 15 on the right bank (d).

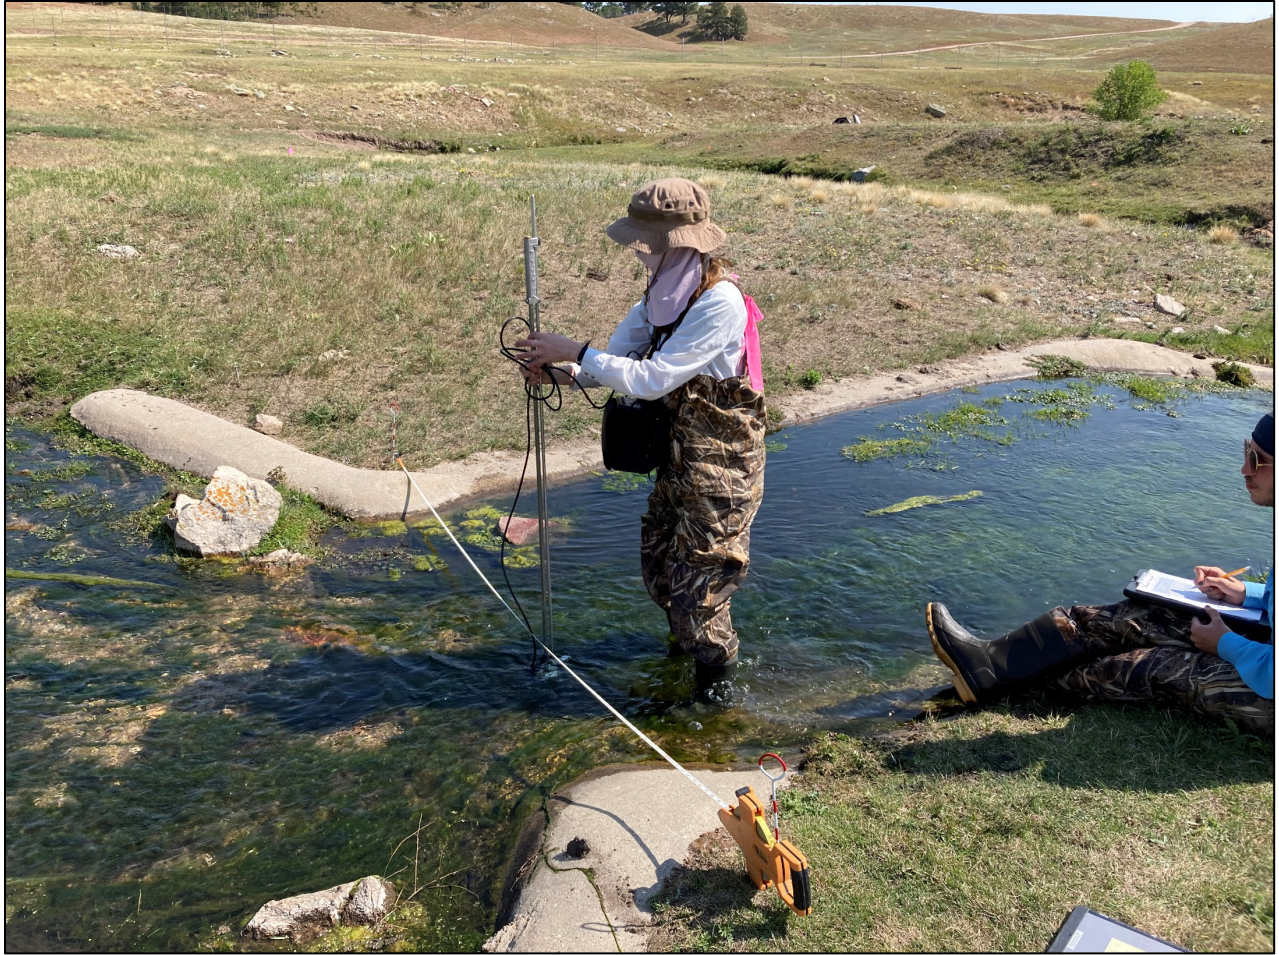
The last component of physical characteristics was the discharge which was measured 15m upstream of the site at the weir. Measured discharge was measured with a Marsh-McBirney flow meter and was 1.06 cfs using the velocity area method (Figure 10). Cross section mean stream velocity at WICA SCM 001 was 0.51 ft/s. In the future, taking velocity measurements at the detailed transects would be useful to better understand how stream velocity changes throughout the reach. Where the stream is narrow and straight, we would expect stream velocity to be great. Indeed, the transects with the worst bank stability scores were on straight sections of stream.

**Figure 10.** Discharge was measured just upstream of the site at the weir.
