# Rehabilitate Sun Notch Trail Landscape Project

## *2022 Annual Report*

Carolyn S. Wyler, Jennifer S. Hooke, and Eleanor M. Roeder

April 2023

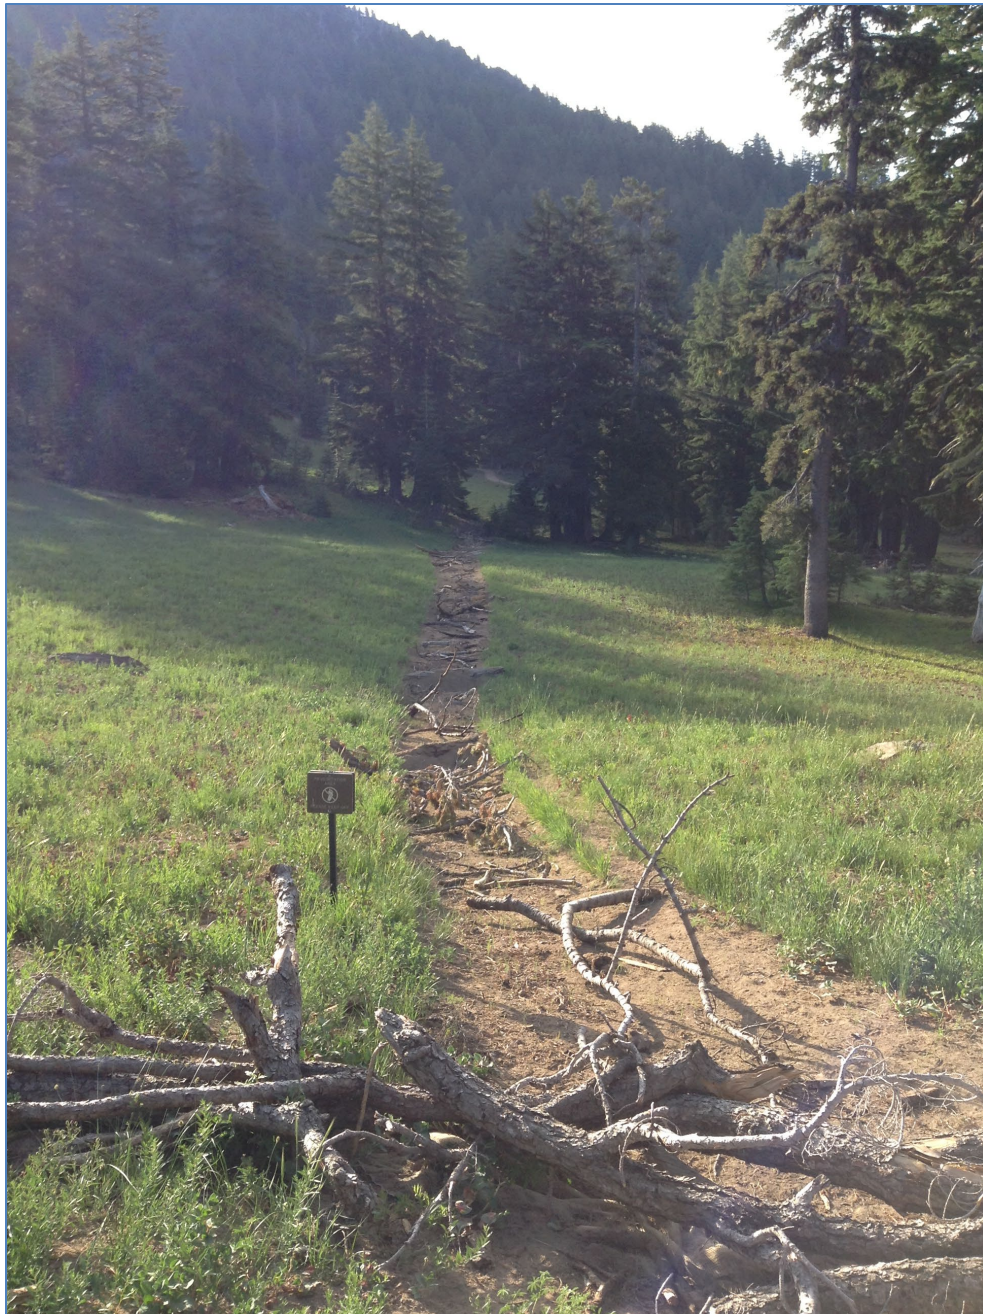
**ON THIS PAGE**

Crater Lake National Park staff and the Northwest Youth Corps planting native vegetation to restore an old, decommissioned trail bed near the Sun Notch Trail. Photo by Carrie Wyler.

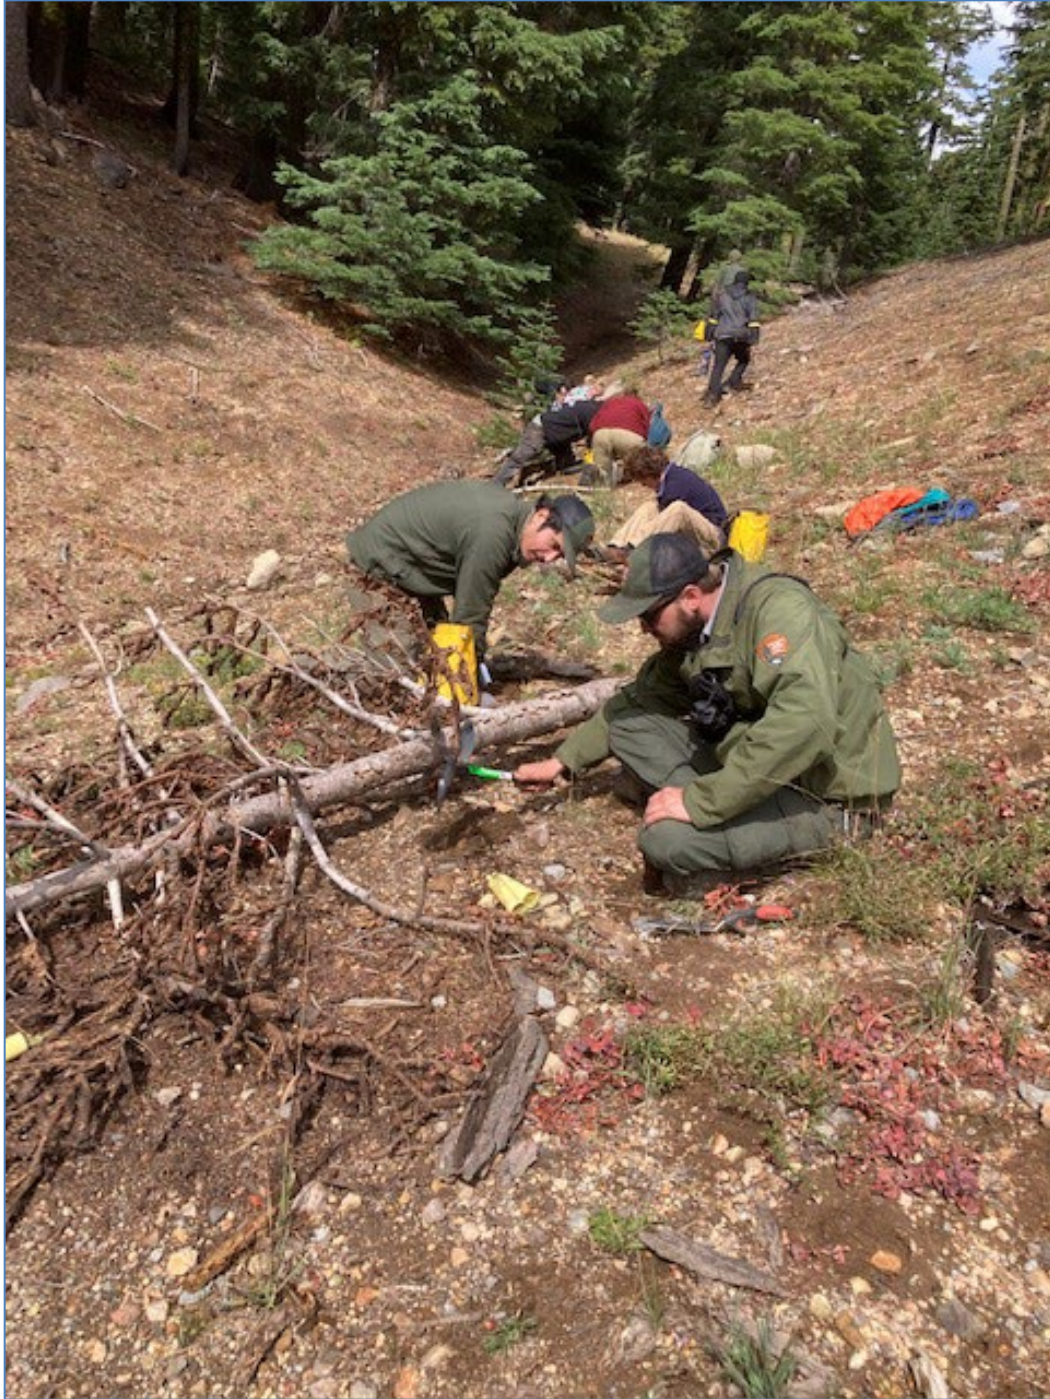
**ON THE COVER**

Decommissioned trail across the Sun Notch meadow. Photo by Carrie Wyler.

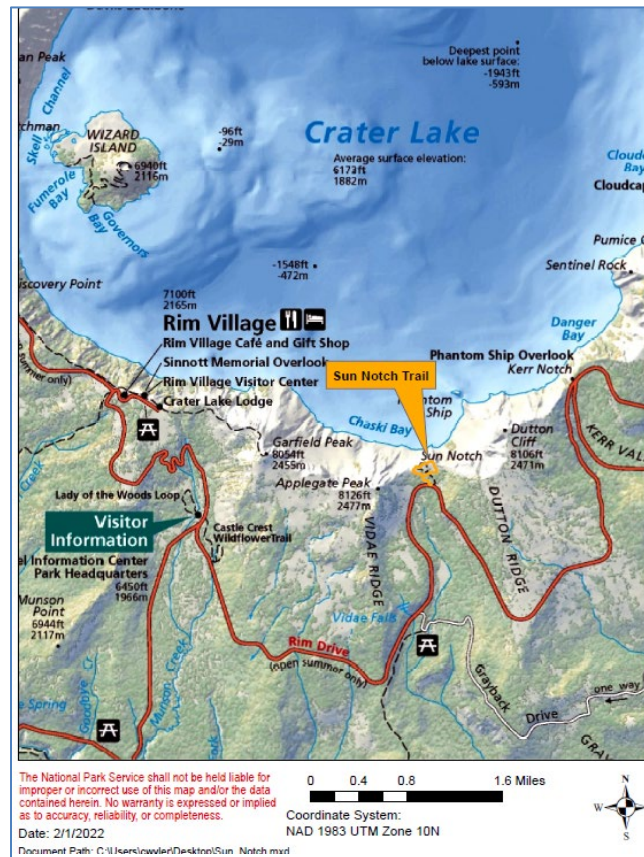
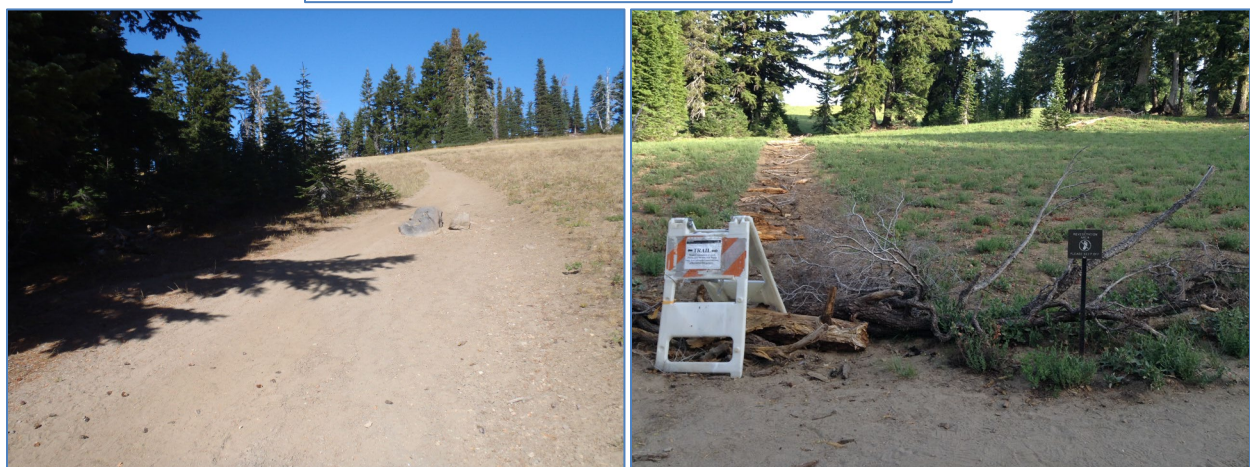
**Figure 2.** Top: Location of the Sun Notch Trail in the park. Map by Carrie Wyler. Bottom left: Original Sun Notch Trail in 2011 before decommissioning; note excessive trail width. Bottom right: Sun Notch Trail segment in 2013 after decommissioning; despite signage, hikers continued to use the old trail beds. Photos by Jen Hooke.

In 2012, the park rerouted the trail around the meadow and decommissioned the old trail beds through the meadow using hand tools. Locally sourced woody debris and litter were scattered over the old trail beds and these sites were seeded with native grass and forb seed from the Sun Notch meadow. Limited funding was available for revegetation at the time of the trail reroute, and vegetation cover within the decommissioned trail beds has been slow to recover primarily due to

continued visitor use and foot traffic along the decommissioned trails. The Rehabilitate Sun Notch Trail Landscape project is a two-year effort to restore disturbed areas and improve the visitor experience through revegetating barren and sparsely vegetated areas that detract from the scenic beauty of the area. An estimated 0.15 acre of disturbed land will be restored as part of this project (Figure 3).

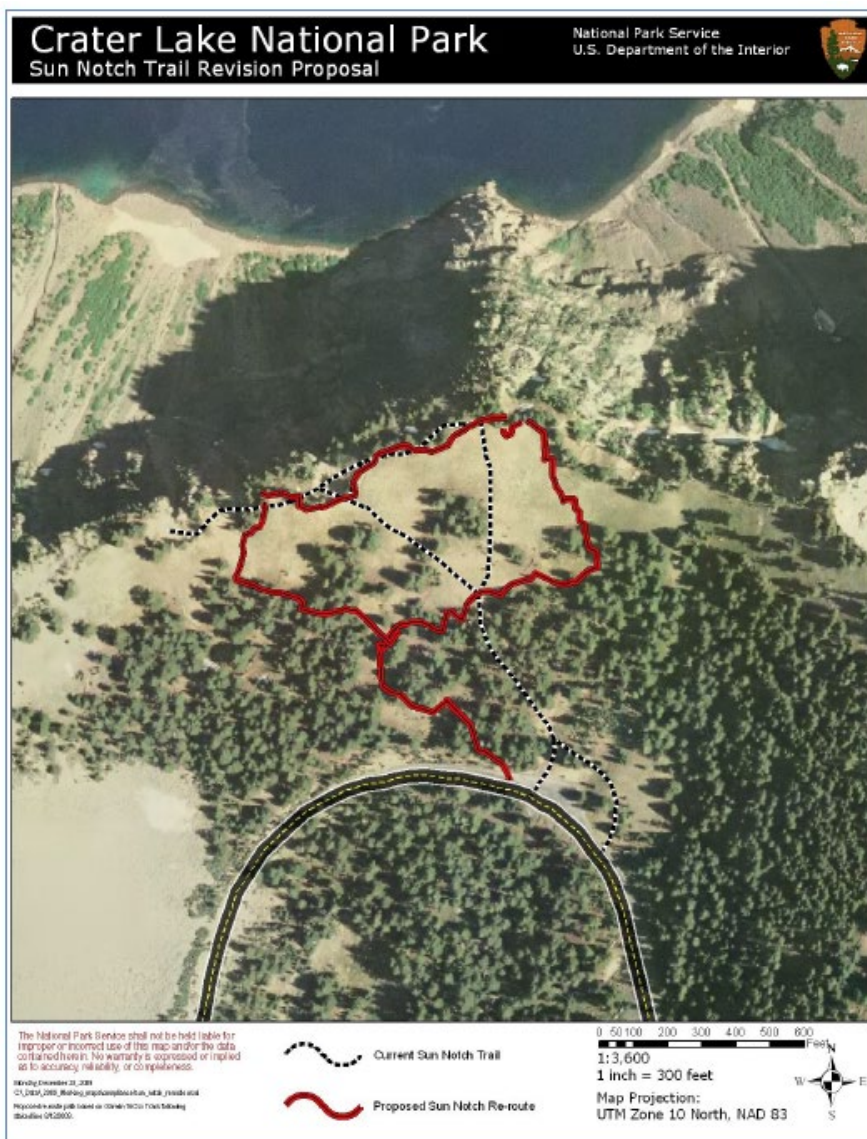
**Figure 3.** Left: The 2012 Sun Notch Trail reroute showing the new trail with a solid red line, and the original trail with a dashed black line. Map by Chris Wayne. Right: The 2022 Rehabilitate Sun Notch Trail Landscape restoration areas are marked with red lines. Map by Scott Heisler.

The Rehabilitate Sun Notch Trail Landscape project was split into three sections to help organize the work flow: meadow decommissioned trails (M1, M2), parking lot to meadow decommissioned trail (PL), and social trails on rim (R1-R3) (Table 1).

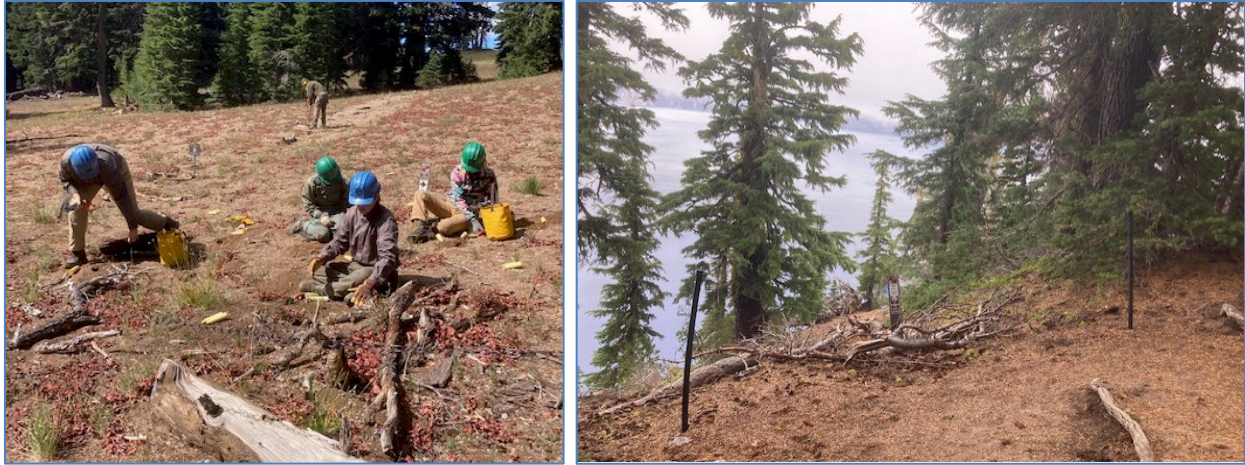
**Figure 4.** Planting in areas of heavy visitor use (left). Using fencing, signs, and woody debris to deter use of a social trail leading into the caldera (right). Photos by Carrie Wyler.

Restoration of disturbed areas (Figure 4) is necessary to facilitate natural succession of vegetation communities, protect the meadow habitat, protect slopes from soil erosion, and prevent invasion by nonnative plant species.

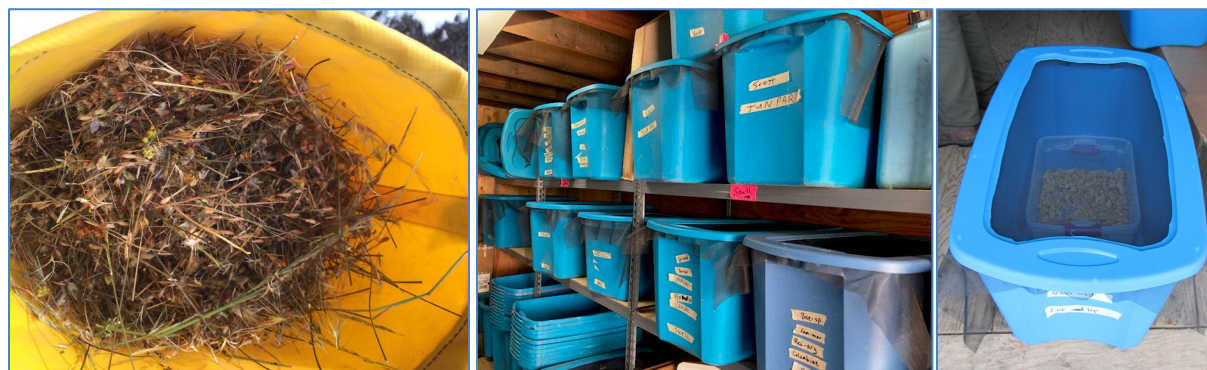
**Figure 5.** Collected seed before cleaning (left). Seed drying and storage facility at park headquarters (middle). Seed drying in a container inside a drying bin with ventilated lid (right). Photos by Carrie Wyler.

When seeds were mature, they were collected, dried, and stored until shipment or cleaning. Large quantities of seed were shipped to the USFS Dorena Genetic Resource Center (DGRC) for cleaning, while smaller quantities were cleaned in house. A single bag was used to collect all the seed from an individual species if the species was to be used for propagation purposes (Figure 5); otherwise, species were combined into seed mixes for ease of collection. Collection bags were labelled with plant species code and collection date. After collection, seeds were transported to the seed drying and storage facility in the Nine Stall garage at park headquarters (Figure 5). Collected seed was placed inside 30-gallon plastic storage totes secured with window screen at the top, allowing ventilation while reducing chances of predation. Plant taxa with very small seeds were first placed in smaller plastic bins before being stored within the larger 30-gallon tubs. The tubs were labelled and organized on shelves by seed zone and plant species (Figure 5).

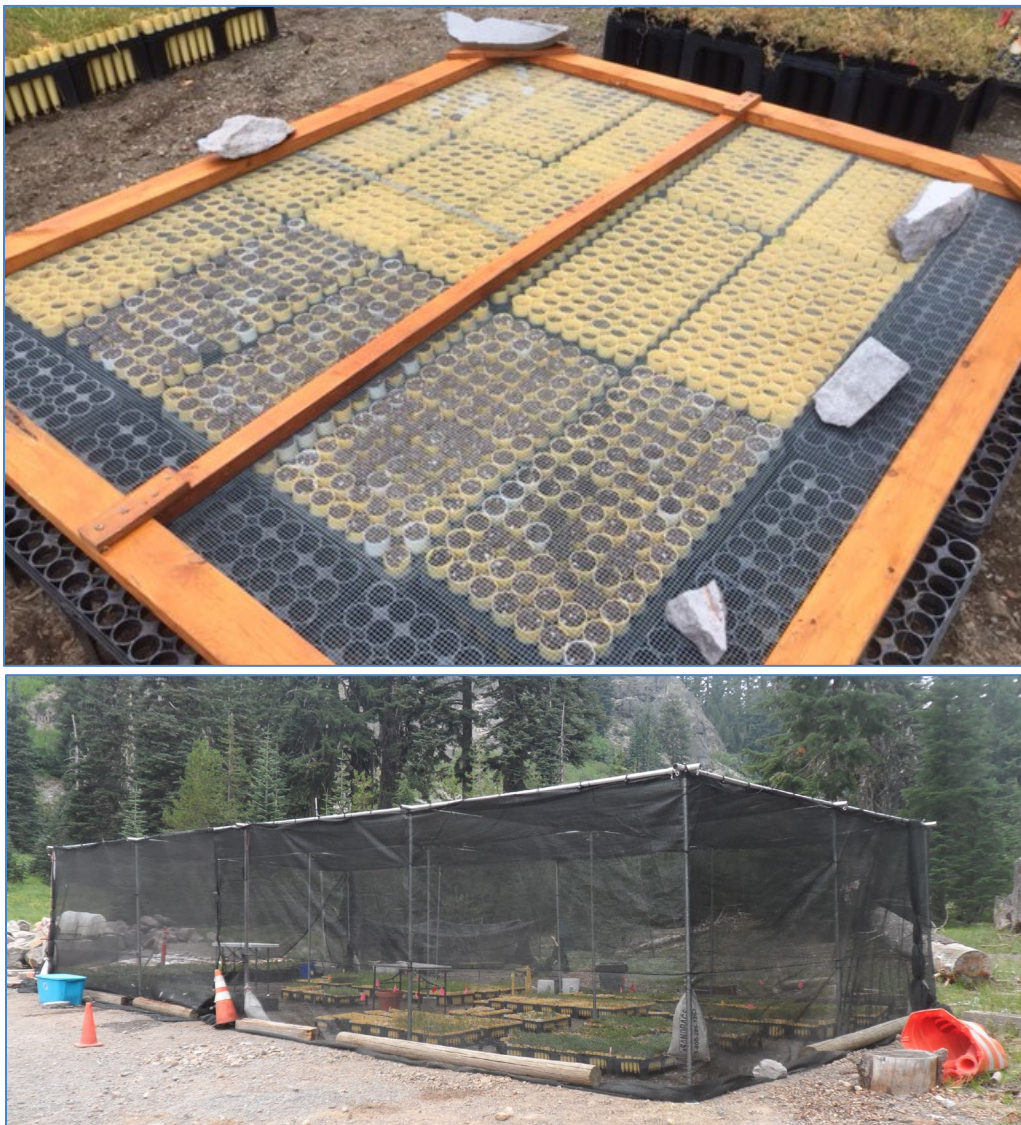
**Figure 6.** Propagated pots with animal exclusion screening on top (top). Shadehouse where propagated plants are stored at the Ball Diamond nursery (bottom). Photos by Carrie Wyler.

Plants were propagated in the fall and then cold stratified during the winter months at the Ball Diamond nursery at park headquarters (Figure 6). Once the snow melted, plants were covered with a shade house (40' x 20' x 10' – Figure 6). Plant propagation included containers of grasses, sedges, and forbs.

Containerized plants were fertilized with Osmocote 14-14-14 slow-release fertilizer. Fertilizer was applied at the beginning of the season when plants emerged from the snow at a rate of 1/8 tsp per planting tube. Descriptions of fertilization procedures can be found in Botany program files in the “Nursery Activities” binder. Any reproductive structures were removed to promote root development and prevent excess evapotranspiration, and dead growth was removed to discourage fungal growth.

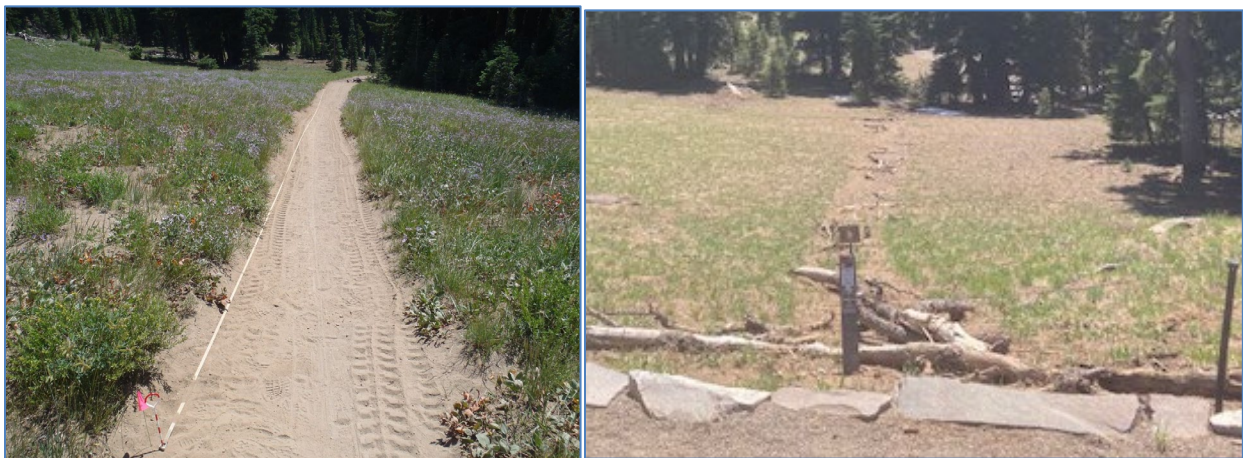
**Figure 8.** Left: Original meadow trail before decommissioning in 2012. Photo by Jen Hooke. Right: The same trail with temporary fencing and signage installed in 2023. Photo by Carrie Wyler.

Temporary fencing and signage measures were installed to encourage visitors to remain along designated trails and to deter further degradation of revegetation sites (Figure 8). Fencing measures used in other areas of the park were utilized for the Rehabilitate Sun Notch Trail Landscape project to maintain a consistent look throughout the park. This fencing is installed each year in the spring and removed in the fall due to the heavy snowpack experienced at this area. To ensure the stability of fencing posts, it was determined that in-ground post receivers were necessary to support posts and facilitate installation each spring. Information on suppliers, order specifications, and installation procedures is on file in the Botany office at park headquarters.

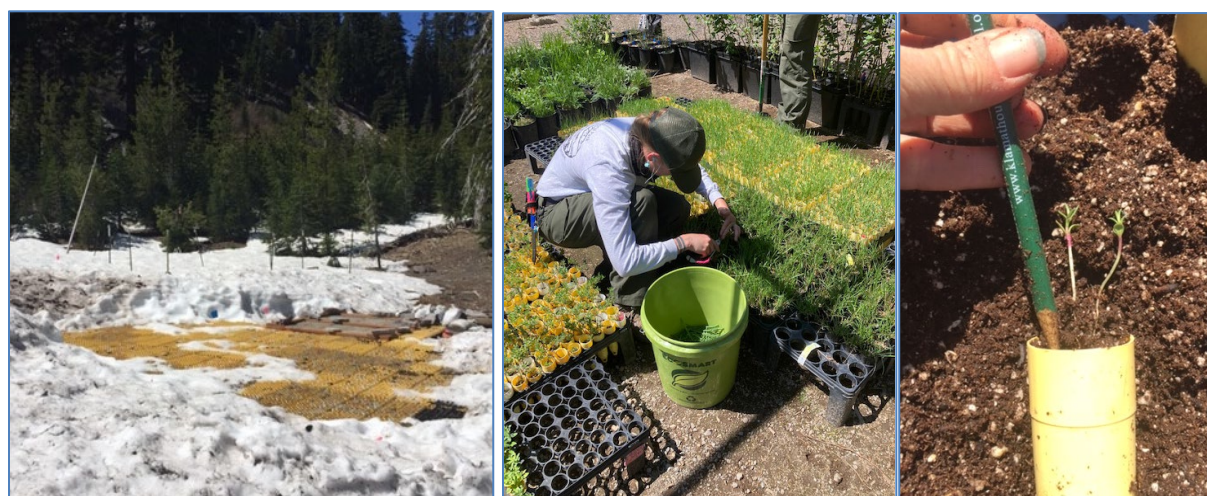
**Figure 9.** Overwintered plants emerging from the snow (left). Cleaning and trimming plants (middle). Plant care at the park's nursery (right). Photos by Carrie Wyler.

After the snow melted in 2022, plants in the Ball Diamond nursery were assessed and inventoried. Pots without any green growth were discarded. Plants with detritus, moss, liverworts, or volunteer plants were cleaned throughout the season (Figure 9).

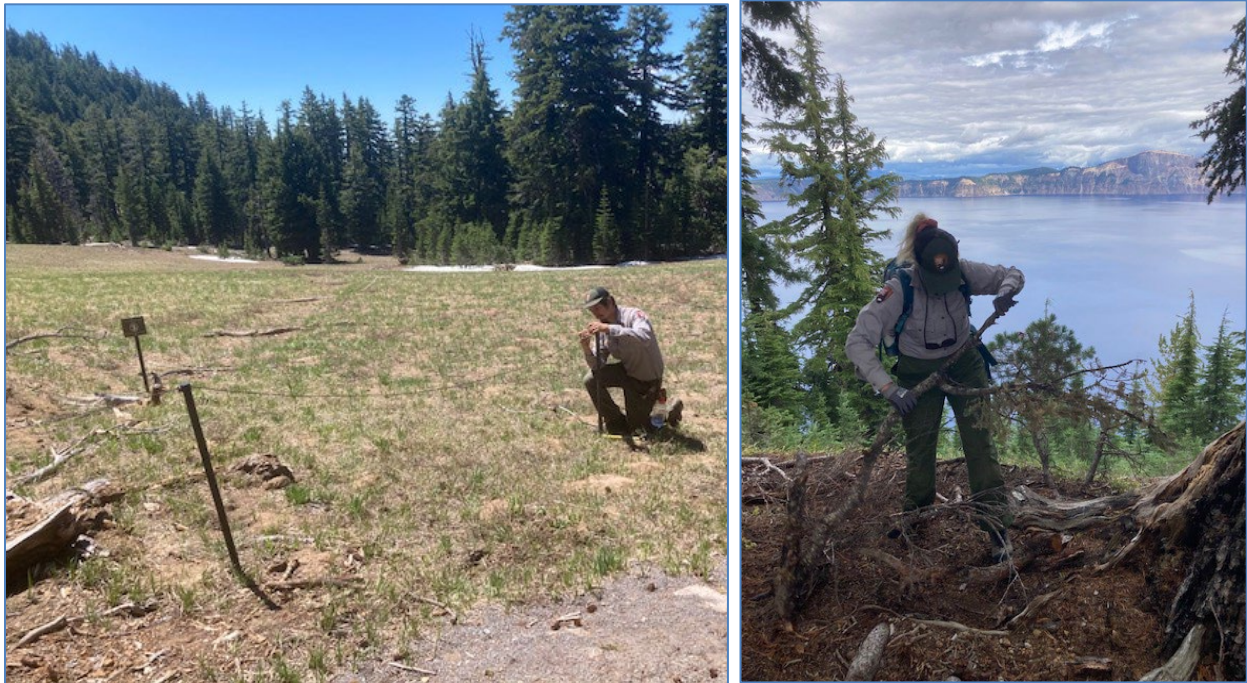
**Figure 10.** Installation of new fencing (left) and social trail obliteration along caldera rim (right). Photos by Carrie Wyler.

In spring of 2022 fence post receivers were placed at both the top and bottom of both decommissioned meadow trails and the decommissioned trail leading to the parking lot. With in-ground receivers in place, powder coated fence posts were installed and chain strung through all receivers (Figure 10). In the fall, posts and chain were removed and winter caps placed on top of receivers. This process will need to be repeated in the spring of 2023 and for the foreseeable future until a more permanent fencing solution is found to deter visitor trampling of the Sun Notch meadow. To encourage visitors to remain on designated trails, woody debris and signs were placed at the origin of social trails to reduce confusion as to the desired visitor circulation pattern. Signs and woody debris will need monitoring and maintenance in future years.

Due to the high visitor trespass along the Sun Notch Trail, smaller social trails were documented and restored. Areas R1-R3 received social trail obliteration treatments with minor planting. All social trails leading into the caldera were prioritized for restoration due to safety concerns.
