## Post Tropical Storm Ian and Hurricane Nicole Storm Report 2022

### Overview

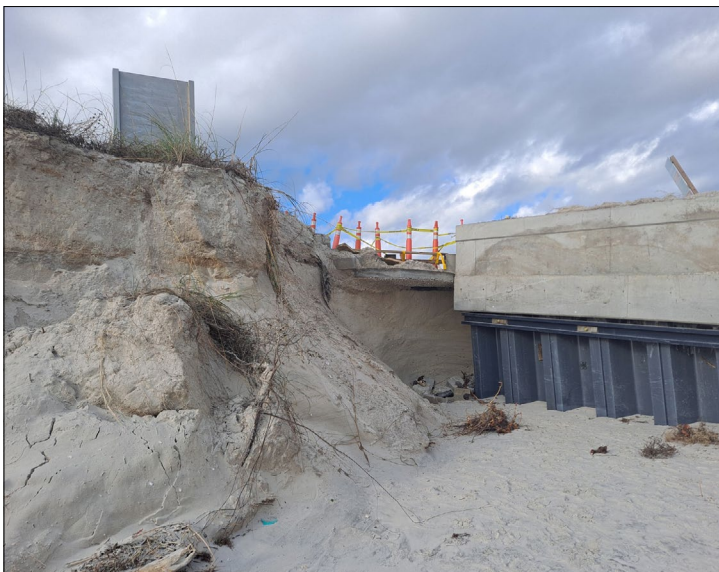
Erosional damage to the car ramp on the Atlantic beachfront at Fort Matanzas National Monument. NPS photo / Kurt Foote, FOMA Staff.

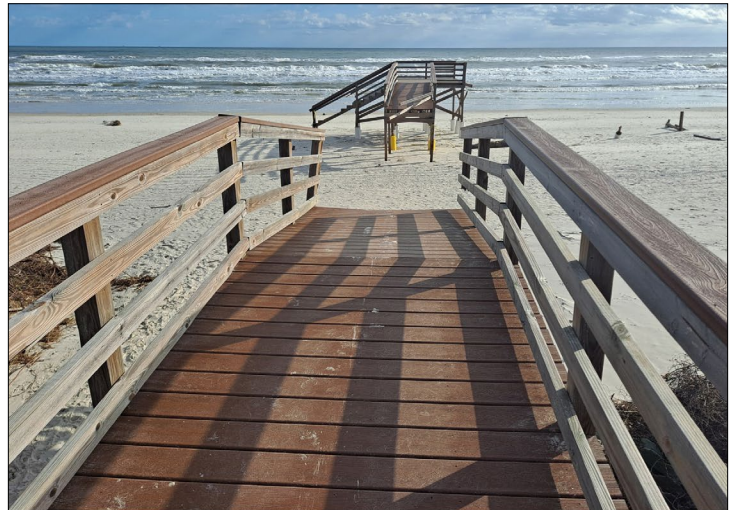
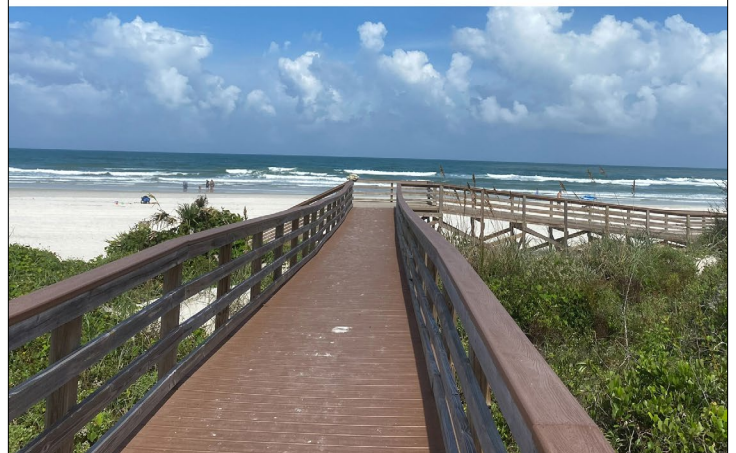
Top, damage to the Fort Matanzas National Monument beach access ramp due to shoreline erosion from Hurricane Nicole in November 2022 (NPS photo / Kurt Foote, FOMA staff). Bottom, beach access boardwalk before the storm on August 28, 2021 (Photo by Melanie Vervaeke).

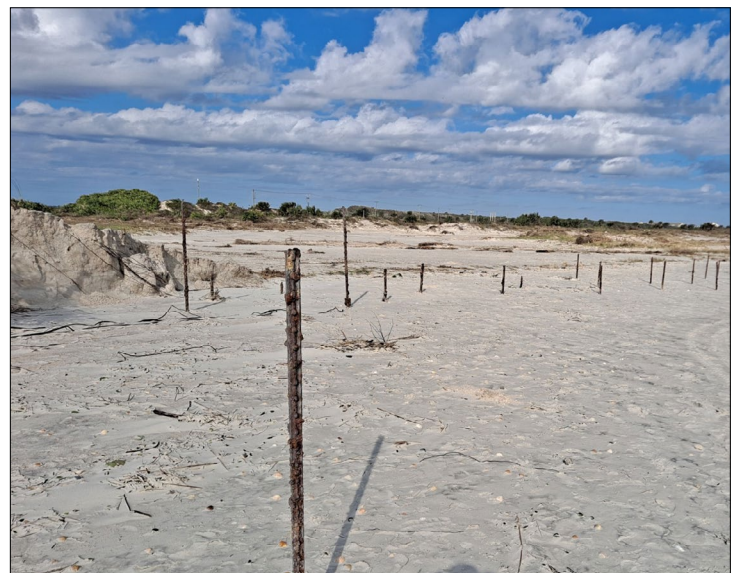
Dune erosion at Fort Matanzas National Monument post Hurricane Nicole November 2022. NPS photo / Kurt Foote, FOMA staff.

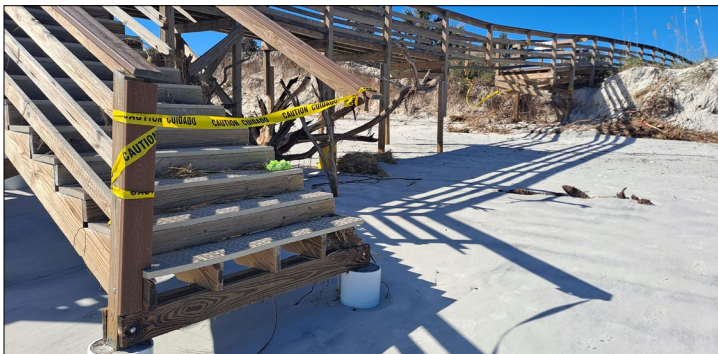
Damage from Tropical Storm Ian at Fort Matanzas National Monument. NPS photo / Kurt Foote, FOMA staff.

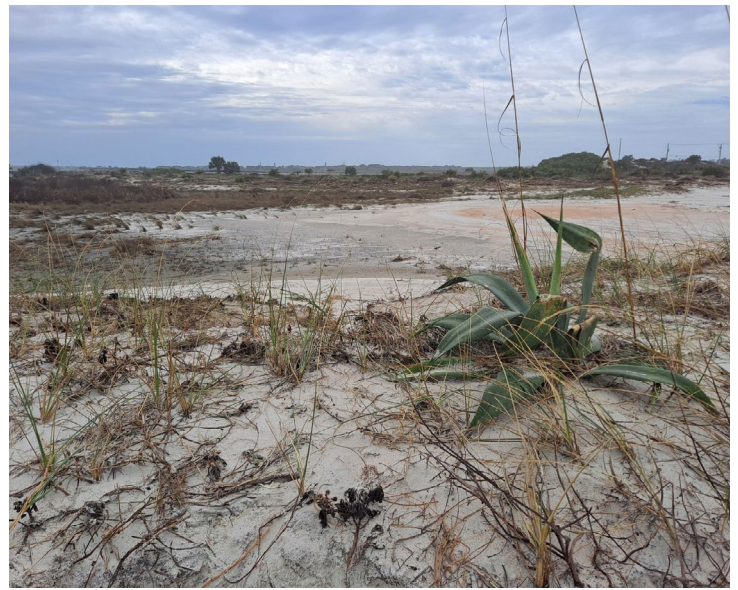
Area of backdunes washed out at Fort Matanzas National Monument. NPS photo / Kurt Foote, FOMA staff.
