# Rehabilitate and Restore Plaikni Falls Trail Landscape

*2022 Annual Report*

April 2023

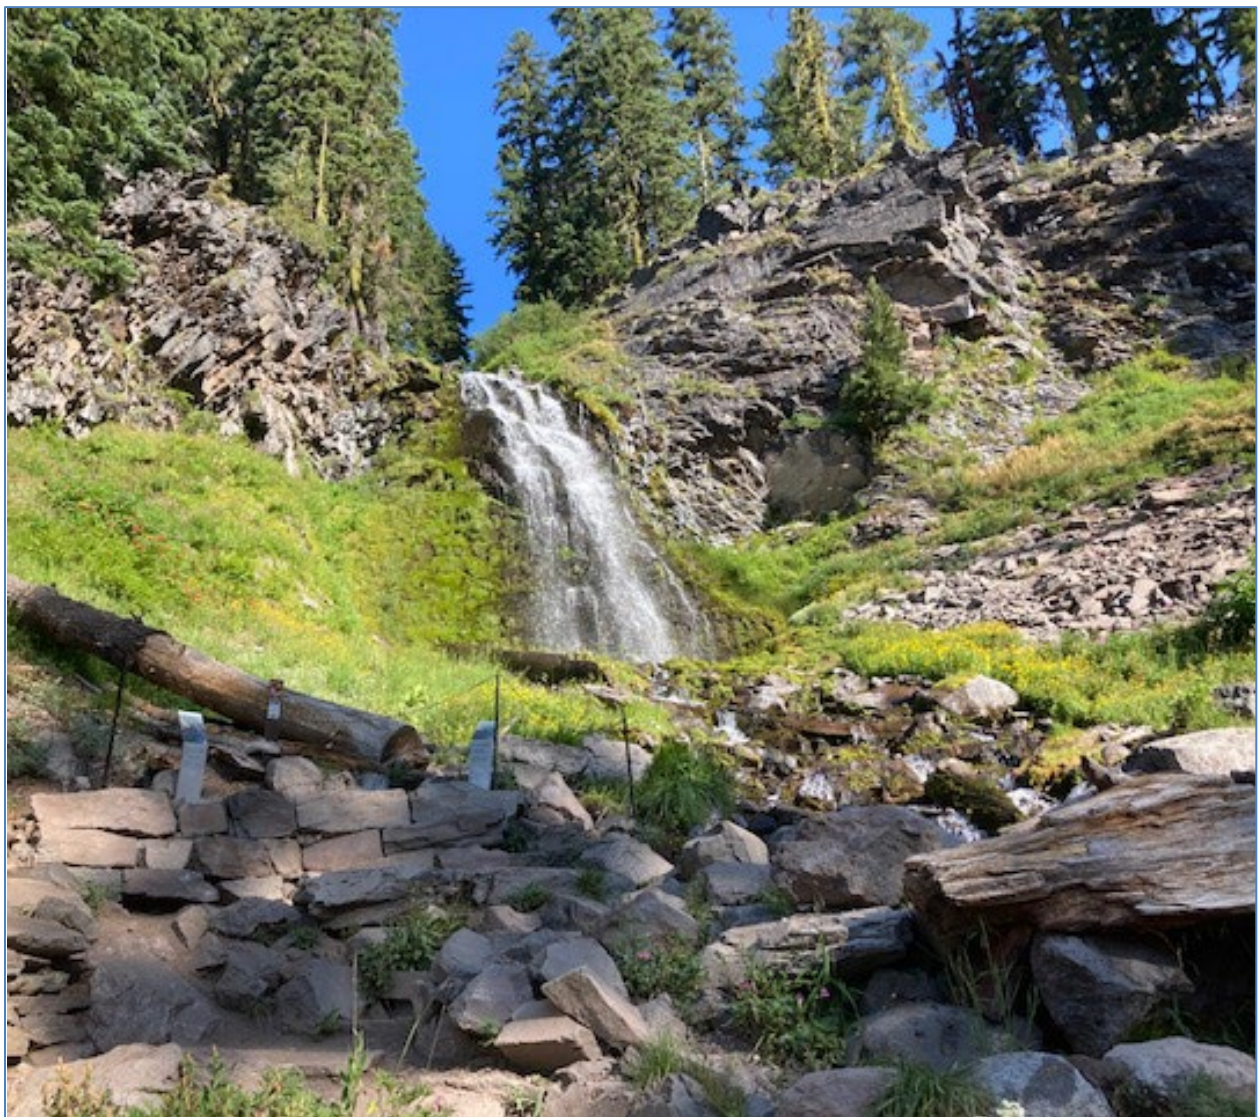
New fence installation to keep visitor damage from occurring above the Plaikni Falls trail terminus. Photo by Carrie Wyler.

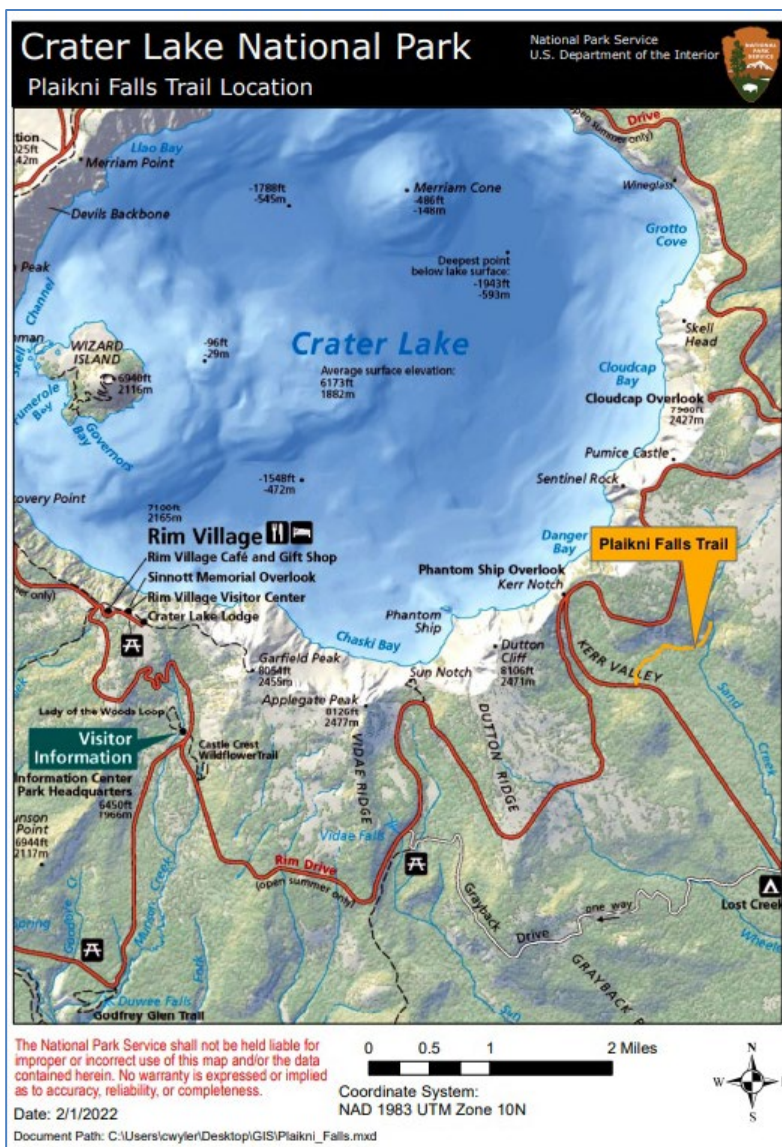
**Figure 2.** Location of Plaikni Falls trail in the park (left). Map by Carrie Wyler. Location of Plaikni Falls restoration sites in disturbed area (right). Map by Scott Heisler.

The 2022 field season focused on documenting restoration site prescriptions, gathering plant materials, obliterating social trails, installing temporary fencing, planting native plants, and seeding restoration sites. Five seasonal Biological Science Technicians (Plants) were partially funded by this project in 2022; season length was from May 24 – September 30. The project area was divided into four sections to facilitate organization and work flow (Table 1 and Figure 2).

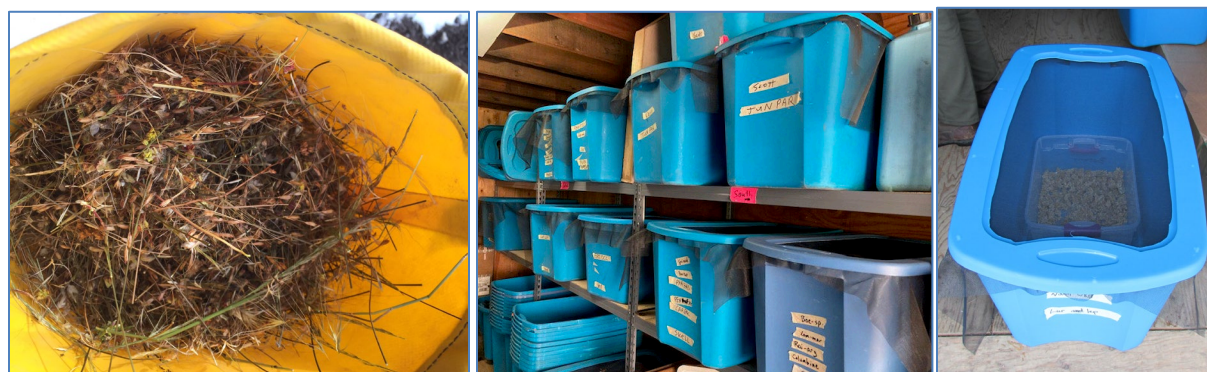
**Figure 4.** Collected seed before drying (left). Seed drying and storage facility at park headquarters (middle). Seed drying in a container inside a drying bin with ventilated lid (right). Photos by Carrie Wyler.

A single bag was used to collect seed from an individual species if the species was to be used for plant propagation purposes (Figure 4); otherwise seed from various species were combined into seed mixes for ease of collection. Bags of seed were labelled with plant species code and collection date. After collection, seeds were transported to the seed drying and storage facility in the Nine Stall garage at park headquarters (Figure 4). Collected seed was placed inside 30-gallon plastic storage totes secured with window screen at the top, allowing ventilation while reducing chances of predation. Plant species with very small seeds were first placed in smaller plastic bins before being stored within the larger 30-gallon tubs. The tubs were labelled and organized on shelves by project, seed zone or restoration site ID, and plant species (Figure 4).

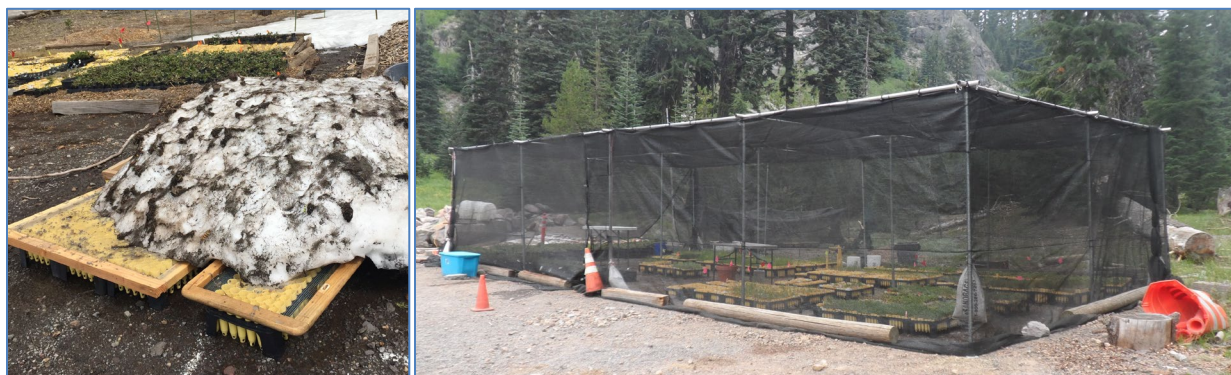
**Figure 5.** Propagated plants melting out in spring 2022 (left). Shadehouse at the Ball Diamond (right). Photos by Carrie Wyler.

Plants propagated were cold stratified during the winter months at the Ball Diamond nursery at park headquarters (Figure 5) by allowing them to overwinter under the snowpack. After snowmelt in June 2022, plants were covered with a shade house (40' x 20' x 10' – Figure 5).

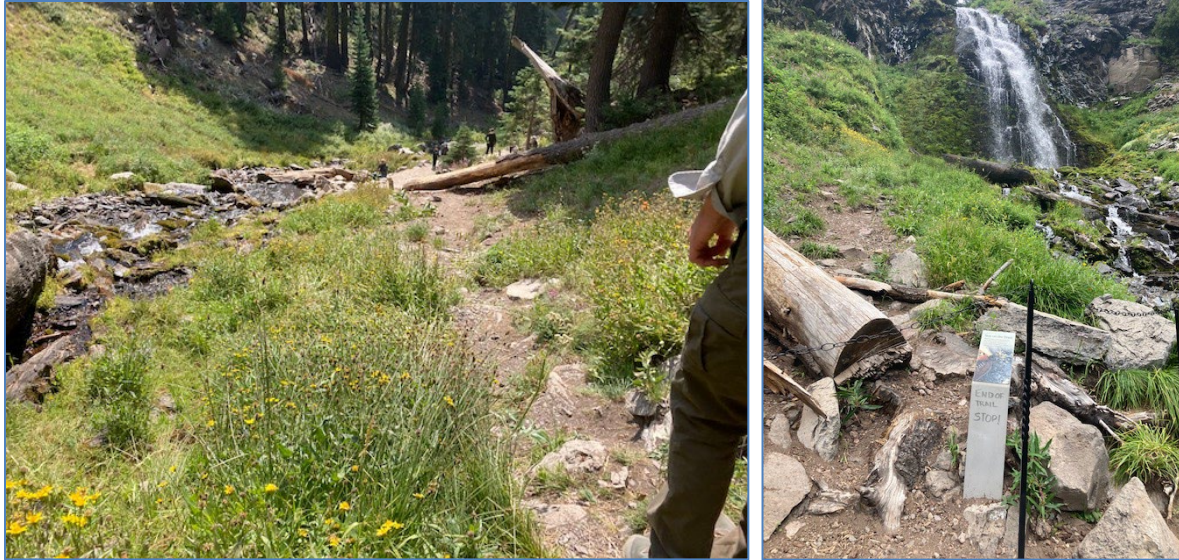
**Figure 7.** Area disturbed by a social trail along the Plaikni Falls Trail (left). Installed signage and fencing at the base of a social trail leading to the waterfall (right). Photos by Carrie Wyler

Areas disturbed by social trails (Figure 7) were restored by re-shaping and scarifying compacted soils with McCleod hand tools. All areas of visitor trespass were restored via light woody debris placement and obstruction of paths with fencing.

Temporary fencing and signage measures were put into place to encourage desired foot traffic and to deter further destruction of disturbed sites (Figure 7). The same fencing materials used to protect other revegetation sites in the park were utilized along the Plaikni Falls Trail landscape to maintain a consistent look throughout the park. In the winter and spring, the area to be fenced is covered with a layer of deep, packed snow. If a fence was left in place over the winter, it would likely become damaged by the weight and shifting nature of the snowpack and could also pose a safety hazard to visitors while partially buried. To ensure the stability of fencing posts, it was determined that in-ground post receivers were necessary to support posts and facilitate installation each spring. Information on suppliers, product numbers, order specifications, and installation procedures is on file in the Botany office at park headquarters.

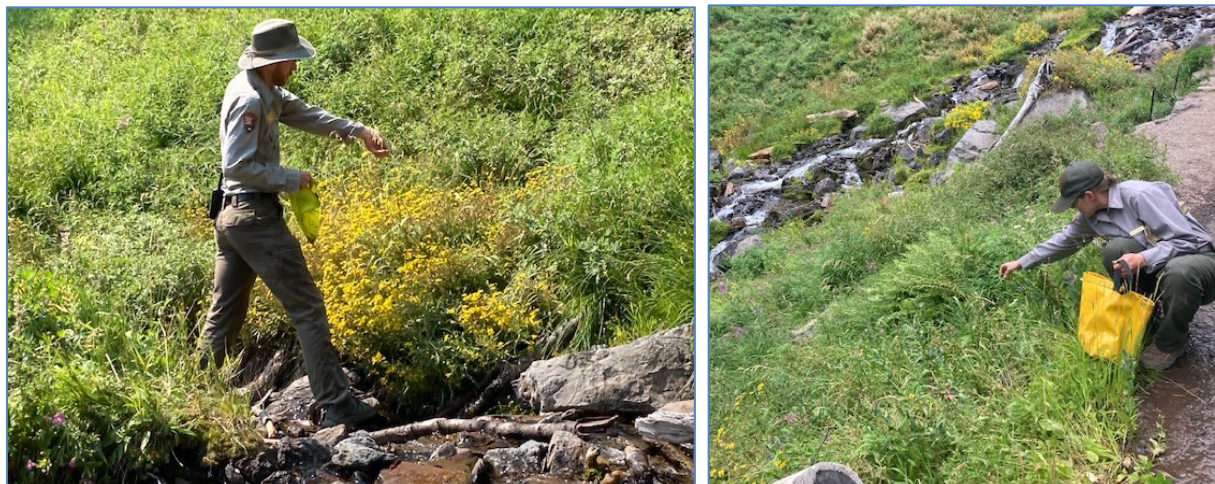
**Figure 8.** Seed collection along the Plaikni Falls Trail. Photos by Carrie Wyler.

Plant materials for this project were collected by park staff during the 2022 field season and will continue to be collected through 2023 (Figure 8). Seed cleaning, processing, and storage is handled by the park's Botany staff.

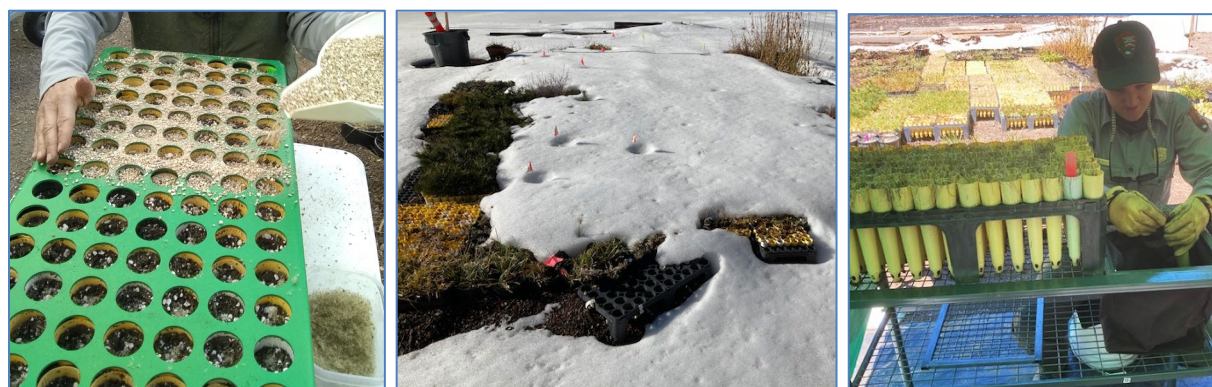
**Figure 9.** Covering seeded pots with vermiculite for propagation (left). Overwintered plants emerging from the snow (middle). Cleaning and trimming plants at the Park's nursery (right). Photos by Carrie Wyler.

Plant propagation for 2022 included containers of grasses, sedges, shrubs, and forbs (Table 6 and Figure 9). After snowmelt in 2022 (Figure 9), overwintered plants were assessed and inventoried. Plants without any green growth or with rotted roots were discarded. Plants with detritus, moss, liverwort, or volunteer plants were cleaned (Figure 9). Detailed reports of daily nursery activities are on file in the Botany office in the Nursery Activities binder.

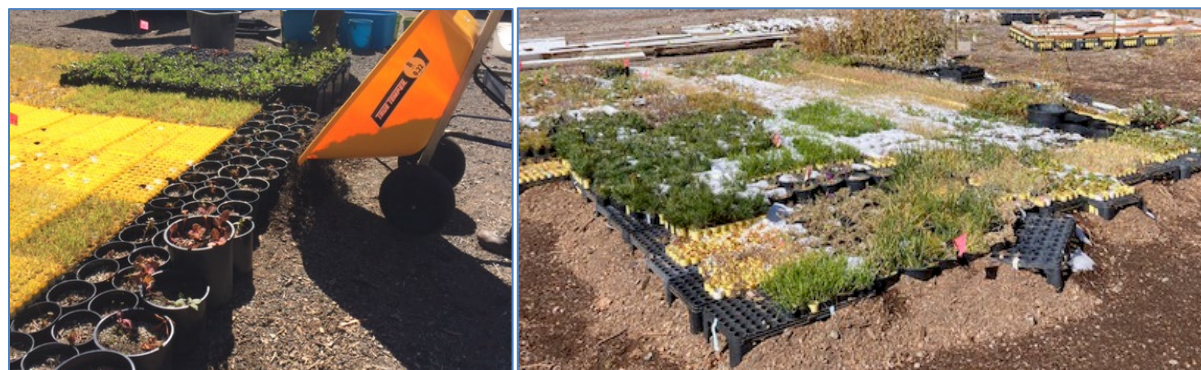
**Figure 10.** Distributing mulch around the edges of pots to insulate against frigid winter temperatures (left). Consolidated plants prior to overwintering (right). Photos by Carrie Wyler.

Despite a successful planting season in 2022, additional plants remain for future revegetation efforts. These will be used during the 2023 planting season along with any seed collected. Plants are being held over the 2022-23 winter at the Ball Diamond nursery to fill in gaps at restoration sites as needed during 2023. When ambient temperature dropped below freezing the containers were consolidated and mulch was stacked around the bases of herbaceous plants to prevent root freezing (Figure 10). These plants will need further care in the summer of 2023 including watering, fertilization, and transplanting into larger containers.
