# Rehabilitate Rim Trail Landscape Project

## *2022 Annual Report*

Carolyn S. Wyler, Scott E. Heisler, and Jennifer S. Hooke

April 2023

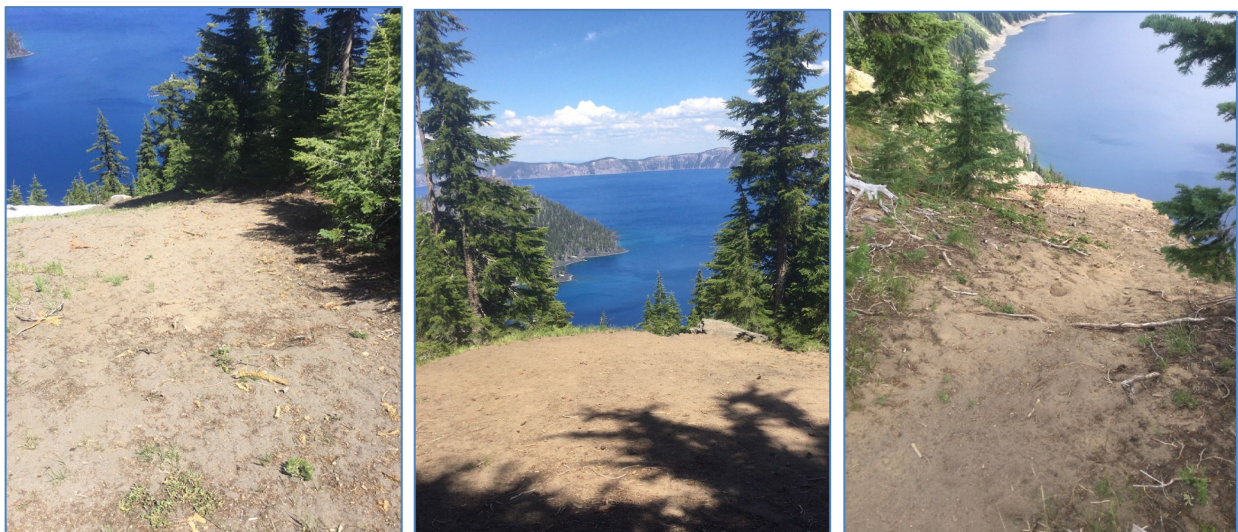
**Figure 2.** Social trails that lead from the Rim Trail into the Crater Lake caldera, which is closed to the public due to safety concerns. Photos by Carrie Wyler.

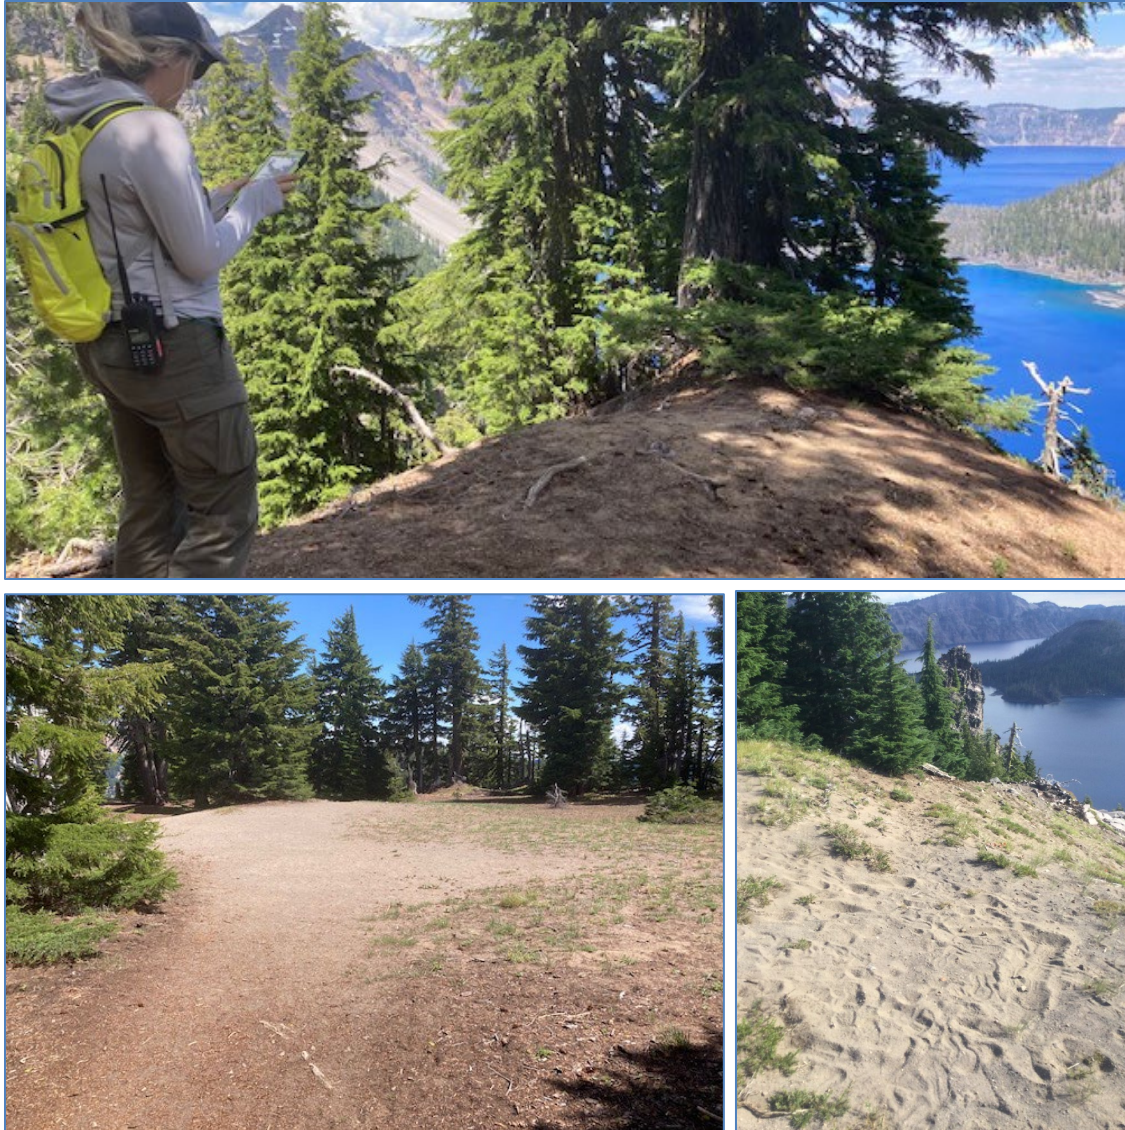
A formal assessment and mapping of revegetation sites within the project area was conducted in early summer 2022 (Figure 3). This assessment identified and characterized problem areas, photo documented sites (Figure 3), gathered area measurements, and refined a plant taxa list to guide seed collection efforts. A master list of revegetation sites can be found in Appendix A.

**Figure 3.** Collecting data on trampled areas along the Rim Trail (top). Excessively wide section of the Rim Trail (bottom left), and trampled area inside the caldera rim (bottom right). Photos by Carrie Wyler.

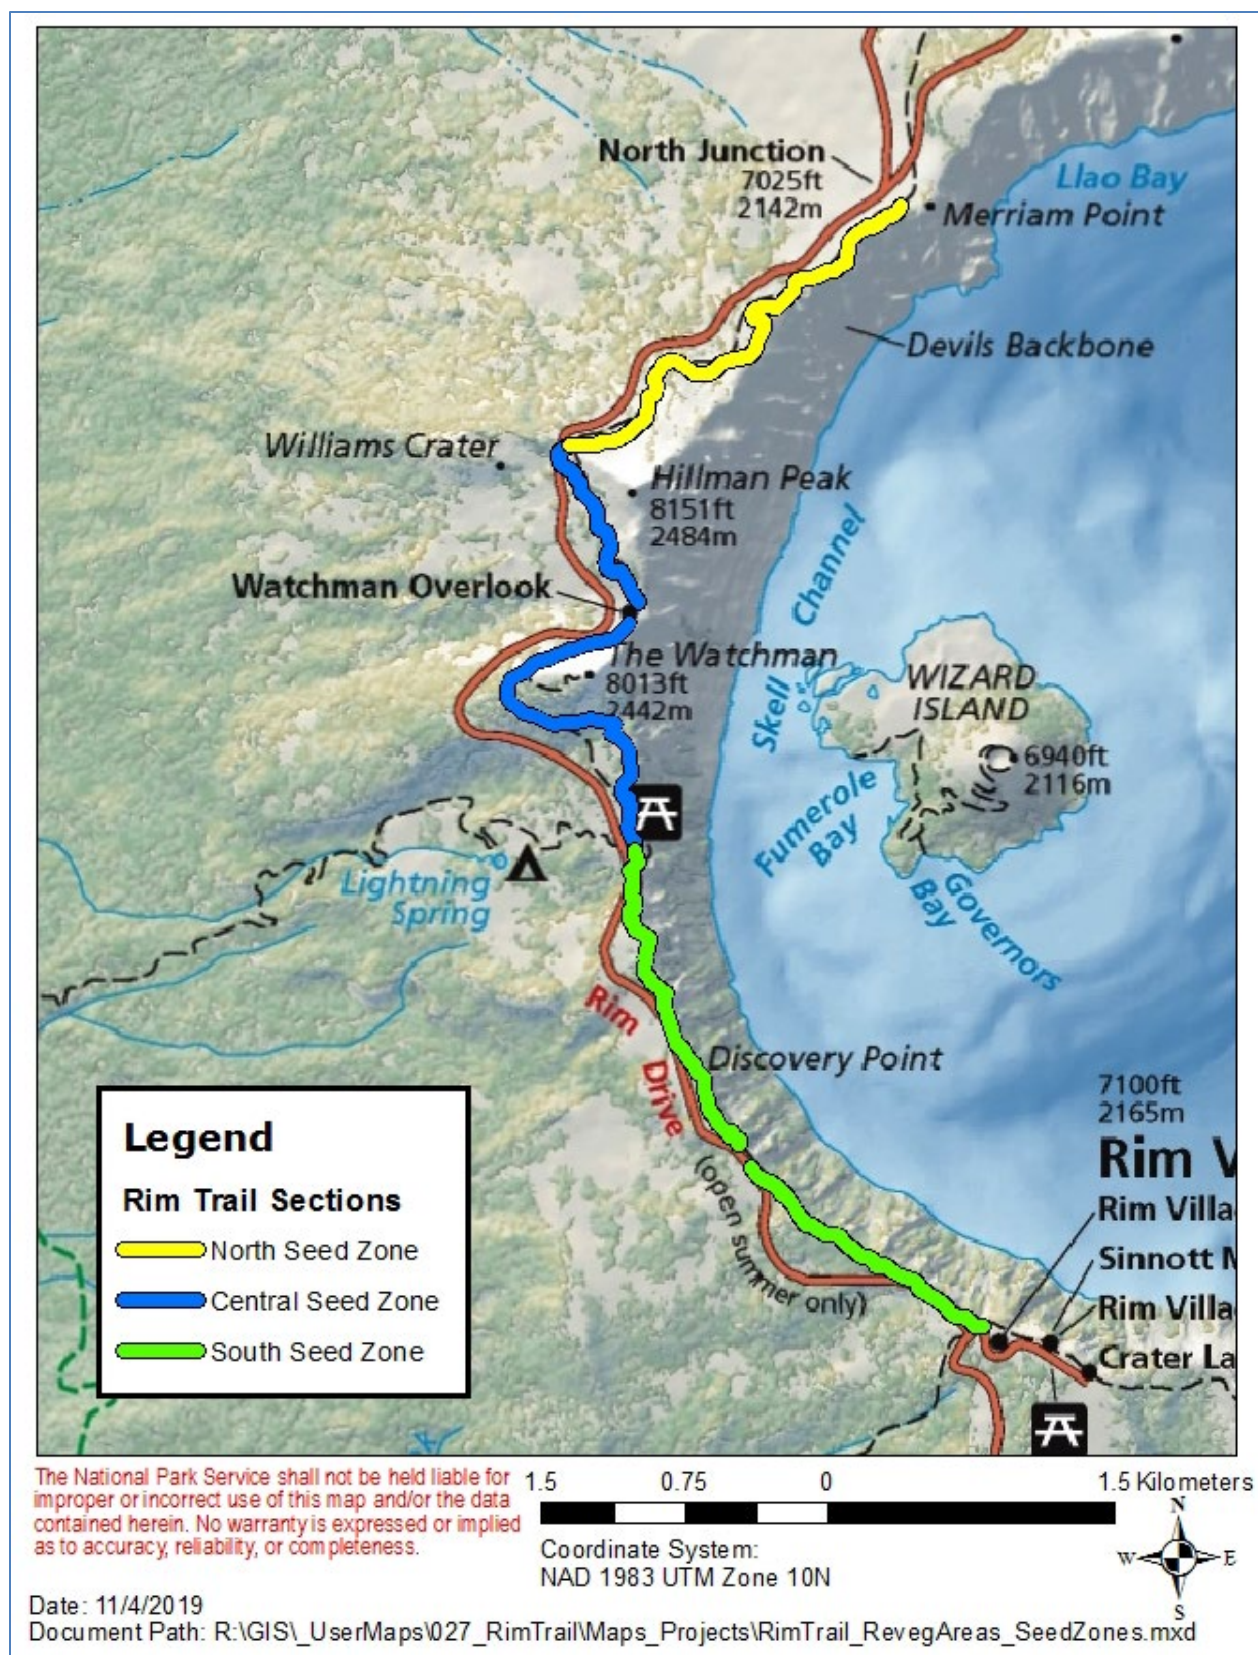
**Figure 4.** Rim Trail sections and seed zones. Map by Scott Heisler.

Due to the proximity in location, the seed collection zones previously developed for the adjacent Rim Drive Rehabilitation Revegetation project (Figure 4) were used for the Rim Trail project. Within these zones, seed was collected from within a half mile of the trail. Species collection lists were developed by surveying plant communities along the trail and assessing the Botany program's success with the use of individual species in previous revegetation efforts (Table 1). Phenology of collection species within the seed collection area was recorded during the 2022 field season. Plant materials were supplemented with previously collected seed that was remaining from the Rim Drive Rehabilitation Revegetation (RDRR) project while being consistent with seed zones.

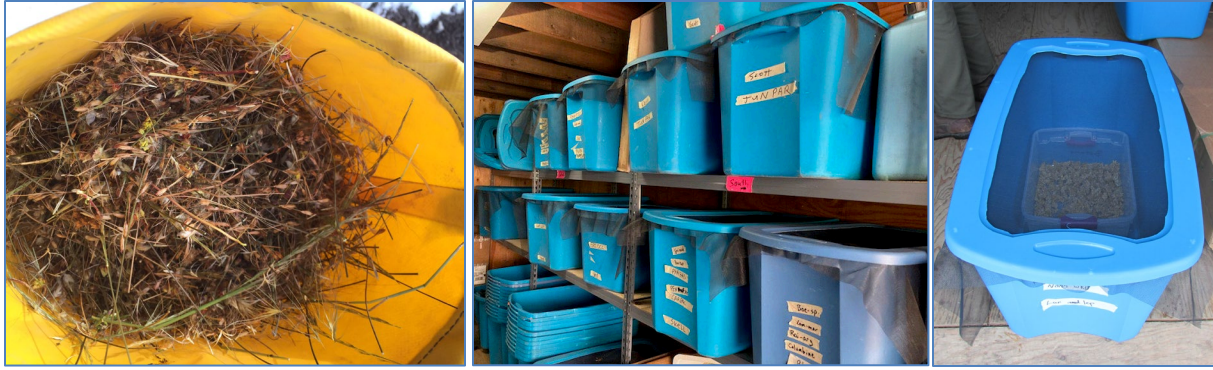
**Figure 5.** Collected seed before cleaning (left). Seed drying and storage facility at park headquarters (middle). Seed drying in a container inside a drying bin with ventilated lid (right). Photos by Carrie Wyler.

When seeds were mature, they were collected, dried, and stored until shipment or cleaning. Large quantities of seed were shipped to the USFS Dorena Genetic Resource Center (DGRC) for cleaning, while smaller quantities were cleaned in house. A single bag was used to collect all the seed from an individual species if the species was to be used for propagation purposes (Figure 6) otherwise species were combined into seed mixes for ease of collection. Collection bags were labelled with species code and collection date. After collection, seeds were transported to the seed drying and storage facility in the Nine Stall garage at park headquarters (Figure 6). Collected seed was placed inside 30-gallon plastic storage totes secured with window screen at the top, allowing ventilation while reducing chances of predation. Plant species with very small seeds were first placed in smaller plastic bins before being stored within the larger 30-gallon tubs. The tubs were labelled and organized on shelves by seed zone and plant species (Figure 5).

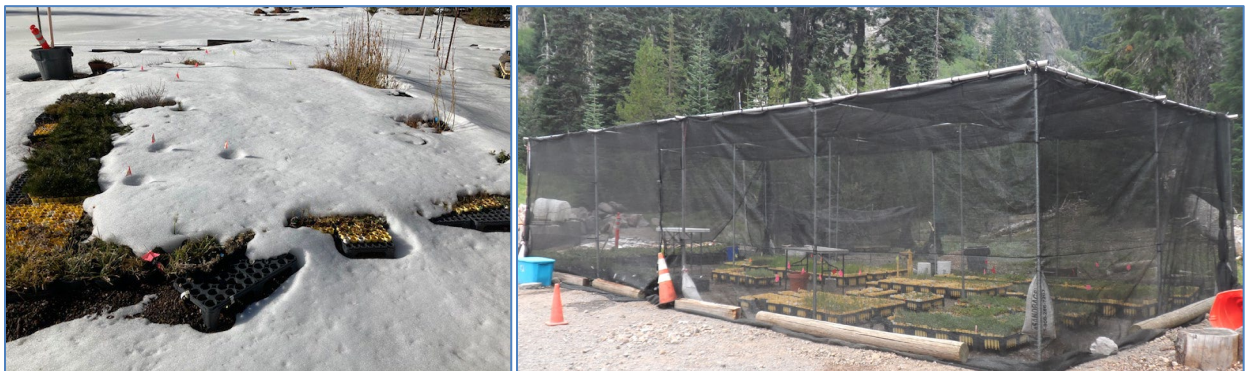
**Figure 6.** Potted plants melting out from winter snowpack (left). Shadehouse at the Ball Diamond nursery (right). Photos by Carrie Wyler.

After the snow melted each season, plants that had been propagated the previous fall were assessed and inventoried and then placed in a shade house (40' x 20' x 10' - Figure 6). Pots without any green growth were discarded. Remaining plants were fertilized with Osmocote 14-14-14 slow-release fertilizer. Fertilizer was applied at the beginning of the season when plants emerged from the snow at a rate of 1/8 tsp per planting tube. Descriptions of fertilization procedures can be found in Botany program files in the "Nursery Activities" binder. Plants with detritus, moss, liverwort, or volunteer plants were cleaned throughout the season.

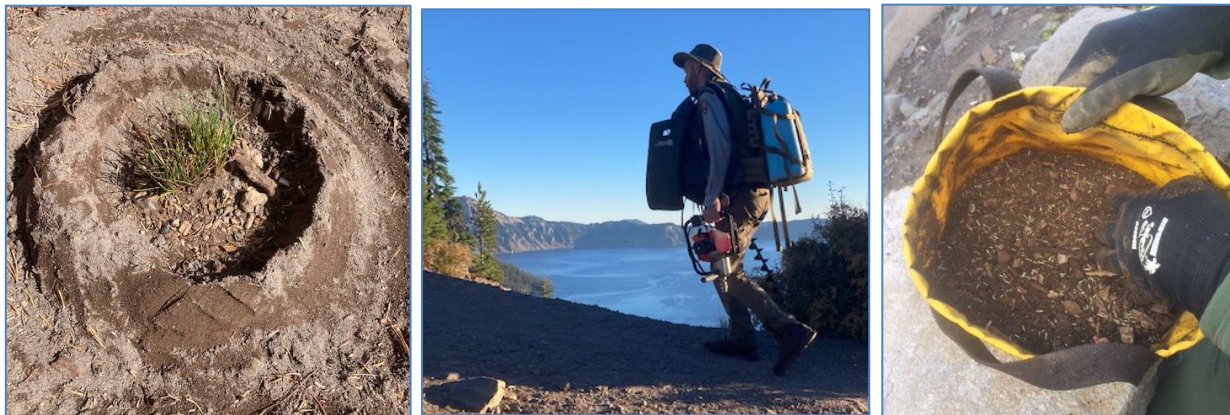
A variety of plant species was planted in the disturbance areas in accordance with the revegetation prescriptions and availability of plant materials. At restoration sites, holes were dug to a depth equal to or greater than the length of the planting tubes. Plants were carefully removed from the tubes by pressing on the sides of the tubes or tapping the rim of the tubes while they were inverted over the planting holes. After the plants had been removed, the roots were inspected for any signs of being root bound, having roots growing upward in the tube (“J”-rooting), or root girdling. If any of these were found, the roots were either trimmed or gently teased apart to encourage root growth and plant establishment. The plants were then placed in planting holes to ensure they were upright perpendicular to the pull of gravity (not relative to the local topography). Soil was then pushed back into the planting holes and tamped down gently to remove any air pockets in the soil. Plantings were installed so that the root collars of the plants were just at or slightly below the surface of the soil. Remaining soil or additional soil from the surrounding area was used to create a berm wall around the plants to facilitate water retention and help stabilize and protect plants. One or two handfuls of compost were then placed in the center of the rings around plants (Figure 8). After mulching the plants were watered from water that was hiked into the site (Figure 8). Planting rates are figured at planting one third of the area, with plants being spaced 12-24” from each other (measured from plant center; plus 10% added to account for plant mortality). Once these plants have become established, they should fill in the remaining area through seed rain.

A site-specific seed mix combined with compost (Figure 7) was prepared and hand-broadcast over planted areas and raked into the soil after planting was completed. Common target rates of seed application in revegetation projects are 60 to 90 live seeds per square foot. Each restoration area received a custom seed mix appropriate to its revegetation prescription. After hand broadcasting, seed were raked into the upper ¼ to ½ inch of topsoil. Revegetation sites will be monitored, and barren or failed areas will be filled in as needed in future years.

**Figure 7.** Outplanted plant with berm and mulch (left). Carrying planting drill and water jugs via frame pack into restoration planting sites (middle). Prepared seed mixed with compost (right). Photos by Carrie Wyler.

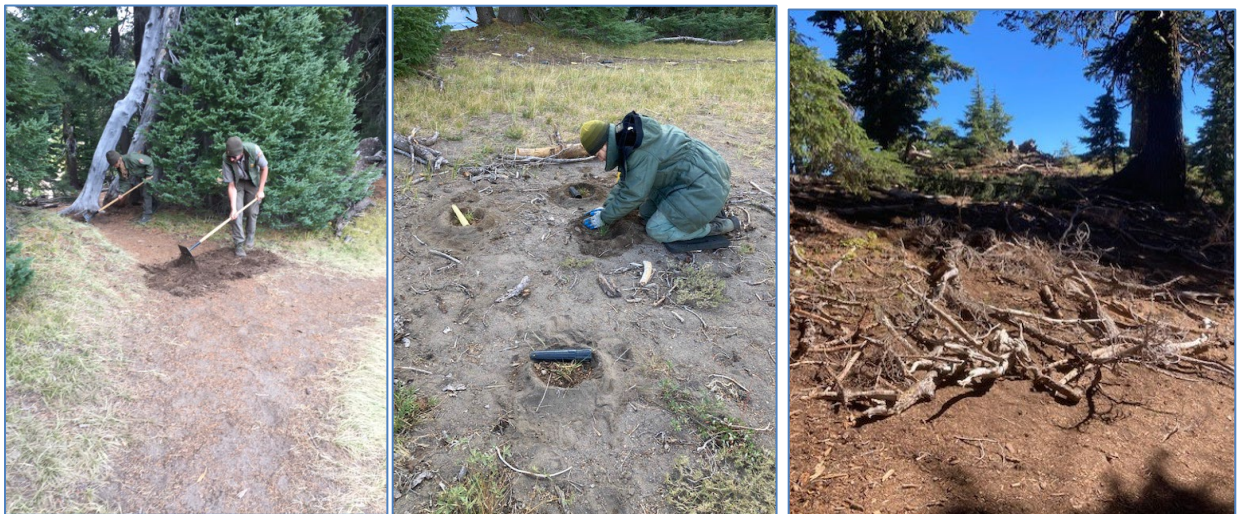
Soil decompaction and tread removal were conducted by hand using a McLeod or pick mattock tool (Figure 8). Following decompaction, planting was completed (Figure 9), duff sourced from adjacent areas was added, and broadcast seeding and raking of collected native seed mixes was conducted to disguise the obliterated path, amend the barren soils, and jumpstart revegetation efforts. Access to the social trails was then obstructed by the addition of large, coarse woody debris and rocks (Figure 8).

**Figure 8.** Decompacting soil on a social trail with a McLeod (left). Planting a disturbed area on the Rim Trail (middle). Obstructing a restoration site with woody debris (right). Photos by Carrie Wyler.

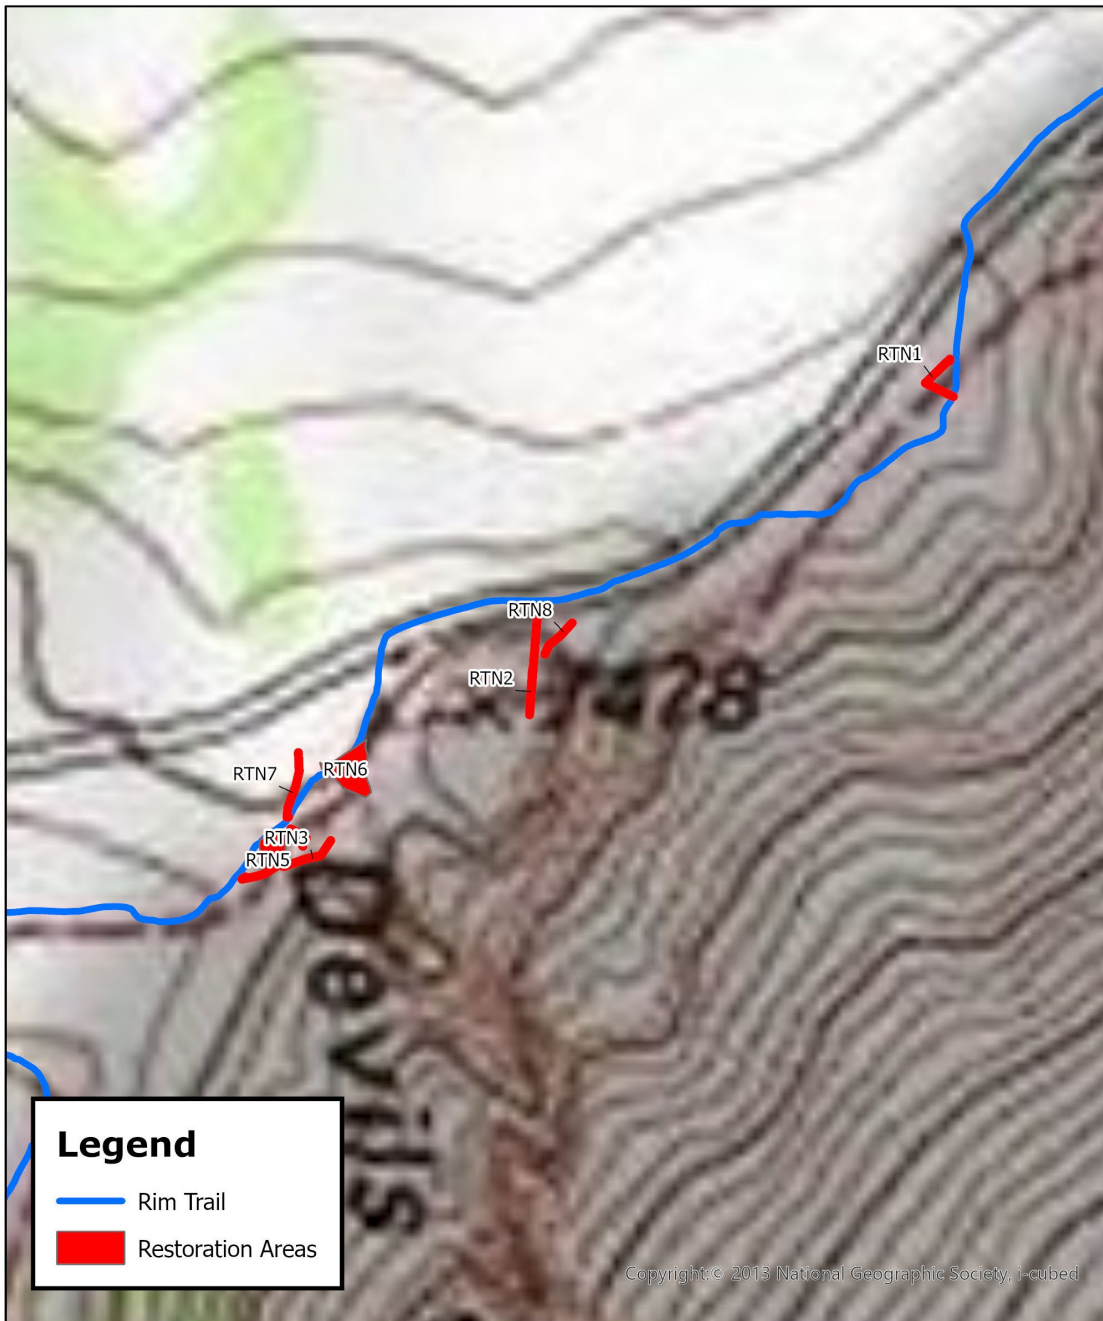
The assessment of disturbed areas identified 75 disturbed sites and 69 sites that could realistically be restored without help from the Trails program. The combined area totaled 0.7 acres. A georeferenced photo database documenting pre-restoration conditions of revegetation sites was created (located on the Botany server), along with accurately mapped boundaries of the sites for each zone (Figures 9-11).

**Figure 9.** Restoration sites for the North section of the Rim Trail. Map by Scott Heisler.

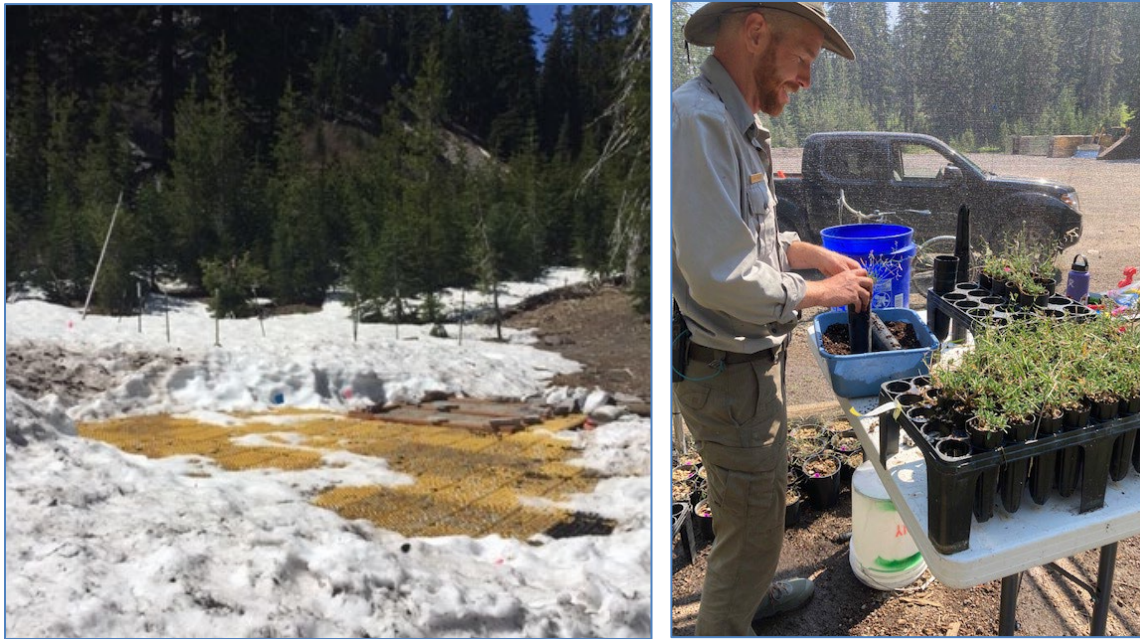
**Figure 12.** Overwintered plants emerging from the snow (left). Cleaning and trimming plants at the park's nursery (right). Photos by Carrie Wyler.

After the snow melted in 2022, plants that had been propagated in previous years were assessed and inventoried (Figure 12). Pots without any green growth were discarded. Plants with detritus, moss,

Starting in 2019, 3,213 living containerized plants were propagated and survived until the 2022 field season (Table 4). Some plants died over the years while others experienced modest growth during the following growing seasons at the Ball Diamond nursery (Figure 12).

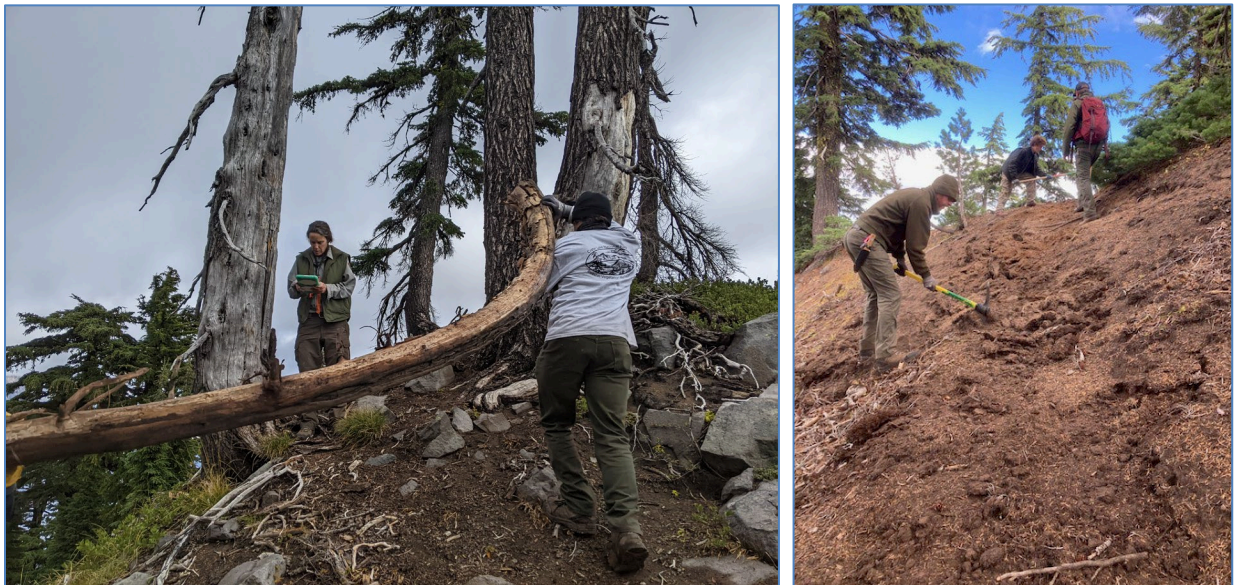
Social trail obliteration was conducted at 69 revegetation sites, encompassing approximately 0.7 acres of area in total (Figure 14). Figure 15 demonstrates before and after pictures of two obliterated social trail sites.

**Figure 14.** Placing locally available woody debris to block access to visitor-created trails and trampled areas (left); decompacting large heavily trampled areas ahead of planting. Photos by Carrie Wyler.

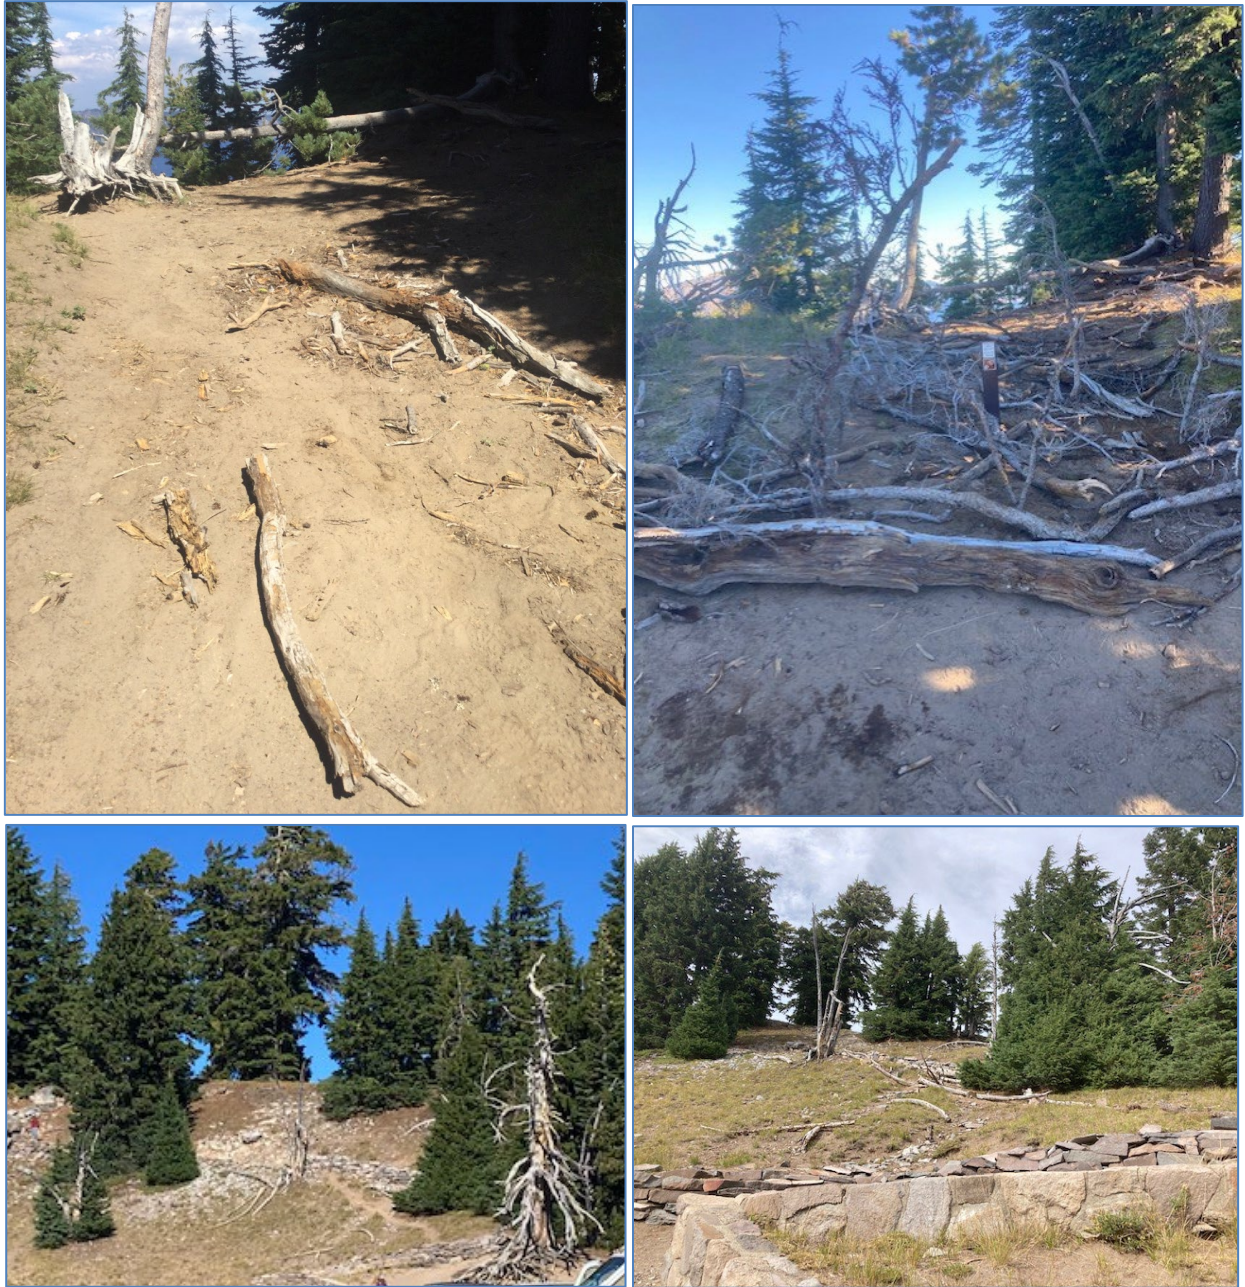
**Figure 15.** Before (left) and after (right) results of social trail obliteration work at two revegetation sites. Photos by Carrie Wyler.

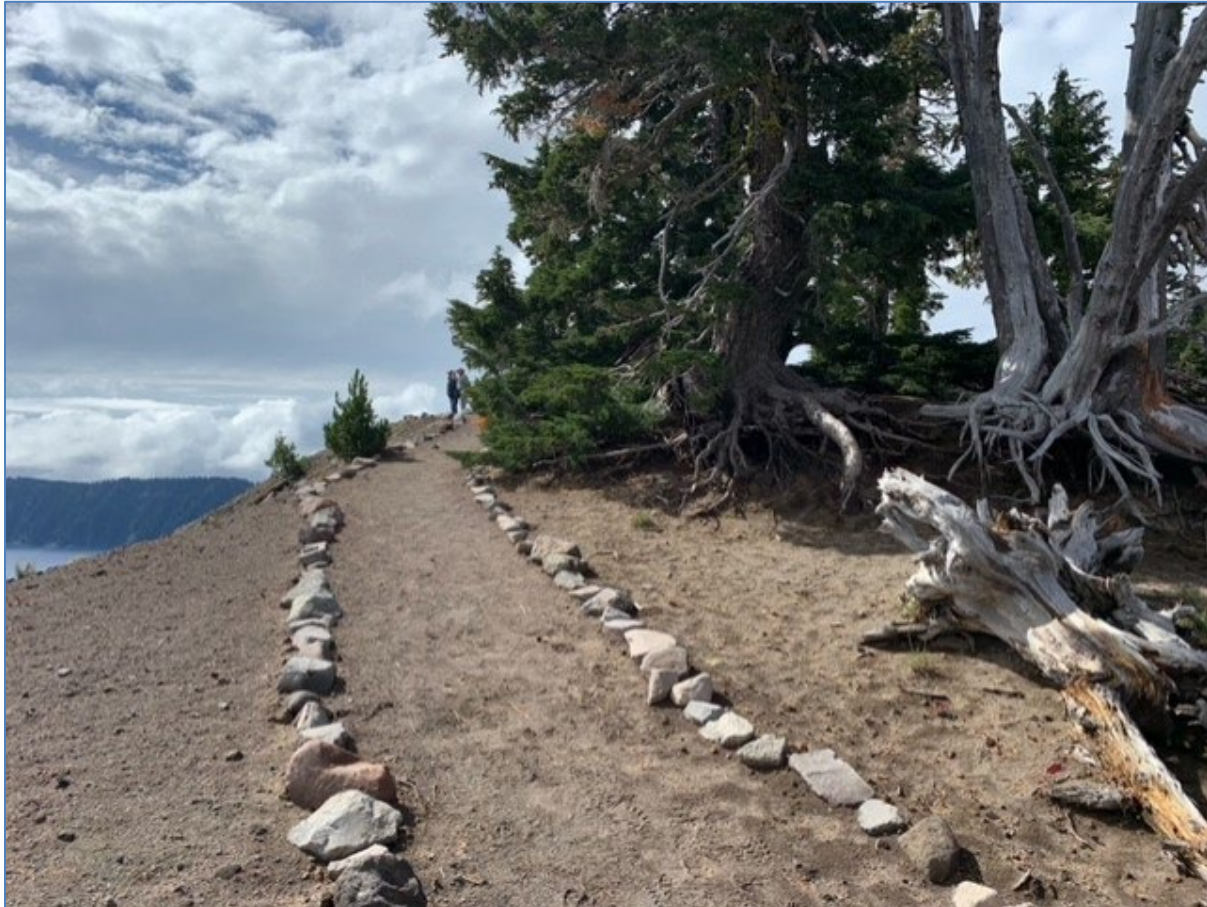
In the summer of 2022, the Trails crew and volunteers delineated a section of the northern portion of the Rim Trail with rocks (Figure 16) in open pumice areas. This delineation seemed to be effective in keeping visitors on the designated trail in these expansive open areas. If time and resources allow more sections of the trail would benefit from this type of rock delineation.

**Figure 16.** Example of an area on the Northern section of the Rim Trail that uses rocks to delineate the trail for a clear path. Photo by Eleanor Roeder.
