# ANALYSIS AND SUSTAINABILITY OF FOUR CONSTRUCTED WATER FEATURES IN THE NATIONAL CAPITAL REGION OF THE NATIONAL PARK SERVICE

MERIDIAN HILL PARK ❖ WOMEN IN MILITARY SERVICE FOR AMERICA MEMORIAL  
FRANKLIN DELANO ROOSEVELT MEMORIAL ❖ CHESAPEAKE & OHIO CANAL NHP

David Tilley  
Tim Williamson  
Walter Zachritz

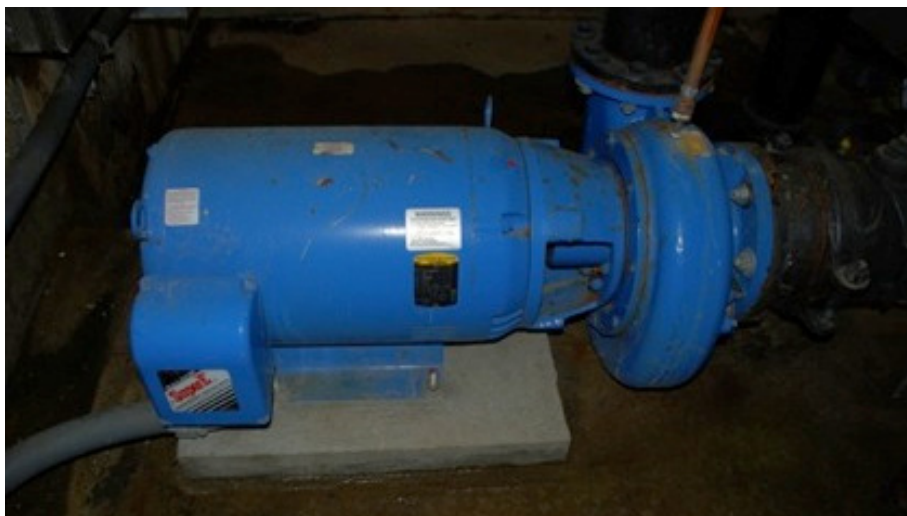
the algae (discussed later in this chapter). A 60 HP pump sends the water back through the various components of the water feature (Figure 3.3). From the fountains and other features, water flows via gravity back to the reservoir. When water is discharged, it flows to the municipal sewer.

**Figure 3.3.** The 60-HP pump at Meridian Hill Park.

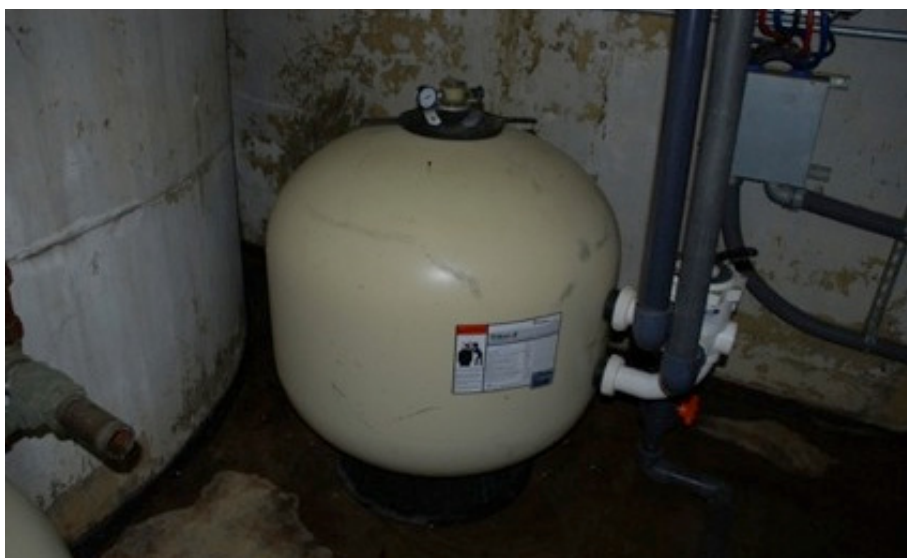
PSFs appear to be standard technology for the many of the NPS water feature designs and system upgrades installed in the 1990- 2005 time period. These sand filters were sized to take less than 5% of the total volume of the feature on a single pass flow basis, but should result in at least one turnover of the total volume of the water feature per day. Typically they are commercial, all-steel or fiberglass, enclosed tanks 3 to 5 feet in height and have a diameter of 24 to 48 inches. They operate in a downflow configuration with 15 to 30 inches of silica sand media typically U.S. Standard Sieve #20 x #30 (ASTM E11 – .850mm x .600mm) silica sand. Water to be filtered is pumped into the top of the filter and distributed over the sand bed. The sand bed is supported by 12-18 inches of coarse gravel, although this is mainly for support. The filtered water is picked up by underdrain piping in the gravel bed and returned to the water feature. A simple pressure gauge on the inlet side of the PSF provide information on the operating pressure of the system (psi). Monitoring this pressure provides the operator with data about the normal operating pressure for an individual system. This data will also give the operator guidance as to when the PSF must be backwashed. Over time the pressure will rise and when it reaches a pressure 8 to 15 psi above the normal operating pressure the sand bed needs to be backwashed. Valving allows the flow to be reversed up through the gravel and sand and expands the sand bed to release entrapped particles of various sizes including algae, fine dirt, and organic debris. This in effect cleans the sand bed. The valving is then reversed and the sand bed resettles and the filtering process resumes and the pressure on the gauge returns to a normal operating pressure.

**Figure 3.4.** One of the sand filters in the pump room at Meridian Hill Park.

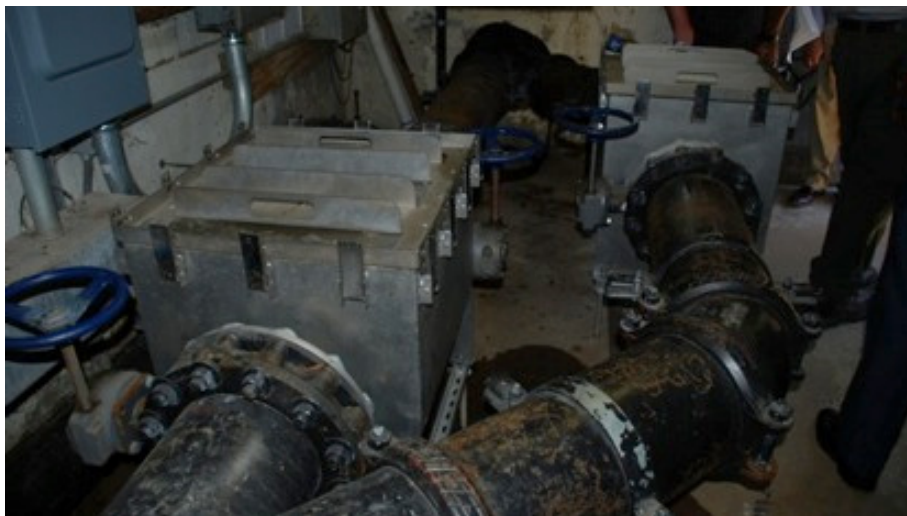
**Figure 3.5.** The screen filters in the pump room at Meridian Hill Park.

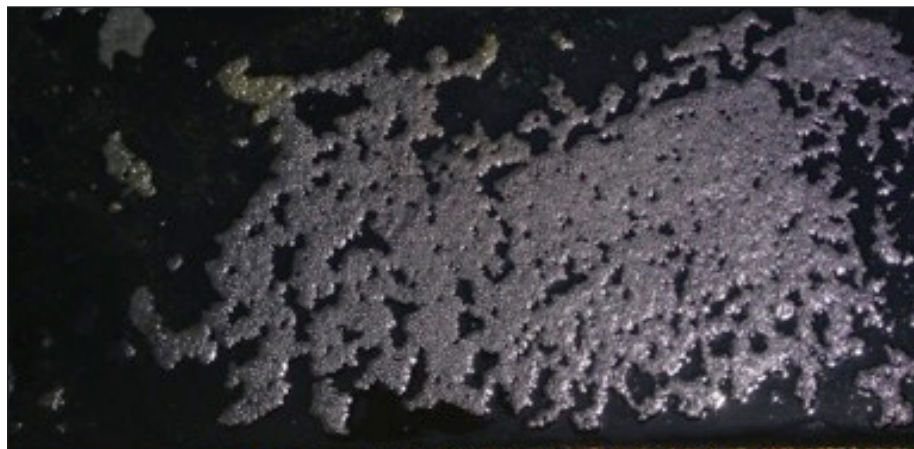
**Figure 3.6.** Foam accumulations in the upper reservoir on July 18, 2014.

growth or materials derived from organics, rather than a foreign foaming agent. Figures 3.6 and 3.7 are examples of the type of foam levels observed at Meridian Hill Park.

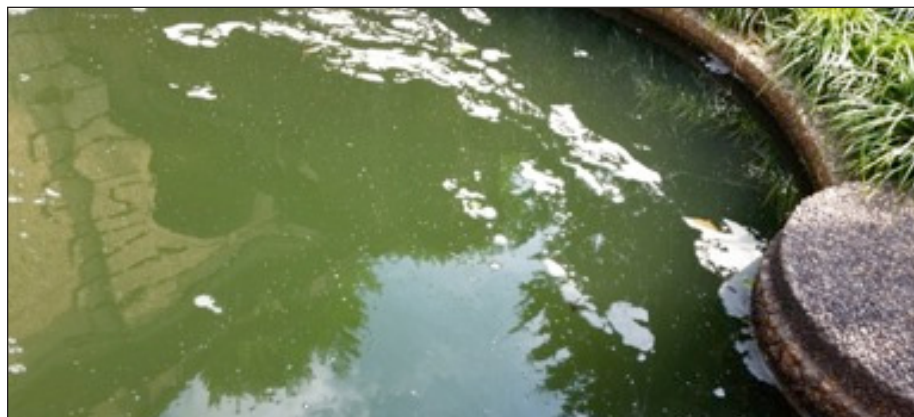
**Figure 3.7.** Foam accumulations in the upper reservoir on August 14, 2014.

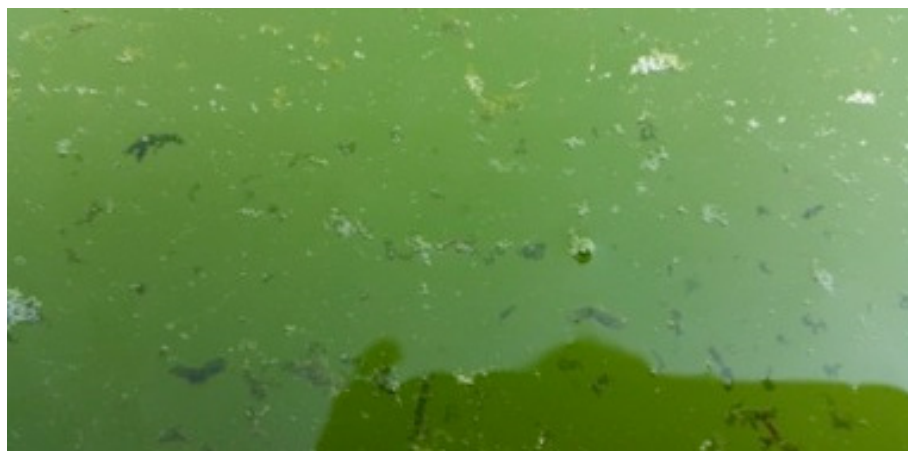
**Figure 3.11.** Algae colonies in early stages of development at Meridian Hill Park. Photo taken July 1, 2014.

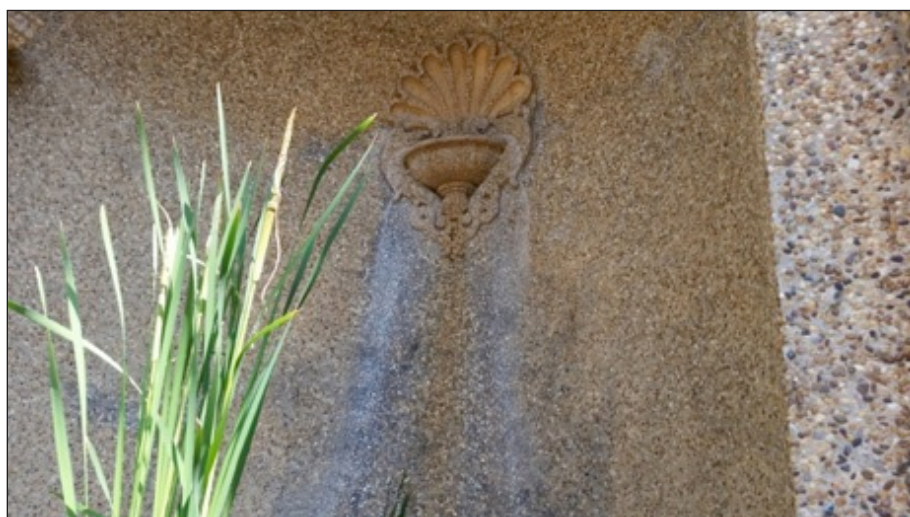
Staining on the walls was documented in the Cultural Landscapes Report of 2001 and was evident during the summer of 2014 (Figure 3.26); however algal blooms were not mentioned in the Cultural Landscapes Report and may be a more recent development due to changes in water treatment in the municipal system (as discussed in Chapter 3). Staining is likely from the deposition of minerals from water during evaporation. Bersani et al (2008) investigated the causes of stains on a 17<sup>th</sup>-century water feature and used a suite of spectroscopies to identify the causes of white staining. They found deposits of “Laurionite” (PbOHCl), calcite, and lead carbonate. Other substances, such as lead compounds and sodium chloride, were found to degrade the stone structure through crystallization and dissolution cycles. They recommended repeated washes of de-ionized water at 40 C° to remove staining from the stone structures. This technique should further considered as a possible management solution for removal of white staining.

**Figure 3.26.** This photo shows the stains on the walls of the CWF. Photo taken June 6, 2014.

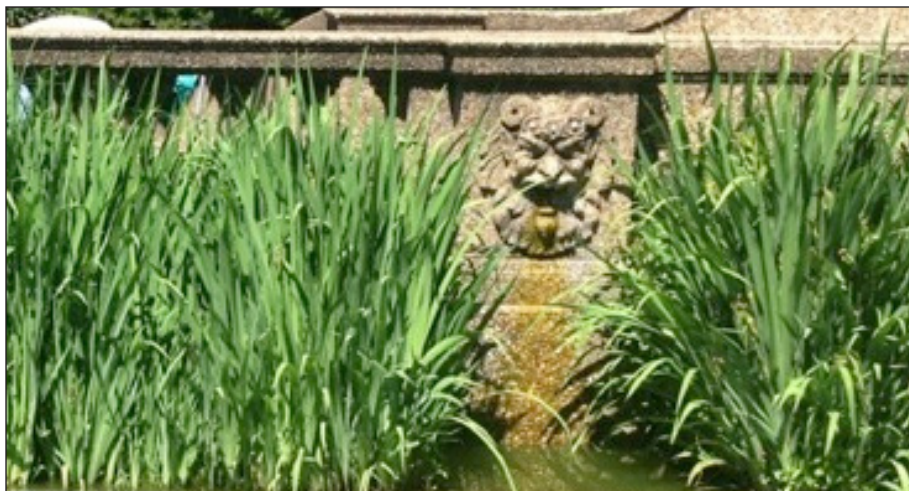
Biofilm growth can occur in humid microclimates, or where splashing water keeps surfaces hydrated. The chief factor in controlling biofilm growth is moisture, although nutrient availability also plays a role (Gaylarde and Morton, 1999). Thus one method to reduce the growth of biofilms would be careful control of water flow, such as the adjustment of fountain spouts so that water does not constantly flow over surfaces; but the control of nutrients (nitrogen and phosphorus) could also help control or reduce the development and growth of biofilms in these features.

**Figure 3.27.** Greenish staining, likely from biofilms and algal growth on the walls of the CWF. Photo taken June 6, 2014.

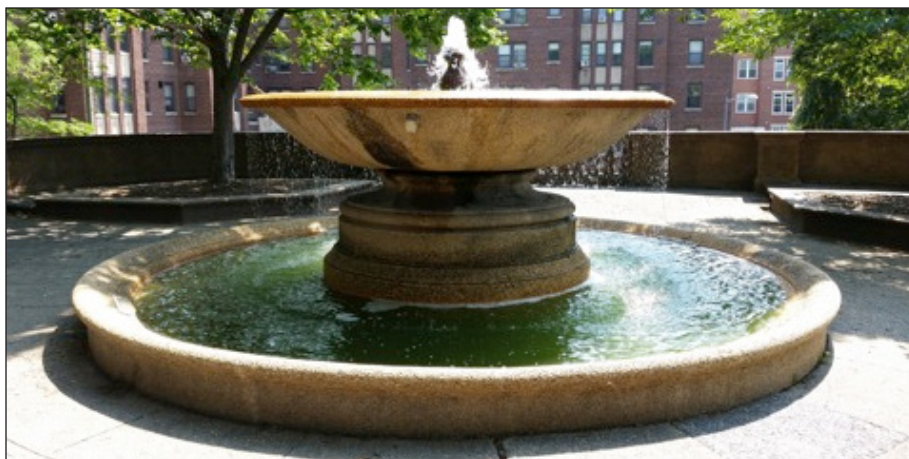
**Figure 3.28.** Blackish staining underneath the top fountain basin. Photo taken July 1, 2014.

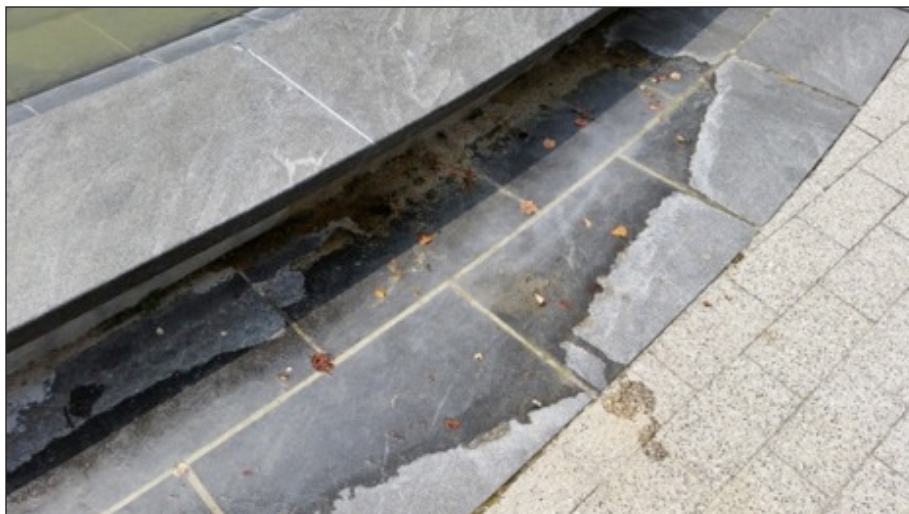
**Figure 4.5.** Leakage along the sides of the reflecting pool. Photo taken August 6, 2014.

The second recommendation is to repair and maintain hydraulic integrity (i.e. repair and seal leaks whenever possible). Three of the four study sites had problems associated with water leaks. The WIMSA site had a large leak due to a gap in the bottom liner around the edge of the main basin. The Meridian Hill Park CWF had small leaks in piping and along the walls of the reflecting pool and the lower plaza cascade basin. The CHOH Canal Terminus Basin had a very large leak that drained water rapidly, but has since been repaired. Since source water often contains nutrients for algae growth, leaky CWFs will have higher nutrient inputs.

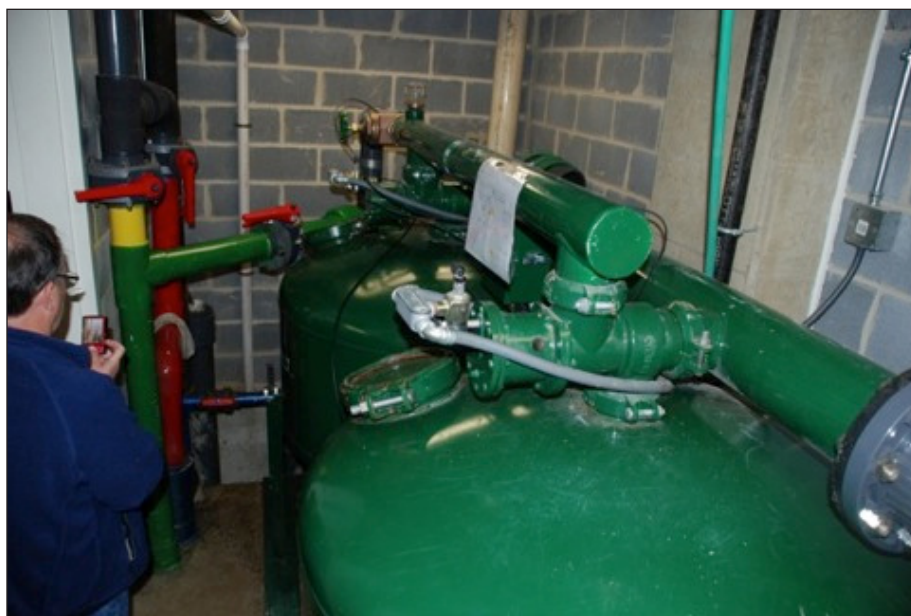
**Figure 4.6.** The clogged sand filters in the pump room of the WIMSA CWF. Photo taken on October 24, 2014.

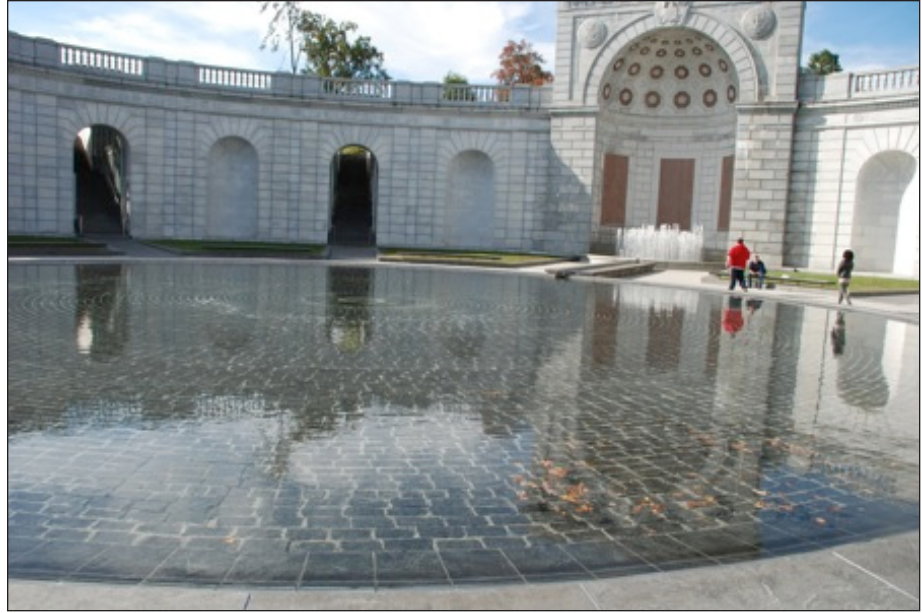
**Figure 4.8.** Clear water in the WIMSA Memorial reflecting pool on October 24, 2014. Note the cobble and mortar bottom structure.

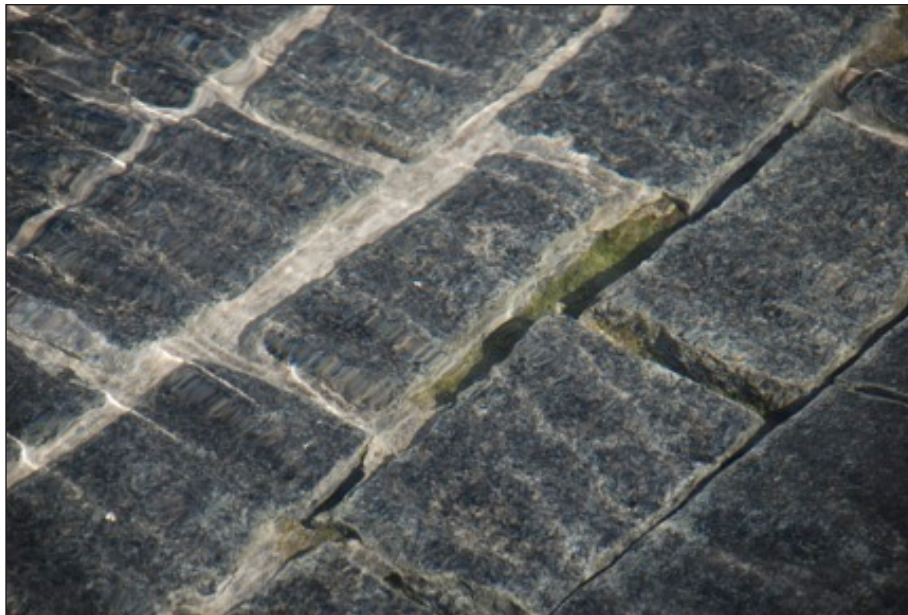
**Figure 4.13.** Algae are difficult to clean when it lies in the space between cobblestones. Photo taken October 24, 2014.

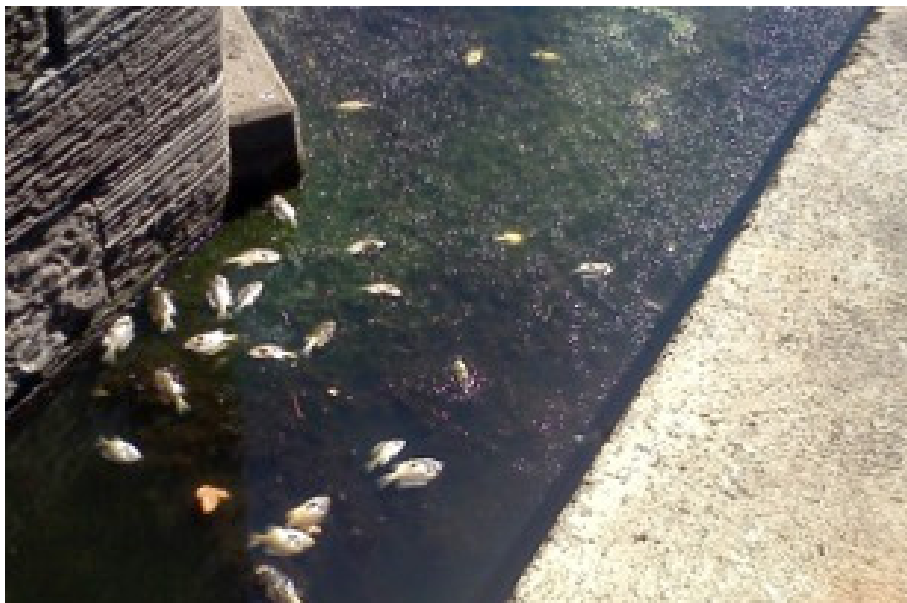
**Figure 6.16.** Dead fish in the CHOH Canal basin that may have caused a spike in  $\text{NH}_3$  concentrations on August 26, 2014.
