# INTENSIVE LEVEL SURVEY OF THE CAPITOL VIEW NEIGHBORHOOD: PHASE I

PREPARED BY KRISTIN DYER  
DYER NEED FOR PRESERVATION LLC  
FOR THE CITY OF OKLAHOMA CITY  
APRIL 2021

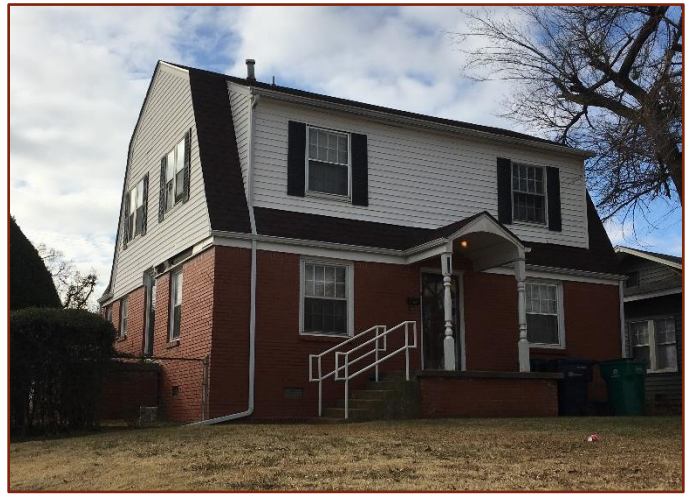
FIGURE 4: 948 NORTHEAST 32ND STREET

“Colonial Revival” is in reference to the renewed interest in English and Dutch-style houses on the Atlantic Seaboard. Early versions of the Colonial Revival were a series of interpretations of earlier Georgian and Adam styles, and the popularity never faded. As time progressed, forms became simplified or characteristics were incorporated into other architectural styles such as the ranch house. Colonial Revival houses featured characteristics such as multi-light double-hung sashes, accentuated front door, and centered entry or full-width porches. In the survey area, there are 12 examples of Colonial Revival houses and were constructed between 1929-1940. **948 Northeast 32<sup>nd</sup> Street** is the only example of the Dutch Colonial variation with its side-gabled gambrel roof.

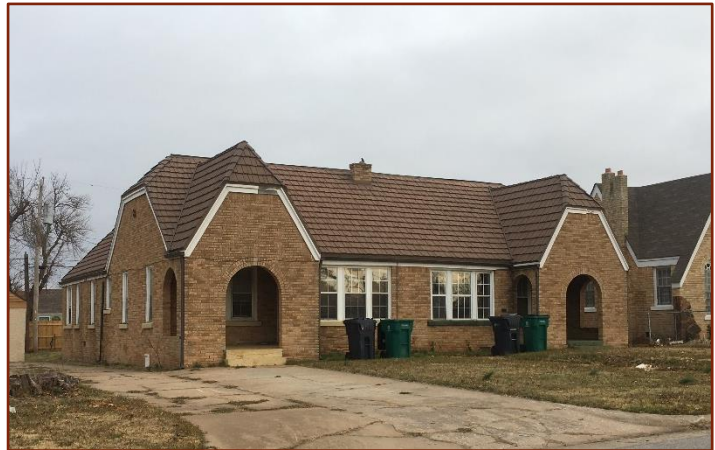
FIGURE 5: 805 NORTHEAST 24TH STREET

The Tudor Revival houses were notable for their asymmetrical design, steeply pitched front facing gables, multiple gables, decorative brickwork, massive chimneys, and half-timbering. In the survey area, there are 37 examples of Tudor Revival houses constructed between 1929 and 1949. The majority of Tudor Revivals are constructed between Northeast 24<sup>th</sup> Street and Northeast 29<sup>th</sup> Street. Constructed in 1932, **805 Northeast 24<sup>th</sup> Street** features a Tudor Revival used as a duplex with separate covered entrances on the façade.

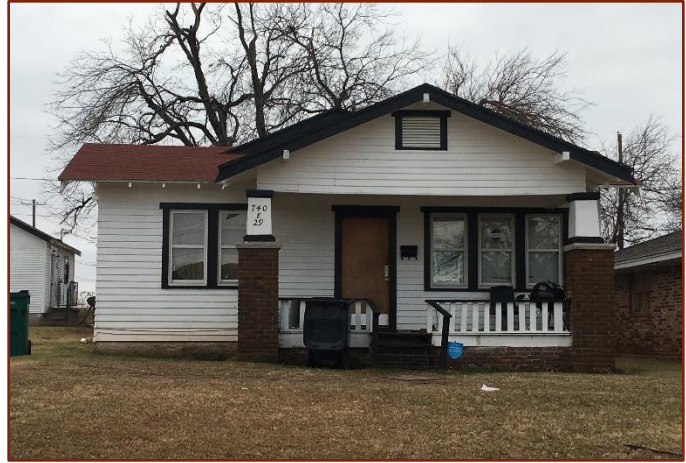
FIGURE 6: 740 NORTHEAST 29TH STREET

There are 28 examples of Bungalow/Craftsman in the survey area constructed primarily in the 1920s and 1930s. Some appeared to be moved to the survey based on aerial imagery. **740 Northeast 29<sup>th</sup> Street**

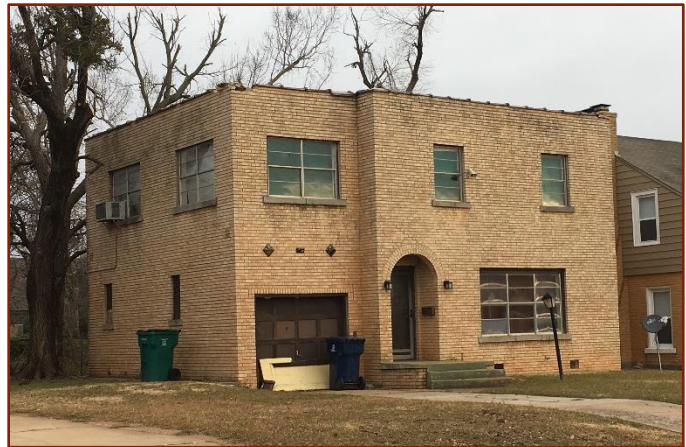
FIGURE 7: 833 NORTHEAST 24TH STREET

The Moderne house was used in residential architecture after 1930. Modernistic architecture became popular during the Arts Décoratifs et Industriels Moderne in 1925, and after the 1930s modernistic building became streamlined to reflect the industrial design for ships, vehicles, and airplanes. Moderne houses features smooth wall surfaces, flat roofs, horizontal grooves or lines, and one or more curved corners. The Moderne house may incorporate glass block and continuous windows around corners.

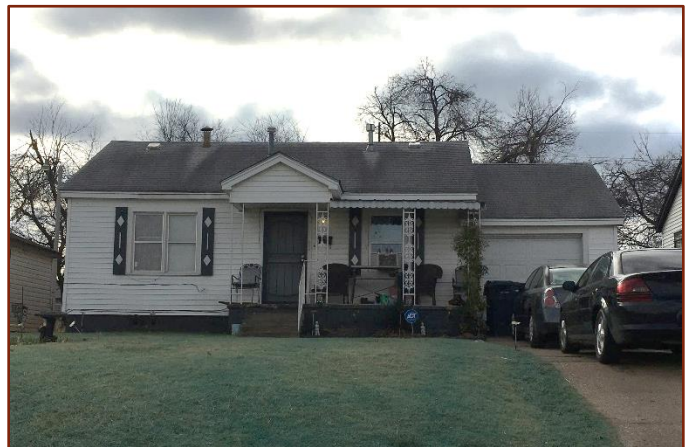
FIGURE 8: 820 NORTHEAST 31ST STREET

during and after World War II to quickly relocate production workers during the war and for returning service members after the war. Minimal Traditional houses were generally one-story with wood siding, detached garages, and minimal or no eave overhang. In the survey area, there are 75 examples of the minimal traditional houses constructed between 1927 through the 1963. The minimal traditional houses are dispersed throughout the survey area the majority constructed between Northeast 28<sup>th</sup> Street through Northeast 34<sup>th</sup> Street. **820 Northeast 31<sup>st</sup> Street** is an excellent example of a Minimal Traditional house with an attached garage. **804 Northeast 28<sup>th</sup> Street** is an excellent example of a Minimal Traditional house with Tudor Revival characteristics with an asymmetrical gable-end, arched entry, and an exterior façade chimney.

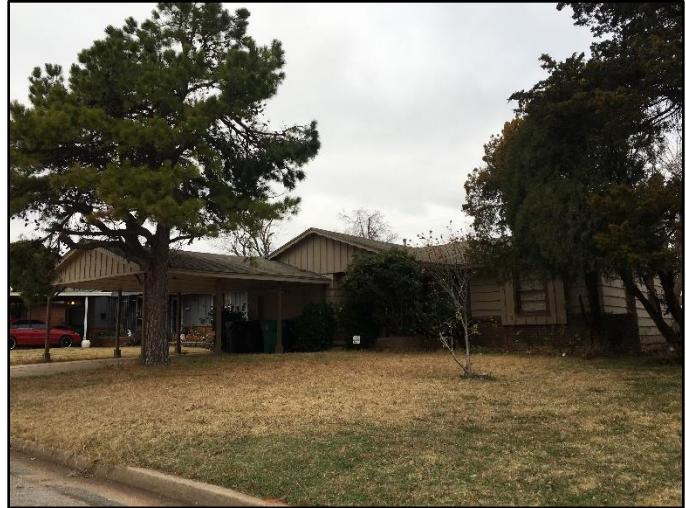
FIGURE 9: 929 NORTHEAST 29TH STREET

beams, and large rear-facing or shielded windows. They are built with a variety of materials including wood, stone, or brick, and feature recessed doors not visible from the street. There are 10 examples of Contemporary style houses within the survey area constructed predominantly between the 1950s - 1970s. Constructed in c. 1963, **824-826 Northeast 26<sup>th</sup> Street** is a contemporary-style duplex with a deep recessed carport under the wide hipped gable-end.

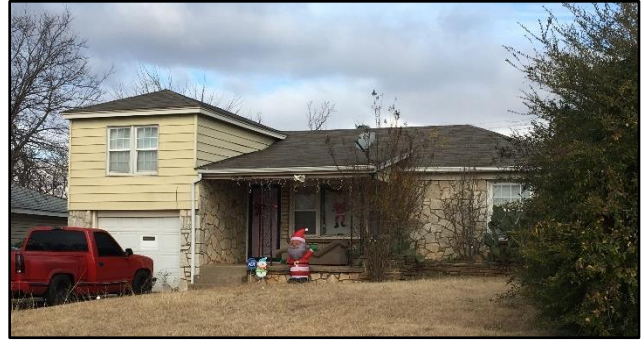
FIGURE 11: 915 NORTHEAST 31ST STREET

The Split-Level is known as a form of a structure that mirrors the architectural details of Ranch, Stylized Ranch, and Contemporary Styles. It modifies these one-story architectural styles by creating a second-story use by splitting the one-story in mid-height to create two wings or by integrating the garage into the landscape with the living area on the second story. The three separate levels create a staggered and separated space. The Split-Level became popular for sloped grades by tucking the garage under the house or by separating noisy spaces from quiet spaces. There is one example of a Split-Level house, **915 Northeast 31<sup>st</sup> Street**, constructed in 1955.

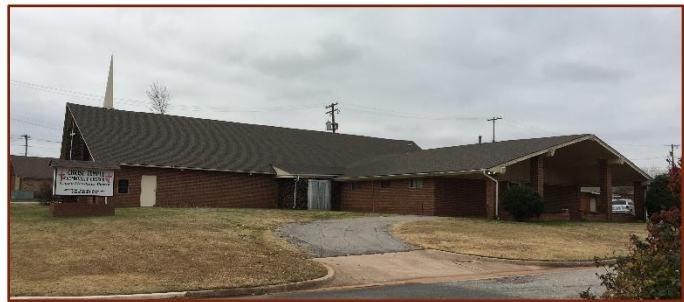
FIGURE 12: 2717 NORTH KELLEY AVENUE

The Modern Movement categorizes structures that express modernism; however, they do not display any emphasis on other modern movement styles such as ranch or contemporary for residential houses or the International Style and New Formalism styles for commercial buildings. The Modern Movement buildings feature minimal detailing and are constructed of brick, concrete, metals, wood, stone, or any combination thereof. In the survey area, there are 43 examples of modern movement buildings constructed between through the 1950s until the 1980s. Many of the churches in the survey area were constructed in the modern movement style such as **2717 North Kelley Avenue** and **2701 North Kelley Avenue**.

| <b>2717</b> | NORTH KELLEY AVENUE | WHILE THIS BUILDING HAS SUFFICIENT INTEGRITY, IT IS NOT INDIVIDUALLY ELIGIBLE, IN ADDITION THERE IS NOT ENOUGH SURROUNDING HISTORIC RESOURCES WITH INTEGRITY TO WARRANT A HISTORIC DISTRICT. |

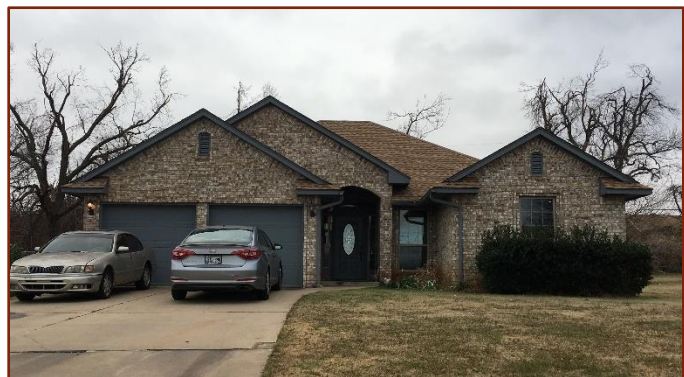
FIGURE 13: 824 NORTHEAST 29TH STREET

celebrate the new millennium with still more drama.” Notable features of the millennium mansion includes complex roof systems with lower cross gable or hips, tall entries, arched entrances, and various window designs. The only example of a millennium mansion is located at **824 Northeast 29<sup>th</sup> Street**, which features a complex roof system and arched entry.

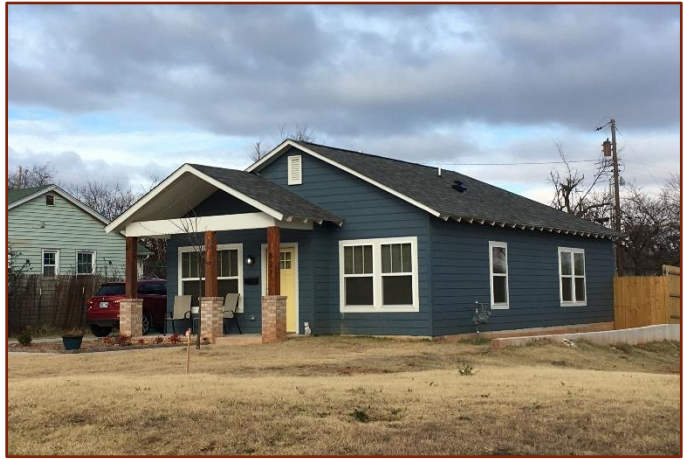
FIGURE 14: 821 NORTHEAST 31ST STREET

Phase I with all being constructed since 2005. **821 Northeast 31<sup>st</sup> Street** features characteristics of a Bungalow/Craftsman with exposed rater tails and jailhouse-style windows. **945 Northeast 29<sup>th</sup> Street** features characteristic of an American Foursquare with its square footprint and full-width porch.

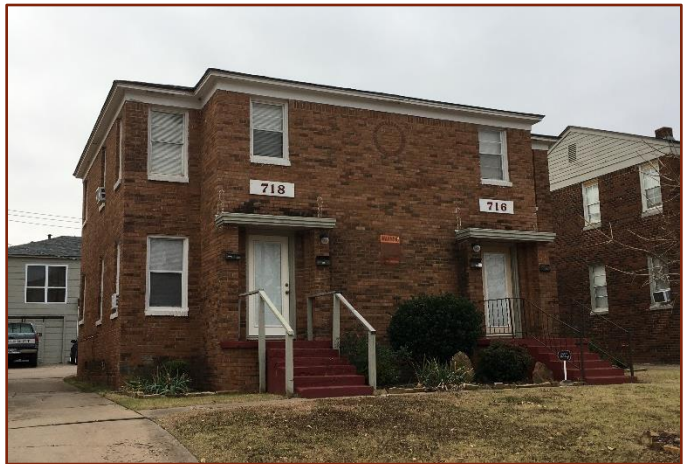
FIGURE 15: 716-718 NORTHEAST 25TH STREET

Commercial-style architecture found within the survey area includes eight multi-family buildings, one commercial business, and one school. This includes variation of one-part commercial block featuring a one-story building with simple brick detailing and glass windows. The other common commercial type is the two-part commercial block, which is typically two-stories with a horizontal division between the first-story and the upper stories. All of the commercial-style buildings found in Phase I feature two-stories except **3631 North Kelley Avenue**. The largest concentration of commercial-style buildings are found along **700 block of Northeast 25<sup>th</sup> Street** with a series of multi-family buildings.

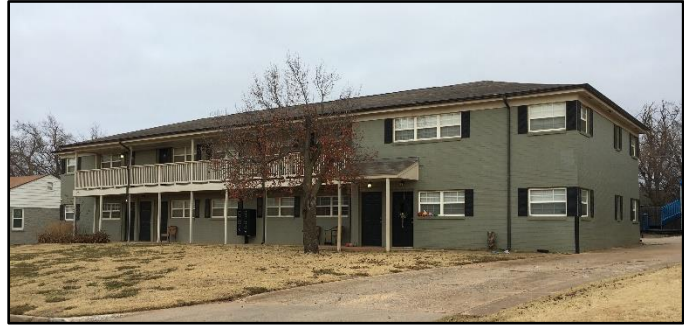
FIGURE 16: 2601 NORTH PHILLIPS AVENUE

long rectangular footprints either directly facing the street or perpendicular to the street. Apartment buildings are typically box-like in design, wood-frame with various veneers, exterior or interior stairwells, and may have off-street parking. Apartment buildings also feature balconies or walk-out landings like 2601 North Phillips Avenue and 2700 North Lindsay Avenue.

North Phillips Apartment Buildings  
Criterion A - Community Planning and Development / Criterion C - Architecture

2601 North Phillips Avenue

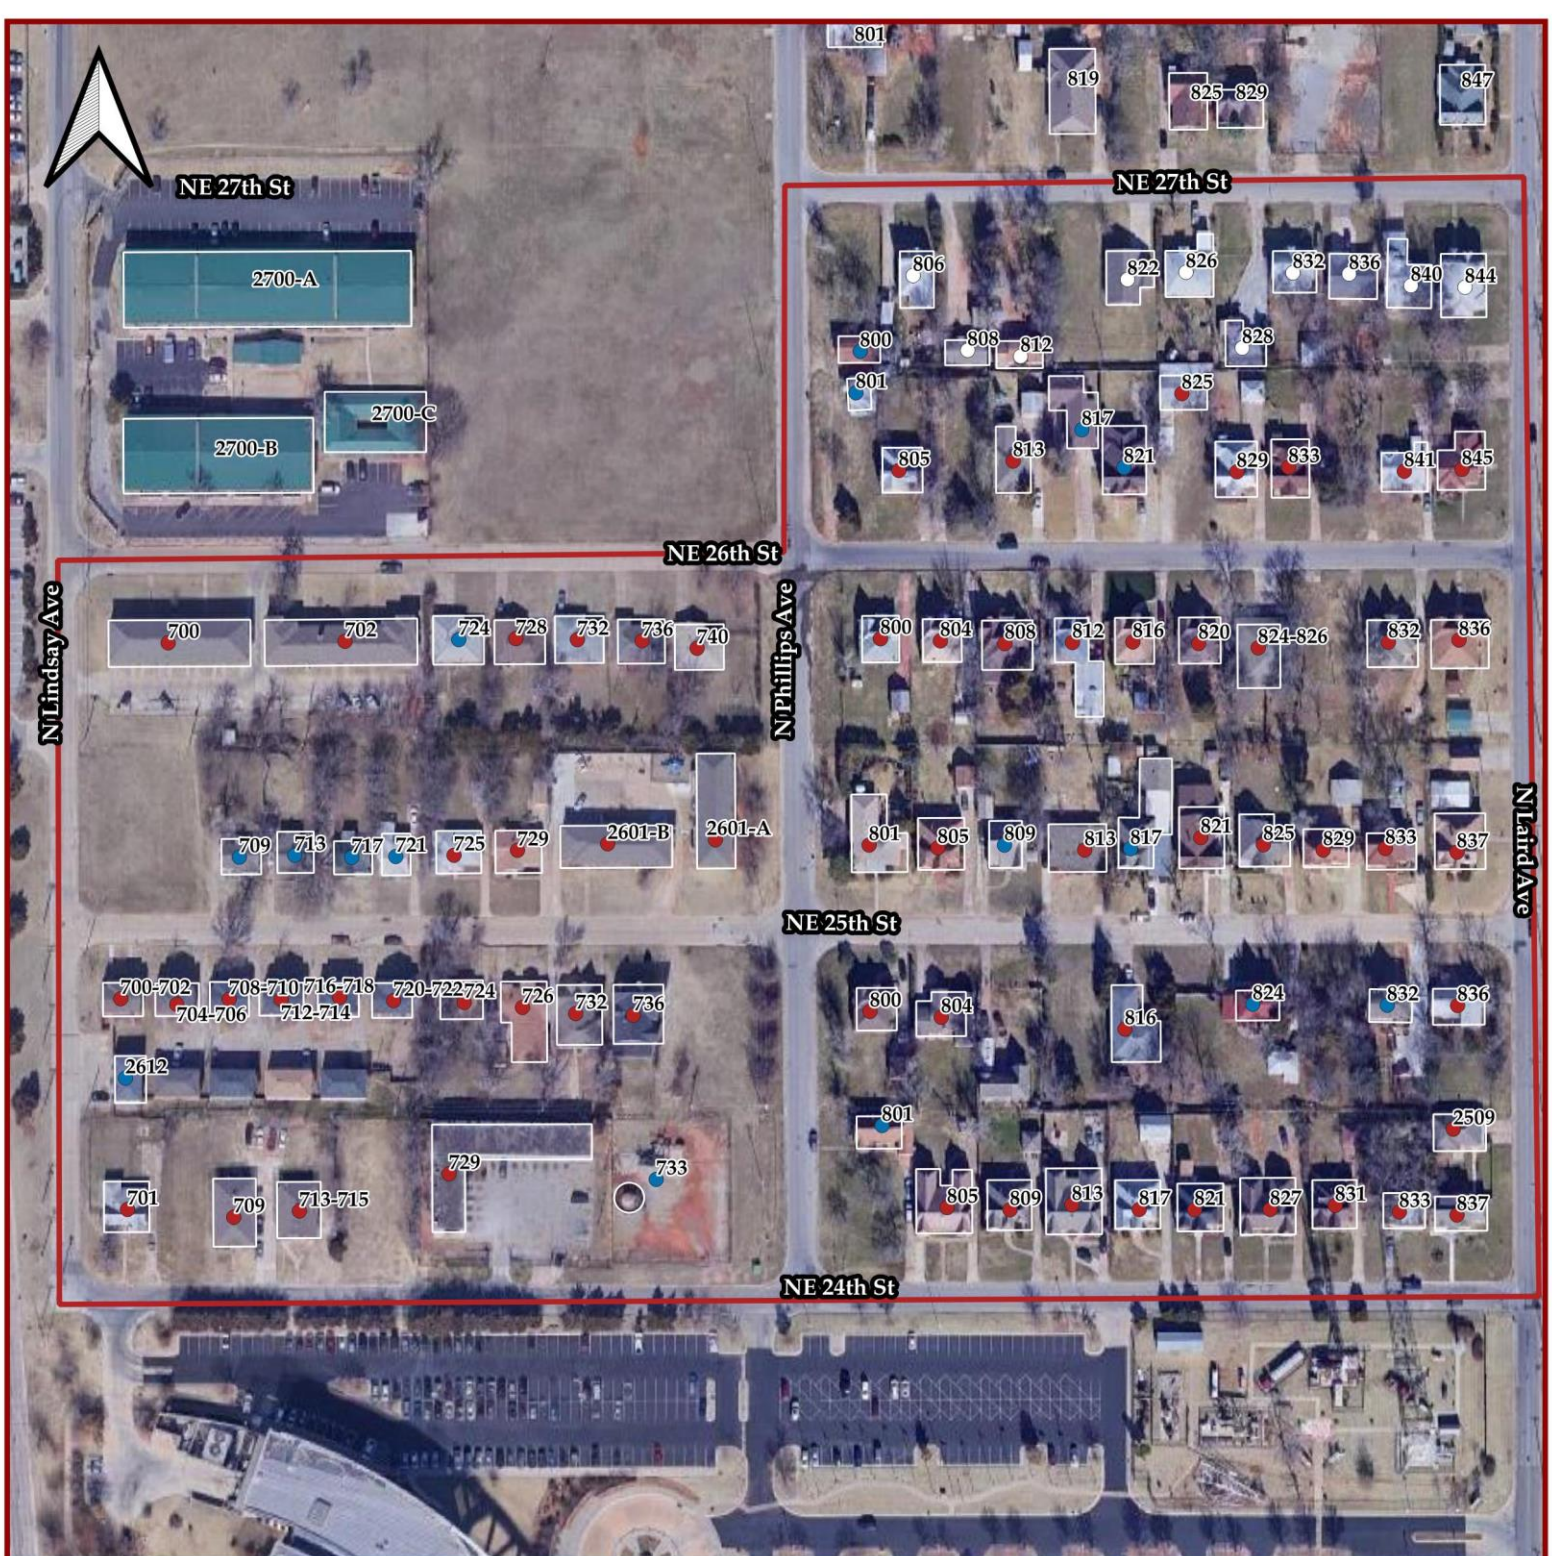
FIGURE 17: MAP; POTENTIAL CAPITOL VIEW HISTORIC DISTRICT

The Capitol View Historic District is eligible for listing in the National Register of Historic Places for local significance under Criterion A in the area of Community Planning and Development as a residential area that was developed during the end of the 19th Century through 1970. The potential historic district is roughly bounded by North Laird Avenue to the east, Northeast 24<sup>th</sup> Street to the south, North Lindsay Avenue to the west, which follow North Phillips Street to Northeast 27<sup>th</sup> Street to the north. Within the boundary, there are 87 primary buildings and one site. During Phase I of the survey, 62 properties were found to retain sufficient integrity to be contributing, and there are 16 properties that are non-contributing. The remaining ten properties are to be determined during Phase II to evaluate their integrity as part of the potential historic district.

The period of significance is between 1929-1975. The area was primarily developed during the first half of the 20<sup>th</sup> century with popular architecture styles such as Tudor Revival, Bungalow/Craftsman, Colonial Revival, and Minimal Traditional. There are over 30 examples of Tudor Revival houses displaying various siding materials and methods of construction. During the period of significance, the historic district saw the discovery of oil northeast of the State Capitol Building in the 1930s, and oil wells were frequent within the historic district and surrounding areas. The trolley and streetcar line ran north and south along North Phillips Avenue, which encouraged prospective homeowners to build within the area. The Oklahoma City streetcar line lost its popularity with the rise of the automobile, and several houses would feature a detached garage as early as 1932. In addition, the potential Capitol View Historic District displays the evolution of multi-family housing within the neighborhood with multiple duplexes in various architectural styles, commercial-style brick-box apartments, and modern movement apartment complexes. The potential Capitol View Historic District is an excellent representation of the changing use of the neighborhood northeast of the Oklahoma State Capitol Building.

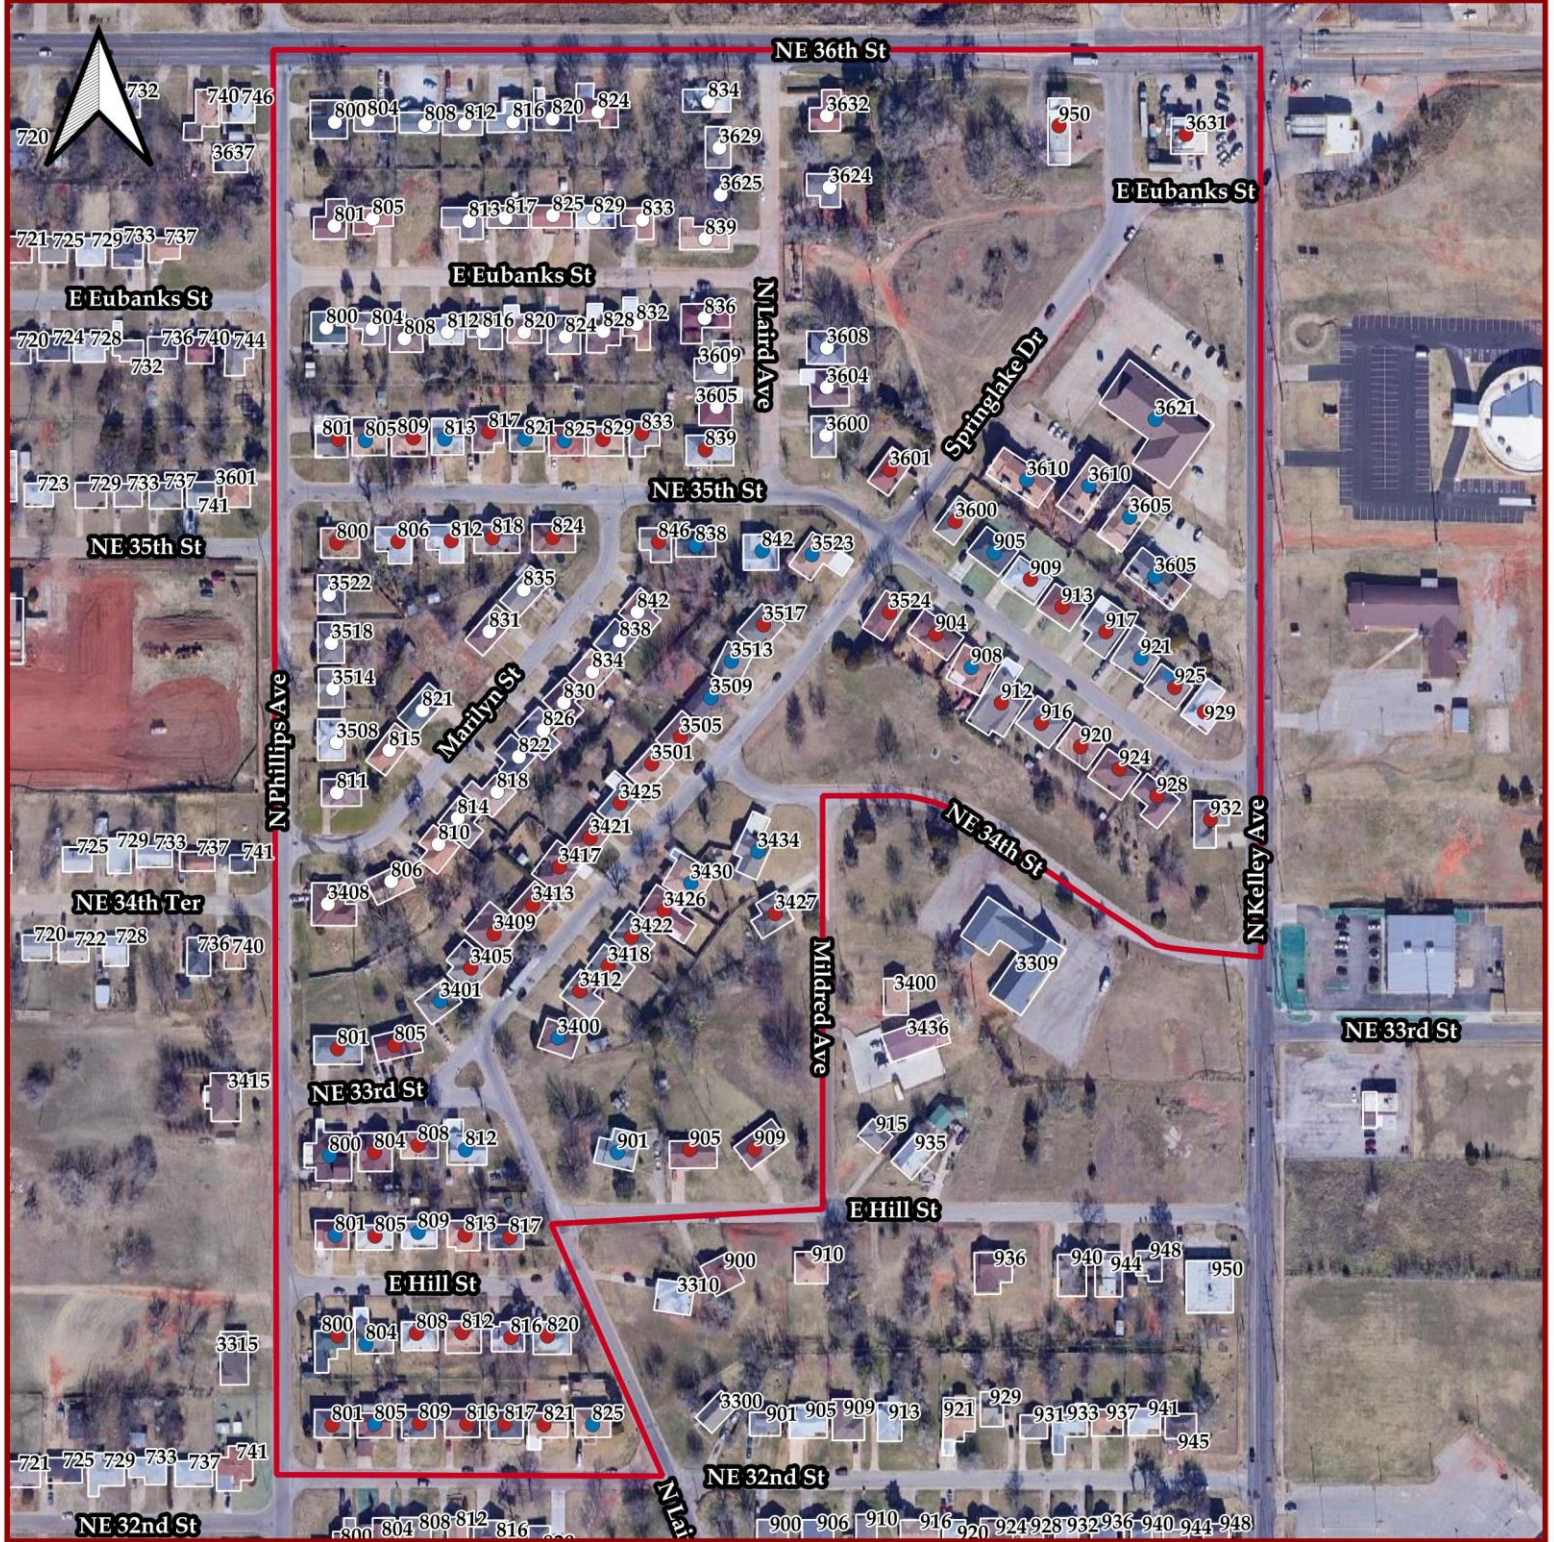
FIGURE 18: MAP; POTENTIAL PARK TERRACE HISTORIC DISTRICT

The Park Terrace Historic District is eligible for listing in the National Register of Historic Places for local significance under Criterion A in the area of Community Planning and Development as a residential area that was developed during the 1950s and 1960s. The historic district boundary encompasses the entire Park Terrace Addition as well as a few houses along Springlake Drive and East Hill Street that complement the development and match the architectural styles. The potential historic district is roughly bounded by North Phillips Avenue to the west, Northeast 36<sup>th</sup> Street to the north, and North Kelley Avenue to the east. The south boundary line is described as proceeding west along Northeast 34<sup>th</sup> Street, then south along Mildred Avenue, then west along East Hill Street, then southeast along North Laird Avenue, then west along Northeast 32<sup>nd</sup> Street to North Phillips Avenue.

Within the boundary, there are 147 primary buildings. During Phase I of the survey, 62 properties were found to retain sufficient integrity to be contributing, and there are 30 properties that are non-contributing. The remaining 55 properties are to be determined during Phase II to evaluate their integrity as part of the potential historic district. The residential area was primarily developed during the 1950s and 1960s with ranch style houses and few commercial businesses. The development strayed from the traditional grid system by using the existing topography and roads to create the Park Terrace neighborhood. The period of significance begins in 1954 with the first wave of construction up to 1975 when construction waned.
