# Trends in Water Quality and Assessment of Vegetation Community Structure in Association with Declining Mangroves

## *A Condition Assessment of American Memorial Park*

Natural Resource Report NPS/PACN/NRR—2023/2610

December 2023

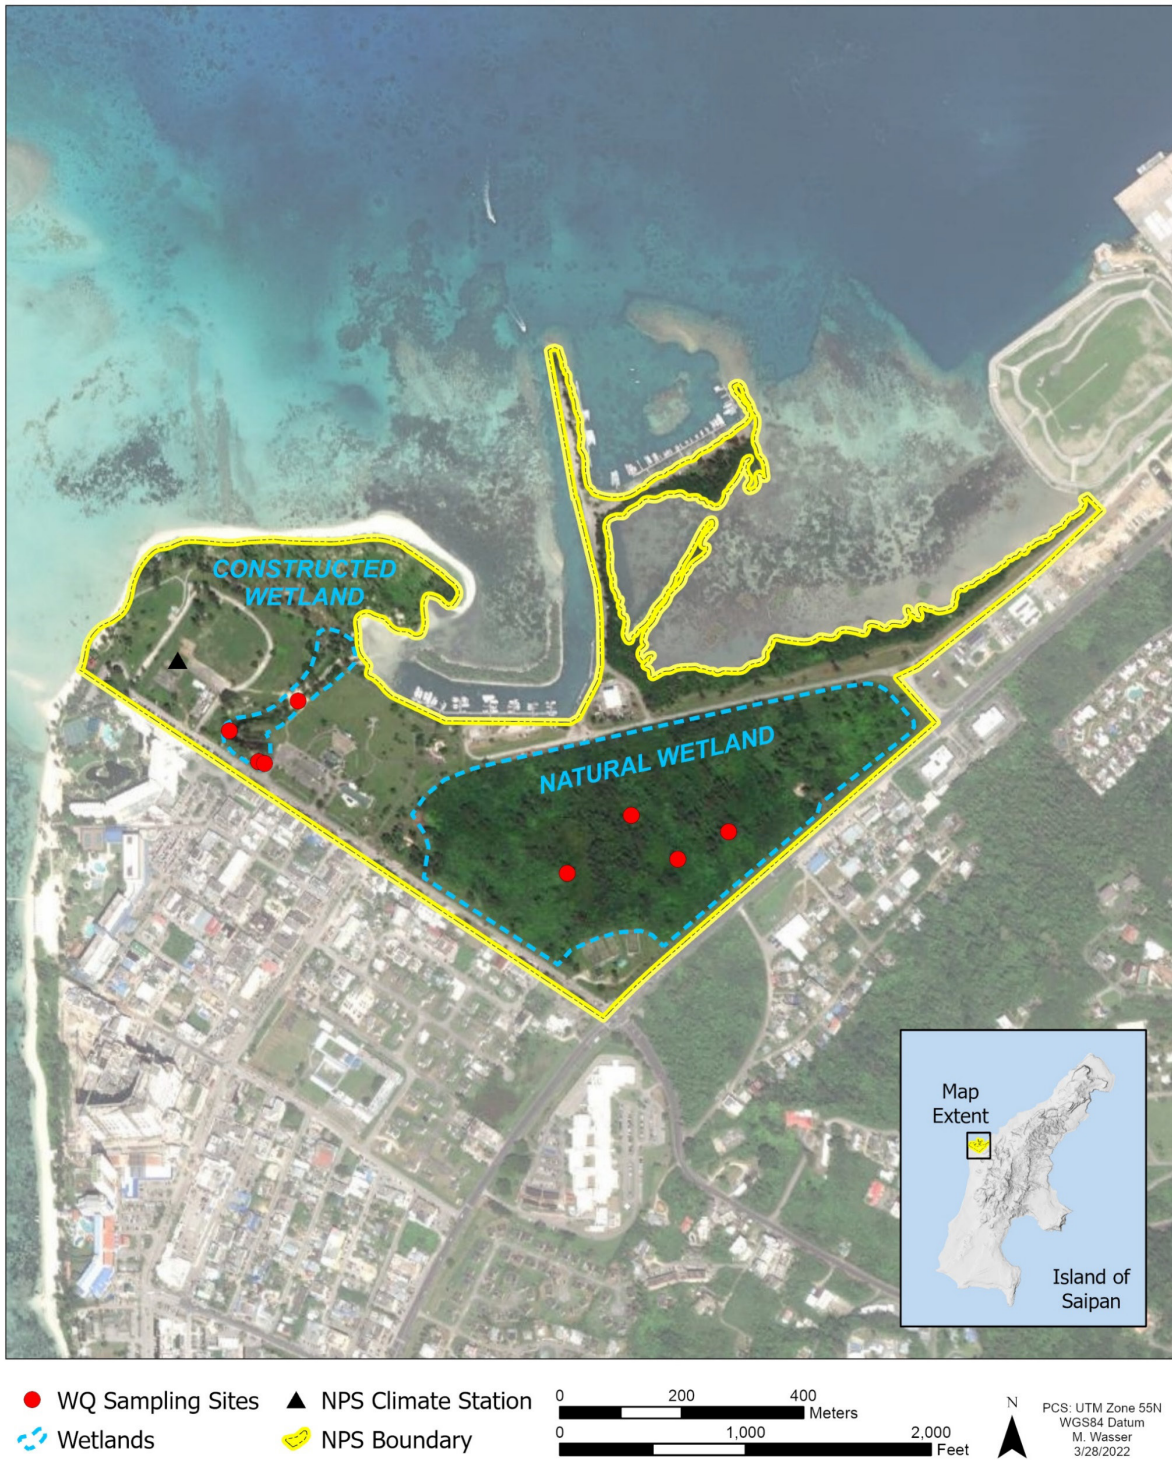
**Figure 1.** American Memorial Park, Saipan, featuring a constructed wetland and a mangrove wetland.

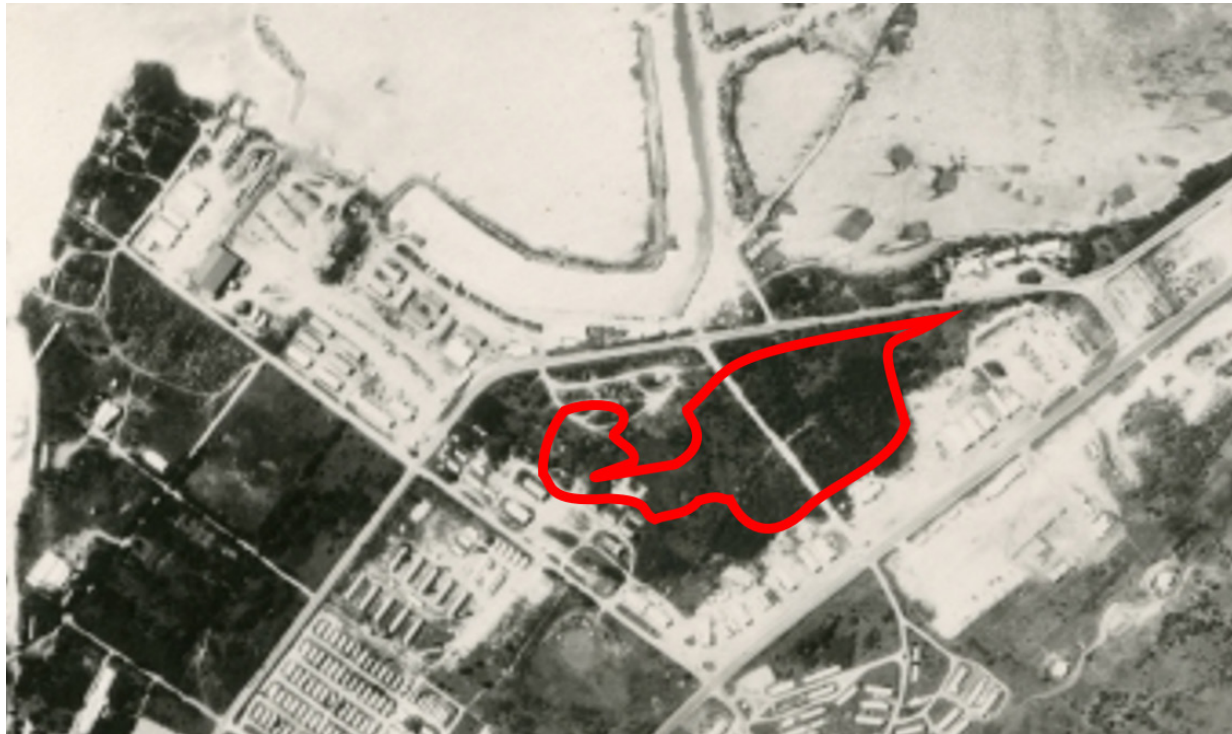
**Figure 2.** Aerial photo dated July 1949 showing structures and roads within the area now designated as the mangrove wetland, and an approximate historical extent of the mangrove wetland (red line) as described by Prasad (1997).

Historically, the mangrove wetland was noted as Muchot Marsh in records as early as 1855 and appeared on a map dated c1914 (Prasad 1997). While the island has been occupied by humans since prehistoric times, the area now designated as the mangrove wetland was developed during World War II (e.g., study sections D and E in Thomas and Price 1979) and later. An archeological survey of the wetland noted a buried sewage line, remains of buildings, a latrine, and assorted artifacts associated with Japanese and American military use during WWII. Prasad (1997) noted other studies which found vegetative evidence of standing water and reviewed historical records noting the presence of the mangrove wetland (Figure 2) and historical landscape changes, concluding that the mangrove wetland may have been connected to the ocean and may have been connected to a patch of mangroves north of Rt. 30 (referred to as Beach Road). A botanical inventory conducted at AMME in 1986 and 1988 (Raulerson and Rinehart 1989) noted that *B. gymnorhiza* was abundant along some transects and recognized as an important component to the ecosystem as the only mangrove species within AMME and Saipan. Raulerson and Rinehart (1989) also noted that “other [“major” or “true” mangrove] species are common to mangrove swamps further south,” possibly referring to *Rhizophora apiculata* and *Rhizophora mucronata* in Guam. A palynological assessment of sediment cores from AMME revealed *B. gymnorhiza* and *Acrostichum aureum* pollen during the Holocene indicating mangrove presence predating that of human arrival (Jarzen and Dilcher 2009). No pollen from the genus *Rhizophora* was recovered from the Jarzen and Dilcher (2009) cores, but the authors state that *Rhizophora* trees did previously occur in the Northern Mariana Islands, including Saipan. McIntosh and Cleghorn (2001) noted the presence of Rhizophoraceae the family containing *Bruguiera*, during archeological surveys. McIntosh and Cleghorn (2010) noted the presence of *B. gymnorhiza* specifically.

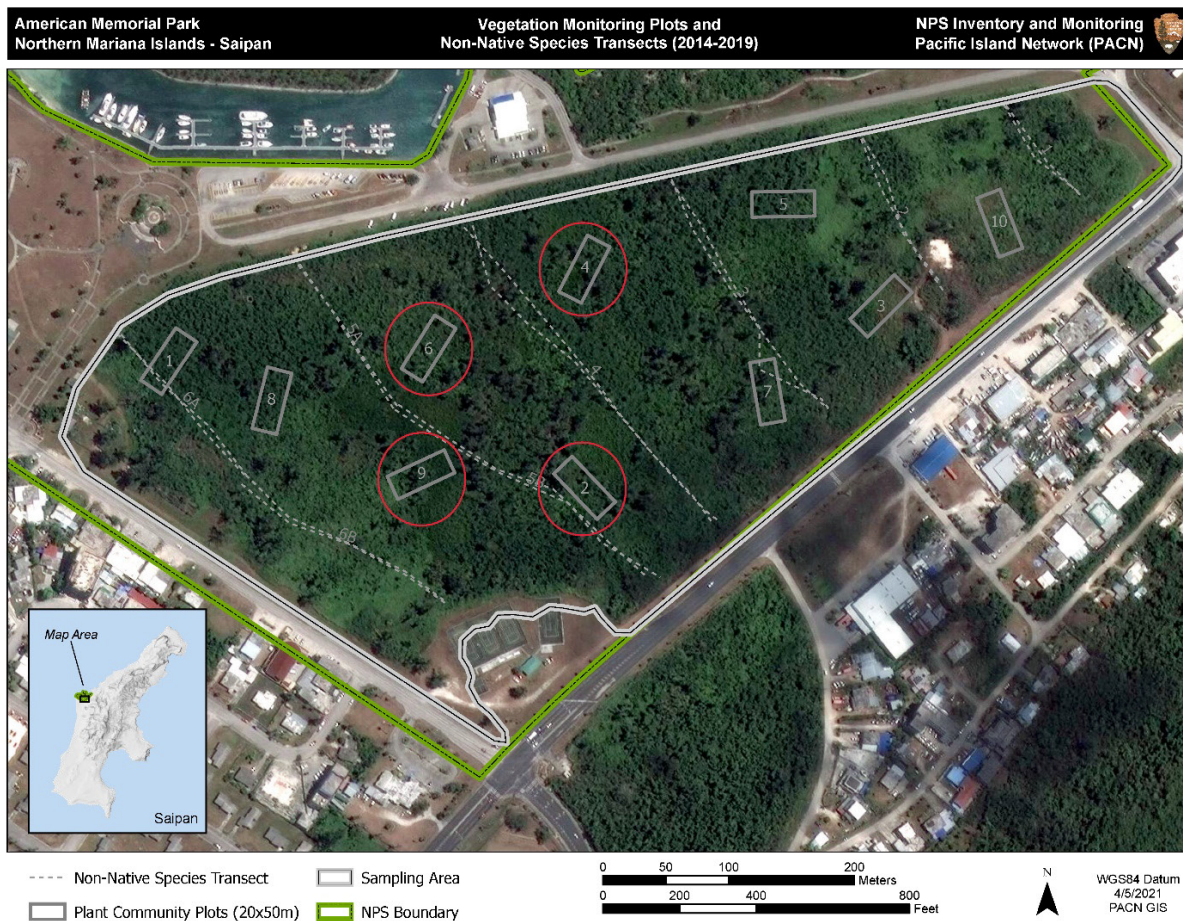
**Figure 4.** Vegetation monitoring plots within American Memorial Park visited in 2014 and 2019. Red circles highlight plots containing *B. gymnorhiza*.

*Bruguiera gymnorhiza* were present in 4 out of 10 monitoring plots (02, 04, 06, 09) located around the interior of the AMME mangrove wetland (Figure 4). From 2014 to 2019, three of the four plots containing *B. gymnorhiza* trees experienced substantial declines in large (>10 cm DBH) individuals (Figure 6). The greatest declines were witnessed within Plot 6, where 57 large trees died within the 1000 m<sup>2</sup> sampling area, translating to a loss of 570 large trees per ha. Medium-sized trees (5<10 cm DBH) and seedling-sized (<1 cm DBH) also declined in several plots, while small-sized *B. gymnorhiza* (1<5 cm DBH) showed signs of recruitment. Three plots showed increased *B. gymnorhiza* cover within the understory (0–2 m from the ground; Figure 7), likely related to the increased density of small-sized mangrove. Within the four mangrove plots, six plant species showed greater increases in cover than the mangrove, these species included: the native langyao fern (*Acrostichum aureum*); the native pago tree (*Hibiscus tiliaceus*), a facultative wetland species with a low-sprawling form; the non-native Indian pluchea shrub (*Pluchea indica*); a non-native vine (*Mikania* sp., likely *Mikania scandens*); an aggressive vine-like native shrub, gasoso (*Colubrina asiatica*), recognized as highly invasive in other locales; and a native banago vine (*Jasminum marianum*). Total understory cover of both native and non-native plants increased within the mangrove plots (Figure 8), presumably from the increased light availability of downed canopy trees during typhoons Soudelor in 2015 and Yutu in 2018. Comparison of photographs taken in 2014 and 2019 illustrate the change in the overall character of vegetation within three of the plots containing mangrove (Figures 9–11).

Plots on the eastern and western edges of the mangrove wetland, where *B. gymnorhiza* was not found (Figure 4), were dominated by non-native grasses, vines, trees, shrubs, and herbs in the understory, all of which are non-mangrove species, thus indicating non-mangrove habitat. Uniquely, the understory of mangrove forests is almost exclusively seedlings, and saplings of the overstory (typically mangrove species) and often lack non-mangrove species (Lugo 1999); an exception being landward transition edges of the mangrove forest or when soil salinity is low (e.g., mangroves in high

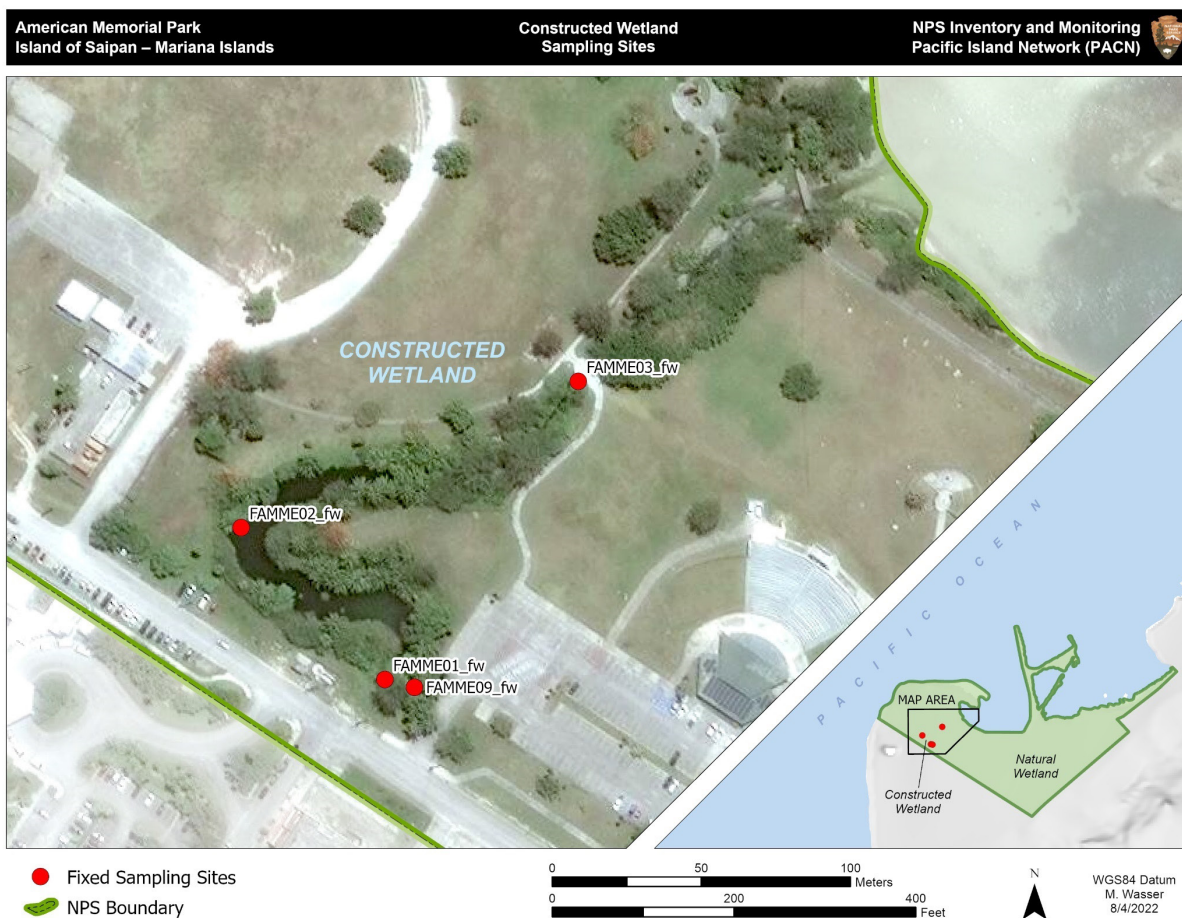
**Figure 5.** The constructed wetland at American Memorial Park. Sewage-contaminated effluent enters at FAMME01\_fw and flows to the shoreline.

Site names for water quality sampling used by PACN were formatted to designate fixed (F) sites, park (e.g., AMME), a number (e.g., 01), and habitat type (“fw” for freshwater). Four fixed sample sites were sampled in the mangrove wetland and four fixed sites were sampled in the constructed wetland. Because the constructed wetland was made to mitigate high nutrient concentrations before stormwater drain effluent entered the ocean, the linear pattern of nutrients along the length of the wetland channel was examined. Note that FAMME01\_fw is located at the outlet of the stormwater drain, FAMME09\_fw is located within an area typically overgrown with emergent aquatic plants, and that the channel flows north-easterly to the shoreline (Figure 5).

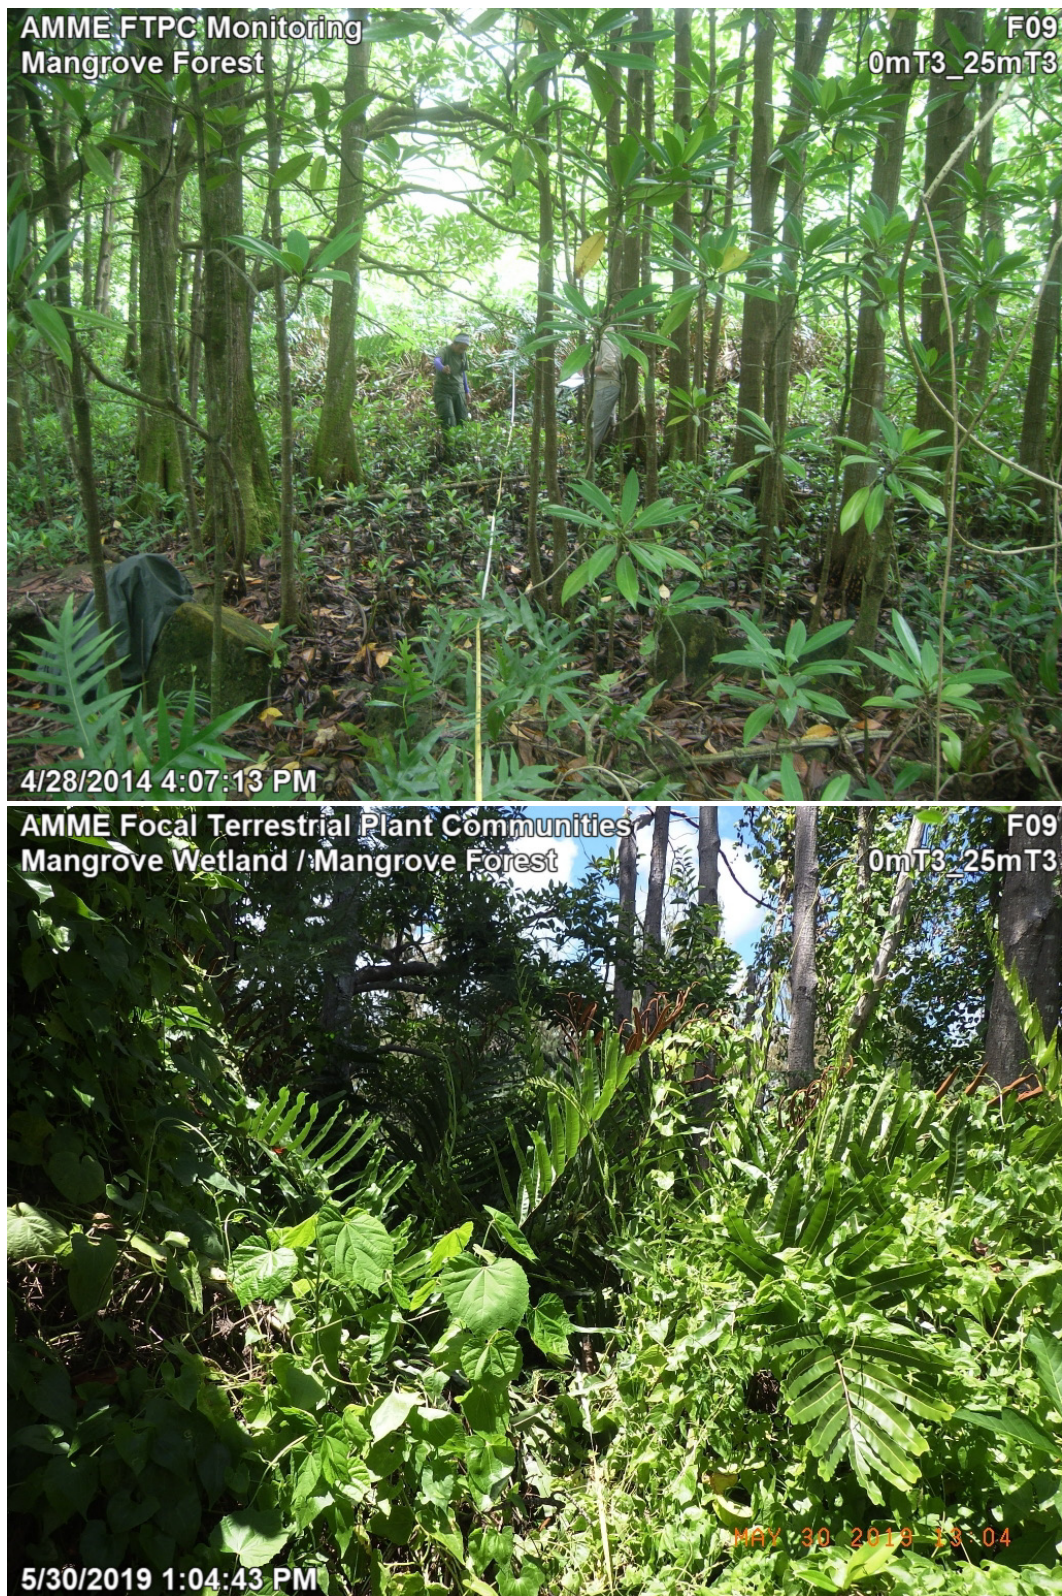
**Figure 9.** AMME vegetation plot 09 in 2014 (top) and 2019 (bottom) showing decrease in canopy cover and increase in understory density.

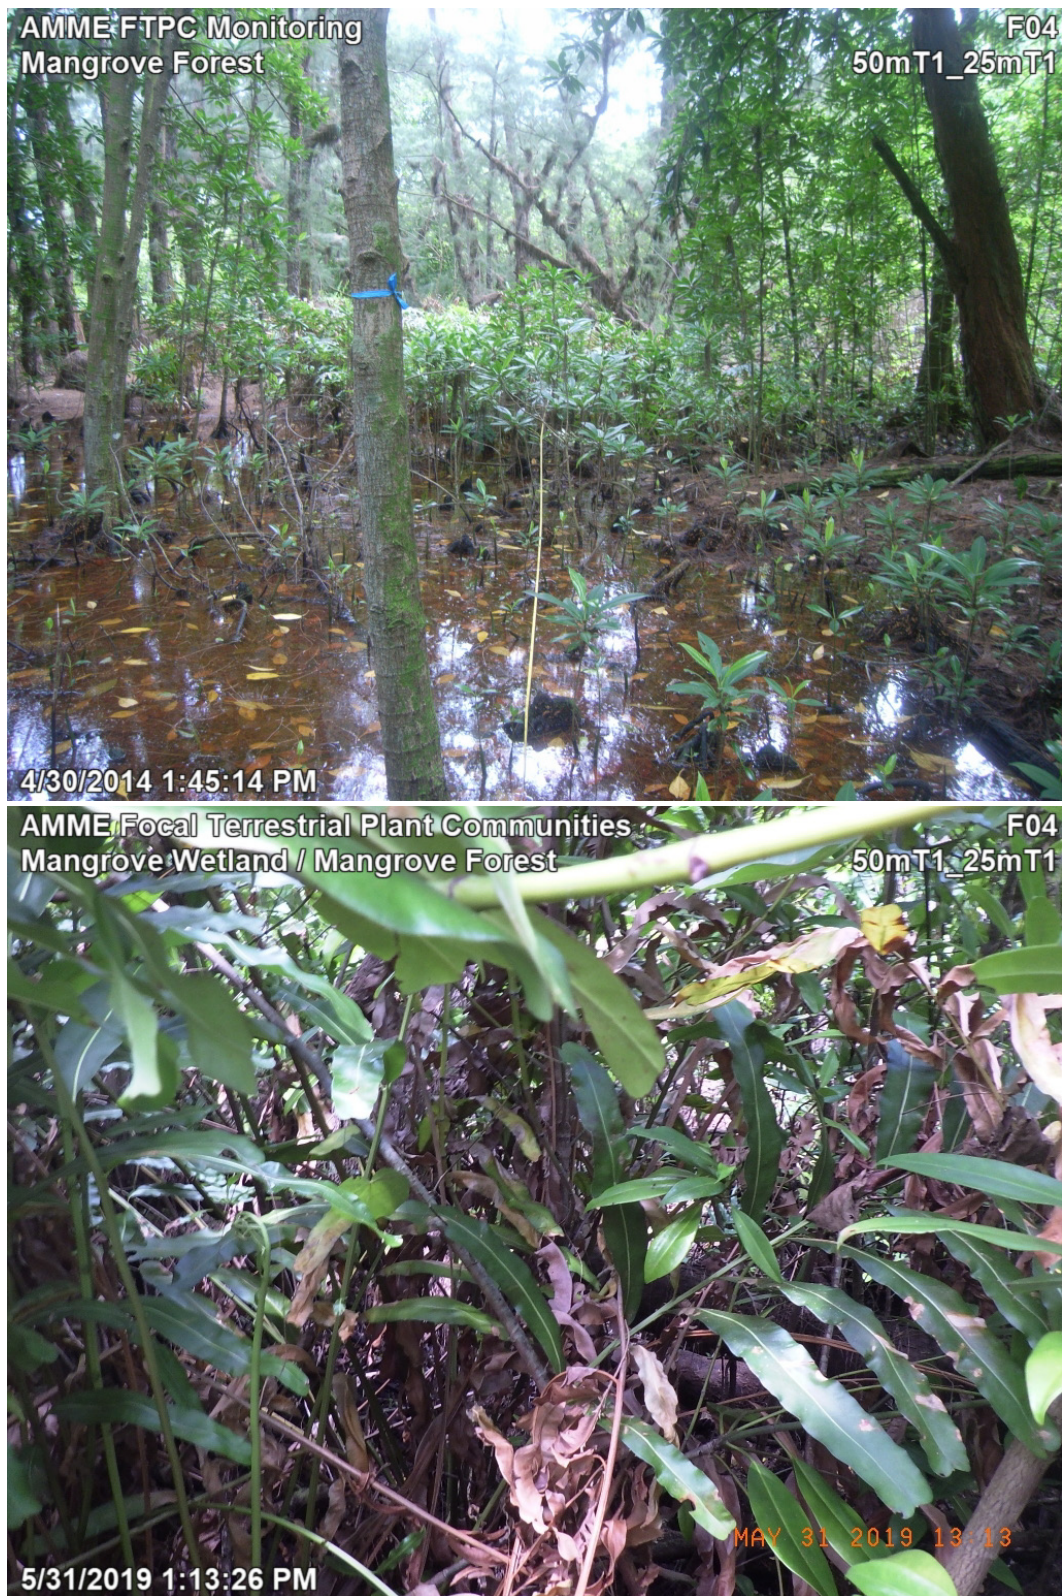
**Figure 11.** AMME vegetation plot 04 in 2014 (top) and 2019 (bottom) showing decrease in open water and increase in understory density, in this case *A. aureum*).
