## United States Department of the Interior

To: Bill Hulslander, Chief of Resource Management ASIS  
From: Peter Sharpe Ph.D., PWS, Hydrologist, Northeast Region  
Subject: Wetland Delineation Report for Travel, ASIS, 20-23 April 2022

ASIS Entrance Station – Soils Map

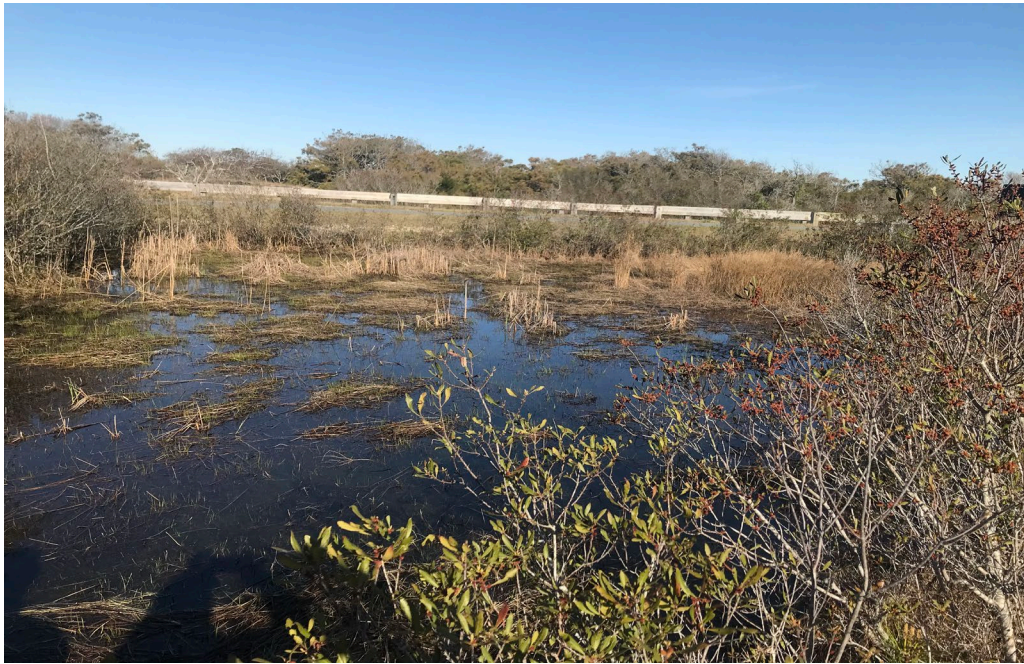
**Wetland 1 (Size – 0.24 ac):** This habitat's landscape position relative to the park entrance and adjacent visitor parking lot, as well as clear signs of manipulated earthwork, suggest that this wetland as anthropogenic in origin. Subsequent feedback from park staff in February of 2023 confirmed this assessment as the site is a designed wetland mitigation system for the North Ocean Beach parking area. The habitat exhibited characteristics of a palustrine, emergent, non-persistent, seasonally flooded-saturated Cowardin Class wetland (PEM2E – Photograph 1). Wetland soils exhibited soil characteristics of a depleted matrix (Indicator F3) the site appeared to be a constructed habitat with clear topographic breaks between upland/wetland habitats. Primary wetland hydrology appeared to come from drainage associated with the adjacent parking lot and roadway along with direct precipitation. A potential for some tidal flooding/influence from the dual culvert system traversing the roadway and providing drainage connectivity between Wetlands 2 and 3 was also noted but no surface water flow between Wetland 1 and 2 was observed during this investigation. The dominant plant species observed within the wetland were *Morella cerifera* (primarily along the wetland boundary) and *Typha angustifolia*. Other notable plant species that were observed within the wetland but did not exhibit relative abundances great enough to qualify as dominant species via the 50/20 rule included: *Typha latifolia*, *Phalaris arundinacea*, *Juncus effusus* and *Solidago sempervirens*.

Photograph 1 (P1) – Wetland 1 (PEM2E) view is west looking at the habitat and boundary flags which terminate at the northern entrance road toe-of-slope in the background. Photo Date 20 April 2022 – P. Sharpe.

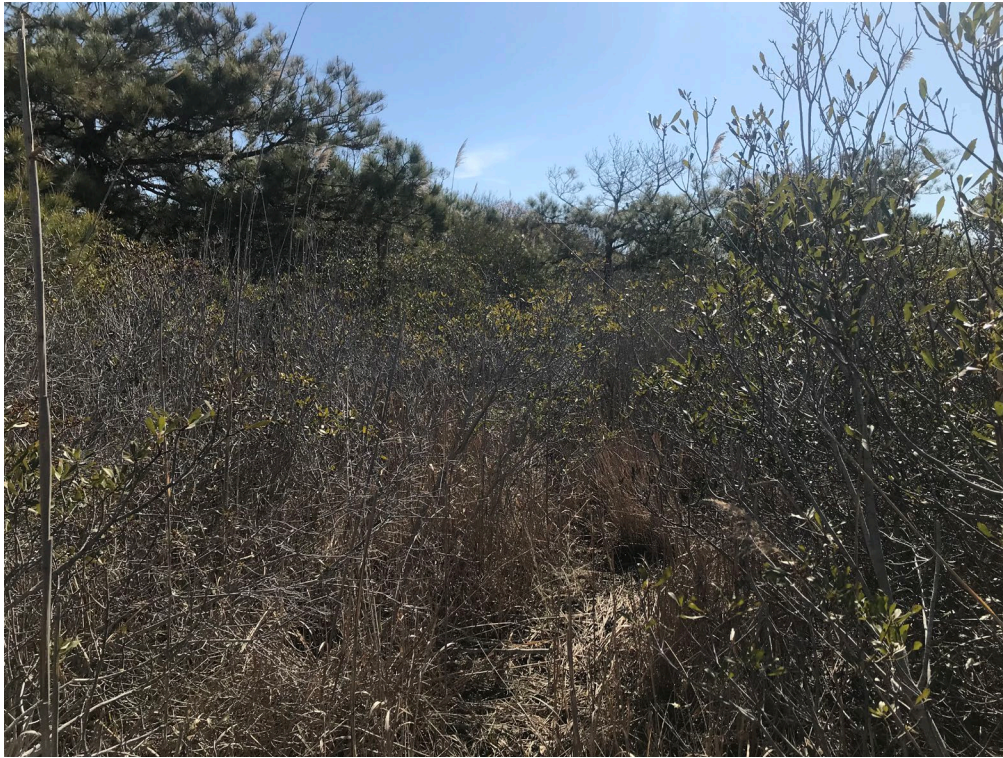
**Wetland 2 (Size –2.42 ac):** This wetland system is a *Morella cerifera* dominated palustrine, scrub-shrub, broad leaved deciduous, saltwater tidal, irregularly flooded habitat (PSS1P). The source of tidal influence is a pair of concrete culverts traversing Bayberry Drive connecting this system to the various habitats within Wetland 3. This site likely also receives hydrology from overland flows, direct precipitation, groundwater, and infrequent coastal over wash/flooding events. Wetland soils at this location were very dark (Indicator A11) with a very sandy soil texture indicative of the coastal setting. Apart from the *Morella cerifera* within the shrub layer, the other dominant plant species observed was *Phragmites australis* within the herbaceous zone along with non-dominate species such as *Juncus effusus* and *Solidago sempervirens*.

Photograph 2 (P2) – Wetland 2 (PSS1P) view is East looking at the extensive *Morella cerifera* shrub dominated community within this site. Photo Date 20 April 2022 – P. Sharpe.

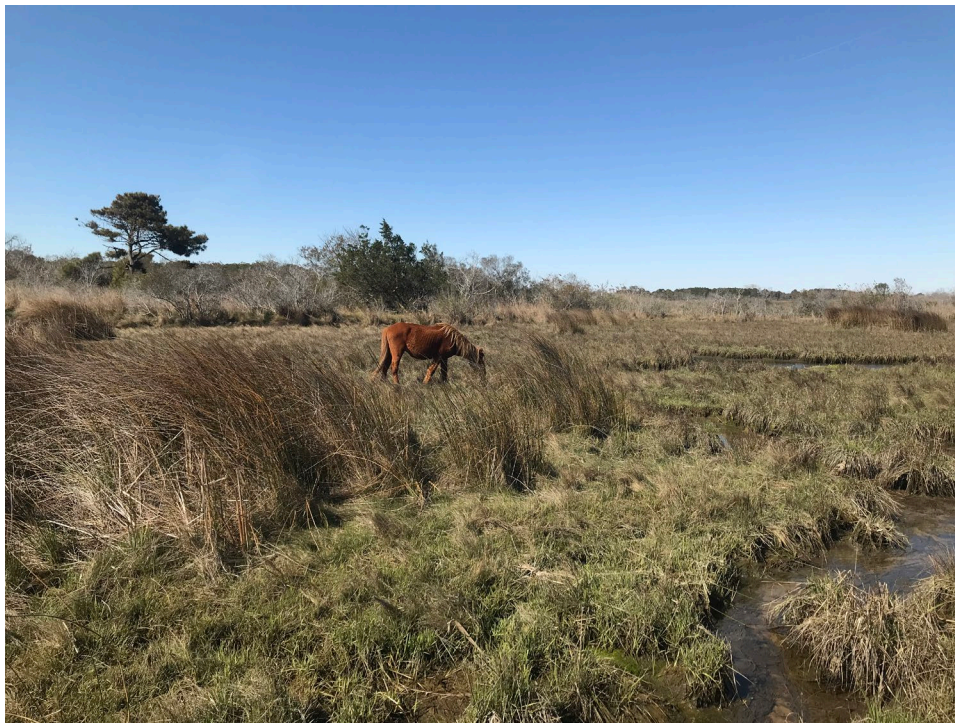
**Wetland 3 (Habitat Sizes – 1.15 ac PEM1N; 0.68 ac PSS1P; 0.03 ac PUB3N):** This wetland system is a mosaic of tidally influenced habitats directly adjacent to the Sinepuxent Bay. The largest of these habitats shown in Photo 3 is the palustrine, emergent, persistent, regularly flooded-saturated wetland component. This emergent wetland system appears to be under tidal influence and was characterized by *Spartina patens* and *Phragmites australis* with scattered patches of *Eleocharis acicularis* throughout. The scrub/shrub community was nearly identical in plant species composition and hydrologic nature as the PSS1P habitat found in Wetland 2 and there was also a very small tidally influenced palustrine, unconsolidated bottom, regularly flooded, mud bottomed habitat (PUB3N) which served as the primary hydrologic outfall point for Wetland 2. As evidenced in Photo 3 wild horse herbivory was evident throughout the site.

Photograph 3 (P3) – Wetland 3 (PSS1P/PEM1N) view is southwest looking at the emergent wetland habitat and active wild pony grazing. Photo Date 20 April 2022 – P. Sharpe.

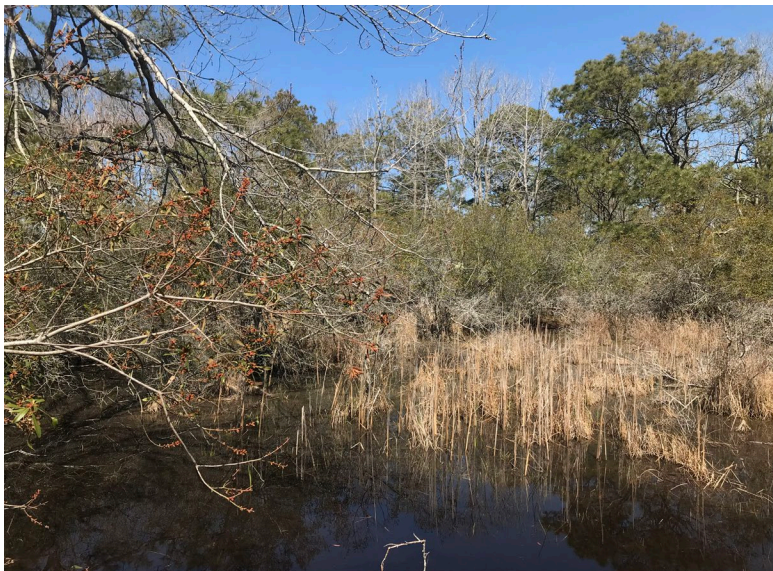
Photograph 4 (P4) – Wetland 4 (PSS) view is southwest looking through the shrub layer. Photo Date 20 April 2022 – P. Sharpe.

**Wetland 4 (Total Size – 3.88 ac PSS1P and 0.06 ac PUB3N):** Wetland 4 is comprised of the same scrub/shrub habitat evident throughout wetlands 2 and 3, (PSS1P) (Photo 4).

Soil test pits indicated high levels of sandy material within the upper 14 inches of the soil like the other sites and dark indicator F3 (Depleted Matrix) soils. Hydrology at this location appeared to be less tidally influenced (compared to Wetland 3 for example), but the wetland boundaries that extended beyond our study area limits quickly changed to a more tidally influenced emergent marsh consistent

with the PEM1N habitat found within Wetland 3. One difference between the PSS community of Wetland 4 to that of Wetlands 2 and 3 was the presence of some mature *Acer rubrum* trees. While these red maple trees were present and met the 50/20 dominance test for vegetation their aerial coverage (17.5%) was dwarfed by the scrub/shrub layer of *Morella cerifera* (87.5%). Additionally, the red maple trees that appeared to exhibit the greatest health and vigor were typically located on high hummocks or along the saturated edges of the wetland system see Photo 4. The herbaceous plant species cover was sparse at this time of year but dominated by *Andropogon virginicus* and *Agrostis* sp. Another small likely tidally influenced open water area (PUB3N) was also mapped within this habitat.

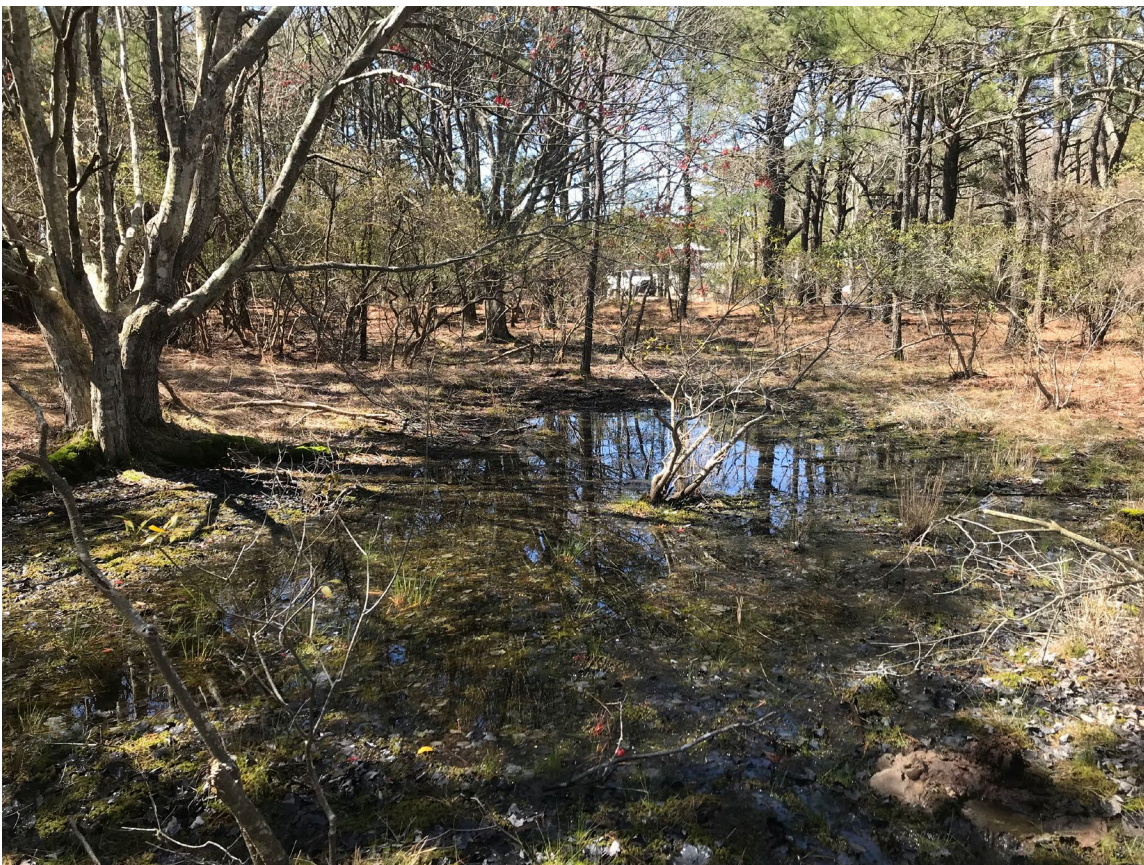
**Wetland 5 (Size – 0.06 ac PUB3N):** This wetland system appeared to be a shallow concave wetland system primarily receiving its hydrology from direct precipitation, some overland flows (though this is likely a minor component of the sites water budget) and potentially ground water.

Photograph 5 (P5) – Wetland 5 (PUB) view is south looking at the main wetland prism, note the sparse cover of macrophytic plants except for *Huperzia lucidula* found throughout the wetted perimeter of this photo. Photo Date 20 April 2022 – P. Sharpe.

As a sparsely vegetated concave surface (see Photo 5) there was very little vascular plants

present within the wetland prism excluding *Hyperzia lucidula* which was present throughout the wetted perimeter of the wetland area. Soils at this location displayed a very thin peat layer (0-3) inches followed by a 12-inch-thick sandy loam textured stripped matrix (Indicator S6).

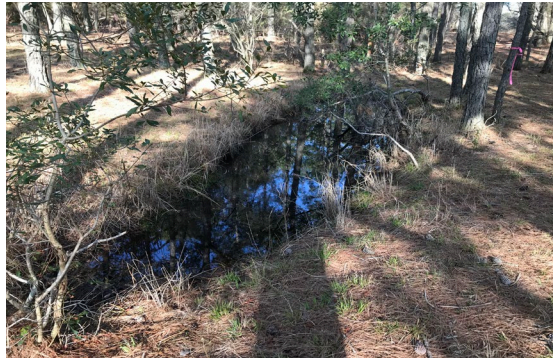
Though these mapped systems were below what we would typically identify and map in the field (0.1 ac is the usual threshold), their clustered presence and proximity to Wetland 5 warranted mapping and inclusion within this report. None of these systems exhibited hydrophytic plant characteristics at the time of the investigation or obvious surface water connections to each other or the nearby bay. These systems lie within a forested area dominated by *Pinus taeda* with a sparse understory layer primarily composed of *Smilax rotundifolia*. The current theory regarding their origin is that these pockets of standing water may have been the remnants of past excavation activities and that they are currently deep enough to intercept a seasonally high groundwater table. Water depths within these small pools ranged from 9-2.5 inches and no vascular plants were observed within the wetland prisms, nor were any signs of aquatic or semi-aquatic life observed as well. *Sphagnum* moss was evident throughout the wetted perimeter of the sites and as this was a single point in time survey conclusions regarding wildlife use (or non-use) as well as wetland hydroperiods (wet/dry cycles) should be taken with caution. Wetlands 5-8 represent a wetland mosaic of shallow sparsely vegetated isolated depressions located within a small stand of loblolly pines that could serve as excellent habitat

Wetland 6 (PUB) small pool. View is south  
21 April 2022 by P. Sharpe

for obligate vernal pool species and these would be prime locations for inclusion in any herpetological follow-up investigations.

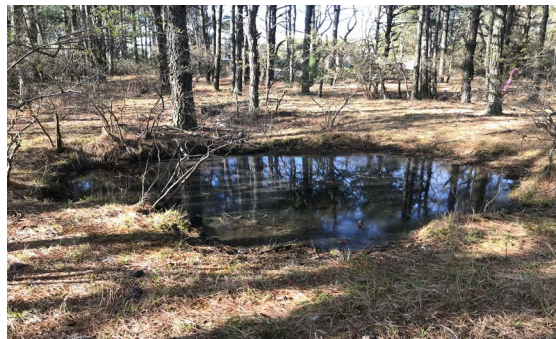
Wetland 7 (PUB) small pool. View is south  
21 April 2022 by P. Sharpe.

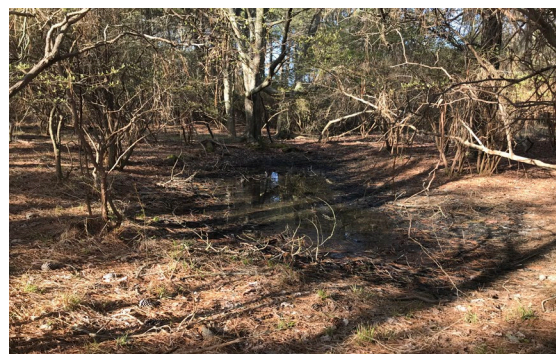
Wetland 8 (PUB) small pool View is south.  
21 April 2022 by P. Sharpe
