# NPS Wildfire Risk Assessments Assessment Locations

## Fort Bowie National Historic Site

# NPS Wildand Fire Risk Assessment - Facility Wildfire Risk Assessment Summary

## Unit - Location: FOBO - Fort Bowie National Historic Site

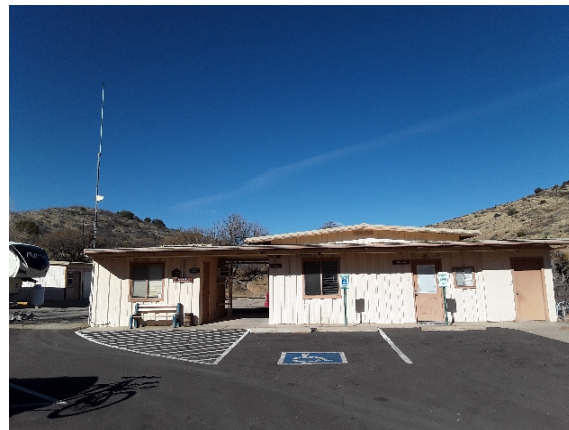
2021\_FOBO\_74987\_BLDGFB-01-Maintenance Building/Office/Shop\_Front.jpg

Defensible Space: 100 ft treated

Siding Material: Wood or open sided

Propane Tanks: Present and fuels clearance

Water Supply: Limited or dependent on electricity

Assessment Comments: hydrants are near facility but source is limited to a nearby 10,000 gallon tank

Score: 49  
Rating: Moderate  
Asset Priority Index (API): 42

| Label # | Facility/Community Name | Assessment Scale | Site Visit Type | Firewise Zone | Treatment | Treatment Description | Person Hours |
|---|---|---|---|---|---|---|---|
| 1 | BLDGFB-01-Maintenance Building/Office/Shop | Individual Facility | Initial | 2 | Remove dead or dying component of shrubs and trees | | 4.0 |

| Facility/Community Name | Assessment Scale | Triage Category | Tactic Description | Person Hours | Equipment Description | Equip. Qty |
|---|---|---|---|---|---|---|
| BLDGFB-01-Maintenance Building/Office/Shop | Individual Facility | PrepLeave | Fuels reduction - emphasis on fuels around propane tanks | 6.0 | - | |
| | | | Install sprinkler system - | 6.0 | - | |

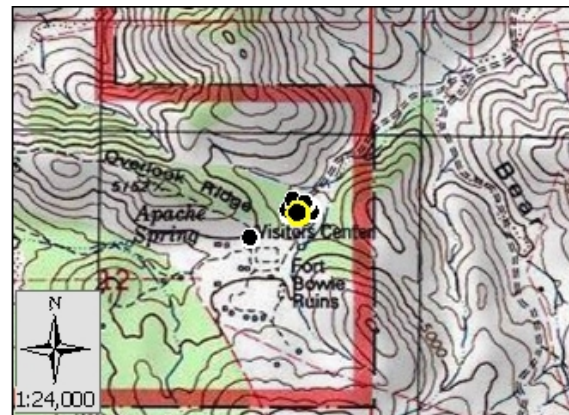
**Primary Access:** Road  
**Ingress/Egress:** One roads in/out  
**Access Width:** 1 lane (<18ft)  
**Access Condition:** Non-surfaced- gravel,dirt,grade<5%

**Bridge Condition:** None/nonflammable,load limit will not limit response  
**Access & Turnarounds:** Access is <300 ft from facility w/o turnaround  
**Facility Number/Sign:** Marked and clearly visible

**Roof Material:** Noncombustible or not applicable  
**Siding Material:** Wood or open sided  
**Foundation:** Closed, 6in to 30in masonry exposed  
**Fences/Decks:** None or noncombustible

**Firewood:** None  
**Propane Tanks:** Present and fuels clearance  
**Water Supply:** Limited or dependent on electricity  
**Overhead Hazards:** No overhead hazards

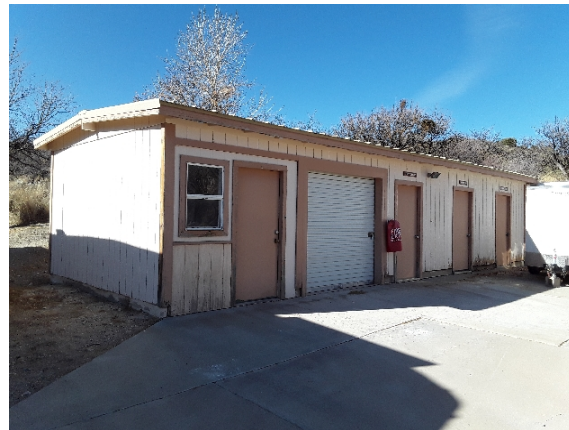
2021\_FOBO\_75007\_Front.jpg

**Defensible Space:** 30 ft treated  
**Fuel Load (w/in 300 ft):** Light  
**Fuel Type (w/in 300ft):** Grass,shrub,hardwood litter  
**Topography (w/in 300ft):** Slope 31% to 40%

**Safety Zones:** Potential safety zone(s) in area  
**Additional Obstacles:** None  
**Triage Category:**  
**Hazmat:** gas pumps adjacent  
**Assessment Comments:** hydrants are near facility but source is limited to a nearby 10,000 gallon tank

**Score: 50**  
**Rating: Moderate**  
**Asset Priority Index (API): 42**

| Label # | Facility/Community Name | Assessment Scale | Site Visit Type | Firewise Zone | Treatment | Treatment Description | Person Hours |
|---|---|---|---|---|---|---|---|
| 2 | BLDGFB02-Fire Cache/Storage/Tool Shed Building | Individual Facility | Initial | 2 | Remove dead or dying component of shrubs and trees | | 5.0 |

| Facility/Community Name | Assessment Scale | Triage Category | Tactic Description | Person Hours | Equipment Description | Equip. Qty |
|---|---|---|---|---|---|---|
| BLDGFB02-Fire Cache/Storage/Tool Shed Building | Individual Facility | PrepLeave | Fuels reduction - | 5.0 | - | |
| | | | Install sprinkler system - | 4.0 | - | |

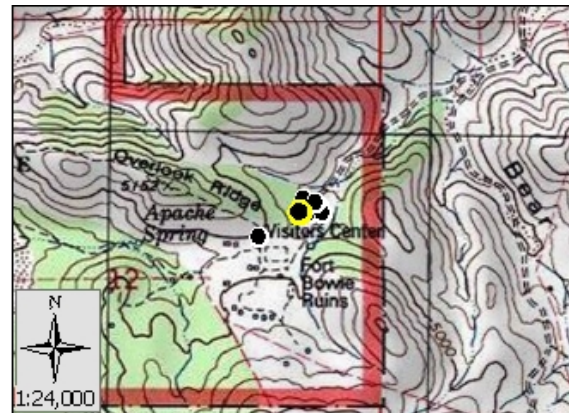
**Primary Access:** Road  
**Ingress/Egress:** One roads in/out  
**Access Width:** 1 lane (<18ft)  
**Access Condition:** Non-surfaced- gravel,dirt,grade>5%

**Bridge Condition:** None/nonflammable,load limit will not limit response  
**Access & Turnarounds:** Access is <300 ft from facility w/o turnaround  
**Facility Number/Sign:** Marked and clearly visible

**Roof Material:** Noncombustible or not applicable  
**Siding Material:** Rock, concrete, metal  
**Foundation:** Open or deck  
**Fences/Decks:** None or noncombustible

**Firewood:** None  
**Propane Tanks:** Present and fuels clearance  
**Water Supply:** Limited or dependent on electricity  
**Overhead Hazards:** No overhead hazards

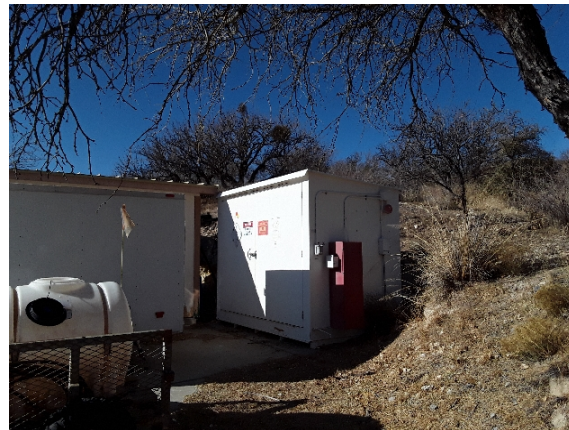
2021\_FOBO\_75018\_BLDGFB02-Haz-Mat Building\_Front.jpg

**Defensible Space:** 30 ft treated  
**Fuel Load (w/in 300 ft):** Light  
**Fuel Type (w/in 300ft):** Grass,shrub,hardwood litter  
**Topography (w/in 300ft):** Slope 31% to 40%

**Safety Zones:** Potential safety zone(s) in area  
**Additional Obstacles:** Hazmat, UXO,etc. , PLEASE COMMENT  
**Triage Category:**  
**Hazmat:** gas pumps adjacent

**Assessment Comments:** hydrants are near facility but source is limited to a nearby 10,000 gallon tank

**Score: 53**  
**Rating: Moderate**  
**Asset Priority Index (API): 39**

| Label # | Facility/Community Name | Assessment Scale | Site Visit Type | Firewise Zone | Treatment | Treatment Description | Person Hours |
|---|---|---|---|---|---|---|---|
| 3 | BLDGFB02-Haz-Mat Building | Individual Facility | Initial | 1 | Flammable ground cover such as leaf litter, woody debris or highly flammable vegetation should be removed | Clear fuels within zone 1. | 4.0 |
| | | Individual Facility | Initial | 2 | Remove dead or dying component of shrubs and trees | | 4.0 |

| Facility/Community Name | Assessment Scale | Triage Category | Tactic Description | Person Hours | Equipment Description | Equip. Qty |
|---|---|---|---|---|---|---|
| BLDGFB02-Haz-Mat Building | Individual Facility | PrepLeave | Engine on scene - One engine sufficient to protect and secure in the event of wildfire. | 6.0 | - | |

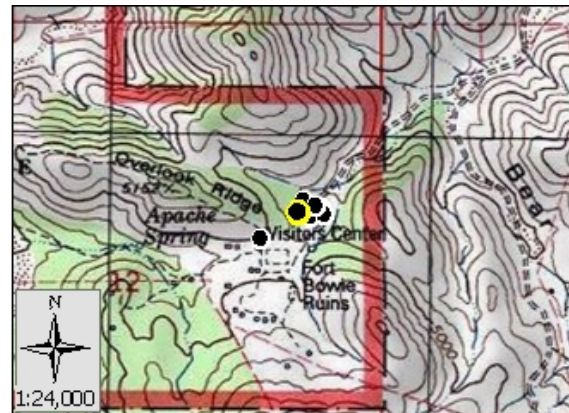
**Primary Access:** Road  
**Ingress/Egress:** One roads in/out  
**Access Width:** 1 lane (<18ft)  
**Access Condition:** Non-surfaced- gravel,dirt,grade>5%

**Bridge Condition:** None/nonflammable,load limit will not limit response  
**Access & Turnarounds:** Access is >300ft from facility w/o turnaround  
**Facility Number/Sign:** Marked and clearly visible

**Roof Material:** Noncombustible or not applicable  
**Siding Material:** Rock, concrete, metal  
**Foundation:** Closed, < 6in masonry exposed  
**Fences/Decks:** Combustible, adjacent, clear of veg/debris

**Firewood:** None  
**Propane Tanks:** None  
**Water Supply:** Limited or dependent on electricity  
**Overhead Hazards:** No overhead hazards  
**Safety Zones:** Potential safety zone(s) in area

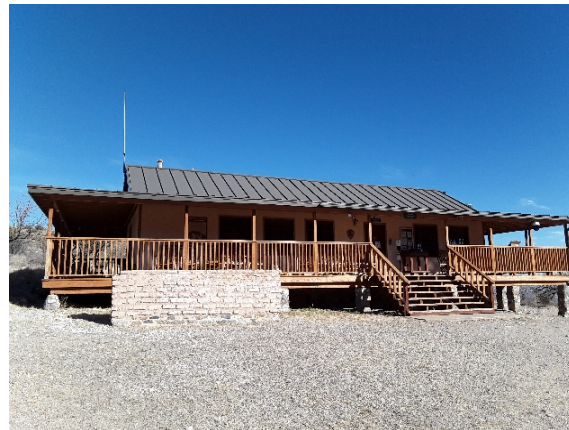
2021\_FOBO\_69672\_BLDG-FB13 Visitor Center\_Front.jpg

**Defensible Space:** 30 ft treated  
**Fuel Load (w/in 300 ft):** Light  
**Fuel Type (w/in 300ft):** Grass,shrub,hardwood litter  
**Topography (w/in 300ft):** Slope 21% to 30%

**Additional Obstacles:** None  
**Triage Category:**  
**Hazmat:**  
**Assessment Comments:** hydrants are near facility but source is limited to a nearby 10,000 gallon tank

**Score: 50**  
**Rating: Moderate**

| Label # | Facility/Community Name | Assessment Scale | Site Visit Type | Firewise Zone | Treatment | Treatment Description | Person Hours |
|---|---|---|---|---|---|---|---|
| 4 | BLDG-FB13 Visitor Center | Individual Facility | Initial | 1 | Mow dead/dying grass to less than 4 inches | | 2.0 |
| | | Individual Facility | SiteVisit | 2 | Mow dead/dying grass to less than 4 inches | | 2.0 |

| Facility/Community Name | Assessment Scale | Triage Category | Tactic Description | Person Hours | Equipment Description | Equip. Qty |
|---|---|---|---|---|---|---|
| BLDG-FB13 Visitor Center | Individual Facility | PrepLeave | Install sprinkler system - | 6.0 | - | |

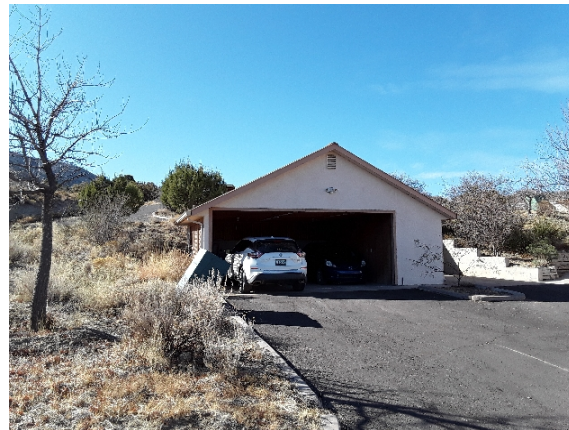
2021\_FOBO\_75066\_Carport\_Front.jpg

**Facility Number/Sign:** None or not clearly visible

**Defensible Space:** 30 ft treated

**Assessment Comments:** retaining walls on back sides. hydrants are near facility but source is limited to a nearby 10,000 gallon tank

**Score: 50**  
**Rating: Moderate**

| Label # | Facility/Community Name | Assessment Scale | Site Visit Type | Firewise Zone | Treatment | Treatment Description | Person Hours |
|---|---|---|---|---|---|---|---|
| 5 | Carport | Individual Facility | Initial | 1 | Mow dead/dying grass to less than 4 inches | | 1.0 |
| | | Individual Facility | Initial | 2 | Remove dead or dying component of shrubs and trees | | 3.0 |

| Facility/Community Name | Assessment Scale | Triage Category | Tactic Description | Person Hours | Equipment Description | Equip. Qty |
|---|---|---|---|---|---|---|
| Carport | Individual Facility | PrepLeave | Fuels reduction - | 8.0 | - | |

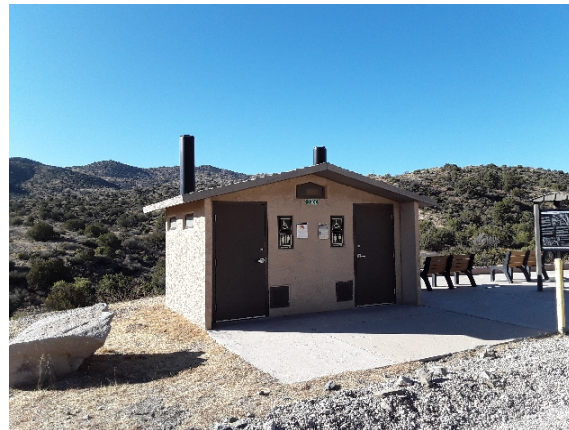
2021\_FOBO\_113242\_Front.jpg

**Fences/Decks:** None or noncombustible  
**Firewood:** None  
**Propane Tanks:** None  
**Water Supply:** No reliable water source nearby  
**Overhead Hazards:** Overhead hazards will limit aircraft

**Safety Zones:** Potential safety zone(s) in area  
**Additional Obstacles:** None  
**Triage Category:**  
**Hazmat:**  
**Assessment Comments:** approximately 6 miles out on 2 lane dirt road

**Score: 47**  
**Rating: Moderate**  
**Asset Priority Index (API): 64**

| Label # | Facility/Community Name | Assessment Scale | Site Visit Type | Firewise Zone | Treatment | Treatment Description | Person Hours |
|---|---|---|---|---|---|---|---|
| 6 | Comfort Station | Individual Facility | Initial | 0 | | | |

| Facility/Community Name | Assessment Scale | Triage Category | Tactic Description | Person Hours | Equipment Description | Equip. Qty |
|---|---|---|---|---|---|---|
| Comfort Station | Individual Facility | Standalone | Other, please describe. - none necessary. light fuel loading | | - | |

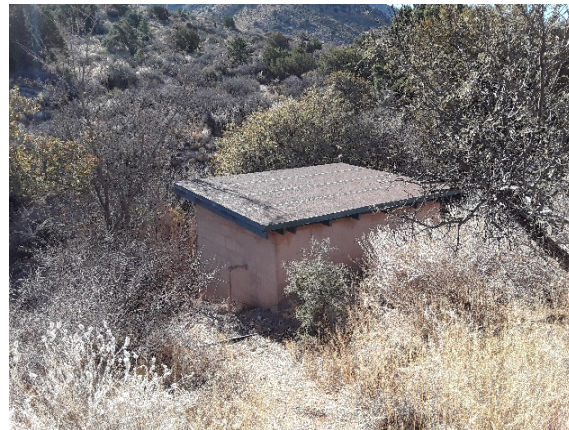
2021\_FOBO\_not found \_Pumphouse\_Front.jpg

**Assessment Comments:** hydrants are near facility but source is limited to a nearby 10,000 gallon tank

**Score: 70**  
**Rating: High**

| 7 | Pumphouse | Individual Facility | SiteVisit | 1 | Flammable ground cover such as leaf litter, woody debris or highly flammable vegetation should be removed | | 3.0 |
| | | Individual Facility | SiteVisit | 1 | Open crown spacing 10 to 30 feet depending on slope | | 3.0 |

| Facility/Community Name | Assessment Scale | Triage Category | Tactic Description | Person Hours | Equipment Description | Equip. Qty |
|---|---|---|---|---|---|---|
| Pumphouse | Individual Facility | PrepLeave | Fuels reduction - | 3.0 | - | |

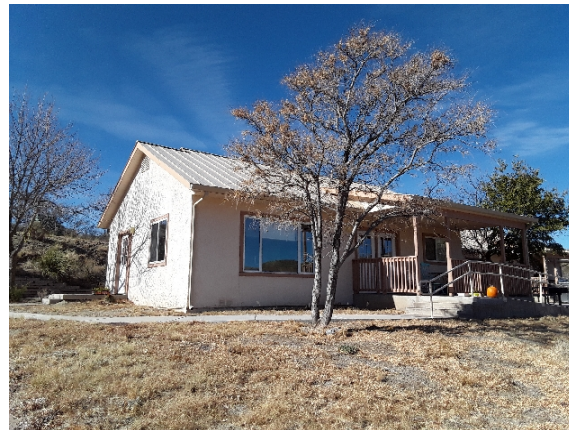
2021\_FOBO\_75051\_Quarters #30\_Front.jpg

**Assessment Comments:** hydrants are near facility but source is limited to a nearby 10,000 gallon tank

**Score: 53**  
**Rating: Moderate**  
**Asset Priority Index (API): 52**

| 8 | Quarters #30 | Individual Facility | Initial | 1 | Mow dead/dying grass to less than 4 inches | | 1.0 |
| | | Individual Facility | Initial | 2 | Remove dead or dying component of shrubs and trees | | 6.0 |

| Facility/Community Name | Assessment Scale | Triage Category | Tactic Description | Person Hours | Equipment Description | Equip. Qty |
|---|---|---|---|---|---|---|
| Quarters #30 | Individual Facility | PrepLeave | Install sprinkler system - | 8.0 | - | |
| | | | Fuels reduction - | 12.0 | - | |

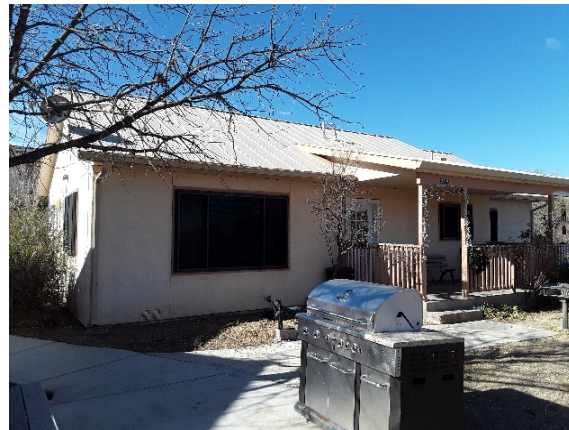
2021\_FOBO\_75060\_Front.jpg

**Assessment Comments:** hydrants are near facility but source is limited to a nearby 10,000 gallon tank. shed behind house is privately owned

**Score: 53**  
**Rating: Moderate**  
**Asset Priority Index (API): 52**

| 9 | Quarters #31 | Individual Facility | Initial | 1 | Mow dead/dying grass to less than 4 inches | | 1.0 |
| | | Individual Facility | Initial | 2 | Remove dead or dying component of shrubs and trees | | 8.0 |

| Facility/Community Name | Assessment Scale | Triage Category | Tactic Description | Person Hours | Equipment Description | Equip. Qty |
|---|---|---|---|---|---|---|
| Quarters #31 | Individual Facility | PrepLeave | Install sprinkler system - | 8.0 | - | |
| | | | Fuels reduction - | 12.0 | - | |

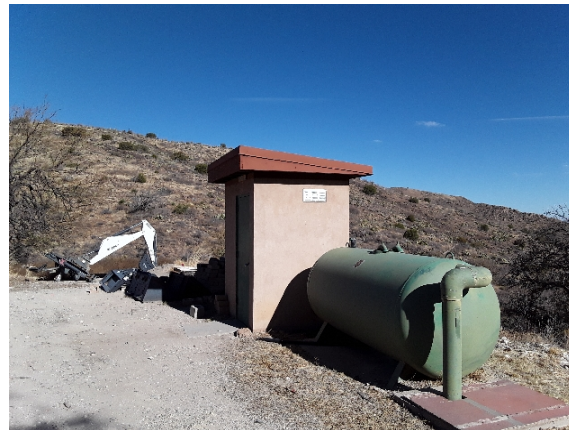
2021\_FOBO\_FOBO\_UNK Utility Shed\_UNK Utility Shed\_Front.jpg

**Roof Material:** Noncombustible or not applicable  
**Siding Material:** Rock, concrete, metal  
**Foundation:** Closed, < 6in masonry exposed  
**Fences/Decks:** None or noncombustible

**Firewood:** None  
**Propane Tanks:** Present and fuels clearance  
**Water Supply:** Limited or dependent on electricity  
**Overhead Hazards:** No overhead hazards

**Safety Zones:** Potential safety zone(s) in area  
**Additional Obstacles:** None  
**Triage Category:**  
**Hazmat:**  
**Assessment Comments:** Adjacent to unknown tank. hydrants are near facility but source is limited to a nearby 10,000 gallon tank

**Score: 53**  
**Rating: Moderate**  
**Asset Priority Index (API):**  
 N/A

| 10 | UNK Utility Shed | Individual Facility | SiteVisit | 1 | Flammable ground cover such as leaf litter, woody debris or highly flammable vegetation should be removed | | 4.0 |

| Facility/Community Name | Assessment Scale | Triage Category | Tactic Description | Person Hours | Equipment Description | Equip. Qty |
|---|---|---|---|---|---|---|
| UNK Utility Shed | Individual Facility | PrepLeave | Fuels reduction - | 5.0 | - | |
