# NPS Wildfire Risk Assessments Assessment Locations

## Fort Union Trading Post National Historic Site Overview

# Fort Union Trading Post

# NPS Wildland Fire Risk Assessment - Facility Assessment

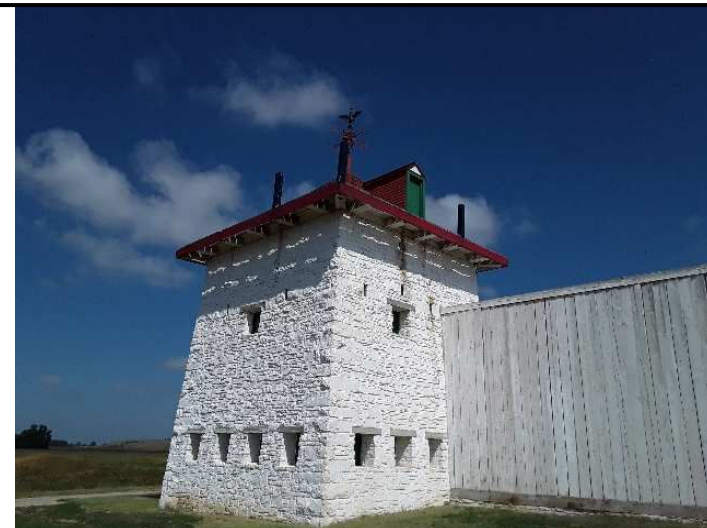
**Facility Name:** FOUS - Southwest Bastion

**Rating:** High

**Fuel Type:** Grass/tundra, northern hardwood litter

**Fuel Load:** Moderate

**Defensible Space:** Less than 30 ft treated

**Roof Material:** Combustible or no roof

**Water Supply:** No reliable water source nearby

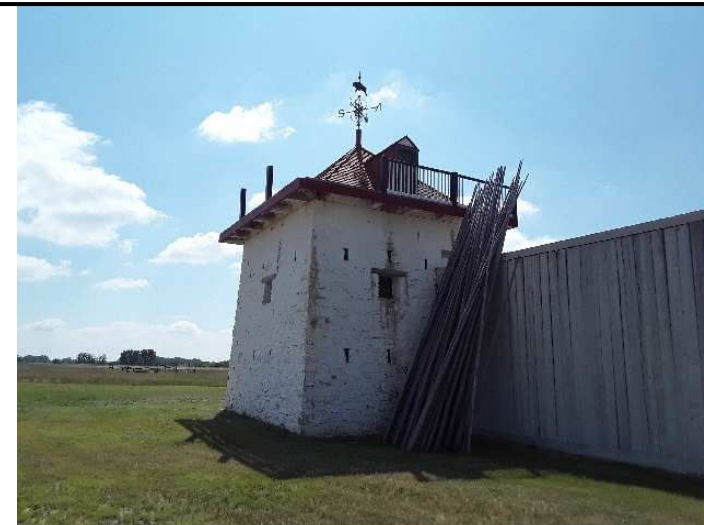
**Facility Name:** FOUS - Northeast Bastion

**Rating:** Moderate

**Fuel Load:** Light or no wildland fuels

**Defensible Space:** 30 ft treated

**Roof Material:** Combustible or no roof

**Water Supply:** No reliable water source nearby

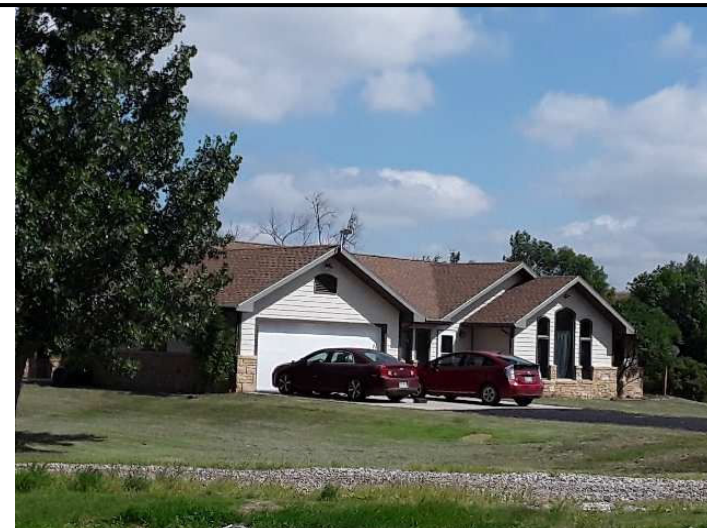
**Facility Name:** 00000179 Q179 Permanent Quarters

**Rating:** Moderate

**Fuel Type:** Grass and shrub, hardwood litter

**Fuel Load:** Moderate

**Defensible Space:** 30 ft treated

**Roof Material:** Fire resistant- tar,rubberized

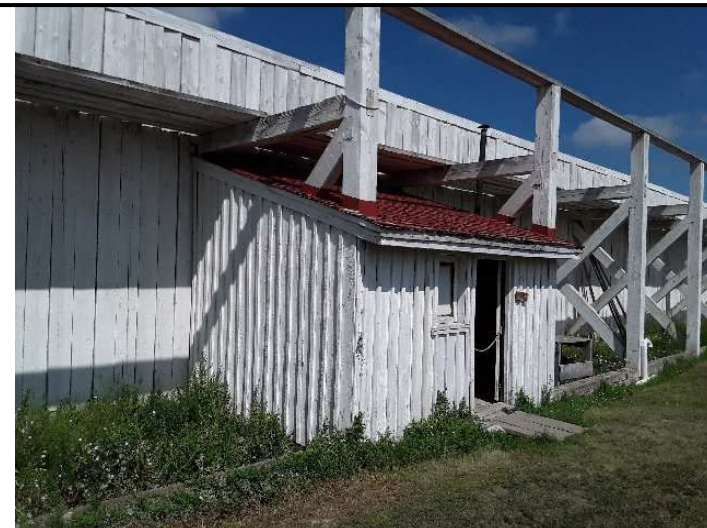
**Facility Name:** FOUS - B21 West Craftsmen Shop

**Rating:** High

**Defensible Space:** 30 ft treated

**Roof Material:** Combustible or no roof

**Foundation:** Closed, Less than 6in masonry exposed

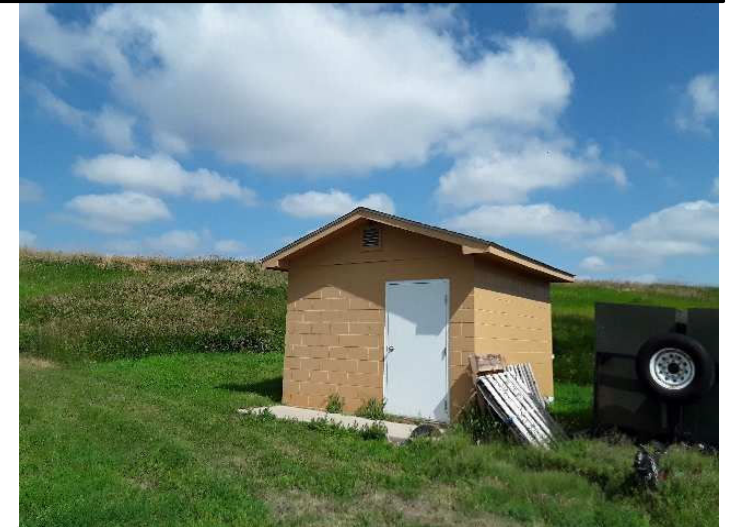
**Facility Name:** FOUS - B17 Water Treatment Building

**Rating:** Moderate

**Fuel Load:** Moderate

**Defensible Space:** 30 ft treated

**Roof Material:** Fire resistant- tar,rubberized

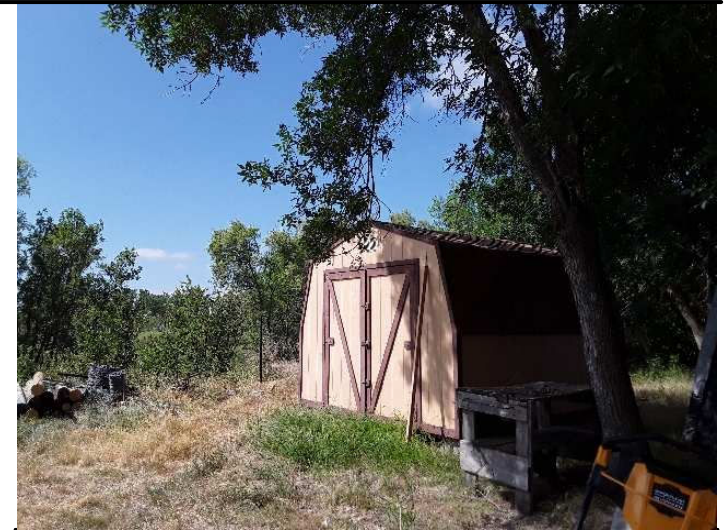
**Facility Name:** FOUS - B2 Maintenance Shed

**Rating:** High

**Defensible Space:** No defensible space

**Siding Material:** Wood or open sided

**Foundation:** Open or deck

**Propane:** Present and fuels clearance

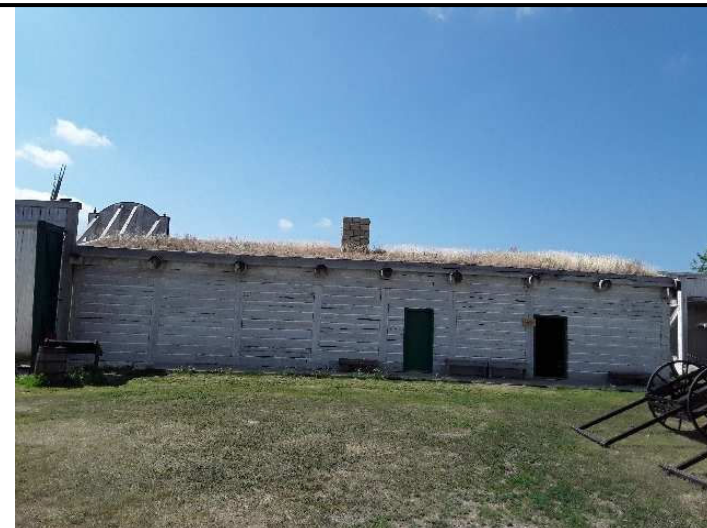
**Facility Name:** FOUS - B20 Tradehouse

**Rating:** Moderate

**Roof Material:** Combustible or no roof

**Siding Material:** Log construction

**Comments:** Sod roof with growing grass and large frame timbers.

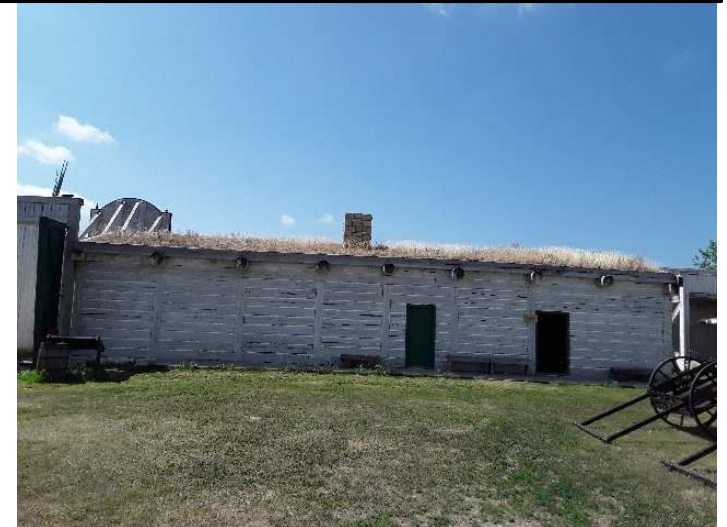
**FMSS ID:** 11672, **Local ID:**

**Rating:** Moderate

**Roof Material:** Combustible or no roof

**Siding Material:** Log construction

**Comments:** Sod roof with growing grass and large frame timbers.

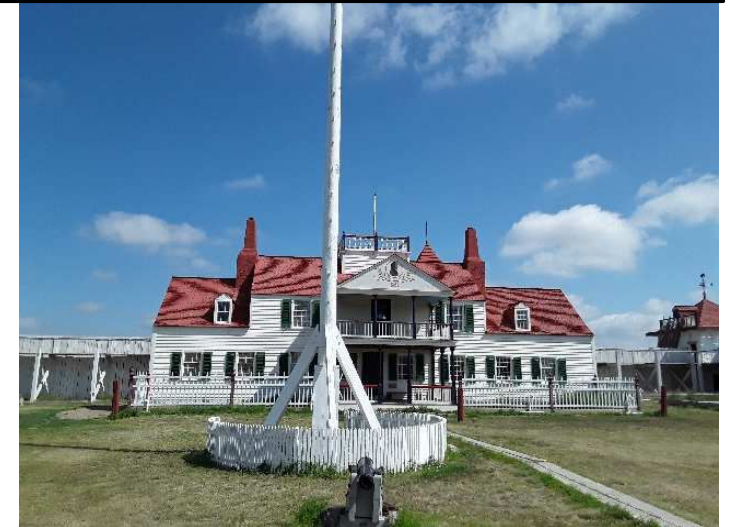
**Facility Name:** FOUS - B15 Visitor Center/Bourgeois House

**Rating:** Moderate

**Roof Material:** Combustible or no roof

**Siding Material:** Wood or open sided

**Foundation:** Open or deck

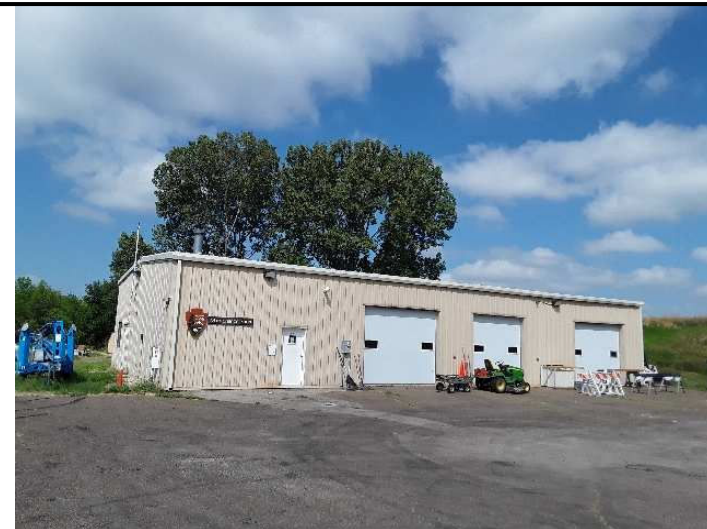
**Facility Name:** FOUS - B16 Maintenance Shop

**Rating:** Moderate

**Defensible Space:** 30 ft treated

**Roof Material:** Noncombustible or not applicable

**Propane:** Present and fuels clearance

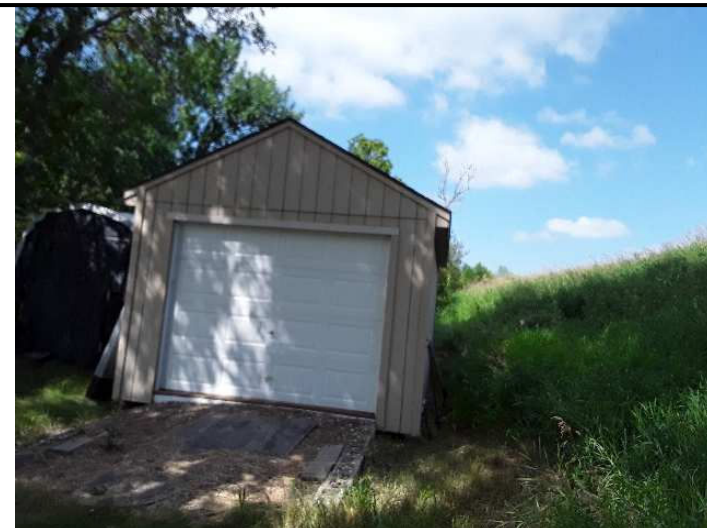
**Facility Name:** FOUS Storage Shed

**Rating:** High

**Defensible Space:** No defensible space

**Siding Material:** Wood or open sided

**Foundation:** Open or deck

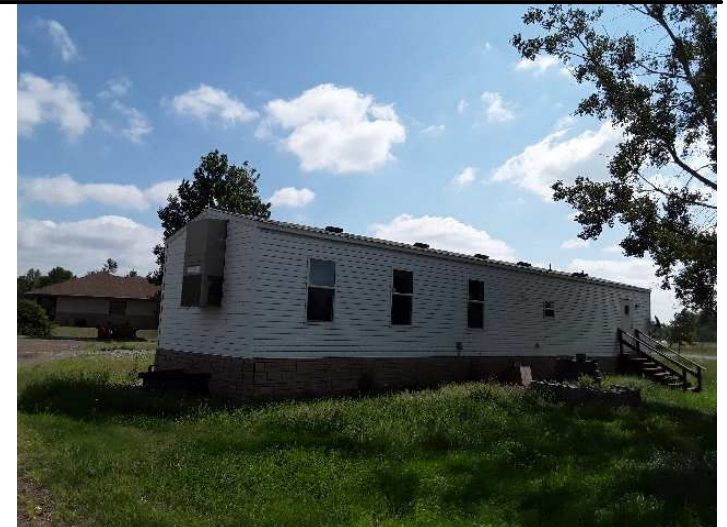
**Facility Name:** Mobile Home

**Rating:** Moderate

**Roof Material:** Fire resistant- tar,rubberized

**Siding Material:** Vinyl

**Foundation:** Open or deck

**Comments:** Not known if facility is a residence or office space.

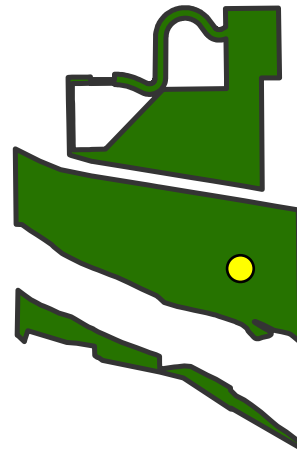
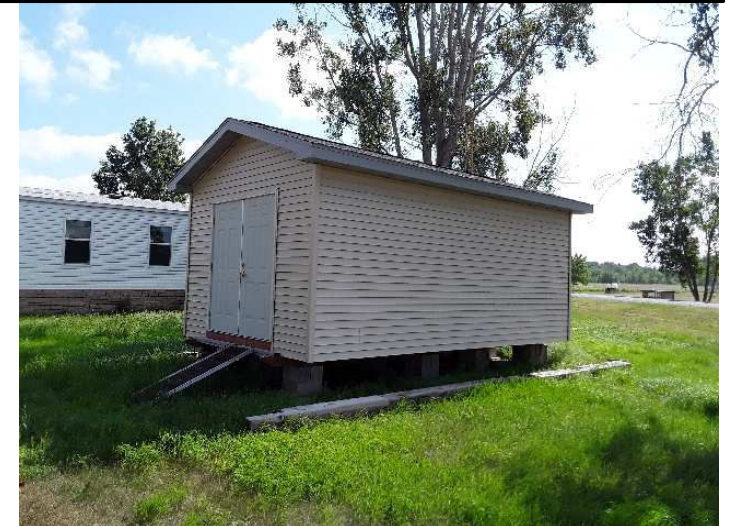
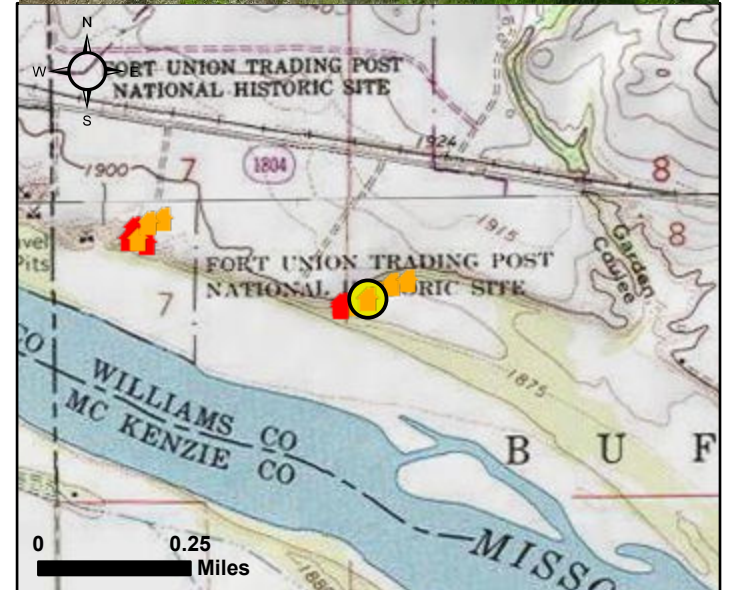
**Foundation:** Open or deck

**Comments:** Not known if facility is a residence or office space.
