# Geomorphic and Ecological Responses to Human Modification of the Fremont River, Capitol Reef National Park, Utah

Science Report NPS/SR—2024/112

Taylor M. Johaneman<sup>1</sup>, Katherine B. Lininger<sup>1</sup>, Derek M. Schook<sup>2</sup>, Michael Martin<sup>2</sup>

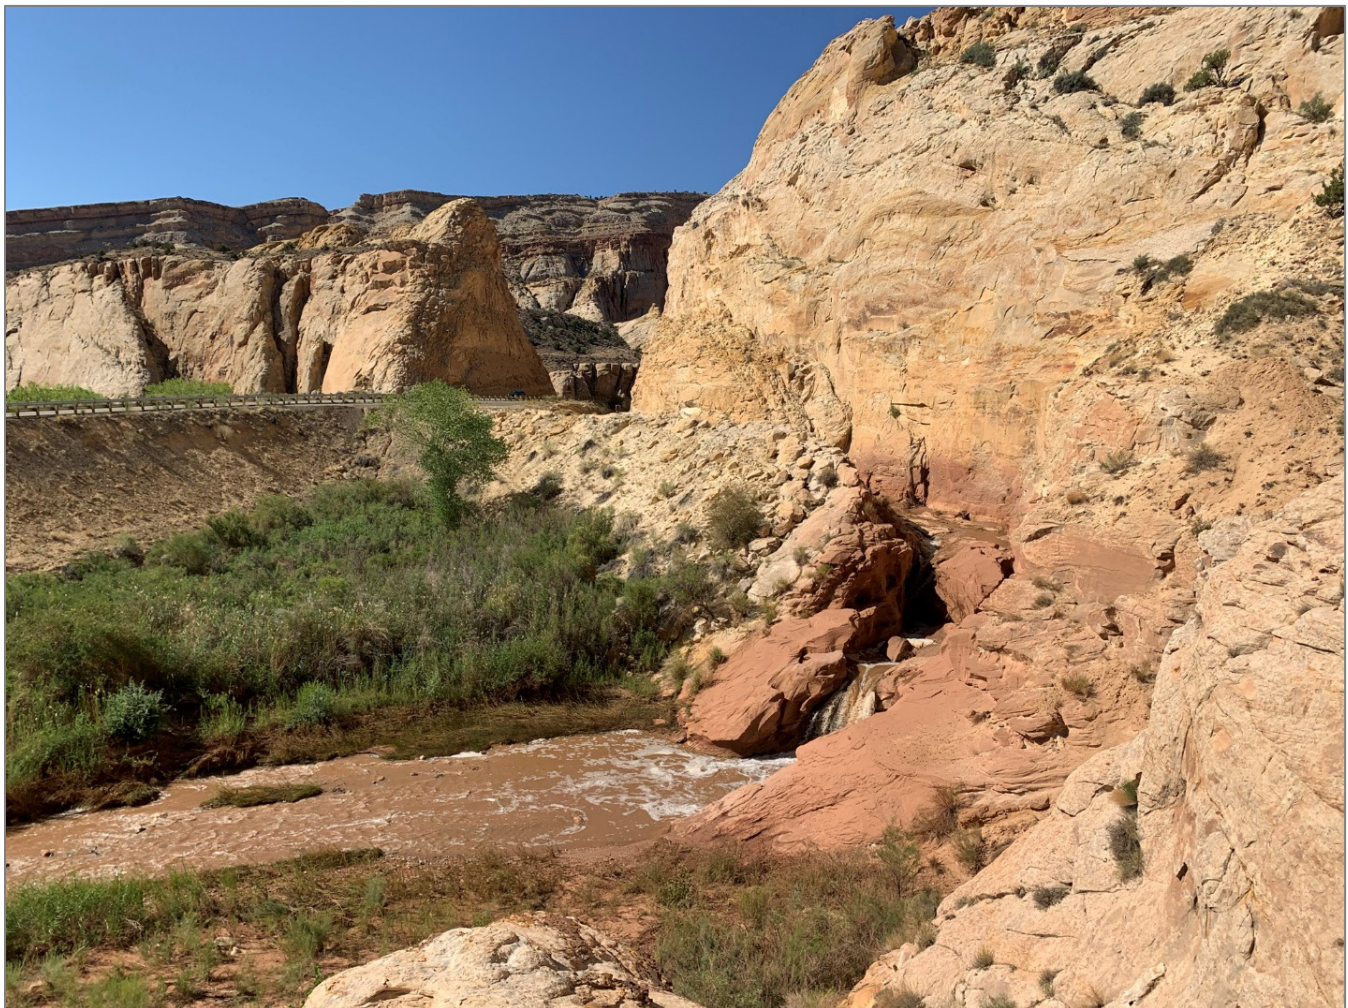
Upstream view of the Fremont River adjacent to Utah State Route 24, including part of a multi-tiered waterfall that ends the river's artificially cut flow path through Navajo Sandstone.

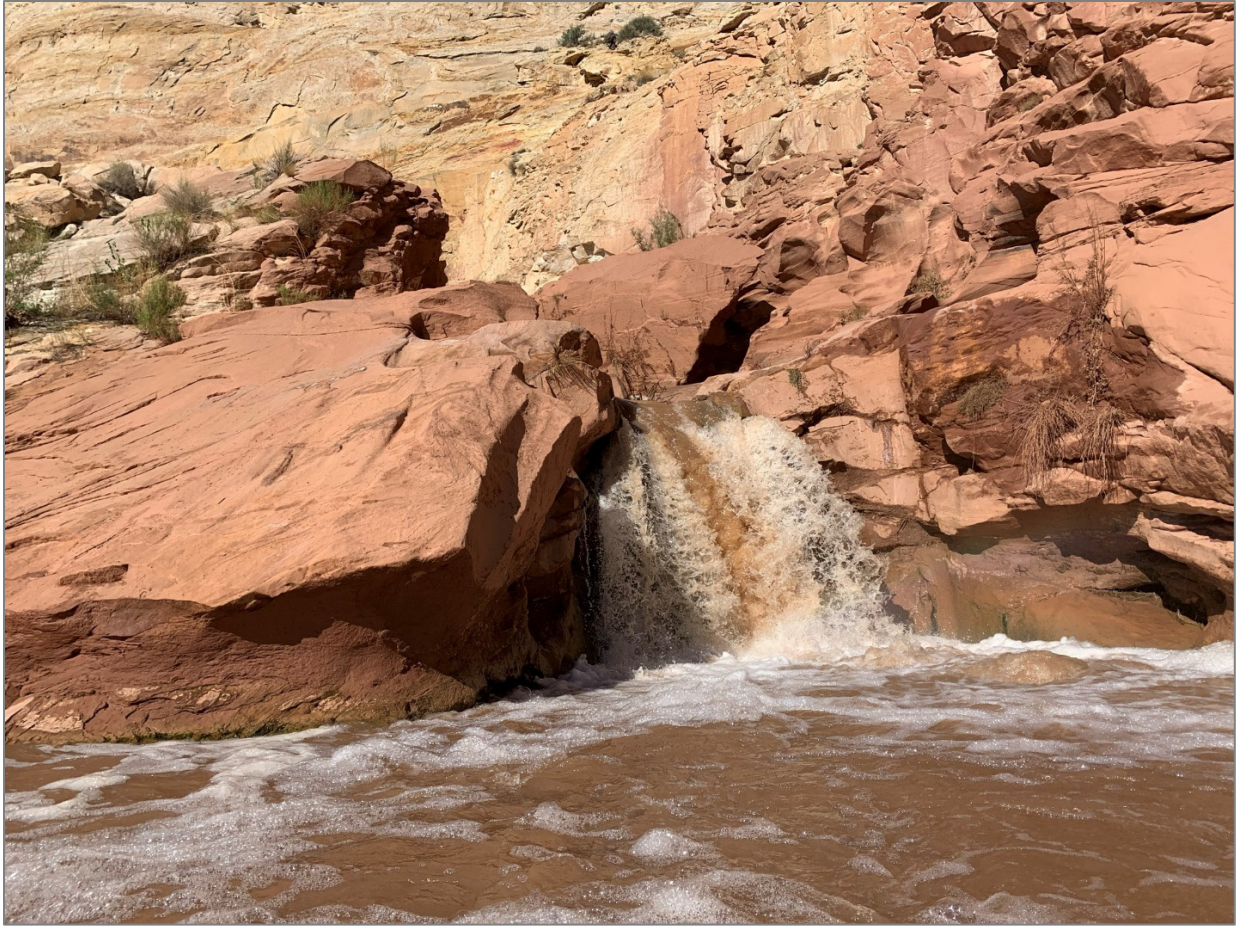
**Figure 1.** Upstream view of the knickpoint and plunge pool on the Fremont River, showing where it exits the Navajo Sandstone within the artificially cut off reach.

Channel modifications and road construction resulted in the development of a knickpoint (Figure 1) and an abandoned meander on the Fremont River in 1962. Knickpoints often migrate upstream during their development (Gardner 1983). We investigated the knickpoint's migration rate and effects on channel planform throughout the past 70 years using historic and current aerial imagery and topographic surveys of channel slope and channel cross-section using a total station. We collected images from 1958, 1974, and 2018 using Earth Explorer and the Utah Geologic Survey website. Aerial images ranged in scale and resolution. Images from 1974 and 2018 were georeferenced by the download provider. The 1958 image was georeferenced in ArcMap version 10.8.1 (root mean square error for georeferencing was 4.785 m). Using this series of aerial images, we attempted to identify the location of the knickpoint, how it has changed through time, and its effects on channel planform. We also measured the depth of the slot channel (e.g., the bedrock channel incised into a bedrock bench) in the knickzone (an over-steepened bedrock channel that extends up to 200 m upstream of the knickpoint) to estimate a minimum amount of incision since knickpoint formation (Figure 2). Because we do not know the elevation of the channel bed in the knickzone when the river was re-routed, a very conservative estimate of incision since 1962 is the difference between the top of the bedrock bench and the bottom of the slot channel.

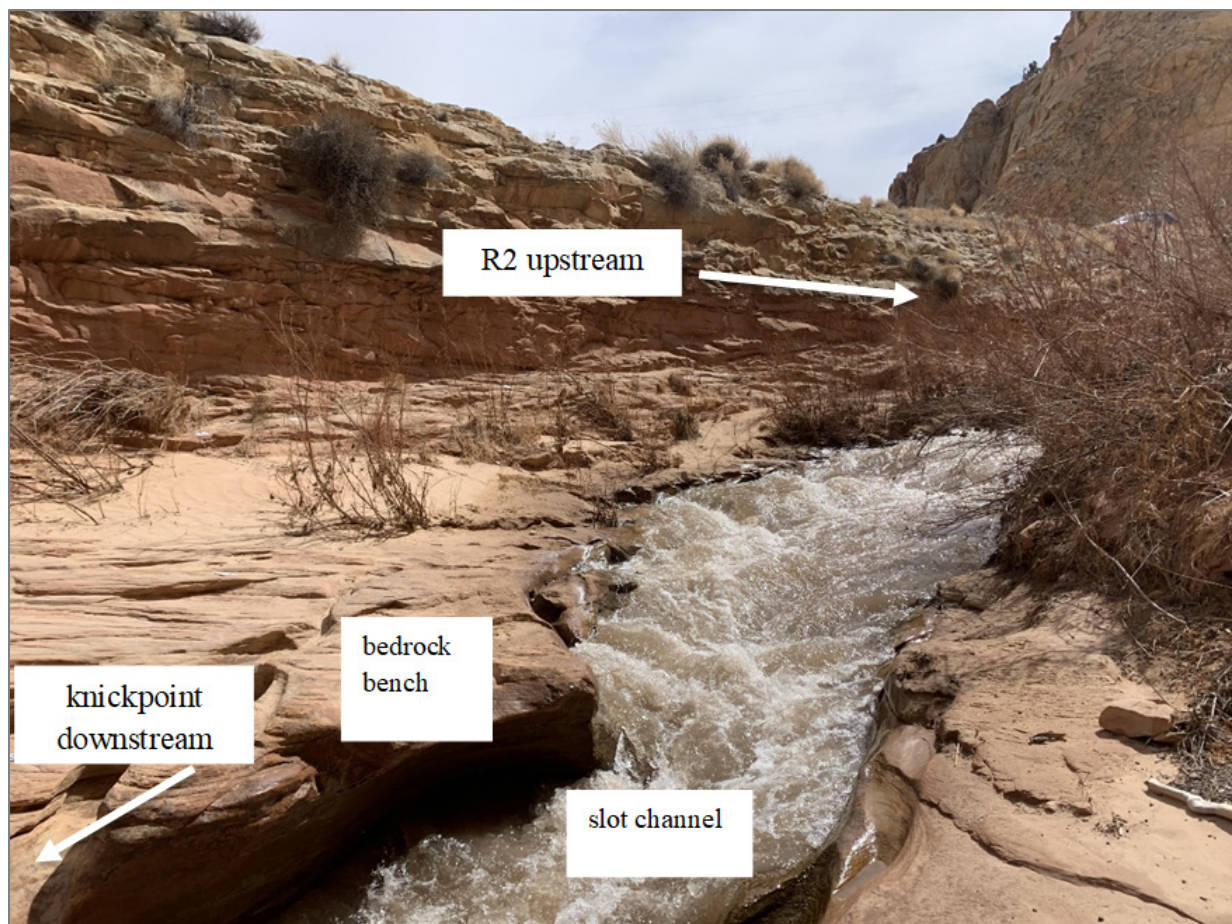
**Figure 2.** Image of the incised bedrock slot channel in the knickzone, looking upstream. The knickpoint is located just downstream of this slot channel and study reach 2 (R2) is located just upstream.

Due to the poor resolution of historic imagery and the size of the knickpoint relative to the scale, we could not accurately identify the knickpoint's location and thus could not determine the migration rate of the knickpoint itself. Although the knickpoint was difficult to identify, the images did show how the channel changed from 1958 to 2018. In 1958, the meander had not yet been cutoff and the channel in its current alignment with a knickpoint did not exist. The Fremont River had several secondary channels and flowed through the now-abandoned meander (Figure 3). In 1974, after the meander was cut off and the knickpoint was formed, the Fremont had fewer secondary channels (Figure 3). Imagery from 2018 shows a single channel (Figure 3). Thus, it is likely that the knickpoint creation and local oversteepening has simplified the channel planform. Although we cannot determine the rate of knickpoint migration from historic imagery, we have determined that the knickpoint has incised downward through the bedrock since its formation in 1962 and has developed a slot channel over the past 60 years. A slot channel is a narrow bedrock channel that forms when a stream or river flows over a bedrock surface and incises downward; downward incision in slot channels is typically greater than bank erosion (Johnson, Whipple, and Sklar 2010), thus slot channels are typically narrow and deep. The formation and development of slot channels through Navajo sandstone, which is the same lithology as the knickpoint and knickzone in this study, has been observed in the nearby Henry Mountains (located 40 km SE of CARE; Johnson, Whipple, and Sklar 2010), and found that the slot channels found in the Henry Mountains undergo rapid fluvial erosion. Depth measurements of the slot channel within the knickzone (Figure 3) indicate that it has incised downward at least 3 m since its formation in 1962. Measurements of the difference in elevation between the bedrock bench and the bottom of the slot channel (Figure 2) ranged from 1.42 m to 3.5 m.
