Re: 3330-6N Mission 66 Development within the Bartlett Cove Residential District

1. **Name of Property** Mission 66 Development within the Bartlett Cove Residential District: GBQ-3 Residence, GBQ-5 Residence and GBA-10 Recreation Center and Storage

## GBQ-3 Residence

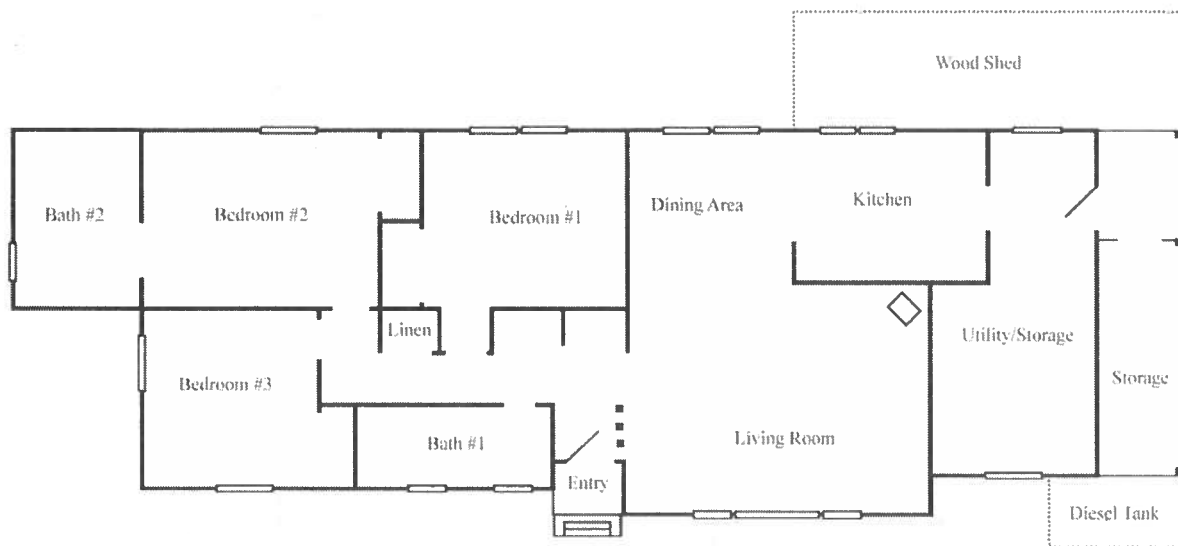
Drawing 3: GBQ-3, Current Floor Plan. Based on Drawing No. NM-GB-3012A and field observations.

The interior of the house has a three bedroom, two bath plan (Drawing 3). Entering from the front door, to the right is the living room, dining area, galley kitchen and utility room. To the left one enters a hallway to the private side of the house, leading to a hallway bath, two closets, a built-in linen closet, the three original bedrooms, and the new bathroom addition, located en suite in the east corner bedroom. The walls have a pebbled plaster finish, as do the ceilings, all painted white. Wood trim stained a natural color is found throughout the house around the baseboards and the windows. The kitchen, bathrooms, and utility area have vinyl flooring, while the rest of the floors are carpeted. The house is heated by a forced air furnace, a system original to the house.

Alterations Overall GB-3 has moderate physical integrity. While the exterior of the house appears very similar between historic and recent photographs, several notable changes have been made (Drawings 3 and 4). As previously noted, three additions have been made to the outside of the house, and the original outdoor wood shed has been enclosed to create extra storage. The siding, which was originally stained so as to show off the cedar siding, has been painted, as has the concrete foundation. All the original 2/2 single hung wood windows (with matching awning storm windows) have been replaced with 1/1 vinyl windows. On the roof, the original wood enclosed metal flue chimney,

The interior floor plan has been moderately altered since the time of construction. The house was constructed with a three bedroom, two bath plan; the hallway bathroom, which is one large bathroom today, used to be divided into two smaller bathrooms, with entrance doors right next to each other in the hallway. The living room has also changed, with the fireplace being removed and replaced with a corner oriented wood burning stove. All of the interior finishes and fixtures, save for the hallway linen closet, have been replaced. Originally, the floors throughout the house were covered in asphalt (asbestos) tiles, but are now carpet and linoleum.<sup>8</sup> The kitchen has also been completely remodeled, with new cabinets and appliances. The overall layout of rooms, however, remains the same.

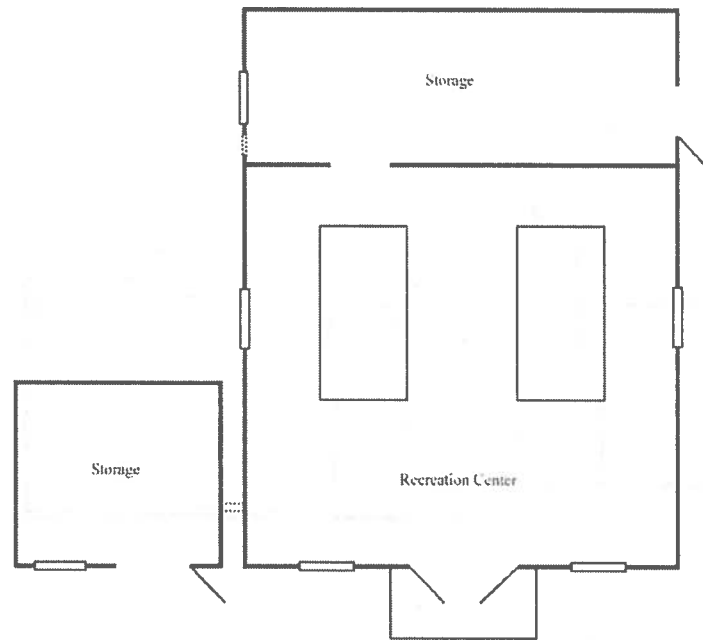
Drawing 5: GBA-10 Recreation Center and Storage, Current Plan. Based on Drawing No. NM-GB-3009A and field observations.

While GBA-10 was originally erected as a power house, it is currently being used as a mixture of employee recreation space<sup>10</sup> (dubbed "The Erratic" by park employees) in the main building and equipment storage in the rear addition (Drawing 5). The interior of the main space has painted concrete floors, with gaming tables perched on the raised slabs where the generators were seated (Photo 16). The walls are clad in plywood paneling which is painted an off-white color, framed with cream trim. The ceiling is also off-white, and braced with two red steel beams that are further supported by two 3 1/2" diameter steel pipes that bridge the gap between the beams and the concrete slab.

Alterations Overall the building retains a high degree of physical integrity with moderate additions that do not obscure the original form of the building (Drawings 5 and 6). However, it is no longer part of the utility infrastructure of the park, and now stands isolated amongst the newer seasonal employee

Alterations of the interior of GBA-10 Recreation Center and Storage include: removal of power generators and repurposing as recreation center; addition of a flat ceiling inside the structure, which originally had open rafters; enclosing of one rear façade window and opening of one window for interior entrance for lean-to addition. The plywood paneling and trim appear consistent as compared to the finishes called for in the original working drawings for the structure". However, what is there currently is likely a newer addition, added after the rear wall was altered to accommodate the lean-to.

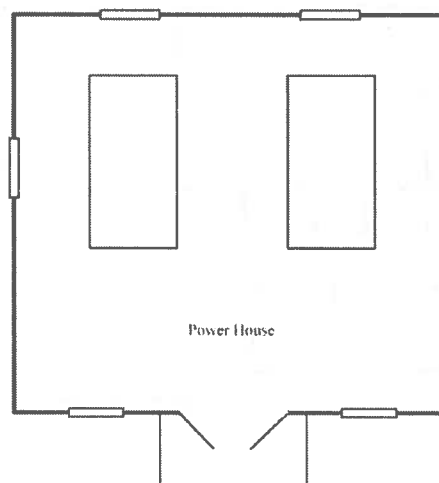
Drawing 6: GBA-10 Power House, Original Plan. Based of Drawing No. NM-GB-3009A.

Out of the three buildings in the district, GB-10 retains the most physical integrity. Originally built in 1958 as a power house, it was equipped with two diesel-fueled electrical generators to provide power for the whole NPS Bartlett Cove complex that was proposed during Mission 66 (Photo 12).

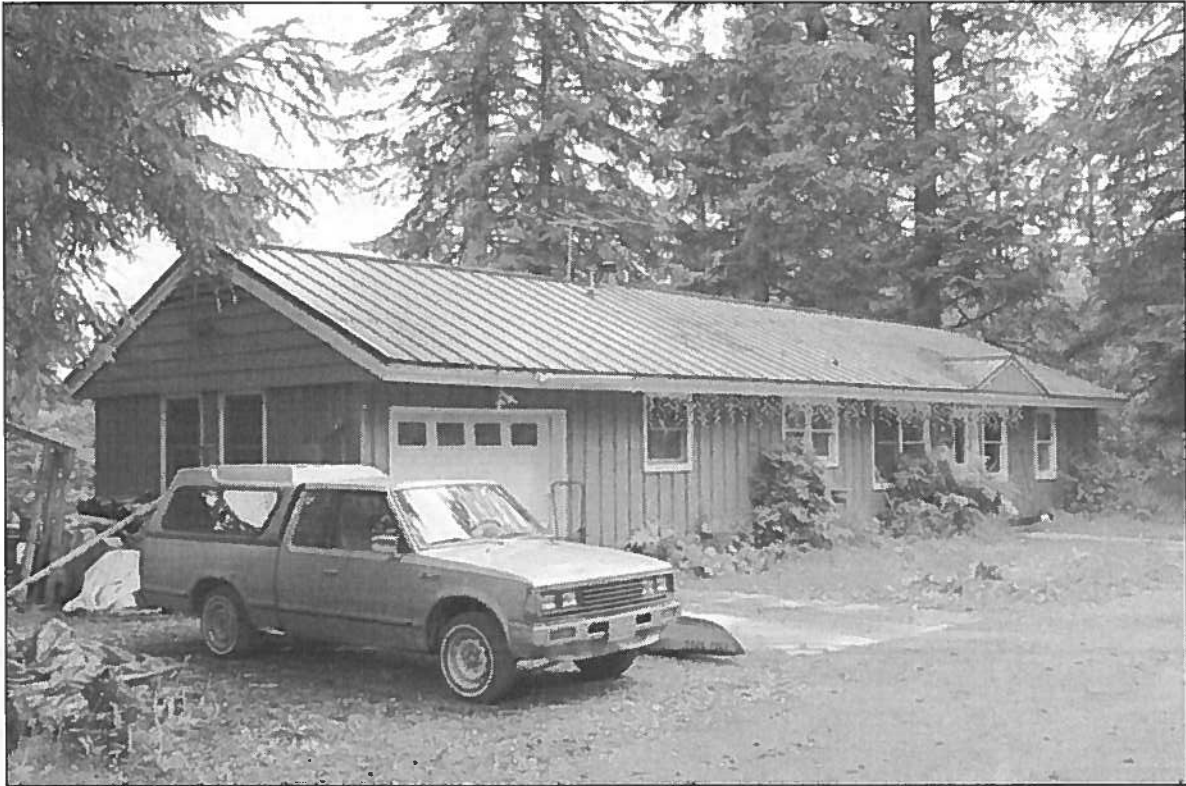
The main entrance on the front (south) elevation is offset to the right (east) end of the building, while the garage is at the left (west) end (Photo 2). A single step leads up from the concrete sidewalk to the stoop in front of the entryway. The front door itself is metal with a single fixed upper window, opening into a mudroom. It is flanked to the right by a 1/1 single hung vinyl window. A gable-like pediment protrudes from the roofline, covering the porch and directing water away from the entrance. The window, door, and gable pediment are new, added when the original recessed front porch was enclosed to create the mudroom; the original breadth of the porch is indicated by the width of the exterior concrete stoop. The window fenestration pattern across the façade is original, though all the original 2/2 double hung wood windows (with matching storm windows) have been replaced with 1/1 single hung vinyl windows. The window order is as follows, from left to right: a short 1/1 window, two identical 1/1 windows grouped together in a single frame, two longer 1/1 windows, the front door, the new 1/1 window (not original), and another long 1/1 window. All the windows on the front elevation, as well as every other elevation, are either brand new or replacement vinyl windows. The wood trim around the windows and doors is possibly original, but this could not be conclusively determined. The garage door is also a replacement.

Photo 2: GBQ-5 Residence, Southwest Elevations facing north.

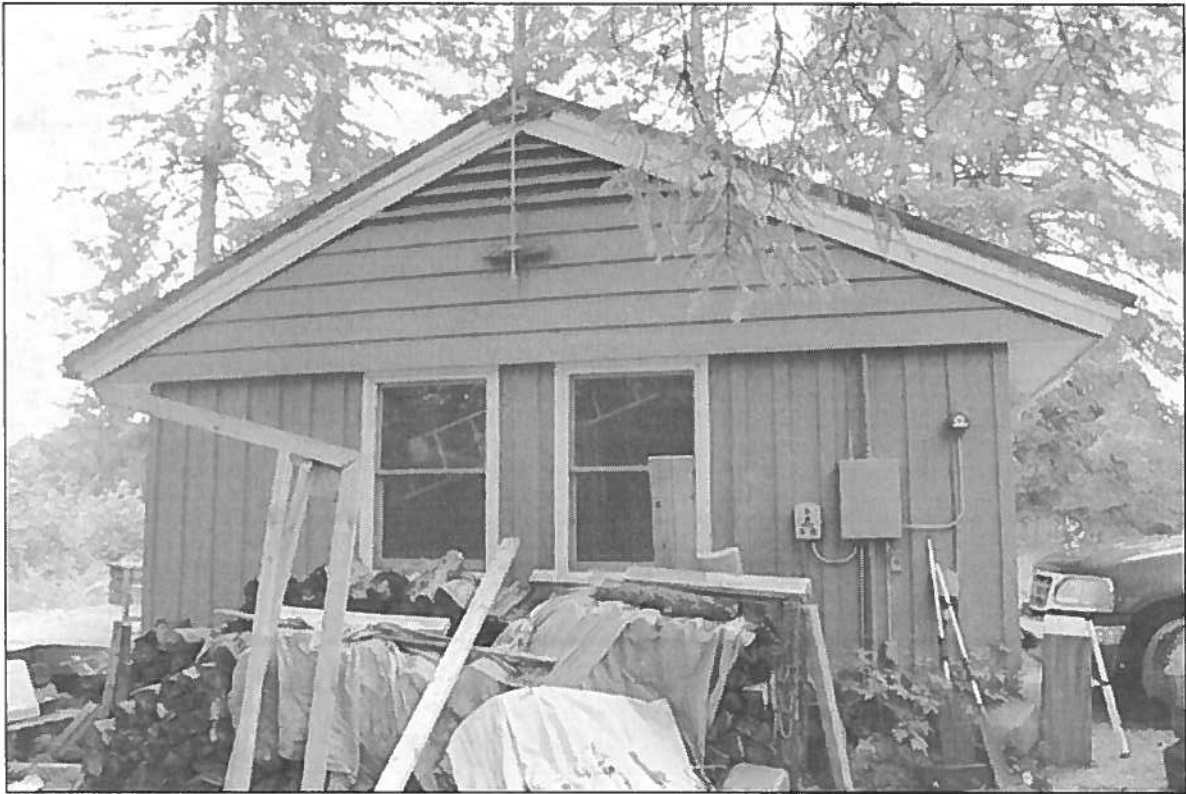
The left (west) elevation is relatively simple, with two 1/1 single hung vinyl replacement windows in the center of the façade, capped with the roof gable (Photo 3). The roof projects slightly out from the body of the house, creating a shallow jetty. The wall underneath the gable is clad in wood beveled horizontal lap siding. This end of the house has no projecting eaves, but is instead flush with the façade. The house's external utilities all enter on this side of the building, both electrical and phone. There is also an antenna strapped to the upper portion of the roof jetty. A large wood pile partially obscures the lower portion of the elevation.

Photo 3: GBQ-5 Residence, West Elevation facing northeast.

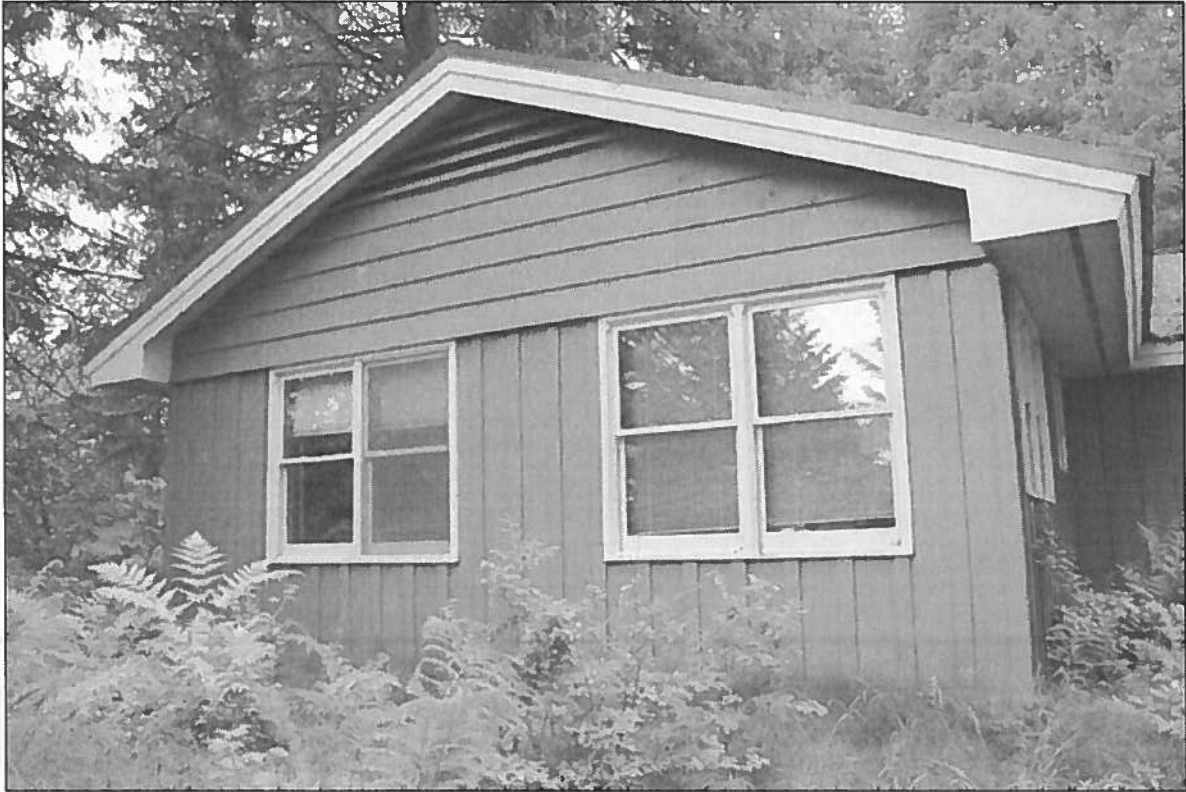
Photo 5: GBQ-5 Residence, Northwest elevation Master Suite Addition.

imitates the gable ends of the main body of the house. However, it lacks the protruding jetty, has a slightly overhanging eave, and has 'wingtip' trim at the ends of the gables, imitating the gable end treatment on house GBQ-3 (compare Photos 5 and 9). The shed side eaves also have long, narrow vents screened with fine mesh, unlike the unvented eaves on the rest of the house.

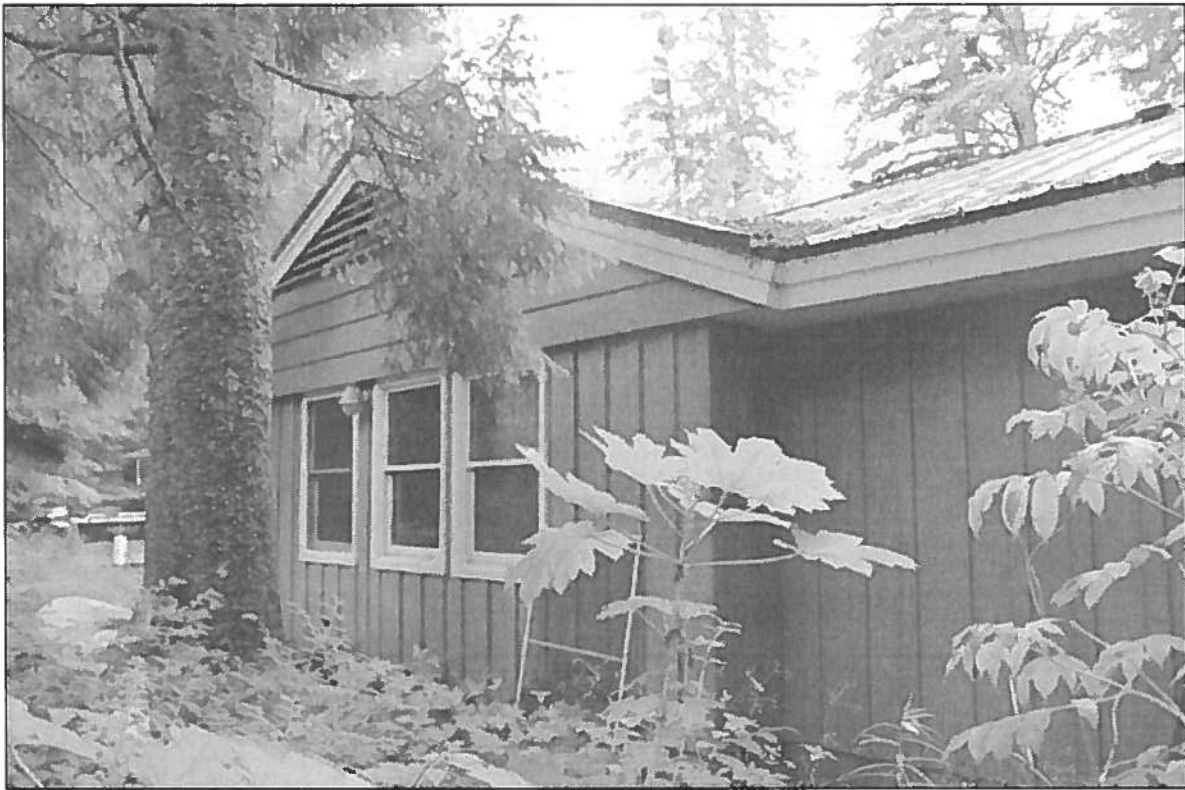
The right (northeast) elevation was originally the same to the opposite end, but has been elongated by the master suite addition (Photo 6). This side of the addition is plain board and batten siding, while the end of the main house has three 1/1 single hung vinyl windows. The right (north) window has been added since the original construction, providing extra light into the interior bedrooms.

Photo 6: GBQ-5 Residence, Northeast Elevation facing southwest.

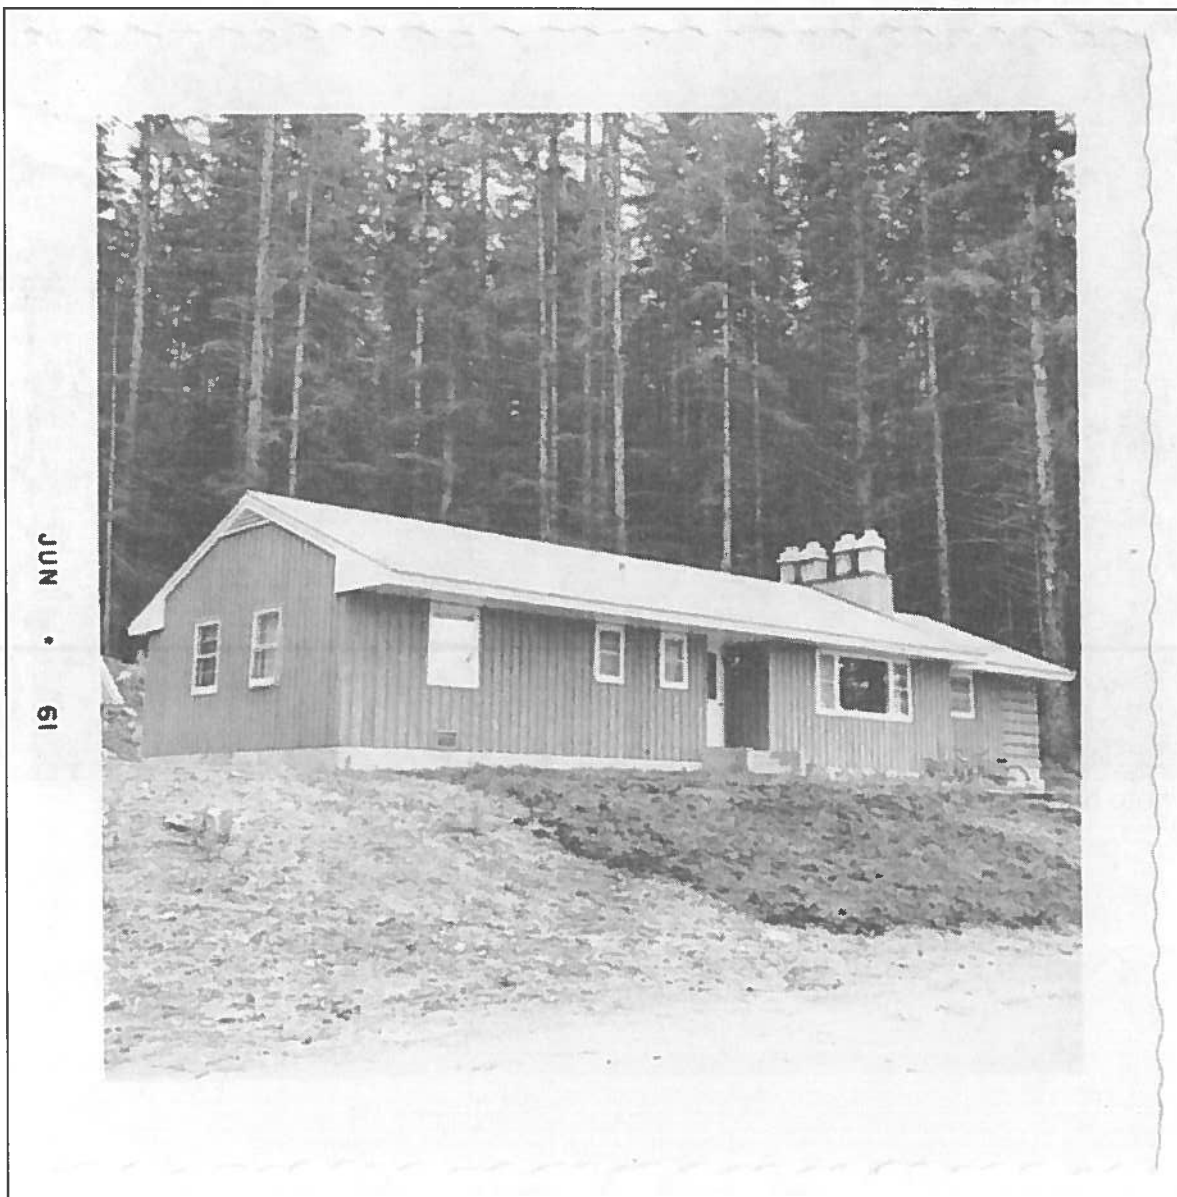
Construction on GBQ-3 began just as GBQ-5 was finished in September 1957. This three bedroom, two bathroom residence was completed in April 1958 (Photo 7). Similar to GBQ-5, this residence has a ranch-style plan, but was not constructed based on the same plans, or by the same contractor. GBQ-3 is a one story side gable house with a rectangular plan (Photo 8). It has three additions; two lean-to shelters on the front (northwest) and rear (southeast) elevations, and an enclosed bathroom addition on the left (northeast) side. The foundation of the building consists of a board formed concrete stem wall with additional wood posts on concrete blocks supporting the floor within the perimeter wall. The bathroom addition had a raised foundation concealed by wood boards. The structure is wood frame construction, clad in cedar vertical board and batten siding and painted a muted taupe. The wood trim around the windows, door, and roofline is painted a contrasting off-white color. The low pitched gable roof is covered with metal sheet roofing with enclosed eaves, containing narrow eave vents. As an added decorative element, the eave ends

Photo 7: Historic Photograph, GBQ-3 Residence, Left Front. Taken June, 1961. GLBA Maintenance Building Files.

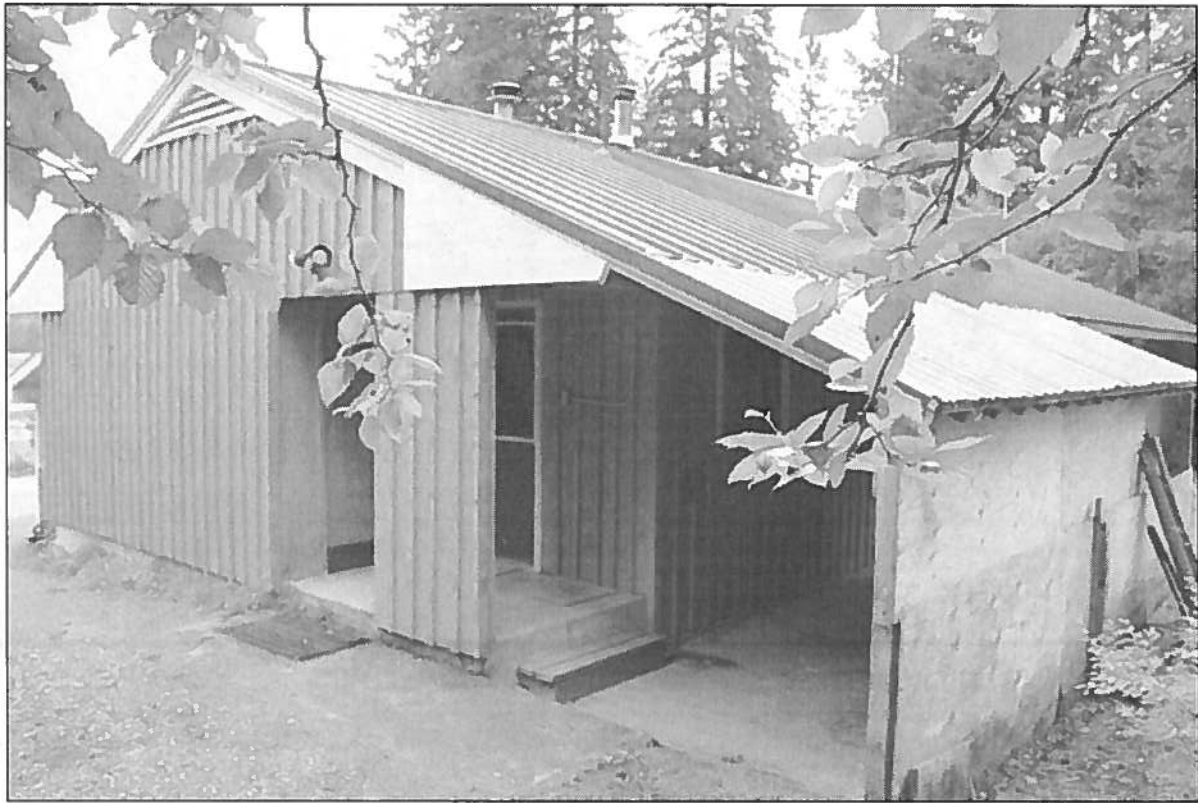
The right (southwest) elevation has an incised corner porch at the south corner (Photo 9). Two doors are located here, one metal door, matching the front door but painted teal, that leads into the utility room of the house, and the other is a wooden hollow core door that leads to an enclosed storage room with shelving. The board and batten siding runs all the way up the façade, from ground level and underneath the roof gable, a detail also mimicked on the opposite end of the house. However, the lower portion of the siding does not align with that of the gable; this is because this wall is a newer addition, first enclosed circa 1976.<sup>5</sup> The storage room was an exposed wood shed in the original construction.<sup>6</sup> The roofline has also been extended toward the rear of the building because of a lean-to addition made to that side of the house.

Photo 9: Building GBQ-3 Residence, Southwest Elevation facing northeast.

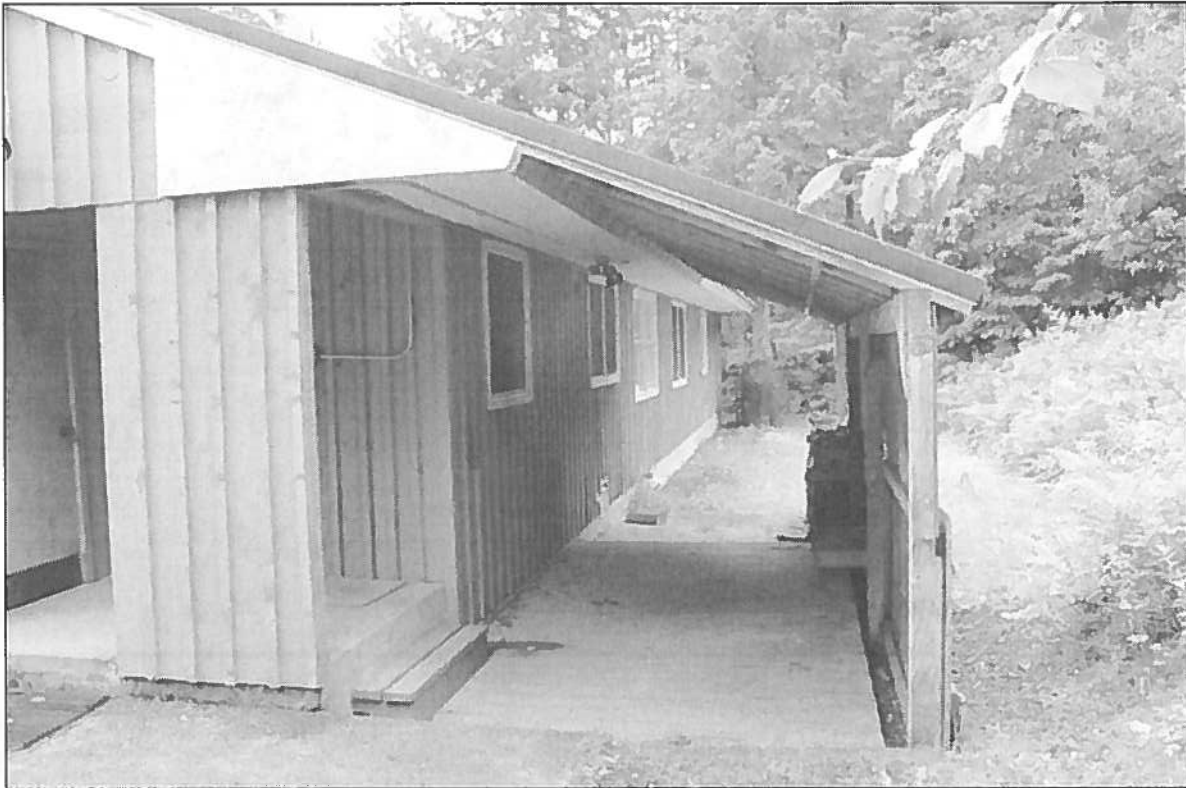
The rear (southeast) elevation is similar to the front, with two louvered foundation vents, but with a different fenestration pattern (Photo 10). The order of windows is as follows, from left (south) to right (east): one small 1/1 window, two small 1/1 windows in one frame, two longer 1/1 windows in a single frame, again two longer 1/1 windows in a single frame, then a final longer

Photo 10: Building GBQ-3 Residence, South Elevation facing northeast.

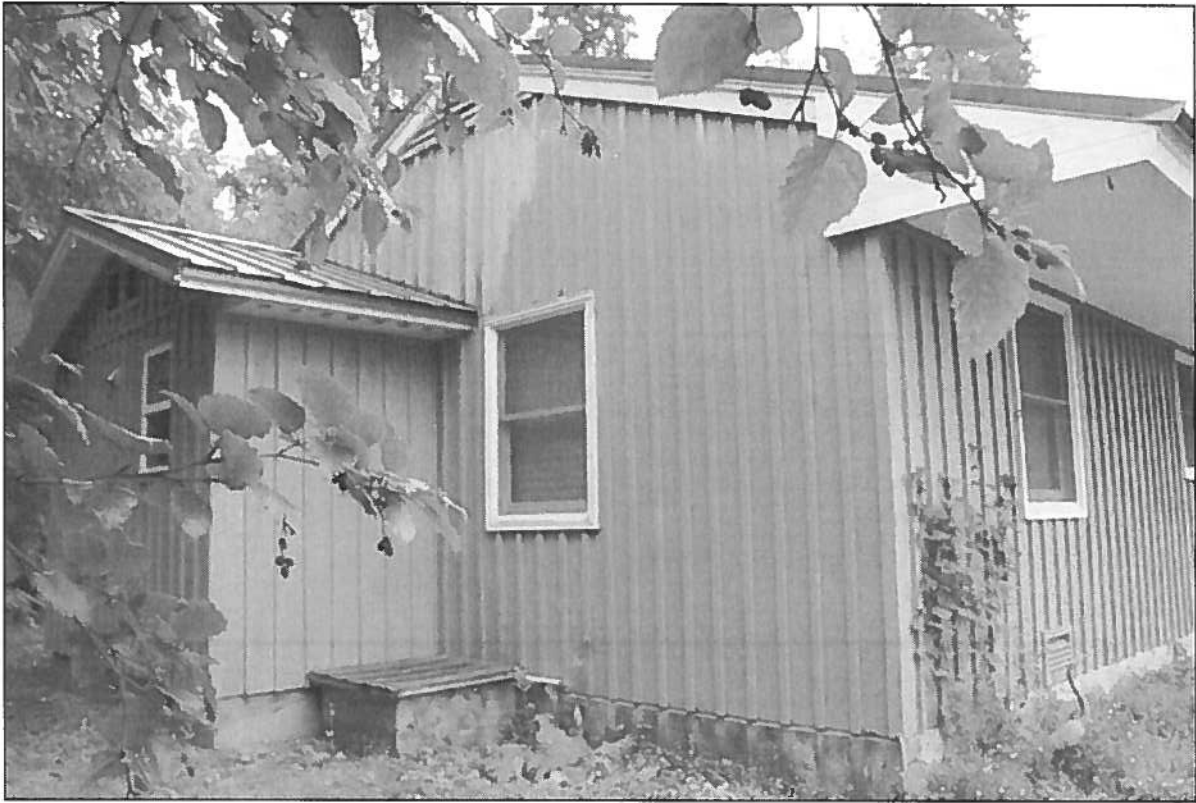
Photo 11: Building GBQ-3 Residence, Northeast elevation facing southwest.

The left (northeast) side of the building originally had two 1/1 windows centered on the façade, but the window near the east corner has been removed and a bathroom addition added (Photo 11). The addition is clad in board and batten siding to mimic the original building, though the roof and eave details are quite different. Rather than being eave-less on the gable end as the main building, the bathroom addition has a projecting eave with a simple modillion detail. It also had a square gable vent instead of a triangular type featured on the original building. On the shed side, the eave vents also do not match with the house, consisting of round holes instead of a narrow mesh vent. The addition has a single 1/1 vinyl window. Along with the addition, a foundation crawl space access has been added at the connection between the building and the addition. It is covered with a removable plywood lid for easy access.

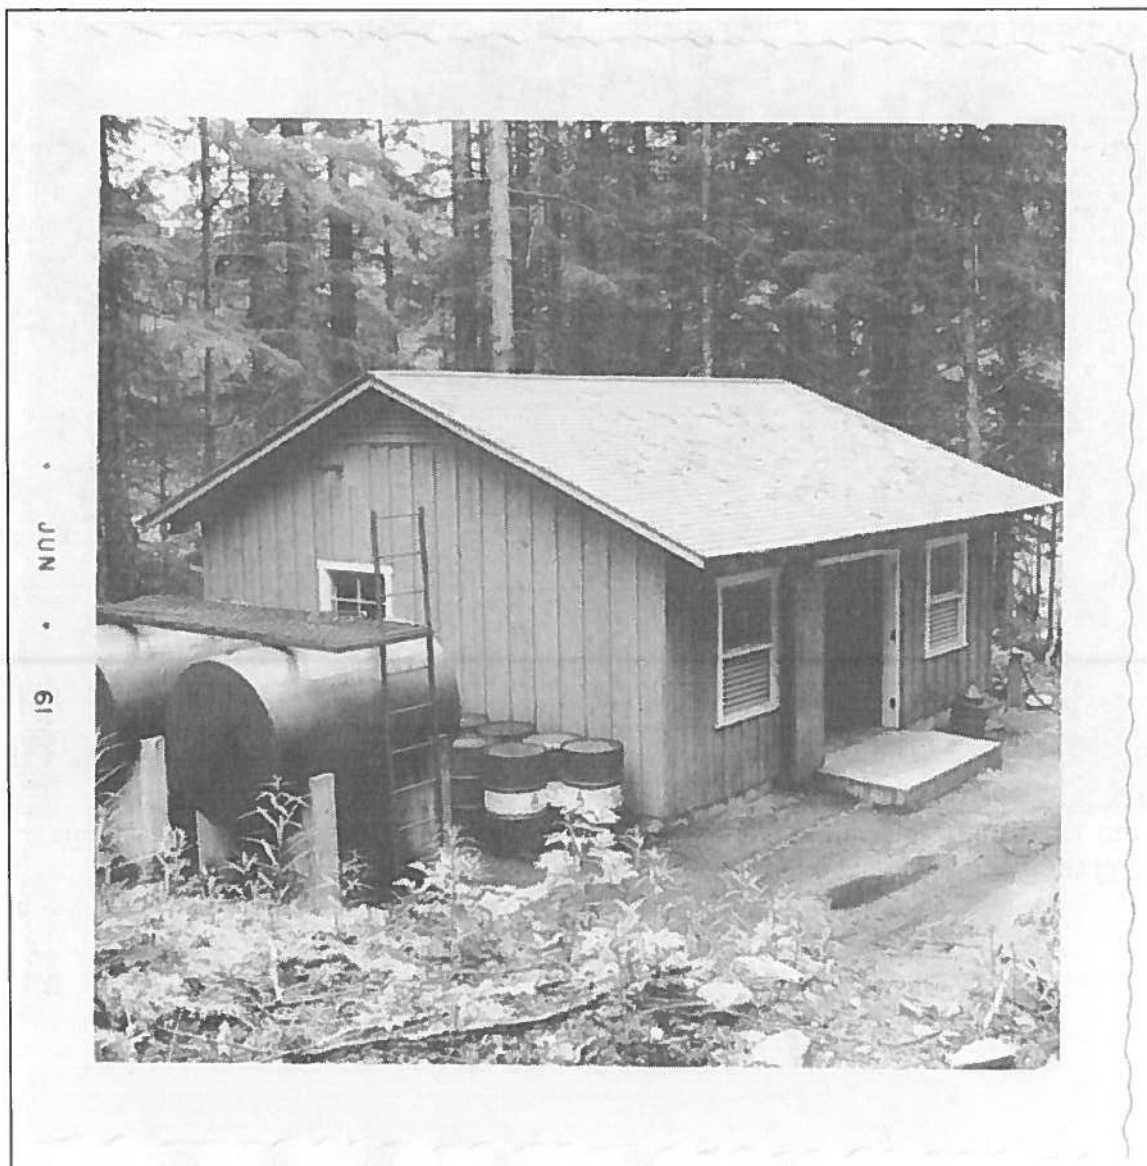
Photo 12: Historic Photograph, GBA-10 Power House. Taken June 1961. GLBA Maintenance Building Files.

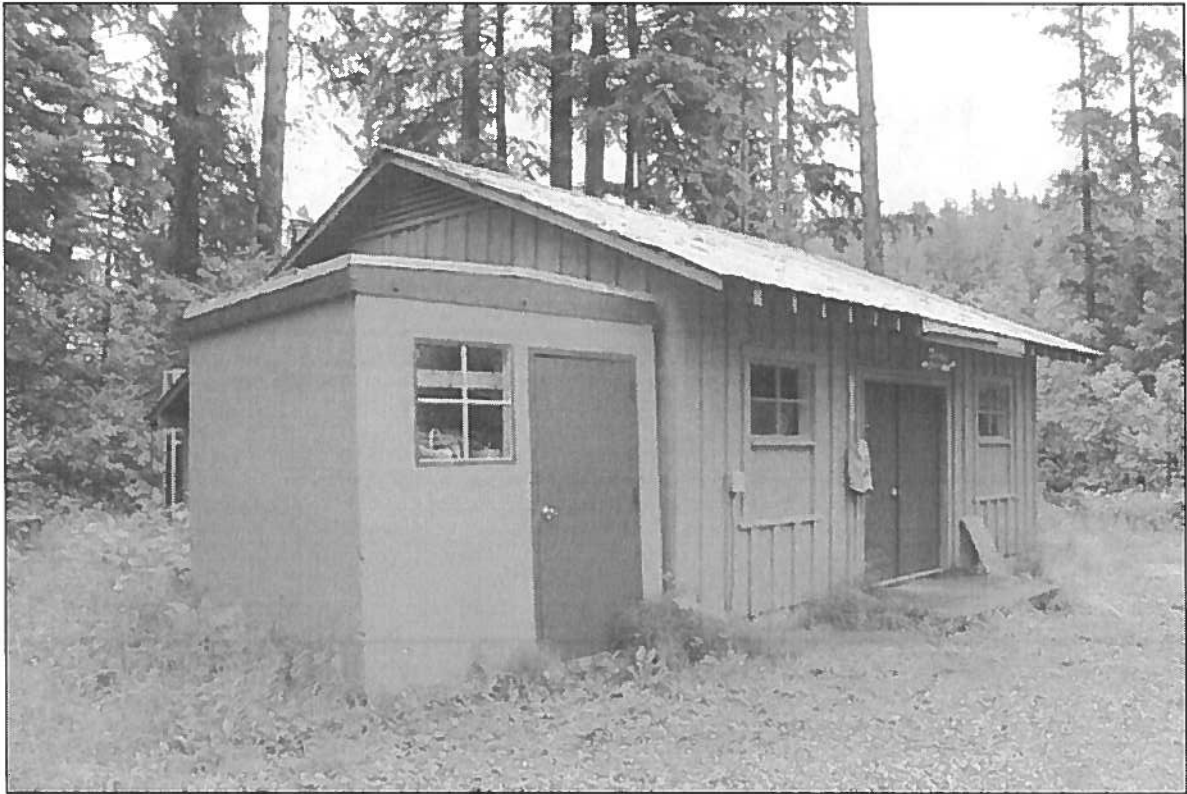
This one story, side gable utility building is rectangular in plan with one lean-to rear (northwest) addition and an adjacent storage shed to the left (northeast) (Photo 13). The original part of the structure has a board formed concrete slab foundation, with two additional 12" thick rectangular concrete slabs

Photo 13: GBA-10 Recreation Center and Storage. Northeast and Northwest Elevations, facing south.

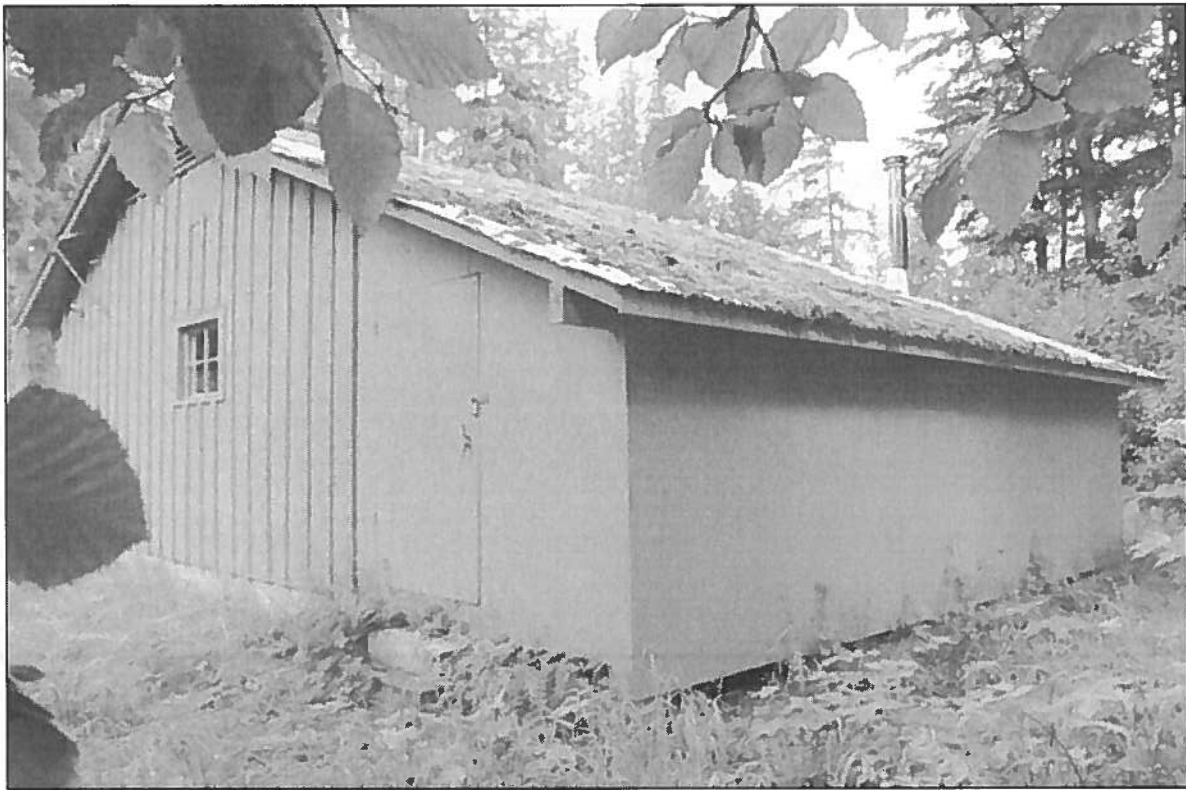
Photo 14: GBA-10 Recreation Center and Storage, Southwest and Southeast Elevations, facing north.

The front (southwest) elevation has a centrally located steel double door with a concrete slab at the exterior entrance. The door is flanked by two windows. The windows have fixed four-pane steel sashes above, and plywood panels covering louvered vents in the lower sash. An aluminum gutter hangs off the edge of the eave, directing rain to either side of the entry. The right (southeast) side of the main building has one centrally located window with four fixed panes identical to the upper sash on the front windows; the addition has a simple plywood door with two concrete steps placed in front of it (Photo 14). The rear (northeast) façade is plain plywood (Photo 15). The left (northwest) side of the building is a mirror of the right, while the addition has a single 1/1 aluminum sash window and a rectangular metal louvered vent (Photo 15). There is a plywood storage shed sitting at the north corner of the building. It is not attached bodily to the main construction, but a conduit pipe does connect the two structures.

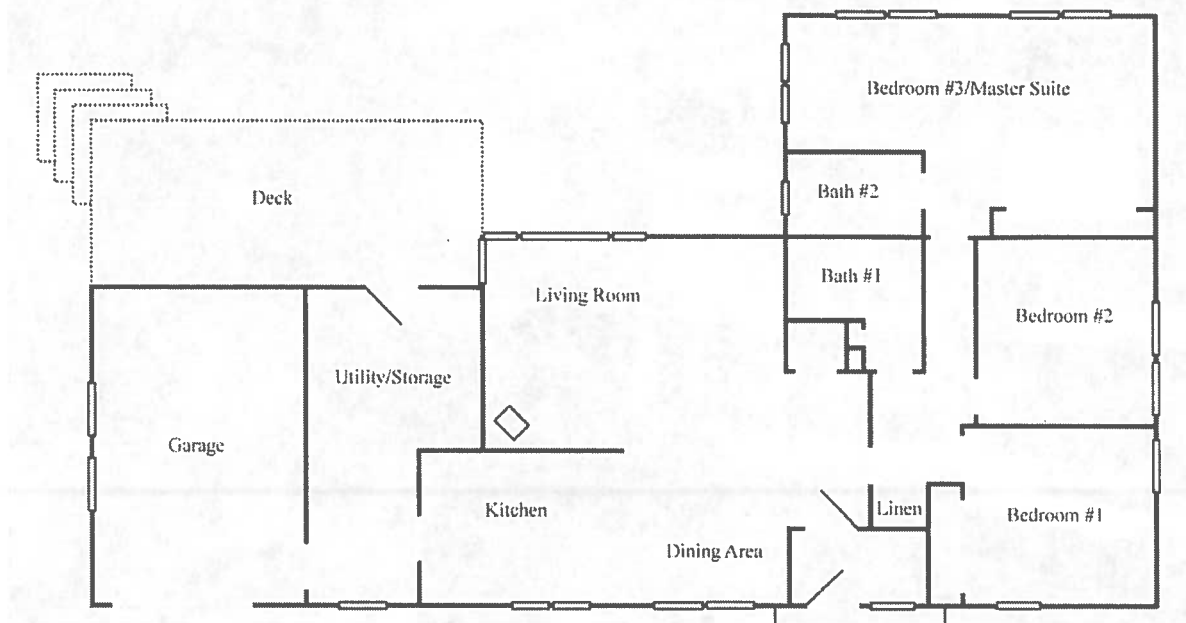
Drawing 1: GBQ-5 Residence, Current Floor Plan. Based on Drawing No. NM-GB-3007A and field observations.

The interior of the house has a three bedroom, two bath plan (Drawing 1). Entering from the front door, to the left is the living room, dining area, galley kitchen, utility room and garage. To the right one enters a hallway to the private side of the house, leading to two bedrooms, a hallway bathroom, an original built-in linen closet, and ending at the new master suite, which has a private bath. The kitchen, bathrooms, and utility area have vinyl flooring, while the rest of the floors are carpeted. The walls have a pebbled plaster finish, as do the ceilings. White beveled baseboard and window trim is consistent throughout the house, save for in the master suite, where the window trim is a simpler design stained a natural wood color. The house is heated by a baseboard heating system.

Alterations Overall GBQ-5 has fair to moderate physical integrity. While the exterior of the house appears very similar between historic and recent photographs, several notable changes have been made (Drawings 1 and 2). As previously noted, the front porch has been enclosed into a mudroom, with a gabled pediment over the front door. The large rear master suite and deck have also been constructed. The siding, which used to be stained so as to show off the cedar siding, has been painted, as has the concrete foundation. All the original 2/2 double hung sash wood windows (with matching awning storm windows) have been replaced with 1/1 vinyl windows, and new windows have been added, altering the fenestration of all but the southwest façade. On the roof, the original wood enclosed metal flue chimney, which supported an interior fireplace in the living room, has been completely removed and replaced with two separate metal pipe chimneys. The roof also used to be clad in cedar shingles, which were replaced with metal roofing in 1982<sup>1</sup>. A deck was also added in 2008 and is accessed through a new door outside from the utility room.<sup>2</sup>

The interior floor plan of the house has also been altered since the time of construction. The front porch was enclosed to create a mud room. The hallway was widened by removing the closet from Bedroom #2 to add the master suite (which postdates 1985<sup>3</sup>), bringing the total number of bedrooms to three and bathrooms to two. All the interior finishes, however, have been completely changed. The floors throughout the house used to be painted concrete, first replaced with vinyl and carpet in 1983<sup>4</sup>. The walls used to be painted, with no textured finish. All the interior trim is also likely a replacement, as it is consistent between both original and new parts of the house. The kitchen has also been completely remodeled, with new cabinets and appliances. The living room has also changed, with the fireplace being removed and replaced with a corner oriented wood burning stove.
