# NPS Wildfire Risk Assessments Assessment Locations

## Joshua Tree National Park - Overview

# NPS Wildland Fire Risk Assessment - Facility Assessment

**Facility Name:** 49 Palms Canyon Vault Toilet (single)

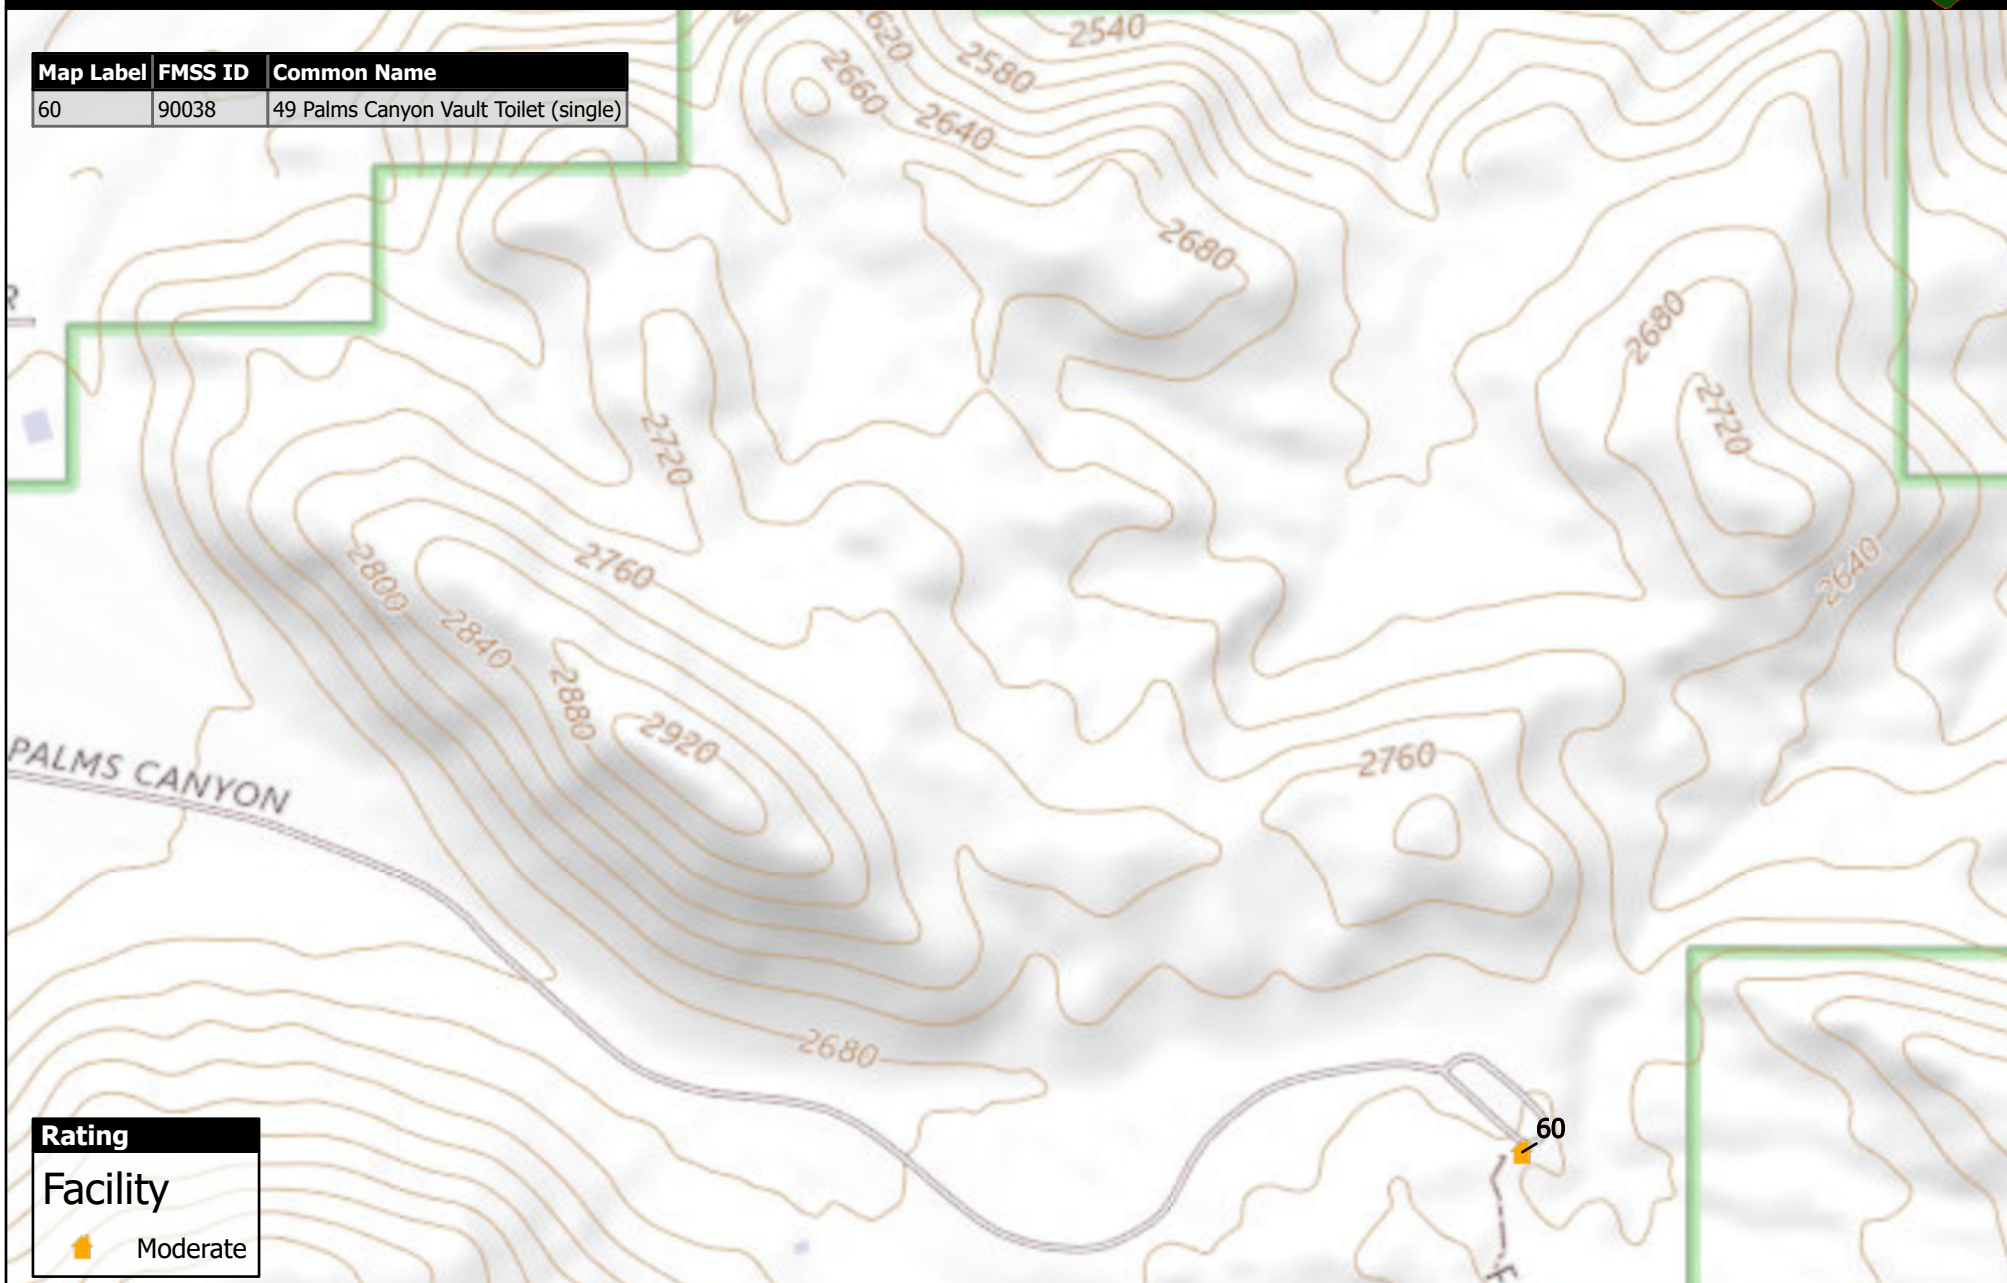
# 49 Palms Canyon Vault Toliet

| Map Label | FMSS ID | Common Name |
|---|---|---|
| 60 | 90038 | 49 Palms Canyon Vault Toilet (single) |

| Rating |
|---|
| Moderate |

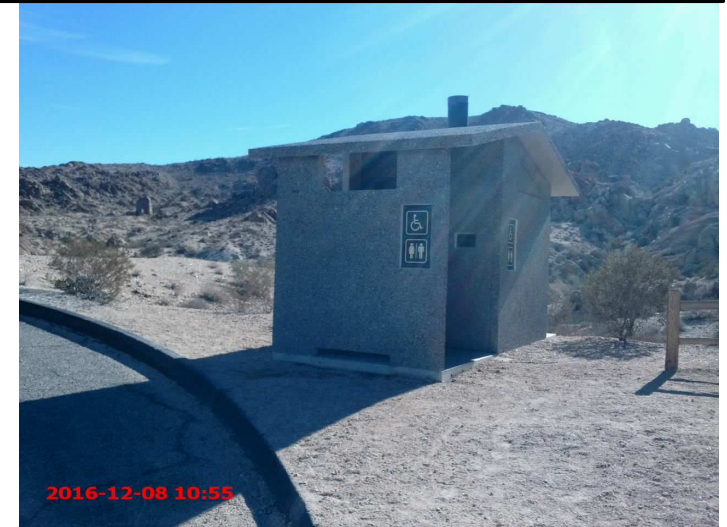
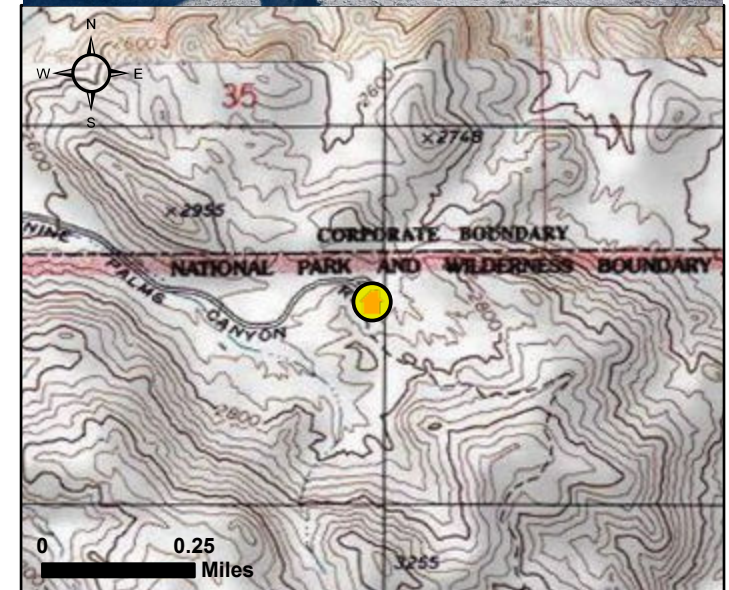
**Rating:** Moderate

**Fuel Type:** Shrub or timber

**Fuel Load:** Light or no wildland fuels

**Defensible Space:** Greater than 100ft treated

**Roof Material:** Noncombustible or not applicable

**Siding Material:** Rock, concrete, metal

**Water Supply:** No reliable water source nearby

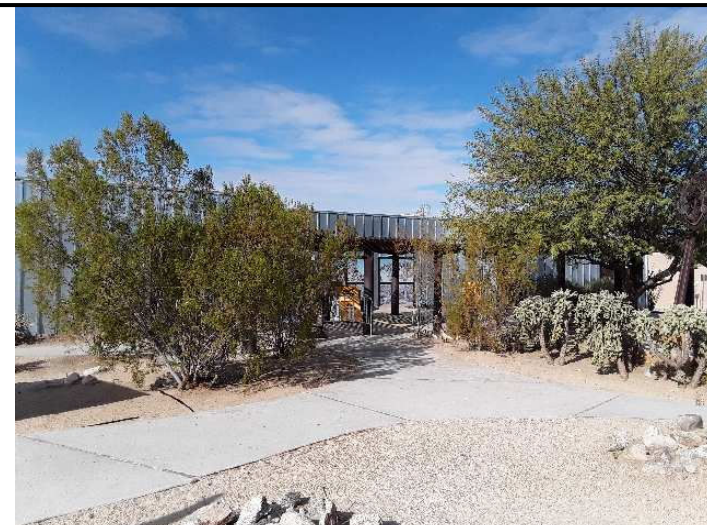
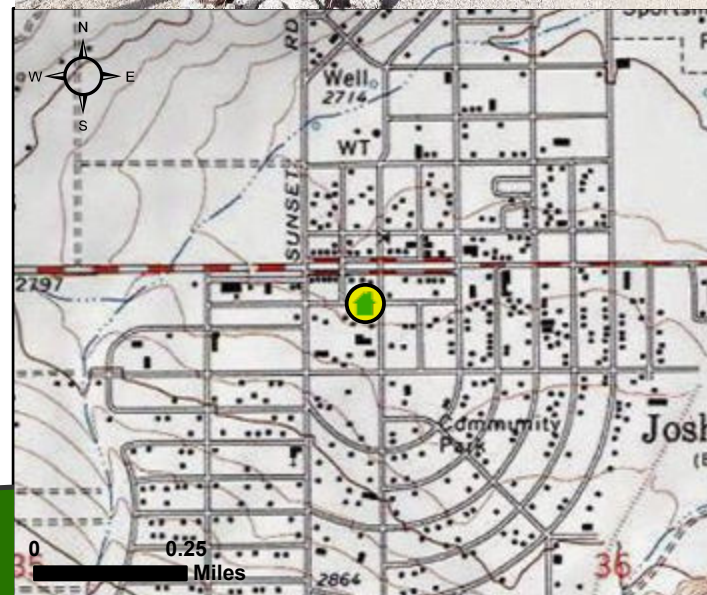
**Rating:** Low  
**Protection Level:** Not Designated,  
**Resources of Concern:** Unknown  
**Occupied:** Yes  
**In Community:** No,  
**Revisit Interval:** 5 yrs  
**Map Label:** 59

**Primary Access:** Road  
**Ingress Egress:** 2 or more roads in/out  
**Access Width:** 2 lanes (Greater than 24')  
**Access Condition:** Surfaced-paved, grade Less than 5%  
**Bridge Condition:** Less than 300 ft with turnaround  
**Access and Turnarounds:** Less than 300 ft with turnaround  
**Facility Number or Sign:** Marked and clearly visible  
**Fuel Type:** Shrub or timber  
**Fuel Load:** Light or no wildland fuels  
**Defensible Space:** Greater than 100ft treated  
**Topography:** Slope Less than 5%  
**Roof Material:** Noncombustible or not applicable  
**Siding Material:** Rock, concrete, metal  
**Foundation:** Closed, Less than 6in masonry exposed  
**Firewood:** None  
**Water Supply:** Pressurized hydrant(s) or fixed sprinkler system  
**Propane:** None  
**Overhead Hazards:** No overhead hazards  
**Comments:**
