# NPS Wildfire Risk Assessments Assessment Locations

## NATR - Natchez Trace National Parkway

# NPS Wildand Fire Risk Assessment - Facility Assessment

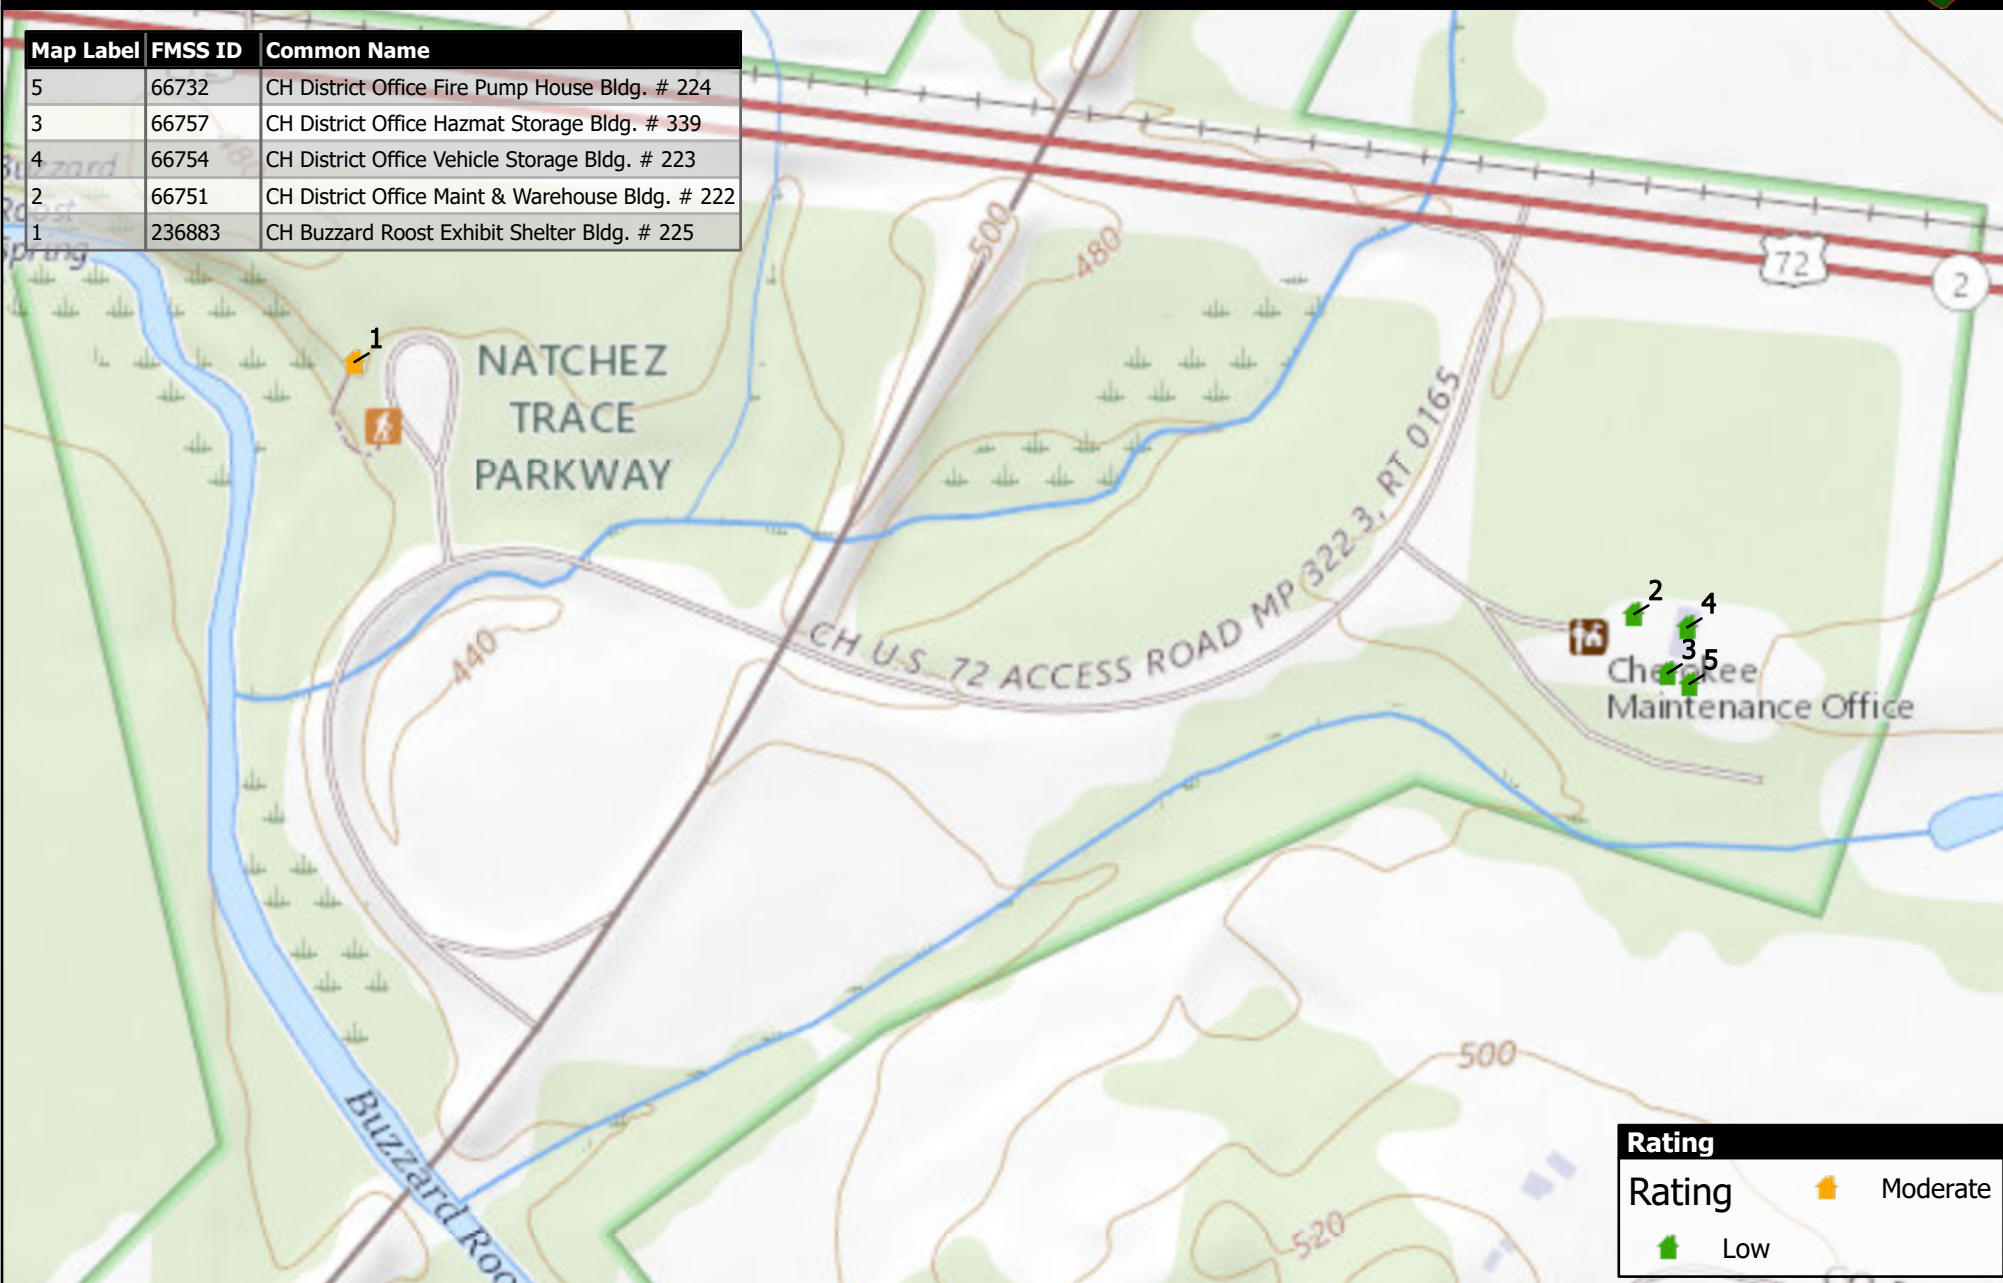
# CH Buzzard Roost

| Map Label | FMSS ID | Common Name |
| 5 | 66732 | CH District Office Fire Pump House Bldg. # 224 |
| 3 | 66757 | CH District Office Hazmat Storage Bldg. # 339 |
| 4 | 66754 | CH District Office Vehicle Storage Bldg. # 223 |
| 2 | 66751 | CH District Office Maint & Warehouse Bldg. # 222 |
| 1 | 236883 | CH Buzzard Roost Exhibit Shelter Bldg. # 225 |

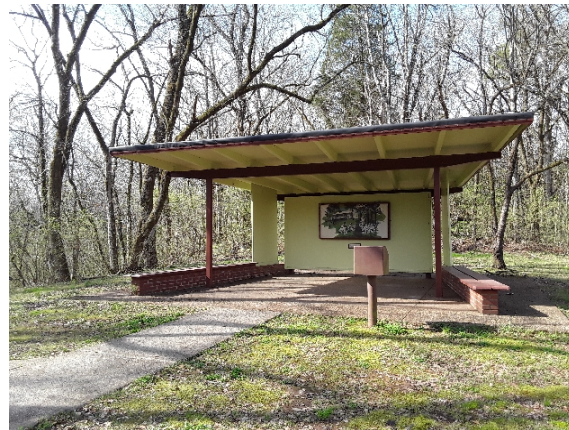
2021\_NATR\_236883\_CH Buzzard Roost Exhibit Shelter Bldg. # 225\_Front.jpg

## Facility: CH Buzzard Roost Exhibit Shelter Bldg. # 225

Rating: Moderate

Defensible Space: 30 ft treated

Fuel Load (w/in 300 ft): Moderate

Fuel Type (w/in 300ft): Shrub or timber

Topography (w/in 300ft): Slope 31% to 40%

Siding Material: Wood or open sided

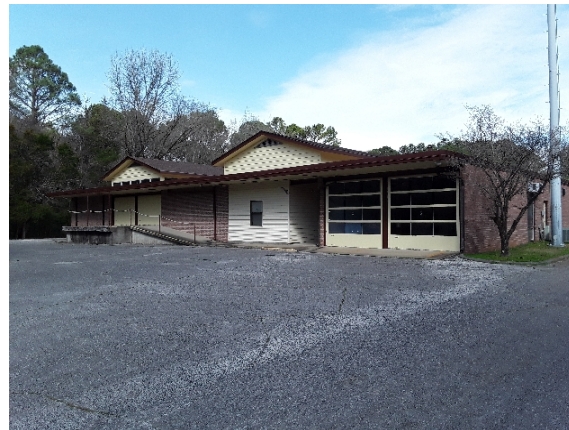
2021\_NATR\_66751\_CH District Office Maint & Warehouse Bldg. # 222\_Front.jpg

## Facility: CH District Office Maint & Warehouse Bldg. # 222

Rating: Low

Propane Tanks: Present and fuels clearance

Overhead Hazards: Overhead hazards will limit aircraft

Hazmat: fuel pumps

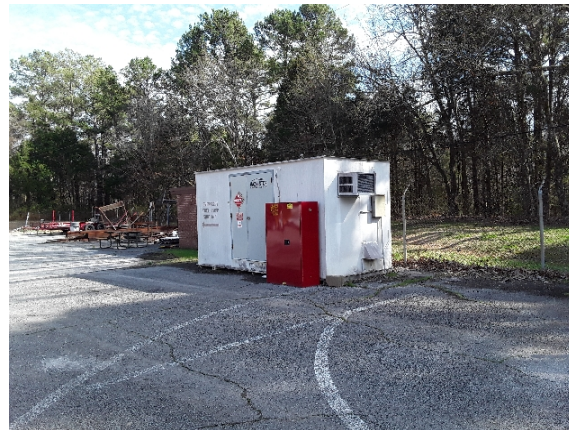
2021\_NATR\_66757\_CH District Office Hazmat Storage Bldg. # 339\_Front.jpg

## Facility: CH District Office Hazmat Storage Bldg. # 339

**Rating:** Low

**Overhead Hazards:** Overhead hazards will limit aircraft

**Hazmat:** fuel, oil

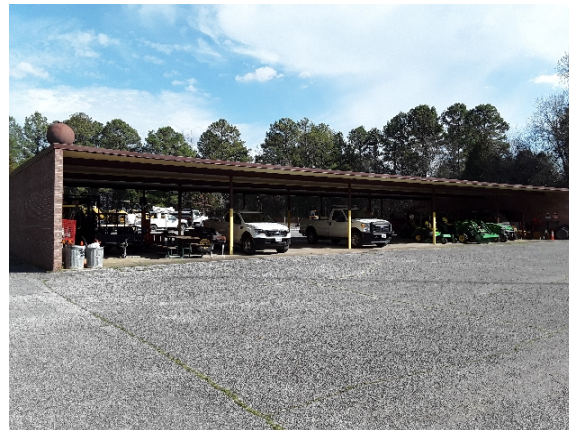
2021\_NATR\_66754\_CH District Office Vehicle Storage Bldg. # 223\_Front.jpg

## Facility: CH District Office Vehicle Storage Bldg. # 223

Rating: Low

Defensible Space: 100 ft treated

Siding Material: Wood or open sided

Hazmat: fuel, oil

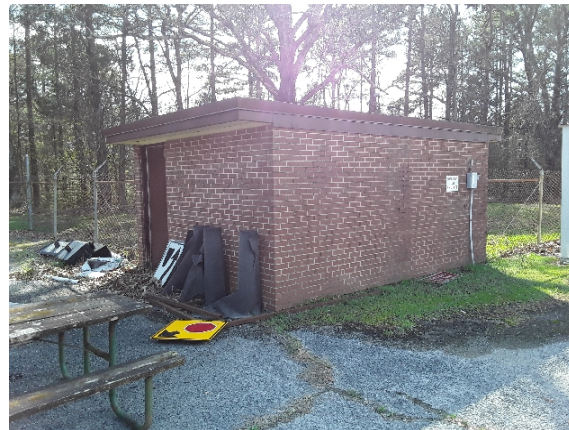
2021\_NATR\_66732\_CH District Office Fire Pump House Bldg. # 224\_Front.jpg

## Facility: CH District Office Fire Pump House Bldg. # 224

Rating: Low

Defensible Space: 30 ft treated

Hazmat: hazmat storage adjacent
