# NPS Wildfire Risk Assessments Assessment Locations

## Monocacy National Battlefield- Overview

Baker Farm Area  
MONO - Monocacy National Battlefield

# NPS Wildland Fire Risk Assessment - Facility Assessment

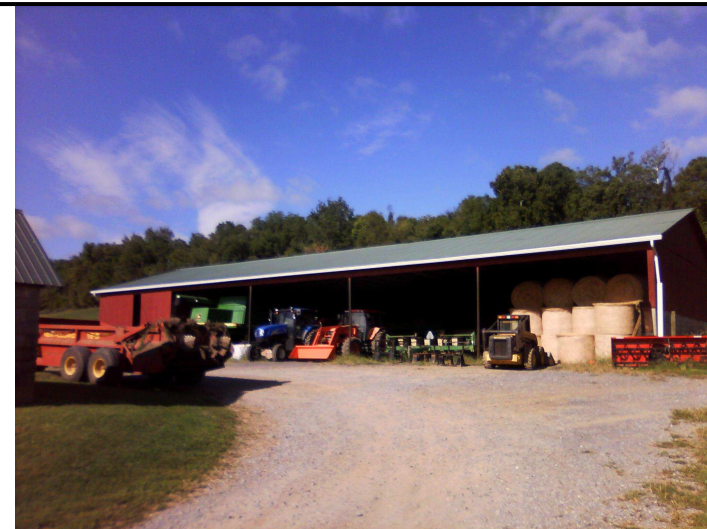
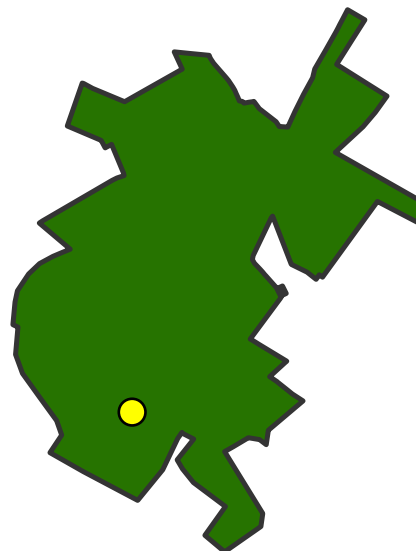
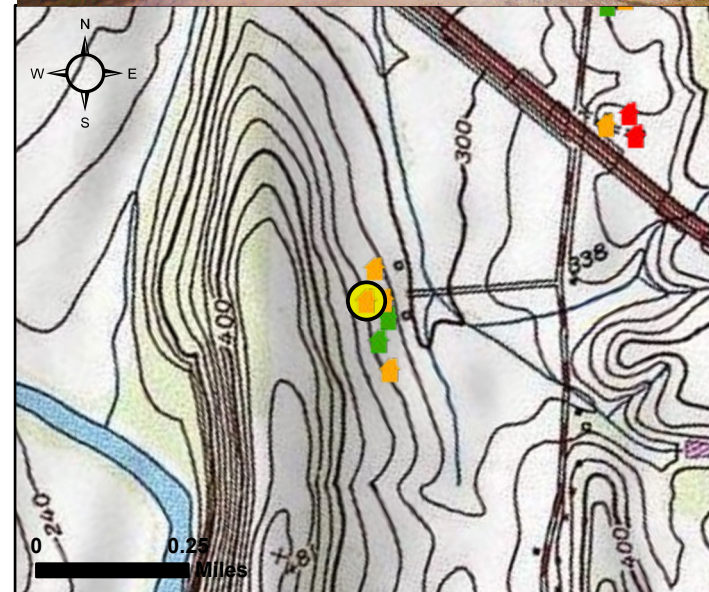
**Facility Name:** Equipment Storage

**Rating:** Moderate

**Fuel Type:** Grass/tundra,northern hardwood litter

**Fuel Load:** Light or no wildland fuels

**Defensible Space:** Less than 30 ft treated

**Roof Material:** Noncombustible or not applicable

**Siding Material:** Wood or open sided

**Foundation:** Closed, Greater than 30in masonry exposed or N/A

**Water Supply:** Limited or dependent on electricity

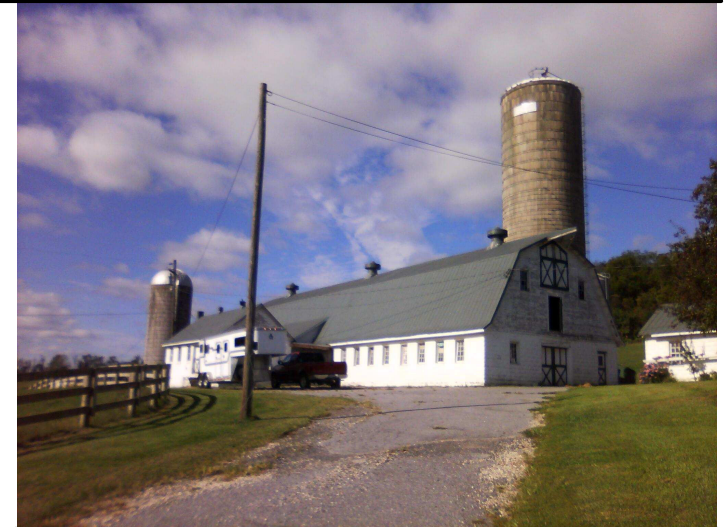
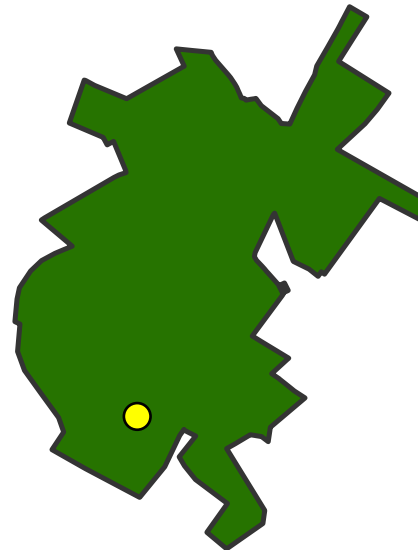
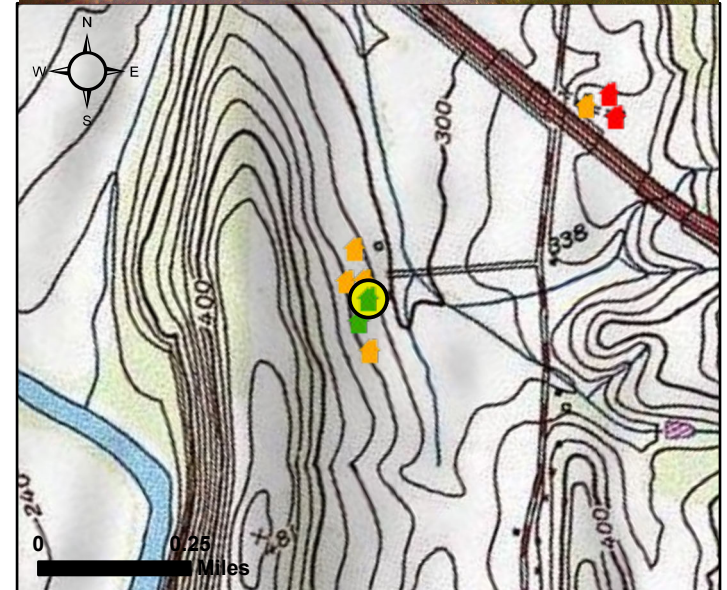
**Facility Name:** Dairy Barn

**Rating:** Low

**Fuel Type:** Grass/tundra, northern hardwood litter

**Fuel Load:** Light or no wildland fuels

**Defensible Space:** 100 ft treated

**Roof Material:** Noncombustible or not applicable

**Siding Material:** Wood or open sided

**Foundation:** Closed, Greater than 30in masonry exposed or N/A

**Water Supply:** Limited or dependent on electricity

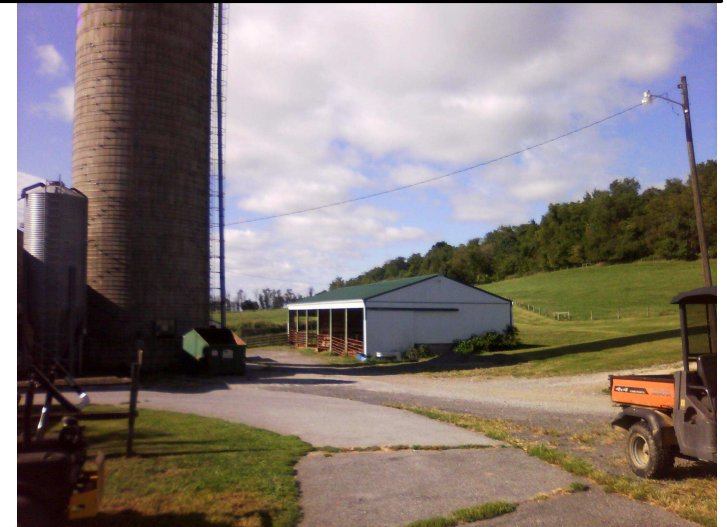
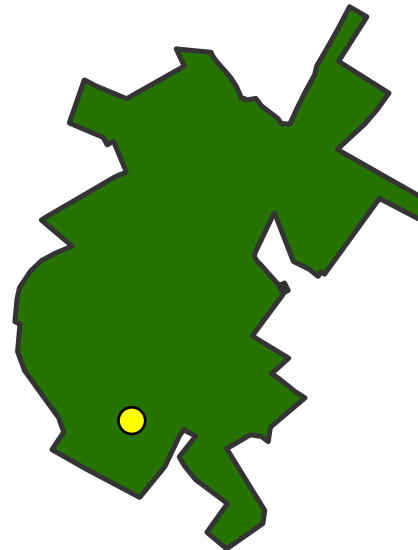
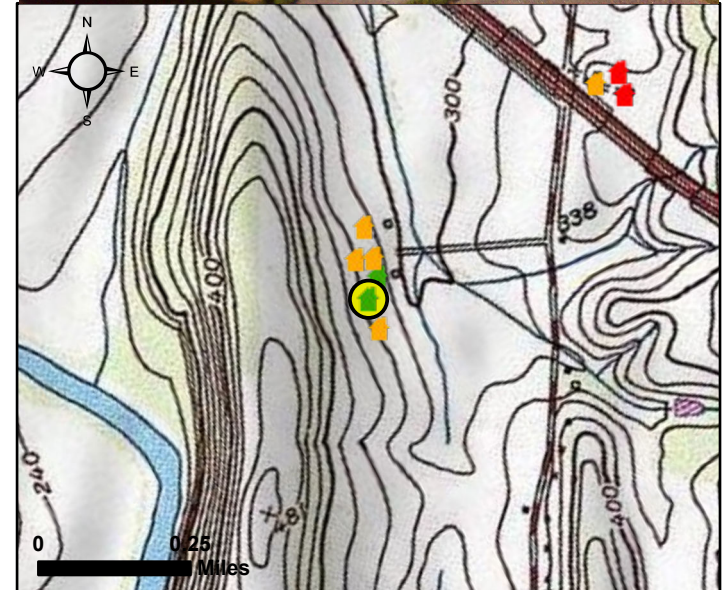
**Facility Name:** Barn

**Rating:** Low

**Fuel Type:** Grass/tundra,northern hardwood litter

**Fuel Load:** Light or no wildland fuels

**Defensible Space:** 100 ft treated

**Roof Material:** Noncombustible or not applicable

**Siding Material:** Wood or open sided

**Foundation:** Closed, Less than 6in masonry exposed

**Water Supply:** Limited or dependent on electricity

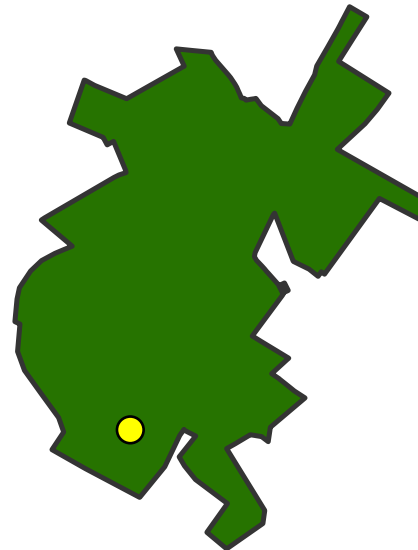
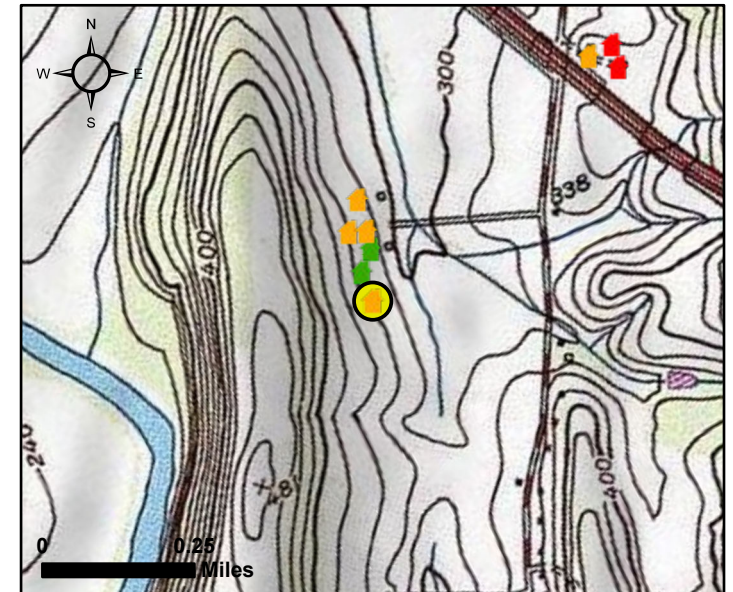
**Facility Name:** Barn

**Rating:** Moderate

**Fuel Type:** Grass/tundra,northern hardwood litter

**Fuel Load:** Light or no wildland fuels

**Defensible Space:** Less than 30 ft treated

**Roof Material:** Noncombustible or not applicable

**Siding Material:** Wood or open sided

**Foundation:** Closed, Less than 6in masonry exposed

**Water Supply:** Limited or dependent on electricity

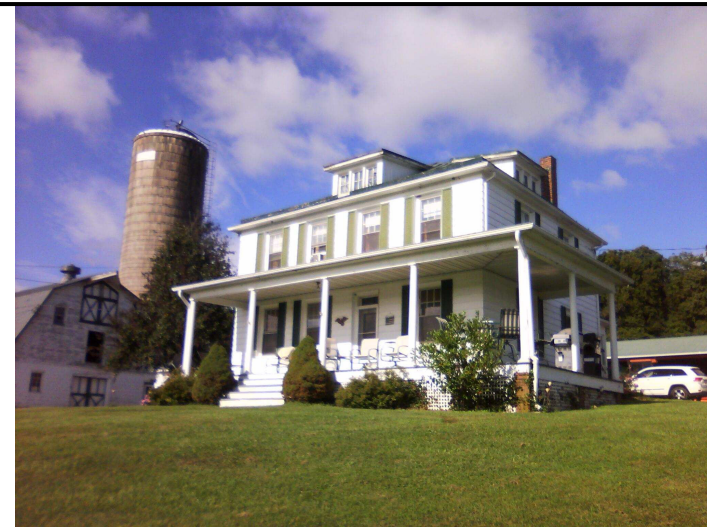
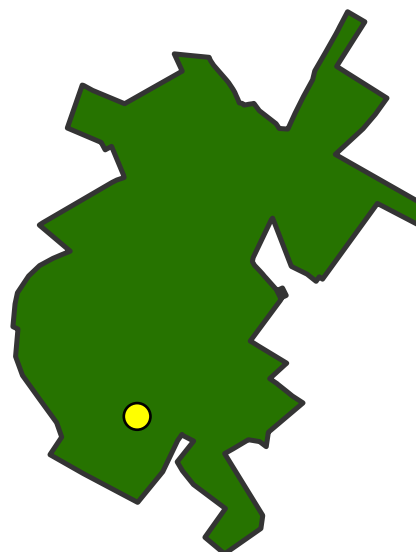
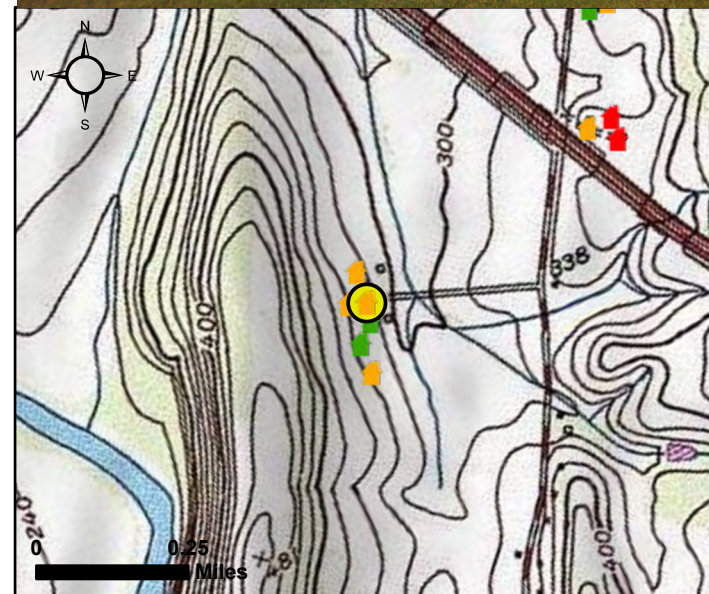
**Facility Name:** Baker House

**Rating:** Moderate

**Fuel Type:** Grass/tundra,northern hardwood litter

**Fuel Load:** Light or no wildland fuels

**Defensible Space:** 100 ft treated

**Roof Material:** Combination of fire resitant and combustible

**Siding Material:** Wood or open sided

**Foundation:** Closed, Less than 6in masonry exposed

**Water Supply:** Limited or dependent on electricity

**Comments:** From FMSS\_Export - FRPP\_PREDUSE:  
Bldg. Cultural Ctr (GSF)

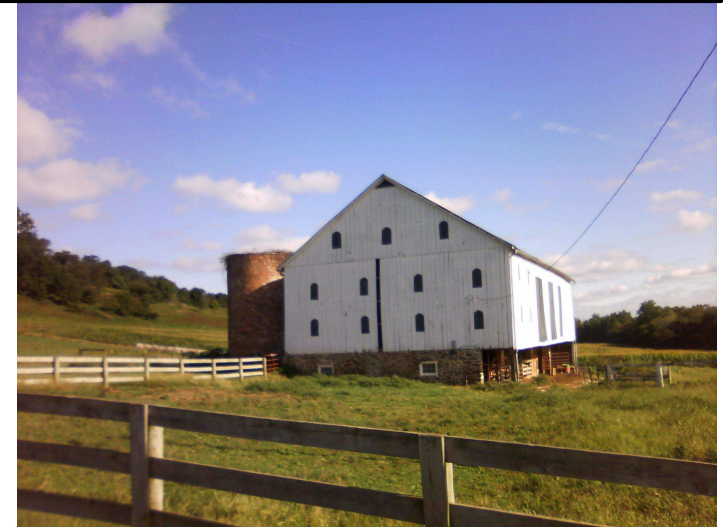
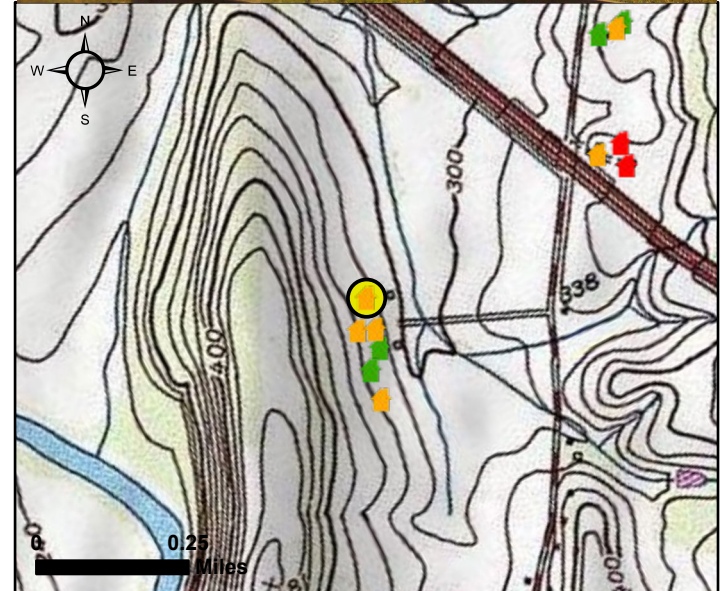
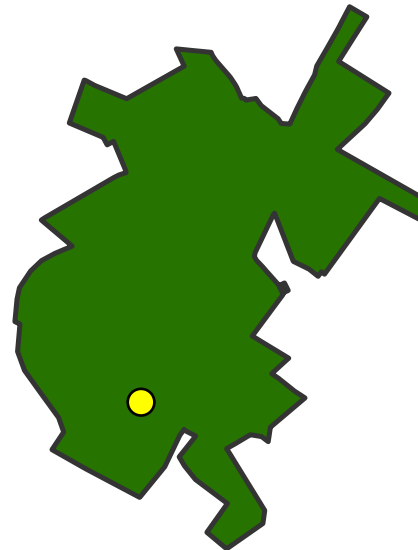
**Facility Name:** Baker Barn

**Rating:** Moderate

**Fuel Type:** Grass/tundra,northern hardwood litter

**Fuel Load:** Light or no wildland fuels

**Defensible Space:** Less than 30 ft treated

**Roof Material:** Noncombustible or not applicable

**Siding Material:** Wood or open sided

**Foundation:** Closed, Greater than 30in masonry exposed or N/A

**Water Supply:** Limited or dependent on electricity

**Comments:** From FMSS\_Export - FRPP\_PREDUSE:  
Bldg. Barn Stable (GSF)
