# Stream Channel Monitoring for Devils Tower NM

## *2022 Data Report*

Natural Resource Data Series NPS/DETO/NRDS—2023/xxx

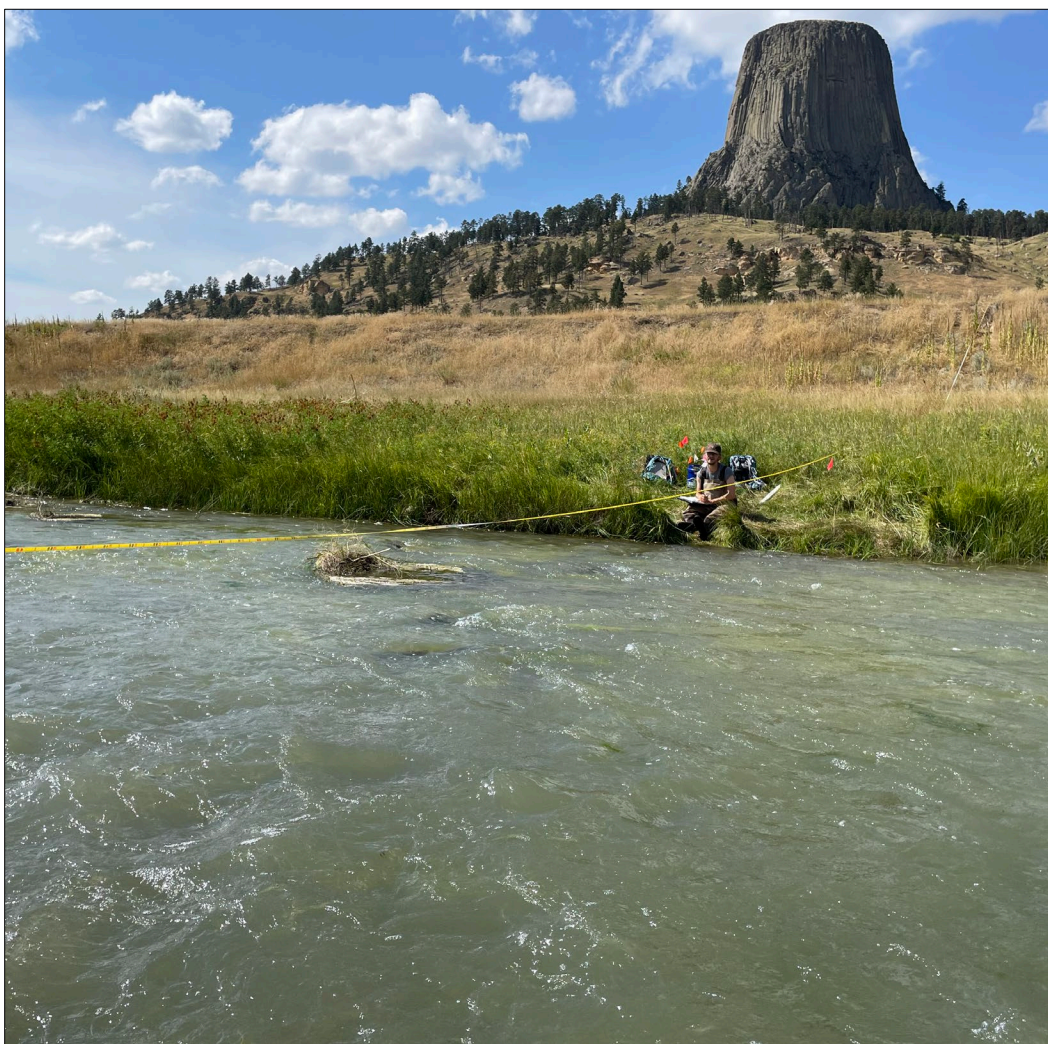
View of DETO SCM 001, facing downstream, June 2022.

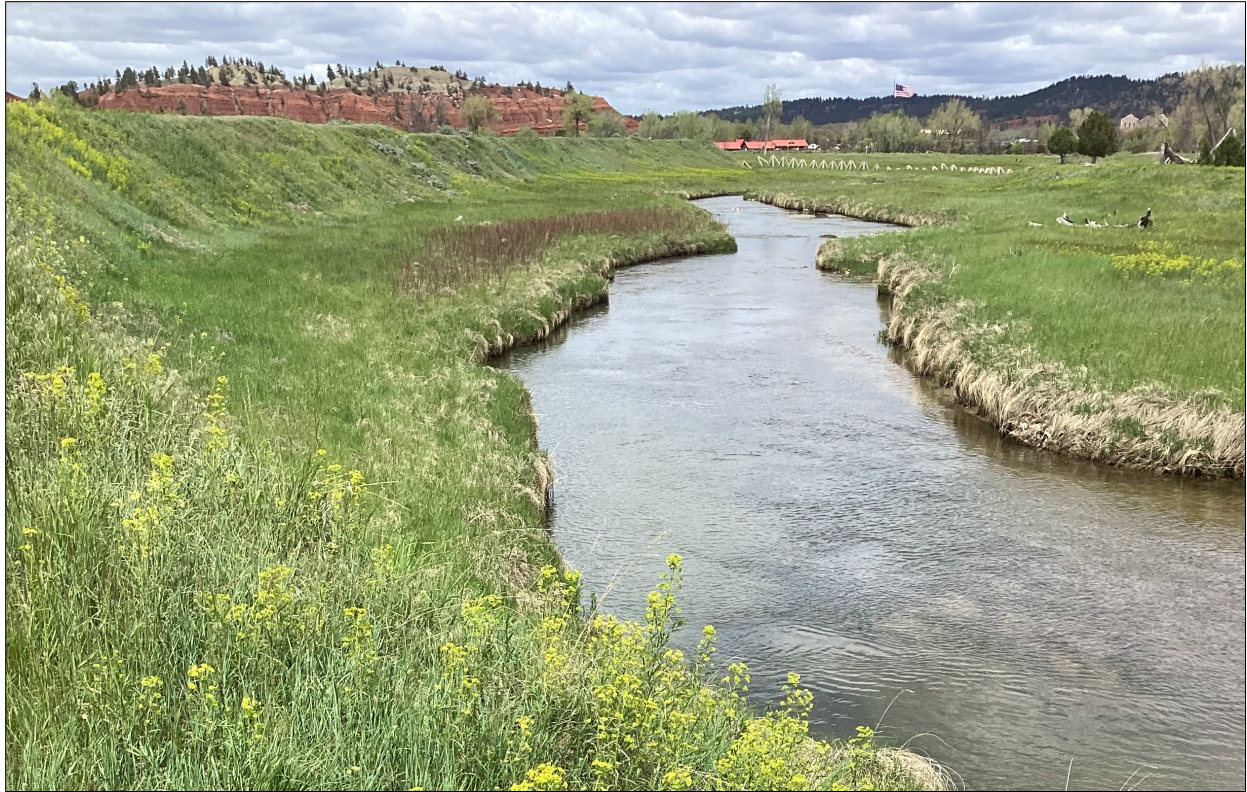
Cross-section at DETO SCM 001, with the Tower behind, August 2022.

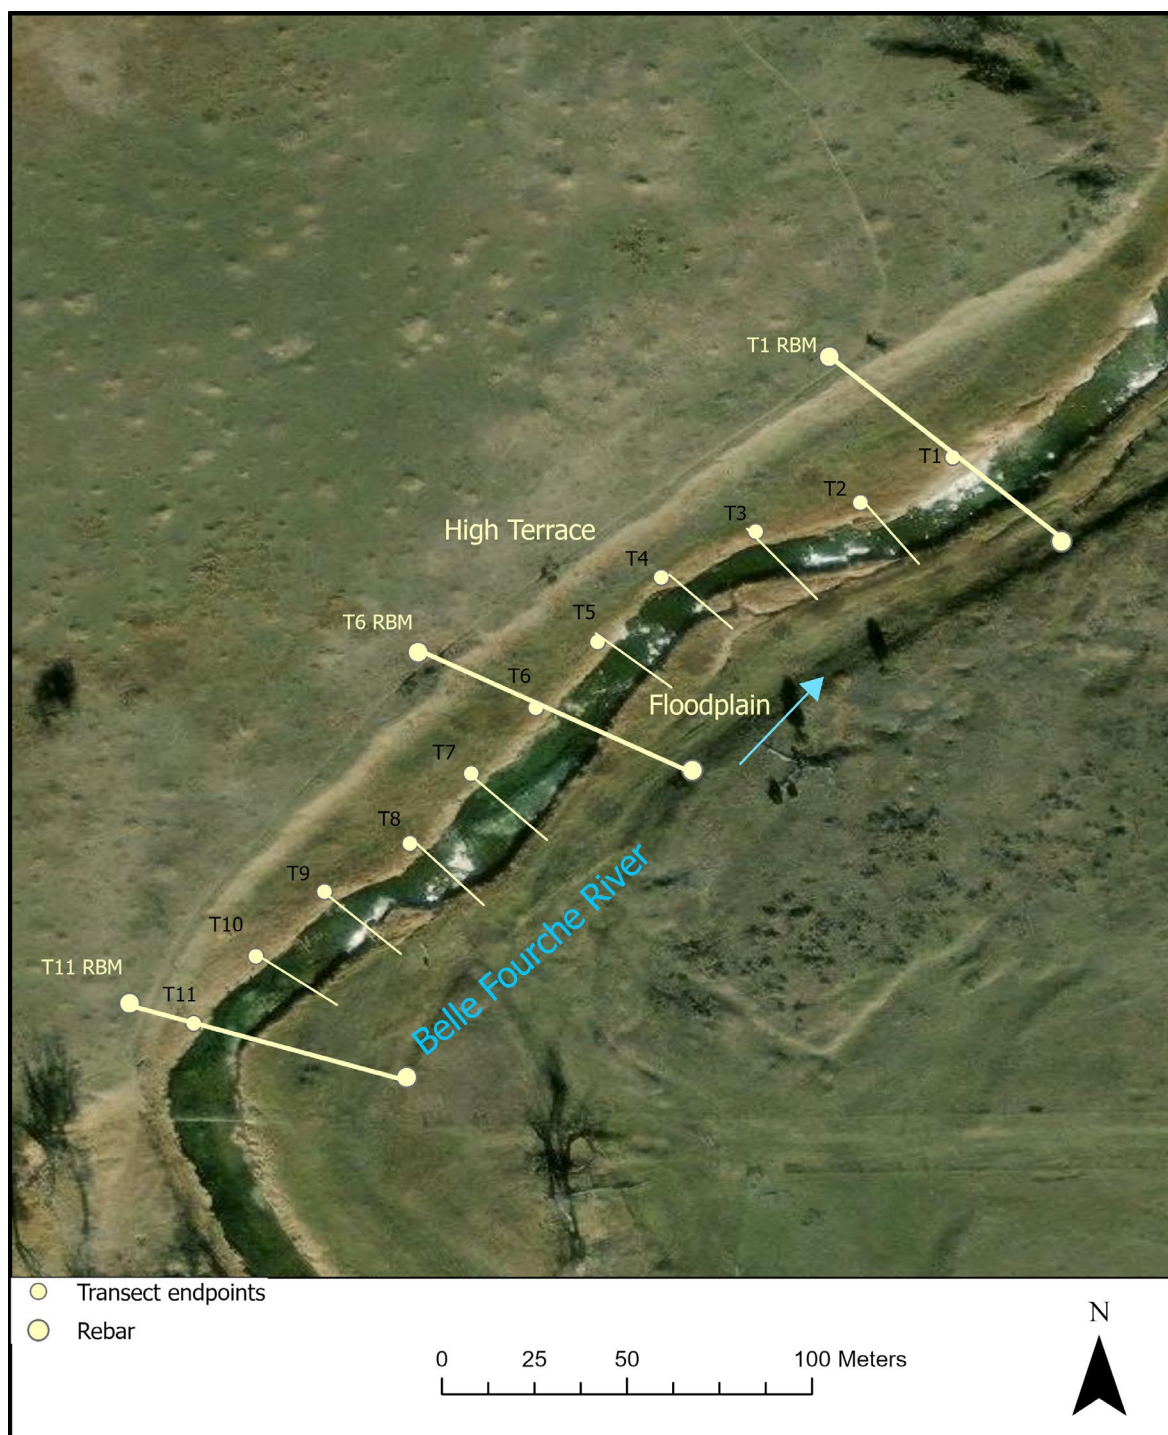
**Figure 2.** Layout of sampled reach of DETO stream channel monitoring site DETO SCM 001. Transects number 1-11 running from down to upstream.

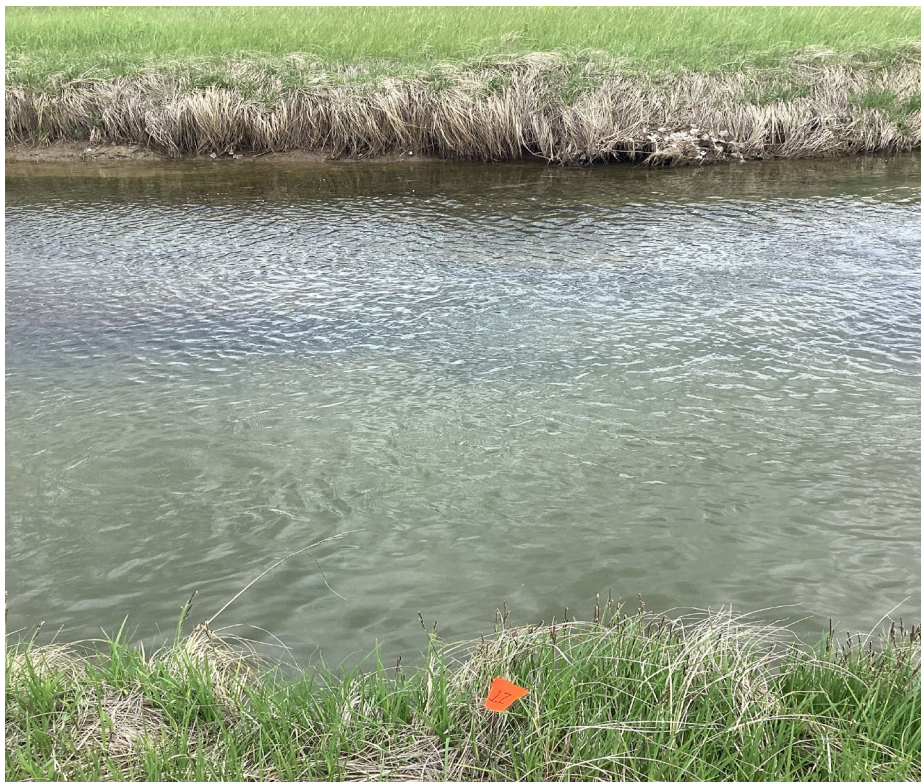
**Figure 4.** DETO stream channel monitoring site SCM 001 at T11 (upstream) end. This transect had an “unstable” BSI score for bank stability (11.5).

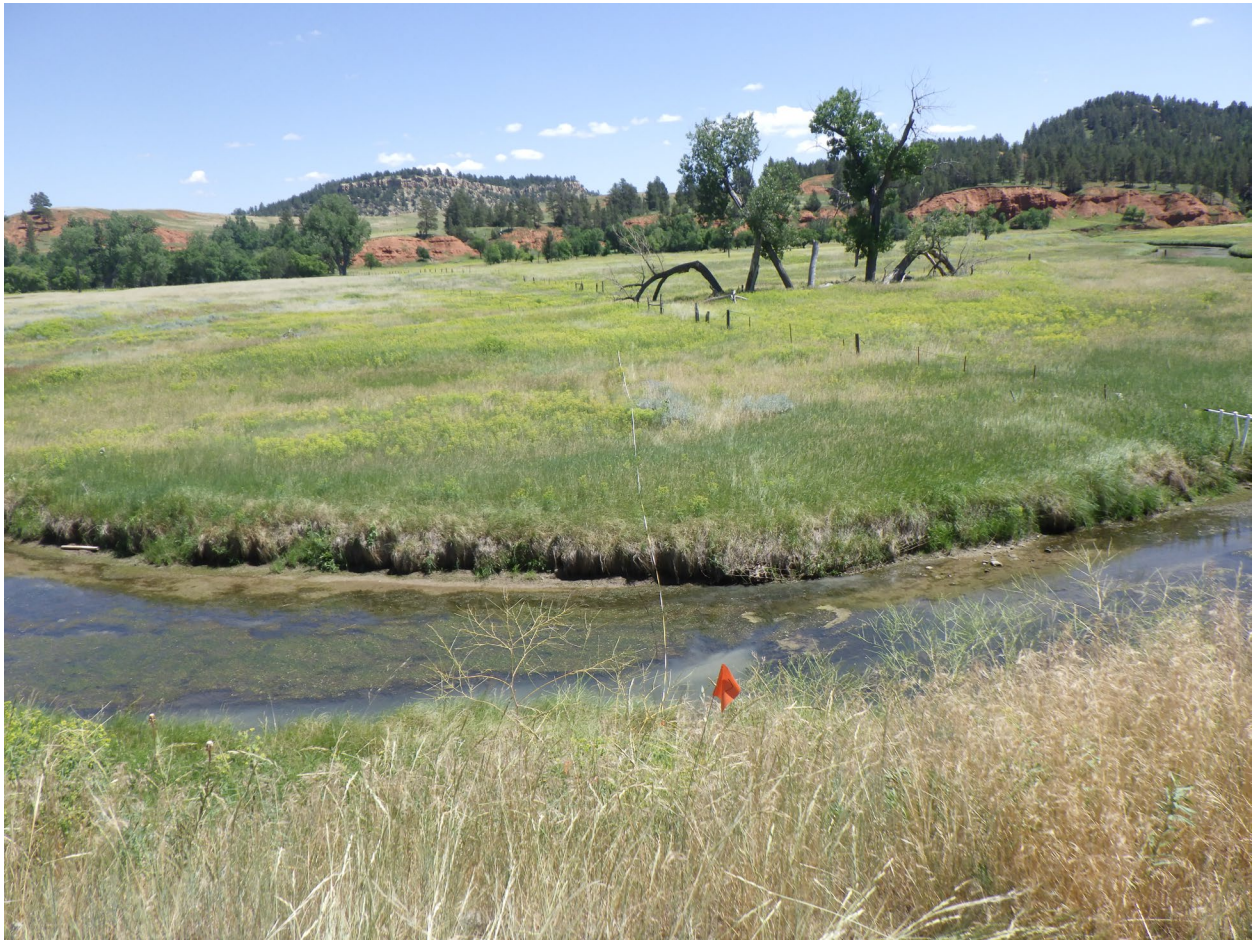
**Figure 5.** DETO stream channel monitoring site SCM 001 at T11 (upstream) end from left channel top. The right bank is largely covered in vegetation with good access to the floodplain, yet it has some undercut and exposed banks.

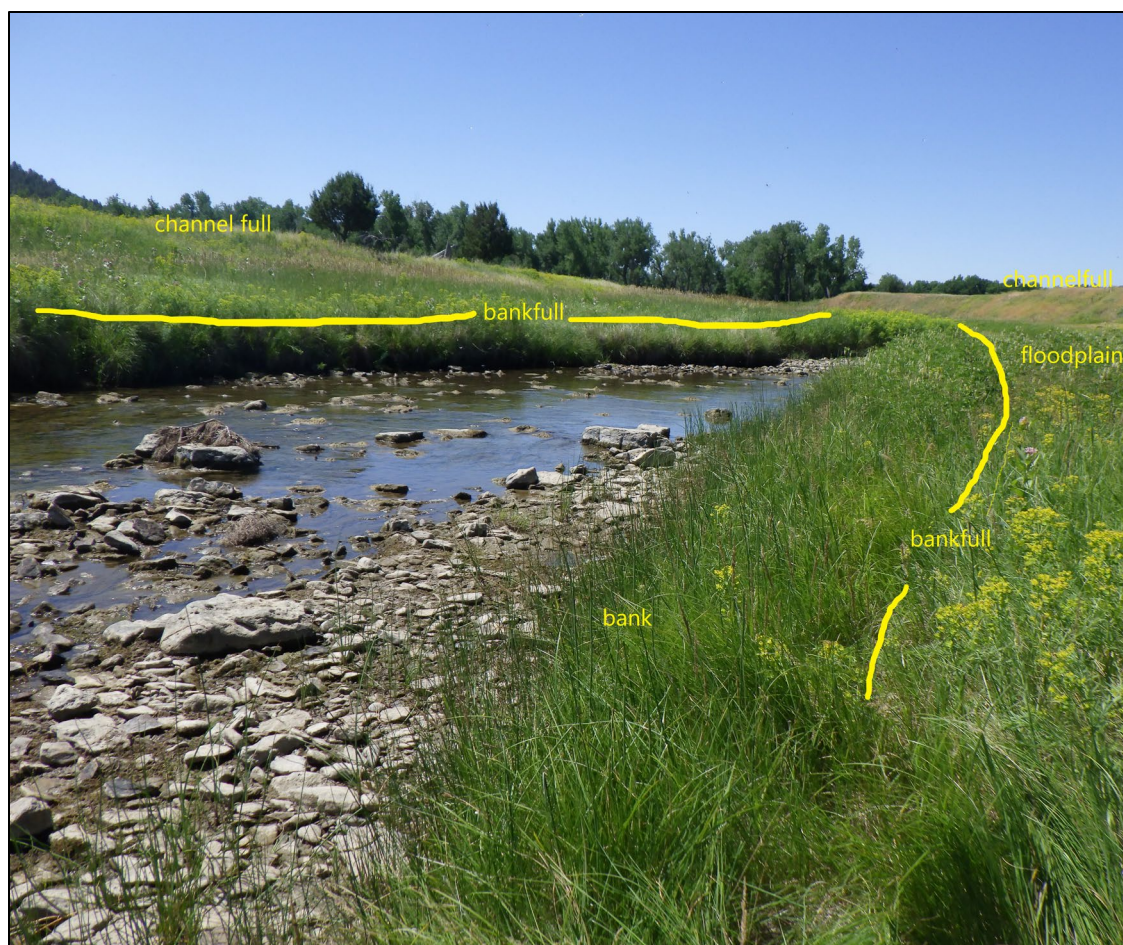
Figure 8 shows channel diagnostic features from T1 looking upstream.

**Figure 8.** Bank and channel features from T1 looking upstream, taken earlier in the summer, July 2022 at low flow.

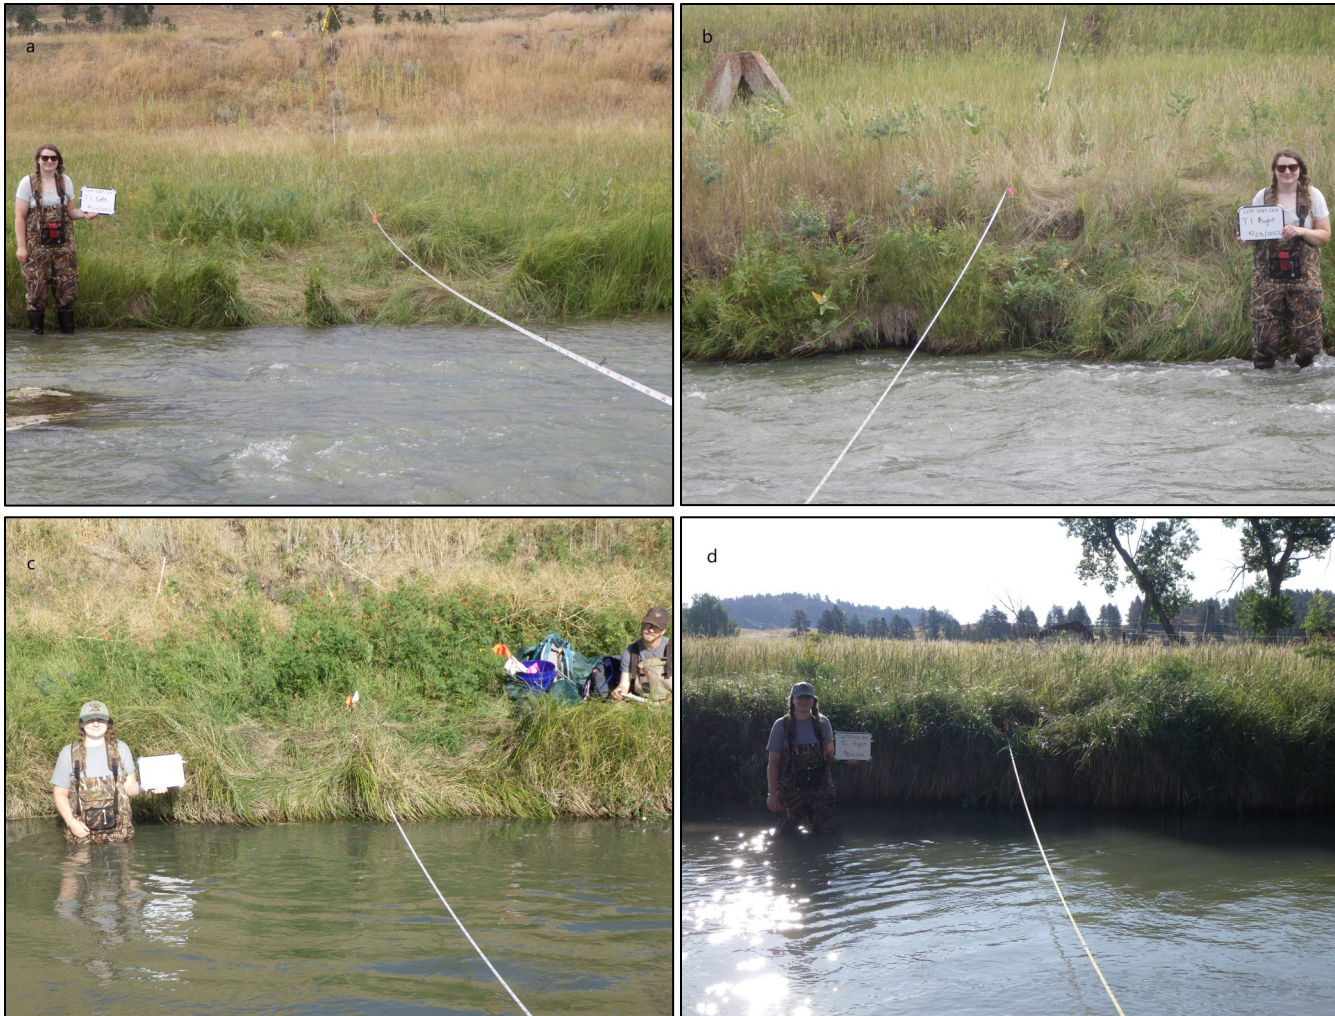
Transect 11 was the worst scoring transect overall for stability, while Transect 1 was the best. Pictures comparing transect 1 and 11 banks are below (Figure 9). High bank angles, higher bank heights, less cohesive substrate, and lack of vegetation contributed to the transects with higher bank instability.. Undercuts on some of the banks contributed to bank instability.

**Figure 9.** Transect 1 shows little erosion and has bank stability of score of 7.50 on the left bank (a) and 9.50 on the right bank (b). Transect 11 shows high areas of erosion and has bank stability of score of 12.5 on the left bank (c) and 12.5 on the right bank (d). While the right bank at T1 did have a .08 m by .07 undercut, undercutting was much more severe at T11 with a .22m x .42 m undercut on the left bank and a .12 x .1 m undercut on the right bank.

This site will be revisited in 3 years to see if channel widening is occurring. Given the amount of undercut banks and the substantial widening of the channel and bank full areas moving downstream (Figure 10), we would expect erosion effects to get worse at T11. Channel change can be regarded as a redistribution of the imbalance between sediment and water (Schmidt and Wilcock 2008, Thorne and Lewin 2020). The revisits will allow us to better identify areas of sediment deposition and erosion and if these areas have changed from the 2022 visit.

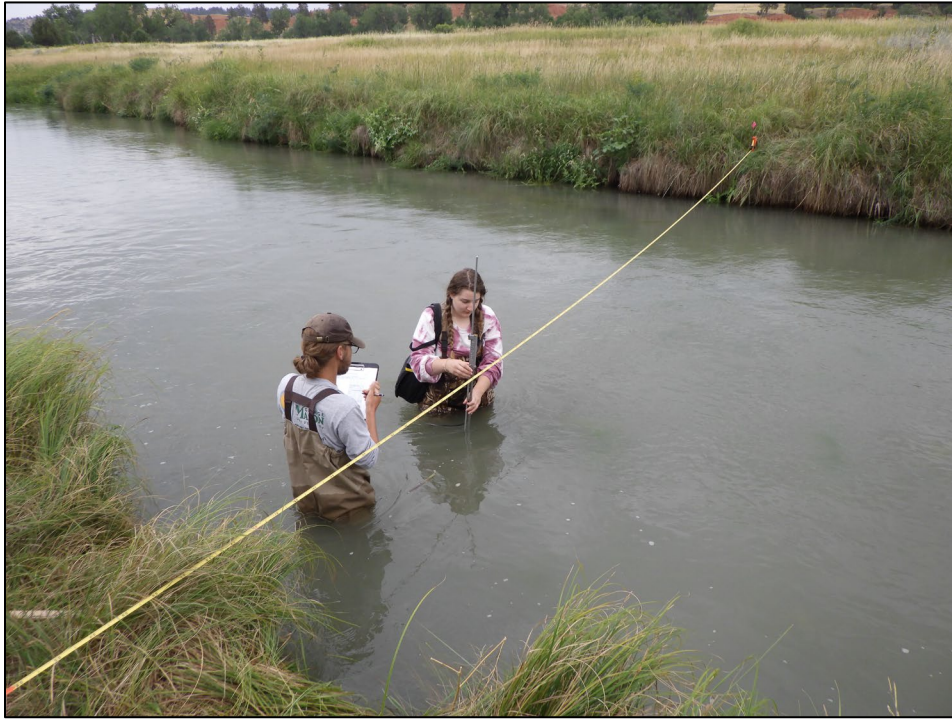
**Figure 11.** Discharge was measured at the upstream end of the site, along the T11 detailed transect.
