# Stream Channel Monitoring for Knife River Indian Villages NHS

## *2022 Data Report*

Natural Resource Data Series NPS/KNRI/NRDS—2023/xxx

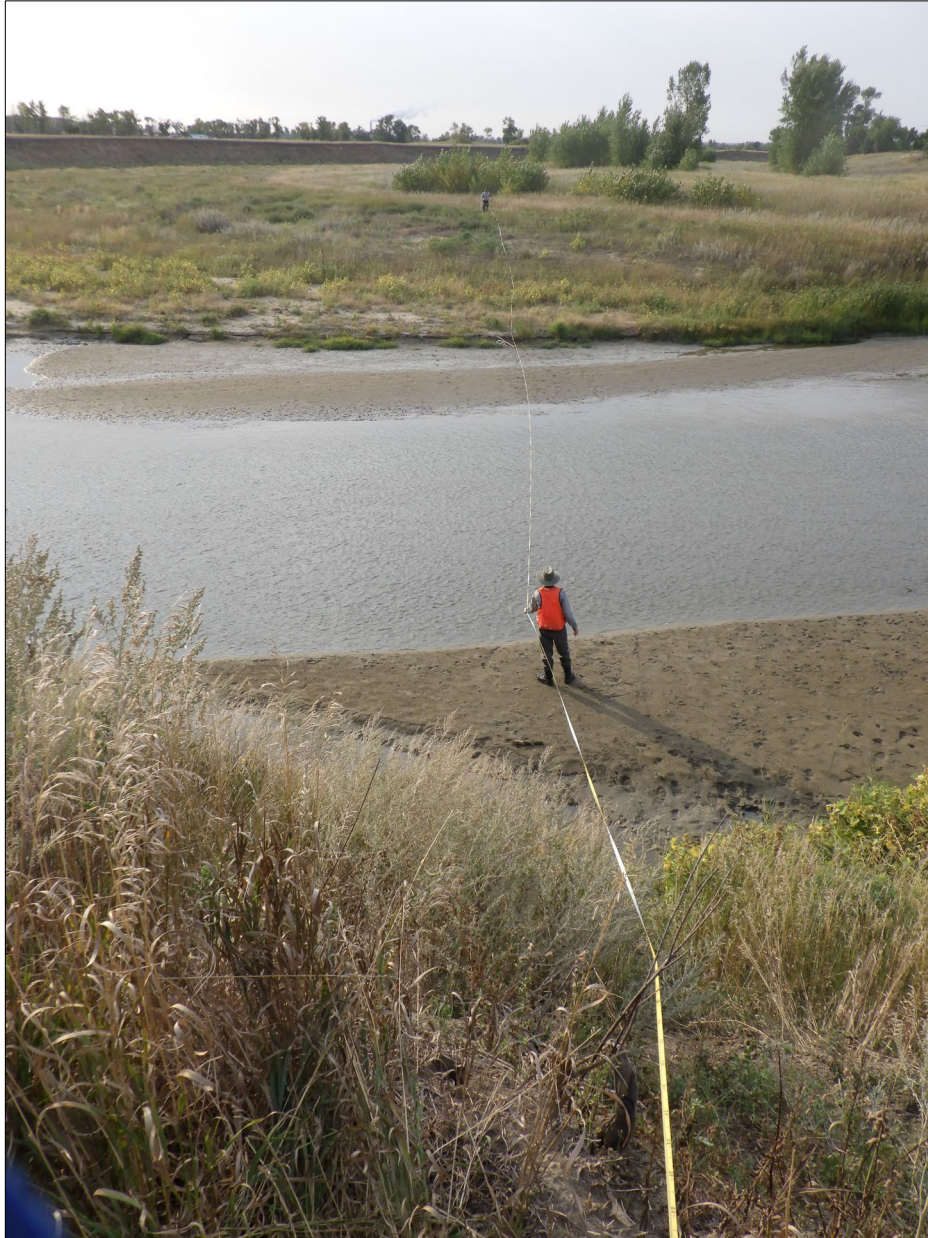
Setting up measurements for a detailed transect at T1 at KNRI SCM 001.

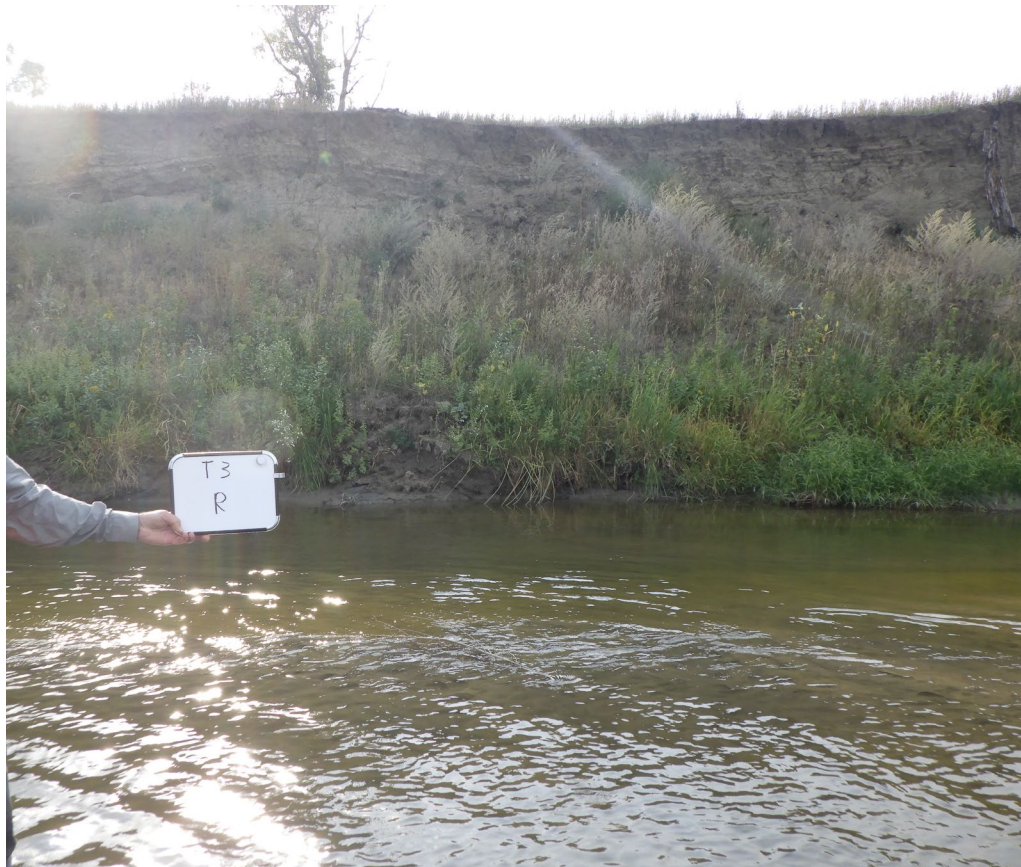
**Figure 5.** KNRI stream channel monitoring site SCM 001 at T3 (downstream) end. This is one of the fastest eroding banks on Unnamed Bend according to Sexton 2012 while it had a moderate BSI score for bank stability (11.5).

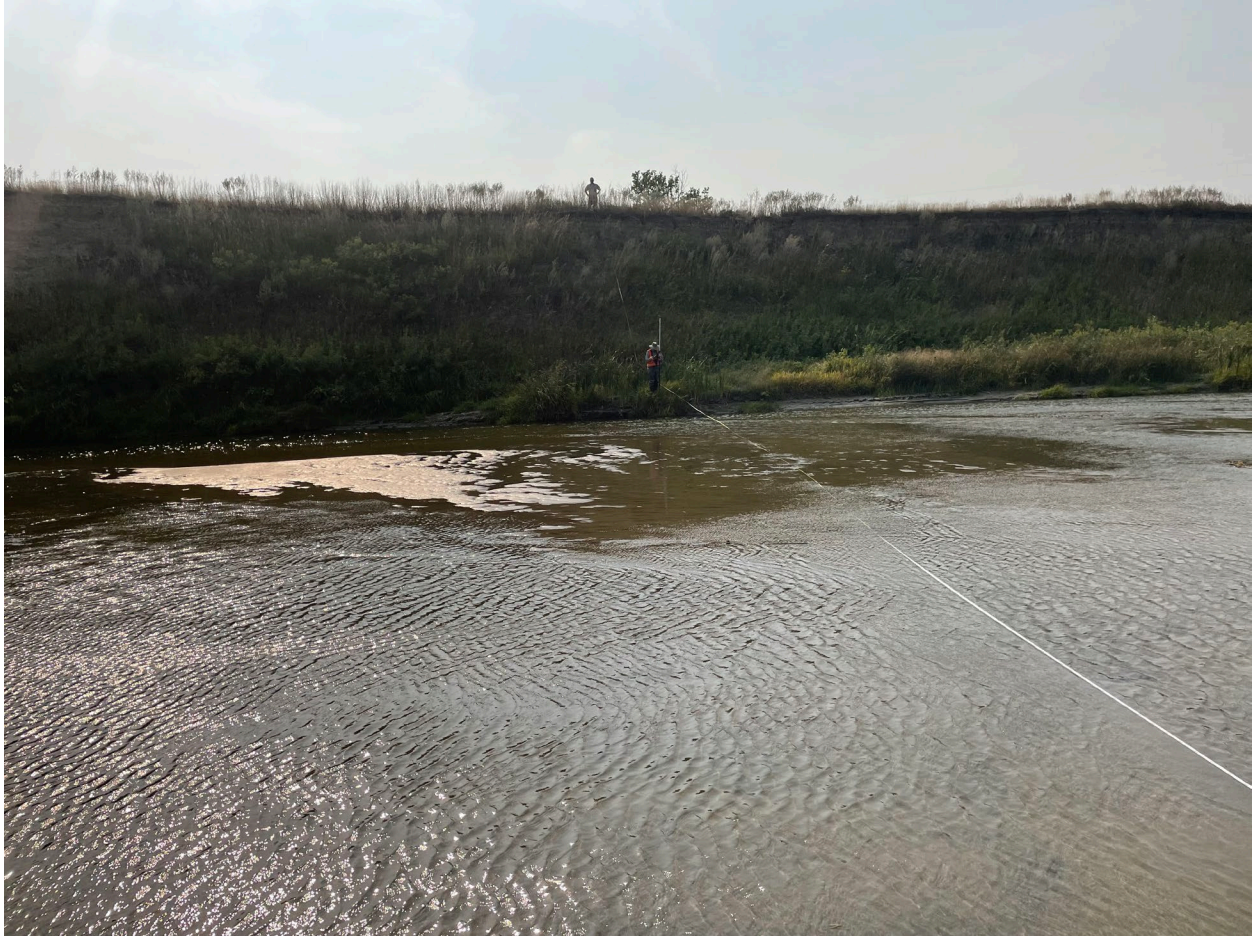
**Figure 6.** KNRI stream channel monitoring site SCM 001 at T11 (upstream) end. Despite the high banks (8m), the bank is largely covered in vegetation and has a small floodplain forming atop eroded material at the base. It scored a 15 on BSI index for bank instability (“unstable”). Good access to the floodplain is available on the left bank.

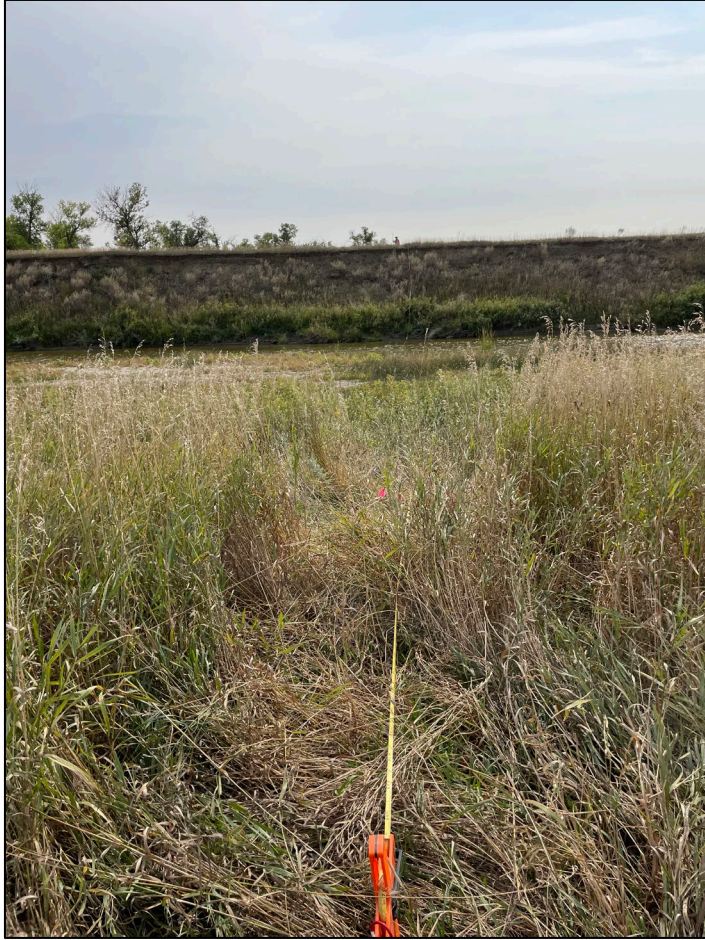
**Figure 7.** View of detailed transect from the LBM at T6 showing the steep right bank which is located in the middle of the cutbank meander.

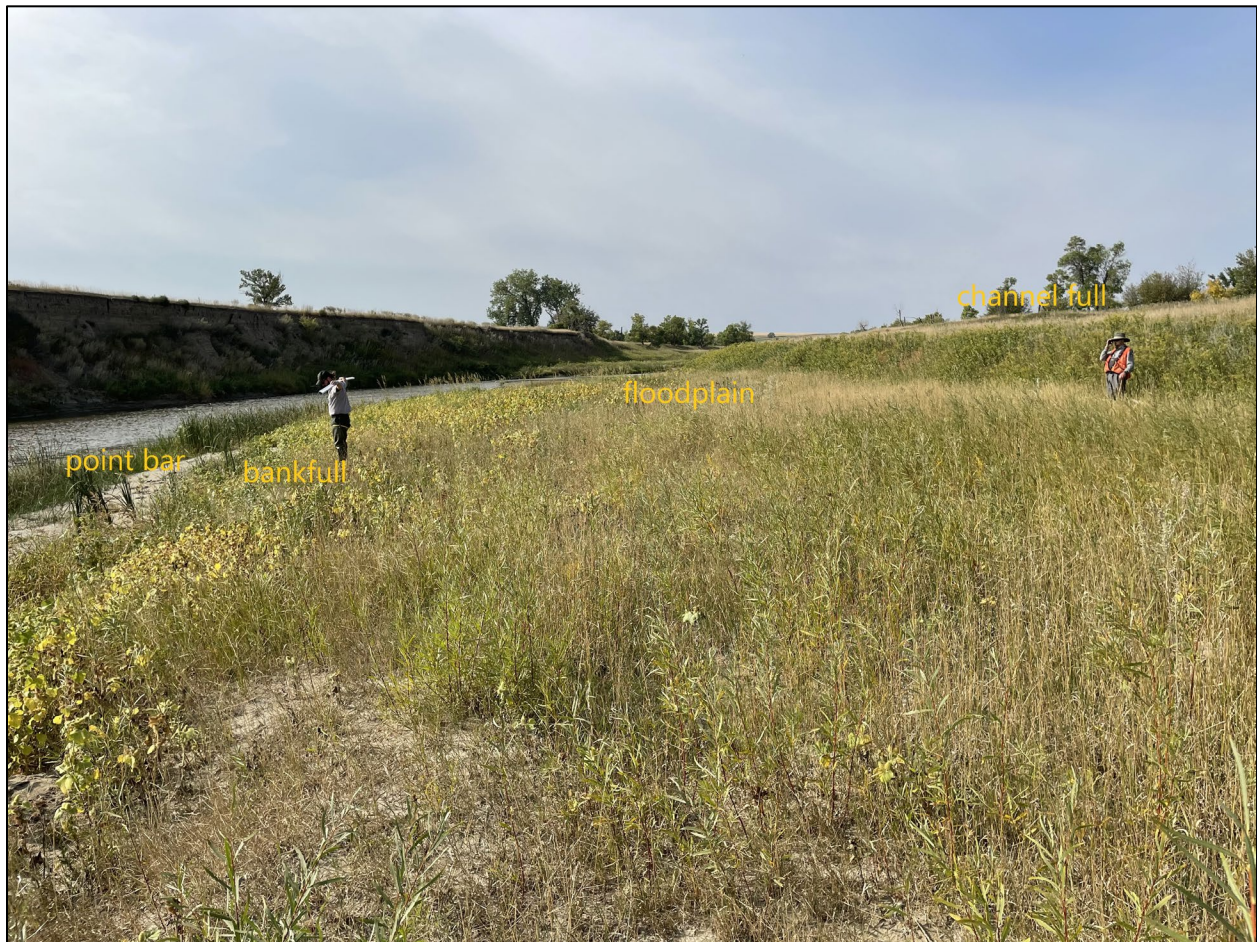
**Figure 10.** NGPN crew takes bank-full measurements at Transect 5. One crew member stands at bank-full, while the other is at the back of the floodplain.

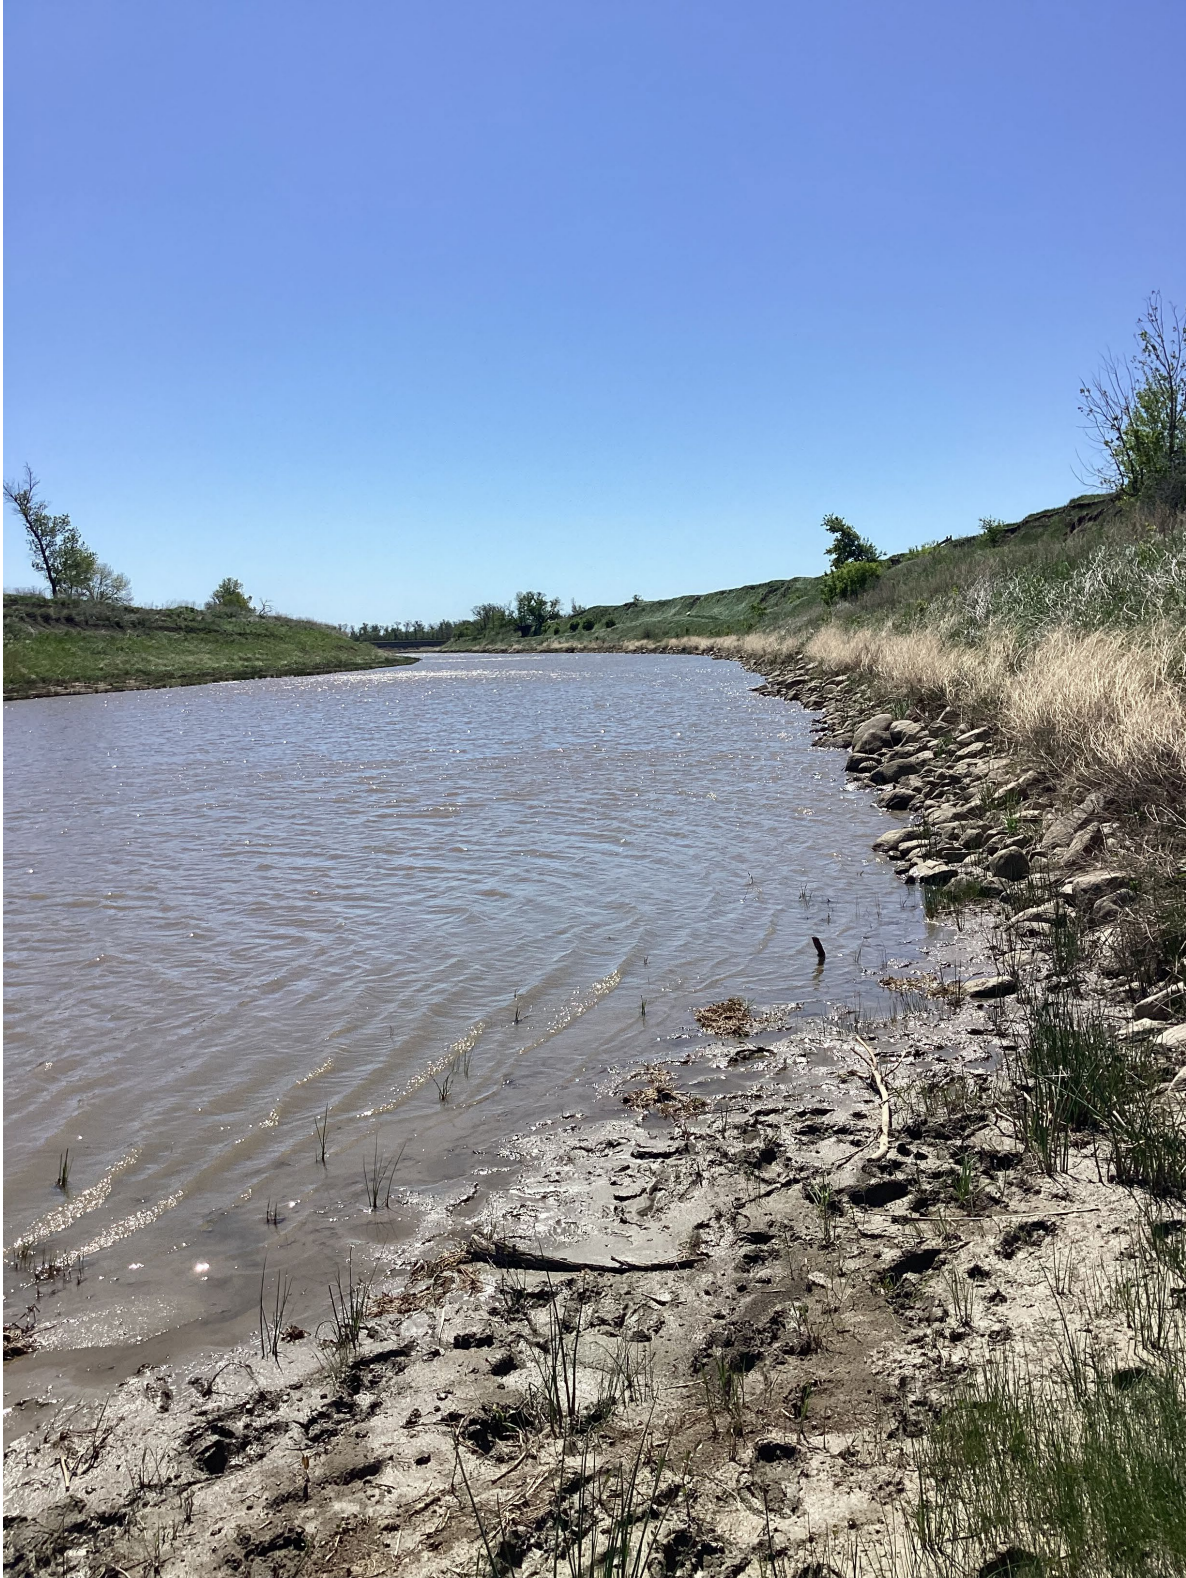
Bank erosion is measured in the original protocol in a qualitative manner by recording erosion and type (none, slump, or lateral) within a meter up and downstream of each transect. 54% of bank measurements according to this method showed erosion. Overwhelmingly erosion was on the right bank which had 81.8% of the banks eroding while the left showed only 18% of the bank eroding. To compare to Rust 2006, additional measurements were taken by measuring the length of streambank eroded at each transect. A 10-m section was measured on each bank at each transect. 108 m out of 220-m bank length were recorded as eroded, representing 49.1 % of the streambank. 84.5% of the right bank was eroding, while only 13.6 % of the left bank was eroding. This more quantitative measure of erosion was included in the 2022 revision of the Wadeable Stream Field Data Collection protocol [DataStore – Wadeable Stream Reach Scale Field Data Collection: Stream Channel Monitoring \(nps.gov\)](#). Figure 12 shows the right bank restabilizing at the base.

**Figure 12.** Restabilized base of right bank (outside bend) looking downstream toward T1. Note silt clay substrate, cobble-sized rock and vegetation stabilizing the lower bank.

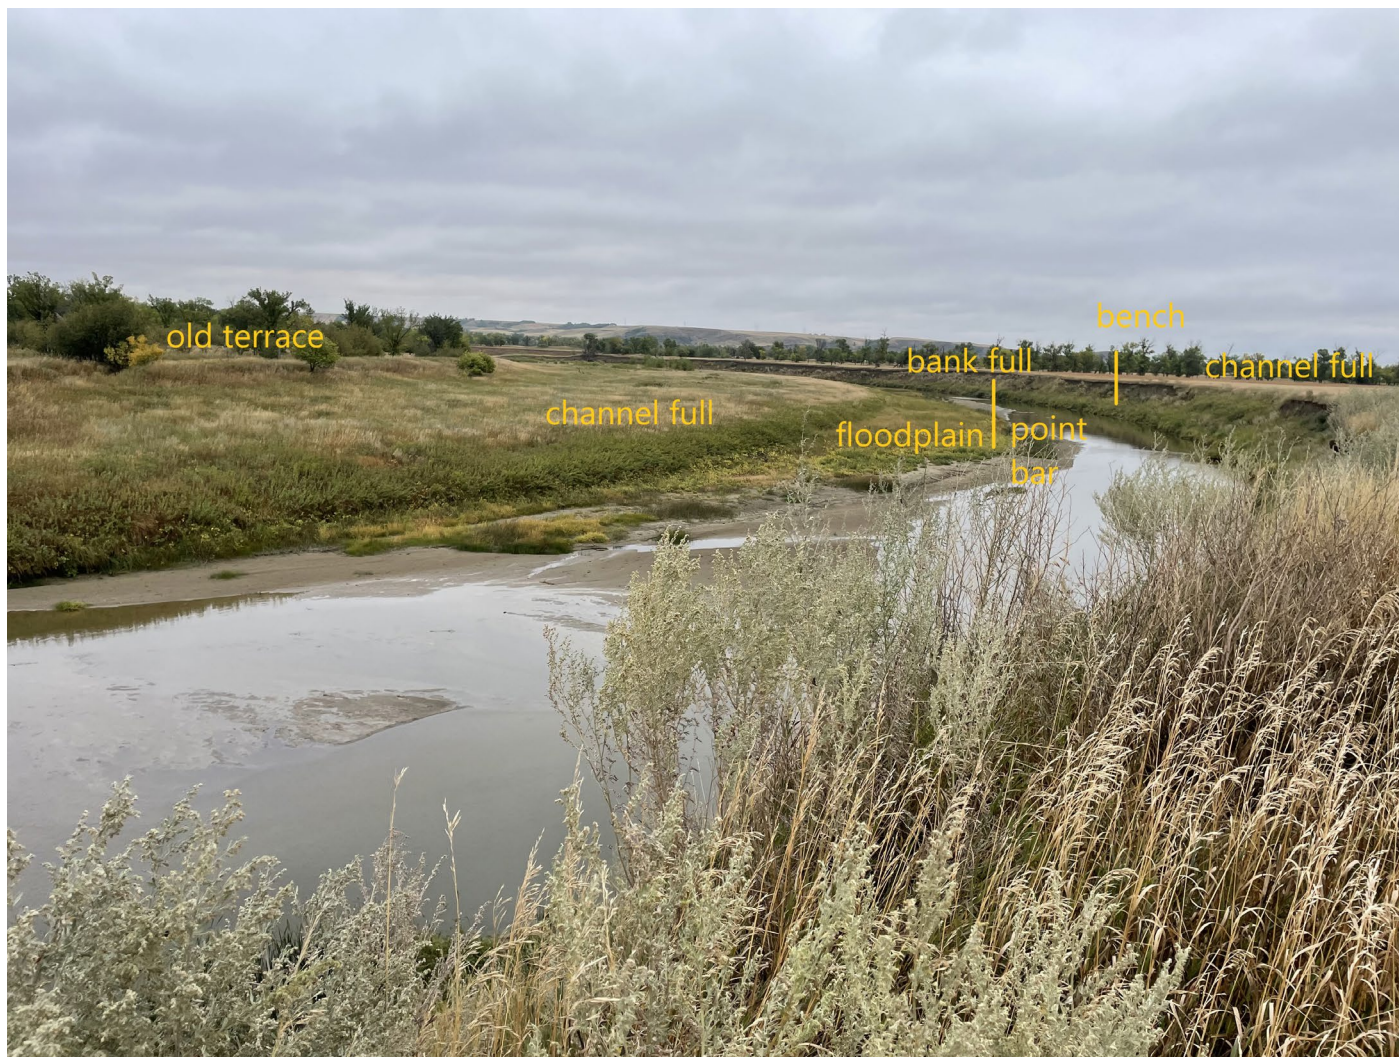
**Figure 13.** Site overview from right bank at T11 looking downstream.

This site will be revisited in 3 years to see if bed degradation is occurring or if the channel morphology has changed (Figure 13). Channel change can be regarded as a redistribution of the imbalance between sediment and water (Thorne and Lewin 1974, Schmidt and Wilcock 2008, Skalak et al 2013). The revisits will allow us to better identify areas of sediment deposition and erosion and if these areas have changed from the 2022 visit.

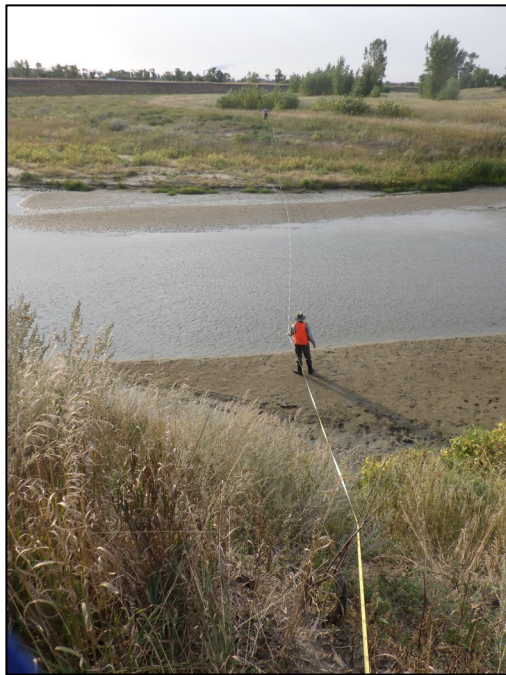
The last component of physical characteristics was the discharge which was measured along the T1 transect. Measured discharge was measured with a Marsh-McBirney flow meter and was 19.46 cfs using the velocity area method (Figure 14). The river was extremely shallow and the sensor was not always fully submerged, and so it was not an optimal place or time to take a measurement. As part of the protocol we measured it, also we wanted a rough idea of how the velocity varied across the stream. The measured discharge at the gage at the time was 27.8 cfs. Cross section mean stream velocity at KNRI SCM 001 was 0.74 ft/s (0.22m/s). In the future, taking velocity measurements at all of the detailed transects would be useful to better understand how stream velocity changes throughout the reach. Where the channel is narrow and straight, ie channelized, we would expect stream velocity to be greater than in a meandering stream. In a meandering stream, we would expect velocity to be greater toward the outside bends on the meanders (Gordon 2007).

**Figure 14.** Discharge was measured at the downstream end of the site, along the T1 detailed transect.
