# Stream Channel Monitoring for Theodore Roosevelt National Park

## *2022 Data Report*

Natural Resource Data Series NPS/THRO/NRDS—2023/xxx

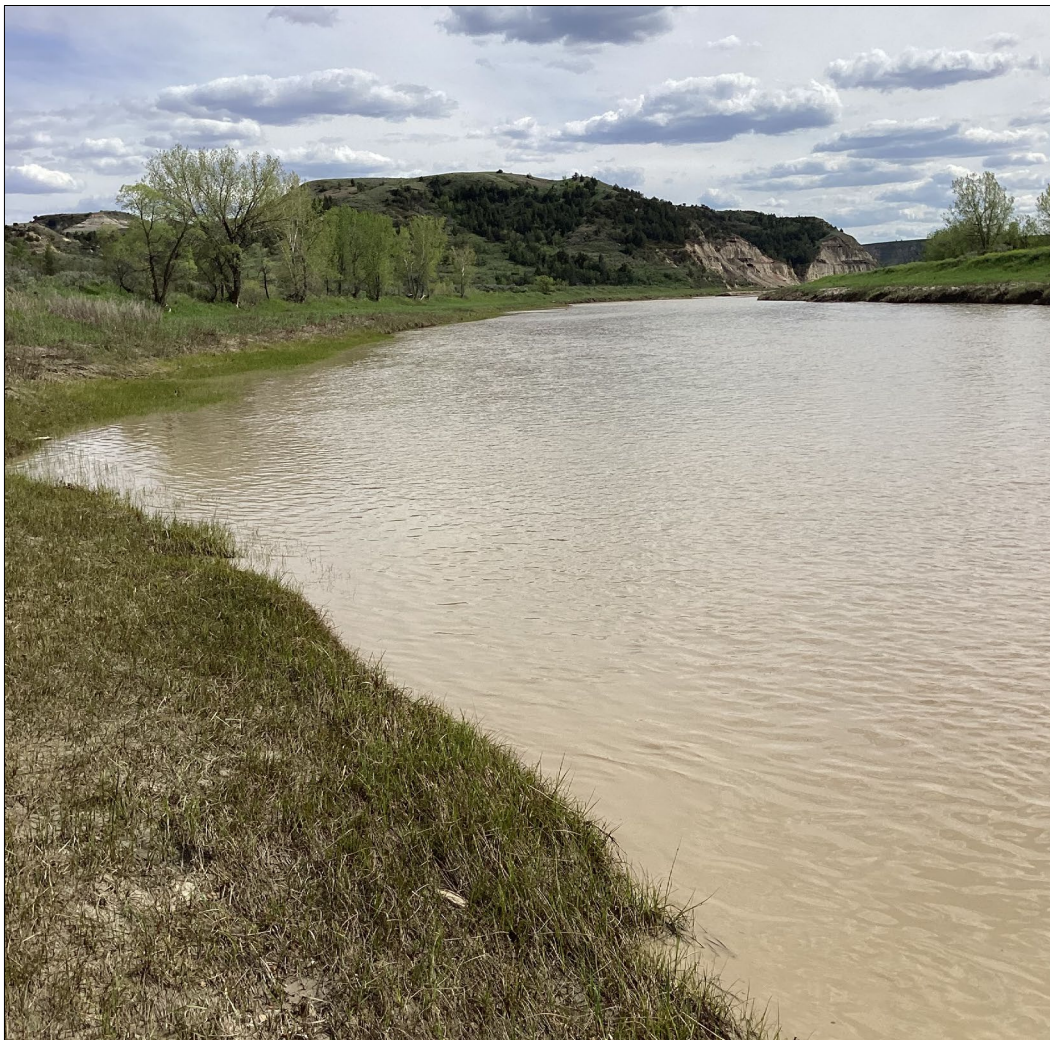
**ON THE COVER**

THRO SCM 001's full banks in May 2022.  
Photograph courtesy of Northern Great Plains Network, National Park Service.

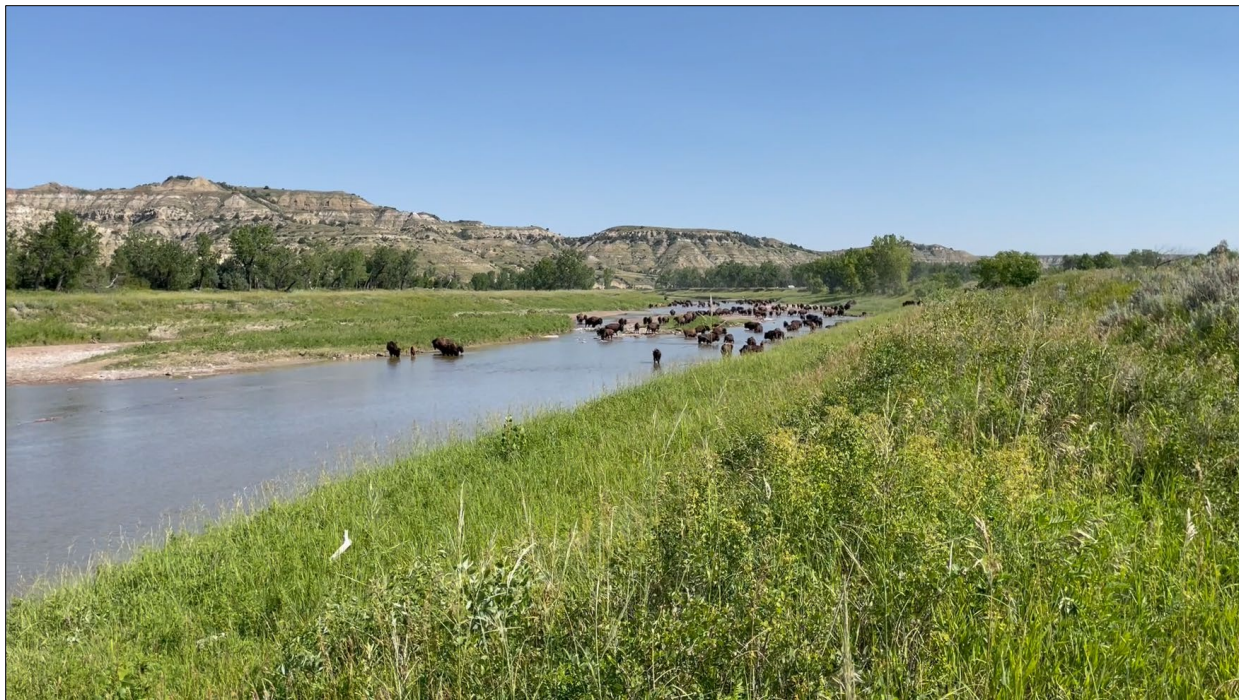
**ON THIS PAGE**

View of THRO SCM 001, facing downstream toward Cottonwood campground and congregating bison, August 2022.  
Photograph courtesy of NGPN, National Park Service.

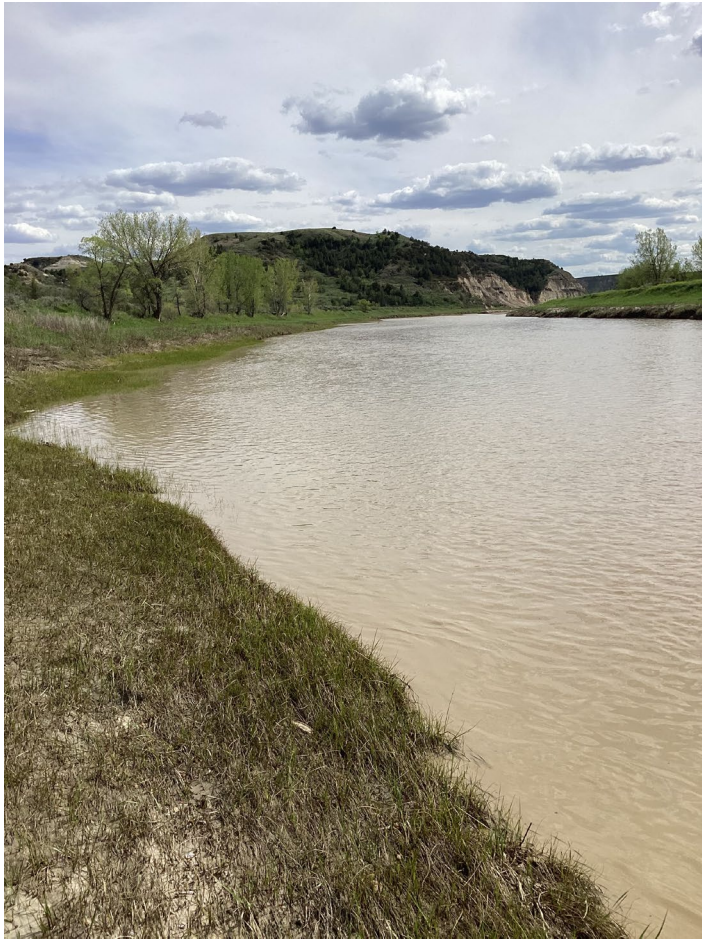
**Figure 5.** THRO stream channel monitoring site SCM 001 at T1 (downstream) end from right bank during bank-full conditions in May 2022. The right bank is largely covered in vegetation with good access to the floodplain.

Reach characteristics include measurements from the detailed (total station) transects on three permanently marked transects and reach-level measurements on all transects. Active fluvial erosion is occurring within a relatively small area between the water and bank-full; the angle can be steep on cut banks and difficult to capture with the total station. Access to the floodplain is maintained throughout the reach.

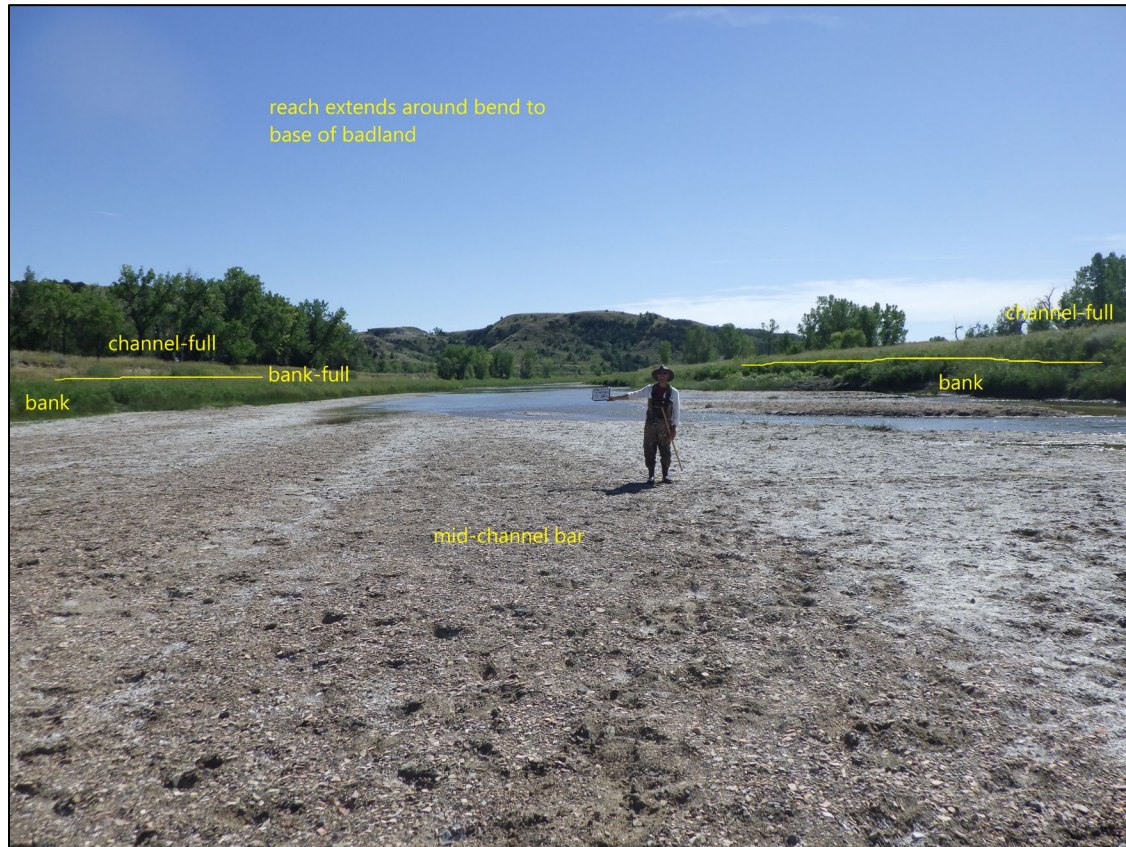
**Figure 8.** Bank and channel features from T1 looking upstream, taken August 2022.

Figure 8 shows channel diagnostic features from T1 looking upstream.

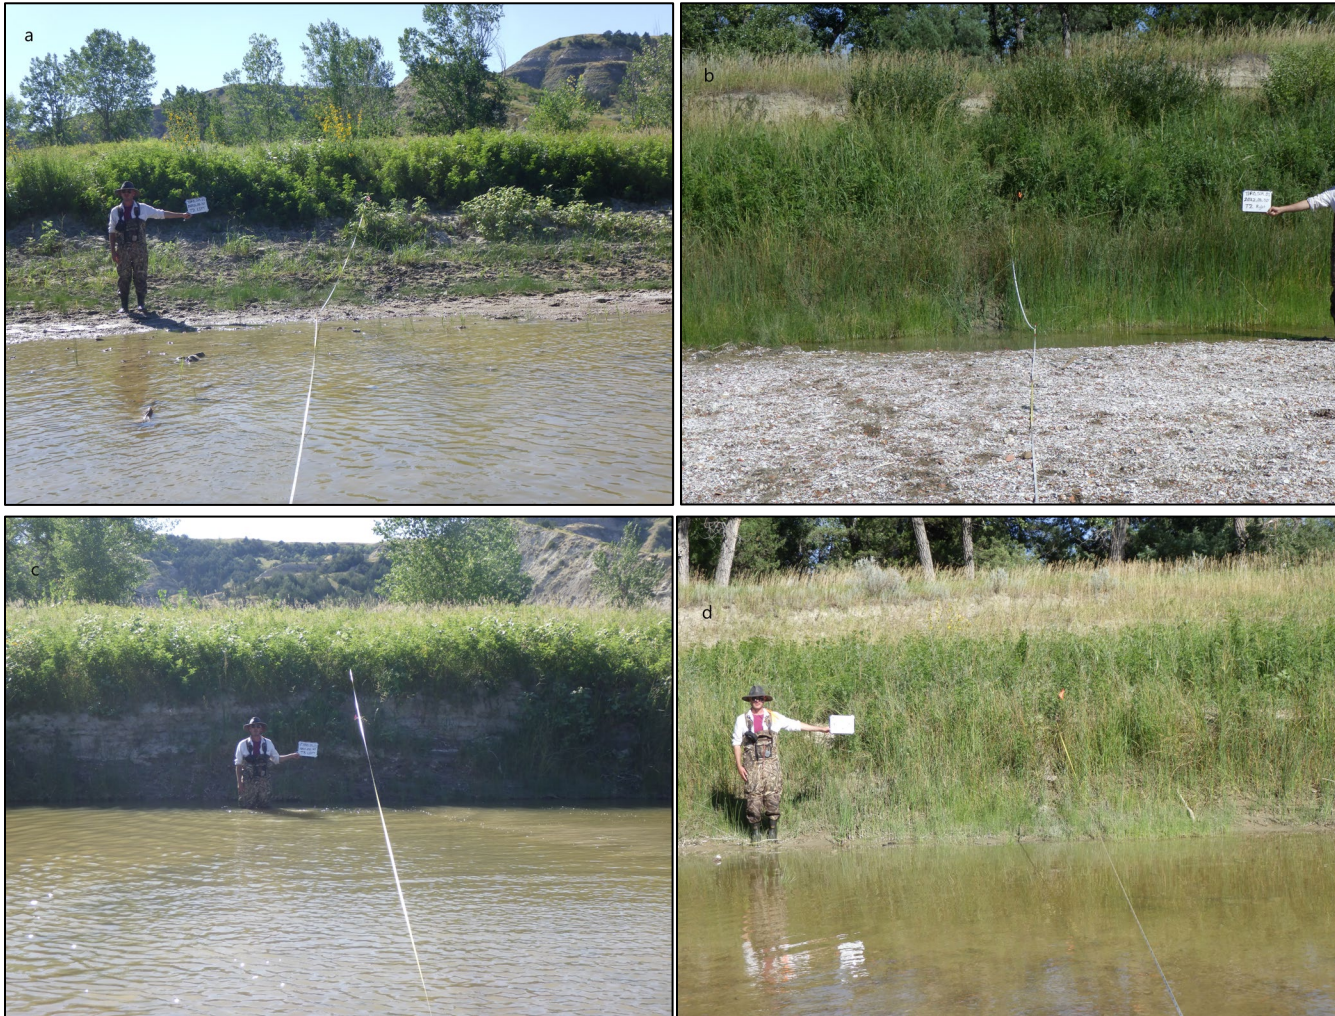
**Figure 9.** Transect 2 shows little erosion and has bank stability of score of 11.5 on the left bank (a) and 9.50 on the right bank (b) and is considered “at-risk” overall. Transect 3 has a bank stability of score of 17 on the left bank (c) and 13 on the right bank (d) and is considered “unstable”.

Transect 3 was the worst scoring transect overall for stability, while Transect 2 was the best. Pictures comparing transect 2 and 3 banks are below (Figure 9). Unstable substrate (gravel-sand) contributed most to the transects with higher bank instability as well as bank height and bank angle.

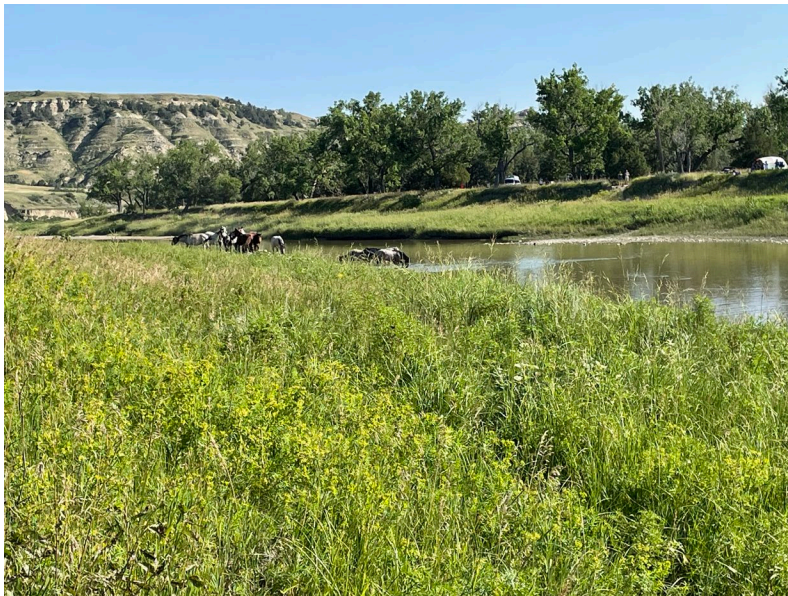
**Figure 10.** Site overview from right bank at T11 looking downstream.

This site will be revisited in 3 years to see if channel widening is occurring. Channel change can be regarded as a redistribution of the imbalance between sediment and water (Thorne and Lewin 2020). The revisits will allow us to better identify areas of sediment deposition and erosion and if these areas have changed from the 2022 visit.
