# NPS Wildfire Risk Assessments Assessment Locations

# Rattlesnake Springs

# NPS Wildand Fire Risk Assessment - Facility Assessment

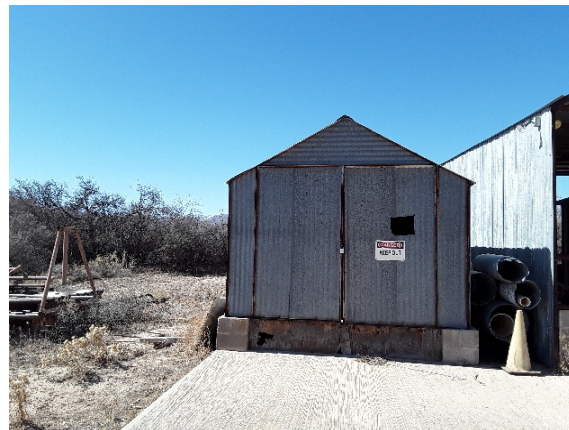
2020\_CAVE\_RS Shed\_Front.jpg

## Facility: RS Shed

Defensible Space: 30 ft treated

Fuel Load (w/in 300 ft): Heavy

Fuel Type (w/in 300ft): Grass,shrub,hardwood litter

Roof Material: Noncombustible or not applicable

Siding Material: Rock, concrete, metal

Foundation: Closed, 6in to 30in masonry exposed

Score: 51  
Rating: Moderate

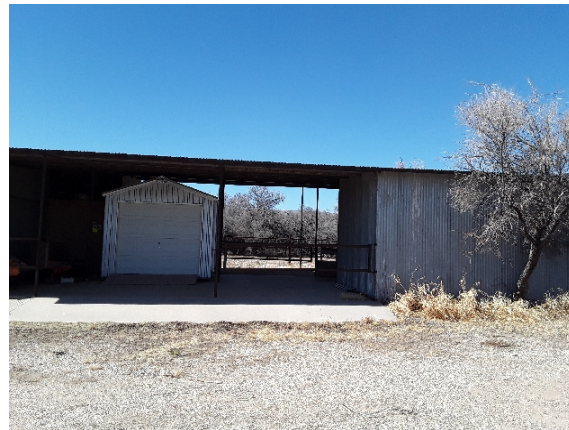
2020\_CAVE\_15608\_RS Barn\_Front.jpg

## Facility: RS Barn

**Defensible Space:** No defensible space  
**Fuel Load (w/in 300 ft):** Moderate  
**Fuel Type (w/in 300ft):** Shrub or timber  
**Topography (w/in 300ft):** Slope <5%

**Roof Material:** Noncombustible or not applicable  
**Siding Material:** Rock, concrete, metal  
**Foundation:** Closed, 6in to 30in masonry exposed  
**Fences/Decks:** None or noncombustible

**Score: 60**  
**Rating: Moderate**  
**Asset Priority Index (API):**  
**7**

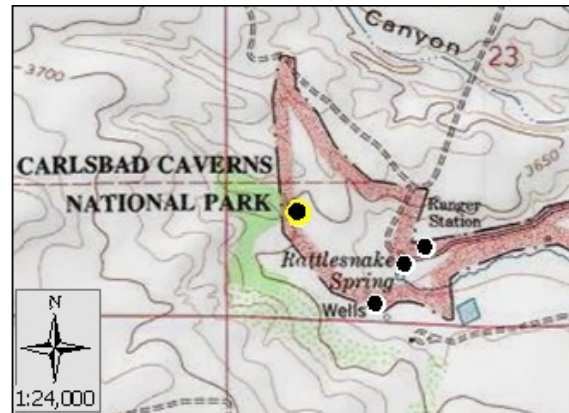
**Primary Access:** Road  
**Ingress/Egress:** One roads in/out  
**Access Width:** 1 lane (<18ft)  
**Access Condition:** Non-surfaced- gravel,dirt,grade<5%

**Bridge Condition:** Nonflammable, load limit will limit response  
**Access & Turnarounds:** Access is <300 ft from facility w/turnaround  
**Facility Number/Sign:** None or not clearly visible

**Roof Material:** Noncombustible or not applicable  
**Siding Material:** Rock, concrete, metal  
**Foundation:** Closed, >30in masonry exposed or N/A

**Fences/Decks:** None or noncombustible  
**Firewood:** None  
**Propane Tanks:** None  
**Water Supply:** No reliable water source nearby  
**Overhead Hazards:** Overhead hazards will limit aircraft

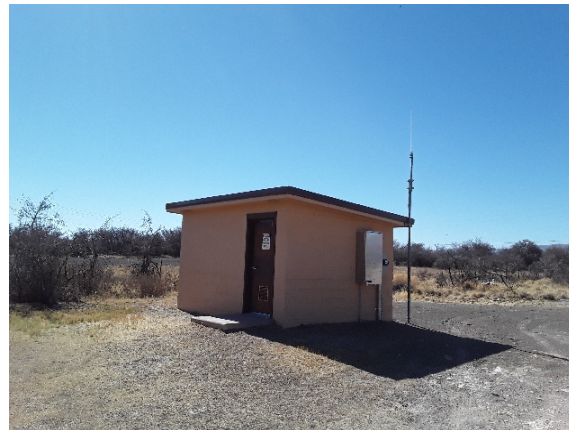
2020\_CAVE\_81658\_RS Well House\_Front.jpg

## Facility: RS Well House

**Defensible Space:** 30 ft treated  
**Fuel Load (w/in 300 ft):** Light  
**Fuel Type (w/in 300ft):** Grass,shrub,hardwood litter  
**Topography (w/in 300ft):** Slope <5%

**Score: 47**  
**Rating: Moderate**  
**Asset Priority Index (API): 29**

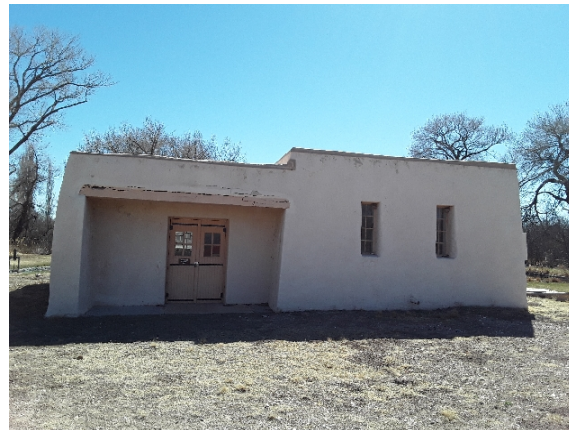
2020\_CAVE\_15602\_RS Pump House\_Front.jpg

## Facility: RS Pump House

**Defensible Space:** 30 ft treated  
**Fuel Load (w/in 300 ft):** Heavy  
**Fuel Type (w/in 300ft):** Grass,shrub,hardwood litter  
**Topography (w/in 300ft):** Slope <5%

**Roof Material:** Noncombustible or not applicable  
**Siding Material:** Rock, concrete, metal  
**Foundation:** Closed, >30in masonry exposed or N/A

**Fences/Decks:** None or noncombustible  
**Firewood:** None  
**Propane Tanks:** None  
**Water Supply:** Reliable water source nearby  
**Overhead Hazards:** Overhead hazards will limit aircraft

**Score: 49** **Asset Priority Index (API): 42**  
**Rating: Moderate**

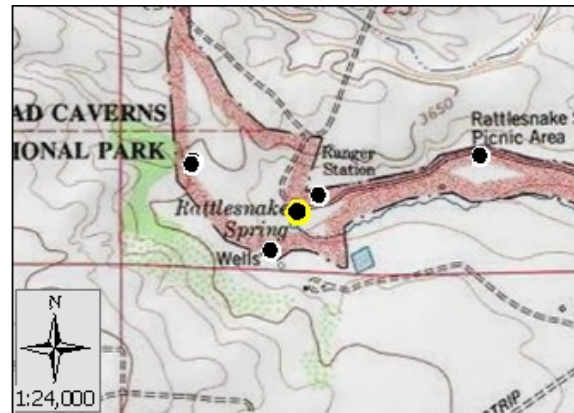
**Primary Access:** Road  
**Ingress/Egress:** One roads in/out  
**Access Width:** 1 lane (<18ft)  
**Access Condition:** Non-surfaced- gravel,dirt,grade<5%

**Bridge Condition:** None/nonflammable,load limit will not limit response  
**Access & Turnarounds:** Access is <300 ft from facility w/turnaround  
**Facility Number/Sign:** Marked and clearly visible

**Roof Material:** Fire resistant- tar,rubberized  
**Siding Material:** Rock, concrete, metal  
**Foundation:** Closed, < 6in masonry exposed  
**Fences/Decks:** None or noncombustible

**Firewood:** None  
**Propane Tanks:** Present and fuels clearance  
**Water Supply:** Reliable water source nearby  
**Overhead Hazards:** No overhead hazards

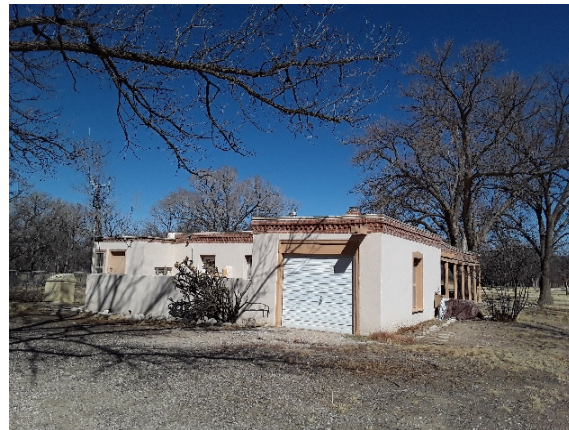
2020\_CAVE\_15588\_RS Residence\_Front.jpg

## Facility: RS Residence

**Defensible Space:** 100 ft treated  
**Fuel Load (w/in 300 ft):** Light  
**Fuel Type (w/in 300ft):** Grass,shrub,hardwood litter  
**Topography (w/in 300ft):** Slope <5%

**Score: 31**  
**Rating: Low**

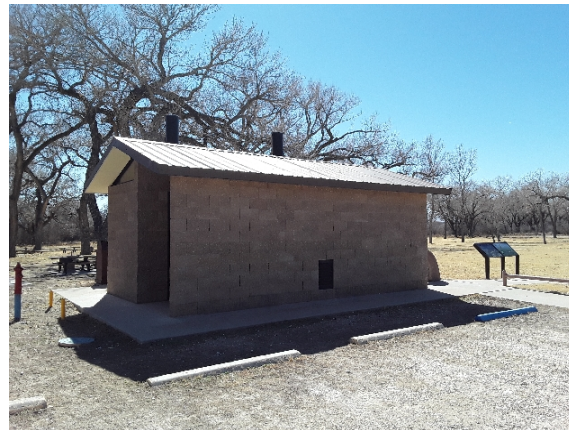
2020\_CAVE\_82424\_RS Double Vault Toilet\_Front.jpg

## Facility: RS Double Vault Toilet

**Defensible Space:** >100ft treated  
**Fuel Load (w/in 300 ft):** Light  
**Fuel Type (w/in 300ft):** Grass,shrub,hardwood litter  
**Topography (w/in 300ft):** Slope <5%

**Roof Material:** Noncombustible or not applicable  
**Siding Material:** Rock, concrete, metal  
**Foundation:** Closed, >30in masonry exposed or N/A

**Fences/Decks:** None or noncombustible  
**Firewood:** None  
**Propane Tanks:** None  
**Water Supply:** Reliable water source nearby  
**Overhead Hazards:** No overhead hazards

**Score: 26**  
**Rating: Low**
