NPS Wildfire Risk Assessment Project

## BIBE- Barker Lodge Overview

Barker Lodge  
BIBE - Big Bend National Park

# NPS Wildand Fire Risk Assessment - Facility Assessment

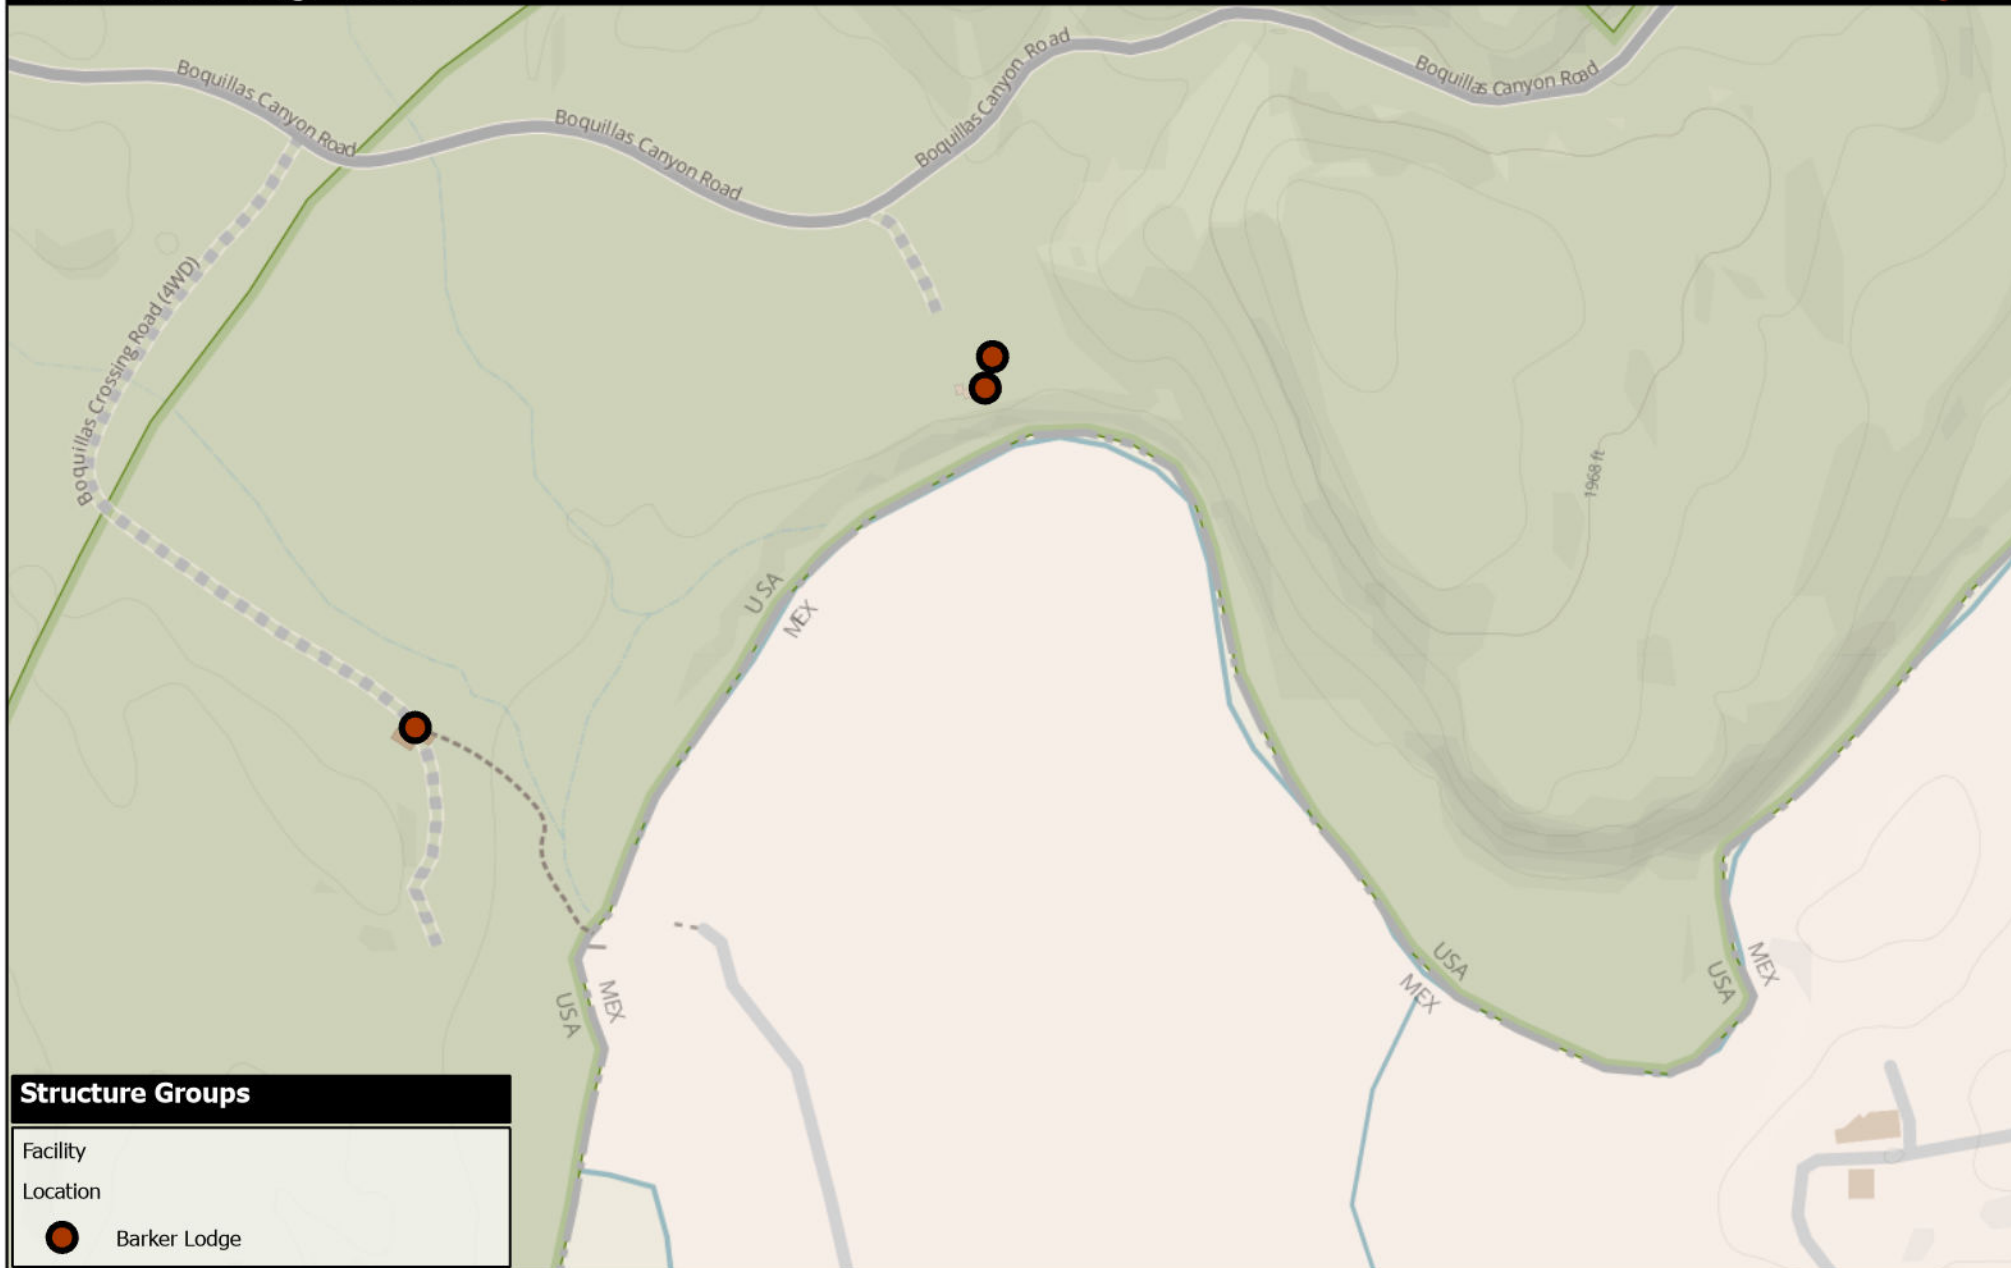
| Map Label | FMSS ID | Common Name |
|---|---|---|
| 3 | 72496 | BH0110a Barker Lodge Garage - RGV |
| 2 | 55655 | QH0110 Barker Lodge RGV |
| 1 | 231284 | B0435 Visitor Contact Station, BOC (Port of Entry Building) |

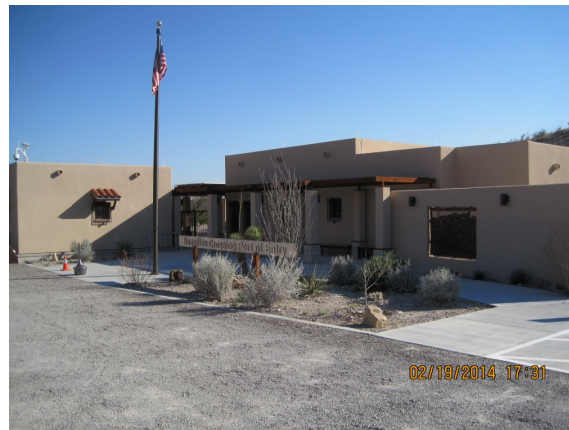
2014\_BIBE\_231284\_B0435 Visitor Contact Station, BOC (Port of Entry Building)\_Front.jpg

**Defensible Space:** 30 ft treated  
**Fuel Load (w/in 300 ft):** Moderate  
**Fuel Type (w/in 300ft):** Shrub or timber  
**Topography (w/in 300ft):** Slope 5% to 20%

**Roof Material:** Noncombustible or not applicable  
**Siding Material:** Rock, concrete, metal  
**Foundation:** Closed, >30in masonry exposed or N/A

**Fences/Decks:** None or noncombustible  
**Firewood:** None  
**Propane Tanks:** Present and fuels clearance  
**Water Supply:** Reliable water source nearby

**Overhead Hazards:** Overhead hazards will limit aircraft  
**Safety Zones:** Potential safety zone(s) in area  
**Additional Obstacles:** None  
**Triage Category:**

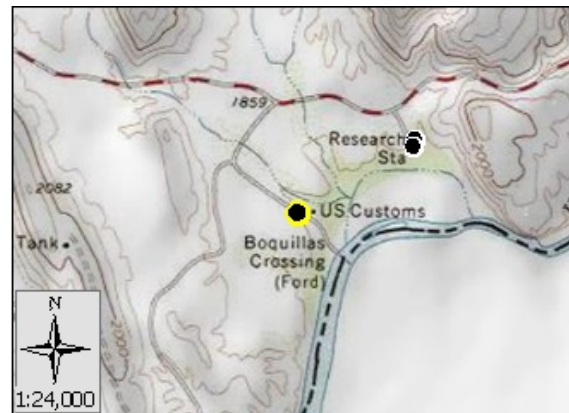
**Score: 47** **Asset Priority Index (API): 65**  
**Rating: Moderate**

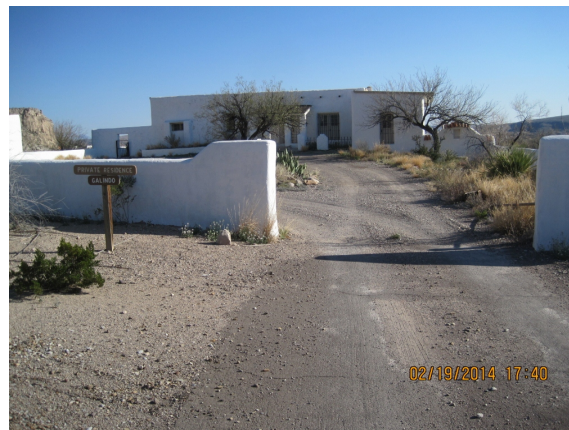
2014\_BIBE\_55655\_QH0110 Barker Lodge RGV\_Front.jpg

**Defensible Space:** 30 ft treated  
**Fuel Load (w/in 300 ft):** Light  
**Fuel Type (w/in 300ft):** Grass,shrub,hardwood litter  
**Topography (w/in 300ft):** Slope 5% to 20%

**Roof Material:** Fire resistant- tar,rubberized  
**Siding Material:** Rock, concrete, metal  
**Foundation:** Closed, >30in masonry exposed or N/A  
**Fences/Decks:** None or noncombustible

**Firewood:** None  
**Propane Tanks:** None  
**Water Supply:** Reliable water source nearby  
**Overhead Hazards:** No overhead hazards  
**Safety Zones:** Potential safety zone(s) in area

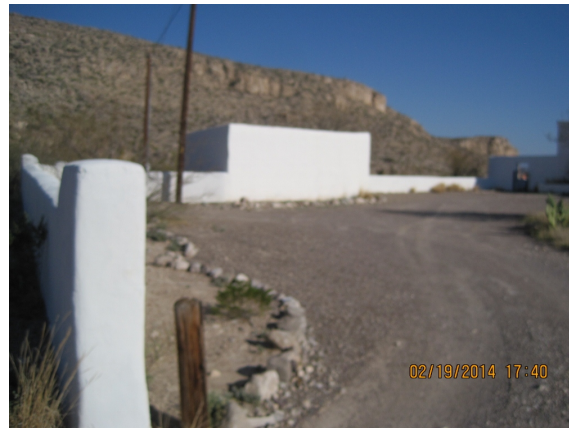
2014\_BIBE\_72496\_BH0110a Barker Lodge Garage - RGV\_Front.jpg

**Defensible Space:** <30 ft treated  
**Fuel Load (w/in 300 ft):** Light  
**Fuel Type (w/in 300ft):** Grass,shrub,hardwood litter  
**Topography (w/in 300ft):** Slope 5% to 20%

**Roof Material:** Fire resistant- tar,rubberized  
**Siding Material:** Rock, concrete, metal  
**Foundation:** Closed, >30in masonry exposed or N/A  
**Fences/Decks:** None or noncombustible

**Firewood:** None  
**Propane Tanks:** None  
**Water Supply:** Reliable water source nearby  
**Overhead Hazards:** No overhead hazards  
**Safety Zones:** Potential safety zone(s) in area

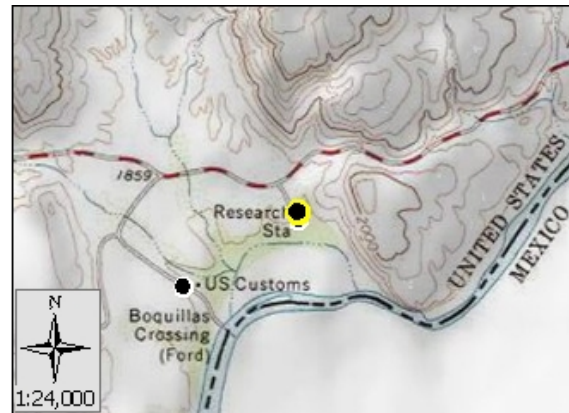
**Score: 46**  
**Rating: Moderate**  
**Asset Priority Index (API): 40**
