# NPS Wildfire Risk Assessments Assessment Locations

## Tonto National Monument

# NPS Wildand Fire Risk Assessment - Facility Wildfire Risk Assessment Summary

## Unit - Location: TONT - Tonto National Monument

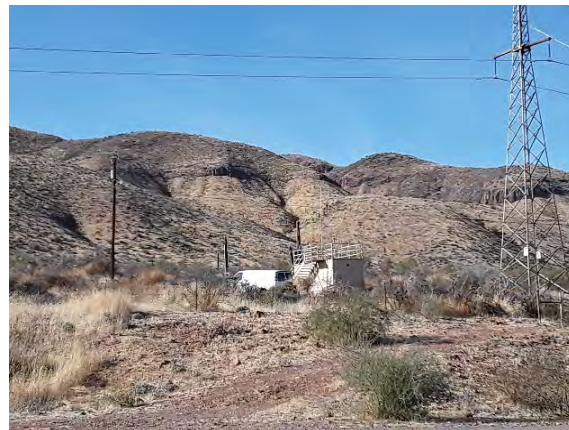
2021\_TONT\_65890\_Air Quality Station\_Front.jpg

**Primary Access:** Road  
**Ingress/Egress:** One roads in/out  
**Access Width:** 1 lane (<18ft)  
**Access Condition:** Non-surfaced- gravel,dirt,grade>5%

**Bridge Condition:** None/nonflammable,load limit will not limit response  
**Access & Turnarounds:** Access is <300 ft from facility w/o turnaround  
**Facility Number/Sign:** None or not clearly visible

**Roof Material:** Noncombustible or not applicable  
**Siding Material:** Rock, concrete, metal  
**Foundation:** Open or deck  
**Fences/Decks:** None or noncombustible

**Firewood:** None  
**Propane Tanks:** None  
**Water Supply:** Reliable water source nearby  
**Overhead Hazards:** Overhead hazards will limit aircraft

**Safety Zones:** No safety zone(s) in area  
**Additional Obstacles:** Hazmat, UXO,etc. , PLEASE COMMENT  
**Triage Category:**  
**Hazmat:** high voltage

**Assessment Comments:** Gate to facility is locked, 2 sets of high voltage power lines adjacent to facility. short walk from hwy 188

**Score: 70**  
**Rating: High**

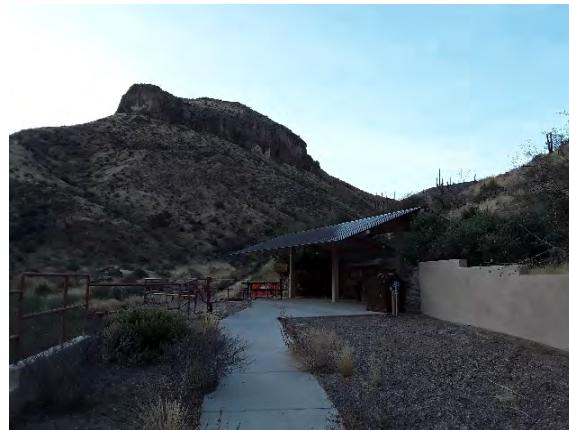
2021\_TONT\_65945\_Interpretive Ramada\_Front.jpg

**Access Condition:** Surfaced-paved, grade>5%

**Foundation:** Closed, >30in masonry exposed or N/A

**Score: 58**  
**Rating: Moderate**

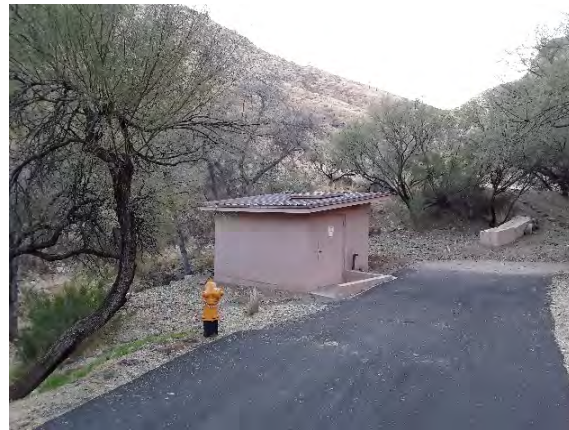
2021\_TONT\_236450\_Pump House\_Front.jpg

**Foundation:** Closed, < 6in masonry exposed

**Assessment Comments:** Obstacles-this structure is in a steep narrow canyon, nearest potential safety is down canyon at admin building

**Score: 47**  
**Rating: Moderate**

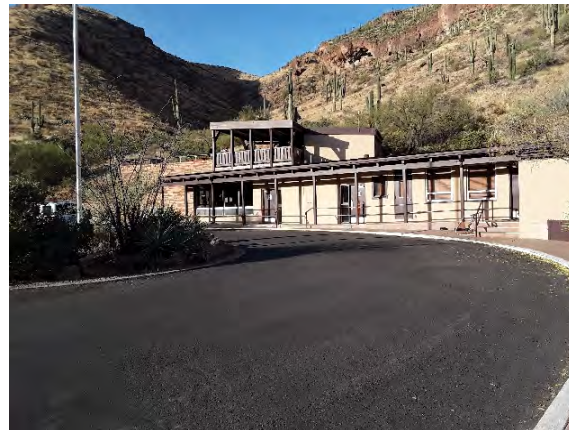
2021\_TONT\_65941\_Visitor Center\_Front.jpg

**Assessment Comments:** special resources of concern: historic pottery and textiles.

Observation deck roof is wood materials.

**Score: 47**  
**Rating: Moderate**

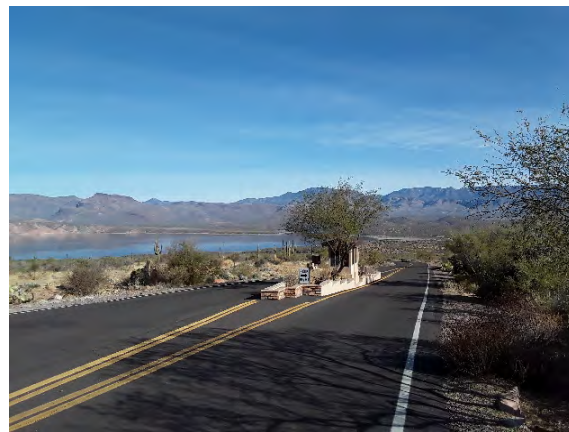
2021\_TONT\_89966\_Entry Kiosk\_Front.jpg

**Score: 30**  
**Rating: Low**

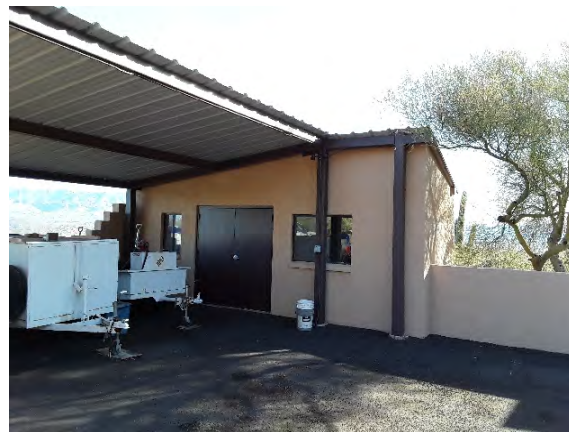
2021\_TONT\_75793\_Fire Cache\_Front.jpg

**Hazmat:** flammable fuel locker near D side

**Score: 44**  
**Rating: Low**

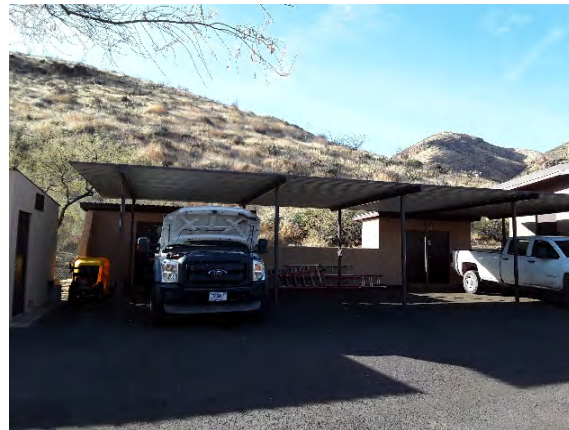
2021\_TONT\_99752\_Four Bay Carport\_Front.jpg

**Siding Material:** Rock, concrete, metal  
**Foundation:** Closed, >30in masonry exposed or N/A  
**Fences/Decks:** None or noncombustible  
**Firewood:** None

**Propane Tanks:** None  
**Water Supply:** Pressurized hydrant(s) or fixed sprinkler system  
**Overhead Hazards:** No overhead hazards  
**Safety Zones:** Potential safety zone(s) in area

**Additional Obstacles:** Hazmat, UXO,etc. , PLEASE COMMENT  
**Triage Category:**  
**Hazmat:** fuel locker nearby  
**Assessment Comments:**

**Score: 44**  
**Rating: Low**

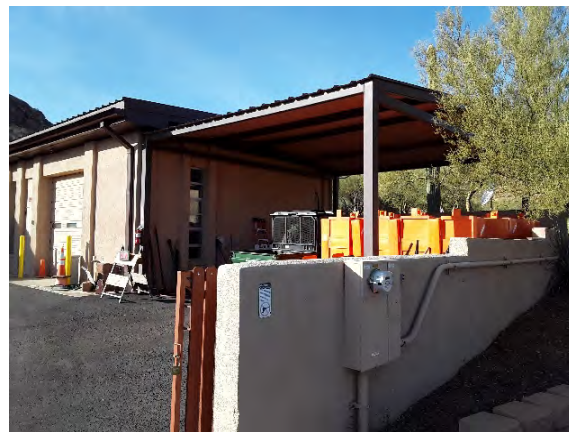
2021\_TONT\_99753\_Heavy Equipment Carport\_Front.jpg

**Siding Material:** Rock, concrete, metal  
**Foundation:** Closed, >30in masonry exposed or N/A  
**Fences/Decks:** None or noncombustible  
**Firewood:** None

**Propane Tanks:** None  
**Water Supply:** Pressurized hydrant(s) or fixed sprinkler system  
**Overhead Hazards:** Overhead hazards will limit aircraft

**Score: 44**  
**Rating: Low**

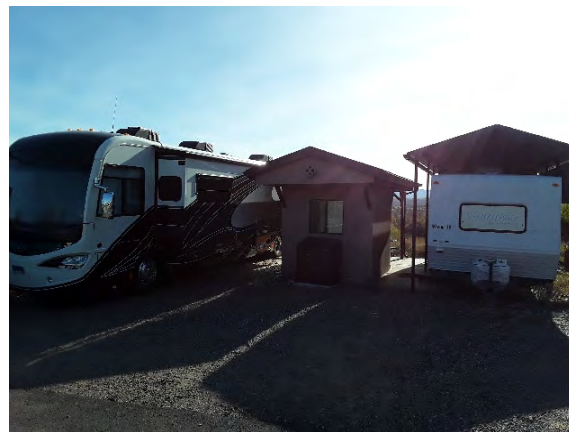
2021\_TONT\_80275\_Laundry Building\_Front.jpg

**Score: 53**  
**Rating: Moderate**

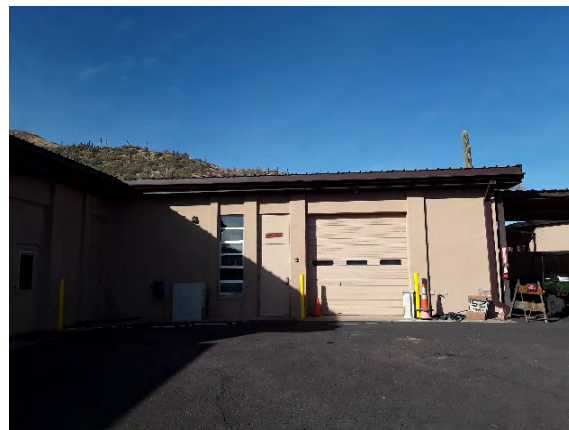
2021\_TONT\_75789\_Maintenance Shop\_Front.jpg

**Score: 41**  
**Rating: Low**

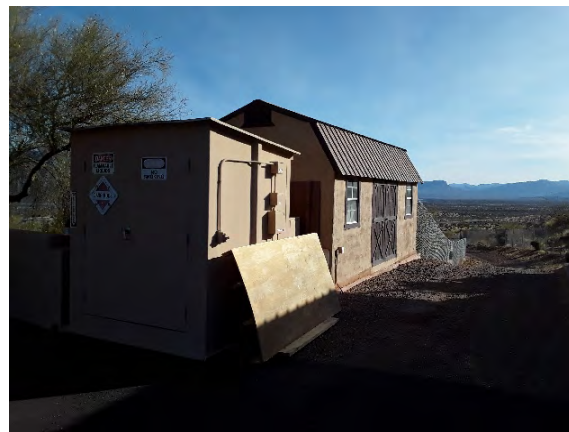
2021\_TONT\_75791\_Paint Shed\_Front.jpg

**Siding Material:** Rock, concrete, metal  
**Foundation:** Closed, >30in masonry exposed or N/A  
**Fences/Decks:** None or noncombustible  
**Firewood:** None

**Additional Obstacles:** Hazmat, UXO,etc. , PLEASE COMMENT  
**Triage Category:**  
**Hazmat:** fuel locker adjacent  
**Assessment Comments:**

**Score: 44**  
**Rating: Low**

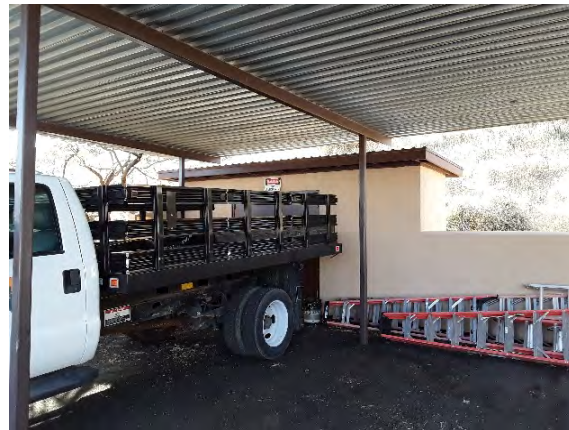
2021\_TONT\_75796\_Powered Equipment Shed\_Front.jpg

**Additional Obstacles:** Hazmat, UXO,etc. , PLEASE COMMENT  
**Triage Category:**  
**Hazmat:** welding shed nearby  
**Assessment Comments:**

**Score: 44**  
**Rating: Low**

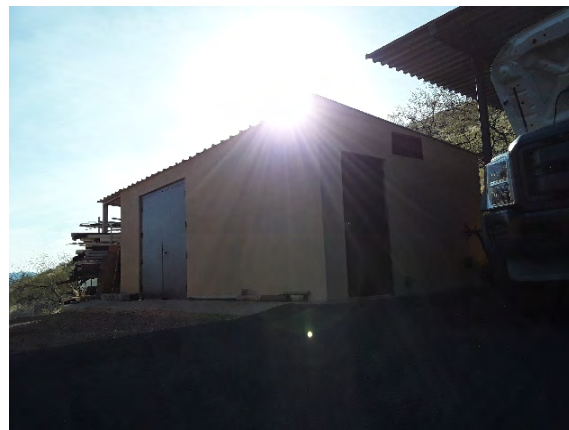
2021\_TONT\_75792\_Tool Shed\_Front.jpg

**Overhead Hazards:** Overhead hazards will limit aircraft

**Hazmat:** fuel locker across driveway

**Assessment Comments:** Some flammable debris stored behind this building should be removed if fire is imminent

**Score: 47**  
**Rating: Moderate**

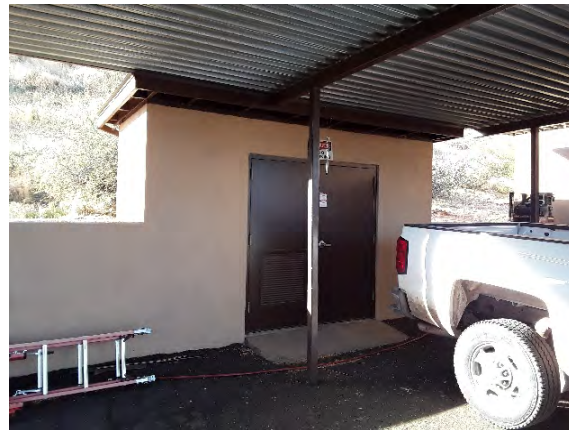
2021\_TONT\_75795\_Welding Shed\_Front.jpg

**Additional Obstacles:** Hazmat, UXO,etc. , PLEASE COMMENT  
**Triage Category:**  
**Hazmat:** contains acetylene gas and oxygen gas  
**Assessment Comments:**

**Score: 44**  
**Rating: Low**
