# NPS Wildfire Risk Assessments Assessment Locations

## Wupatki National Monument

NPS Wildfire Risk Assessment Project

# NPS Wildand Fire Risk Assessment - Facility Wildfire Risk Assessment Summary

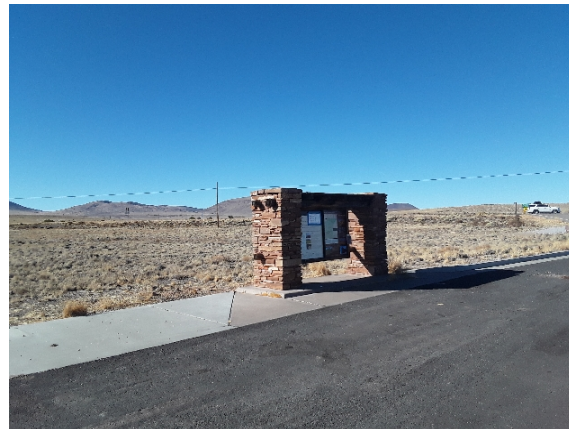
2020\_WUPA\_search not found \_Kiosk / Entrance Sign\_Z.jpg

**Roof Material:** Combustible or no roof  
**Siding Material:** Rock, concrete, metal  
**Foundation:** Closed, >30in masonry exposed or N/A  
**Fences/Decks:** None or noncombustible

**Firewood:** None  
**Propane Tanks:** None  
**Water Supply:** No reliable water source nearby  
**Overhead Hazards:** No overhead hazards  
**Safety Zones:** Potential safety zone(s) in area

**Score: 62**  
**Rating: Moderate**

| Label # | Facility/Community Name | Assessment Scale | Site Visit Type | Firewise Zone | Treatment | Treatment Description | Person Hours |
|---|---|---|---|---|---|---|---|
| 1 | Kiosk / Entrance Sign | Individual Facility | Initial | 1 | Flammable ground cover such as leaf litter, woody debris or highly flammable vegetation should be removed | | 0.5 |

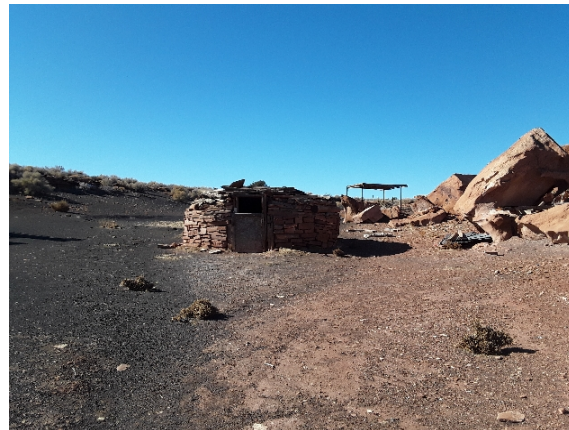
2020\_WUPA\_search not found \_Peshlaki Hogan\_Z.jpg

**Siding Material:** Rock, concrete, metal  
**Foundation:** Open or deck  
**Fences/Decks:** None or noncombustible  
**Firewood:** None  
**Propane Tanks:** None

**Water Supply:** Limited or dependent on electricity  
**Overhead Hazards:** No overhead hazards  
**Safety Zones:** Potential safety zone(s) in area  
**Additional Obstacles:** None

**Score: 62**  
**Rating: Moderate**  
**Asset Priority Index (API):**  
N/A

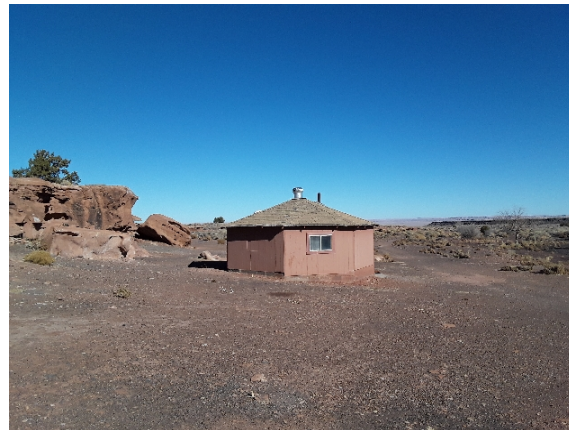
2020\_WUPA\_search not found \_Peshlaki Hogan\_Z.jpg

**Siding Material:** Vinyl  
**Foundation:** Closed, < 6in masonry exposed  
**Fences/Decks:** None or noncombustible  
**Firewood:** None  
**Propane Tanks:** None

**Water Supply:** No reliable water source nearby  
**Overhead Hazards:** No overhead hazards  
**Safety Zones:** Potential safety zone(s) in area  
**Additional Obstacles:** None

**Score: 48**  
**Rating: Moderate**  
**Asset Priority Index (API):**  
N/A

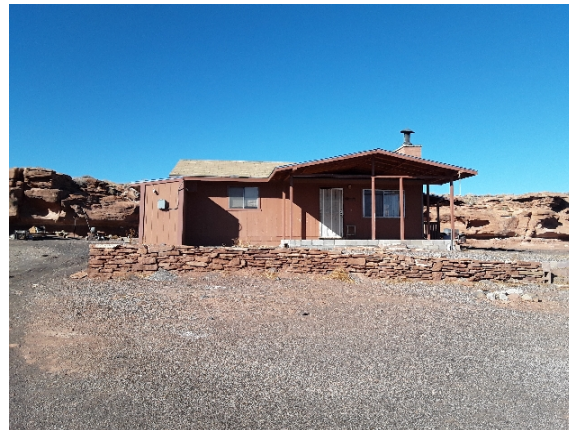
2020\_WUPA\_search not found \_Peshlaki House\_Z.jpg

**Siding Material:** Vinyl  
**Foundation:** Closed, < 6in masonry exposed  
**Fences/Decks:** None or noncombustible  
**Firewood:** None  
**Propane Tanks:** None

**Water Supply:** No reliable water source nearby  
**Overhead Hazards:** No overhead hazards  
**Safety Zones:** Potential safety zone(s) in area  
**Additional Obstacles:** None

**Score: 58**  
**Rating: Moderate**  
**Asset Priority Index (API):**  
N/A

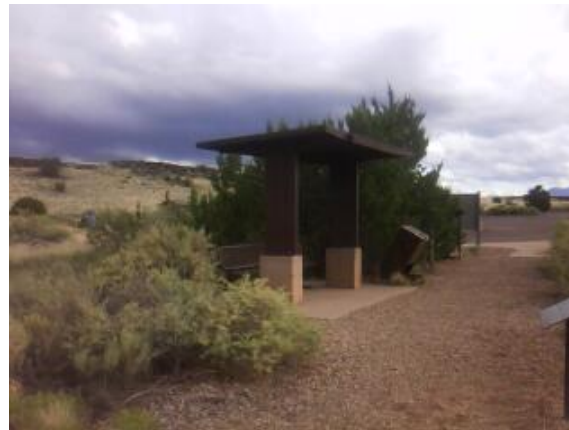
WUPA--Shelter-Front.jpg

**Siding Material:** Wood or open sided  
**Foundation:** Closed, >30in masonry exposed or N/A  
**Fences/Decks:** None or noncombustible  
**Firewood:** None

**Propane Tanks:** None  
**Water Supply:** No reliable water source nearby  
**Overhead Hazards:** No overhead hazards  
**Safety Zones:** Potential safety zone(s) in area

**Score: 86**  
**Rating: None**

| Label # | Facility/Community Name | Assessment Scale | Site Visit Type | Firewise Zone | Treatment | Treatment Description | Person Hours |
|---|---|---|---|---|---|---|---|
| 5 | Shelter | Individual Facility | Initial | 1 | Flammable ground cover such as leaf litter, woody debris or highly flammable vegetation should be removed | | 1.0 |
| | | Individual Facility | Initial | 1 | Limb trees 6 to 15 feet above ground | | 1.0 |

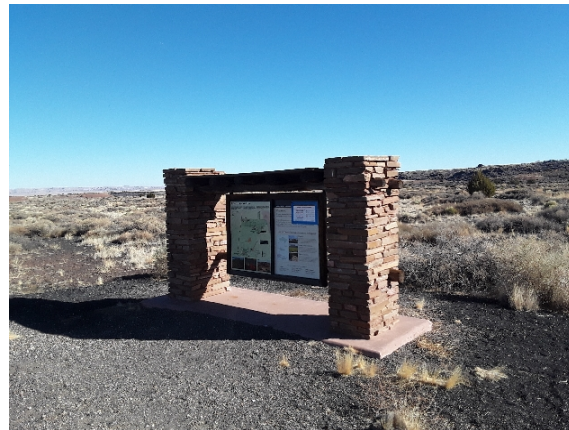
2020\_WUPA\_search not found \_Sign / Kiosk\_Z.jpg

**Roof Material:** Noncombustible or not applicable  
**Siding Material:** Rock, concrete, metal  
**Foundation:** Closed, >30in masonry exposed or N/A

**Fences/Decks:** None or noncombustible  
**Firewood:** None  
**Propane Tanks:** None  
**Water Supply:** No reliable water source nearby  
**Overhead Hazards:** No overhead hazards

**Score: 39**  
**Rating: Low**

| Label # | Facility/Community Name | Assessment Scale | Site Visit Type | Firewise Zone | Treatment | Treatment Description | Person Hours |
|---|---|---|---|---|---|---|---|
| 6 | Sign / Kiosk | Individual Facility | Initial | 1 | Flammable ground cover such as leaf litter, woody debris or highly flammable vegetation should be removed | | 0.5 |

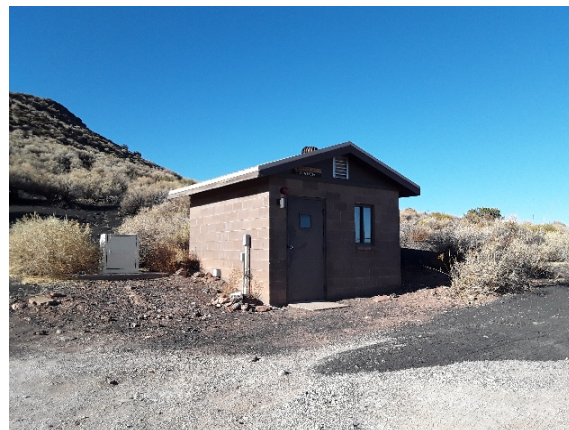
2020\_WUPA\_649816\_Well House\_Z.jpg

**Roof Material:** Fire resistant- tar,rubberized  
**Siding Material:** Rock, concrete, metal  
**Foundation:** Closed, < 6in masonry exposed  
**Fences/Decks:** None or noncombustible

**Firewood:** None  
**Propane Tanks:** Present and fuels clearance  
**Water Supply:** Pressurized hydrant(s) or fixed sprinkler system  
**Overhead Hazards:** No overhead hazards

**Score: 41**  
**Rating: Low**

| Label # | Facility/Community Name | Assessment Scale | Site Visit Type | Firewise Zone | Treatment | Treatment Description | Person Hours |
|---|---|---|---|---|---|---|---|
| 7 | Well House | Individual Facility | Initial | 1 | Flammable ground cover such as leaf litter, woody debris or highly flammable vegetation should be removed | | 2.0 |

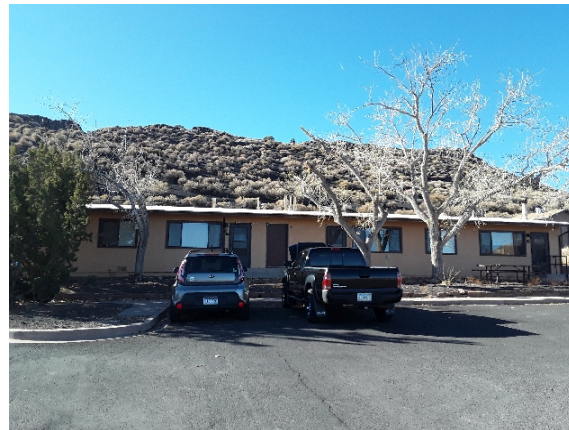
2020\_WUPA\_52912\_WUPA Apt Building\_Z.jpg

**Overhead Hazards:** Overhead hazards will limit aircraft

**Score: 26**  
**Rating: Low**

| 8 | WUPA Apt Building | Individual Facility | Initial | 1 | Clear adjacent and overhanging fuels to create 10 feet spacing between canopy and structure or chimney openings | | 1.0 |
| | | Individual Facility | Initial | 2 | Remove dead or dying component of shrubs and trees | | 4.0 |

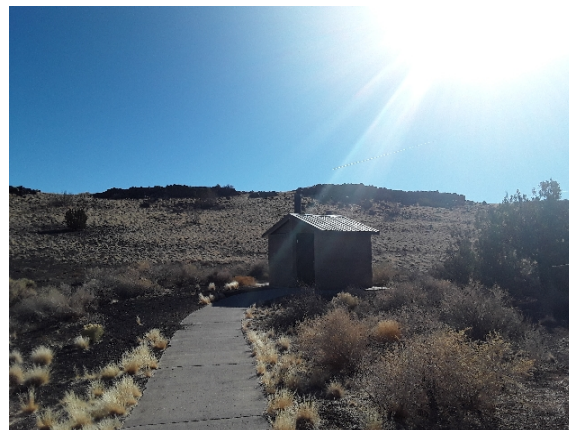
2020\_WUPA\_48508\_WUPA Lomaki Restroom\_Z.jpg

**Roof Material:** Noncombustible or not applicable  
**Siding Material:** Rock, concrete, metal  
**Foundation:** Closed, >30in masonry exposed or N/A

**Fences/Decks:** None or noncombustible  
**Firewood:** None  
**Propane Tanks:** None  
**Water Supply:** No reliable water source nearby  
**Overhead Hazards:** No overhead hazards

**Score: 47**  
**Rating: Moderate**  
**Asset Priority Index (API): 39**

| 9 | WUPA Lomaki Restroom | Individual Facility | Initial | 1 | Flammable ground cover such as leaf litter, woody debris or highly flammable vegetation should be removed | | 1.0 |
| | | Individual Facility | Initial | 1 | Limb trees 6 to 15 feet above ground | | 1.0 |

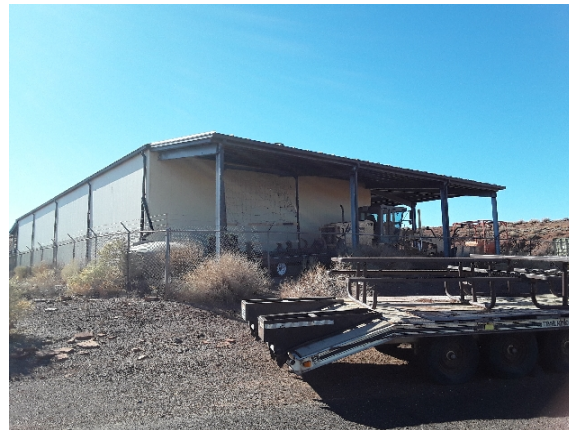
2020\_WUPA\_48510\_WUPA New Heiser Storage Building (Butler Building)\_Front.jpg

Score: 30  
Rating: Low

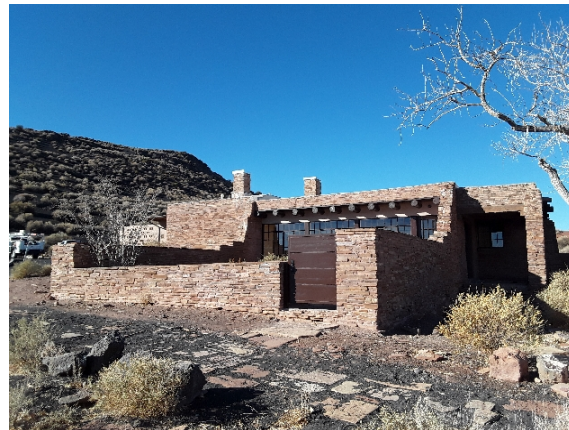
2020\_WUPA\_48521\_WUPA Residence # 1\_Z.jpg

Score: 40  
Rating: Low

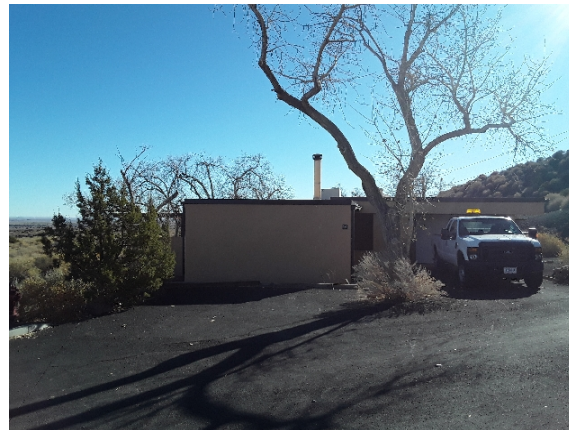
2020\_WUPA\_48523\_WUPA Residence # 10\_Z.jpg

Overhead Hazards: Overhead hazards will limit aircraft

Score: 35  
Rating: Low

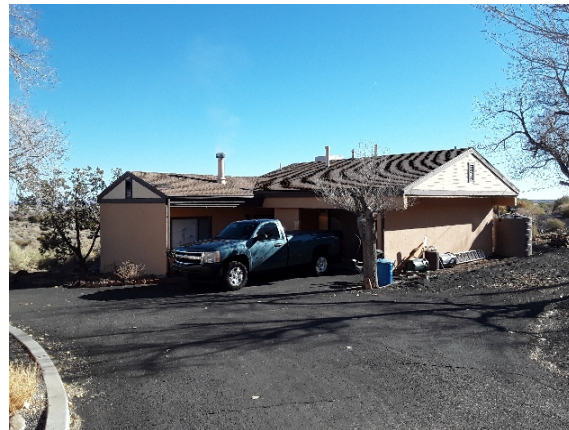
2020\_WUPA\_48524\_WUPA Residence # 12\_Z.jpg

**Overhead Hazards:** Overhead hazards will limit aircraft

**Score: 33**  
**Rating: Low**

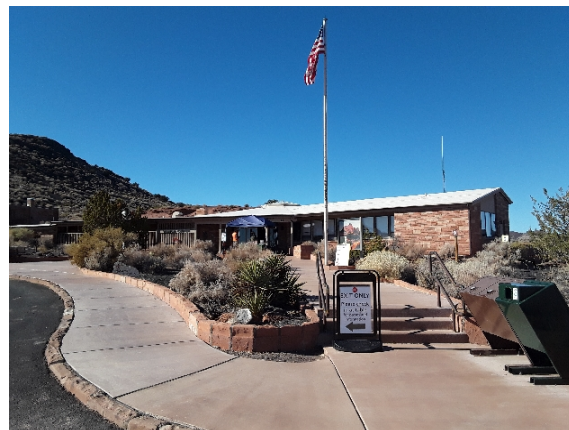
2020\_WUPA\_48501\_WUPA Visitor Center\_Z.jpg

Score: 36  
Rating: Low

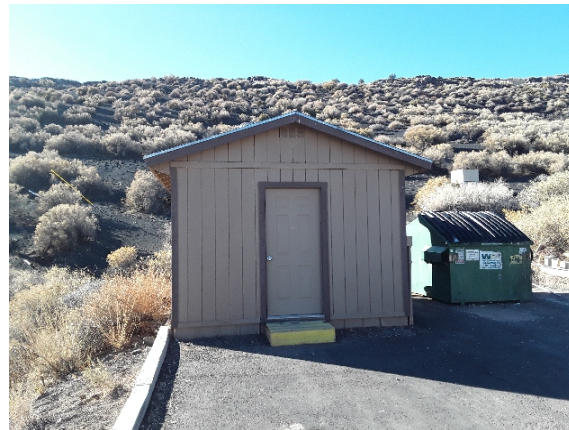
2020\_WUPA\_48503\_WUPA WNPA Shed\_Front.jpg

Foundation: Open or deck

Score: 45  
Rating: Moderate

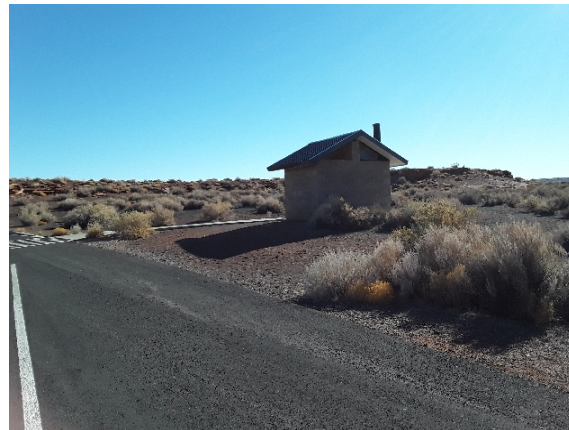
2020\_WUPA\_230950\_WUPA Wukoki Restroom\_Front.jpg

**Siding Material:** Rock, concrete, metal  
**Foundation:** Closed, >30in masonry exposed or N/A  
**Fences/Decks:** None or noncombustible  
**Firewood:** None

**Propane Tanks:** None  
**Water Supply:** No reliable water source nearby  
**Overhead Hazards:** No overhead hazards  
**Safety Zones:** Potential safety zone(s) in area

**Score: 34**  
**Rating: Low**
