# NPS Wildfire Risk Assessments Assessment Locations

## DINO - Dinosaur National Monument Overview

Baker Cabin  
DINO - Dinosaur National Monument

# NPS Wildland Fire Risk Assessment - Facility Assessment

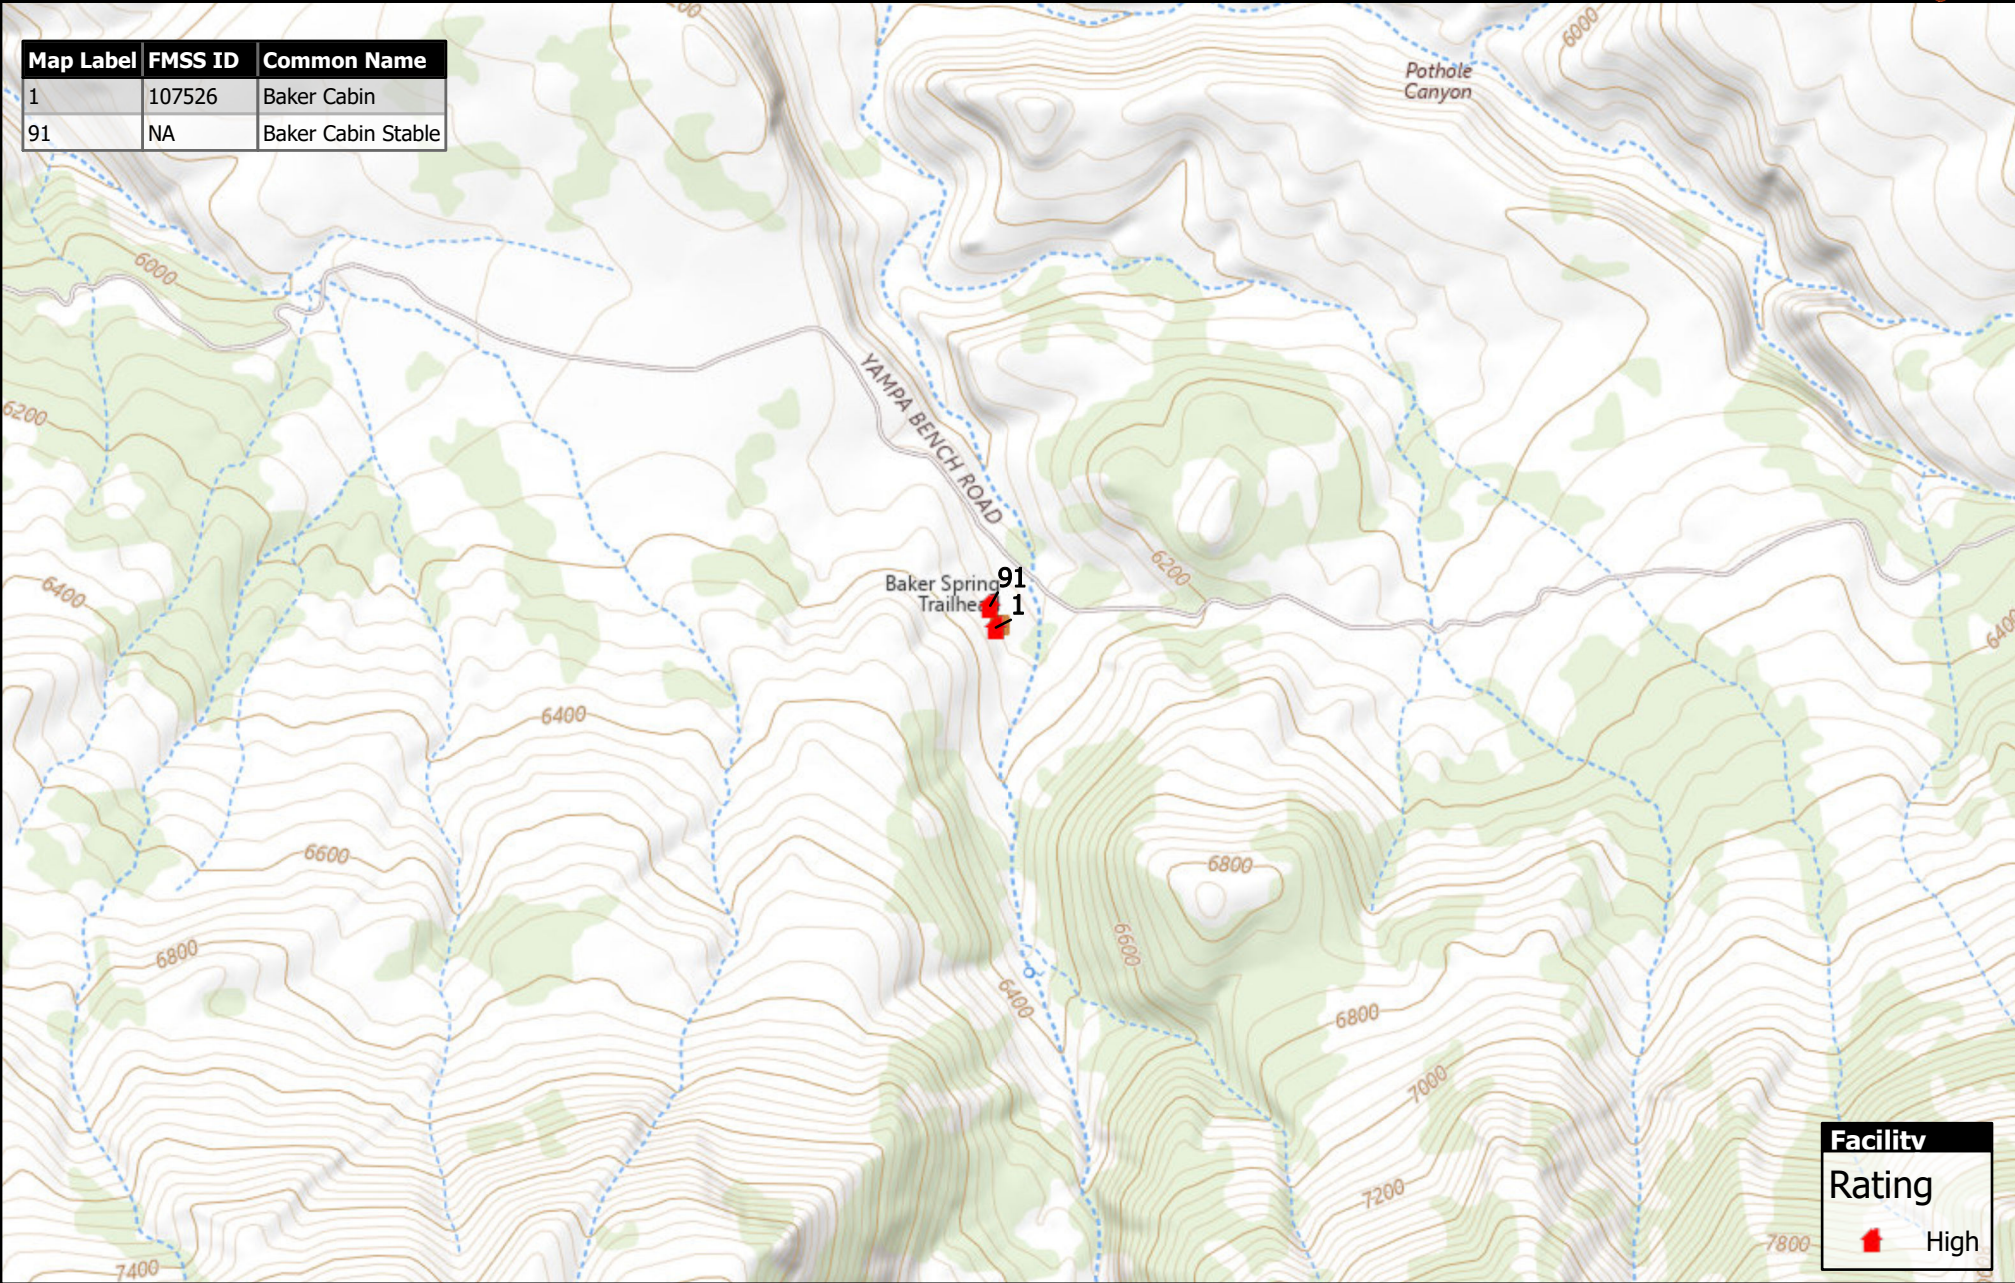
| Map Label | FMSS ID | Common Name |
| 1 | 107526 | Baker Cabin |
| 91 | NA | Baker Cabin Stable |

Facility

Rating

High
