Preservation at Hampton National Historic Site

Funded by the Great American Outdoors Act of 2020, an effort is underway to protect historic structures at Hampton National Historic Site.

**National Park Service, U.S. Department of the Interior**

**January 17, 2024**

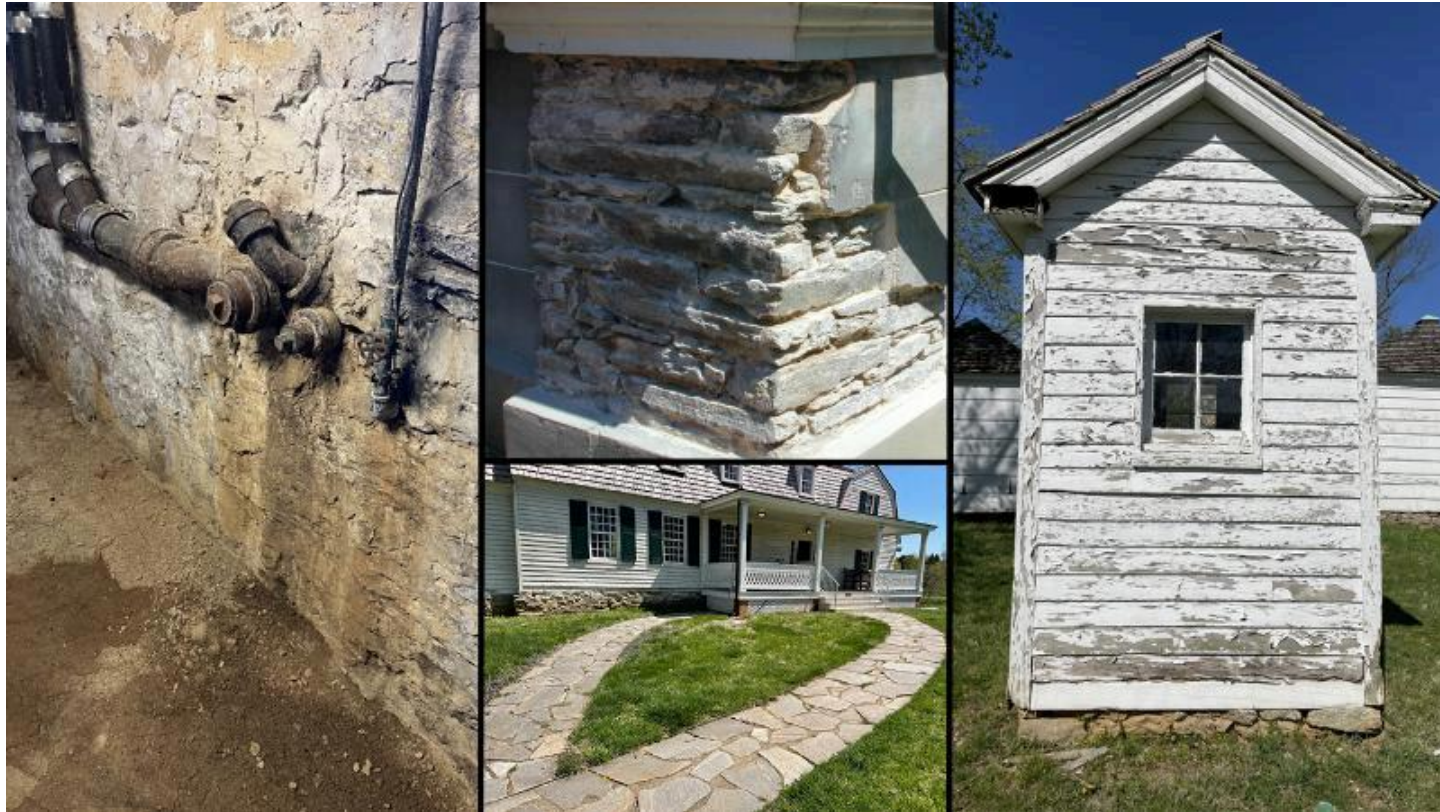
Mechanical, electrical, fire detection and suppression, security, and plumbing systems will be repaired or replaced as needed. Project improvements also include incorporating

Architectural Barriers Act Accessibility Standards (ABAAS), addressing landscape and drainage issues, improving or adding utility connections, and removing non-contributing or non-historic elements.

Opposite: A selection of photographs demonstrating features of historic buildings and landscapes at Hampton NHS that will be addressed as part of the current project, including utility systems at the Overseer's House (left), exterior stucco finishes at the Hampton Mansion (center top), accessibility at the Overseer's House (center bottom), and exterior finishes at the Domestic Service Cluster (right). (Image Credit: National Park Service)

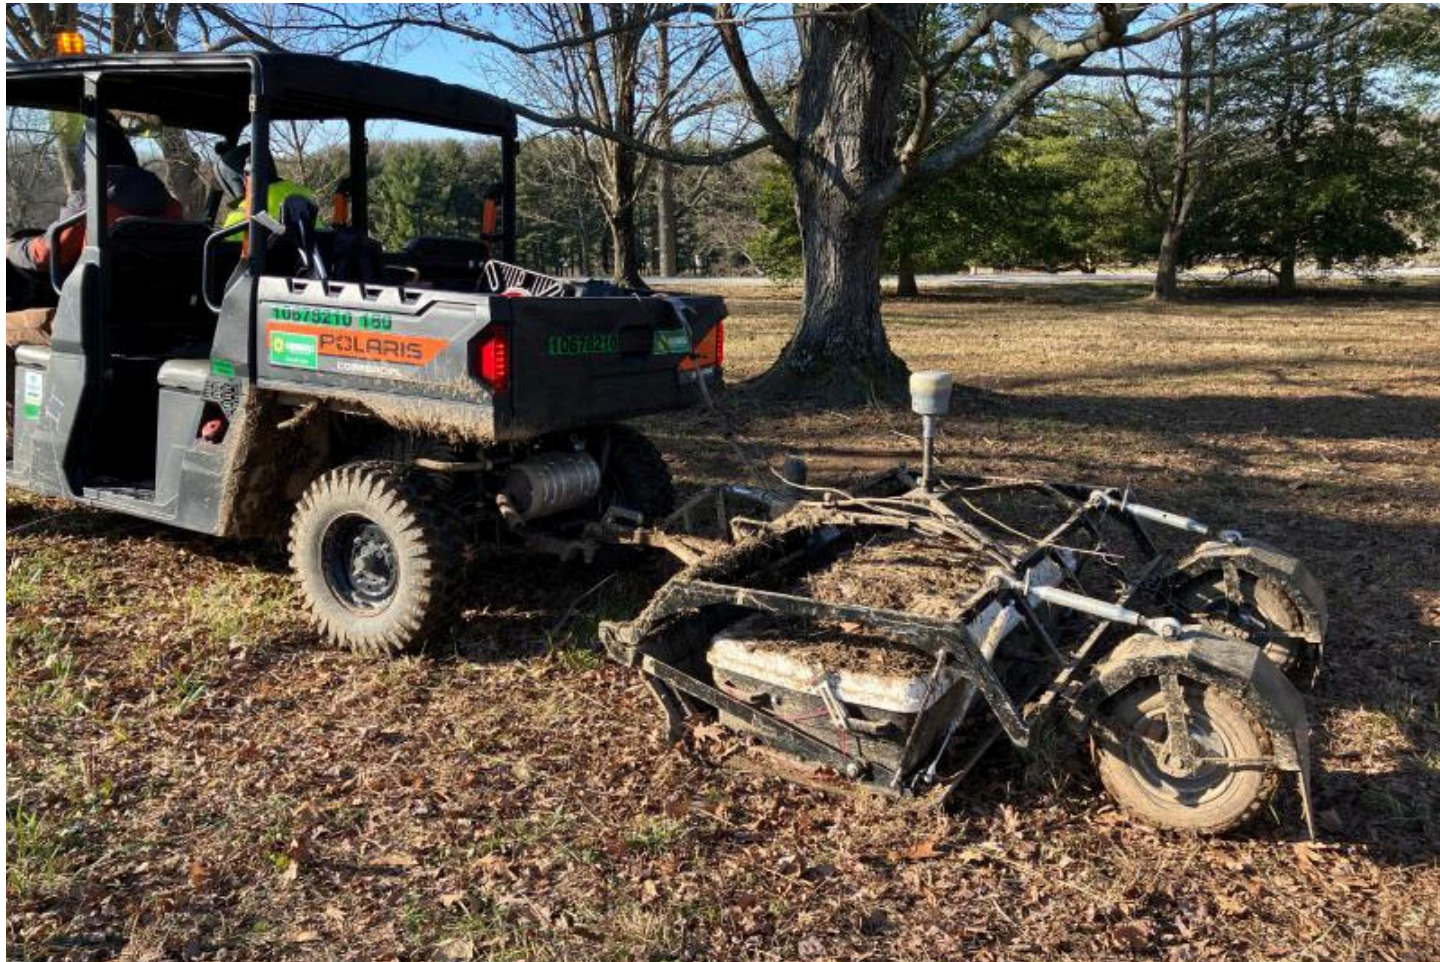
Opposite: A ground-penetrating radar investigation in progress at Hampton National Historic Site in 2023, in preparation for the current project. Ground-penetrating radar is a non-invasive technique that captures data about underground features, which will inform future archeological studies and land management practices. (Image Credit: National Park Service)

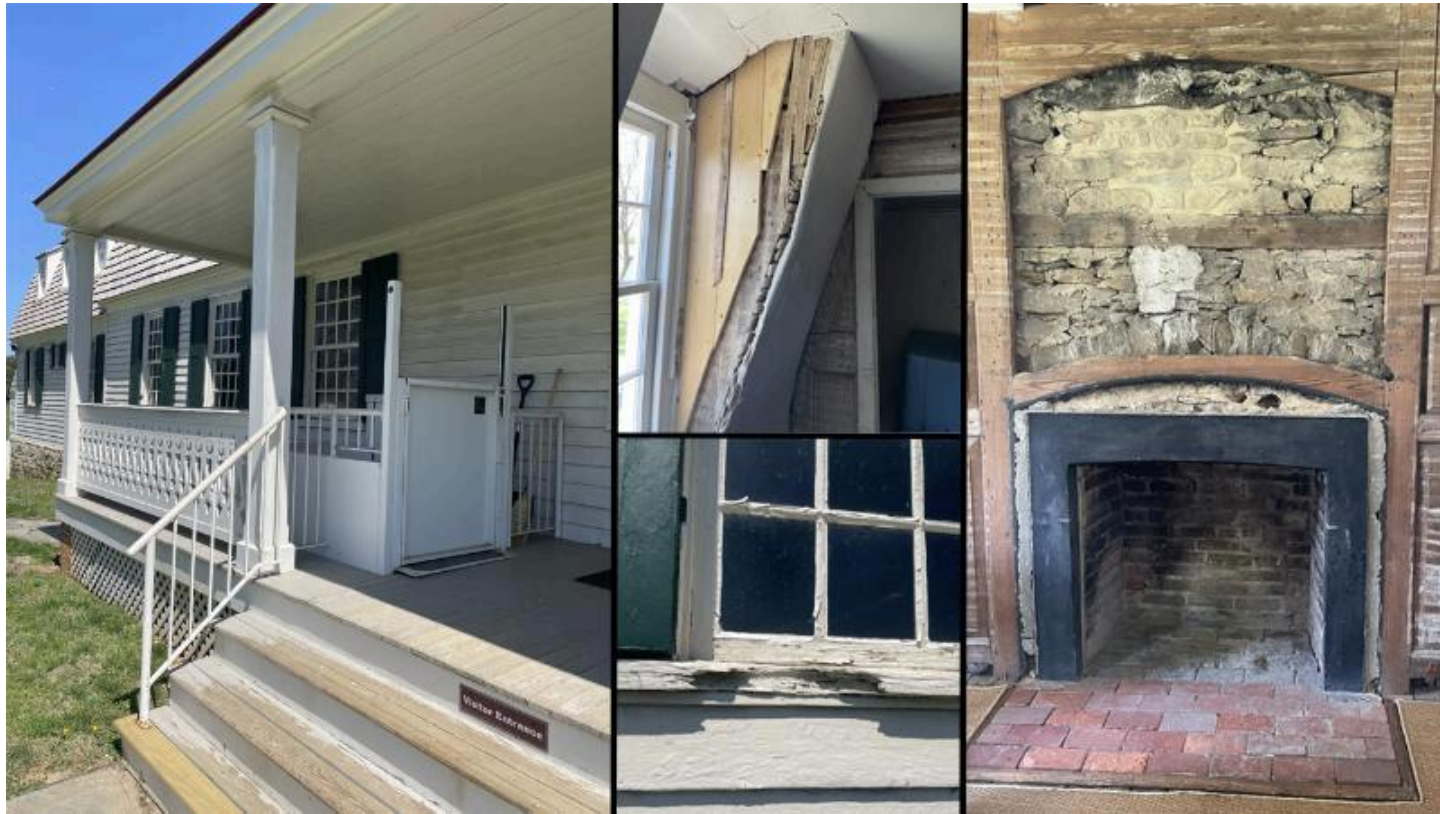
Additional work to be completed at the Overseer's House may include improving accessibility into the building, repairing deteriorating wooden features, repairing interior finishes, and upgrading building systems.

Opposite: A selection of photographs demonstrating features of the Overseer's House that will be addressed as part of the current project, including accessibility at the building's front entrance (left), exterior wooden features (center bottom), and interior finishes (center top, right). (Image Credit: National Park Service)

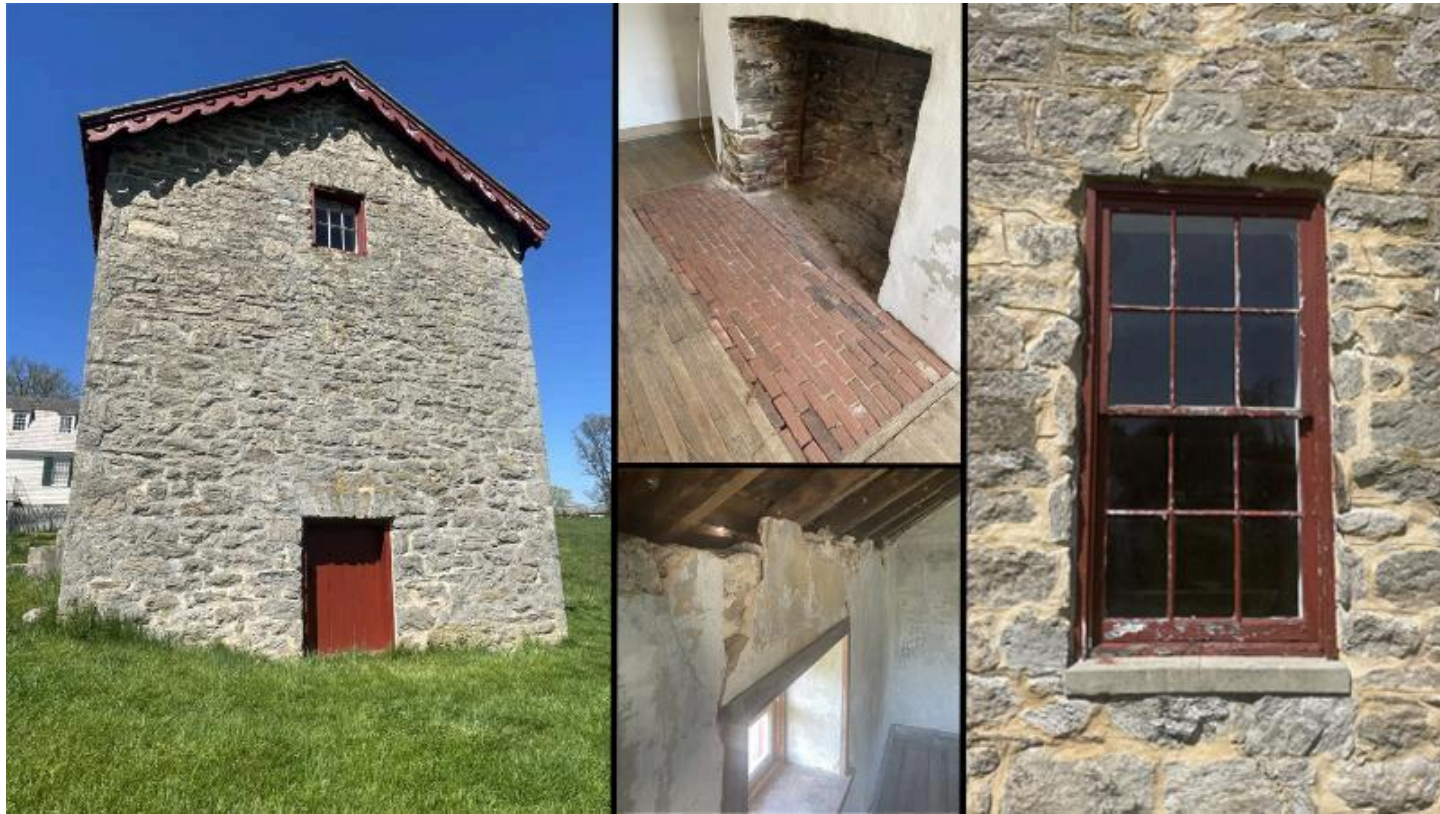
This project will improve accessibility at the entrances to Enslaved Quarters #2 and #3 and will also repair the buildings' roofs, replace rotting woodwork, and repoint masonry walls.

Opposite: A selection of photographs demonstrating features of Enslaved Workers' Quarters #2 and #3 that will be addressed as part of the current project, including exterior masonry walls (left), interior features (center top, center bottom), and woodwork (right). (Image Credit: National Park Service)

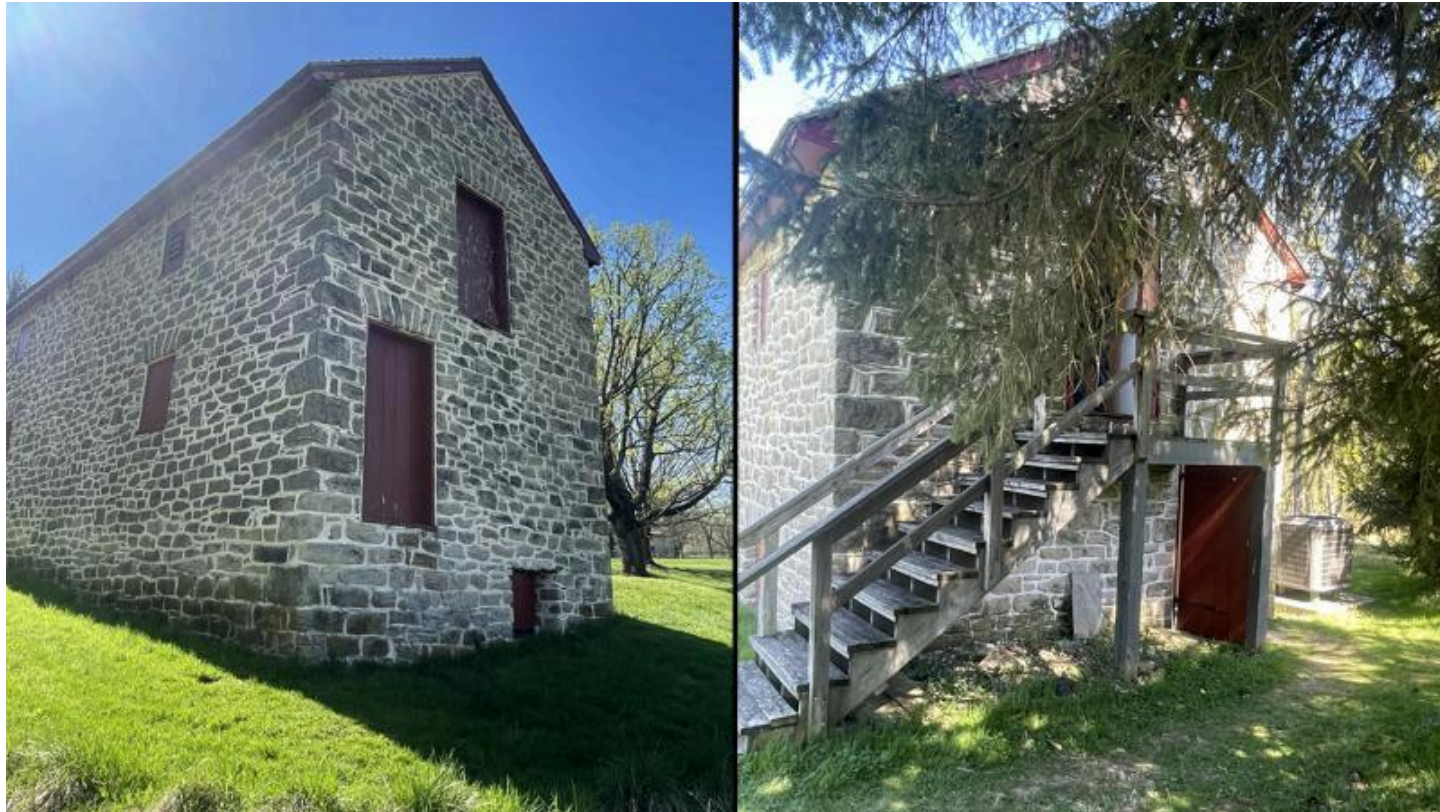
This project may include repairing the Long House Granary's rubble stone masonry walls, replacing the building's gabled wood shingle roof, replacing other deteriorated wooden features, and installing interior high-efficiency lighting. Following completion of the project, the Long House Granary will continue to serve as a landscape feature and provide storage for Park operations.

Opposite: Features of the Long House Granary that will be addressed as part of this project, including rubble stone masonry walls (left) and wooden features (right). (Image Credit: National Park Service)

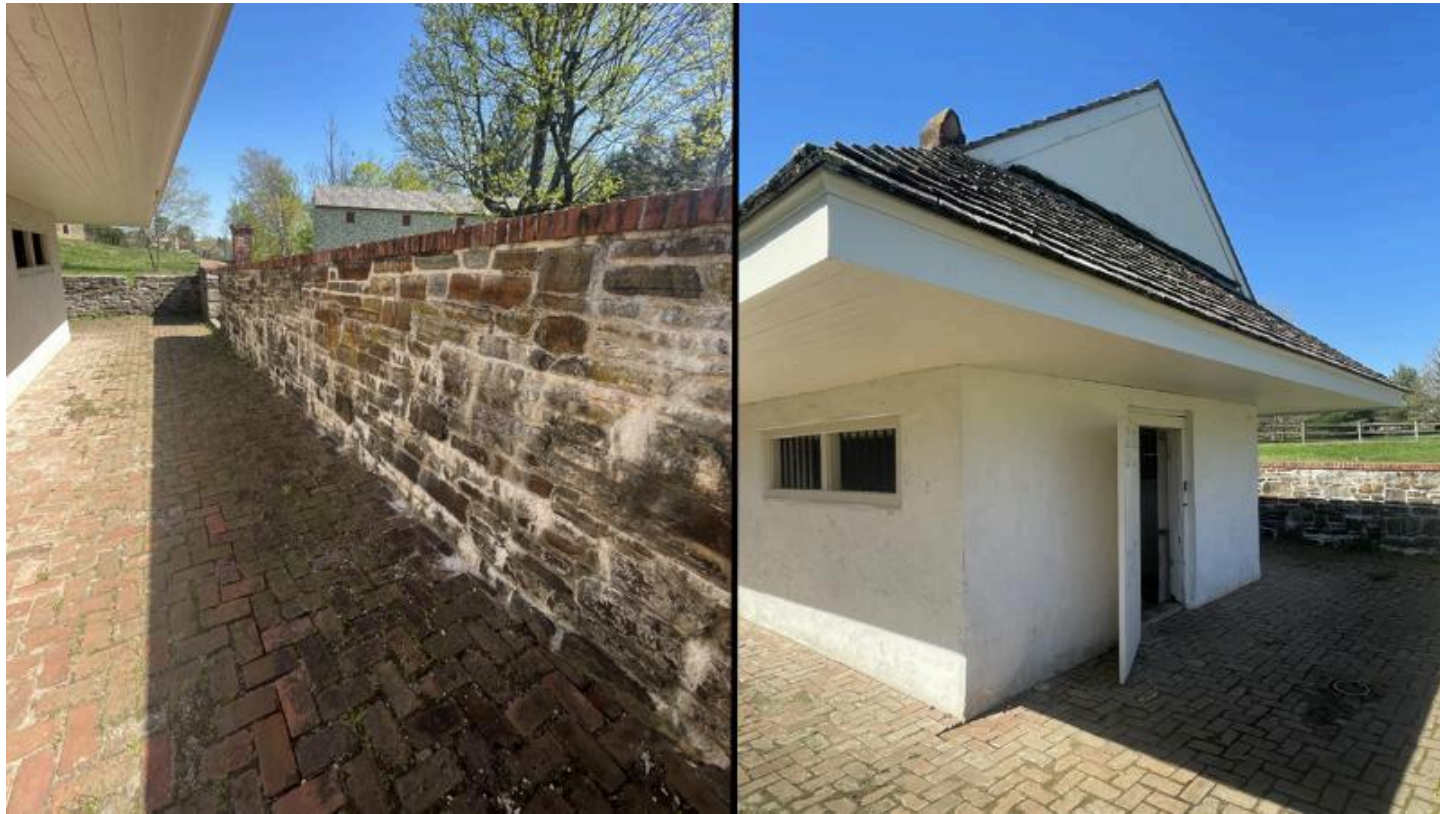
Improvements at the Dairy as part of this project may include replacing the building's shingle roof, repairs to masonry retaining walls, and repairs to deteriorated woodwork. The goal is to preserve and maintain this building as a landscape feature for site interpretation.

Opposite: Features of the Dairy that will be addressed as part of this project, including masonry retaining walls (left), and the shingle roof (right). (Image Credit: National Park Service)

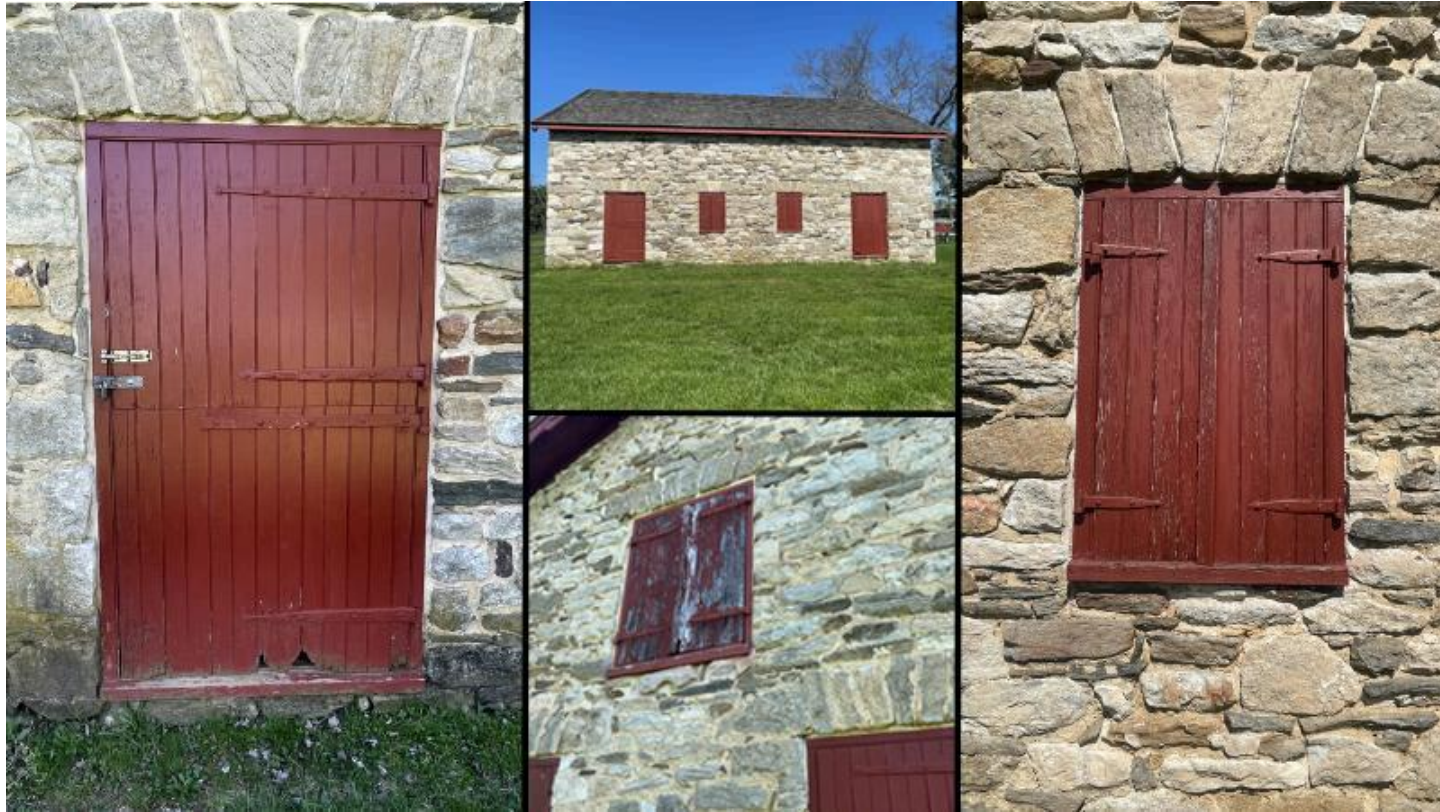
Improvements may include replacing the Mule Barn's roof, repairing deteriorated wooden features, rubble stone masonry repairs, and updating fire detection. The goal is to preserve and maintain the building as a landscape feature to view from the exterior for site

Opposite: Features of the Mule Barn that will be addressed as part of this project, including wooden features (left, center bottom, and right) and rubble stone masonry walls (center top). (Image Credit: National Park Service)

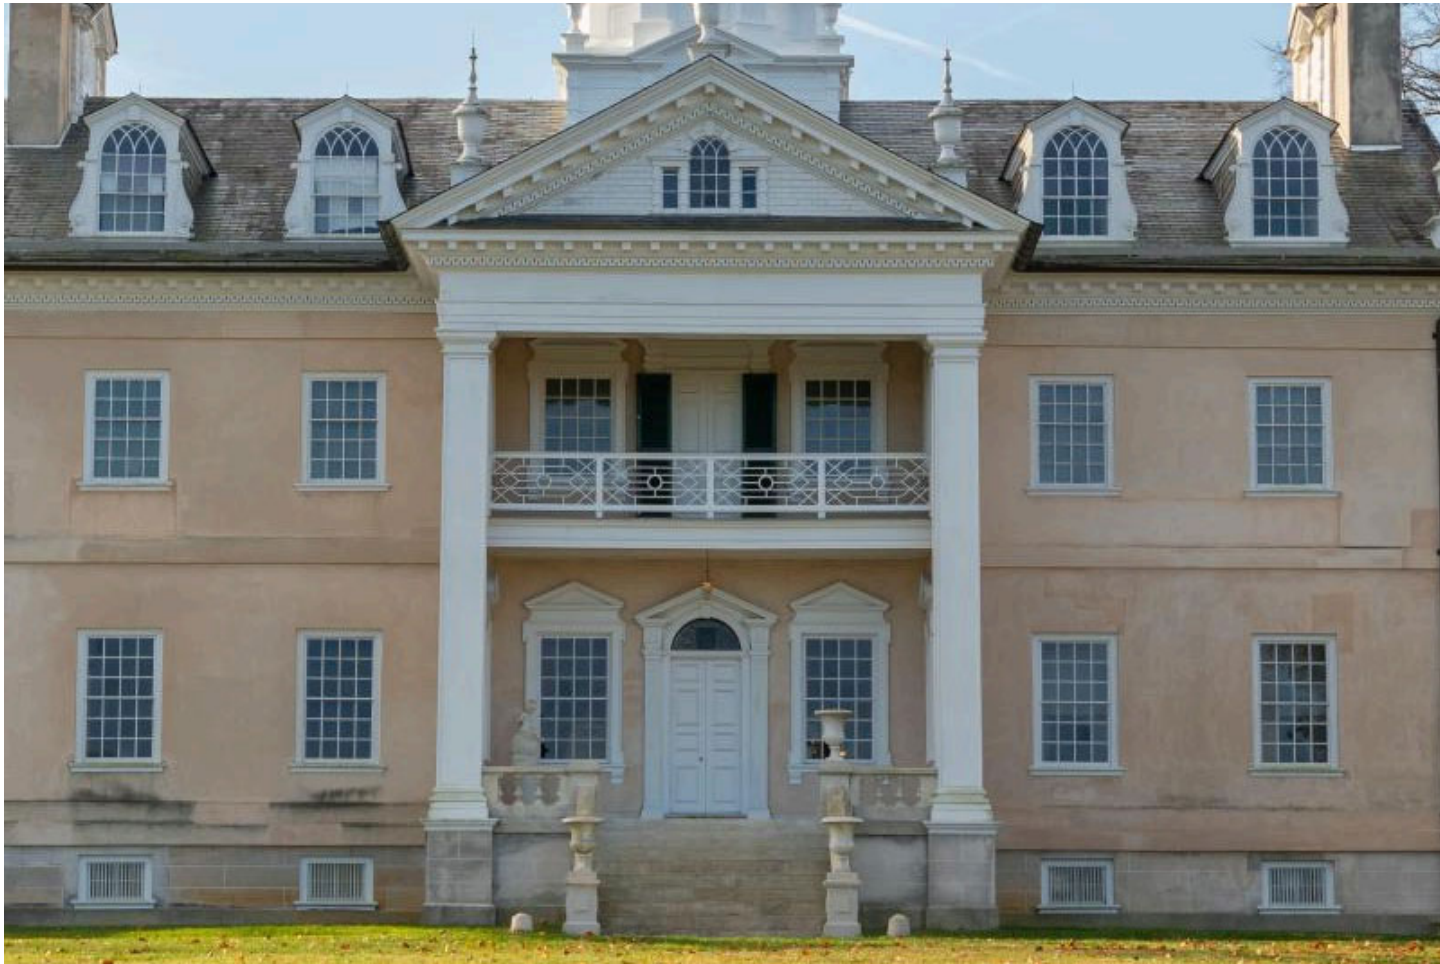
This project will replace stucco covering the exterior of the mansion where it is failing, and the surface will be recoated. Project tasks also include replacing rotted wood trim, making improvements to an existing accessible entrance ramp, and interior painting.

Opposite: North facade of Hampton Mansion, 2021. (Image Credit: Maximilian Franz Photography and National Park Service)

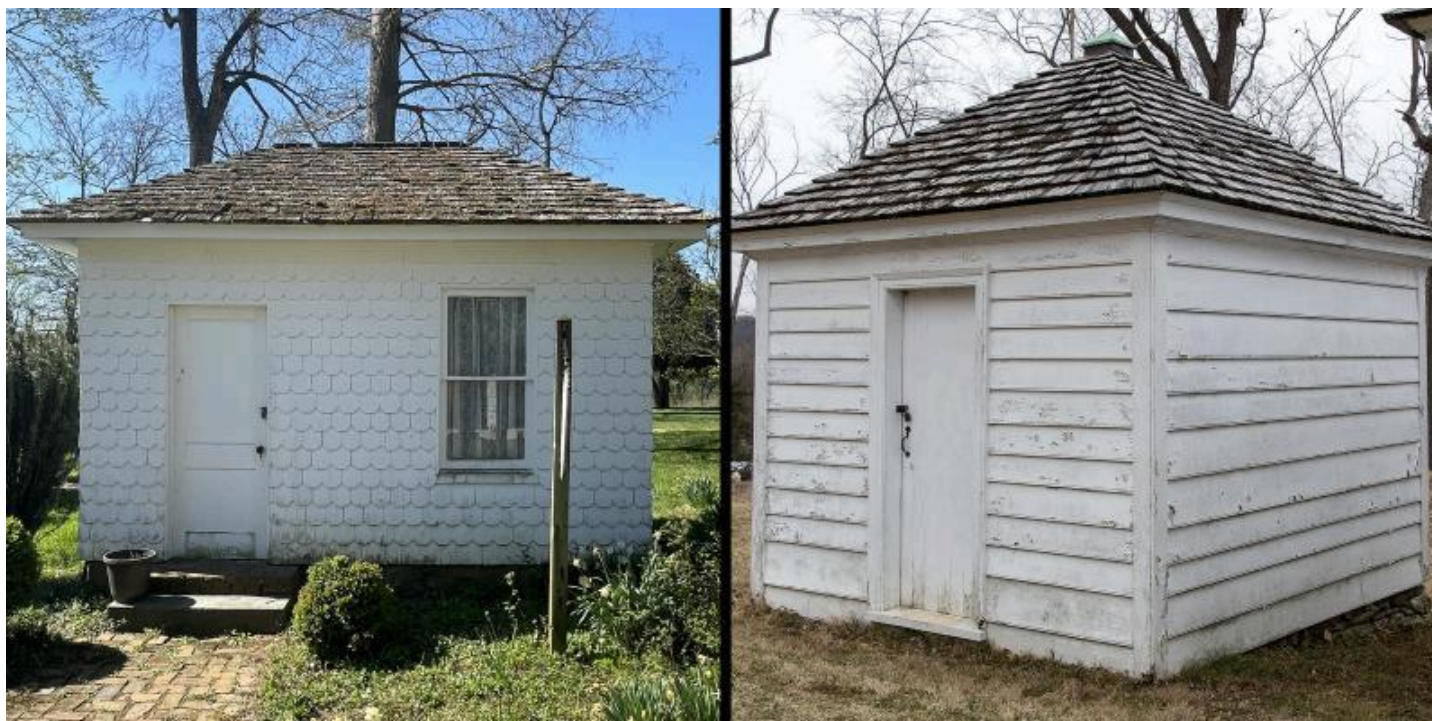
The **Pump House** (left) was constructed ca. 1890–1898 as a single-story wooden structure with fish-scale wooden shingled walls and hipped roof. The foundation is constructed of brick masonry and local stone.

Opposite: The Pump House (left) and the North Outbuilding (right), 2023. (Image Credit: Building Conservation Associates, Inc. and National Park Service)

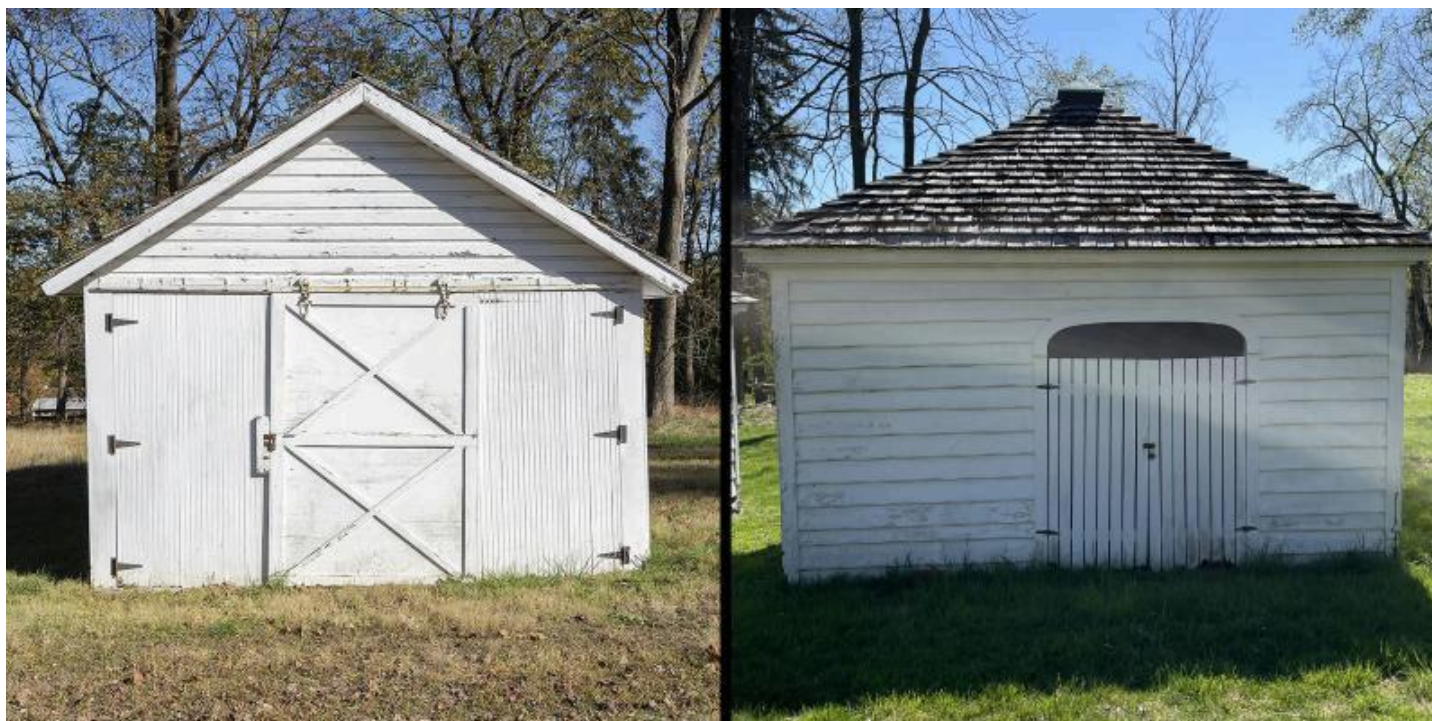
The **North Outbuilding** (right), formerly referred to as a smokehouse, was likely constructed ca. 1790 and could have originally been used for storage. Later, in the early 20th century, it served as a dwelling for paid servants including Bryan Lewis and Gassaway Turner.
