# NPS Wildfire Risk Assessments Assessment Locations

## Hovenweep National Monument

# NPS Wildand Fire Risk Assessment - Facility Wildfire Risk Assessment Summary

## Unit - Location: HOVE - Hovenweep

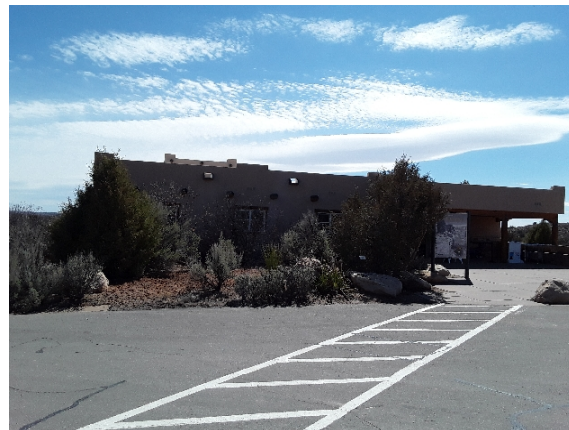
2020\_HOVE\_61476\_Visitor Center\_Front.jpg

**Access & Turnarounds:** Access is <300 ft from facility w/turnaround  
**Facility Number/Sign:** None or not clearly visible  
**Defensible Space:** <30 ft treated

**Fuel Load (w/in 300 ft):** Moderate  
**Fuel Type (w/in 300ft):** Grass,shrub,hardwood litter  
**Topography (w/in 300ft):** Slope 5% to 20%  
**Roof Material:** Noncombustible or not applicable

**Siding Material:** Rock, concrete, metal  
**Foundation:** Closed, >30in masonry exposed or N/A  
**Fences/Decks:** Combustible but separated from facility

**Firewood:** None  
**Propane Tanks:** None  
**Water Supply:** Limited or dependent on electricity  
**Overhead Hazards:** No overhead hazards  
**Safety Zones:** Potential safety zone(s) in area

**Score: 56** **Asset Priority Index (API): 55**  
**Rating: Moderate**

| Label # | Facility/Community Name | Assessment Scale | Site Visit Type | Firewise Zone | Treatment | Treatment Description | Person Hours |
|---|---|---|---|---|---|---|---|
| 1 | Visitor Center | Individual Facility | Initial | 1 | Clear adjacent and overhanging fuels to create 10 feet spacing between canopy and structure or chimney openings | Brush around building 10 to 20 feet. | 0.0 |

| Label # | Facility/Community Name | Assessment Scale | Triage Category | Tactic Description | Person Hours | Equipment Description | Equip. Qty |
|---|---|---|---|---|---|---|---|
| 1 | Visitor Center | Individual Facility | PrepHold | Engine on scene - 1 Type 4 Engine Crew to support and implement burnout | 3.0 | Engine/OtherVehicle-Wildland Heavy Engine, Type 3,4 or 5, EA | 1 |

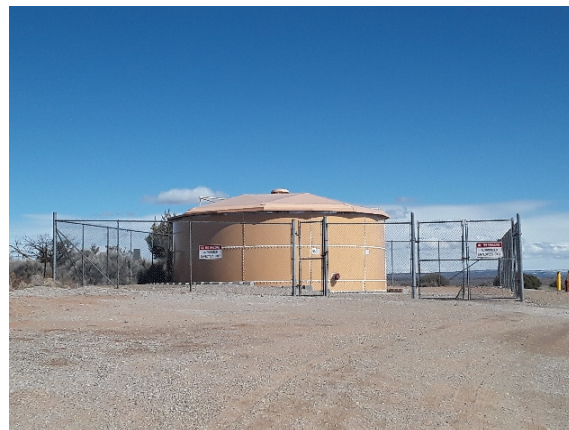
2020\_HOVE\_HOVE-Water Tank\_Water Tank\_Front.jpg

**Access & Turnarounds:** Access is >300 ft from facility w/turnaround  
**Facility Number/Sign:** None or not clearly visible  
**Defensible Space:** >100ft treated

**Fuel Load (w/in 300 ft):** Moderate  
**Fuel Type (w/in 300ft):** Grass,shrub,hardwood litter  
**Topography (w/in 300ft):** Slope 5% to 20%  
**Roof Material:** Noncombustible or not applicable

**Siding Material:** Rock, concrete, metal  
**Foundation:** Closed, >30in masonry exposed or N/A  
**Fences/Decks:** None or noncombustible  
**Firewood:** None

**Score: 39**  
**Rating: Low**

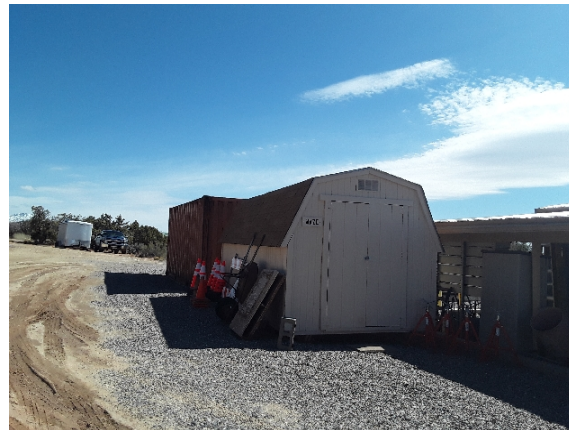
2021\_HOVE\_92563\_maze shed \_Front.jpg

**Access & Turnarounds:** Access is <300 ft from facility w/turnaround  
**Facility Number/Sign:** Marked and clearly visible  
**Defensible Space:** 100 ft treated

**Fuel Load (w/in 300 ft):** Moderate  
**Fuel Type (w/in 300ft):** Shrub or timber  
**Topography (w/in 300ft):** Slope <5%  
**Roof Material:** Noncombustible or not applicable

**Siding Material:** Vinyl  
**Foundation:** Closed, >30in masonry exposed or N/A  
**Fences/Decks:** None or noncombustible  
**Firewood:** None  
**Propane Tanks:** Present and fuels clearance

**Additional Obstacles:** None  
**Triage Category:**  
**Hazmat:** fuel station nearby  
**Assessment Comments:**

**Score: 27**  
**Rating: Low**

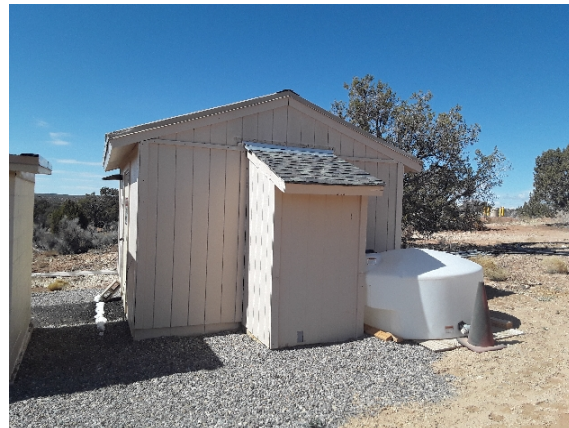
2021\_HOVE\_not found \_well house \_Front.jpg

**Roof Material:** Noncombustible or not applicable  
**Siding Material:** Rock, concrete, metal  
**Foundation:** Closed, >30in masonry exposed or N/A

**Score: 34**  
**Rating: Low**

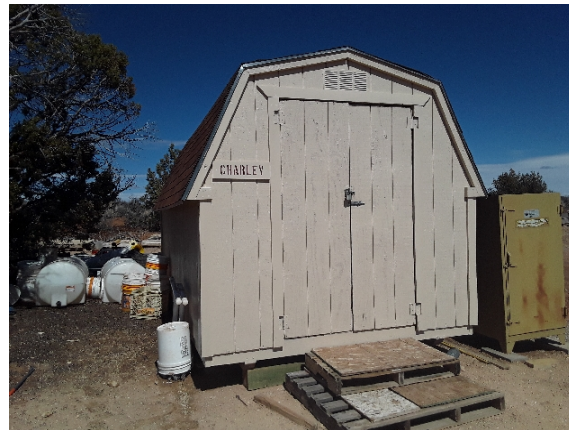
2021\_HOVE\_92566\_HVMA storage shed ( charley)\_Front.jpg

**Siding Material:** Vinyl  
**Foundation:** Closed, >30in masonry exposed or N/A  
**Fences/Decks:** None or noncombustible  
**Firewood:** None  
**Propane Tanks:** None

**Score: 43**  
**Rating: Low**

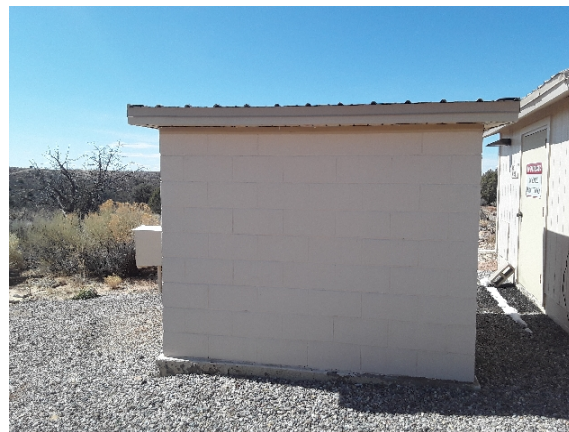
2020\_HOVE\_61481\_Old Pump House\_Front.jpg

**Siding Material:** Wood or open sided  
**Foundation:** Closed, 6in to 30in masonry exposed  
**Fences/Decks:** None or noncombustible  
**Firewood:** None

**Score: 60**  
**Rating: Moderate**

| Label # | Facility/Community Name | Assessment Scale | Triage Category | Tactic Description | Person Hours | Equipment Description | Equip. Qty |
|---|---|---|---|---|---|---|---|
| 6 | Old Pump House | Facility In Community (Housing, Maintenance & Campground) | PrepLeave | Remove flammable materials - Remove fuels away from structure | 5.0 | - | |
| | | | | Fuels reduction - | 5.0 | - | |
| | | | | Engine on scene - Find water source to pump hose lay. | 3.0 | - | |
| | | | | Progressive hoselay - | 2.0 | - | |

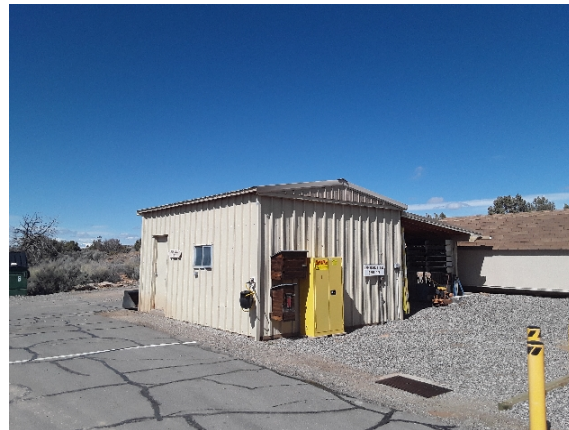
2020\_HOVE\_61485\_Maintenance Shop (San Jose Shed)  
# 5\_Front.jpg

**Siding Material:** Rock, concrete, metal  
**Foundation:** Closed, < 6in masonry exposed  
**Fences/Decks:** None or noncombustible  
**Firewood:** None

**Additional Obstacles:** Hazmat, UXO,etc. , PLEASE COMMENT  
**Triage Category:**  
**Hazmat:** fuel station adjacent  
**Assessment Comments:**

**Score: 38**  
**Rating: Low**

| 7 | Maintenance Shop (San Jose Shed) # 5 | Facility In Community (Housing, Maintenance & Campground) | Initial | 1 | Flammable ground cover such as leaf litter, woody debris or highly flammable vegetation should be removed | Brush around building 10 to 20 feet. | 0.0 |
| | | Facility In Community (Housing, Maintenance & Campground) | Initial | 3 | Remove heavy ground fuels such as logs and stumps | Remove dead/down. | 0.0 |

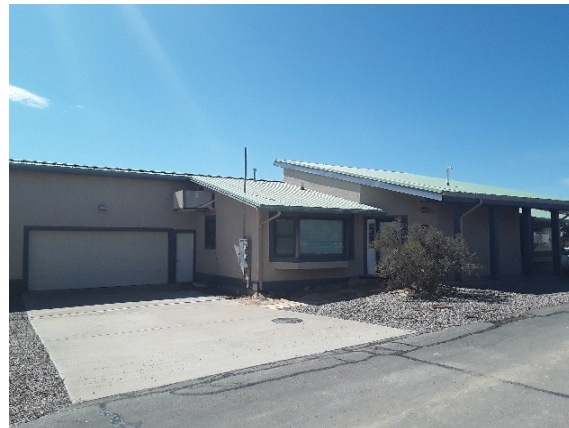
2020\_HOVE\_81575\_H-9 Duplex (Housing # 4)\_Front.jpg

**Propane Tanks:** Adjacent to facility and no fuels clearance  
**Water Supply:** Pressurized hydrant(s) or fixed sprinkler system  
**Overhead Hazards:** No overhead hazards

**Score: 43**  
**Rating: Low**

| 8 | H-9 Duplex (Housing # 4) | Facility In Community (Housing, Maintenance & Campground) | Initial | 1 | Clear adjacent and overhanging fuels to create 10 feet spacing between canopy and structure or chimney openings | Brush around building 10 to 20 feet. | 0.0 |

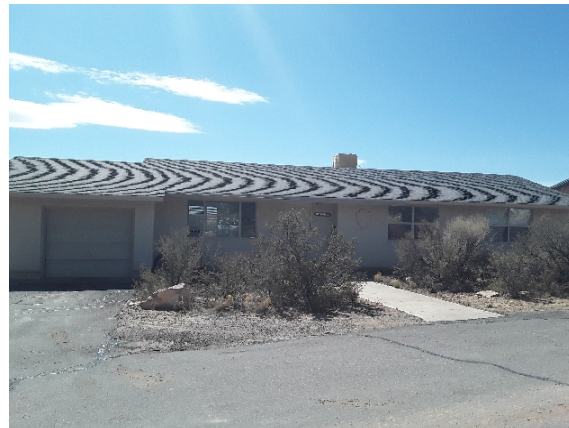
2020\_HOVE\_61512\_H-7 (Housing #3)\_Front.jpg

**Siding Material:** Rock, concrete, metal  
**Foundation:** Closed, >30in masonry exposed or N/A  
**Fences/Decks:** Combustible but separated from facility

**Score: 41**  
**Rating: Low**

| 9 | H-7 (Housing #3) | Facility In Community (Housing, Maintenance & Campground) | Initial | 1 | Flammable ground cover such as leaf litter, woody debris or highly flammable vegetation should be removed | Brush around building 10 to 20 feet. | 0.0 |

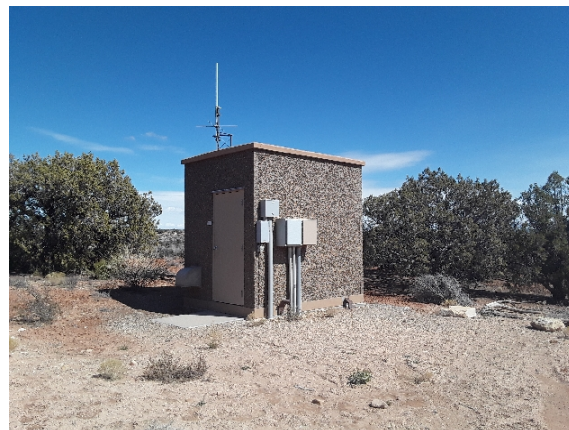
2020\_HOVE\_99313\_Telephone Building\_Front.jpg

**Score: 54**  
**Rating: Moderate**

| Label # | Facility/Community Name | Assessment Scale | Site Visit Type | Firewise Zone | Treatment | Treatment Description | Person Hours |
|---|---|---|---|---|---|---|---|
| 10 | Telephone Building | Facility In Community (Housing, Maintenance & Campground) | Initial | 1 | Flammable ground cover such as leaf litter, woody debris or highly flammable vegetation should be removed | Brush around building 10 to 20 feet. | 0.0 |

| Label # | Facility/Community Name | Assessment Scale | Triage Category | Tactic Description | Person Hours | Equipment Description | Equip. Qty |
|---|---|---|---|---|---|---|---|
| 10 | Telephone Building | Facility In Community (Housing, Maintenance & Campground) | PrepLeave | Fuels reduction - Once fuels have been moved away from structure, building will stand alone. | 2.5 | - | |

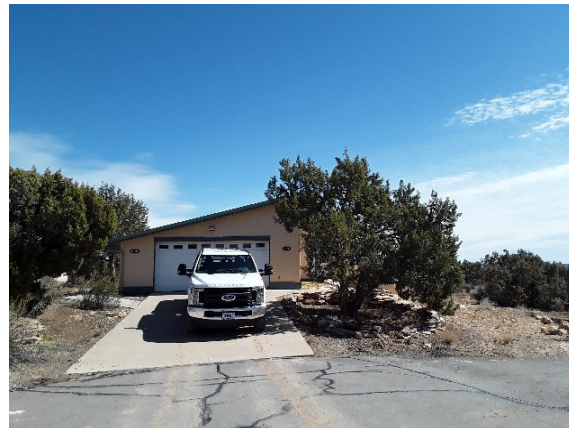
2020\_HOVE\_61503\_H-8 (Housing #2)\_Front.jpg

**Propane Tanks:** Adjacent to facility and no fuels clearance  
**Water Supply:** Pressurized hydrant(s) or fixed sprinkler system  
**Overhead Hazards:** No overhead hazards

**Score: 43**  
**Rating: Low**

| Label # | Facility/Community Name | Assessment Scale | Site Visit Type | Firewise Zone | Treatment | Treatment Description | Person Hours |
|---|---|---|---|---|---|---|---|
| 11 | H-8 (Housing #2) | Facility In Community (Housing, Maintenance & Campground) | Initial | 1 | Flammable ground cover such as leaf litter, woody debris or highly flammable vegetation should be removed | Brush around building 10 to 20 feet. | 0.0 |

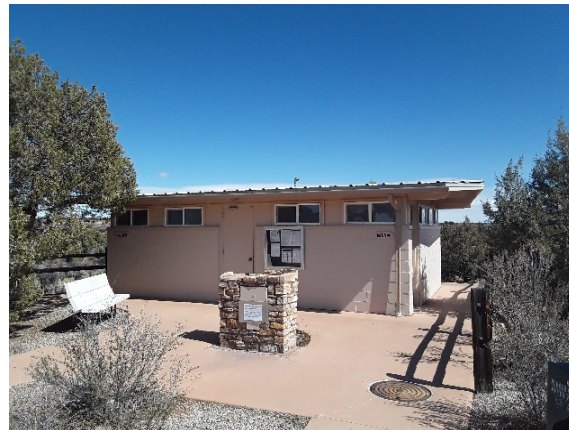
2020\_HOVE\_61514\_Campground Restroom Building\_Front.jpg

Score: 39  
Rating: Low

| Label # | Facility/Community Name | Assessment Scale | Site Visit Type | Firewise Zone | Treatment | Treatment Description | Person Hours |
|---|---|---|---|---|---|---|---|
| 12 | Campground Restroom Building | Facility In Community (Housing, Maintenance & Campground) | Initial | 1 | Clear adjacent and overhanging fuels to create 10 feet spacing between canopy and structure or chimney openings | Brush around building 10 to 20 feet. | 0.0 |
