# NPS Wildfire Risk Assessments Assessment Locations

## KATM - Katmai National Park and Preserve - Overview

KATM - Valley of 10,000 Smokes - Overview

# NPS Wildland Fire Risk Assessment - Facility Assessment

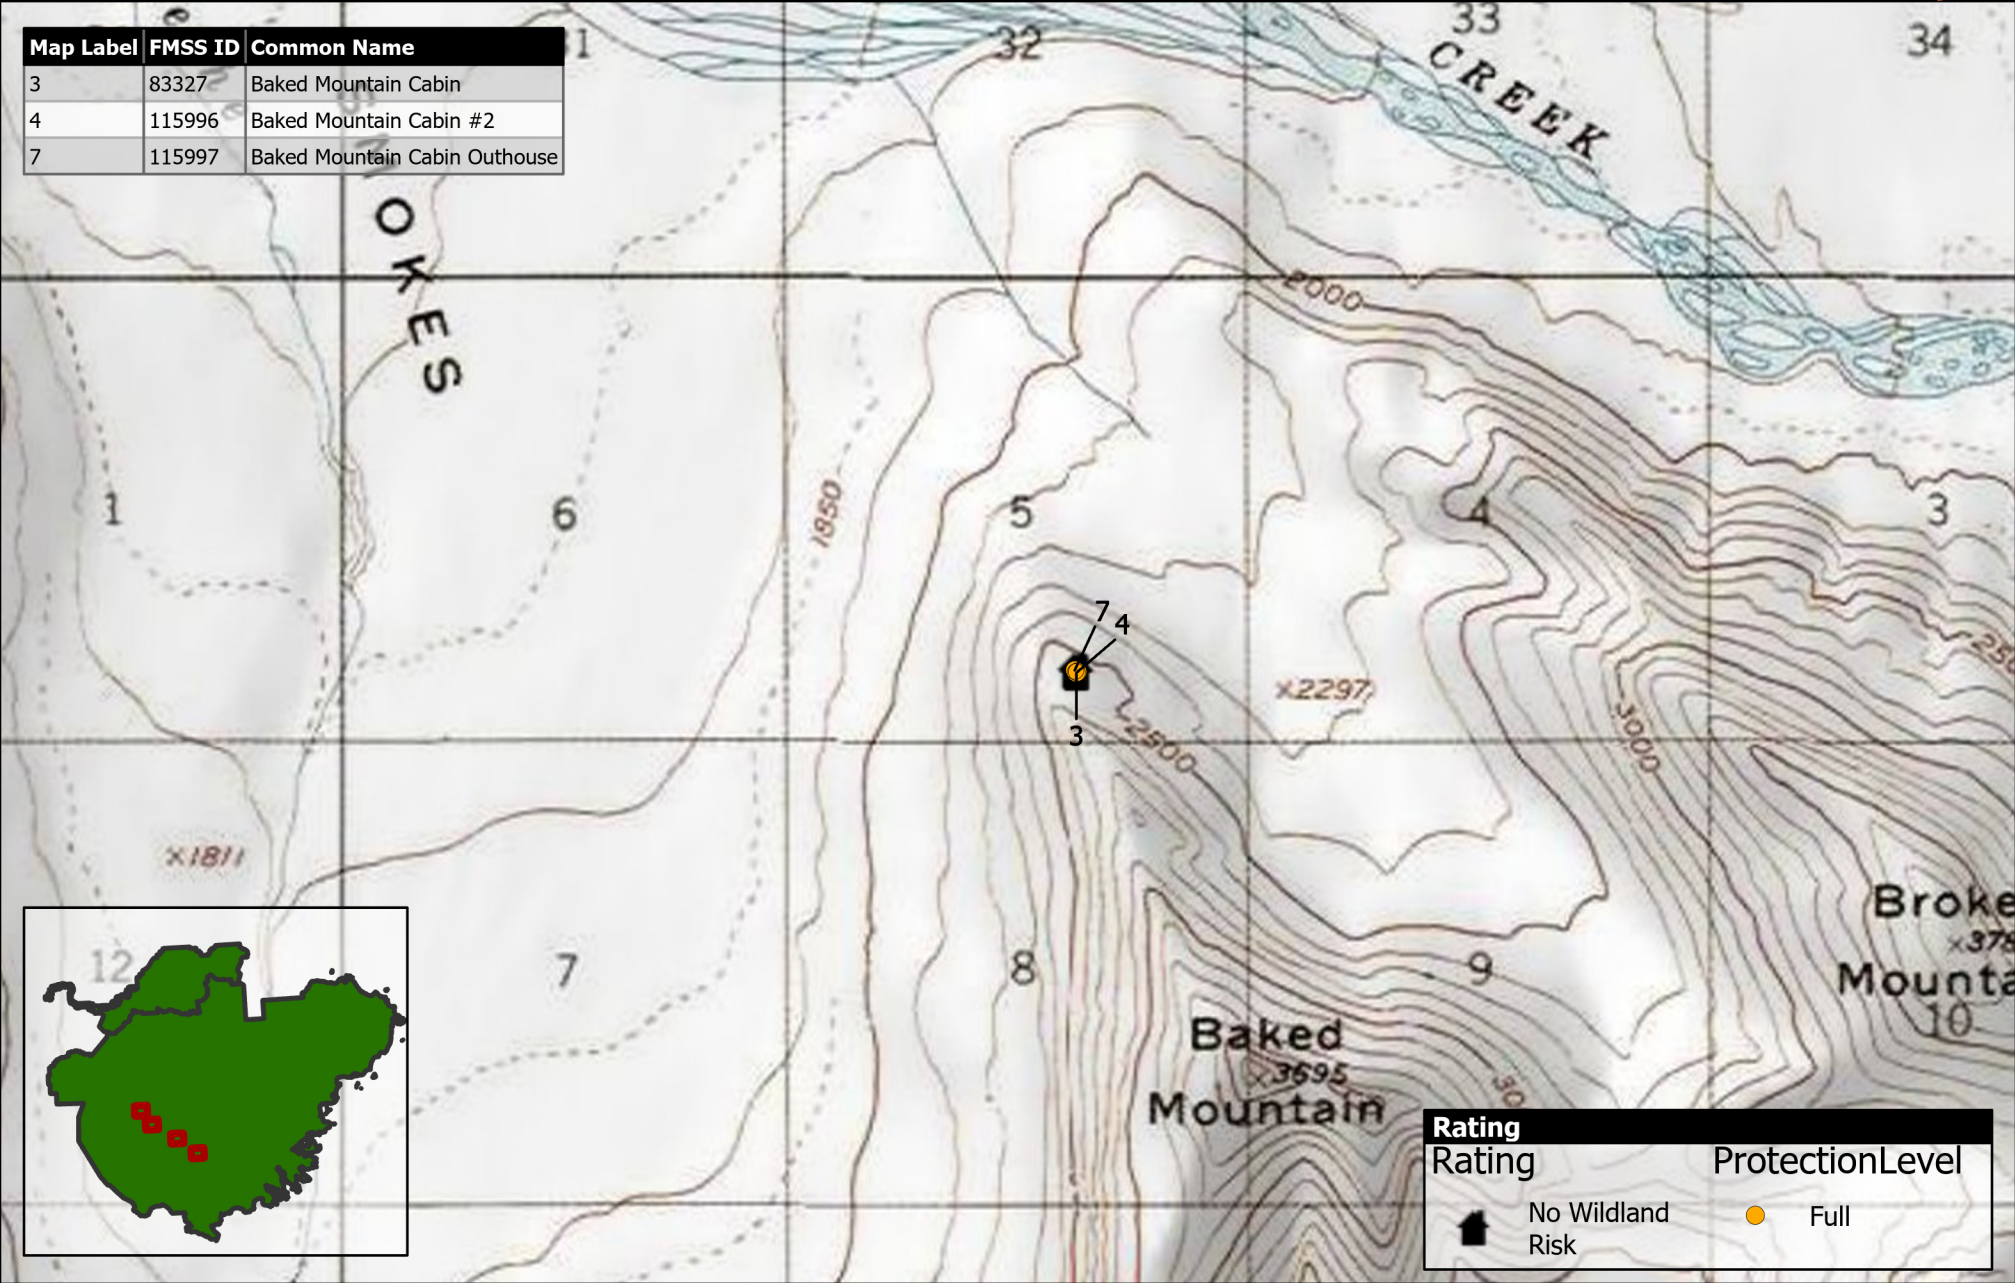
# Baked Mountain

| Map Label | FMSS ID | Common Name |
| 3 | 83327 | Baked Mountain Cabin |
| 4 | 115996 | Baked Mountain Cabin #2 |
| 7 | 115997 | Baked Mountain Cabin Outhouse |

| Rating | Rating | ProtectionLevel |
| | No Wildland Risk | Full |

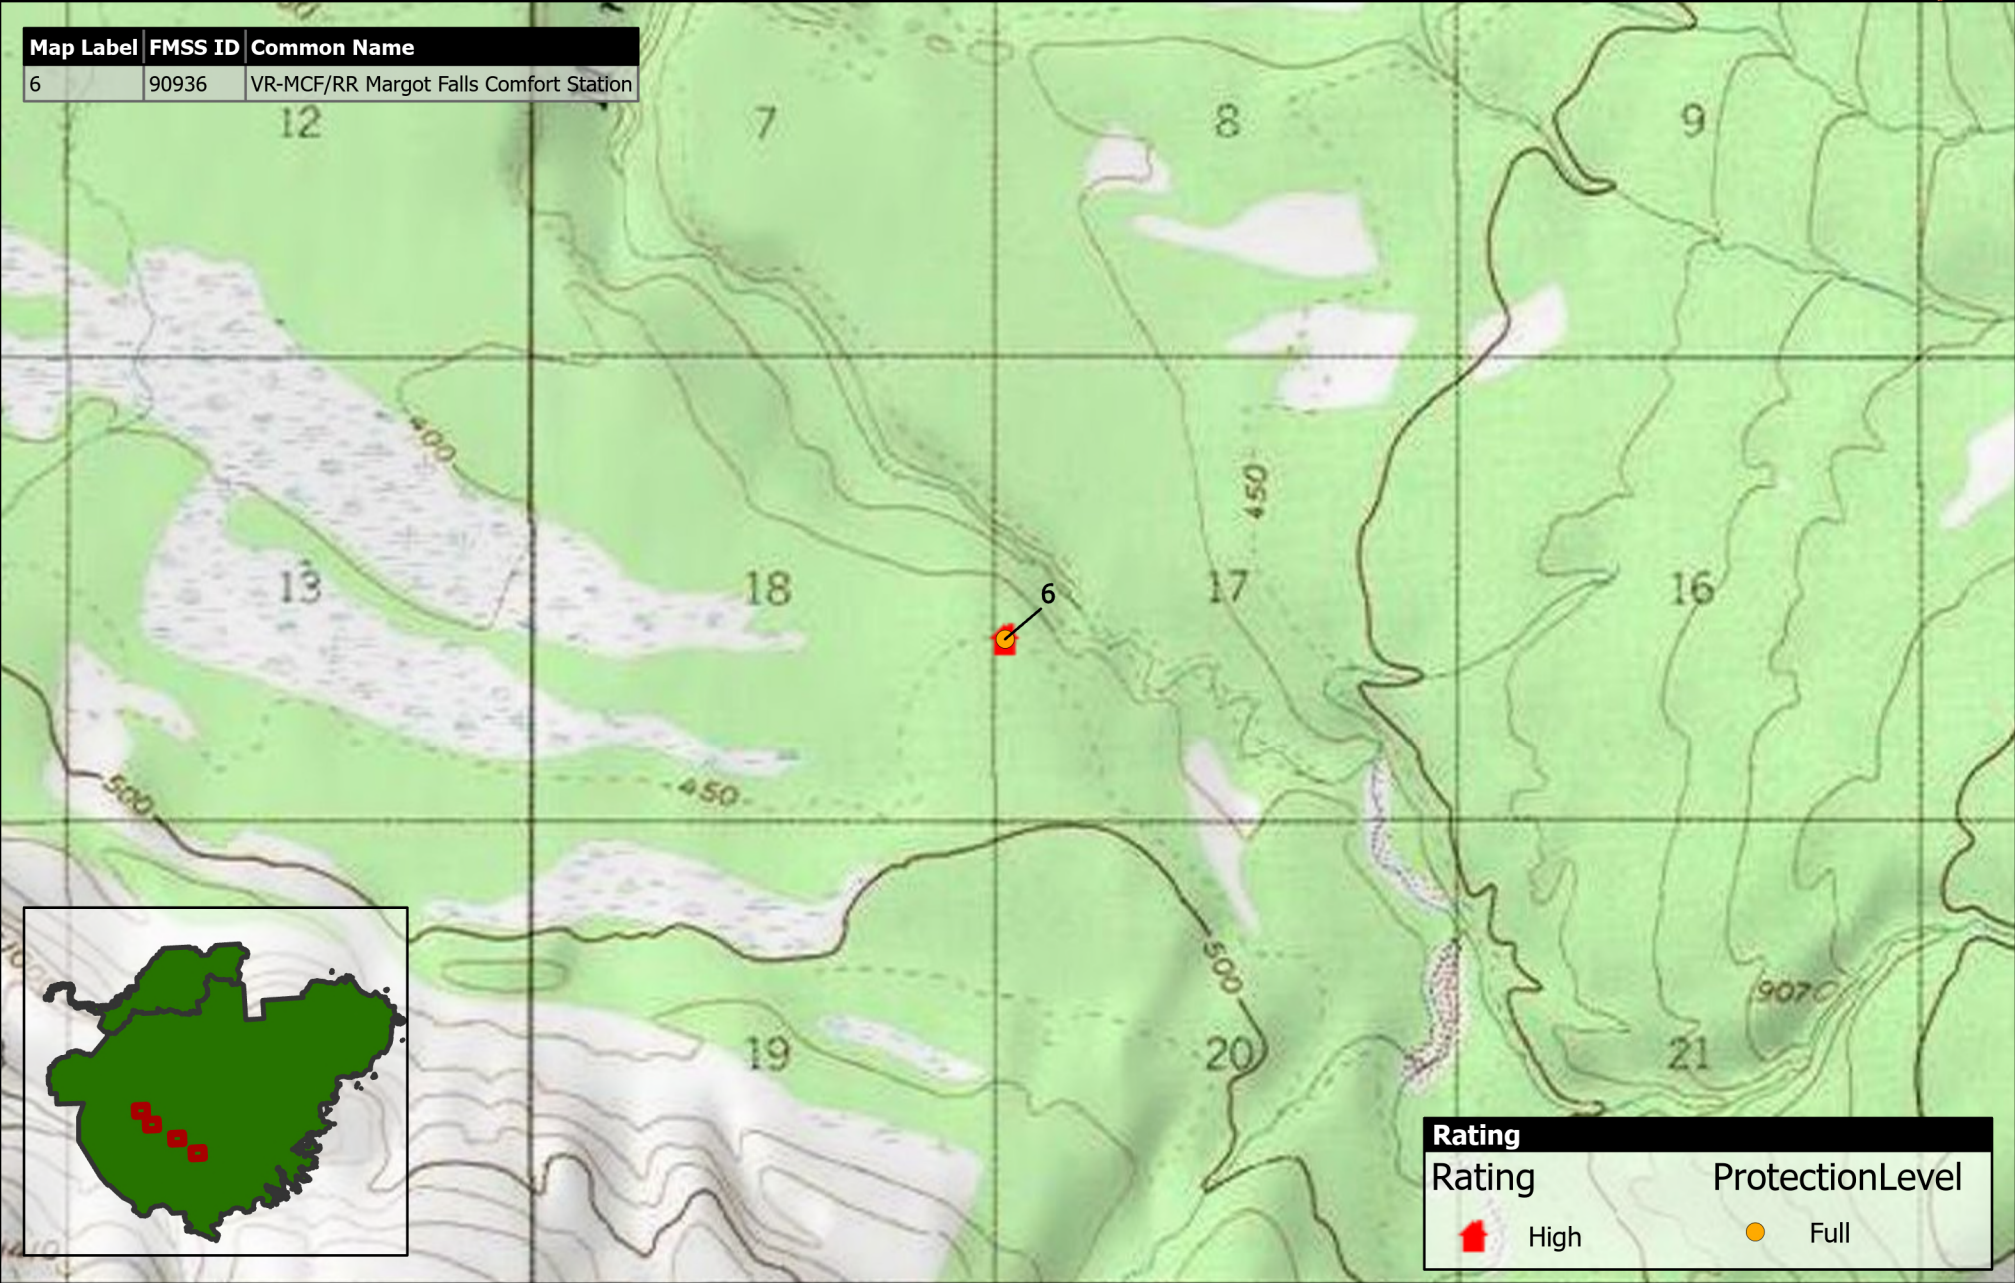
# Margot Falls Comfort Station

| Map Label | FMSS ID | Common Name |
| 6 | 90936 | VR-MCF/RR Margot Falls Comfort Station |

| Rating | ProtectionLevel |
| High | Full |

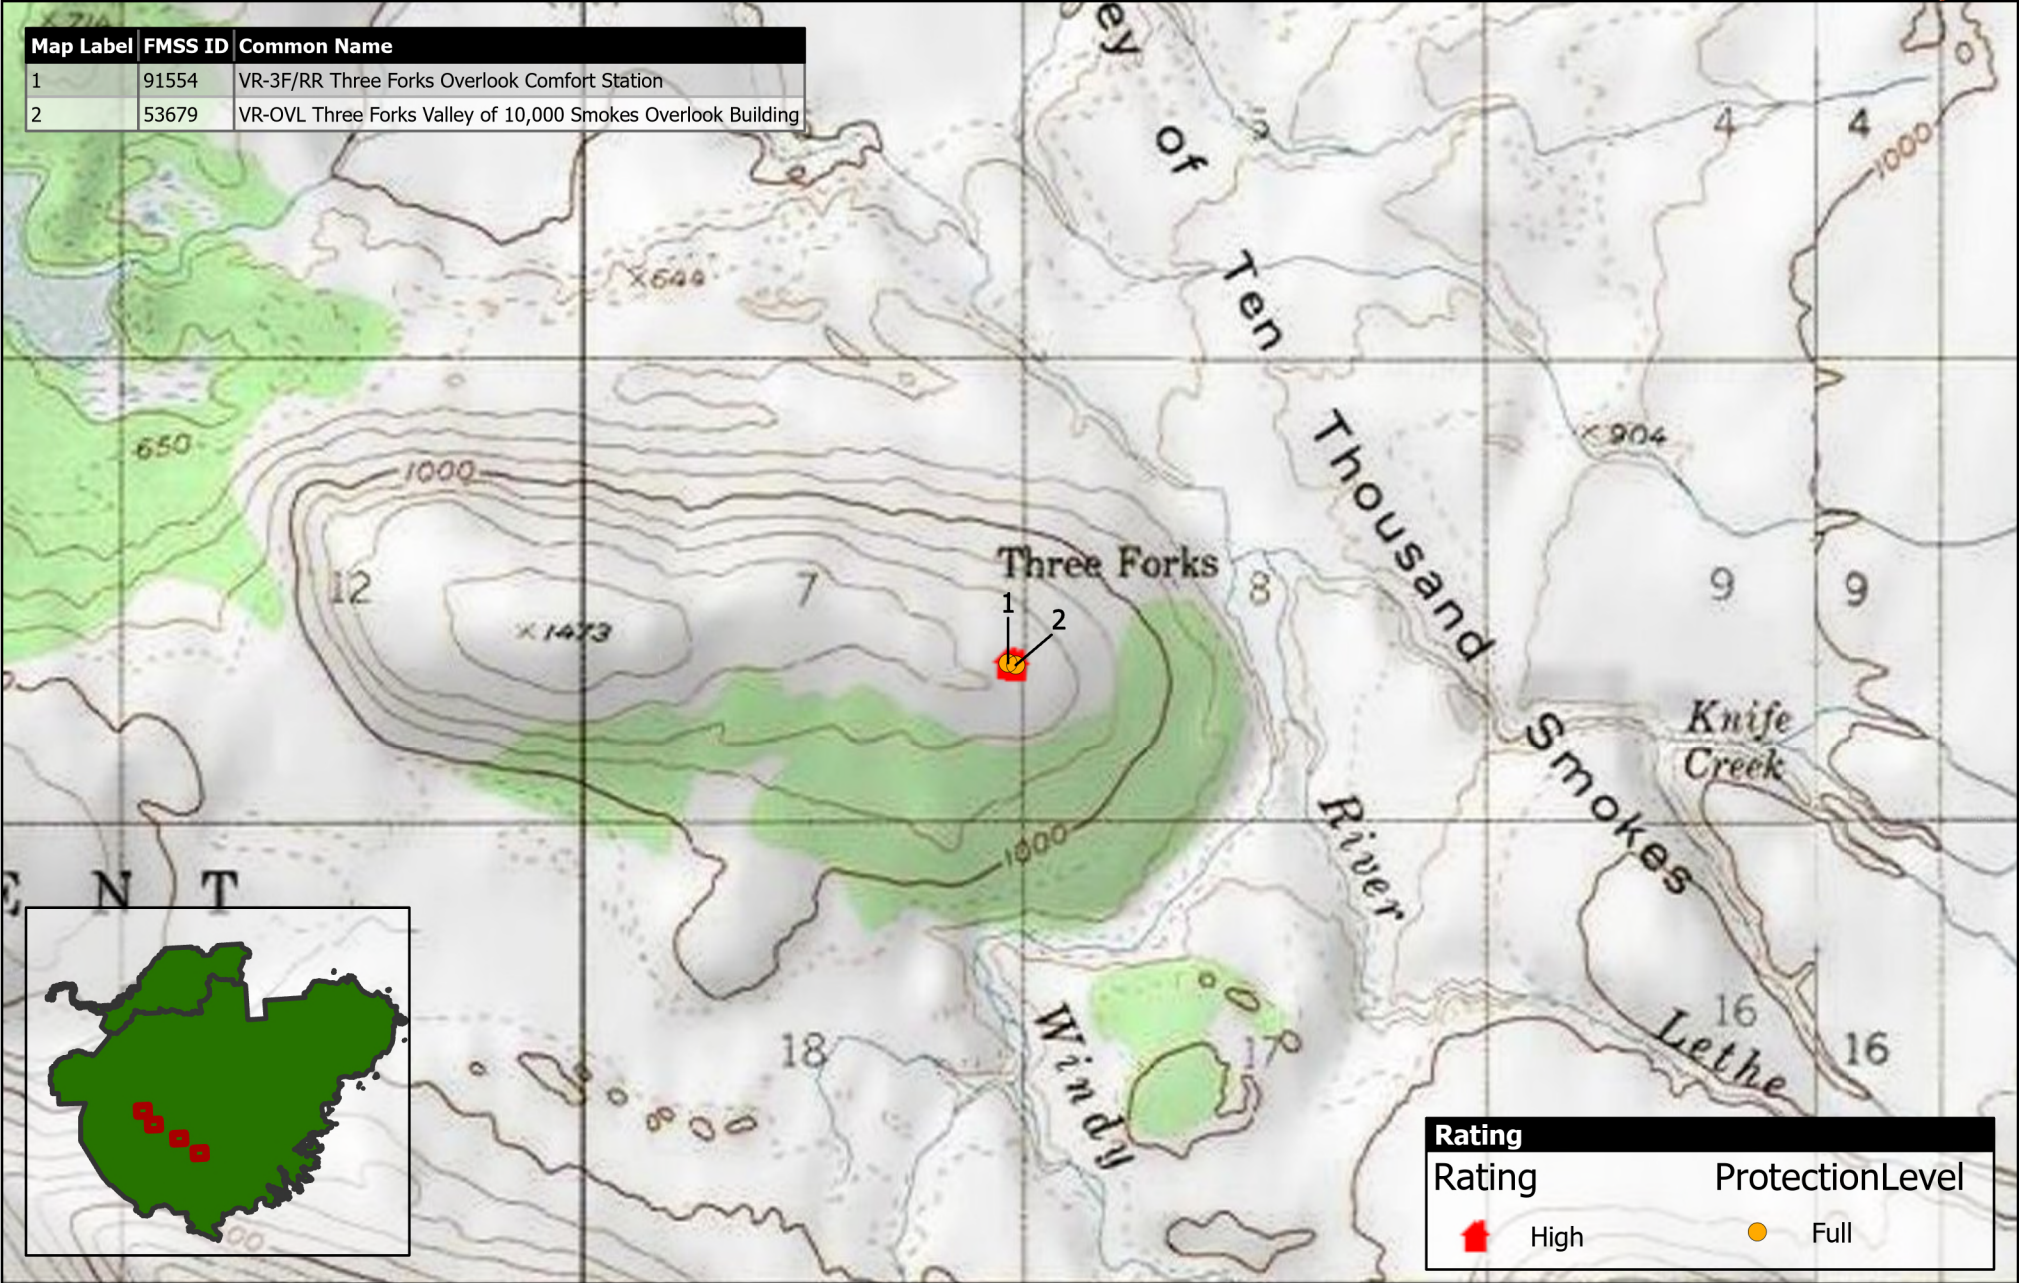
# Overlook

| Map Label | FMSS ID | Common Name |
| 1 | 91554 | VR-3F/RR Three Forks Overlook Comfort Station |
| 2 | 53679 | VR-OVL Three Forks Valley of 10,000 Smokes Overlook Building |

| Rating | | ProtectionLevel | |
| Rating | | | |
| High | | Full | |

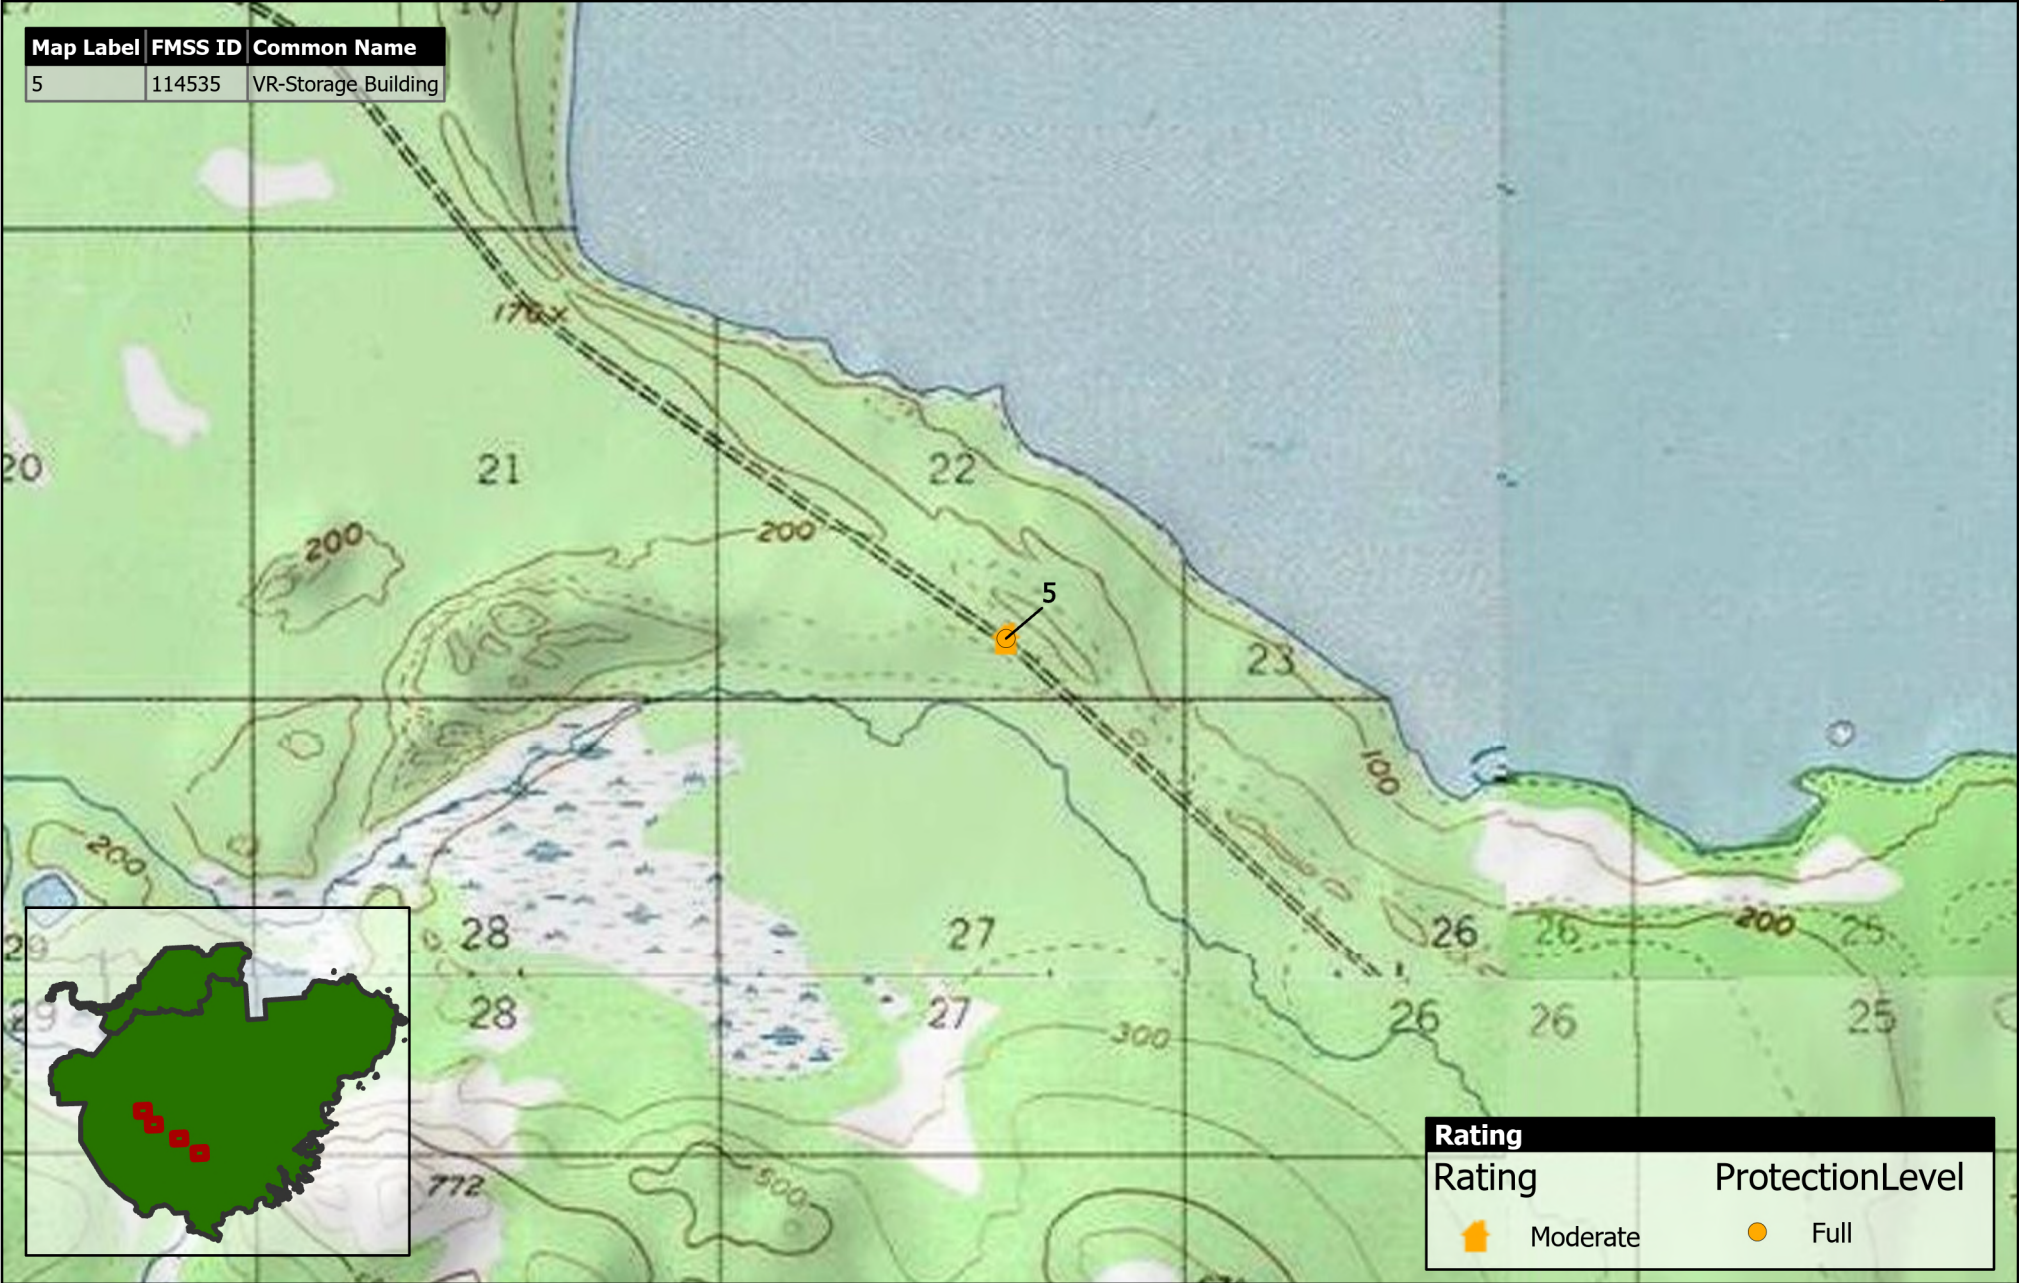
# VR Storage Building

| Map Label | FMSS ID | Common Name |
| 5 | 114535 | VR-Storage Building |

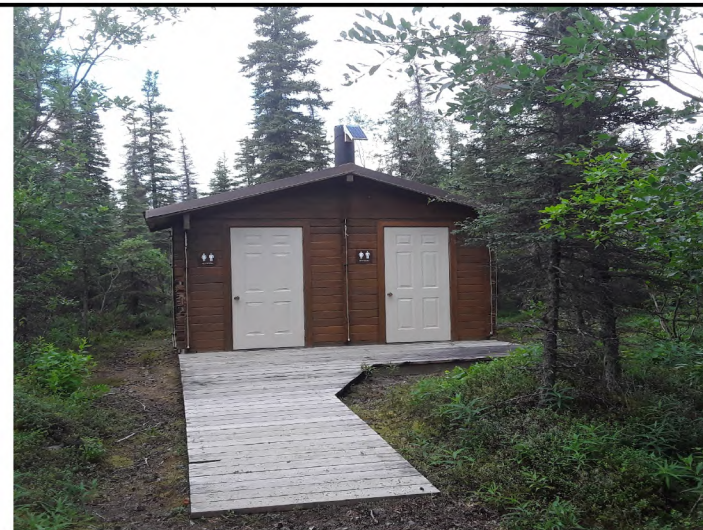
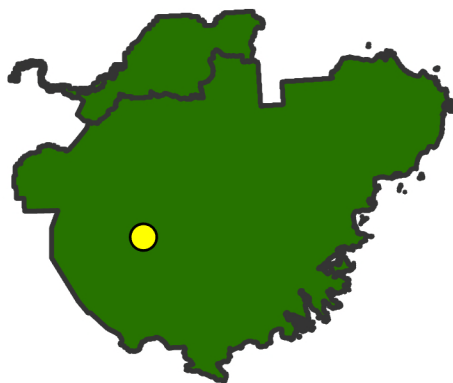
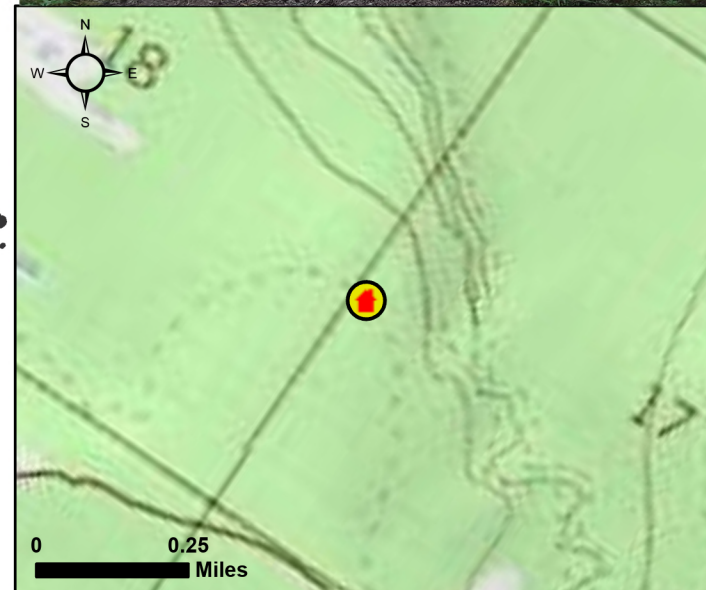
**Facility Name:** VR-MCF/RR Margot Falls Comfort Station

**Rating:** High

**Fuel Type:** Grass/tundra, northern hardwood litter

**Fuel Load:** Very Heavy

**Defensible Space:** Less than 30 ft treated

**Roof Material:** Noncombustible or not applicable

**Siding Material:** Wood or open sided

**Foundation:** Closed, Less than 6in masonry exposed

**Water Supply:** No reliable water source nearby

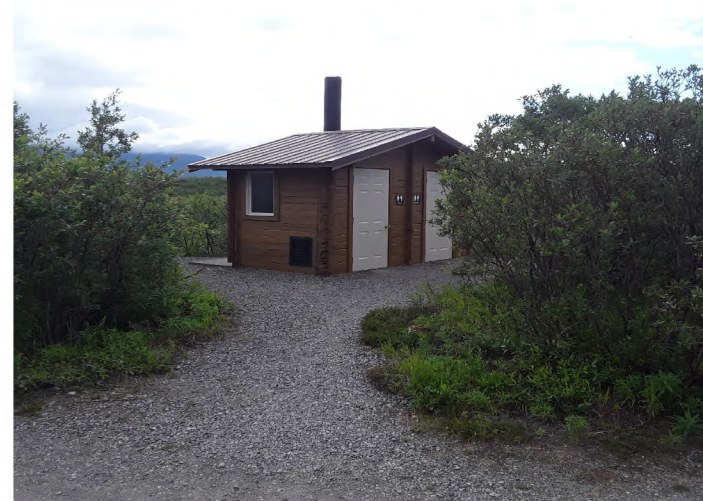
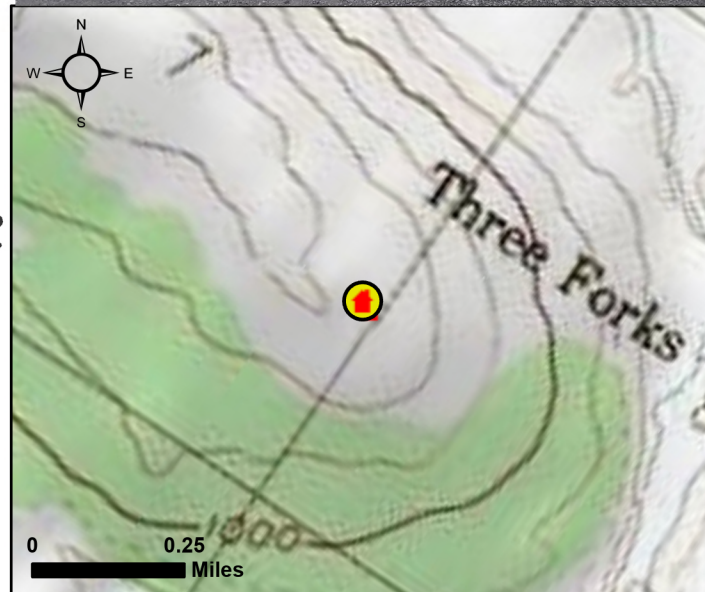
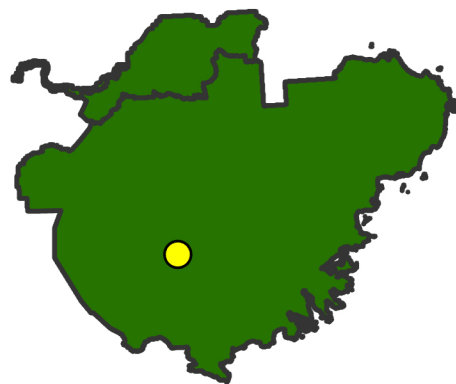
**Facility Name:** VR-3F/RR Three Forks Overlook Comfort Station

**Rating:** High

**Fuel Type:** Grass/tundra, northern hardwood litter

**Fuel Load:** Moderate

**Defensible Space:** Less than 30 ft treated

**Topography:** Slope 5% to 20%

**Siding Material:** Wood or open sided

**Water Supply:** No reliable water source nearby

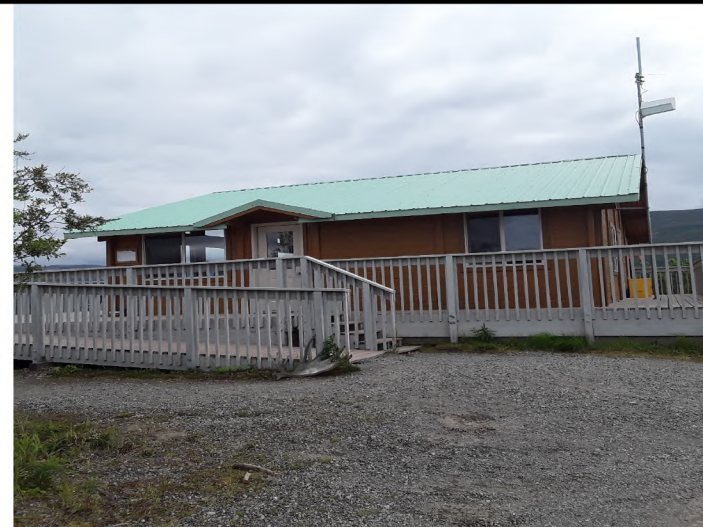
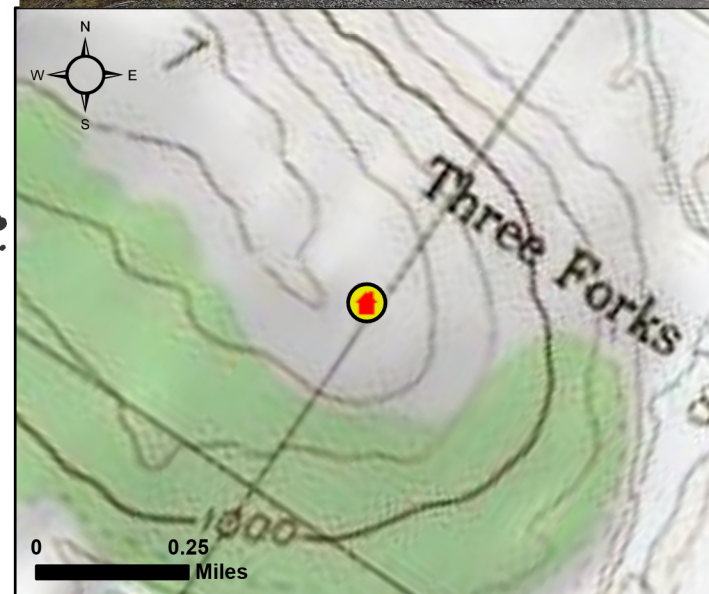
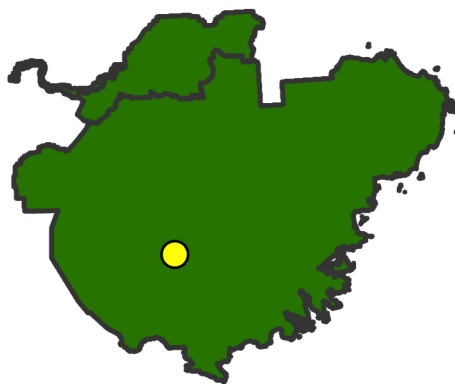
**Rating:** High  
**ProtectionLevel:** Full,  
**Resources of Concern:** Unknown  
**Occupied:** Yes  
**In Community:** No,  
**Revisit Interval:** 4 yrs  
**Map Label:** 2

**Primary Access:** Air  
**Ingress Egress:** N/A, access by foot, boat, or air only  
**Access Width:** N/A, access by foot, boat, or air only  
**Access Condition:** N/A, access by foot, boat, or air only  
**Bridge Condition:** N/A, access by foot, boat, or air only  
**Access and Turnarounds:** N/A, access by foot, boat, or air only  
**Facility Number or Sign:** None or not clearly visible  
**Fuel Type:** Grass/tundra, northern hardwood litter  
**Fuel Load:** Moderate  
**Defensible Space:** Less than 30 ft treated  
**Topography:** Slope 5% to 20%  
**Roof Material:** Noncombustible or not applicable  
**Siding Material:** Wood or open sided  
**Foundation:** Open or deck  
**Firewood:** None  
**Water Supply:** No reliable water source nearby  
**Propane:** Present and little to no fuels clearance  
**Overhead Hazards:** No overhead hazards  
**Comments:**

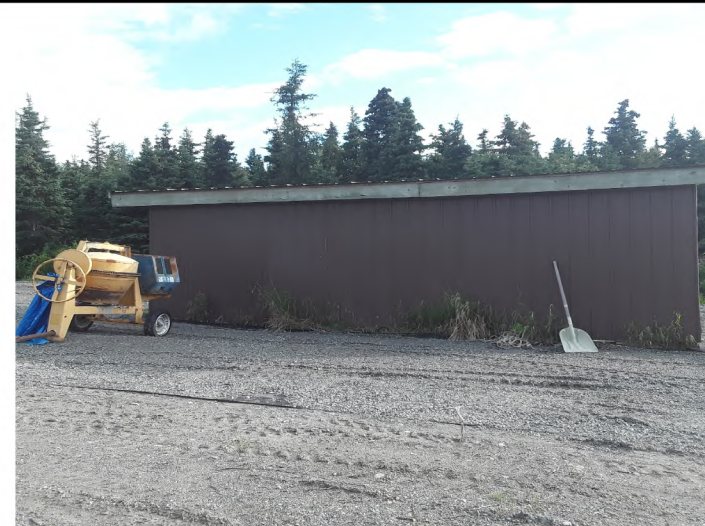
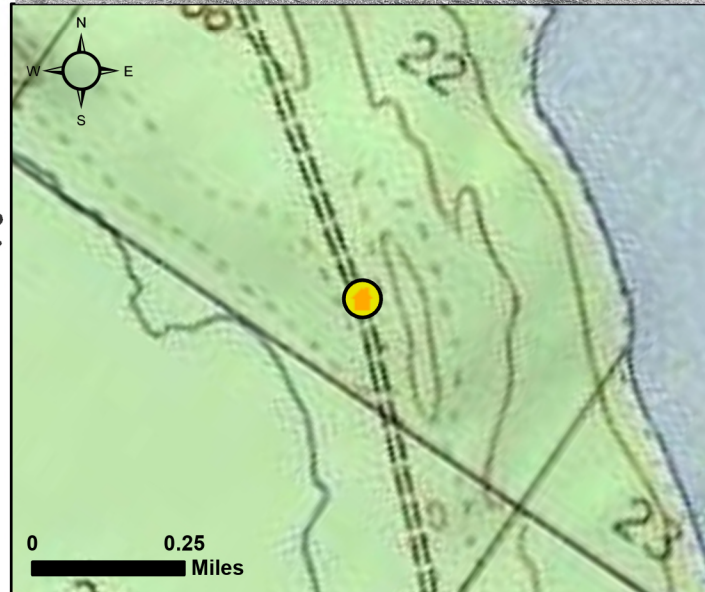
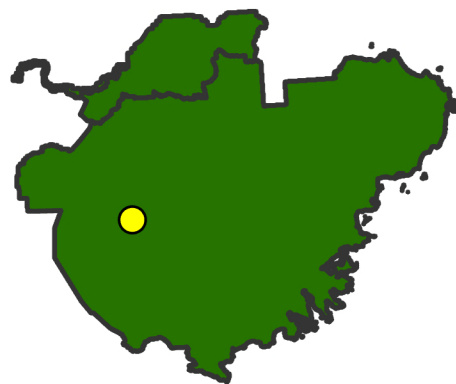
**Facility Name:** VR-Storage Building

**Rating:** Moderate

**Fuel Type:** Grass/tundra, northern hardwood litter

**Fuel Load:** Moderate

**Defensible Space:** 30 ft treated

**Siding Material:** Rock, concrete, metal

**Foundation:** Open or deck

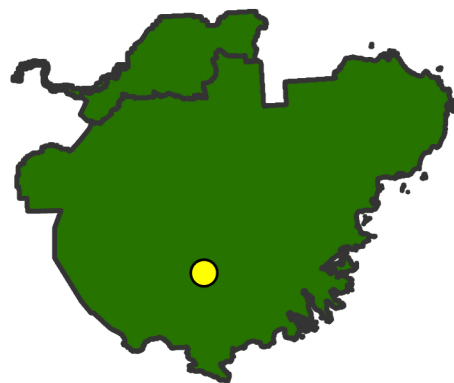
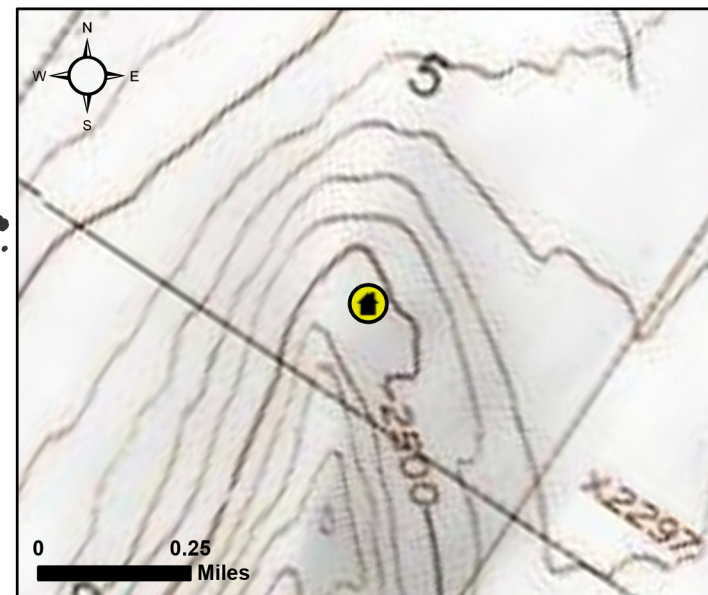
**Facility Name:** Baked Mountain Cabin

**Rating:** No Wildland Risk

**Fuel Type:** No wildland fuel

**Defensible Space:** Greater than 100ft treated

**Comments:** Photos from NP Gallery, verify that these are the correct structures

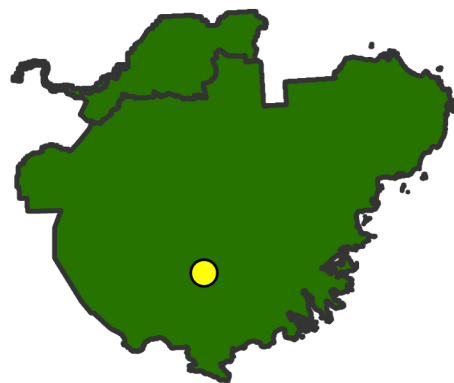
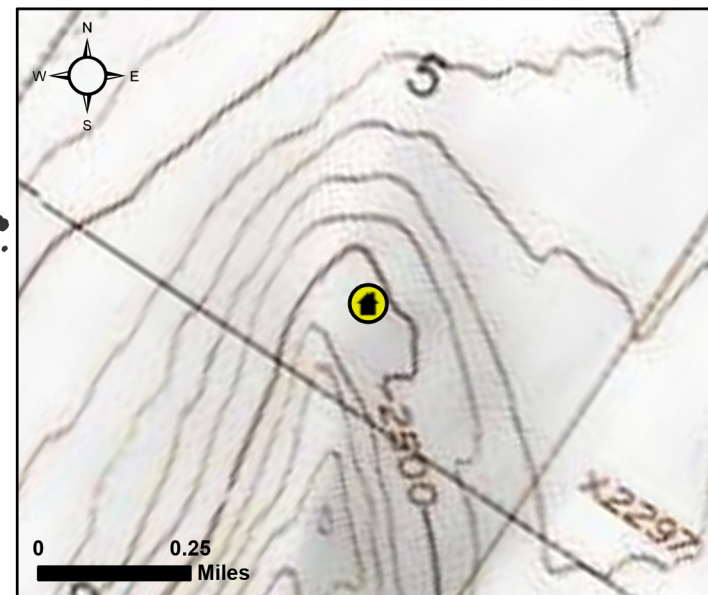
**Facility Name:** Baked Mountain Cabin #2

**Rating:** No Wildland Risk

**Fuel Type:** No wildland fuel

**Defensible Space:** Greater than 100ft treated

**Comments:** Photos from NP Gallery, verify that these are the correct structures

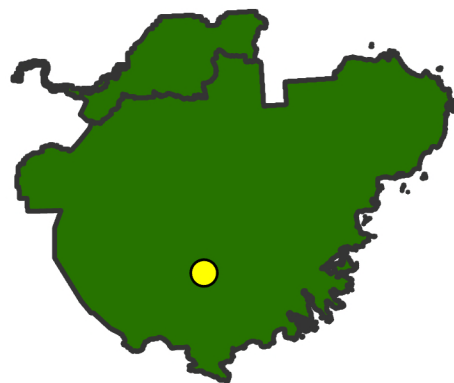
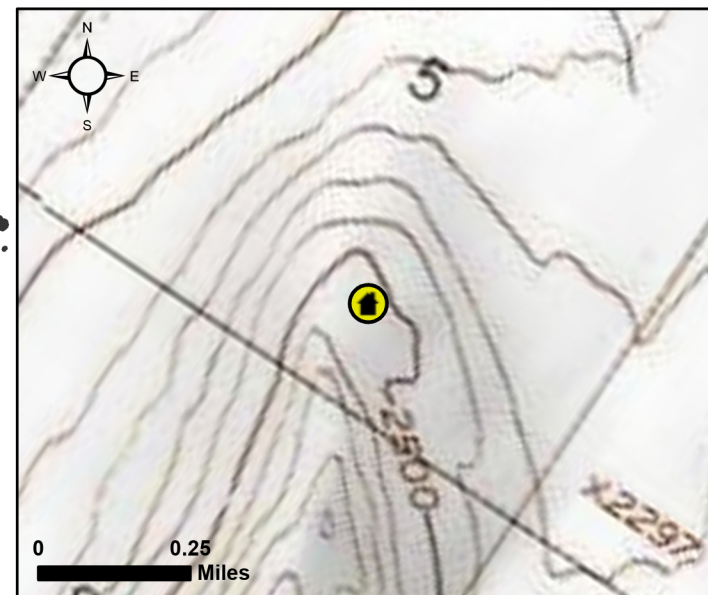
**Facility Name:** Baked Mountain Cabin Outhouse

**Rating:** No Wildland Risk

**Fuel Type:** No wildland fuel

**Defensible Space:** Greater than 100ft treated

**Comments:** Photos from NP Gallery, verify that these are the correct structures
