# Crater Lake North Entrance Road

Crater Lake National Park, Klamath County and  
Douglas County, Oregon

National Register of Historic Places Determination of Eligibility Assessment

Technical Report No. 215422C195382B  
Contract No. 140P2021D0001  
Task Order No. 140P8521F0120  
December 2022 Submittal #3

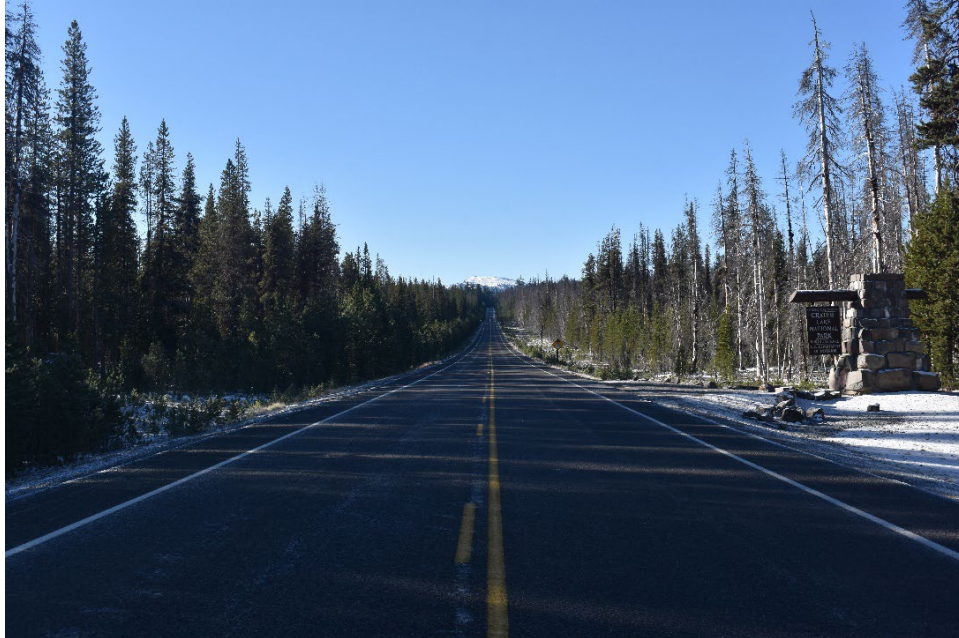
Photograph 1. Overview North Entrance Road at the North Entrance boundary, facing north, October 12, 2021. (OR\_Klamath County and Douglas County\_North Entrance Road\_001)

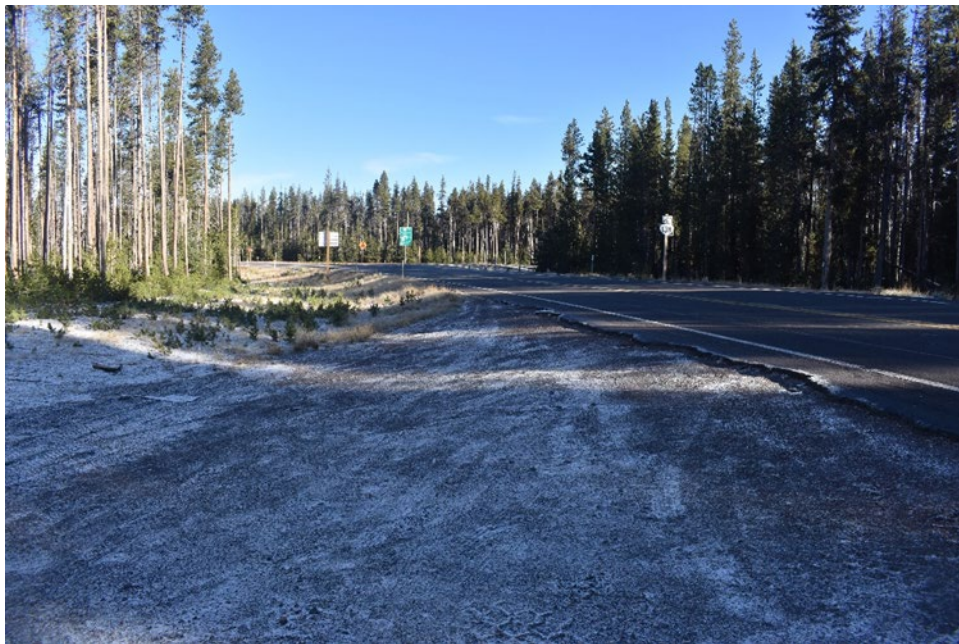
Photograph 2. Overview North Entrance Road facing Oregon Route 138 (OR-138), facing northeast, October 12, 2021. (OR\_Klamath County and Douglas County\_North Entrance Road\_002)

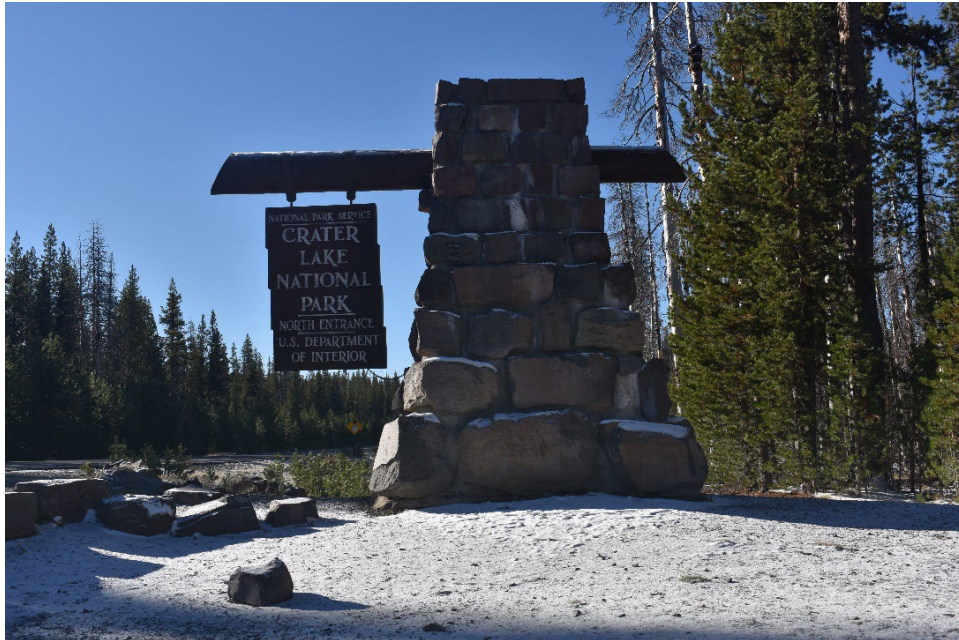
Photograph 3. North Entrance sign at the North Entrance boundary, facing south, October 12, 2021. (OR\_Klamath County and Douglas County\_North Entrance Road\_003)

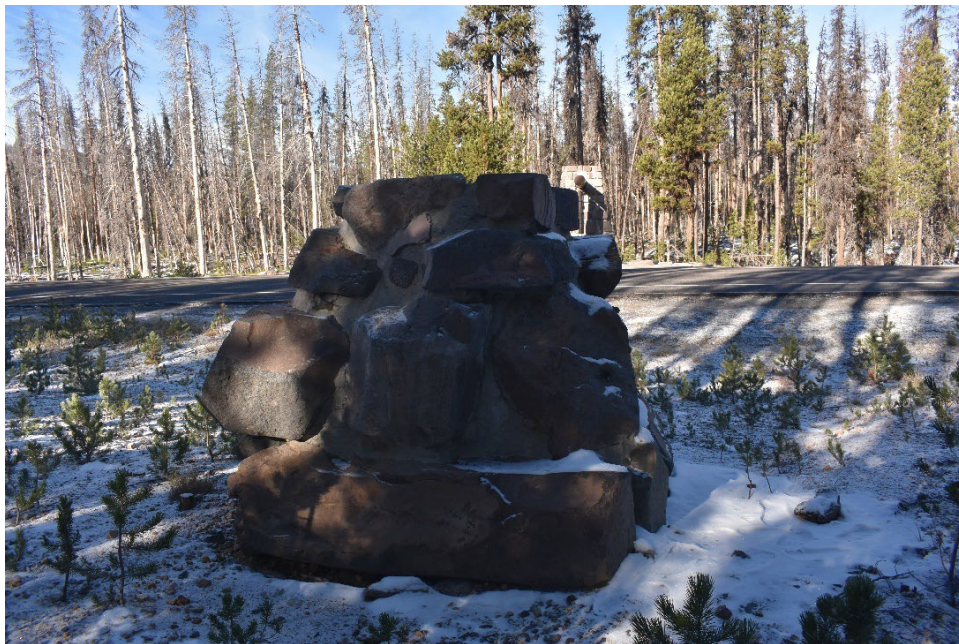
Photograph 4. North Entrance bollards, facing south, October 12, 2021. (OR\_Klamath County and Douglas County\_North Entrance Road\_004)

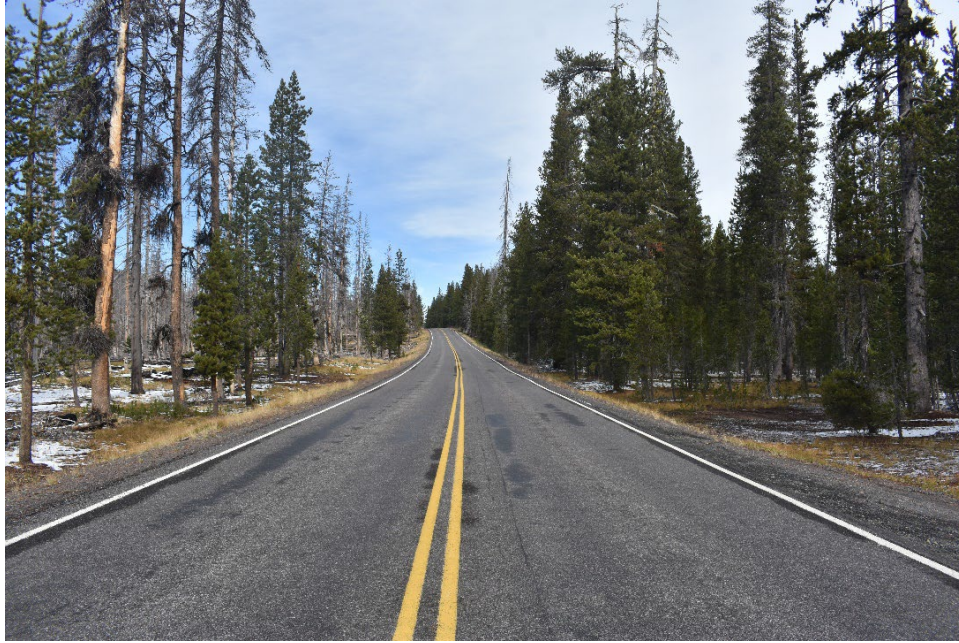
Photograph 5. Overview of vegetation and road, located north of the Pumice Desert, view facing north, October 12, 2021. (OR\_Klamath County and Douglas County\_North Entrance Road\_005).

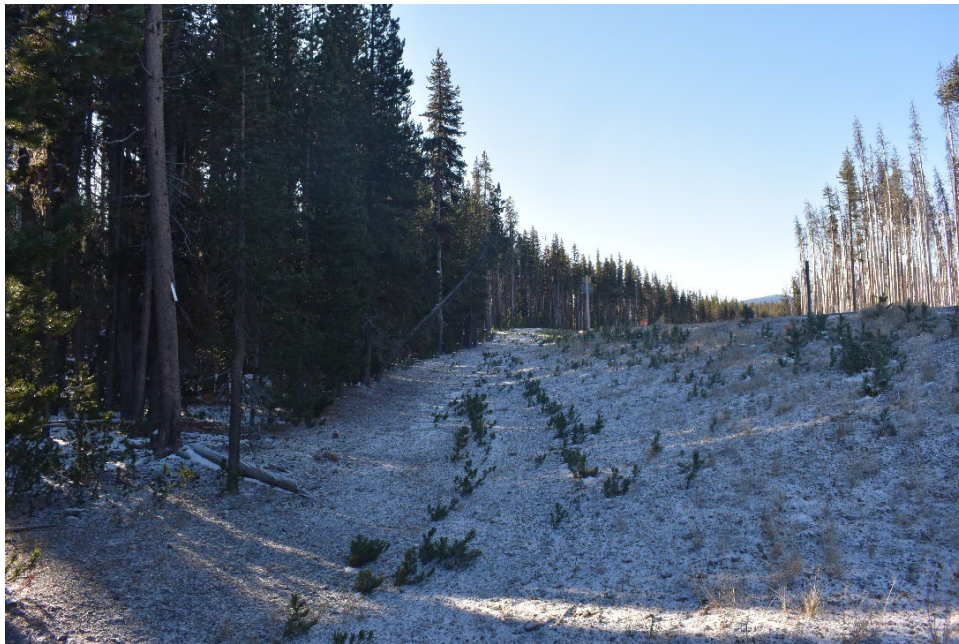
Photograph 6. Overview of vegetation and road, shoulder near the North Entrance, view facing south-southeast, October 12, 2021. (OR\_Klamath County and Douglas County\_North Entrance Road\_006).

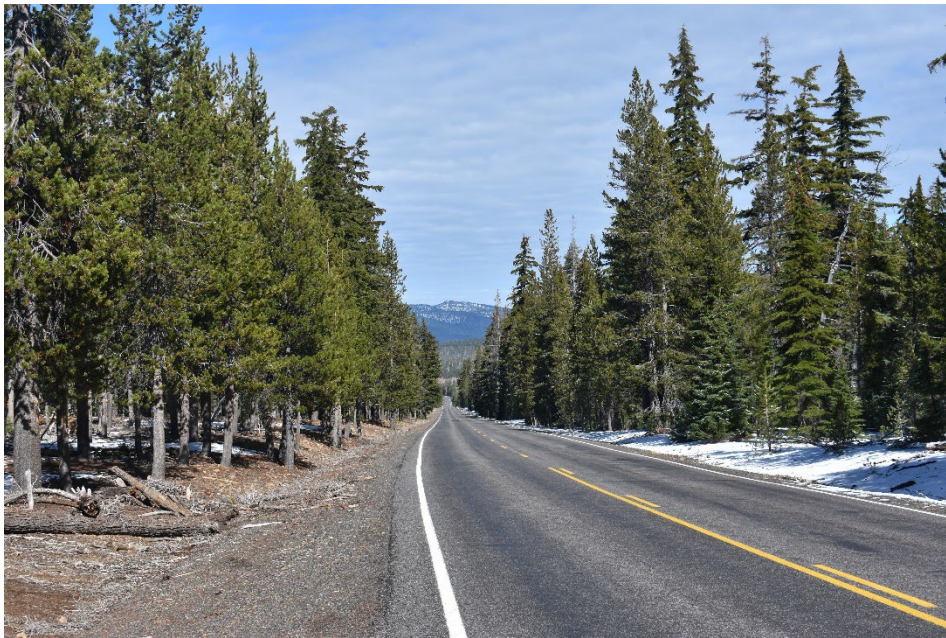
Photograph 7. Overview of road alignment, located north of the Pacific Crest Trail parking area, view facing north, October 12, 2021. (OR\_Klamath County and Douglas County\_North Entrance Road\_007)

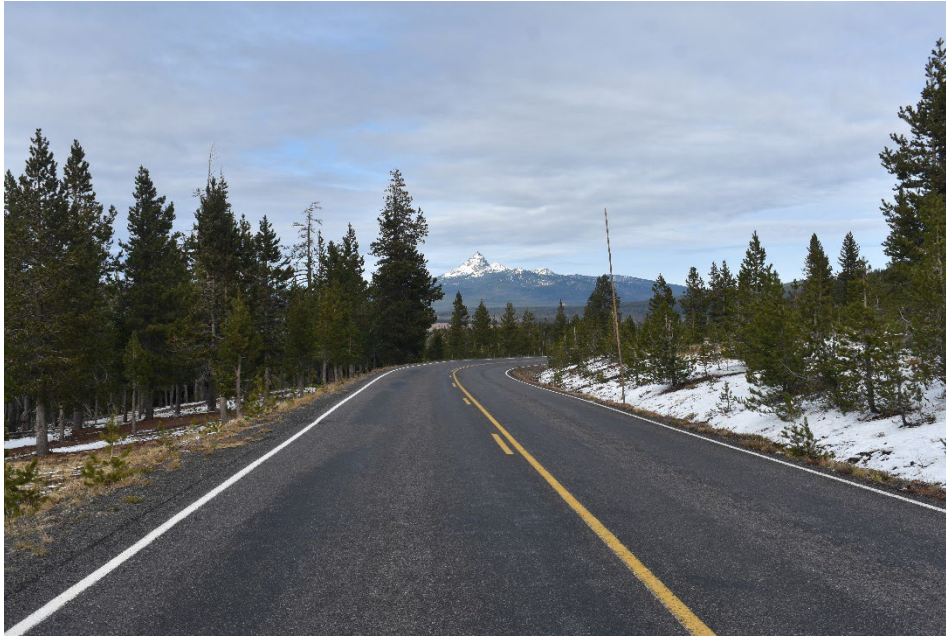
Photograph 8. Overview of curving road alignment located south of the Pacific Crest Trail parking area, view facing north, October 12, 2021. (OR\_Klamath County and Douglas County\_North Entrance Road\_008)

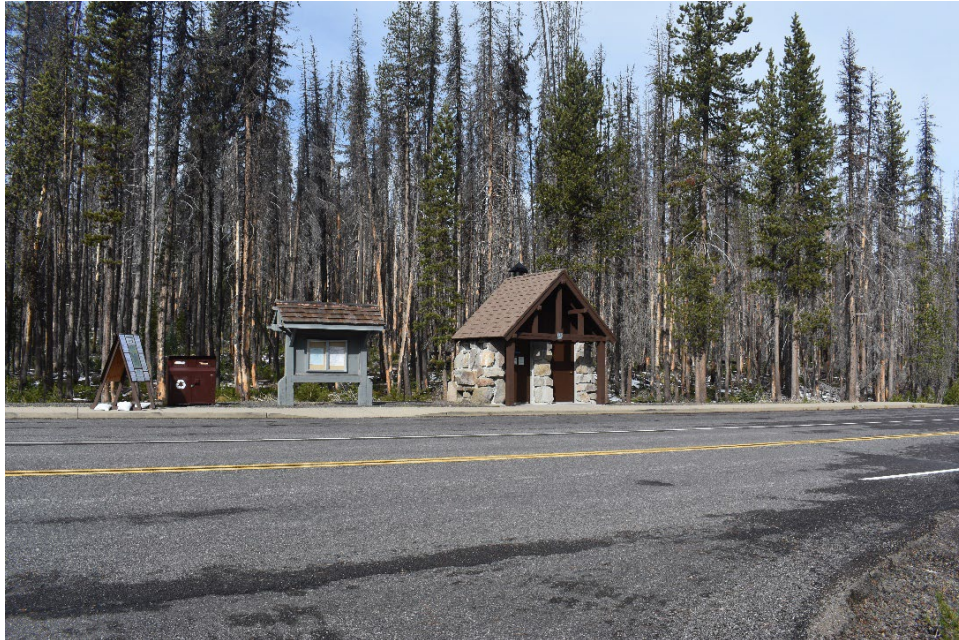
Photograph 9. Overview of the North Entrance Kiosk pullout, view facing northwest, October 12, 2021. (OR\_Klamath County and Douglas County\_North Entrance Road\_009)

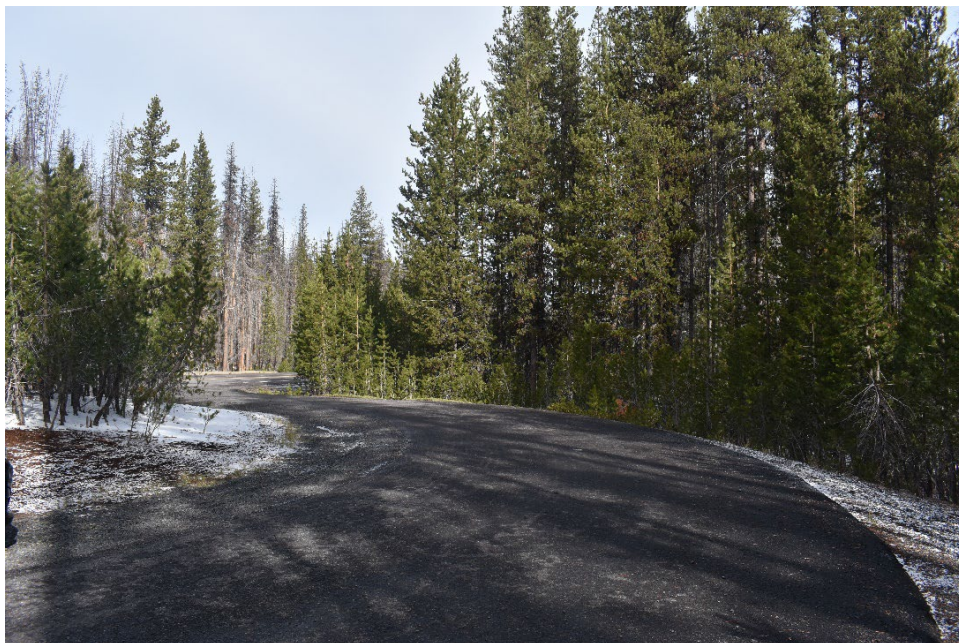
Photograph 10. Overview of the Old (pre-1980) North Entrance Turnaround pullout, view facing northwest, October 12, 2021. (OR\_Klamath County and Douglas County\_North Entrance Road\_010)

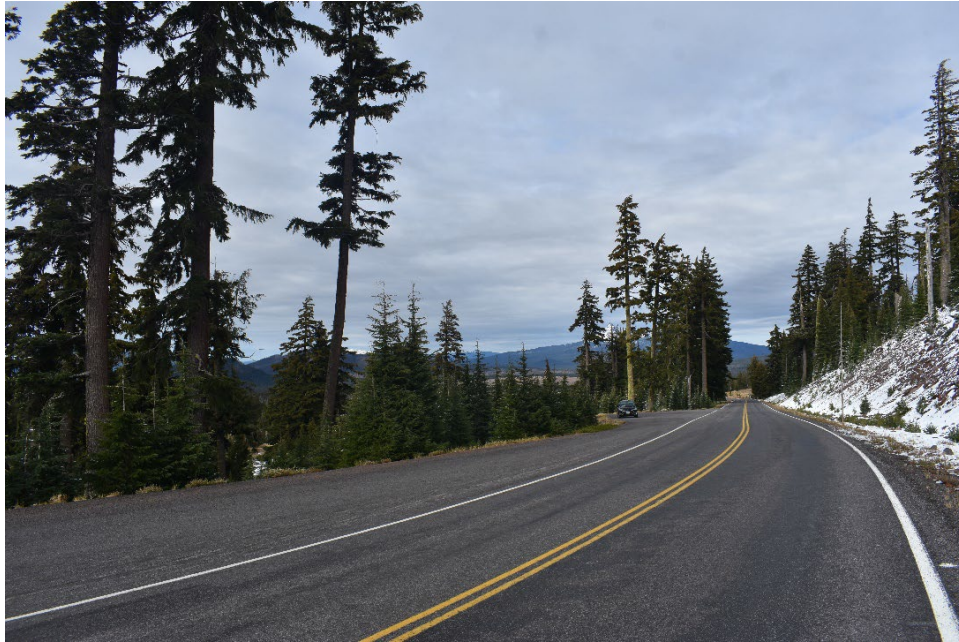
Photograph 11. Overview of the Blowdown Pullout, view facing north, October 12, 2021. (OR\_Klamath County and Douglas County\_North Entrance Road\_011)

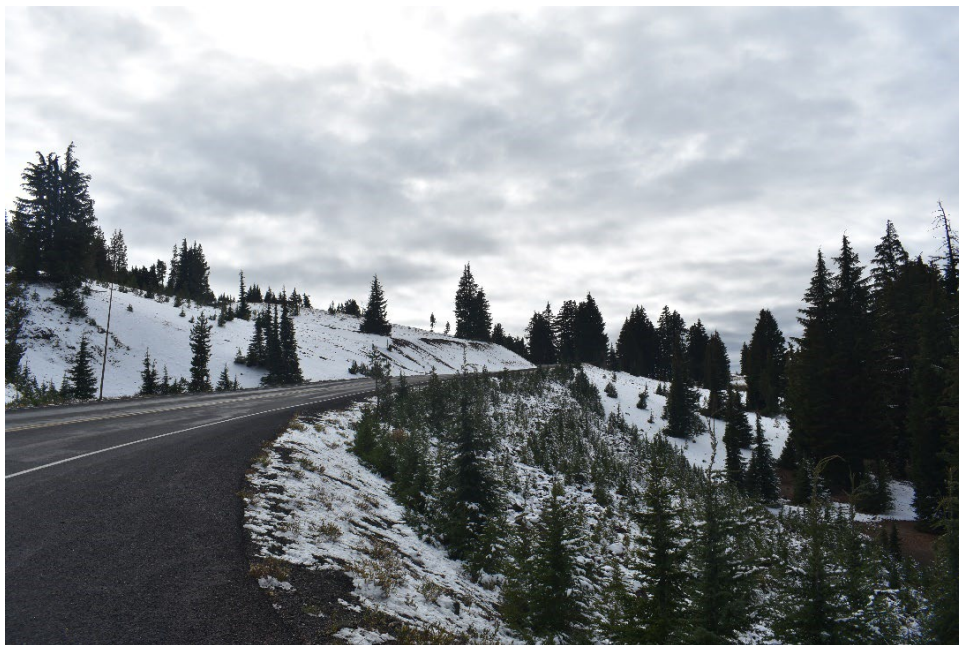
Photograph 12. Overview of the Blowdown Pullout, paved pullout, and road meet, view facing south, October 12, 2021. (OR\_Klamath County and Douglas County\_North Entrance Road\_012)

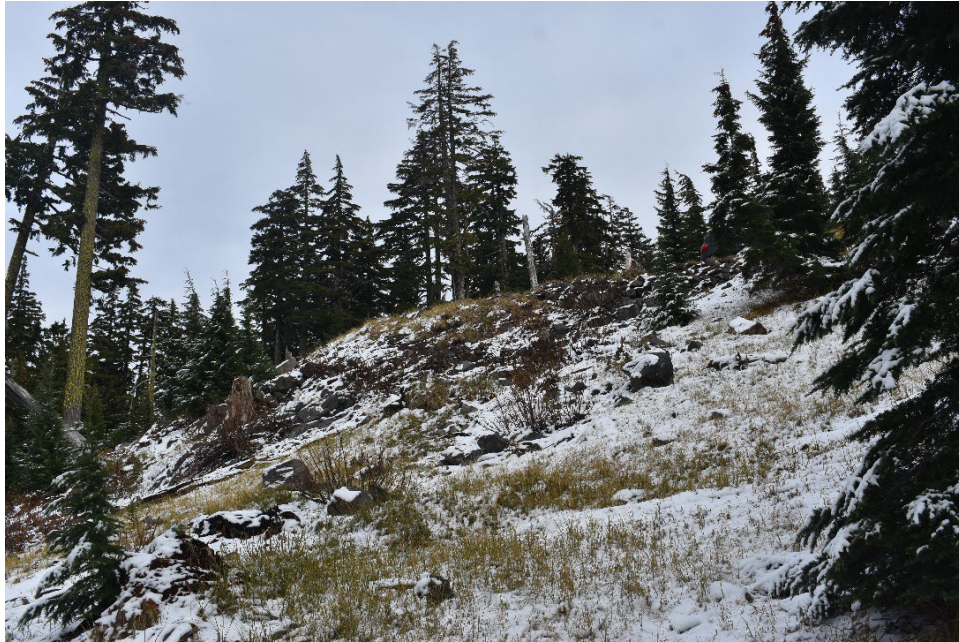
Photograph 13. Overview of the remnants of a retaining wall, approaching the North Junction beneath the Blowdown Pullout, view facing east, October 12, 2021. (OR\_Klamath County and Douglas County\_North Entrance Road\_013)

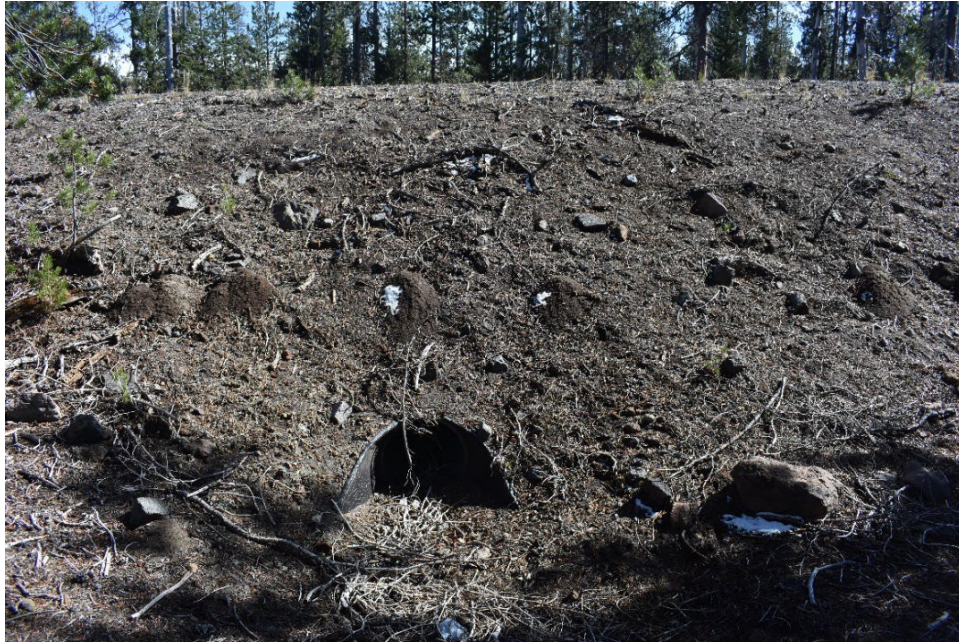
Designed drainage systems throughout CRLA and alongside the North Entrance Road consist of multiple cross drainage systems commonly constructed with a culvert and a masonry headwall to direct the flow of water from snow melt through the culvert. The culverts along the North Entrance Road consist of standard corrugated galvanized steel pipes, measuring approximately eighteen inches in diameter (Photograph 21). Approach roads generally lack headwalls, but often have extended ditches where pumice absorbs the water.<sup>27</sup> Maintenance such as cleaning out and minor repairs of inlets, culverts, and other drainage systems happens on a recurrent basis and at set intervals.<sup>28</sup> Culverts found along the North Entrance Road corridor are of post-Mission 66 construction.

Photograph 21. Culvert on the west side of the North Entrance Road, located south of the Pumice Desert Wayside Exhibit, October 12, 2021. (OR\_Klamath County and Douglas County\_North Entrance Road\_021)

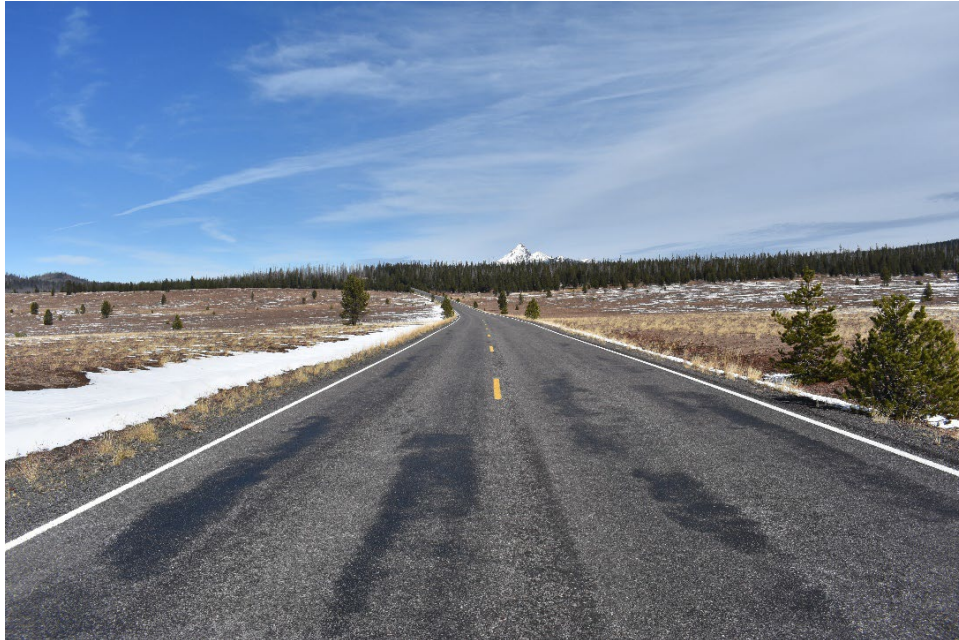
Photograph 22. View of road at the Pumice Desert, view facing north, October 12, 2021. (OR\_Klamath County and Douglas County\_North Entrance Road\_022)

The Pumice Desert is the after effect of the Mount Mazama eruption when ash and pumice flowed down the slopes of the mountain and deposited into the valley that is now flat land with porous deposits and little vegetation (Photographs 22-23). The Pumice Desert wayside exhibit was constructed in 1958 and is an interpretative turnout that currently has a paved asphalt parking loop lined with wooden guardrails and an empty masonry podium, overlooking the Pumice Desert (Photographs 24-27). The Pumice Desert Wayside Exhibit (FN 1) is the only associated feature along the North Entrance Road that has any integrity related to the Mission 66 period of significance. The wooden guardrails exhibit integrity related to Mission 66 considering the MPDF states that during Mission 66, “Other roads continued using log guardrails to maintain a rustic feeling along the corridors.” A stone masonry podium at the wayside exhibit lacks any indication that the feature is associated with Mission 66. Overall, the interpretative turnout lacks distinction related to the Mission 66 period of significance.

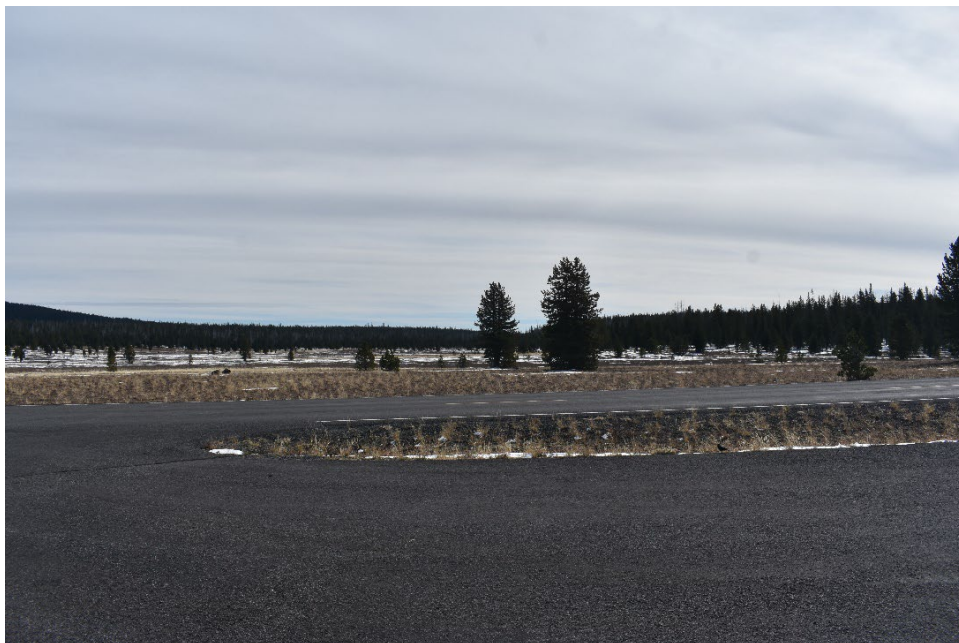
Photograph 23. View of road at the Pumice Desert Wayside Exhibit parking area, view facing east, October 12, 2021. (OR\_Klamath County and Douglas County\_North Entrance Road\_023)

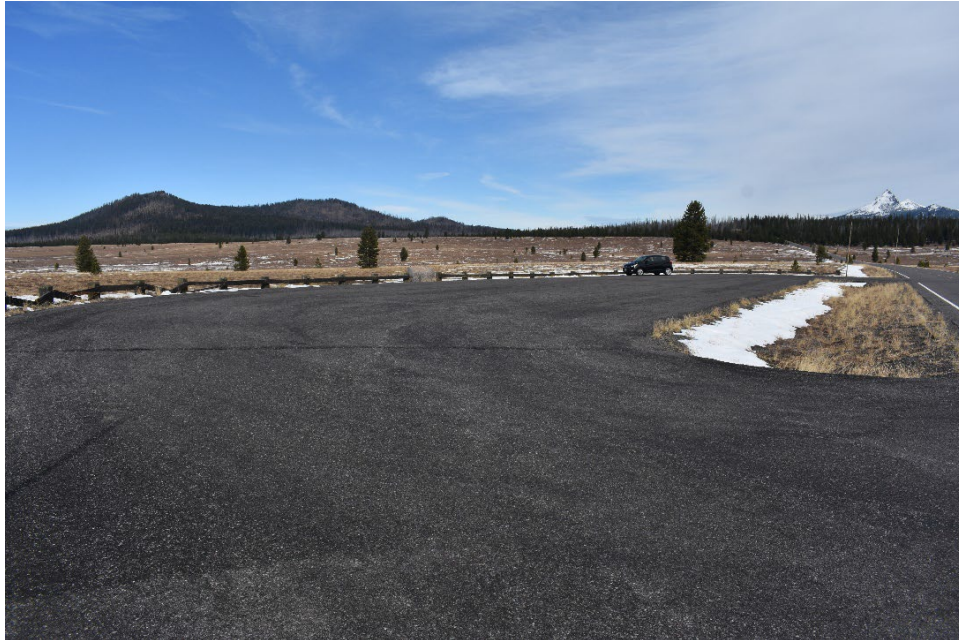
Photograph 24. Overview Pumice Desert Wayside Exhibit parking area, view facing northwest, October 12, 2021. (OR\_Klamath County and Douglas County\_North Entrance Road\_024)

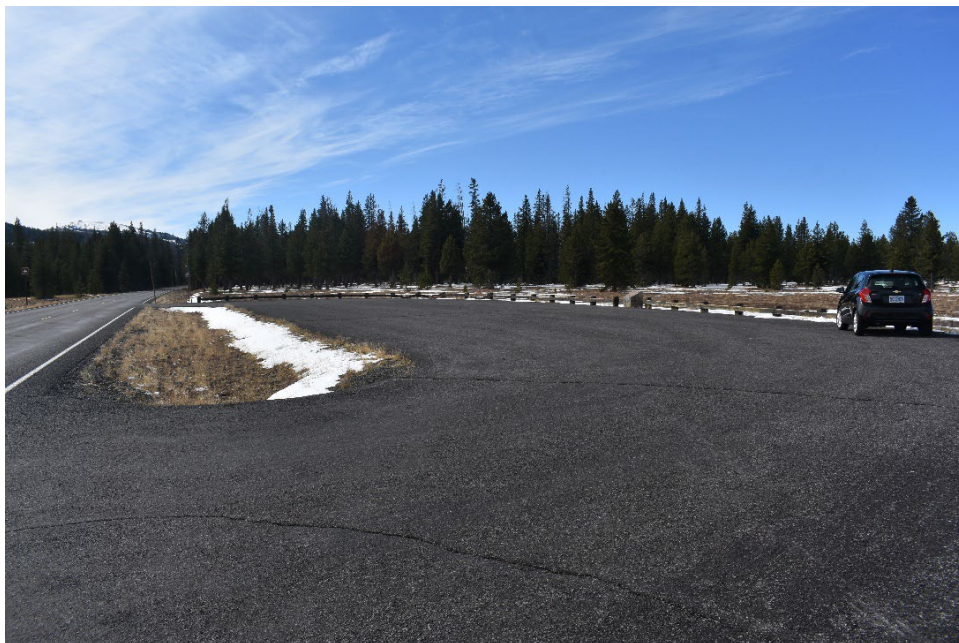
Photograph 25. Overview Pumice Desert Wayside Exhibit parking area, view facing southwest, October 12, 2021. (OR\_Klamath County and Douglas County\_North Entrance Road\_025)

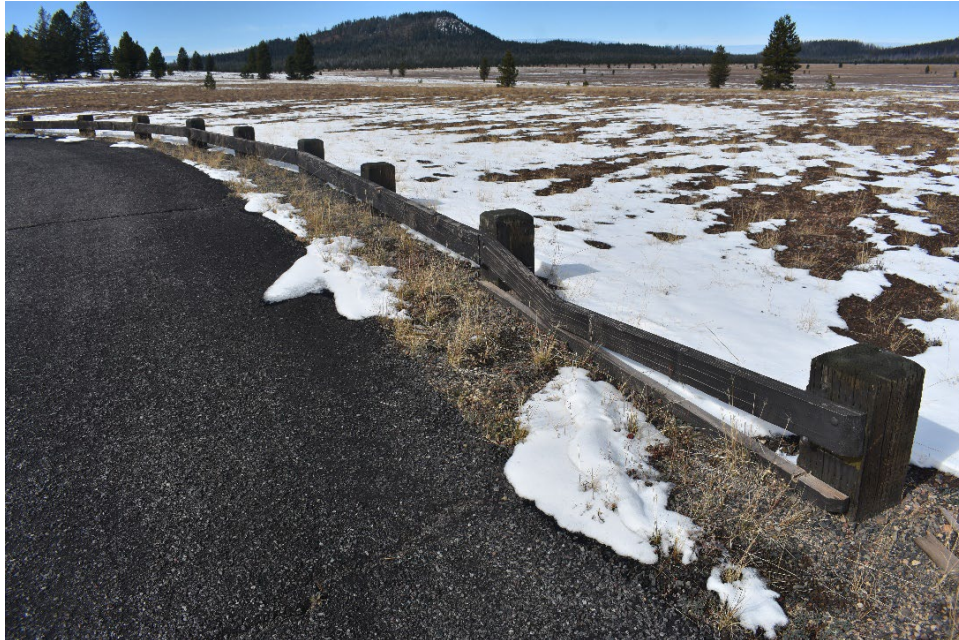
Photograph 26. Overview Pumice Desert Wayside Exhibit guardrail detail, view facing west, October 12, 2021. (OR\_Klamath County and Douglas County\_North Entrance Road\_026)

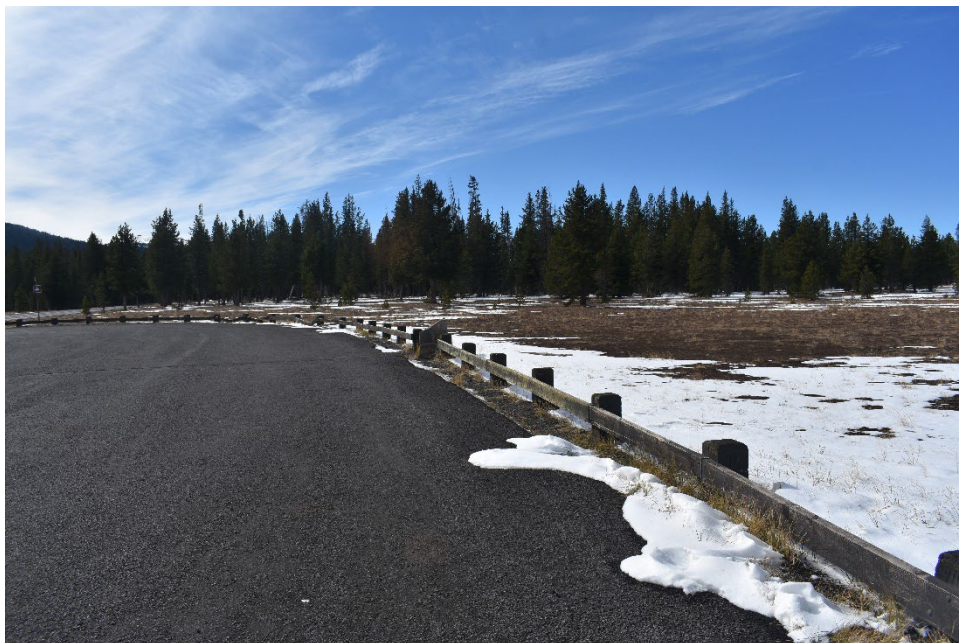
Photograph 27. Overview Pumice Desert Wayside Exhibit guardrail, view facing southwest, October 12, 2021. (OR\_Klamath County and Douglas County\_North Entrance Road\_027)
