# NPS Wildfire Risk Assessments Assessment Locations

## Cape Hatteras National Seashore

# Bodie Island 1

# NPS Wildand Fire Risk Assessment - Facility Assessment

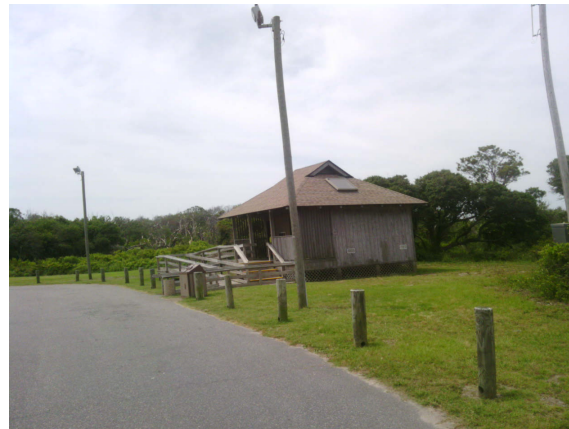
2016\_CAHA\_28884\_BI BD Whalebone Confort Station\_Front.jpg

Assessment Comments: From FMSS\_Export - FRPP\_PREDUSE: Bldg. Comfort Station (GSF)

Score: 41  
Rating: Low

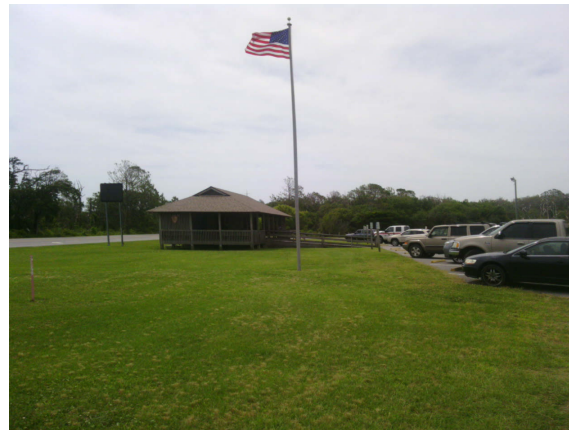
2016\_CAHA\_28883\_BI BD Whalebone Information Station\_Front.jpg

**Roof Material:** Fire resistant- tar,rubberized  
**Siding Material:** Wood or open sided  
**Foundation:** Open or deck  
**Fences/Decks:** Combustible, adjacent, clear of veg/debris

**Additional Obstacles:** None  
**Triage Category:**  
**Hazmat:**  
**Assessment Comments:** From FMSS\_Export - FRPP\_PREDUSE: Bldg. Visitor Cont Stat (GSF)

**Score: 34**  
**Rating: Low**

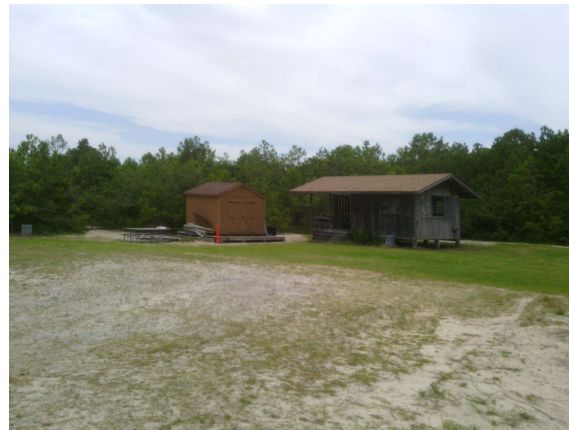
2016\_CAHA\_28962\_BI BD Range Observation Building\_Front.jpg

**Assessment Comments:** From FMSS\_Export - FRPP\_PREDUSE: Bldg. Shed/Outbuilding (GSF)

large communication tower nearby and access is behind a locked gate

**Score: 57**  
**Rating: Moderate**

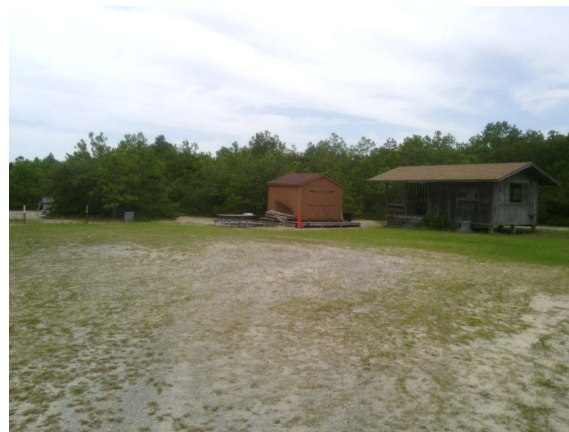
2016\_CAHA\_\_storage building\_Front.jpg

**Assessment Comments:** large communication tower nearby and access is behind a locked gate

**Score: 59**  
**Rating: Moderate**

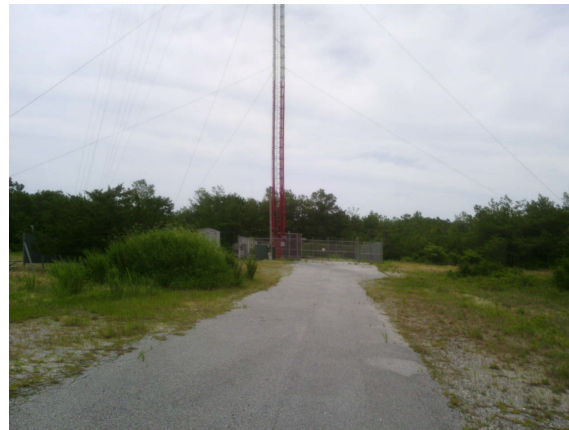
2016\_CAHA\_\_US Communication tower site\_Front.jpg

**Assessment Comments:** large communication tower nearby and access is behind a locked gate

**Score: 62**  
**Rating: Moderate**

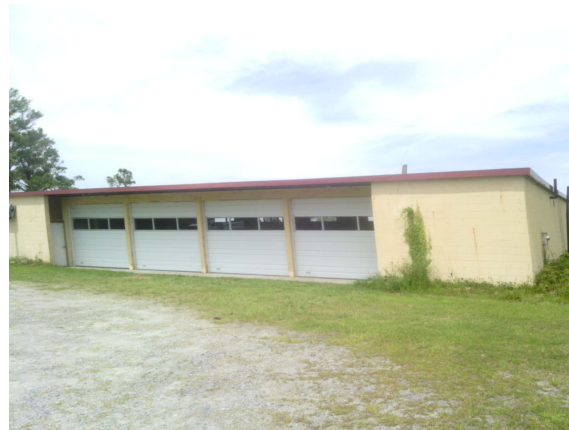
2016\_CAHA\_28929\_BI BD Boneyard Building\_Front.jpg

**Foundation:** Closed, < 6in masonry exposed

**Score: 36**  
**Rating: Low**

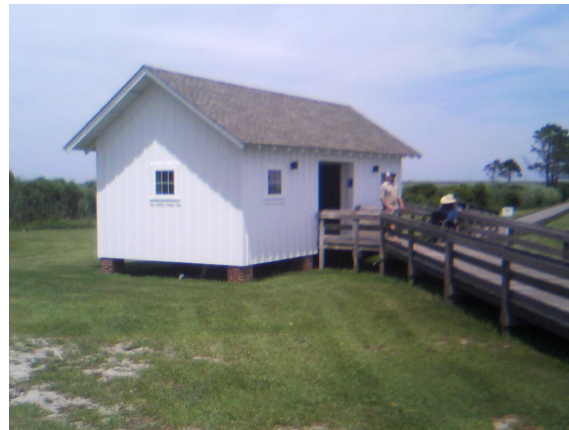
2016\_CAHA\_28928\_BI BD LH Comfort Station\_Front.jpg

**Assessment Comments:** From FMSS\_Export - FRPP\_PREDUSE: Bldg. Comfort Station (GSF)

**Score: 40**  
**Rating: Low**

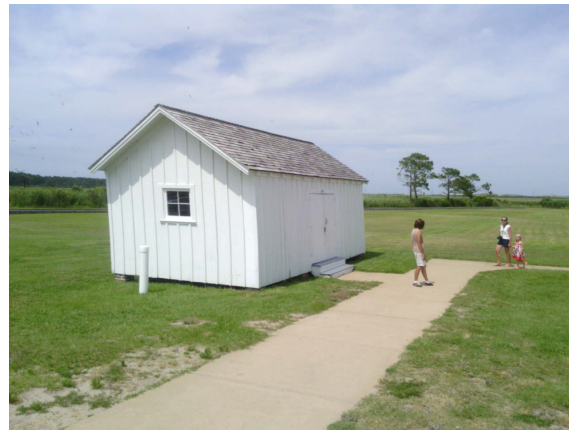
2016\_CAHA\_28926\_LCS 7249-BI HS LH Store House\_Front.jpg

**Assessment Comments:** From FMSS\_Export - FRPP\_PREDUSE: Bldg. Shed/Outbuilding (GSF)

**Score: 48**  
**Rating: Moderate**

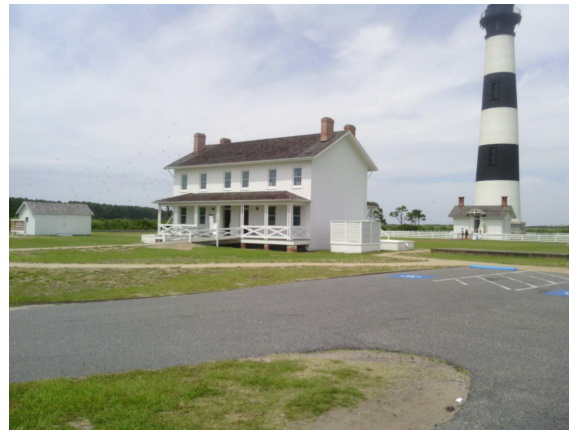
2016\_CAHA\_28924\_LCS 7244-BI HS Keepers Quarters (Visitor Center)\_Front.jpg

**Assessment Comments:** From FMSS\_Export - FRPP\_PREDUSE: Bldg. Office (GSF)

**Score: 40**  
**Rating: Low**

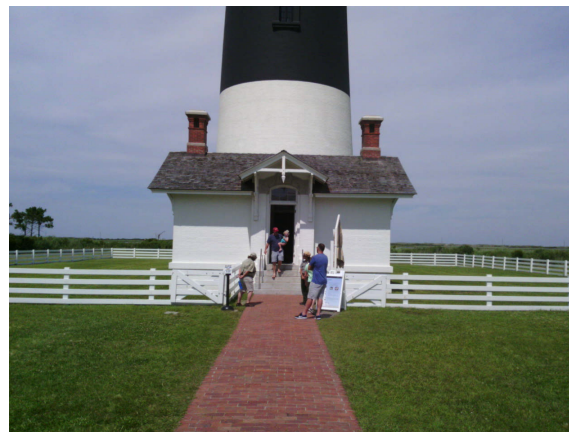
2016\_CAHA\_229422\_BI HS Bodie Island lighthouse oil house\_Front.jpg

Hazmat: attached to lighthouse

Score: 49  
Rating: Moderate  
Asset Priority Index (API): 100

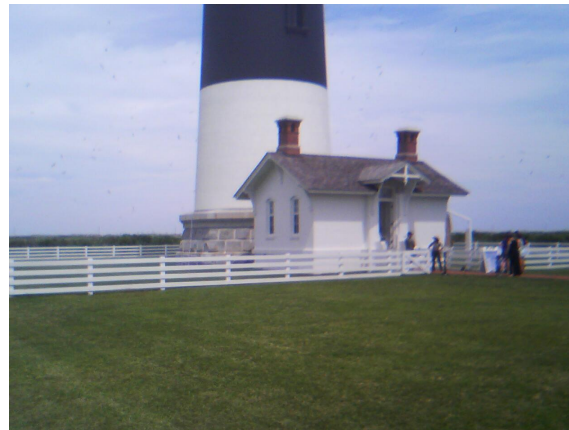
2016\_CAHA\_28923\_LCS 114-BI HS Bodie Island Lighthouse\_Front.jpg

**Assessment Comments:** From FMSS\_Export - FRPP\_PREDUSE: Bldg. Lighthouse (GSF)

**Score: 21**  
**Rating: Low**

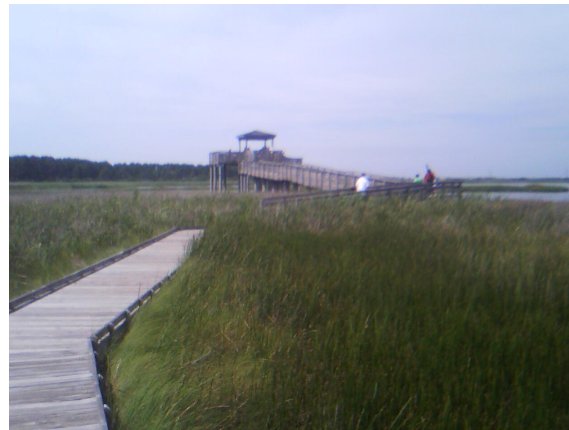
2016\_CAHA\_\_BI Pond Viewing Area\_Front.jpg

Assessment Comments: surrounded by water

Score: 58  
Rating: Moderate

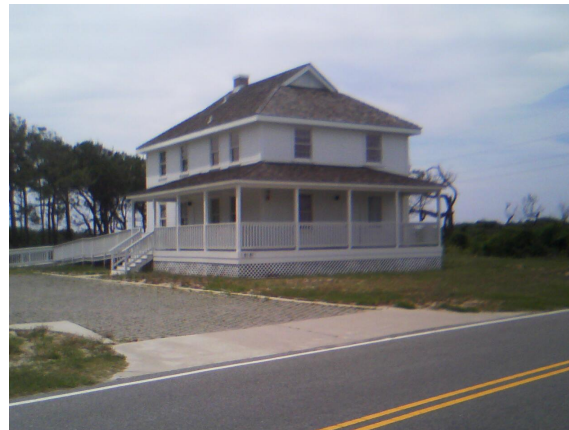
2016\_CAHA\_28912\_BI HS Coast Guard Station (Hilton)\_Front.jpg

Assessment Comments: From FMSS\_Export - FRPP\_PREDUSE: Bldg. Office (GSF)

Score: 68  
Rating: High

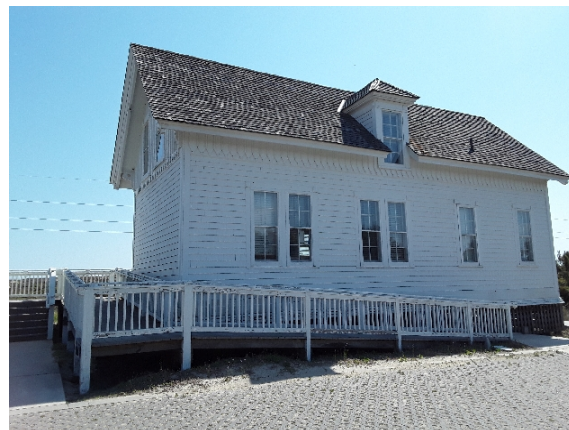
2021\_CAHA\_28913\_BI HS Ranger Station\_Front.jpg

**Assessment Comments:** From FMSS\_Export - FRPP\_PREDUSE: Bldg. Office (GSF)

**Score: 66**  
**Rating: High**

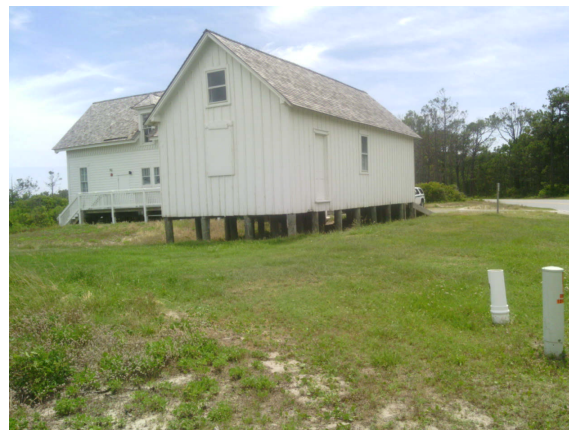
2016\_CAHA\_\_Garage of 28913\_Front.jpg

**Score: 62**  
**Rating: Moderate**

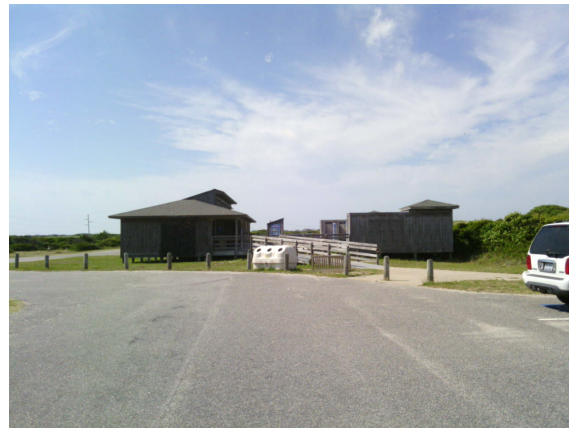
2016\_CAHA\_28918\_BI BD Coquina Comfort Station\_Front.jpg

**Assessment Comments:** From FMSS\_Export - FRPP\_PREDUSE: Bldg. Comfort Station (GSF)

**Score: 52**  
**Rating: Moderate**

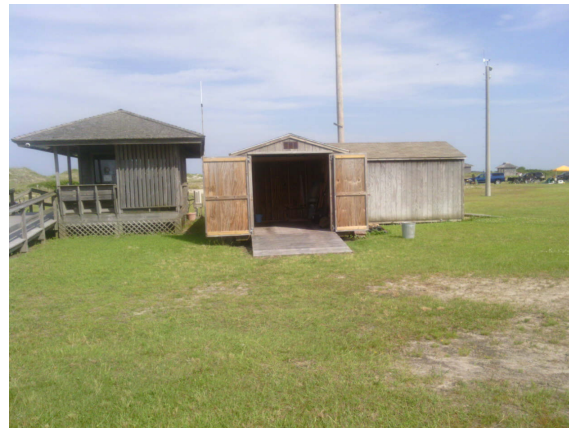
2016\_CAHA\_Electric Vehicle Storage at Oregon Inlet Campground\_Front.jpg

**Assessment Comments:** From FMSS\_Export - FRPP\_PREDUSE:

**Score: 62**  
**Rating: Moderate**

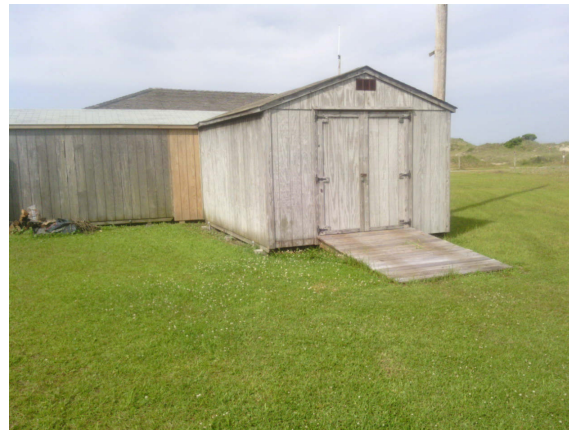
2016\_CAHA\_\_storage building\_Front.jpg

**Siding Material:** Wood or open sided  
**Foundation:** Open or deck  
**Fences/Decks:** None or noncombustible  
**Firewood:** Adjacent to/under deck of facility

**Propane Tanks:** None  
**Water Supply:** Pressurized hydrant(s) or fixed sprinkler system  
**Overhead Hazards:** No overhead hazards  
**Safety Zones:** Potential safety zone(s) in area

**Score: 40**  
**Rating: Low**

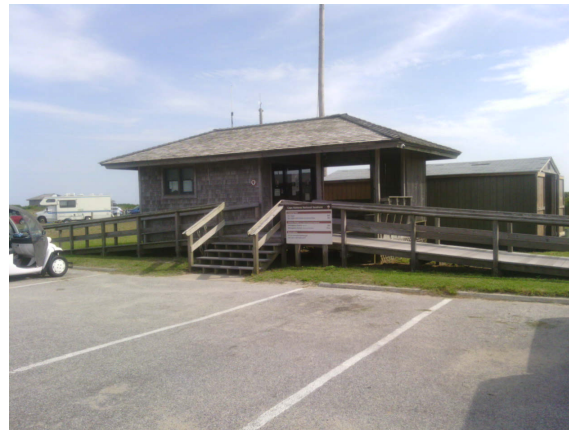
2016\_CAHA\_28935\_BI BD Oregon Inlet CG Kiosk\_Front.jpg

**Assessment Comments:** From FMSS\_Export - FRPP\_PREDUSE: Bldg. Entrance Station (GSF)

**Score: 51**  
**Rating: Moderate**

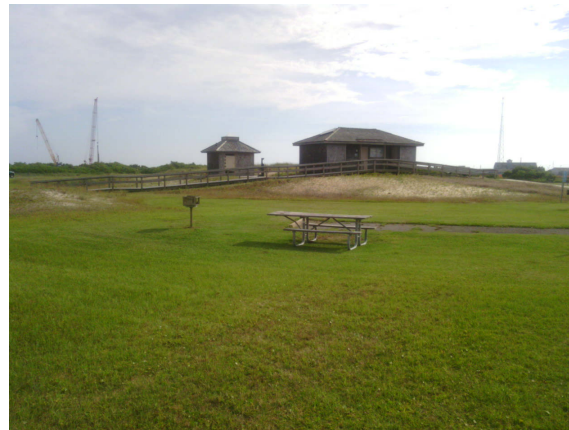
2016\_CAHA\_28944\_BI BD Oregon Inlet CG Loop C Comfort Station\_Front.jpg

**Score: 51**  
**Rating: Moderate**

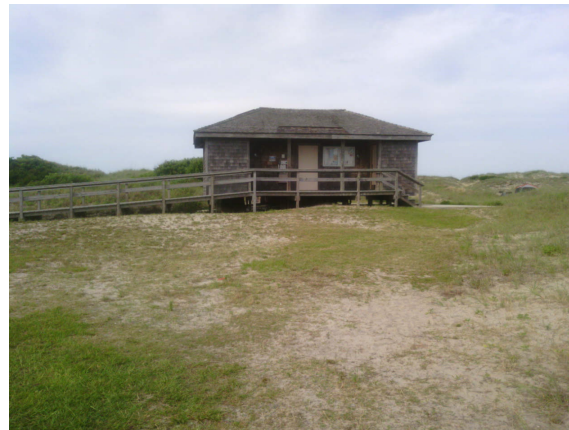
2016\_CAHA\_28940\_BI BD Oregon Inlet CG Loop A Comfort Station\_Front.jpg

**Assessment Comments:** From FMSS\_Export - FRPP\_PREDUSE: Bldg. Comfort Station (GSF)

**Score: 58**  
**Rating: Moderate**

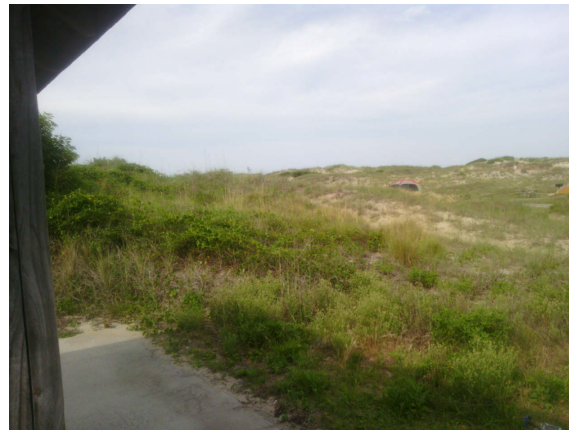
2016\_CAHA\_28939\_BI BD Oregon Inlet CG Loop A Shower Building\_D.jpg

**Assessment Comments:** From FMSS\_Export - FRPP\_PREDUSE: Bldg. Comfort Station (GSF)

**Score: 59**  
**Rating: Moderate**

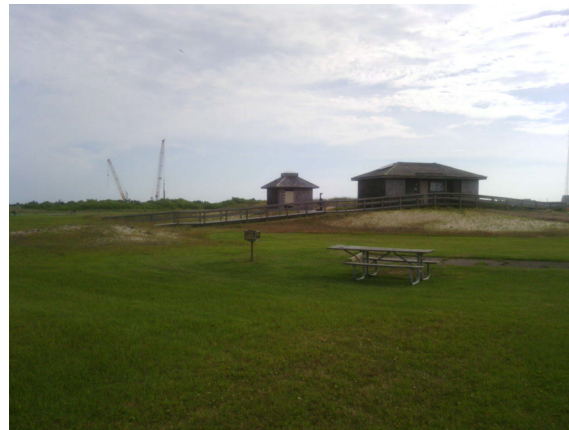
2016\_CAHA\_28943\_BI BD Oregon Inlet CG Loop C Shower Building\_Front.jpg

**Assessment Comments:** From FMSS\_Export - FRPP\_PREDUSE: Bldg. Comfort Station (GSF)

**Score: 52**  
**Rating: Moderate**

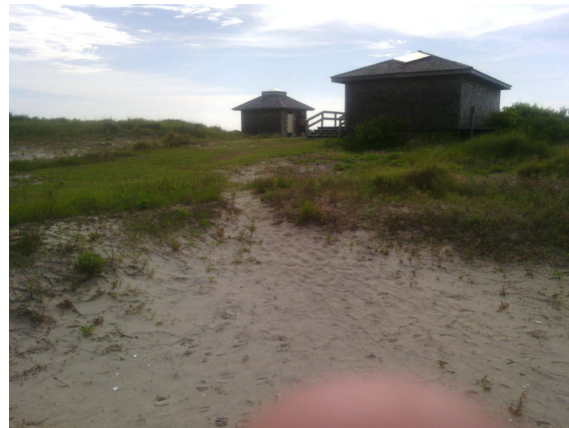
2016\_CAHA\_28941\_BI BD Oregon Inlet CG Loop Shower Building\_Front.jpg

**Score: 52**  
**Rating: Moderate**

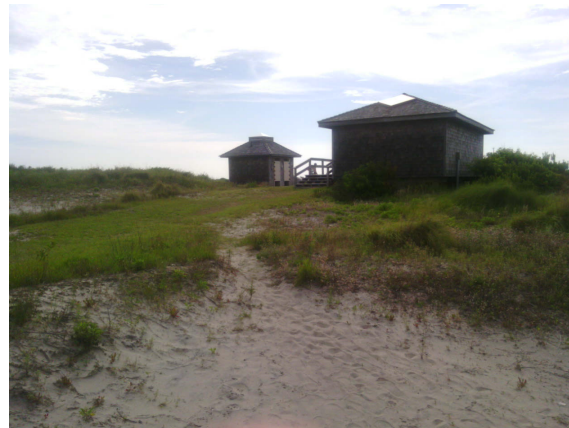
2016\_CAHA\_28942\_BI BD Oregon Inlet CG Loop B Comfort Station\_Front.jpg

**Assessment Comments:** From FMSS\_Export - FRPP\_PREDUSE: Bldg. Comfort Station (GSF)

**Score: 58**  
**Rating: Moderate**

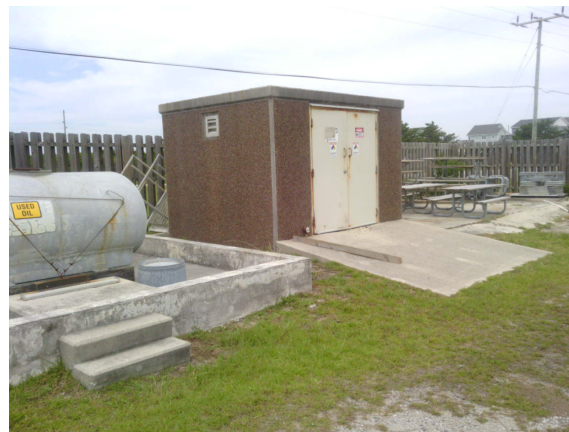
2016\_CAHA\_28909\_BI BD Haz-Mat Building\_Front.jpg

**Score: 24**  
**Rating: Low**

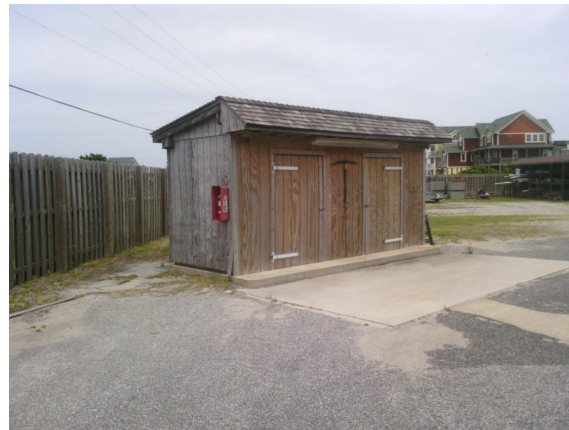
2016\_CAHA\_28893\_BI BD Gas Shed\_Front.jpg

**Safety Zones:** Potential safety zone(s) in area  
**Additional Obstacles:** Hazmat, UXO,etc. , PLEASE COMMENT  
**Triage Category:**  
**Hazmat:** fuel oil tanks next to

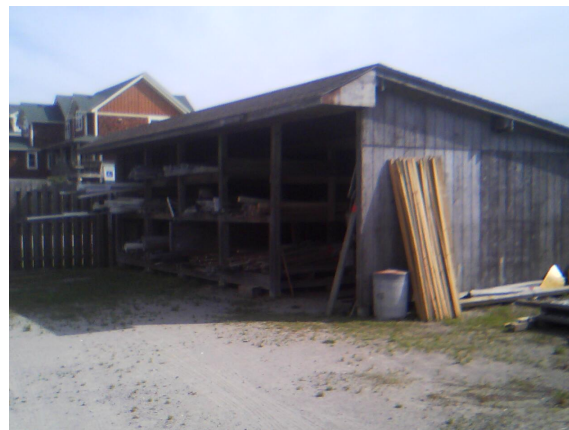
2016\_CAHA\_28890\_BI BD Lumber Shed\_Front.jpg

Hazmat: Fuel oil tanks.

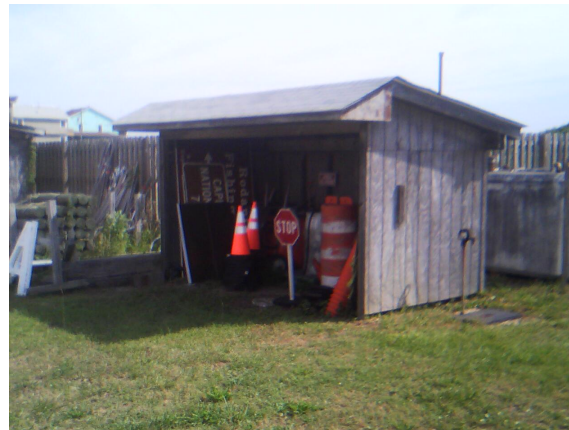
2016\_CAHA\_28891\_BI BD Traffic Cone Shed\_Front.jpg

Fuel oil tank behind.

Score: 38  
Rating: Low

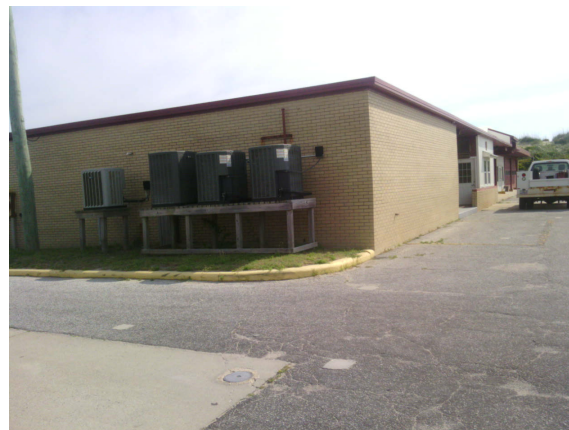
2016\_CAHA\_28888\_BI BD Maintenance Shop\_Front.jpg

adjacent to urban area of Nags Head

**Score: 25**  
**Rating: Low**

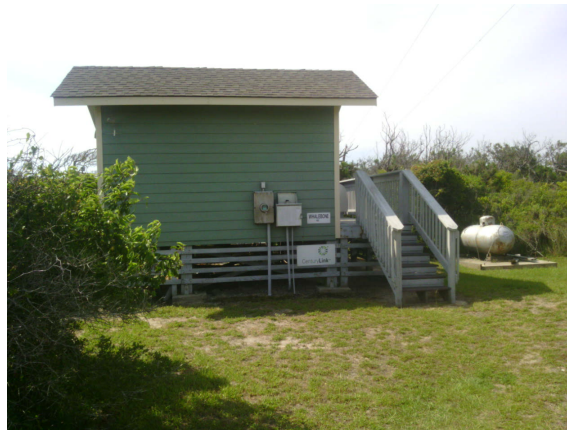
2016\_CAHA\_Utility Shed near Bodie Island Mtce Area\_Front.jpg

**Siding Material:** Wood or open sided  
**Foundation:** Open or deck  
**Fences/Decks:** Combustible, adjacent, clear of veg/debris  
**Firewood:** None

**Propane Tanks:** Present and fuels clearance  
**Water Supply:** Pressurized hydrant(s) or fixed sprinkler system  
**Overhead Hazards:** Overhead hazards will limit aircraft

**Score: 72**  
**Rating: High**

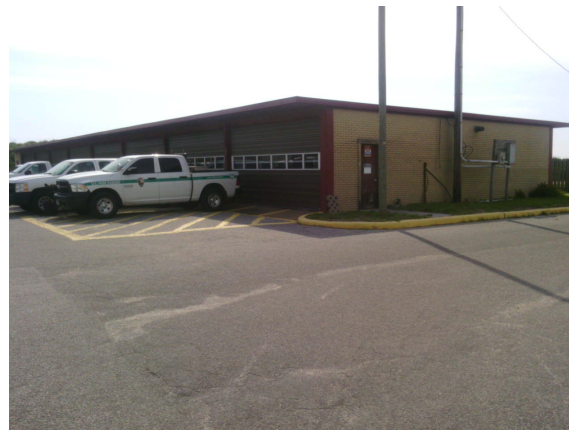
2016\_CAHA\_28887\_BI BD Carpenter Shop\_Front.jpg

**Hazmat:** diesel tanks nearby

**Score: 25**  
**Rating: Low**

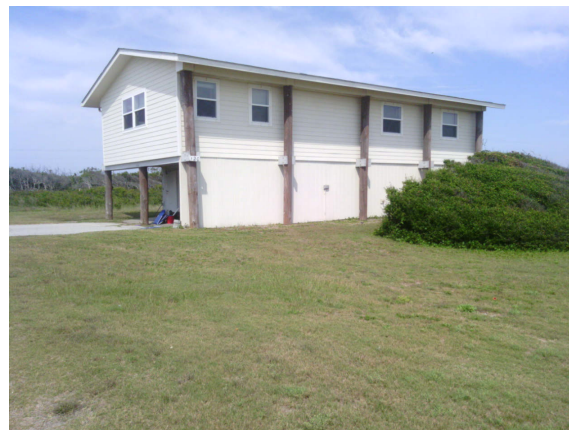
2016\_CAHA\_28903\_BI QT Q120\_Front.jpg

**Assessment Comments:** From FMSS\_Export - FRPP\_PREDUSE: Bldg. Housing, Support (GSF)

**Score: 55**  
**Rating: Moderate**

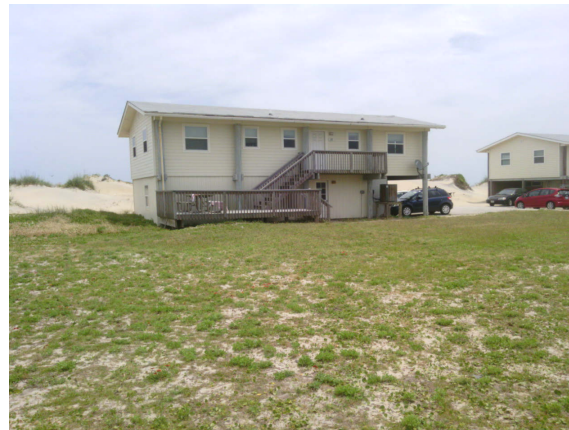
2016\_CAHA\_28898\_BI QT Q117\_Front.jpg

**Assessment Comments:** From FMSS\_Export - FRPP\_PREDUSE: Bldg. Housing, Support (GSF)

**Score: 28**  
**Rating: Low**

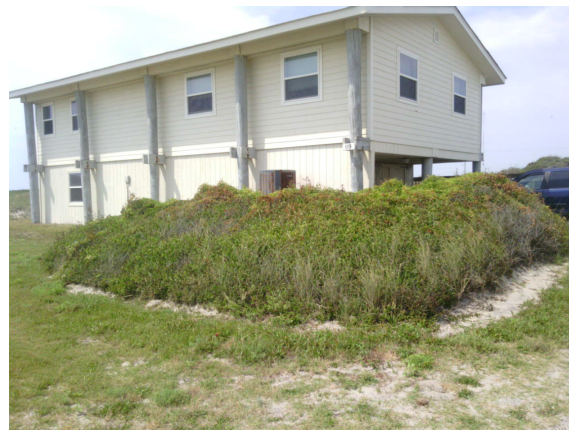
2016\_CAHA\_28901\_BI QT Q119\_Front.jpg

**Assessment Comments:** From FMSS\_Export - FRPP\_PREDUSE: Bldg. Housing, Support (GSF)

**Score: 49**  
**Rating: Moderate**

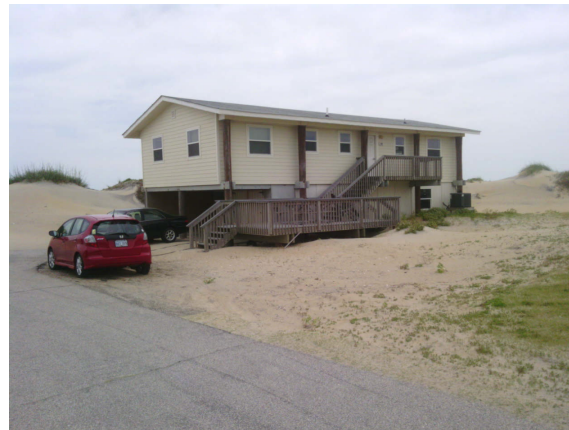
2016\_CAHA\_28900\_BI QT Q118\_Front.jpg

**Score: 26**  
**Rating: Low**

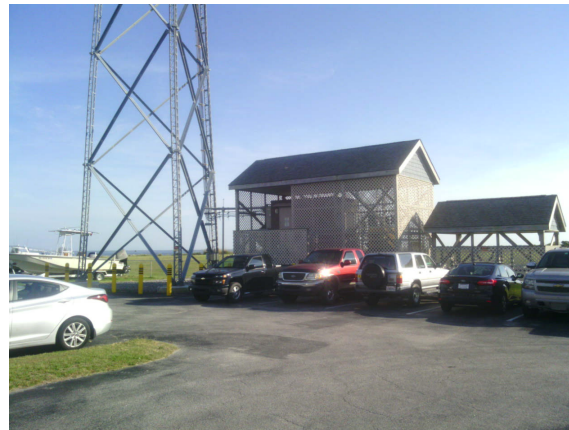
2016\_CAHA\_\_Oregon Inlet Radio Tower\_Front.jpg

**Safety Zones:** Potential safety zone(s) in area  
**Additional Obstacles:** None  
**Triage Category:**  
**Hazmat:** Propane tank.  
**Assessment Comments:**

**Score: 37**  
**Rating: Low**

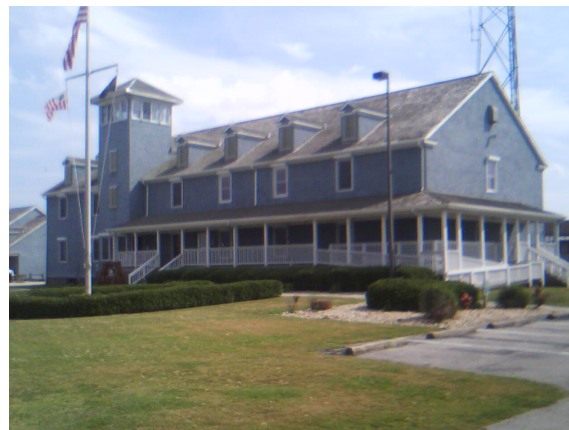
2016\_CAHA\_\_Oregon Inlet Coast Guard - Admin\_Front.jpg

**Score: 56**  
**Rating: Moderate**

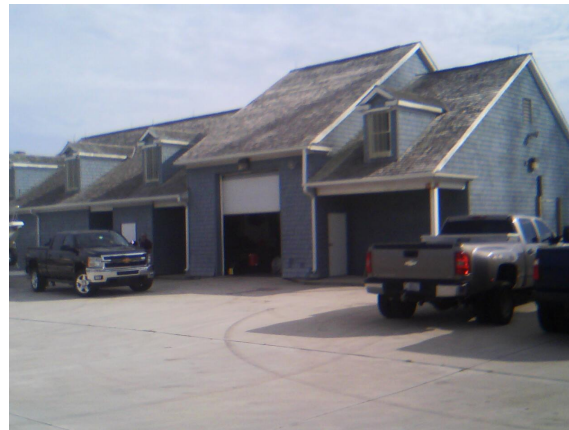
2016\_CAHA\_Oregon Inlet Coast Guard - Boathouse\_Front.jpg

**Hazmat:** Fuel tanks near structure.

**Score: 54**  
**Rating: Moderate**

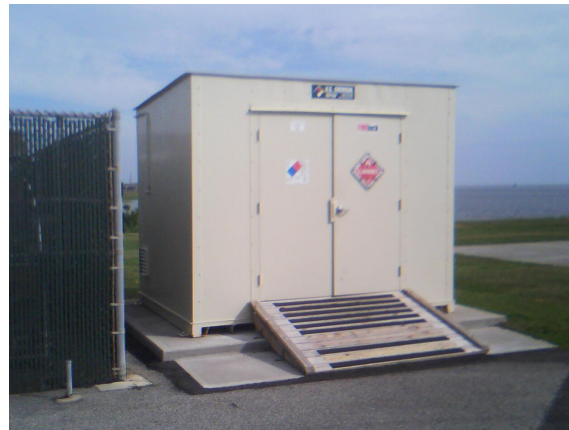
2016\_CAHA\_HAFrontMAT Storage\_Front.jpg

**Safety Zones:** Potential safety zone(s) in area  
**Additional Obstacles:** Hazmat, UXO,etc. , PLEASE COMMENT  
**Triage Category:**  
**Hazmat:** HAZMAT.

**Score: 16**  
**Rating: Low**

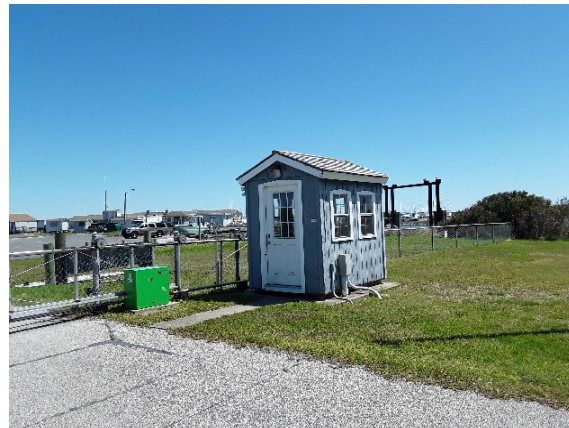
2021\_CAHA\_not found\_Oregon Inlet Coast Guard - Gatehouse\_Front.jpg

**Score: 56**  
**Rating: Moderate**

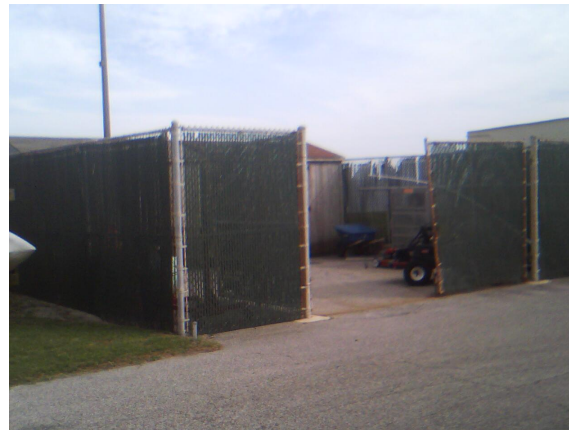
2016\_CAHA\_\_Tool Shed\_Front.jpg

**Hazmat:** Propane tanks and fuel tanks adjacent.

**Score: 31**  
**Rating: Low**

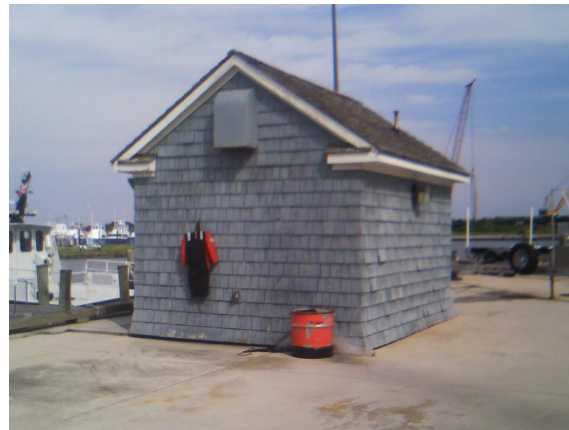
2016\_CAHA\_Oregon Inlet Coast Guard - Dock Shed\_Front.jpg

**Hazmat:** Fuel tank nearby.

**Score: 55**  
**Rating: Moderate**

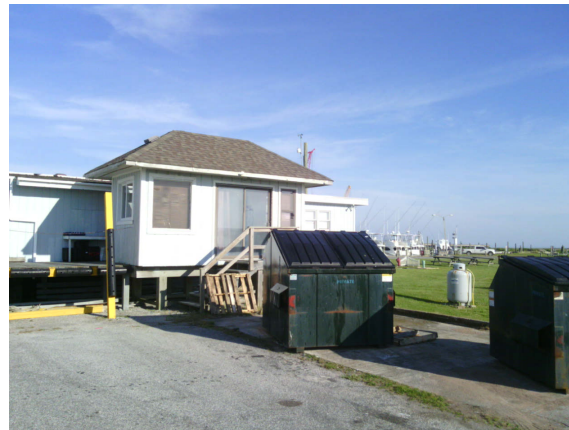
2016\_CAHA\_Fishing Center Storage - soundside booth\_Front.jpg

**Safety Zones:** Potential safety zone(s) in area  
**Additional Obstacles:** None  
**Triage Category:**  
**Hazmat:** propane tank within 20ft  
**Assessment Comments:** From FMSS\_Export - FRPP\_PREDUSE:

**Score: 29**  
**Rating: Low**

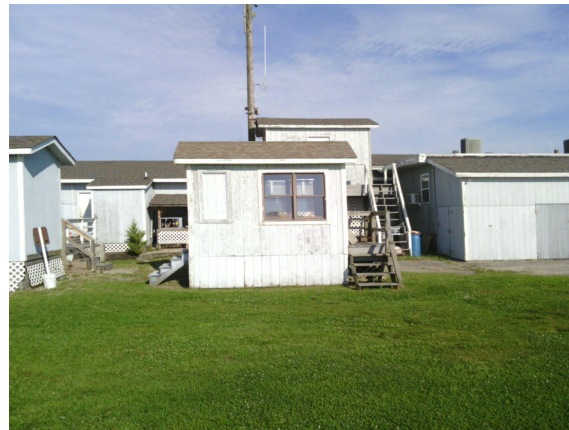
2016\_CAHA\_Fishing Center Storage - flammable\_Front.jpg

**Hazmat:** flammable storage

**Score: 29**  
**Rating: Low**

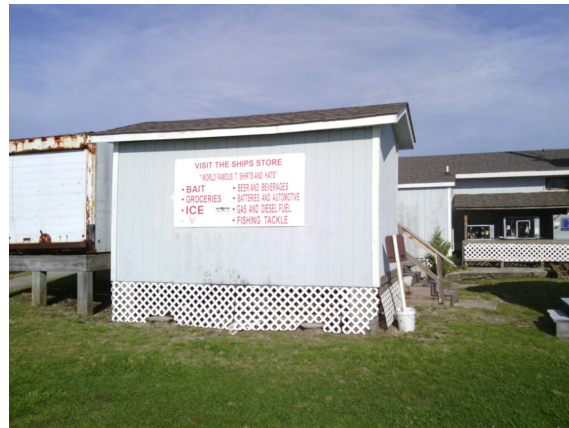
2016\_CAHA\_Fishing Center Storage - sign\_Front.jpg

**Safety Zones:** Potential safety zone(s) in area  
**Additional Obstacles:** Hazmat, UXO,etc. , PLEASE COMMENT  
**Triage Category:**  
**Hazmat:** large fuel tanks within 300ft

**Score: 33**  
**Rating: Low**

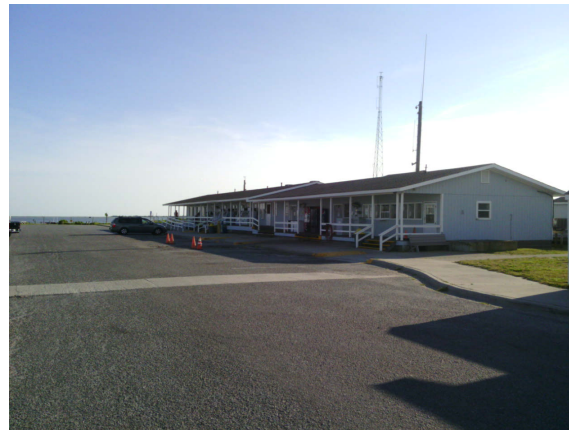
2016\_CAHA\_80998\_BI BD Oregon Inlet Fishing Center\_Front.jpg

**Hazmat:** there are propane tanks and fuel tanks within 100ft of building

**Score: 35**  
**Rating: Low**

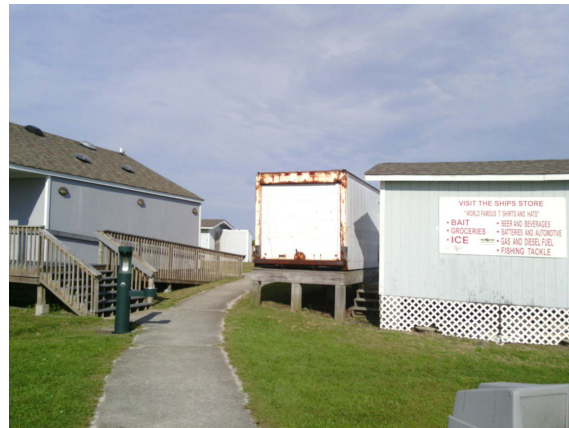
2016\_CAHA\_Fishing Center Storage - old truck box\_Front.jpg

**Additional Obstacles:** Hazmat, UXO,etc. , PLEASE COMMENT  
**Triage Category:**  
**Hazmat:** fuel tanks within 300ft  
**Assessment Comments:** From FMSS\_Export - FRPP\_PREDUSE:

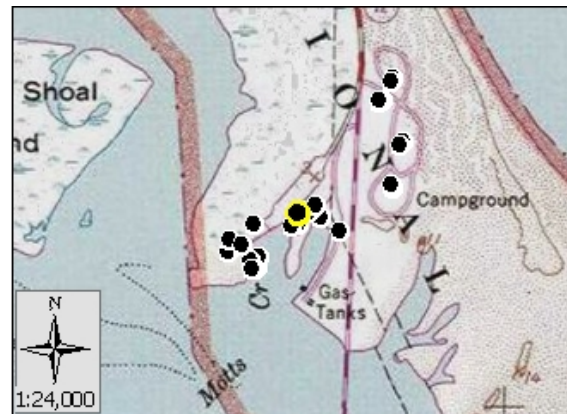
**Score: 26**  
**Rating: Low**

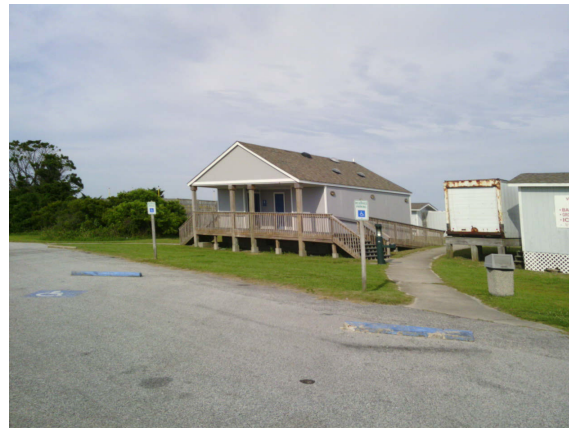
2016\_CAHA\_28948\_BI BD Oregon Inlet Fishing Center Comfort Station\_Front.jpg

**Hazmat:** fuel tanks within 100ft

**Score: 32**  
**Rating: Low**

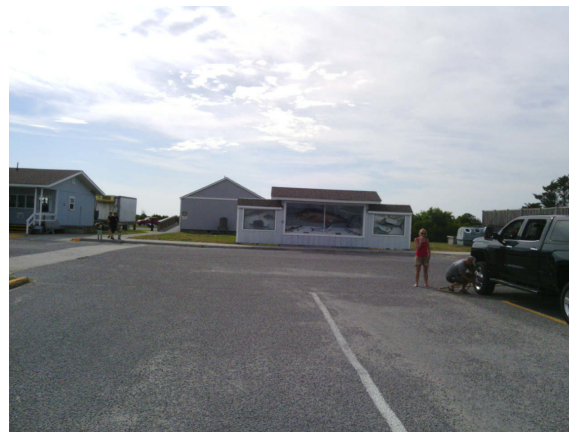
2016\_CAHA\_110389\_BI BD Oregon Inlet Fishing Center Exhibit Building\_Front.jpg

**Score: 33**  
**Rating: Low**

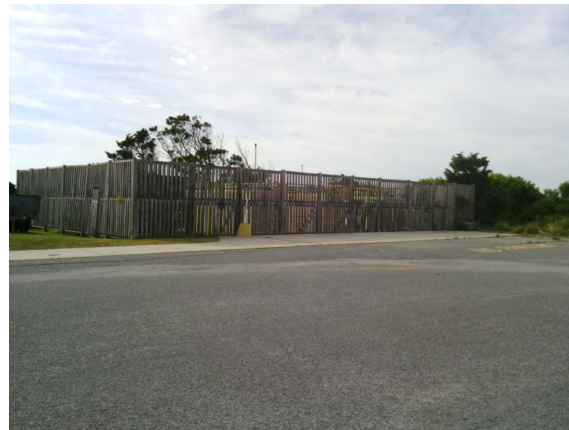
2016\_CAHA\_\_oregon fishing center fuel tanks.\_Front.jpg

**Additional Obstacles:** Hazmat, UXO,etc. , PLEASE COMMENT  
**Triage Category:**  
**Hazmat:** large fuel tanks within  
**Assessment Comments:**

**Score: 56**  
**Rating: Moderate**  
**Asset Priority Index (API):**  
 N/A

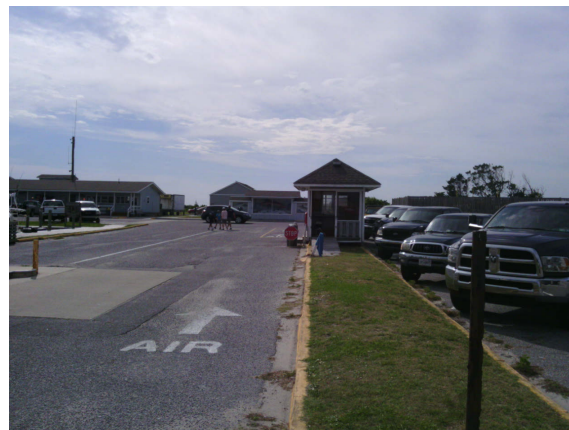
2016\_CAHA\_\_Fishing Center Fuel Kiosk\_Front.jpg

**Hazmat:** this is a fuel station kiosk

**Score: 27**  
**Rating: Low**

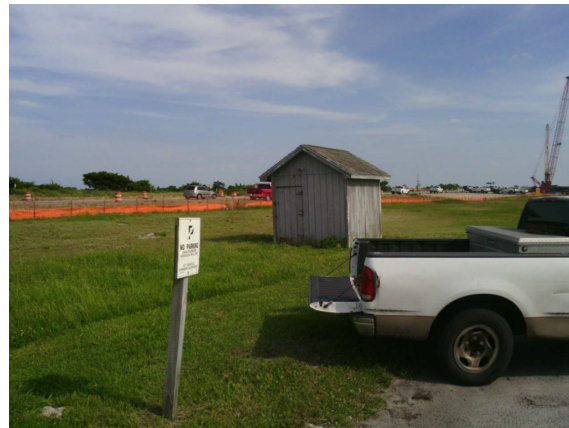
2016\_CAHA\_Fishing Center - shed beyond fuel kiosk\_Front.jpg

**Score: 52**  
**Rating: Moderate**
