Prepared for:  
**Herring River Technical Committee**  
**Wellfleet, Massachusetts**

# Herring River Restoration Project – Low-lying Roadways Review and Discussion

ENSR Corporation  
April 2007 (revised June 25, 2007)  
**Document No.: 04479-003-100**

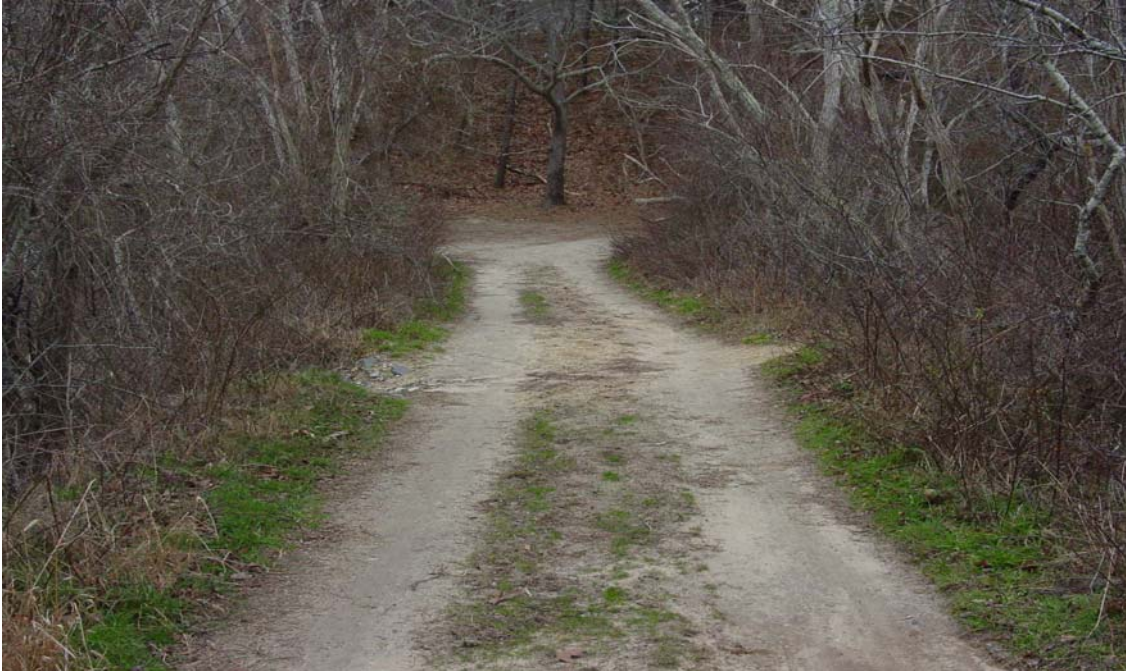
**PHOTO 1**

**SUBJECT:** Location along High Toss Bridge Road where it crosses the Herring River. Intersection with Duck Harbor Road in background.

Raising a road involves placing fill to create new road beds with paved or unpaved surfaces above a specific elevation. A number of the LLRs in the Herring River floodplain traverse areas of relatively low elevation and are not adjacent to higher ground. This is the case with High Toss Bridge Road (Photos 1 and 2; see Appendix C), Old County Road (Photos 3), and Pole Dike Road (Photo 4). In order to raise these roadways and avoid costly retaining wall construction, the toe of each roadway embankment would need to extend horizontally into adjacent wetland resource area, such as Bordering Vegetated Wetland (310 CMR 10.55) and Riverfront Area (310 CMR 10.58), which would alter these areas. In addition, raising a road that traverses a wetland area would likely adversely affect tidal exchange between areas upstream and downstream of the road by creating a causeway. Including supplemental surface water conveyance(s) along the raised road would mitigate this type of adverse affect to a degree and be in the interest of the habitat restoration goals of the larger project. In addition, if certain roadways have sewer lines or stormwater collection facilities, then the rims of the structures would need to be raised, or the structures would need to be re-set to match proposed grades.

High Toss Bridge Road (Figure 8 and Photos 1 and 2) is an infrequently traveled, unpaved, single-lane road that provides an access from Pole Dike Road to Griffin Island. For the portion of High Toss Bridge Road west of its intersection with low-lying Rainbow Lane and nearest the Herring River channel (Photo 5), wetland habitat abuts both the northern (Photo 6) and southern margins of this road. This portion of road is at

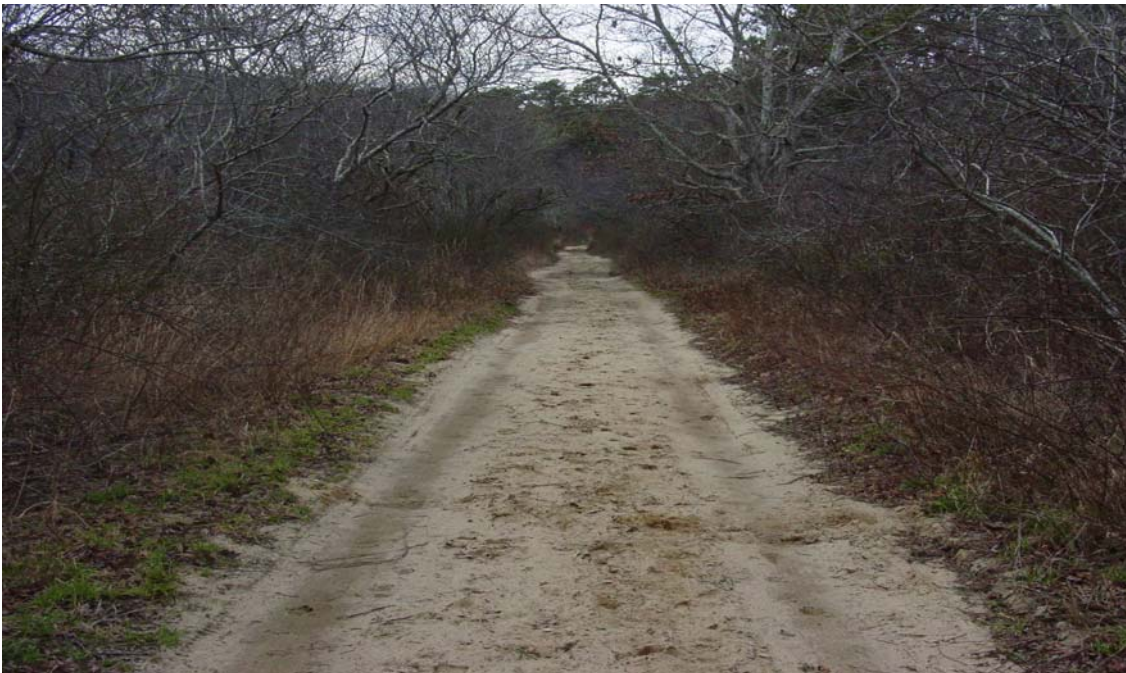
**PHOTO 2**

elevations between 3.0 and 3.5 feet (NAVD88). Much of the surrounding wetland area is at or just below the road surface elevations. It appears that raising this portion of High Toss Bridge Road west of Rainbow Lane by fill placement to an elevation a few to several feet above the existing elevation would necessitate construction of sloped roadway embankments. This construction would result in substantial alteration to vegetated wetland areas and create a causeway.

**SUBJECT:** Portion of High Toss Bridge Road at elevations between 3.0 and 3.5 feet (NAVD88). Both roadway margins abut wetland habitat, which is at similar surface elevation of the road.

Avoiding or minimizing wetland impacts by road relocation or lateral realignment in this section would not be possible due the lack of adjacent land at higher elevations and a close proximity to existing wetland areas. Using vertical retaining walls in place of embankments to minimize direct wetland alteration, while possible, will very likely be considered cost prohibitive and the causeway that would result would not serve the interests of the larger restoration project in our opinion.

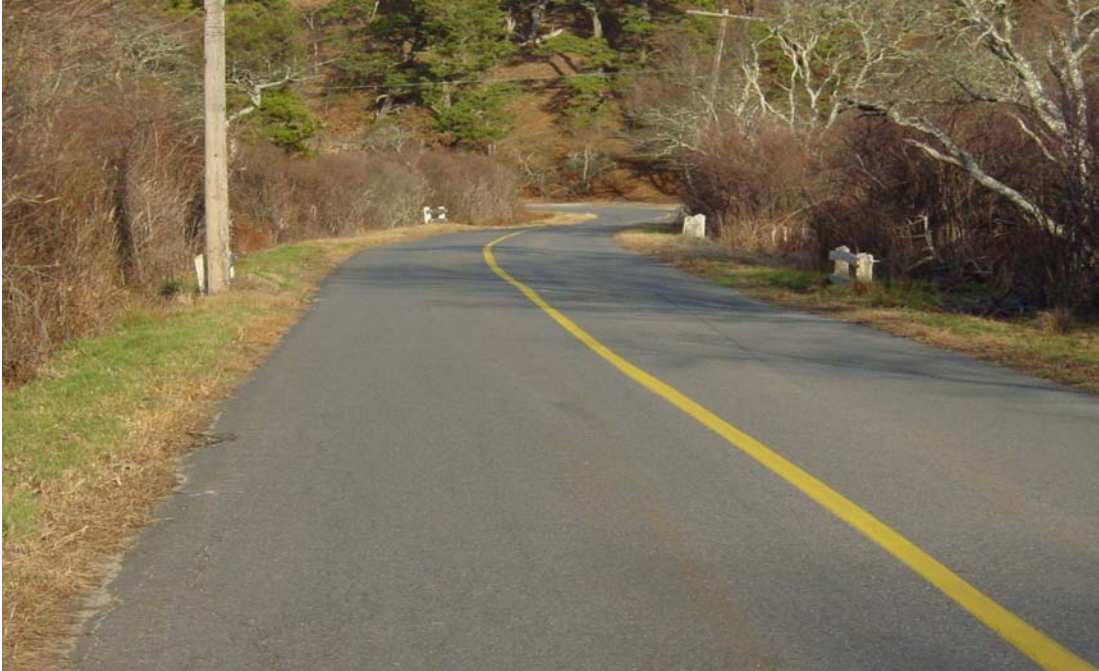
**PHOTO 3**

**SUBJECT:** Portion of Old County Road that traverses Bound Brook and its marsh. Road surface elevations measure between 2.5 and 3.5 feet (NAVD88). Cross-culvert is a 24-inch diameter pipe with inverts at -2.13 and -2.35 feet. **DATE:** 12 January 2007 **ASPECT:** northeast

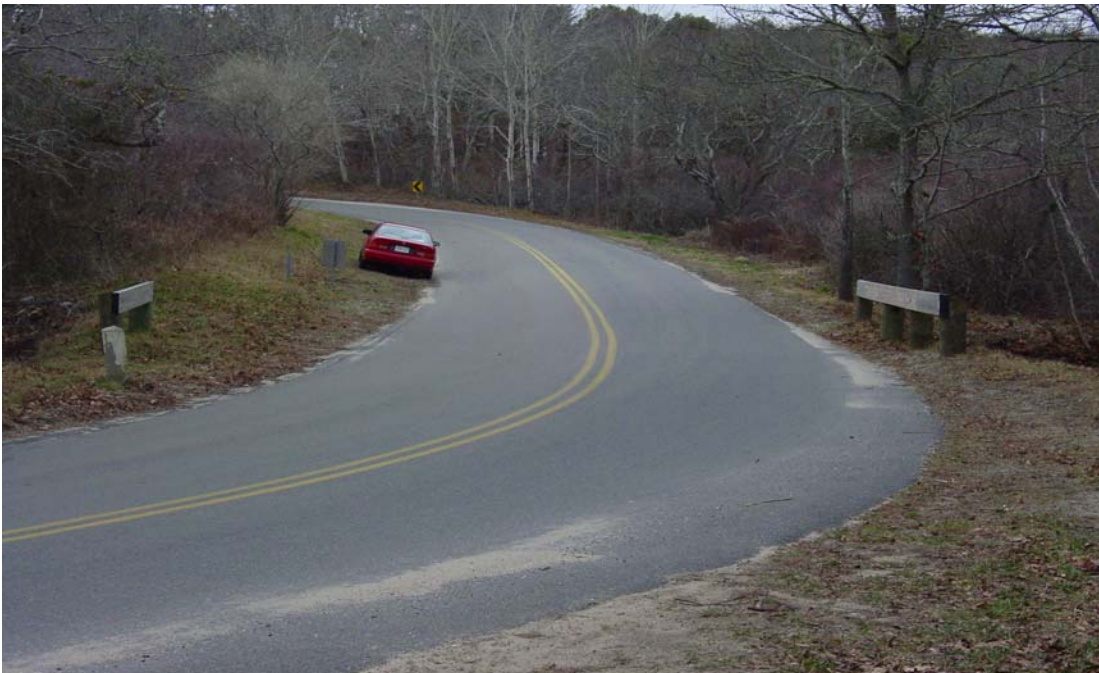
**PHOTO 4**

Pole Dike Road (Figure 16) is a frequently traveled, paved public road, the northernmost portion of which (Photos 4 and 9) crosses Pole Dike Creek. This portion of roadway, which is approximately 300 feet in length, is at elevations below 4.0 feet (NAVD88) for most of this length. The elevation of the road at the creek crossing is 4.67 feet. The densely vegetated wetland areas that border the creek are in close proximity to both margins of the road. Avoiding or minimizing wetland impacts by road relocation or lateral realignment would not be possible here due to both the lack of adjacent land at higher elevations and a close proximity to existing wetland resource areas. It appears that raising the roadway by the necessary number of feet would result in some amount of wetland alteration from construction of sloped roadway embankments. If retaining walls were used in place of sloped embankments, wetland alteration could be greatly reduced or unnecessary.

**SUBJECT:** Portion of Pole Dike Road at Pole Dike Creek crossing where elevations of paved surface is between 3.0 and 3.5 feet (NAVD88). Wetland habitat abuts the margins of both grassed road shoulders.

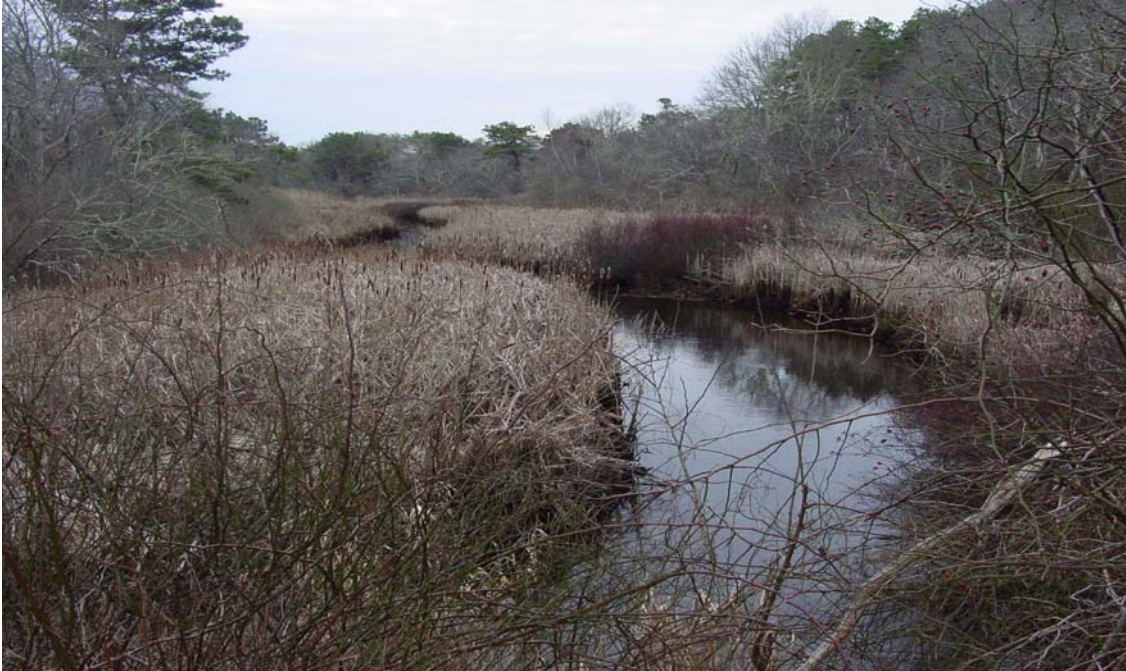
**PHOTO 5**

**SUBJECT:** Segment of Herring River immediately south of High Toss Bridge Road culvert.

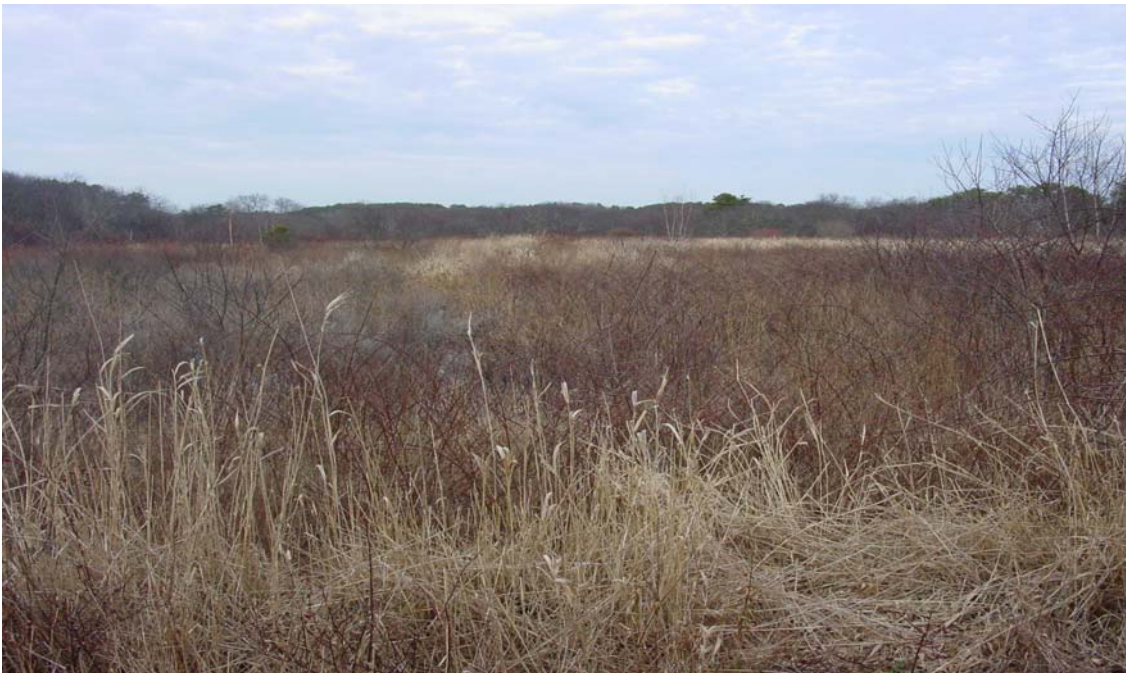
**PHOTO 6**

**SUBJECT:** Emergent marsh and scrub-shrub wetland habitat located just to the north of High Toss Bridge Road and to the east of the Herring River.

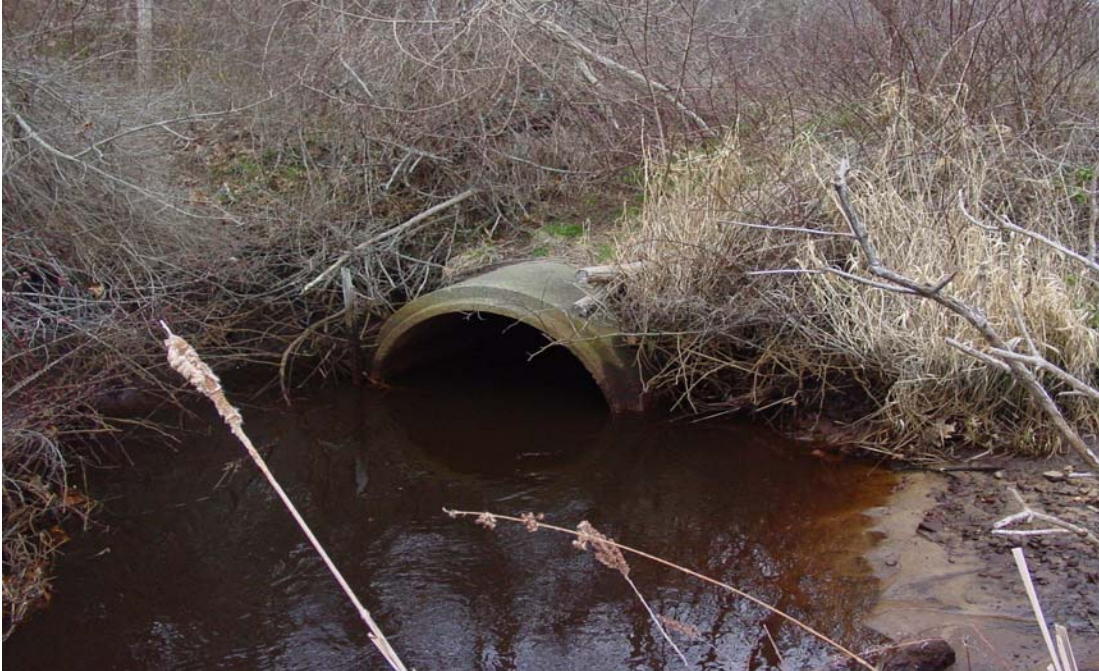
**PHOTO 7**

**SUBJECT:** Downstream (southern) end of culvert that carries the Herring River beneath High Toss Bridge Road. Culvert is approximately 60 inches in diameter (inside) and is approximately 24 feet in length. **DATE:** 12 January 2007 **ASPECT:** northwest

A 60-inch diameter, 24-foot long culvert conveys the Herring River beneath High Toss Bridge Road near its western end (Photos 7 and 8). Replacing this pipe culvert with a larger conveyance structure, such as an open-bottom arch or box culvert, would alleviate the apparent flow restriction caused by the existing culvert and create better conditions for fish passage.

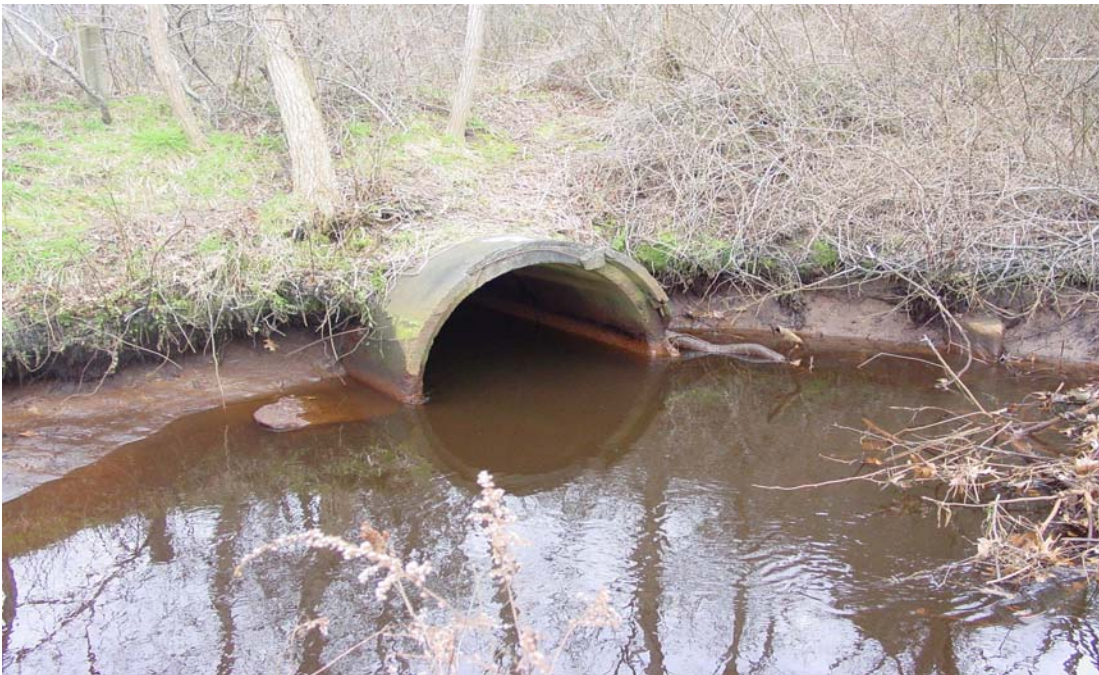
**PHOTO 8**

**SUBJECT:** Upstream (northern) end of High Toss Bridge Road culvert that conveys the Herring River. Top of culvert is 1.66 feet and invert elevation is -3.76 feet (NAVD88).

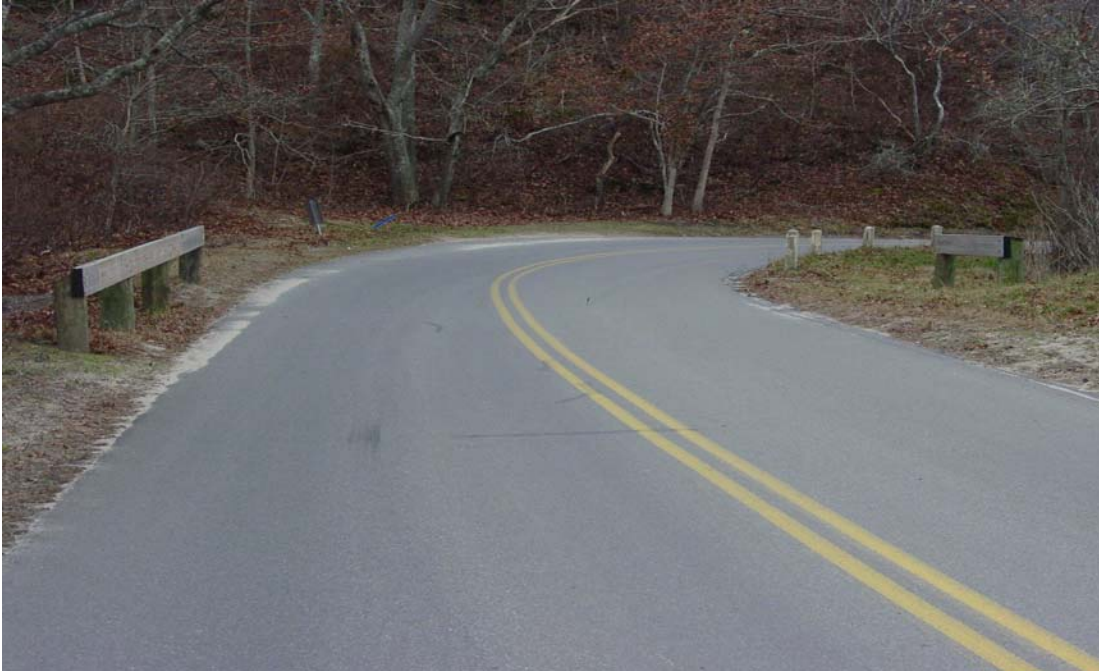
**PHOTO 9**

**SUBJECT:** Portion of Pole Dike Road at Pole Dike Creek crossing where road surface elevation is 4.67 feet at centerline.

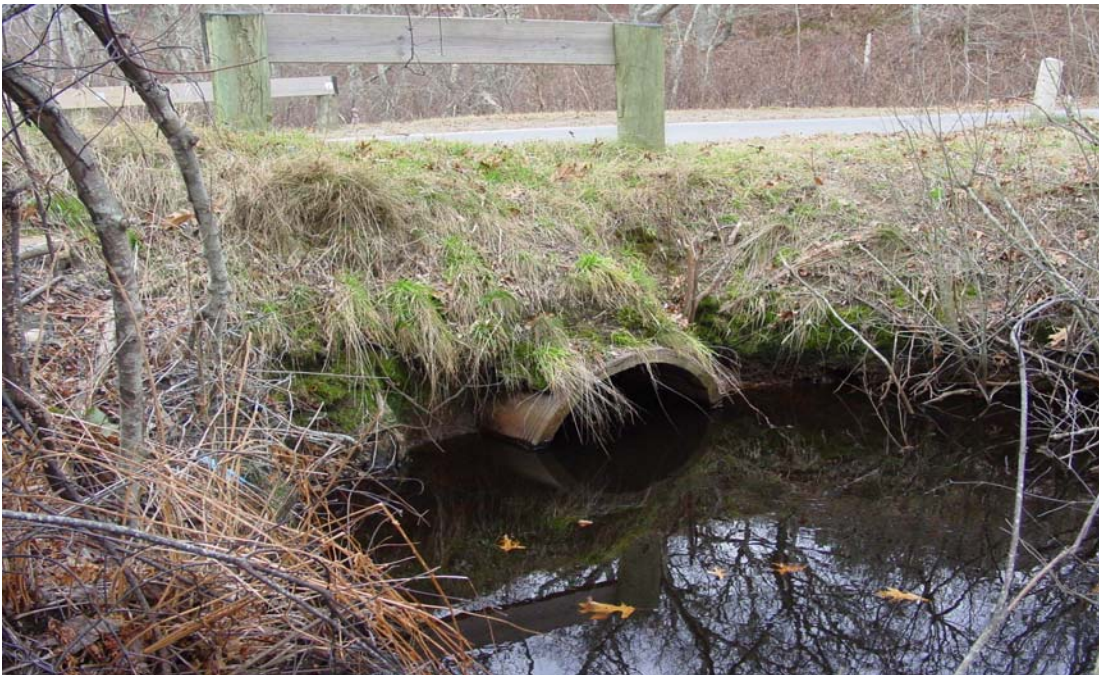
**PHOTO 10**

**SUBJECT** Downstream end of 36-inch diameter culvert that conveys Pole Dike Creek beneath road. Culvert invert elevations are -1.00 feet and -1.30 feet.

A 32-inch diameter (approx.), 40-foot long (approx.) culvert conveys Pole Dike Creek beneath the road (Photo 10). Replacing this pipe culvert with a larger conveyance structure, such as an open-bottom arch or box culvert, would alleviate the apparent flow restriction caused by the existing culvert and create better conditions for fish passage.

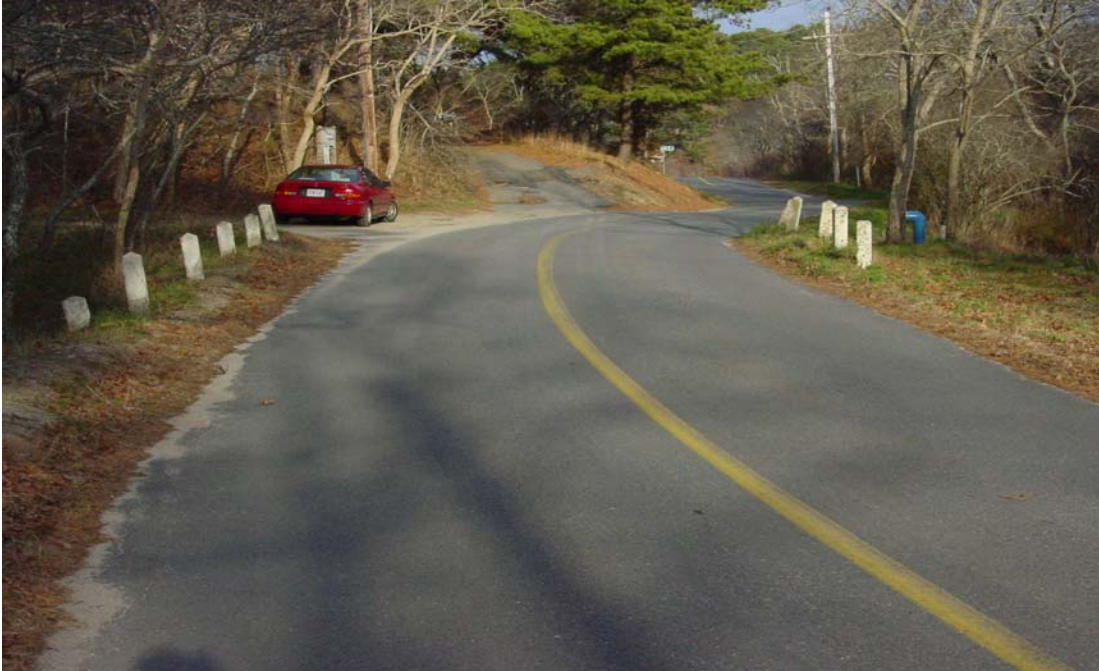
**PHOTO 11**

**SUBJECT:** Bound Brook Island Road at Herring River crossing. Road surface elevation at crossing is 4.45 feet while elevations along road centerline just south of this crossing are between 1.75 and 2.5 feet.

The two segments of Bound Brook Island Road that are at slightly higher elevations, which is the portion that abuts Merrick Island and the portion located to the west of the Pole Dike Road intersection, abut lands that are at higher elevations. It therefore may be possible to realign these road segments onto higher ground so that wetland impacts are avoided or minimized. A 60-inch (approx.) concrete culvert conveys the Herring River beneath Bound Brook Island Road. This culvert (Photos 13 and 14) may be adequately sized for current conditions. Replacing this pipe culvert with a larger conveyance structure, such as a wide box culvert, may be necessary to accommodate increased tidal flooding.

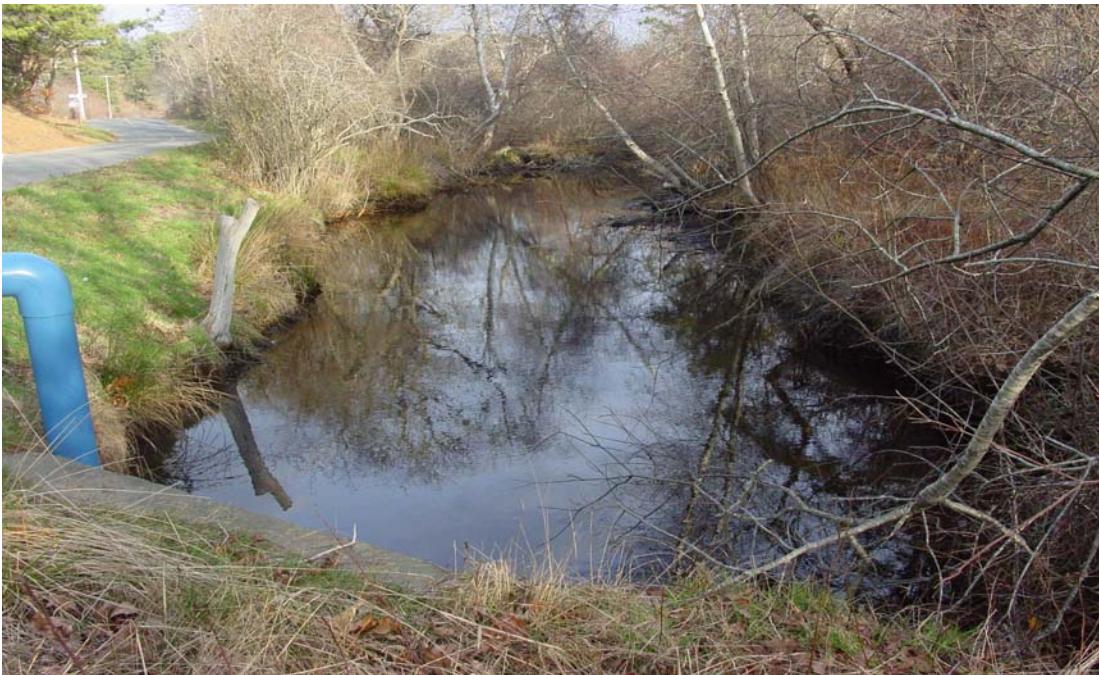
**PHOTO 12**

**SUBJECT:** Herring River as seen from Bound Brook Island Road crossing. (Blue pipe visible in left portion of frame is posted as a fire department water supply.)

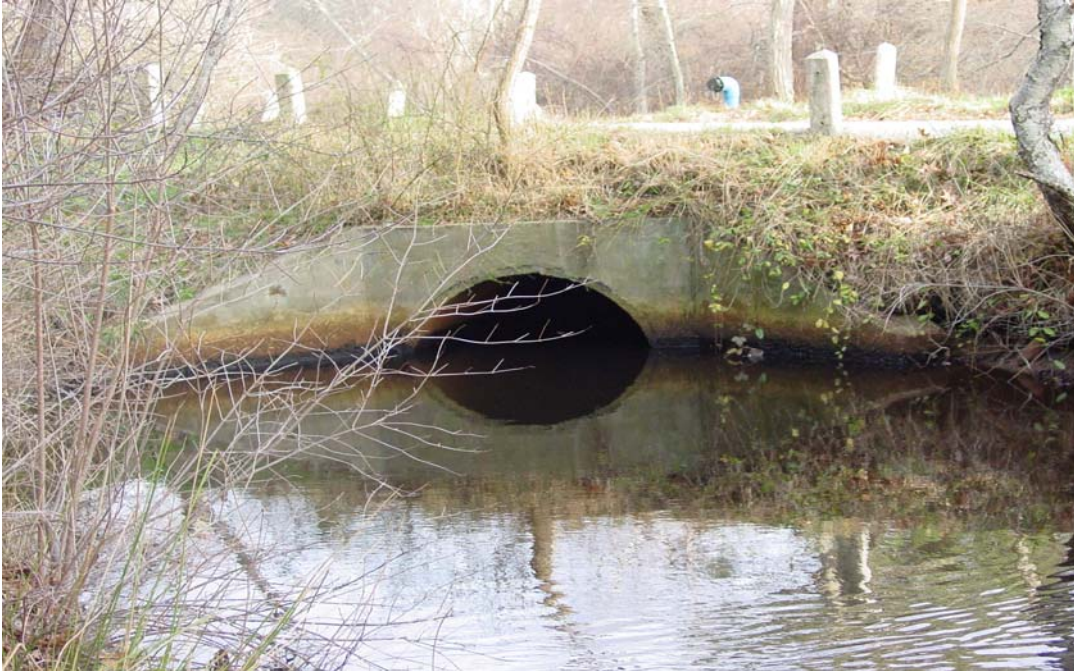
**PHOTO 13**

**SUBJECT:** Downstream (west) end of culvert that carries Herring River beneath Bound Island Brook Road in Wellfleet. Culvert diameter is approximately 60 inches. Top of concrete headwall is at elevation 2.80 feet. **DATE:** 12 January 2007 **ASPECT:** eastern / upstream

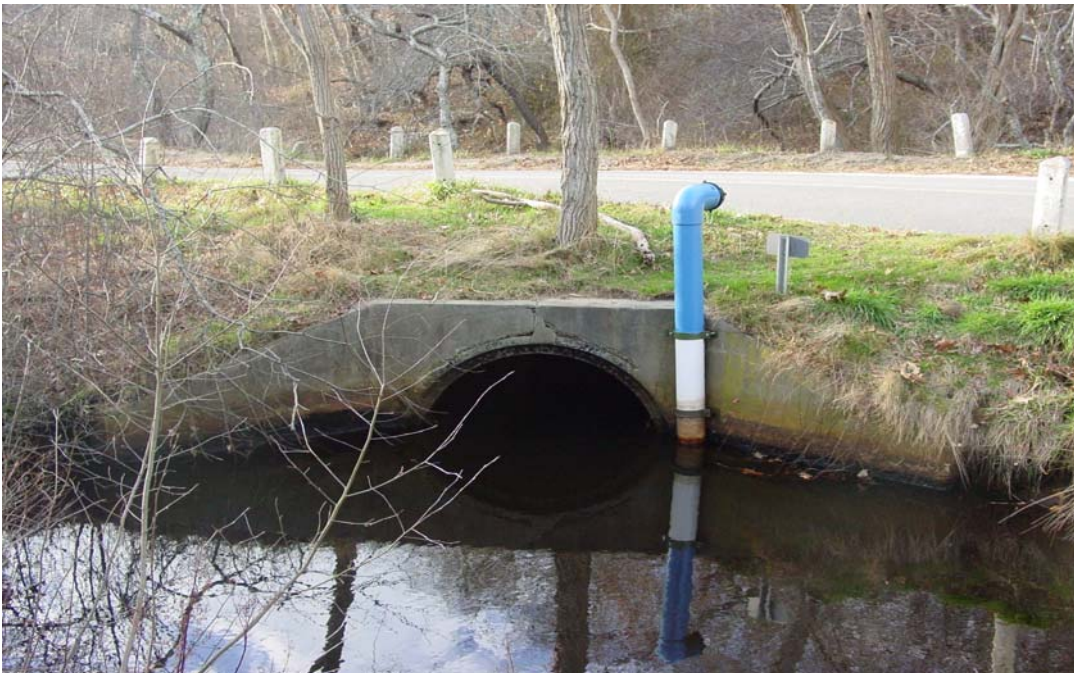
**PHOTO 14**

**SUBJECT:** Upstream (east) end of same culvert that carries Herring River beneath Bound Island Brook Road. Road elevation at the centerline is 4.45 feet (NAVD88). Top of headwall is 2.92 feet.

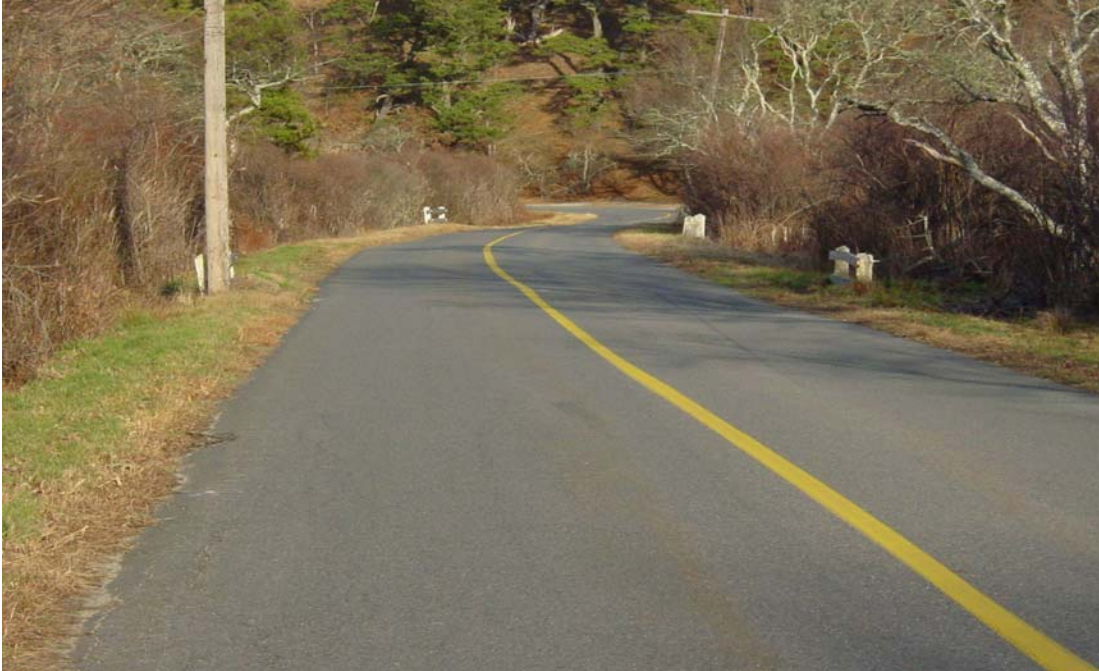
**PHOTO 15**

Along its southernmost portion in Wellfleet this road crosses Bound Brook and the densely vegetated wetland areas that border this stream (Photo 15). This wetland is in close proximity to both margins of the road. The elevations of the road in this segment are between 2.0 and 3.5 feet and the abutting wetland areas appear to be at elevations just below this range. The 24-inch diameter culvert that conveys Bound Brook beneath the road (Photo 16) appeared damaged and/or otherwise obstructed at the time of site inspection.

**SUBJECT:** The southernmost portion of low-lying Old County Road that crosses Bound Brook and the marsh that abuts the brook. Elevations measured along the centerline of this road are between 2.0 and 3.5 feet. **DATE:** 12 January 2007 **ASPECT:** northeastern

Avoiding or minimizing wetland impacts by road relocation or lateral realignment would not be possible in this segment of Old County Road due to both the lack of adjacent land at higher elevations and a close proximity to proximity of existing wetland resource areas. It appears that raising this section of roadway by the necessary number of feet would result in substantial wetland alteration from construction of sloped roadway embankments. Using vertical retaining walls in place of embankments to minimize direct wetland alteration, while possible along this segment of roadway, will likely be considered cost prohibitive and the causeway-like structure that would result would not serve the interests of the larger restoration project in our opinion.

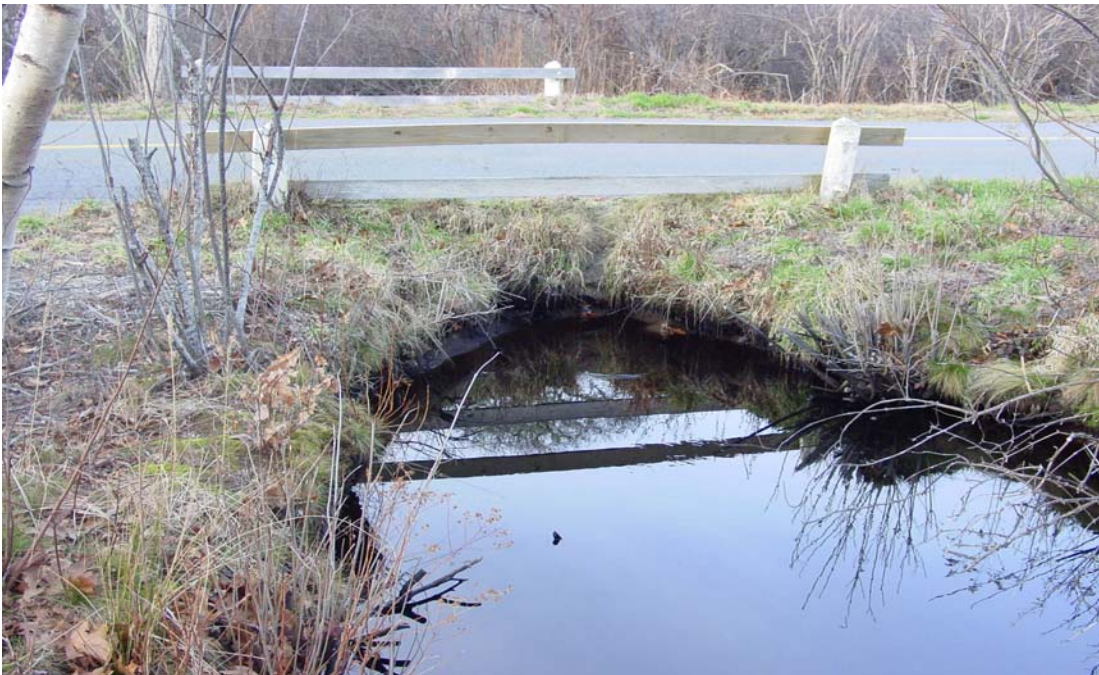
**PHOTO 16**

**SUBJECT:** Downstream end of the cross-culvert that conveys Bound Brook beneath Old County Road. The 24-inch diameter pipe is submerged and appeared damaged and/or obstructed upon observation. Road centerline elevation is 2.69 feet at crossing. **DATE:** 12 January 2007

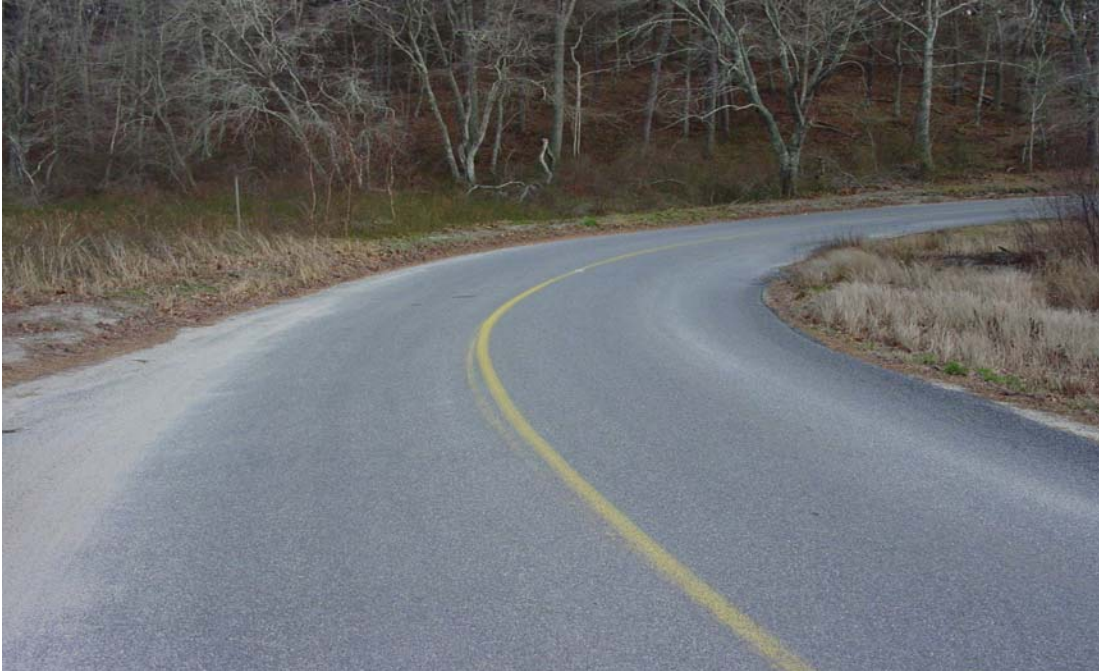
**PHOTO 17**

The northernmost portion of Old County Road in Wellfleet crosses a stream within Paradise Hollow (Figure 13, Photo 17), which is tributary to Bound Brook. The elevation at the centerline of the road was surveyed to be 3.37 feet (NAVD 88). As with other LLR segments that cross streams, completely avoiding or minimizing wetland impacts by road relocation or lateral realignment would not be possible here due to both the lack of adjacent land at higher elevations and a close proximity to existing wetland resource areas. Using vertical retaining walls in place of embankments to minimize direct wetland alteration and increase the road elevation may be practical in this location.

**SUBJECT:** The low-lying portion of Old County Road that crosses Paradise Hollow just south of the Wellfleet-Truro town boundary. The road surface centerline elevation at the culvert is 3.37 feet, which is the lowest elevation point along this portion of road. **DATE:** 12 January 2007 **ASPECT:** southern  
**PROJECT / No.:** Herring River Restoration – Low-lying Roadways Review / 04479-003-100

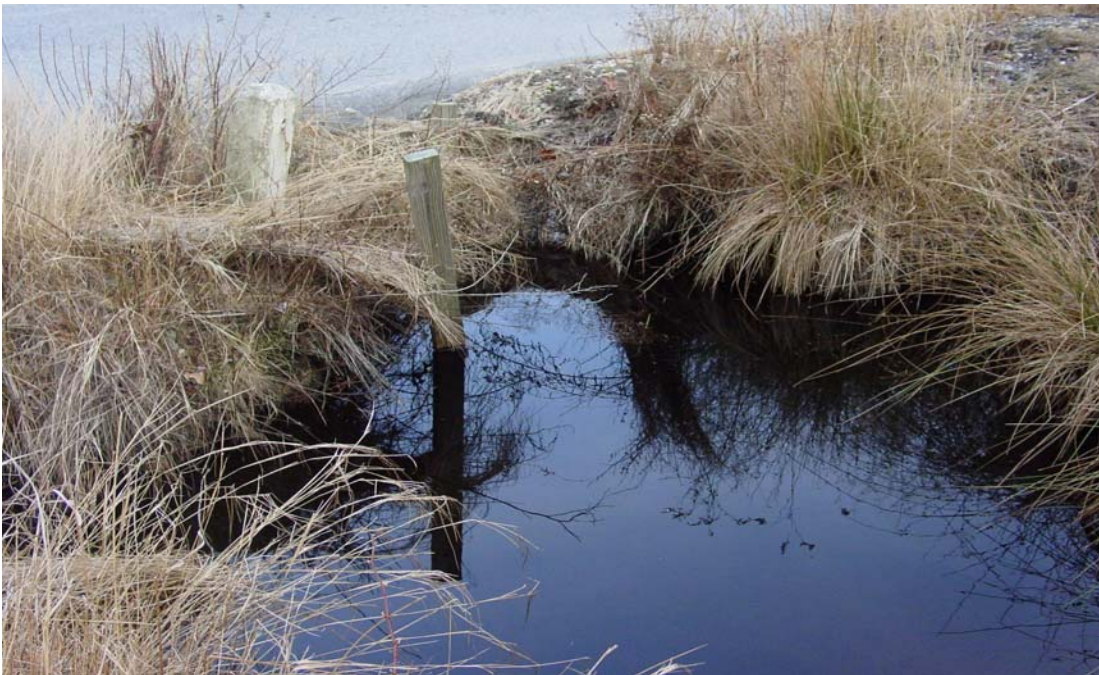
**PHOTO 18**

**SUBJECT:** The downstream end of the cross-culvert that conveys the stream beneath Old County Road. This culvert is approximately eight inches in diameter and appeared partially obstructed to flow. **DATE:** 12 January 2007  
**PROJECT / No.:** Herring River Restoration – Low-lying Roadways Review / 04479-003-100

A measurement by the land surveyor indicates that the existing cross-culvert in this location has an 8-inch diameter. The pipe appeared partially obstructed by sediment and other debris upon inspection (Photo 18). Replacing this pipe culvert with a larger conveyance structure, such as an open-bottom arch or box culvert, may be appropriate here.
