# Assessment of Estuarine Water Quality at Cumberland Island National Seashore

## *2022 Data Summary*

Science Report NPS/SR—2025/238

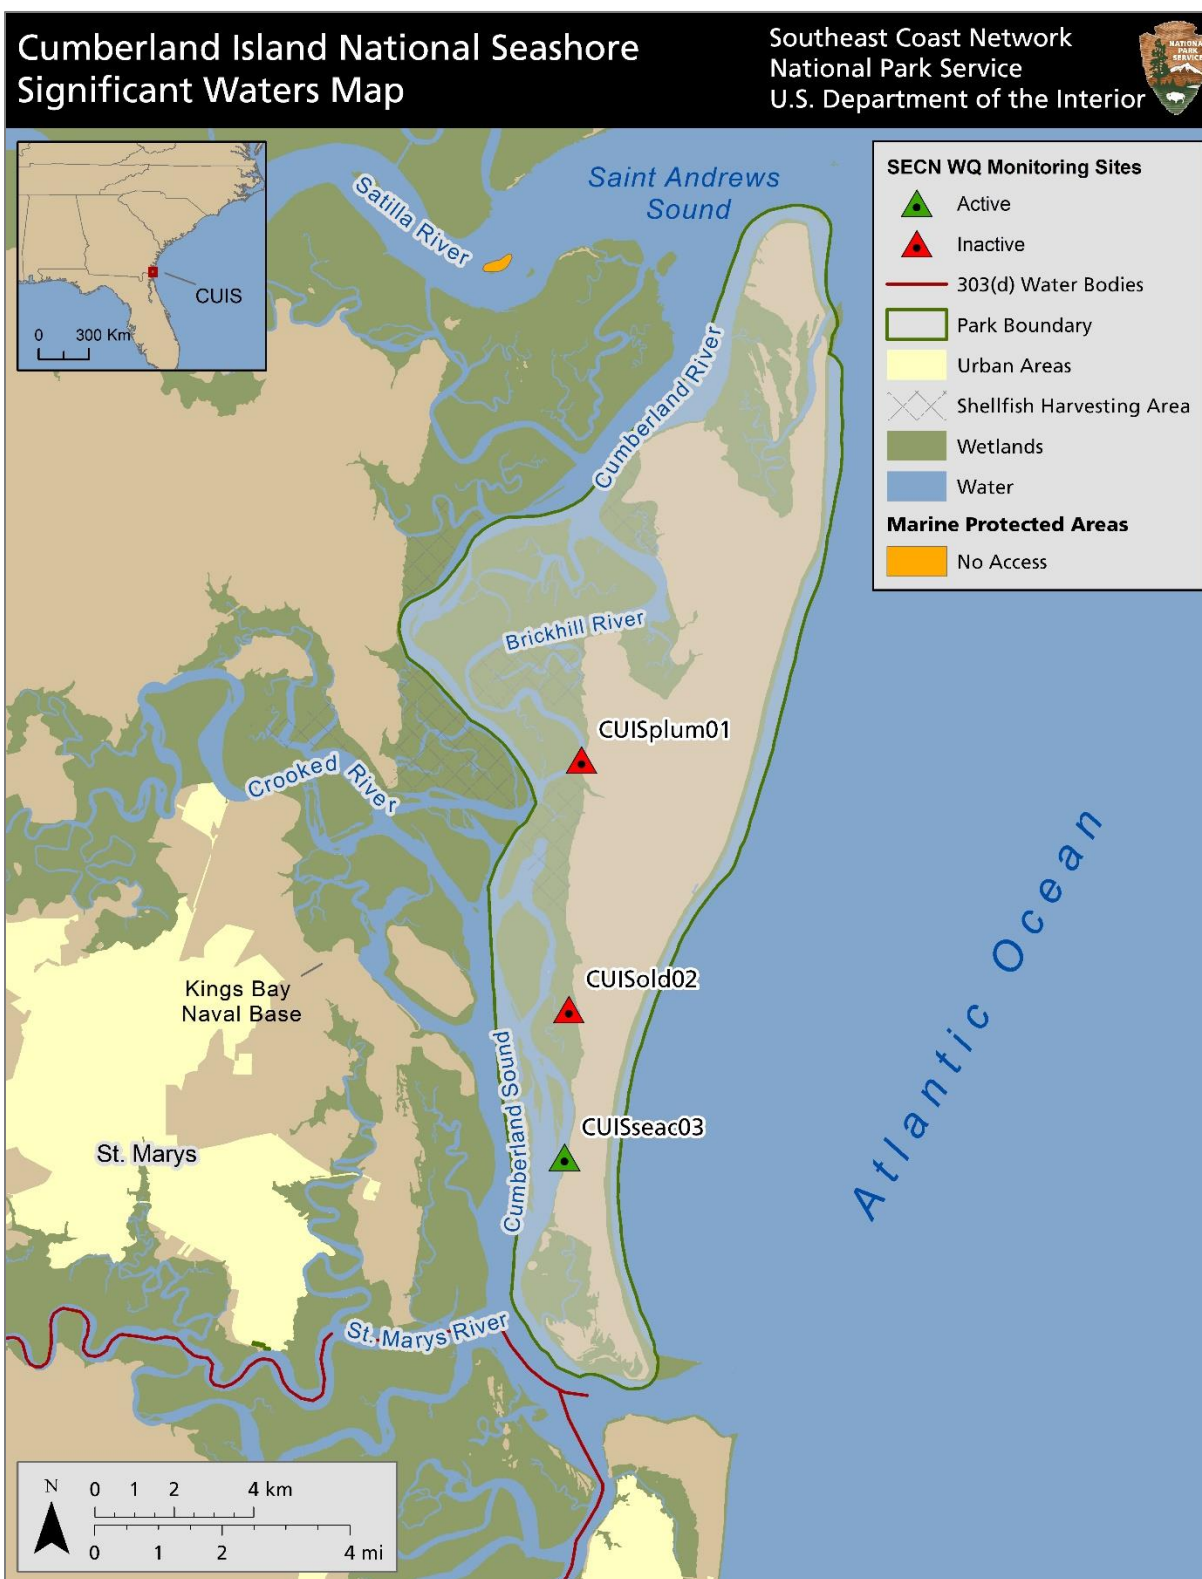
**Figure 1.** Fixed-station water-quality monitoring sites and estuarine and marine water resources in the vicinity of Cumberland Island National Seashore. Indicated are areas of salt marsh (FWS 2024), urbanized area (USCB 2023), 303(d) listed water bodies (EPA 2022), and areas designated with special uses or restrictions. NPS / SECN

Other activities—such as dredging along the estuarine waters just south and east of the island to maintain the submarine access channel to Kings Bay Submarine Base—have the potential to cause episodic deterioration of the water-quality as well as the scenic attributes of the south end of Cumberland Island. Transportation corridors such as rail, interstate highways, and the intracoastal waterway are also potential sources of pollution, particularly catastrophic spills. The Georgia coast has been experiencing an era of fast growth in new residential communities, many of which have sought to incorporate marinas. Recreational pressure could increase on the island, and the threat to resources and critical habitats may also intensify. Erosion on the western side of the island has been a recent concern of resource management at Cumberland Island National Seashore and investigated by local researchers (Jackson 2006, 2010, 2015), the USGS (Calhoun and Riley 2016), and the Southeast Coast Network (Bateman-McDonald 2020). The only aquatic areas in the vicinity of the park to be 303(d) listed are the Amelia River just south of Cumberland Island, the St. Marys River, and parts of Cumberland Sound along the island’s southern tip for elevated mercury levels in fish (Figure 1).

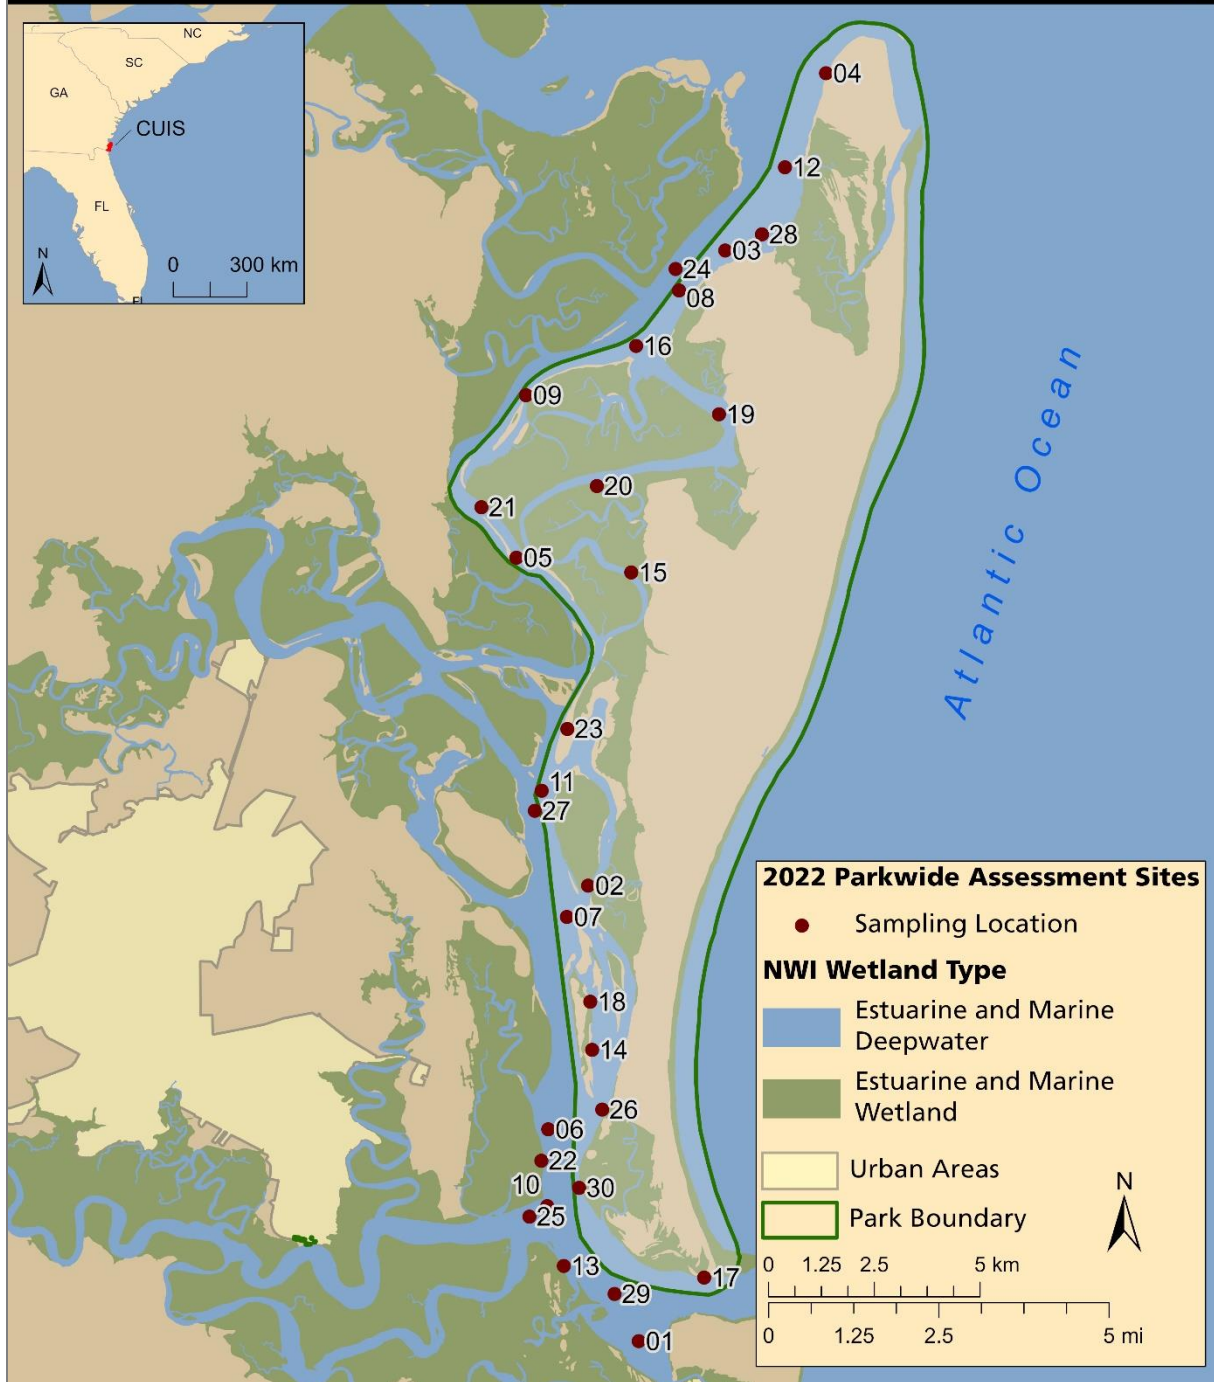
Cumberland Island National Seashore  
2022 Parkwide Assessment Sampling Sites

**Figure 2.** Map showing the location of parkwide assessment sites sampled in July 2022 at Cumberland Island National Seashore. NPS / SECN

In 2022, thirty sites in estuarine waters near the seashore were randomly selected for monitoring following methods developed by the EPA (Table 1, Figure 2; Stevens 1997; Stevens and Olsen 1999; Stevens and Olsen 2004). This method of randomly selecting spatially-balanced sites provides managers with a statistically valid estimate of the overall conditions of the assessed resource within or around the park.

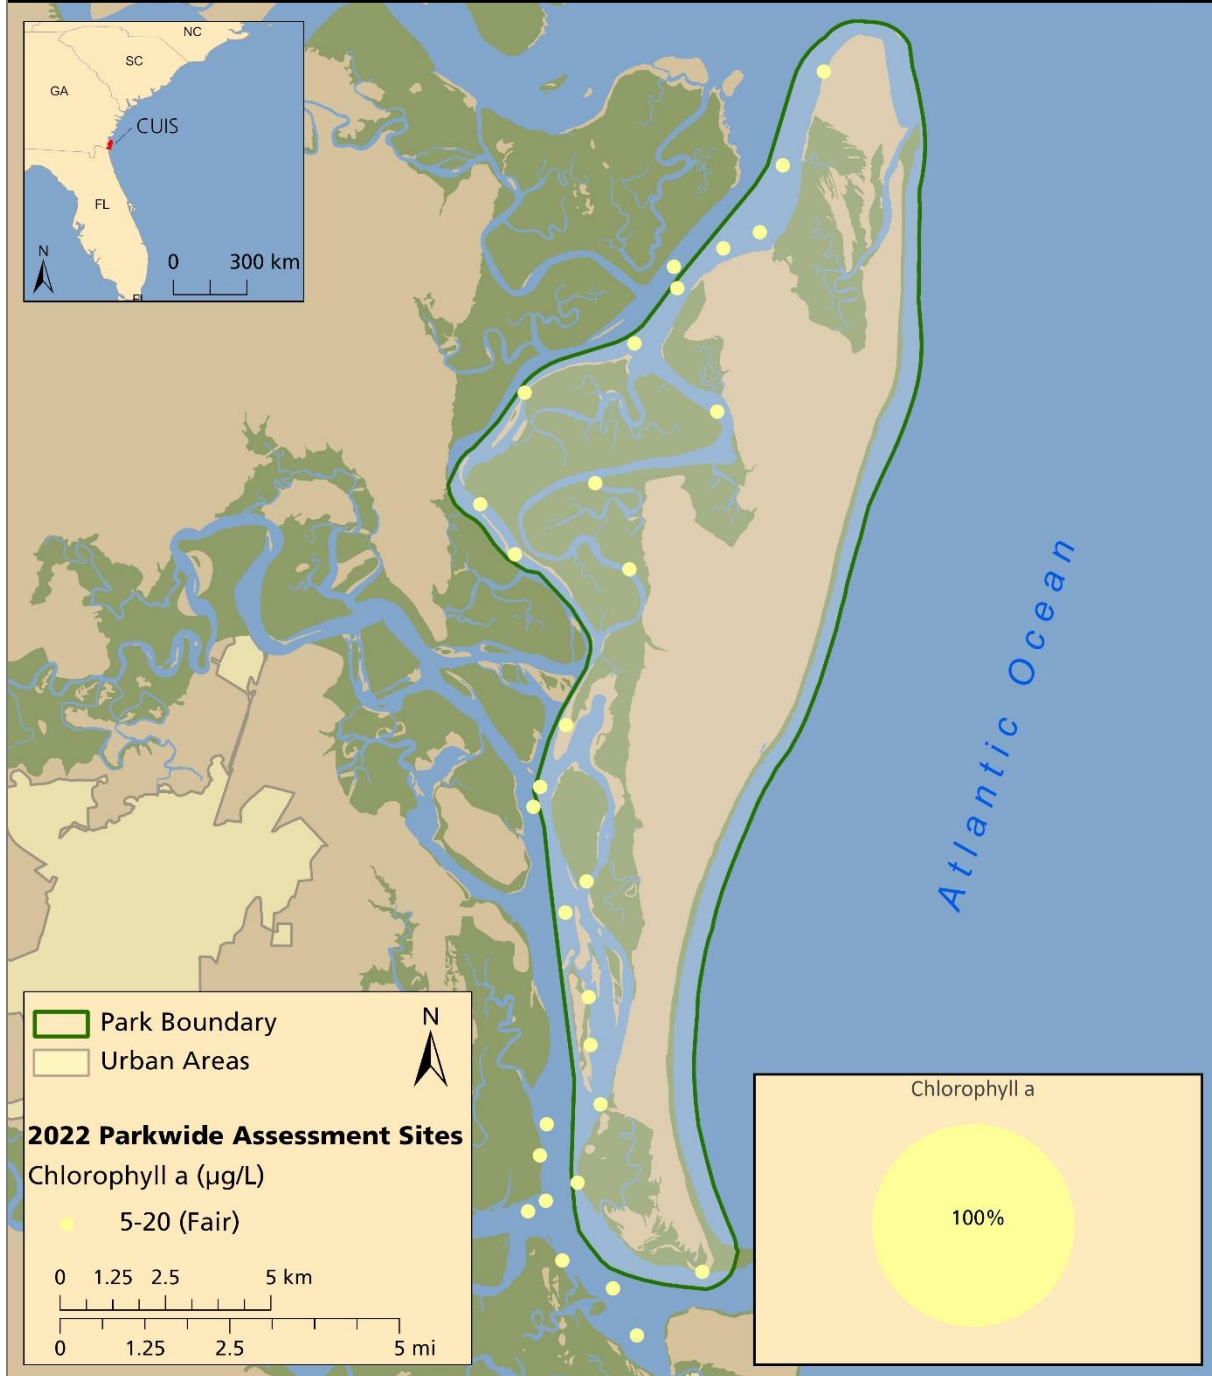
Cumberland Island National Seashore  
2022 Chlorophyll a

**Figure 4.** Chlorophyll a concentrations for sites sampled at Cumberland Island National Seashore July 6–8, 2022. Inset graph shows the percent of sites in each condition category [yellow—fair]. NPS / SECN

- Water clarity was rated good at all thirty sites (100%).
- Chlorophyll *a* concentrations were rated fair at all thirty sites (100%).
- Dissolved inorganic nitrogen (DIN) concentrations were good at all thirty sites (100%).

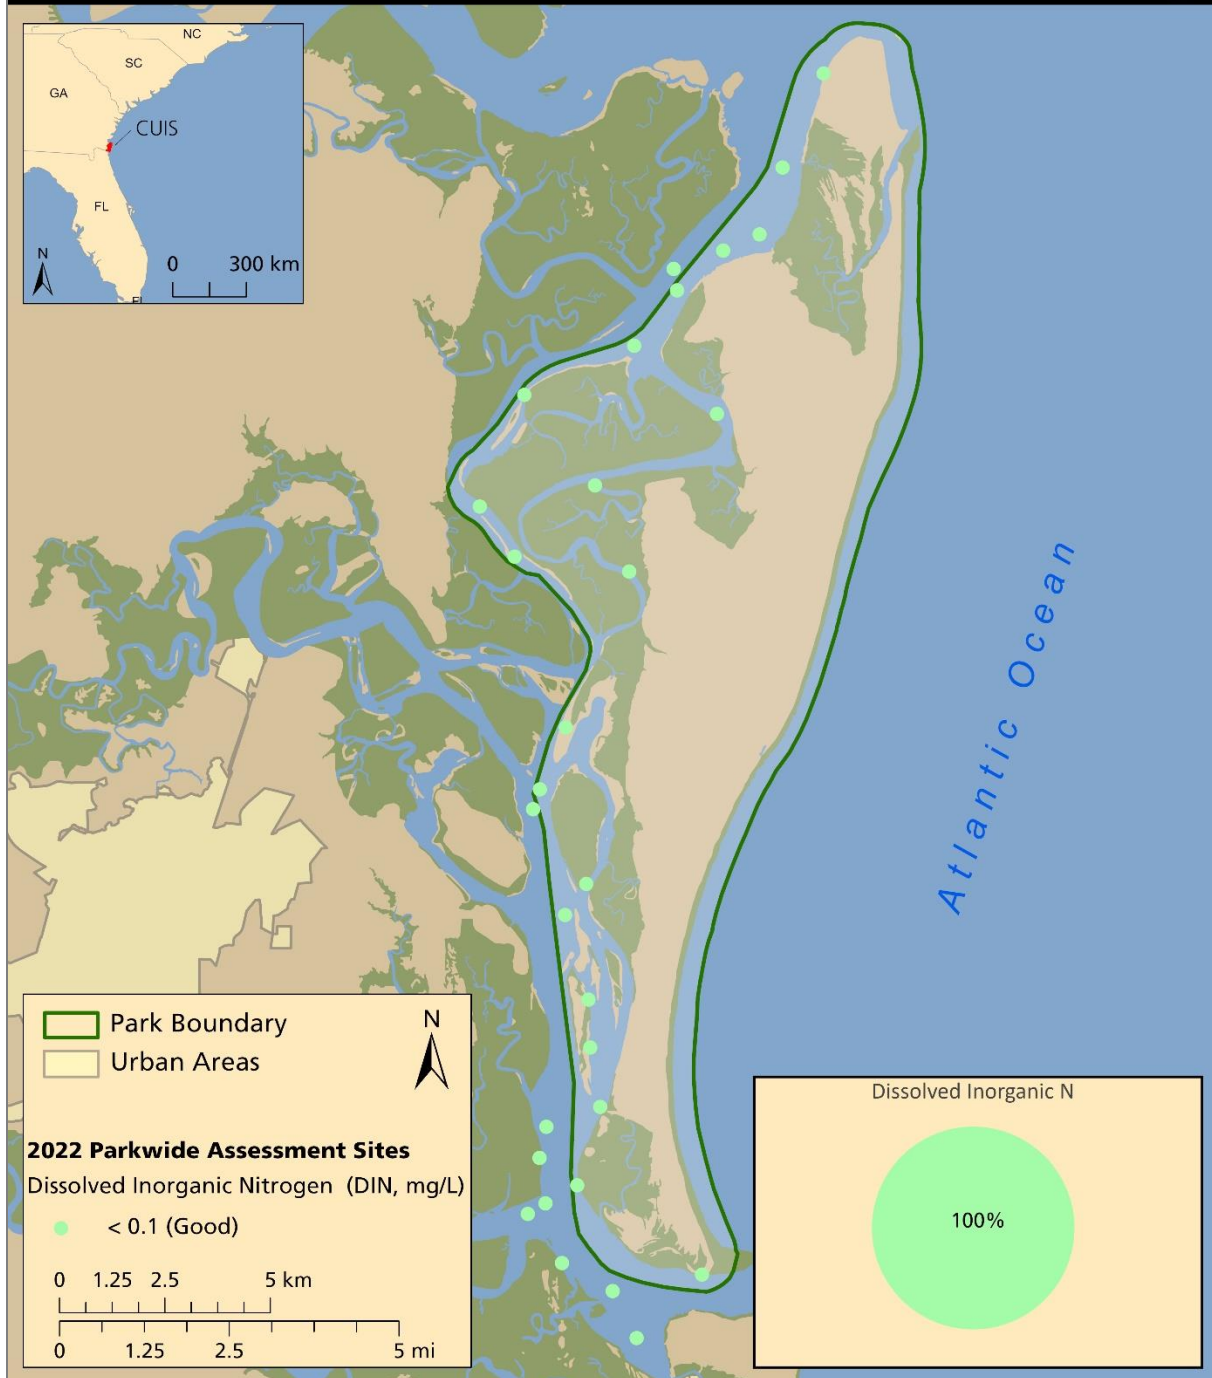
Cumberland Island National Seashore  
2022 Dissolved Inorganic Nitrogen

**Figure 5.** Dissolved inorganic nitrogen concentrations for sites sampled at Cumberland Island National Seashore July 6–8, 2022. Inset graph shows the percent of sites in each condition category [Green—good]. NPS / SECN

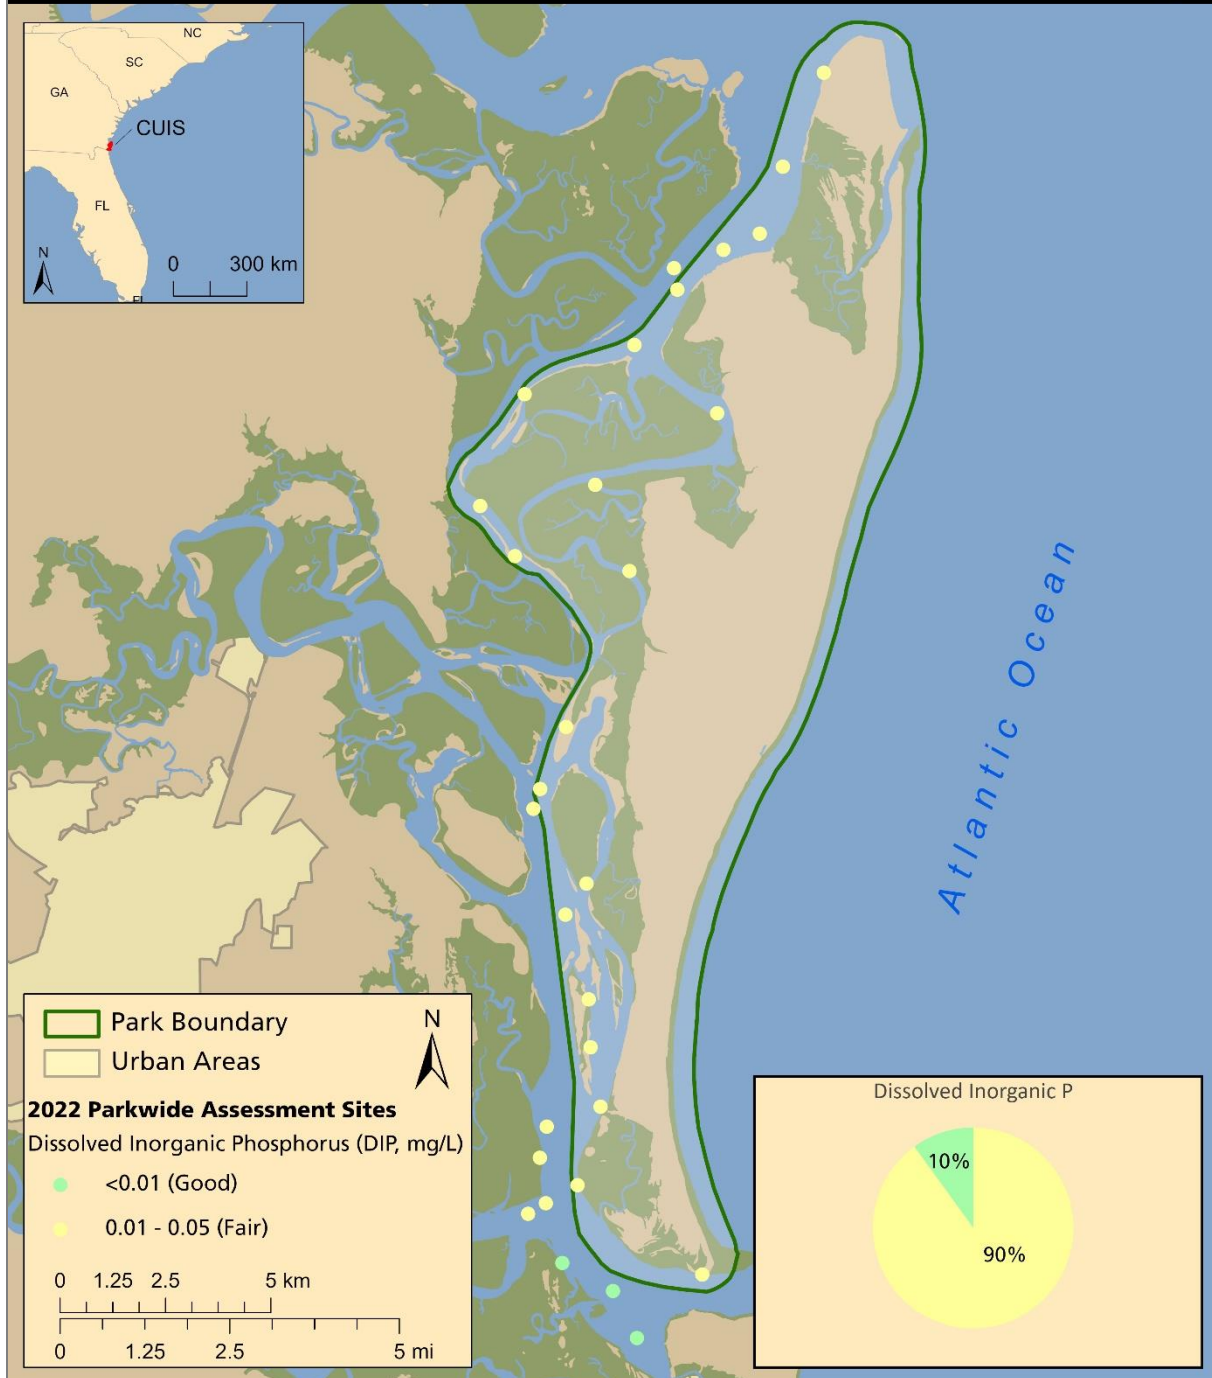
**Figure 6.** Dissolved inorganic phosphorus concentrations for sites sampled at Cumberland Island National Seashore July 6–8, 2022. Inset graph shows the percent of sites in each condition category [Green—good; yellow—fair]. NPS / SECN

- Dissolved inorganic phosphorus (DIP) concentrations were good at three sites (10%) and fair at twenty-seven sites (90%).
- Dissolved oxygen concentrations (bottom) were rated good at twenty-four sites (80%) and fair at six sites (20%).

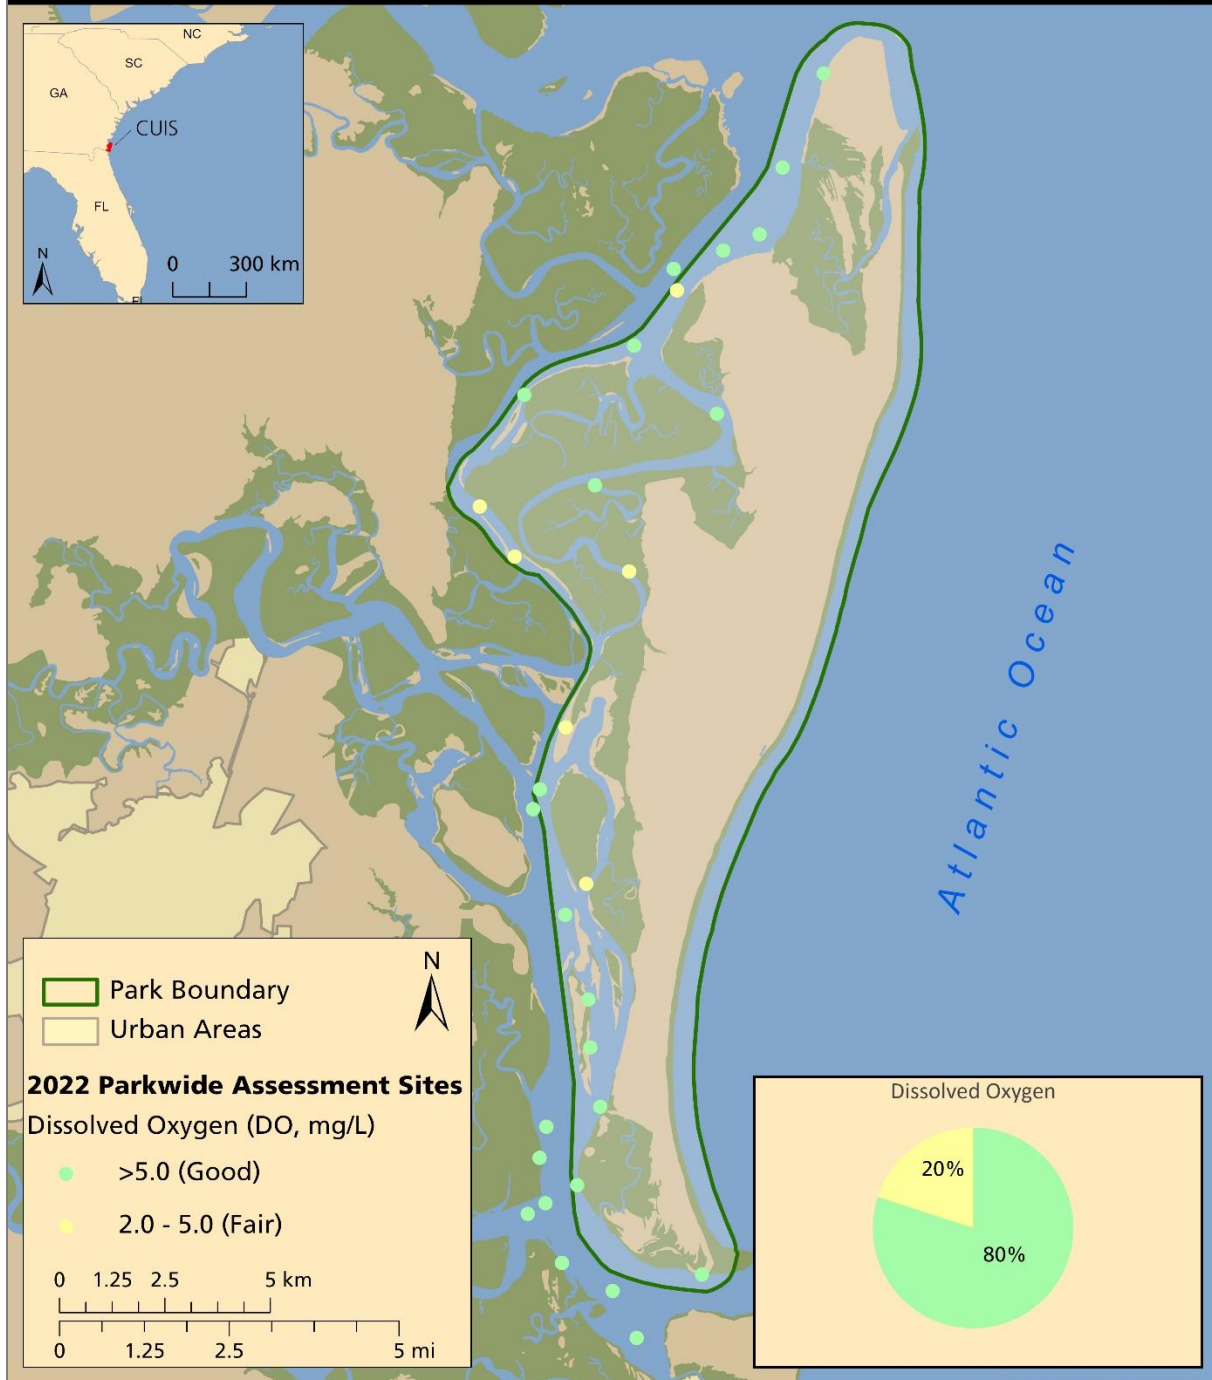
Cumberland Island National Seashore  
2022 Dissolved Oxygen

**Figure 7.** Dissolved oxygen concentrations for sites sampled at Cumberland Island National Seashore July 6–8, 2022. Inset graph shows the proportion of sites in each condition category [Green—good; yellow—fair]. NPS / SECN

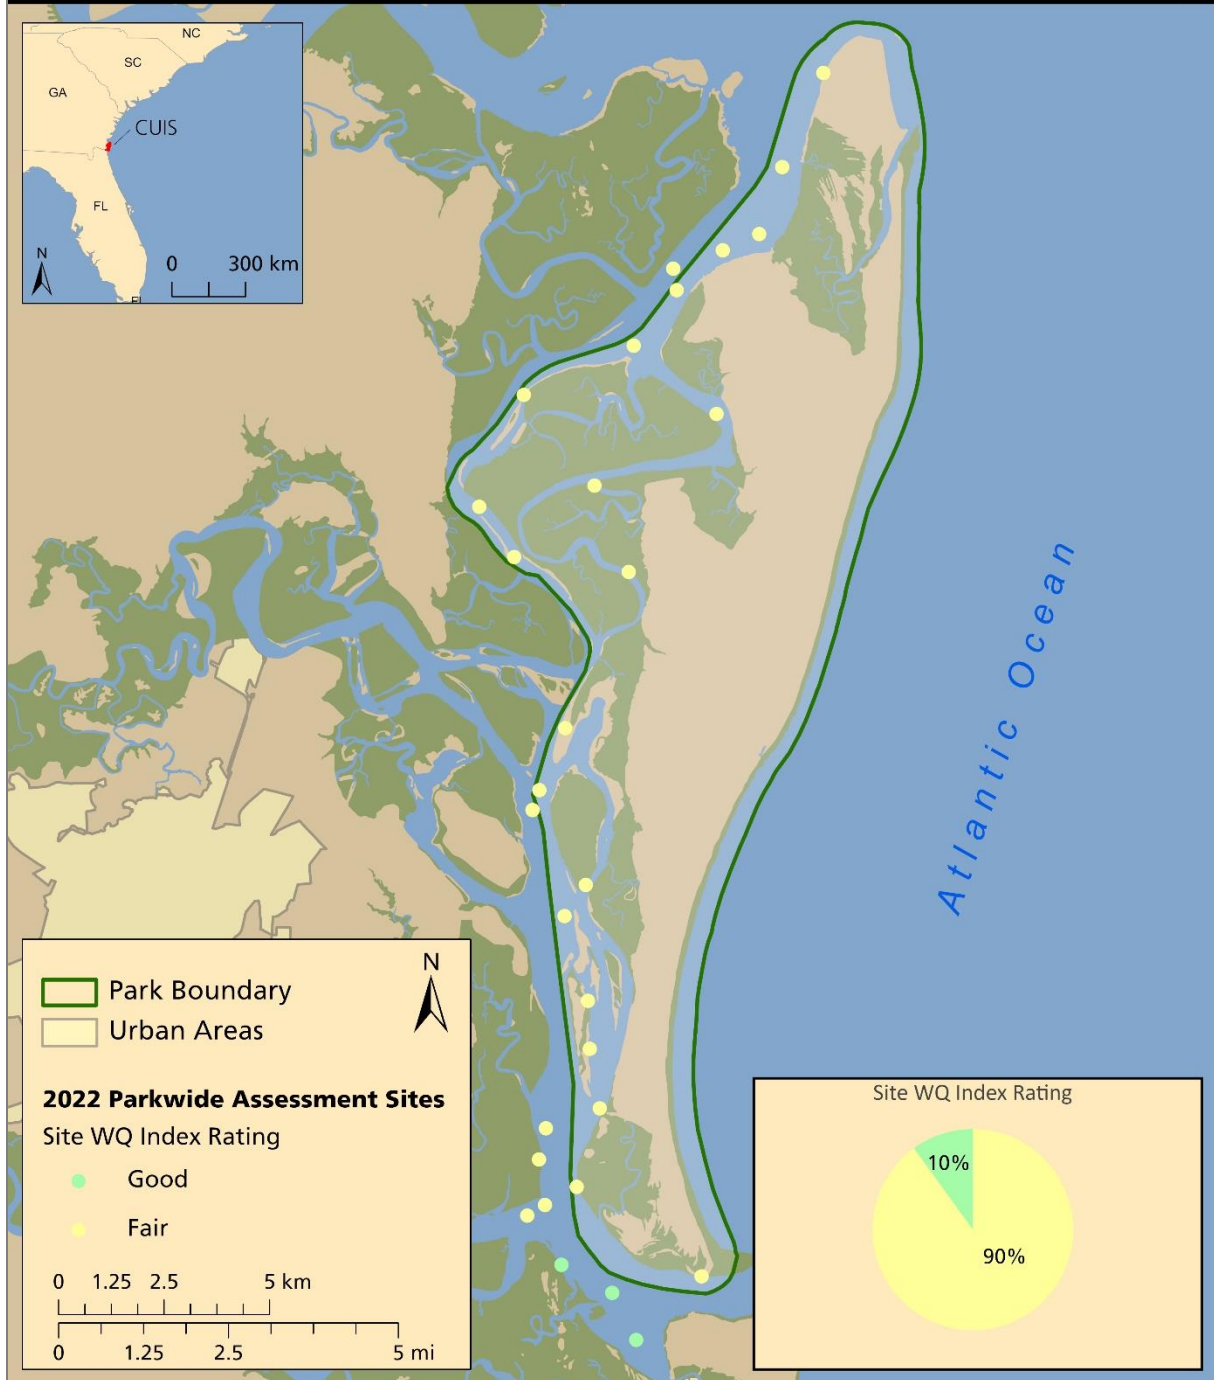
Cumberland Island National Seashore  
2022 Site Water Quality Rating

**Figure 8.** Water-quality index rating for sites sampled at Cumberland Island National Seashore July 6–8, 2022. Inset graph shows the proportion of sites in each condition category [Green—good; yellow—fair].  
NPS / SECN

- A water-quality condition summary index was calculated for each site sampled at Cumberland Island National Seashore based on the categorical assessments of chlorophyll *a*, DIN and DIP concentrations, dissolved oxygen, and water clarity. This summary index indicated good water-quality conditions at three sites (10%) and fair water quality conditions at twenty-seven sites (90%).

- Based on the summary water-quality index rating, overall water-quality conditions at Cumberland Island National Seashore during 2022 sampling were fair. Previous assessments indicated overall park water-quality ratings of fair in 2007, 2012, and 2017. This suggests relatively stable overall water-quality throughout the period of record.
