# Assessment of Estuarine Water Quality at Fort Matanzas National Monument

## *2022 Data Summary*

Science Report NPS/SR—2025/239

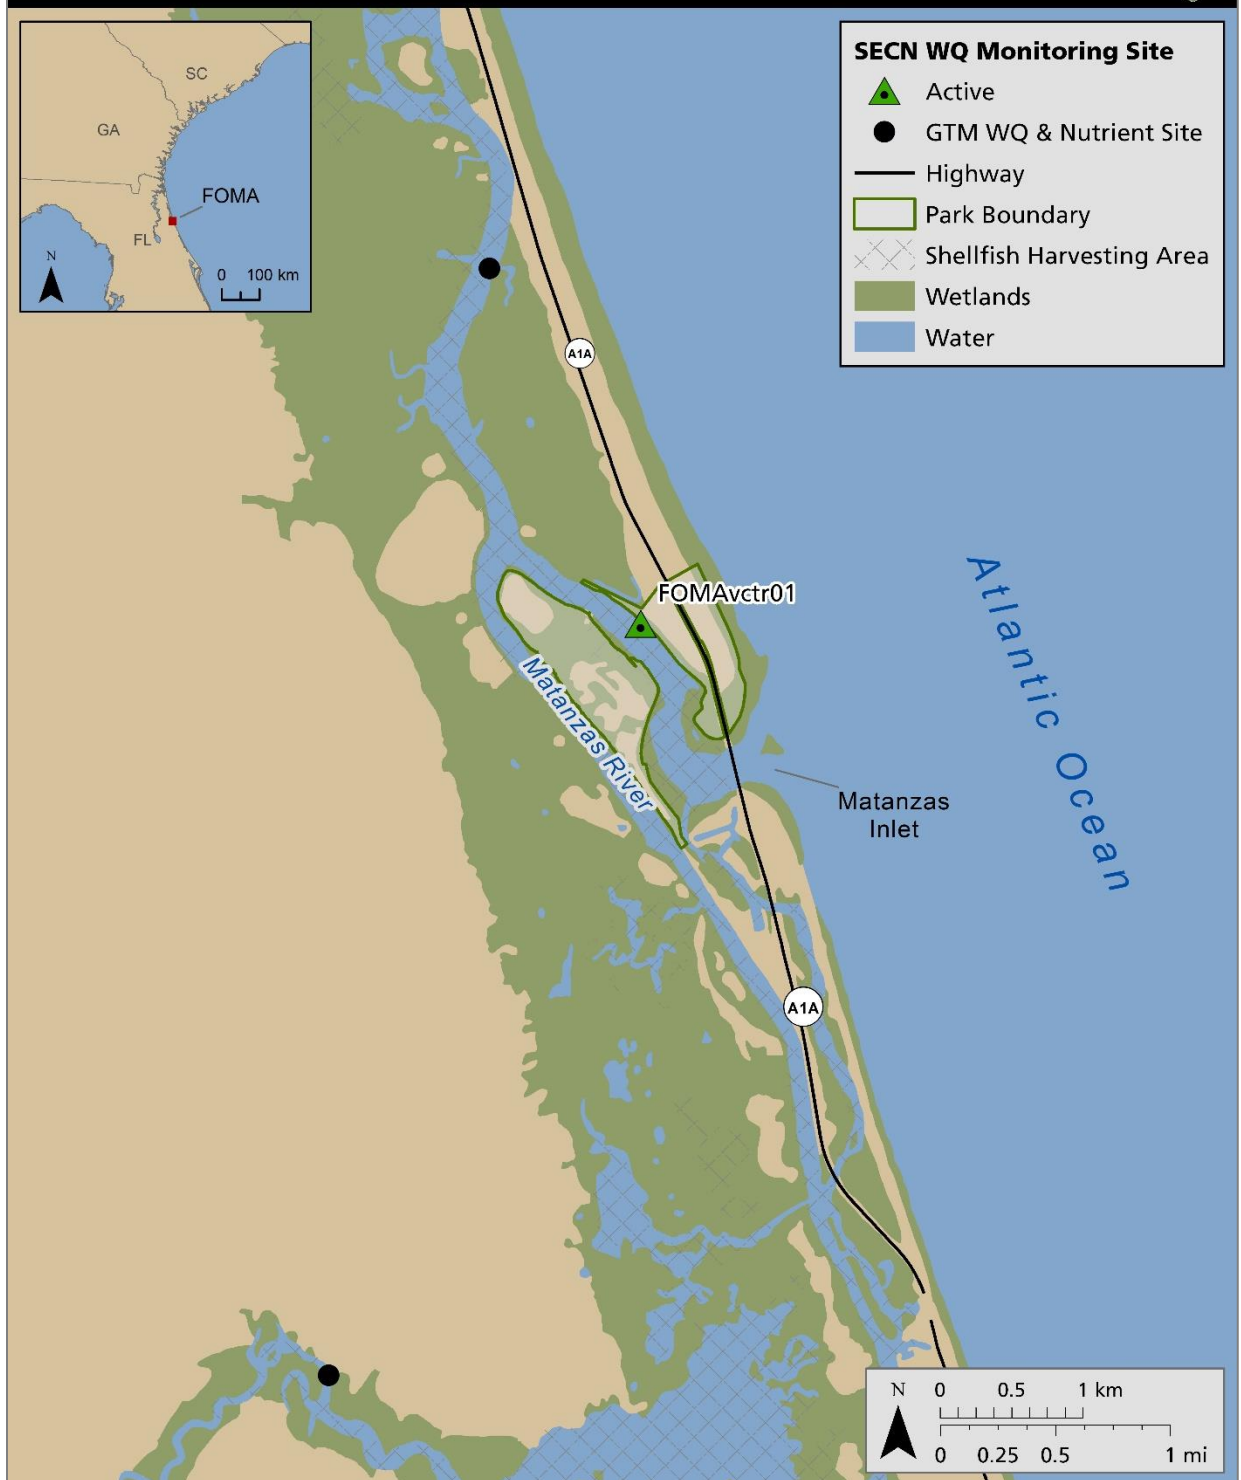
**Figure 1.** Fixed station monitoring sites and estuarine and marine water resources in the vicinity of Fort Matanzas National Monument in Florida. Indicated are areas of salt marsh (FWS 2024), and areas designated as having special uses or restrictions (NOAA 2008). NPS / SECN

The St Johns River Water Management District (SJRWMD) is currently monitoring water quality monthly in the Matanzas River at County Road 312 approximately 15 miles (24.1 kilometers) north of the park as part of their ongoing water-quality assessment program (SJRWMD 2023). Even with the level of development in the watershed, the Matanzas River is one of the most natural areas within the St. Johns River Water Management District's 18-county region along Florida's central east coast and was nominated as an Outstanding Florida Waters (OFW) by the St. Johns River Water Management District (2009).

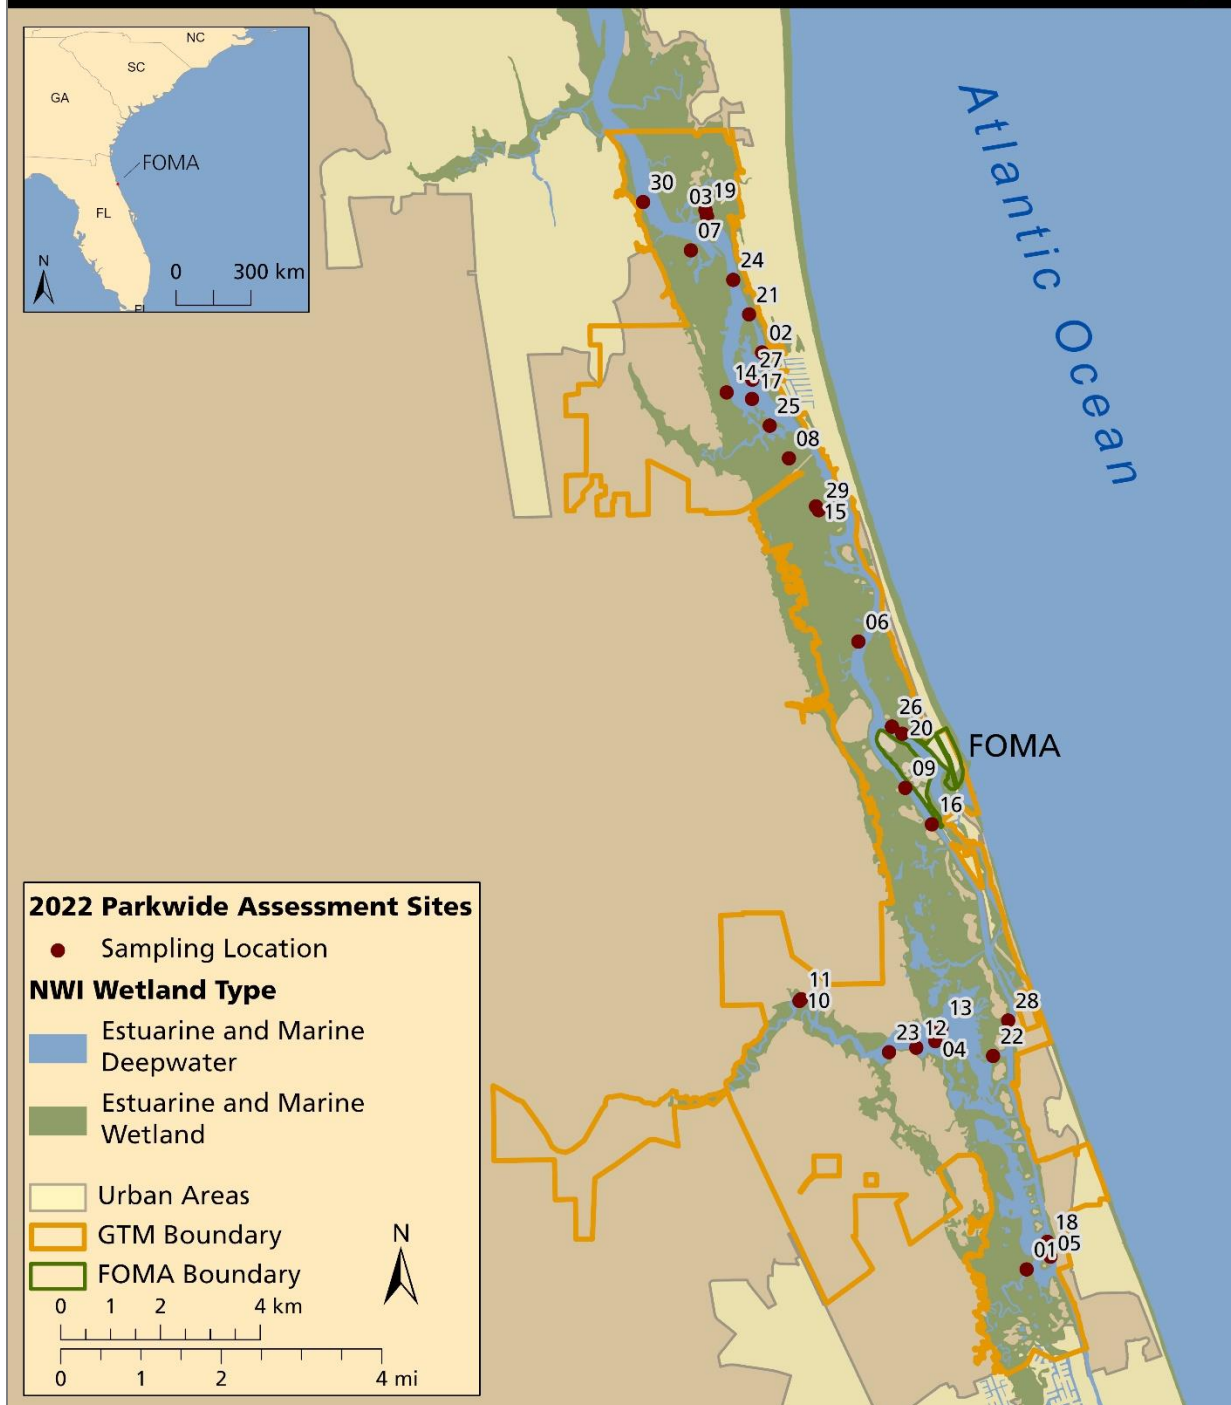
**Figure 2.** Map showing the location of parkwide assessment sites (site numbers from Table 1) sampled in July 2022 at Fort Matanzas National Monument. NPS / SECN

In 2022, thirty sites in estuarine waters near the monument were randomly selected for monitoring following methods developed by the EPA (Table 1, Figure 2; Stevens 1997; Stevens and Olsen 1999; Stevens and Olsen 2004). This method of randomly selecting spatially-balanced sites provides managers with a statistically valid estimate of the overall conditions of the assessed resource within or around the park.
