## **Memorandum – Coastal Engineering Review Pictured Rocks National Lakeshore (PIRO) – Miners Beach Stairs TAR 26824**

10 April 2023

### **REVIEW REQUEST SUMMARY**

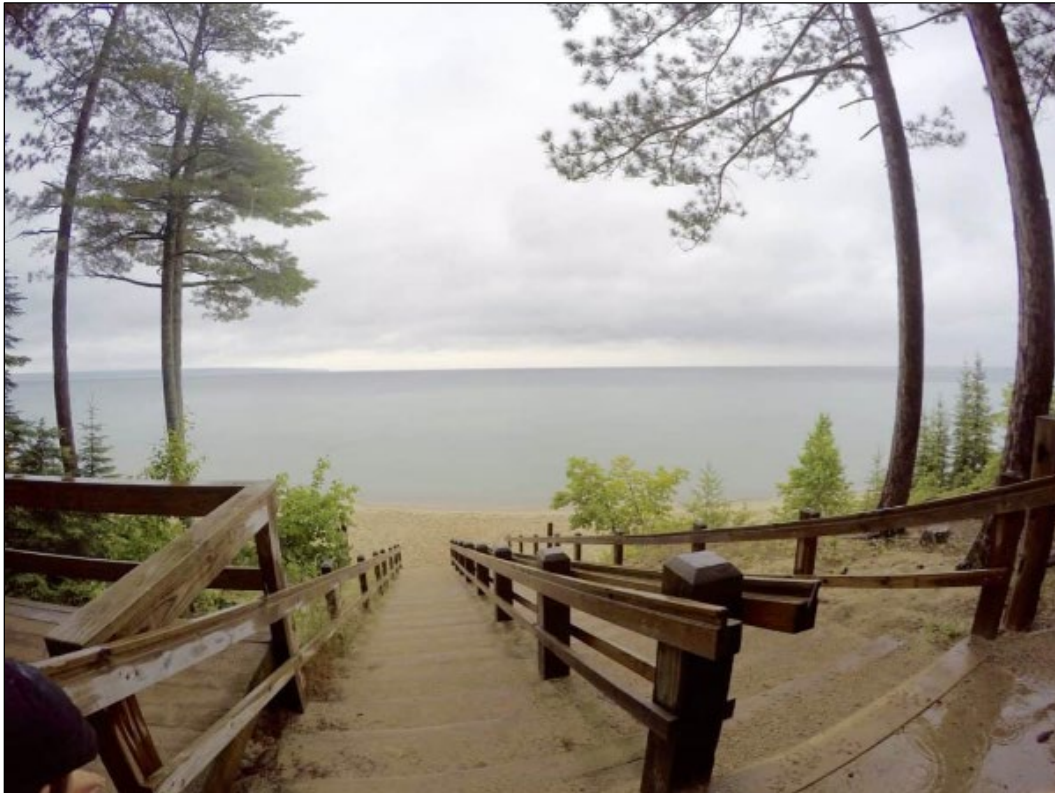
Figure 2 shows the original layout of the stairs. These stairs were made of timber, were approximately 15 feet high, 12 feet wide, 45 feet long and contained about 25 steps (Google Earth Pro 2016). Figure 3 shows the stairs after they were damaged in the October 2022 storm. These stairs are made of timber. Before these stairs were damaged, they were approximately 18 feet high and contained about 18 steps from the top of the bluff to a landing, then 12 steps down to the beach (Google Earth Pro 2021).

**Figure 2. Miners Beach Stairs (Exploration America 2017)**

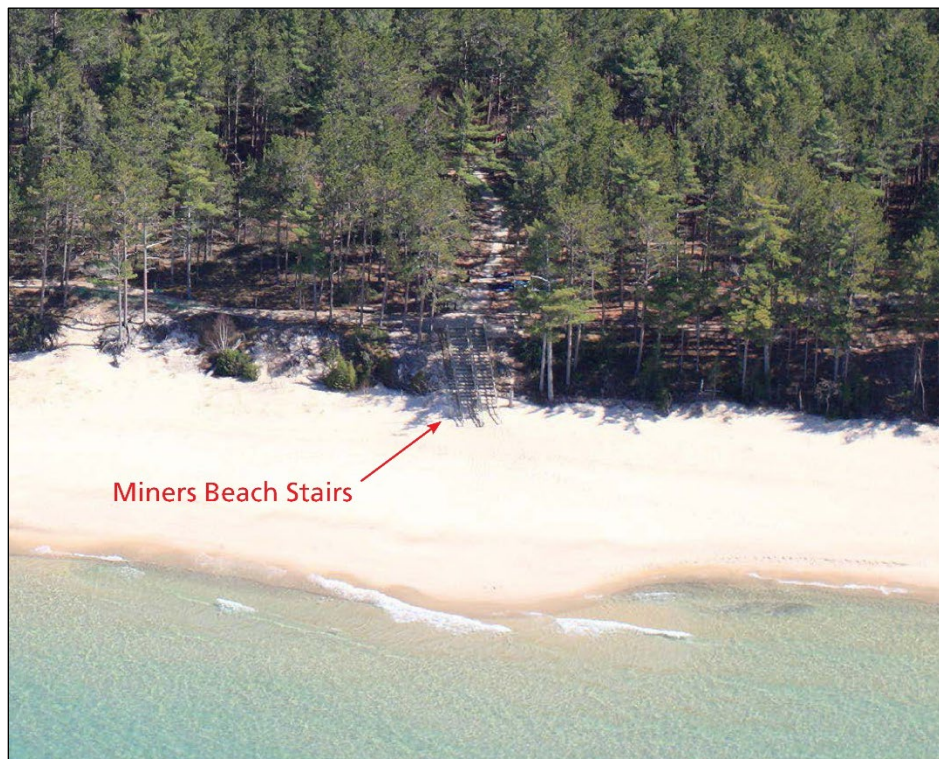
Miners Beach stretches for a mile along Lake Superior and consists of a sandy beach backed by a mostly vegetated sandy bluff approximately 15 feet tall. To either side of Miners Beach are sandstone cliffs that rise and occasionally expose bedrock (NPS 2022). The USDA National Resources Conservation Service soil type for Miners Beach area is 11C – Deer Park sand (Superior Watershed Partnership 2009). The slope at the beach fronting the stairs is 5.1 to 20% and increases to 35.1 to 75% for the bluff (Superior Watershed Partnership 2009). It should be noted that beach slope will vary depending on lake levels and wave factors.

**Figure 4. Shoreline view (EGLE 2023 – Image #SS-0293, Year – 2012)**

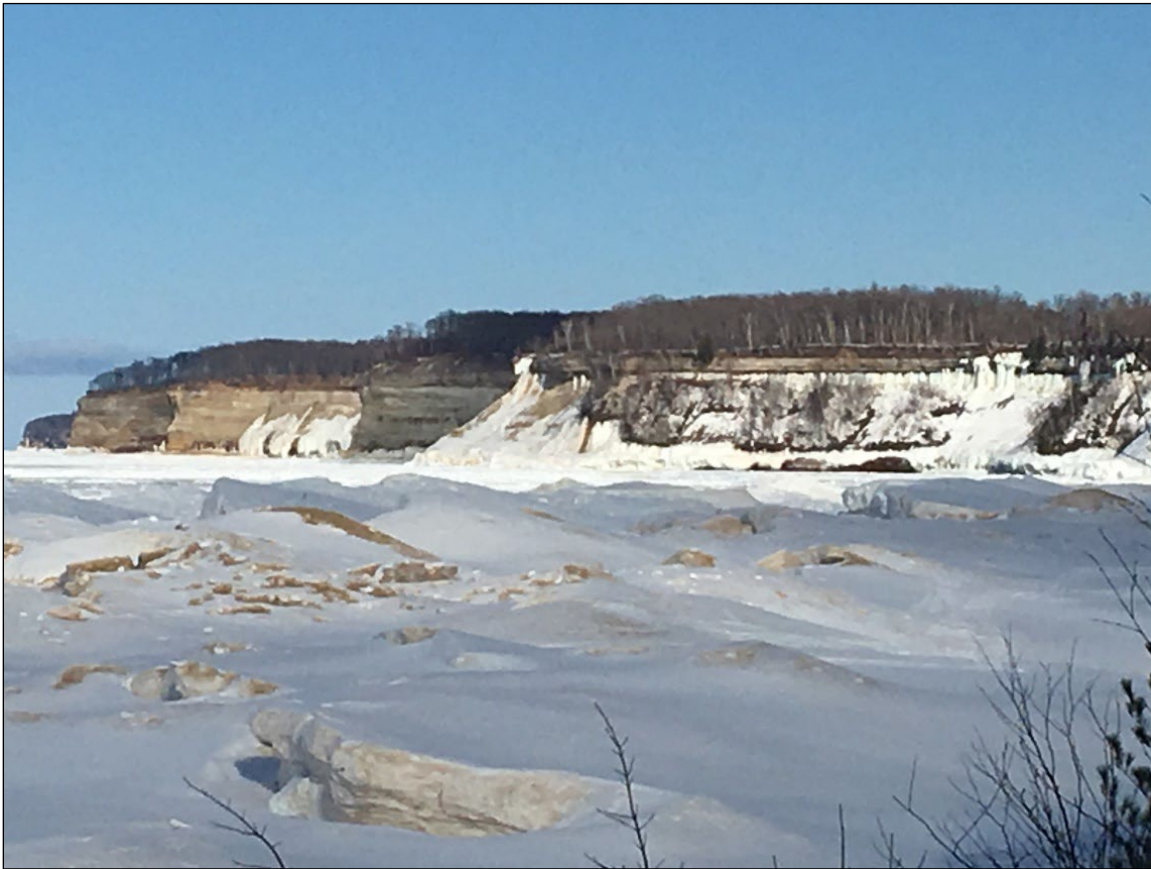
Ice can create vertical and horizontal forces on marine structures and will need to be accounted for in any future stair design. In addition, it may contribute to scour and erosion along the shoreline. As seen in figure 14, ice dramatically affects the shoreline in this area.

**Figure 14. View from Miners Beach towards the cliffs and Bridalveil Falls (NPS 2018b)**

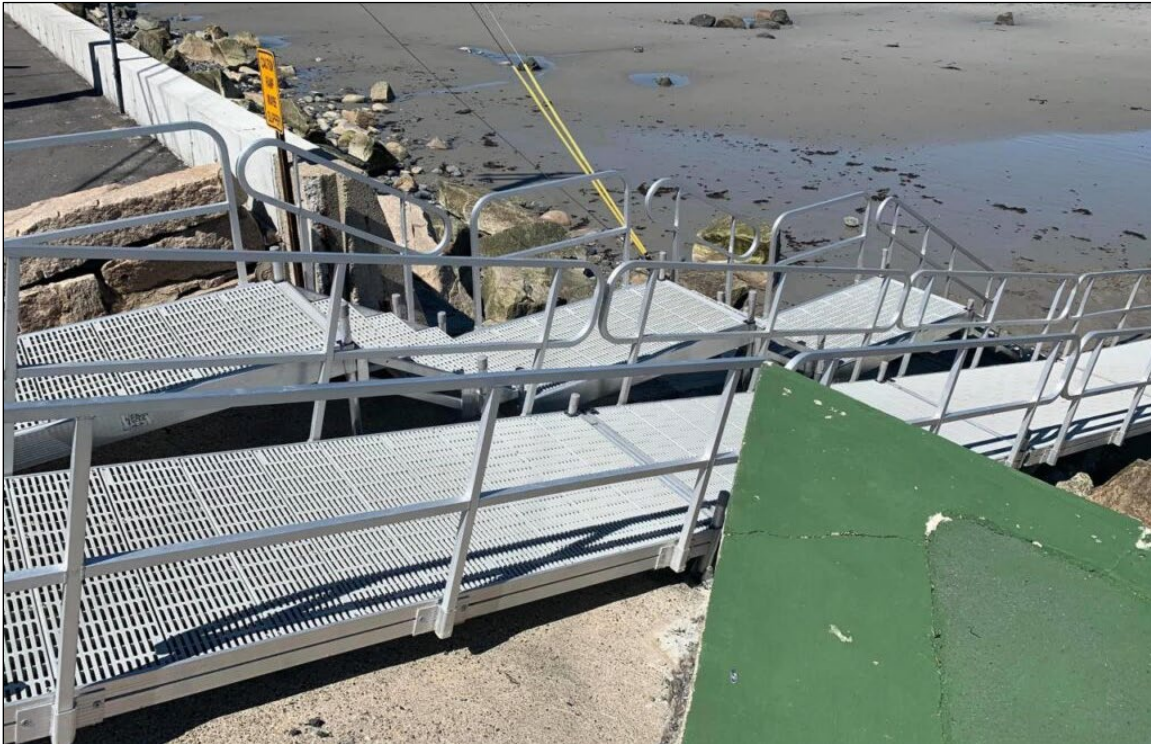
**Figure 16. Commercial Stairs (Dock Doctors LLC 2020)**

4. Robust stair design – This alternative would include developing environmental forces associated with a design criteria and basis of design and designing the stairs to resist those forces. Typically, the 100-yr return period storm event is the recommended design criteria. This alternative could involve replacing the stairs in place or at another location as discussed above. No design for this alternative has been performed but based on the observed damage of the existing stairs, this alternative may require the stairs to be made of a stronger material such as concrete foundation and/or steel or aluminum frame to resist the wave forces. In addition, piles and a concrete foundation may be required to resist the forces. This alternative would likely be the highest cost alternative, but it would be more resilient than other alternatives. Figure 16 shows an example of what these stairs might look like.

To reduce the forces, and reduce the amount of structure required, break-away or flow-through stair treads could be considered. If break-away treads are chosen, stair treads may need to be replaced following storm events.

The primary benefits of this alternative would be safe and resilient access to the beach. These stairs would be designed to resist forces associated with a design storm event. They would reduce the amount of maintenance that is currently required to repair the existing stairs, however the beach grade at the toe of the stairs would need to be maintained. It is estimated that the cost for this alternative would be in the high range.
