# Field reconnaissance of Spud Rock Spring, July 24-26 2018

Don Swann (Saguaro NP biologist) and Eleanor Ludkey (Geoscience-in-Parks), August 4, 2018

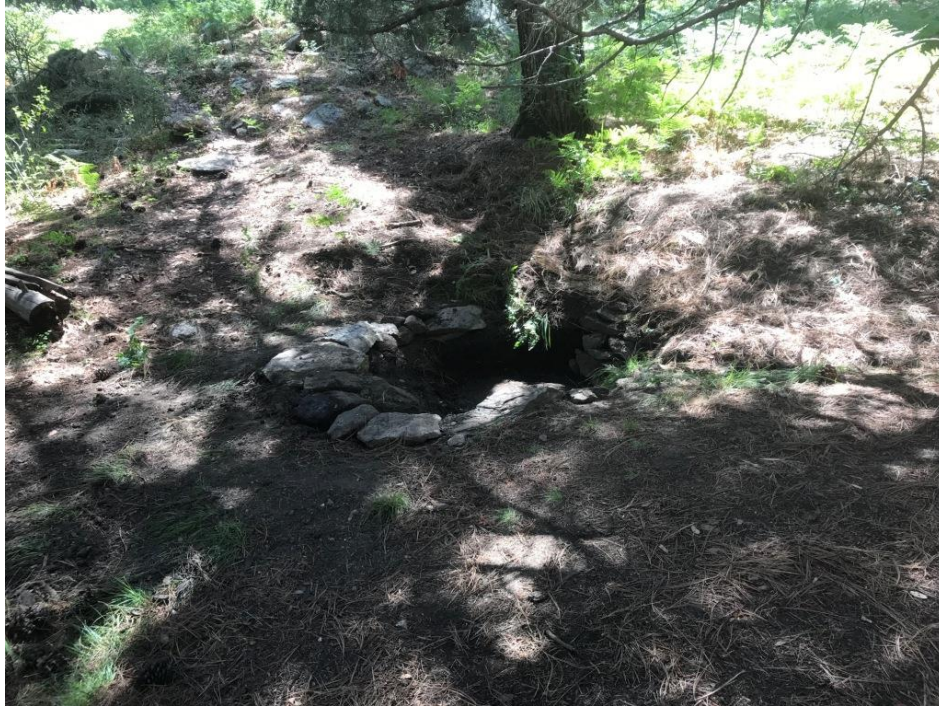
*The current Spud Rock Spring as it appeared on July 27, 2018, when contained approximately 15 gallons of water. Note absence of riparian vegetation characteristics of natural springs.*

Spud Rock Spring (Figure 1) is the major water source for Spud Rock Campground. The Spud Rock area has been occupied for >100 years, and the spring has long been a water source for farming and human and stock use. During the past 10-20 years, Spud Rock Spring has become very unreliable. It often goes dry and for most of the year is simply a mud hole. At least two groups of hikers have become sick from drinking water from the spring in the past few years, despite having claimed to filter it.

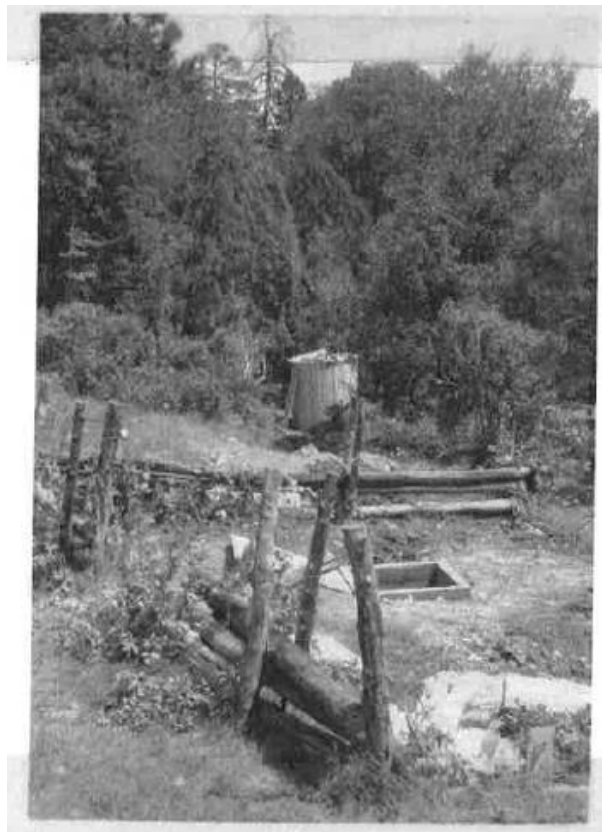
*Spud Rock Spring, Saguaro National Park. Dated 1953. Note concrete spring box in foreground, corral to protect spring area, and water tank in background.*

In 2016 hydrologist Greg Goodwin with the NPS Inventory and Monitoring program (SODN) and intern Janelle Gaun observed evidence of a large, circular foundation located a few meters north of the current spring. In 2017, DS and JG discovered photographs in the park's archives at the Western Archaeological and Conservation Center that suggested that Spud Rock Spring had been significantly altered in the past, and that these alterations may be impacting the spring today. We found records of a construction project on the spring in the 1950s. We also found photos (Figure 2) of a spring box and water tank. It seemed possible that the water tank originally sat on the large foundation found by SODN, which was located some distance downhill from the spring box. This photo made us consider the possibility that the current spring was in fact not Spud Rock Spring, but a catchment basin located in an upland area at the end of a pipe from the spring box.

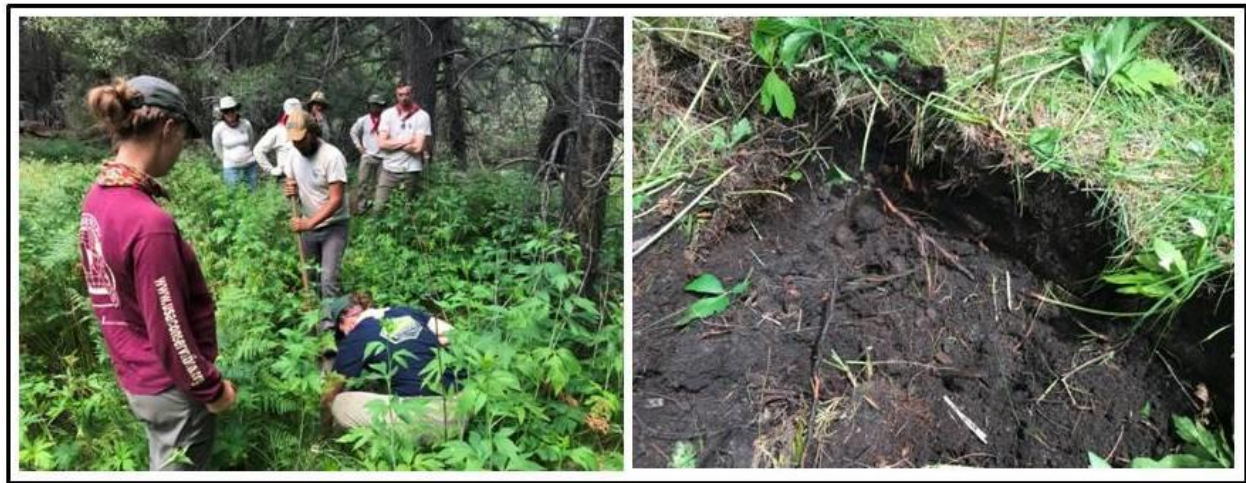
*Figure 3. Initial excavation of spring box, June 24, showing some of the materials removed from the box that were apparently used to fill it when the spring was buried in the 1980s.*

On June 24 we returned to the location and dug into the soggy area. We immediately encountered a concrete wall and discovered a spring box approximately 6" below ground level (Figure 3). We removed the sod and partially excavated the box, which was 93 cm<sup>2</sup> and about 95 cm deep. The spring box was full of mud, and debris that included a few rocks, some large pieces of concrete, a sheet of corrugated metal, some screening material (as from a screen door) and a number of logs (Figure 4). Some of the logs had spikes in them, suggesting they had been part of the fence. After removing some of the material, we located a metal pipe that entered the box at approximately 2' in depth. Then we re-filled the hole.

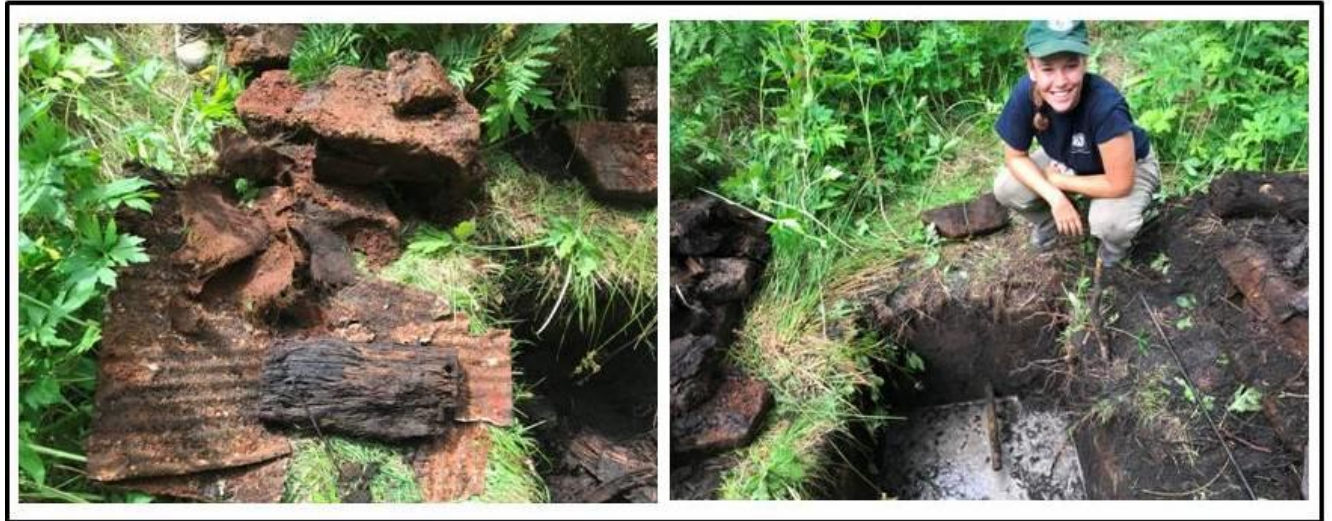
*Figure 4. Left: objects removed from spring. Right: EL with partially excavated spring box showing pipe at approximately 2 ft depth.*

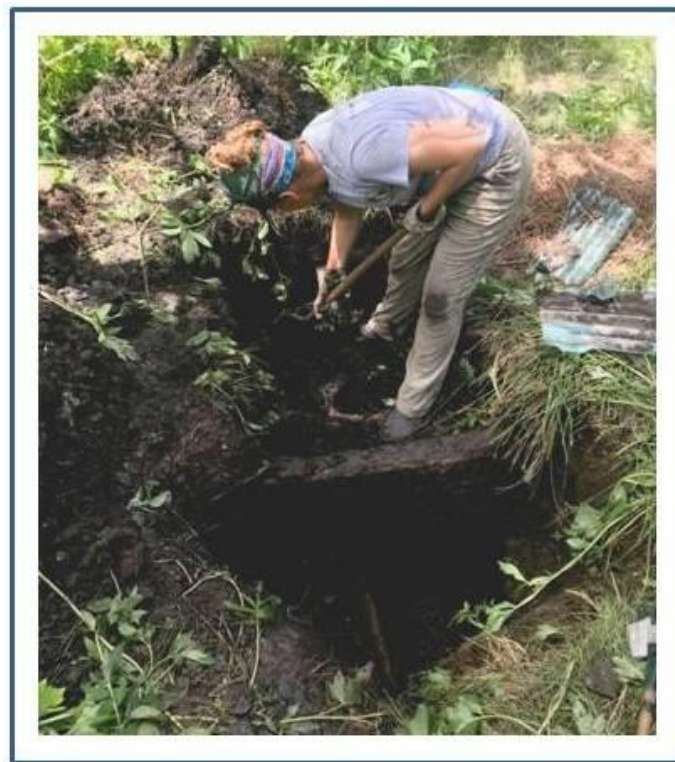
*Figure 5. Pipe shown exiting spring box on north side; EL is in interior of box, re-excavating it on July 26.*

On June 26 we returned and completely excavated the spring box. To confirm that the pipe actually exited the box and had not been cut off there, we dug along the north side of the box. We found a fiberglass sheet in this hole, and confirmed that the pipe exited the box (Figure 5).

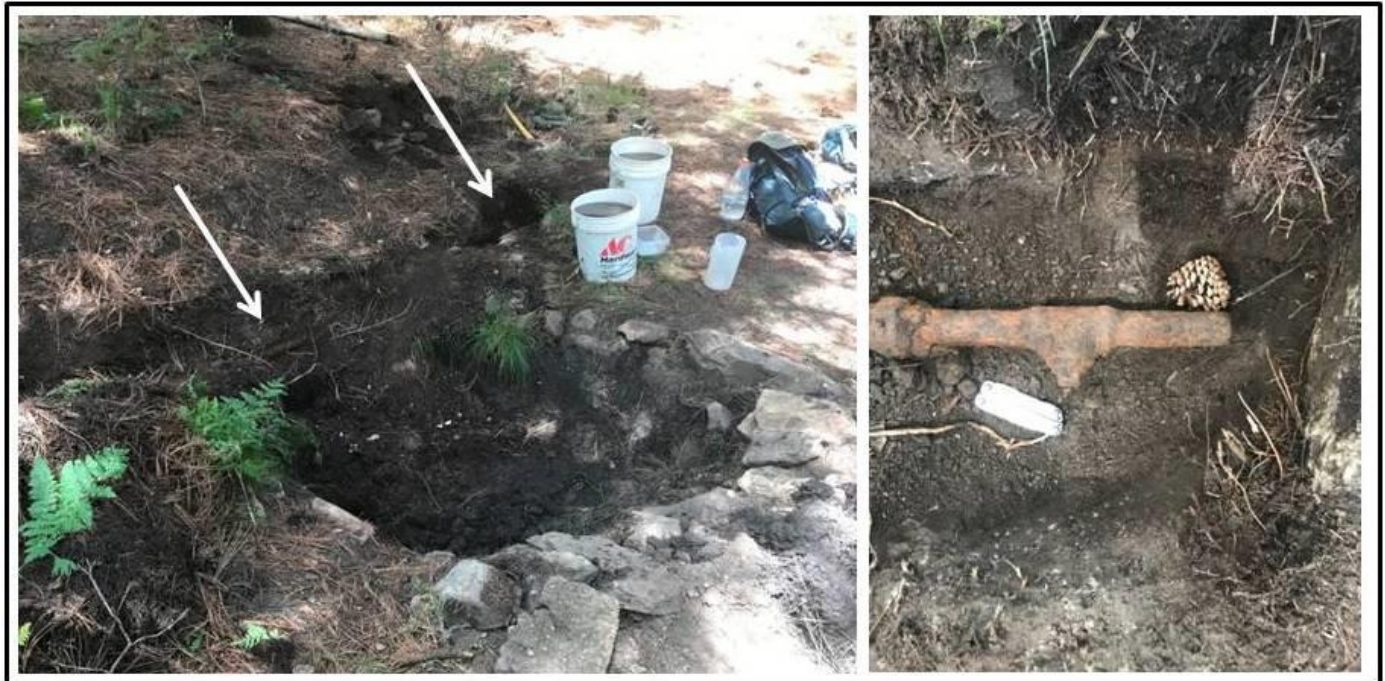
*Figure 6. Left: arrows indicate location of pipe running just uphill of current Spud Rock Spring, approximately 20 m north of spring box. Right: pipe where it has been cut and lies at base of foundation of former water tank, also indicated by right-hand arrow in left figure.*

Following the straight line of the pipe to the current spring, we dug a trench on the uphill side of the spring a few feet SW of it. At a depth of about 6" we came across the pipe again (Figure 5). We excavated the pipe to the north until it dead-ended at the foundation. There we discovered it had been cut (Figure 6).

Based on the cut pipe we surmised that the water in the spring was from the pipe that came from the spring box. To confirm that water was not entering the mud hole from the ground, we excavated the ~15 gallons of water in the spring to see if it would re-fill. It did not, and replaced the water. After two hours, it had still not drained into the soil, confirming there is some type of clay bottom in the hole.

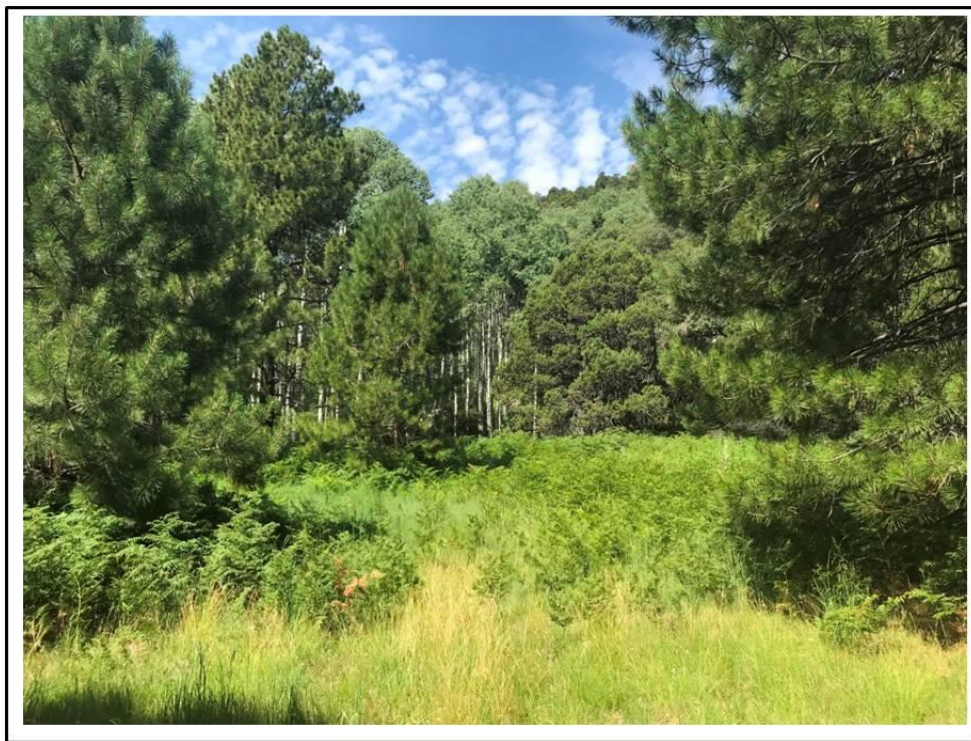
*Figure 7. Spud Rock meadow. This meadow immediately upslope of the spring box presumably contains an alluvial aquifer that provides seasonal water to the spring box.*
