# **DETERMINATION OF ELIGIBILITY FOR THE PINNACLE OVERLOOK DEVELOPED AREA**

## **CUMBERLAND GAP NATIONAL HISTORICAL PARK, LEE COUNTY, VIRGINIA AND BELL COUNTY, KENTUCKY**

**Prepared for  
National Park Service,  
Southeast Regional Office**

**September 2023**

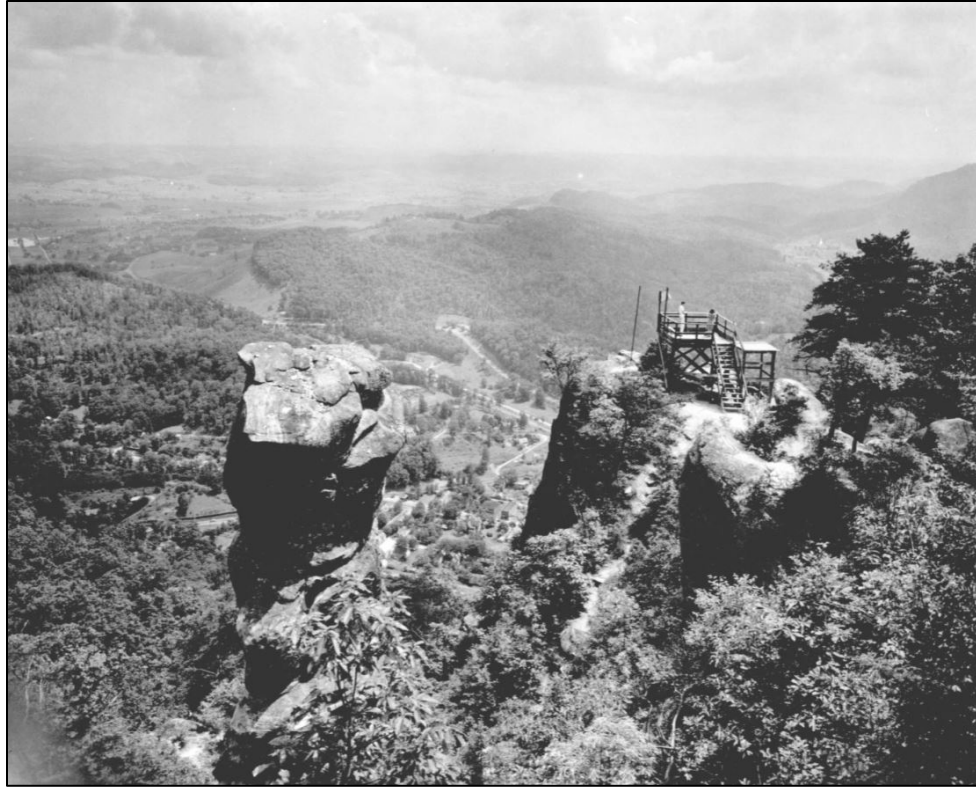
Figure 7. Wooden overlook tower at the Pinnacle, July 1941 (Image courtesy of the Department of Conservation Photograph Collection, 1937–1976, Tennessee State Library and Archives, Nashville, Tennessee).

The Pinnacle consists of a tall rock cliff that overlooks the saddle of Cumberland Gap. The area offers spectacular views of the surrounding countryside and has long been recognized as a point of scenic interest in the tri-state region. The area’s commercial appeal was first explored by businessman J. L. Manring in the late 1920s. In 1928, Manring formed the Sky Land Company to develop a toll road—later known as Skyland Road—to the top of the Pinnacle (Sirna 2015). Following the road’s completion, a dedication ceremony was held in June 1929. Just three months later, the *Lexington Herald* reported that more than 14,000 people had visited the Pinnacle since the completion of Skyland Road (*Lexington Herald* 1929). While the Sky Land Company initially had plans to erect a “model filling station” with a “sanitary lunchroom” and souvenir shop at the Pinnacle, very little infrastructure was actually constructed during this early period (Sirna 2015). Throughout the 1930s and 1940s, facilities at the Pinnacle consisted of an unpaved parking area and primitive wooden lookout tower, with utilities such as electric light and water provided (Figure 7 and Figure 8).

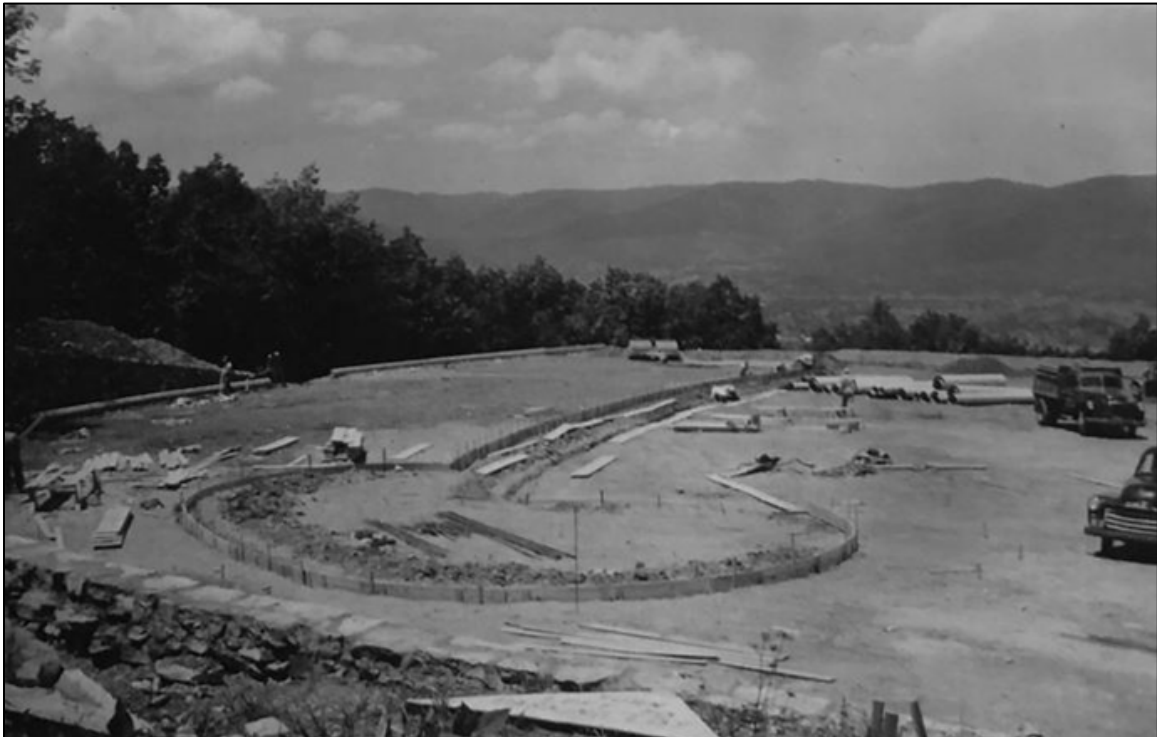
Figure 9. Pinnacle Parking Area under construction, ca. 1956 (Image reprinted from National Park Service 1956).

Following the establishment of Cumberland Gap National Historical Park in September 1955, the redevelopment of the Pinnacle was considered of utmost importance to park officials. In February 1956, working drawings for the construction of a parking area and overlook were developed by the Eastern Office of Design and Construction (EODC) of the National Park Service (National Park Service 1956). The following month, a contract in the amount of \$77,728 was awarded to the Southern Landscape Company of Maryville, Tennessee for the project's construction (*Johnson City Press* 1956). Work commenced in April 1956 in accordance with Contract Drawings NHP-CG 3011 (National Park Service 1956). Early construction was completed by July 1956 and included basic sub-grading of the existing parking area, as well as the construction of drainage structures, retaining walls, and a masonry overlook (Figure 9).

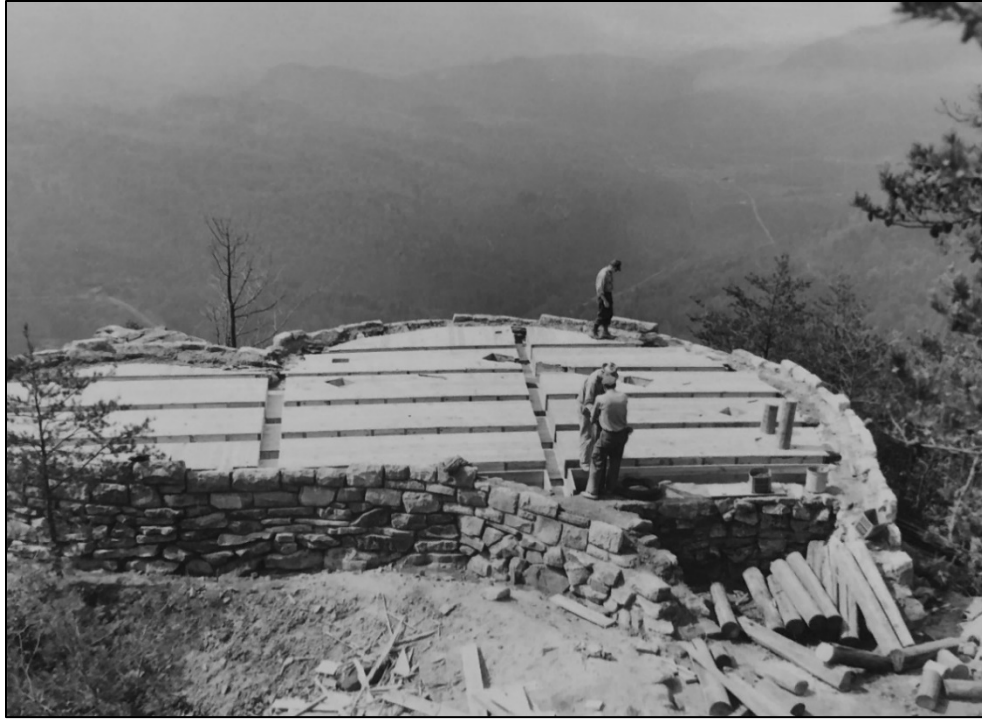
Figure 10. Construction of the Pinnacle Overlook Terrace, taken in April 1956 (Photograph on file at the Cumberland Gap National Historical Park archives, Middlesboro, Kentucky [Classification No. 978, Negative No. 2461]).

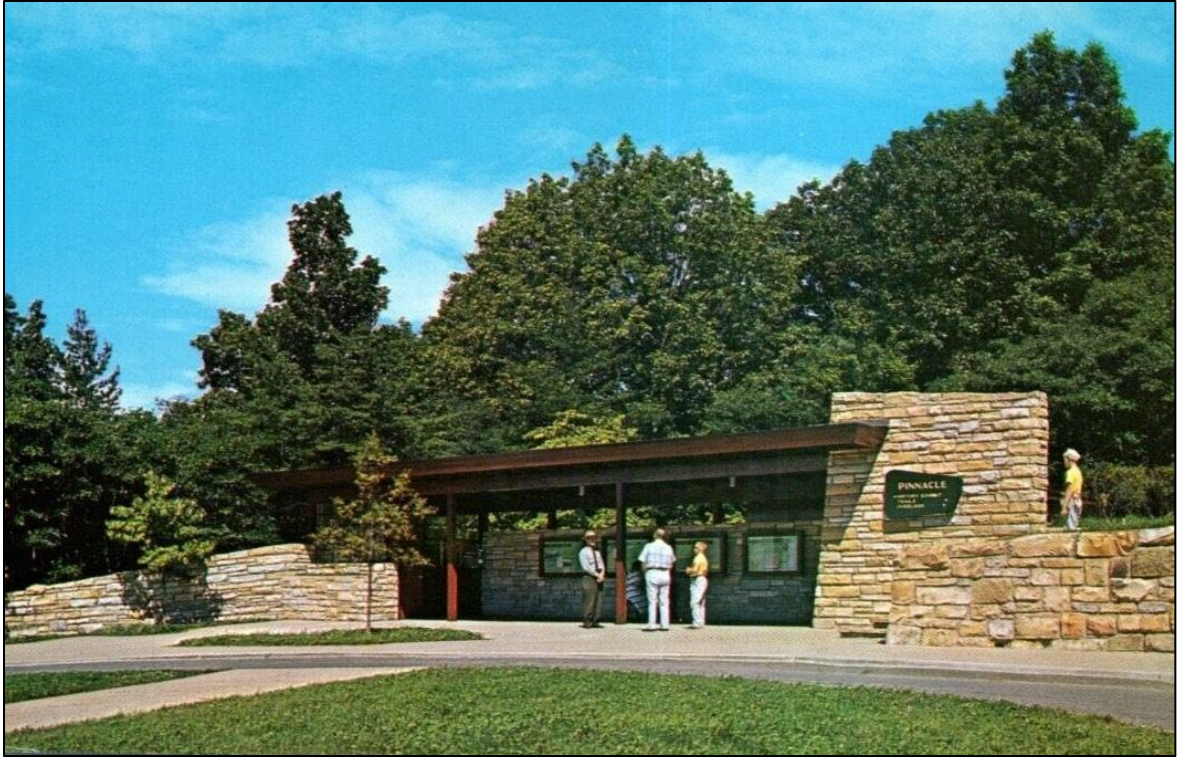
Figure 12. Postcard showing the Interpretive Shelter and Comfort Station as it appeared shortly after construction, ca. 1960s. Note the trailside exhibits installed on the interior (Photograph courtesy of Walter and Co. Inc., Williamsburg, Virginia).

They were approved by Edward Zimmer, Chief of the EODC, as well as Park Superintendent Millard D. Guy, later that summer. The total cost of the shelter's construction was approximately \$20,000 (National Park Service 1957b). Historic plans for the interpretive shelter and comfort station indicate that the structure originally contained a small, enclosed booth on its north end; a large, central display area; and men's and women's restrooms located on the building's southeast corner (Figure 11). According to the Mission 66 Master Plan for Cumberland Gap National Historical Park, the Pinnacle Interpretive Shelter was considered the "hub and heart of interpretive service" and its effectiveness was "largely dependent on operating...as a 'junior' visitor center" (CUGA 1963). Construction of the shelter was completed in February 1957 (Figure 12).

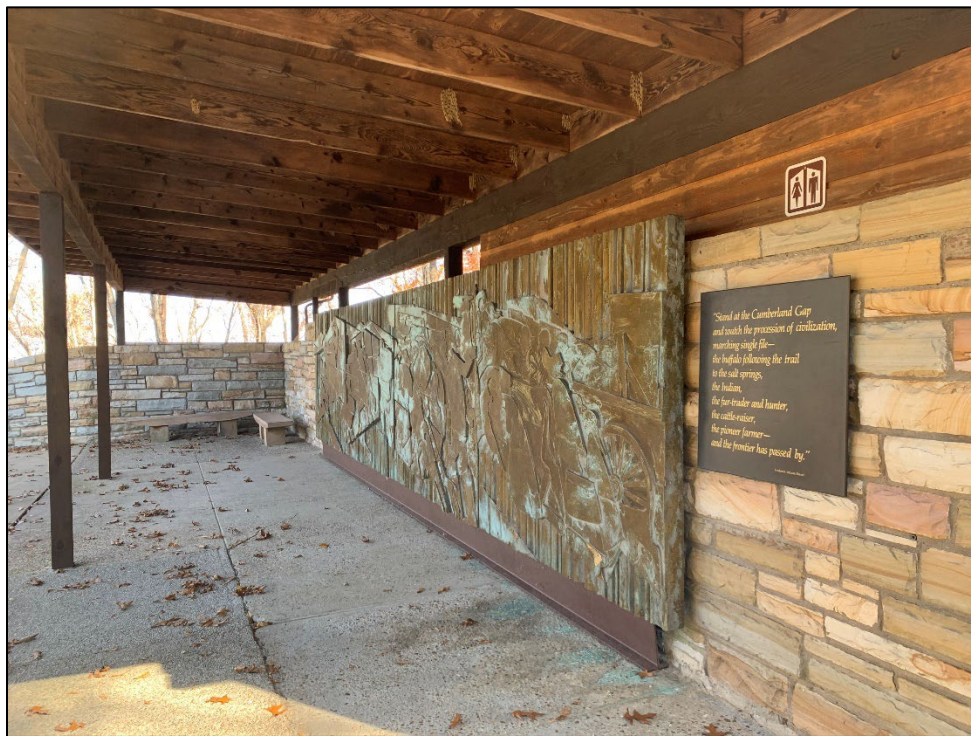
Sometime before 1976, the trailside exhibits located on the interior walls of the interpretive shelter were removed and replaced by a sculptural wood mural created by Franklin Boggs (Photograph 2). Otherwise, all of the changes at the Pinnacle have been related to routine maintenance or the replacement of aging infrastructure and/or landscape features. For example, in 1981, a new water system was constructed for the Pinnacle area. This project was followed, in 1984, by the replacement of the original roof on the Pinnacle Interpretive Shelter and Comfort Station by Montgomery Brothers Roofing Inc. of Nicholasville, Kentucky. The following year, the trails at the Pinnacle were resurfaced by the Kentucky-Virginia Stone Company of Middlesboro. A short spur trail was also constructed on the south side of the Pinnacle Parking Area to provide a wheelchair accessible route to the overlook. While the exact date of the trail's construction is not known, it was likely added sometime after the passage of the Americans with Disabilities Act in 1990.

Photograph 2. View of the current wood sculptural mural displayed on the interior of the Interpretive Shelter and Comfort Station, facing northwest.

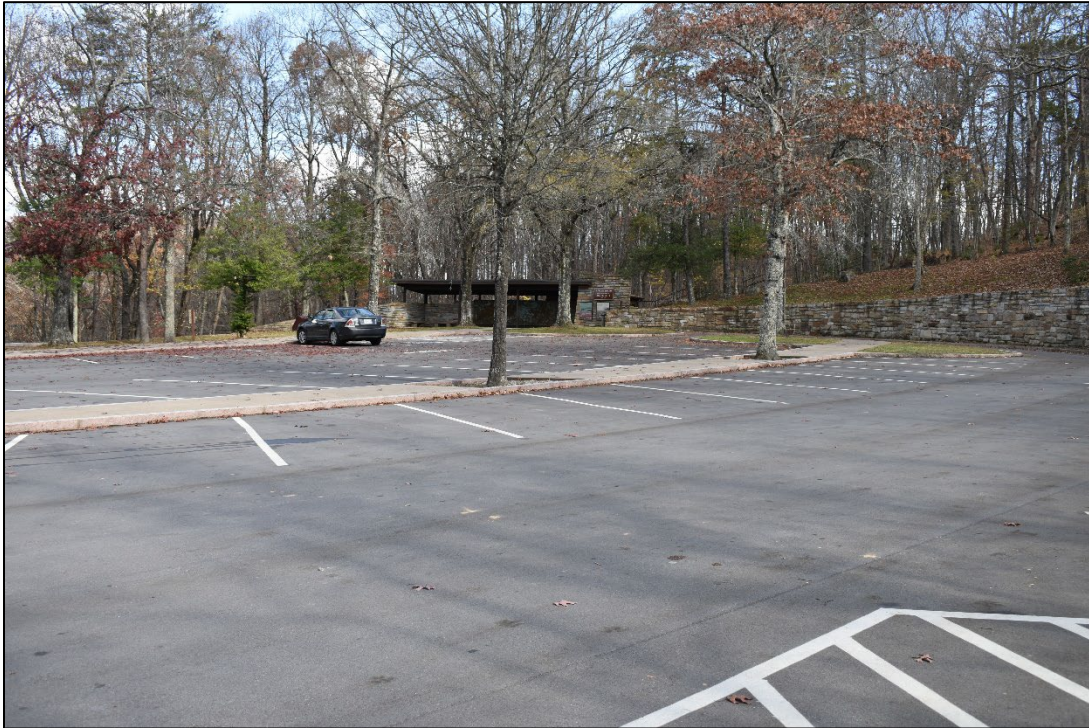
The current circulation system for the Pinnacle Overlook Developed Area centers around the Pinnacle Parking Area, a paved parking lot located at the south end of Pinnacle View Road (formerly Skyland Road). The parking area offers 76 angled parking spaces for automobiles, including three ADA accessible parking spaces. It serves as the central circulation hub for the Pinnacle Overlook Area and provides access to both the Pinnacle Overlook Interpretive Shelter and Comfort Station and the trailhead for the Pinnacle Loop Trail (Photograph 4).

Photograph 4. Overview of the Pinnacle Parking Area, showing its relationship to the Interpretive Shelter and Comfort Station, facing east.

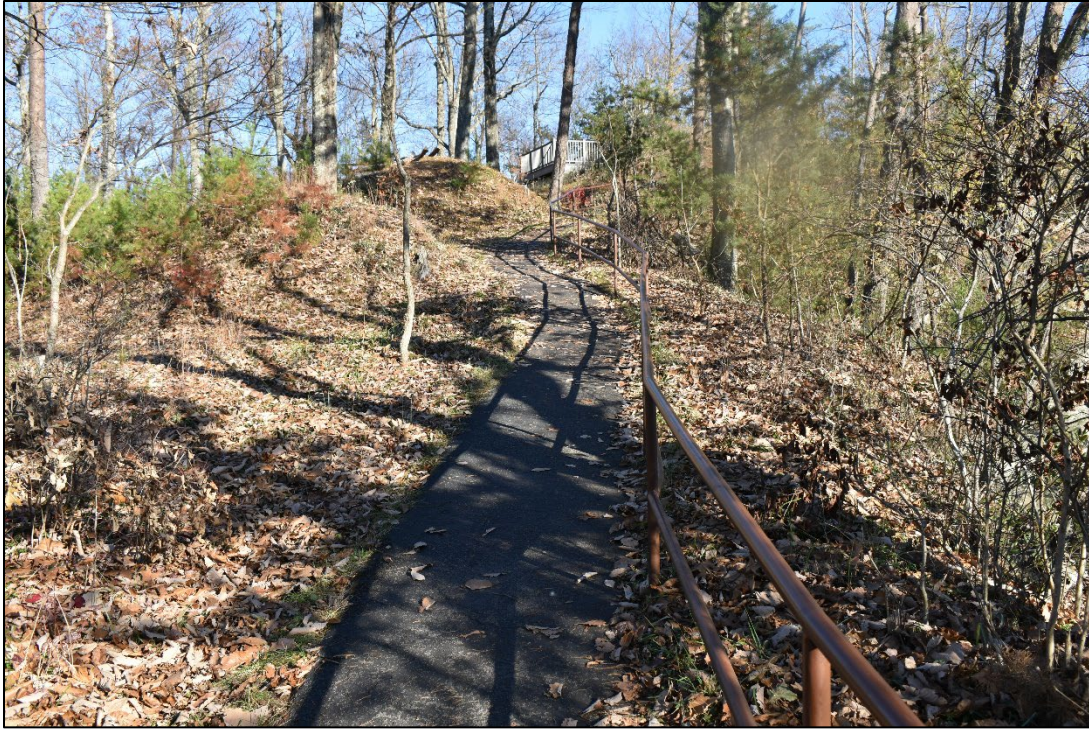
Photograph 5. View of the Pinnacle Overlook Trail showing Fort McCook earthworks, facing northeast.

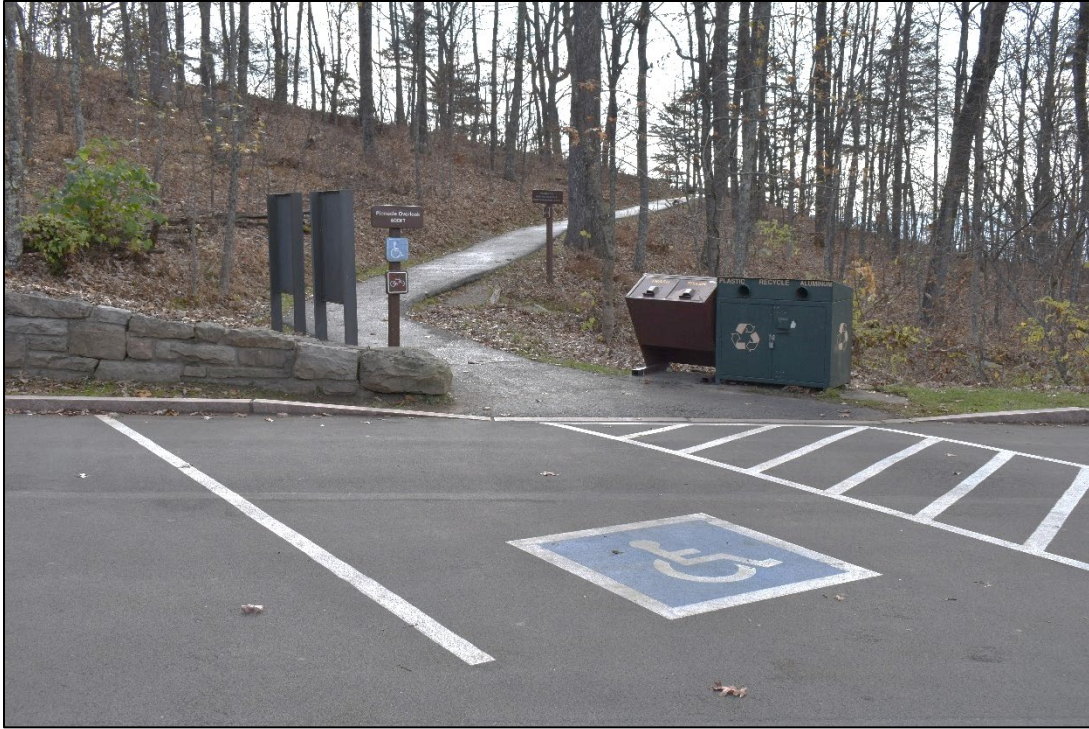
Photograph 6. View of interpretive signage and trash receptacles clustered around the trailhead for the handicap accessible spur of the Pinnacle Loop Trail, facing south.

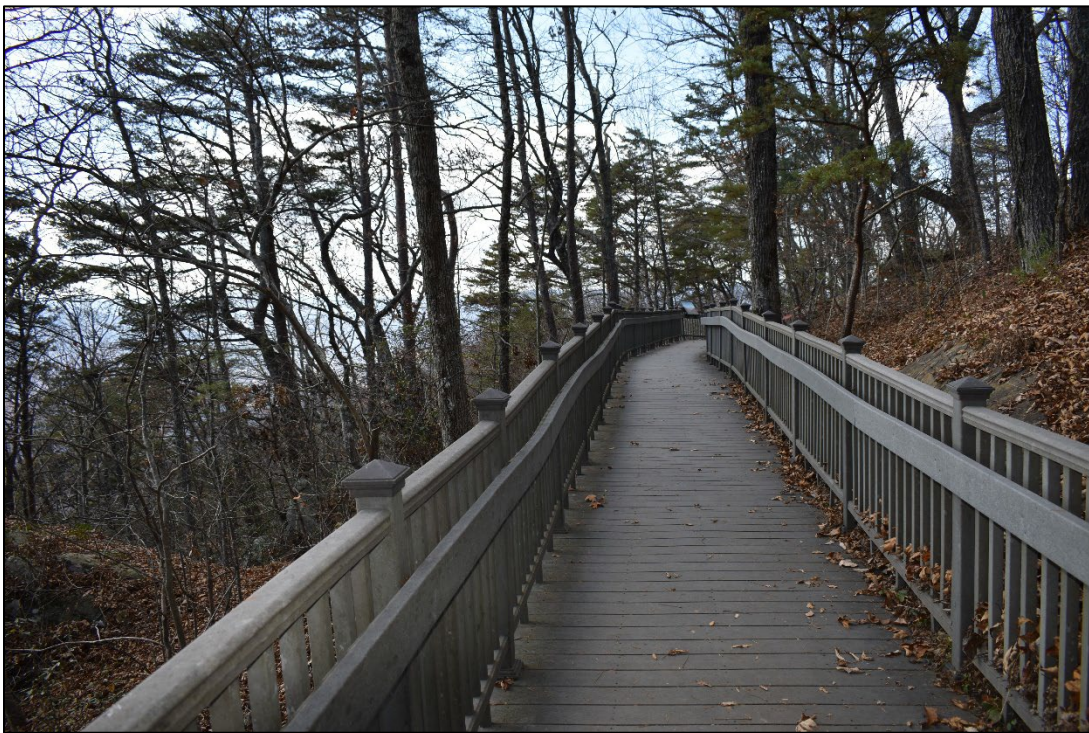
Photograph 7. View of composite boardwalk and railing along the handicap accessible portion of the Pinnacle Loop Trail, facing northeast.

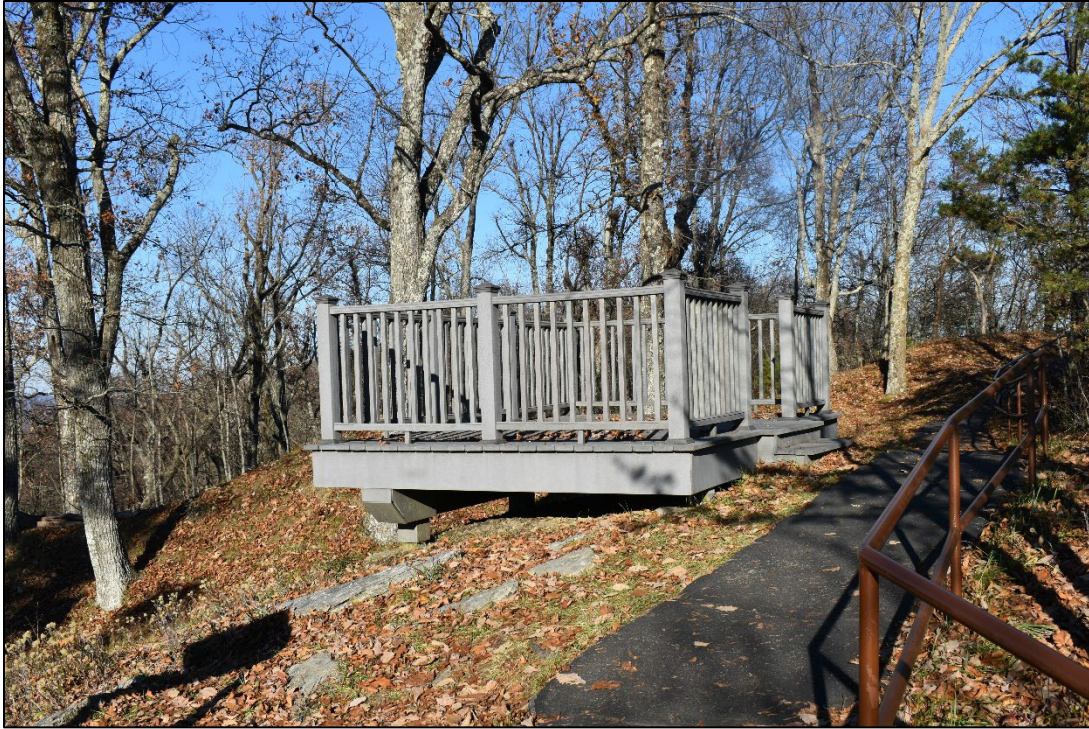
Photograph 8. View of the composite viewing platform at the top of Fort Lyon, facing east.

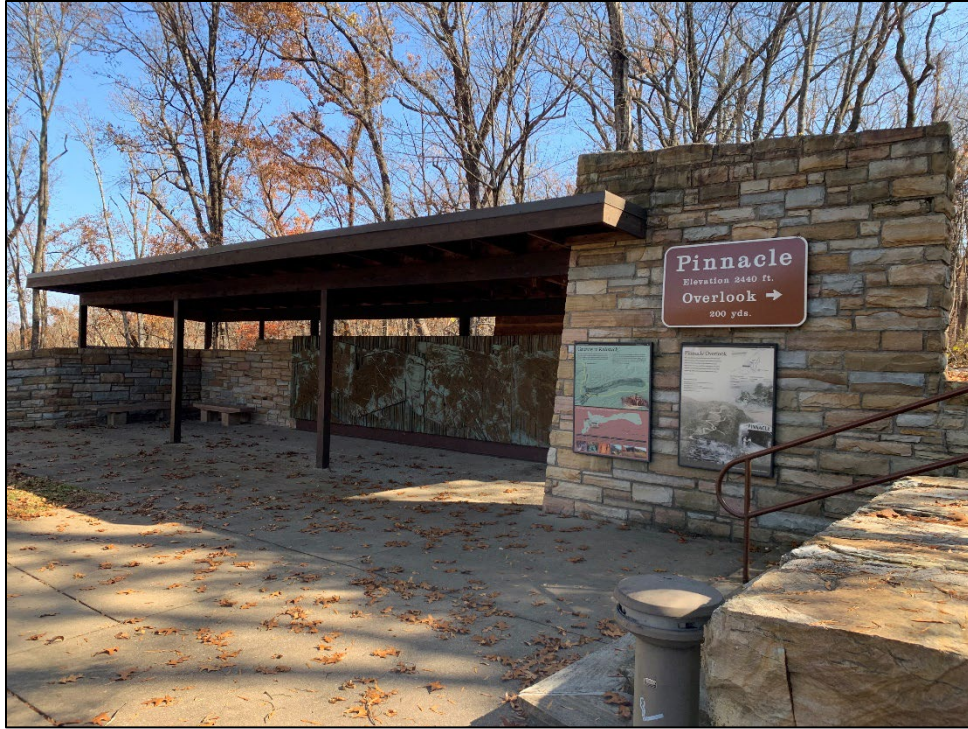
Designed in 1956, the Information Shelter and Comfort Station is a convincing example of the Organic style of architecture, displaying the powerful influence of Frank Lloyd Wright on mid-century American architecture. The tenets of Organic Architecture, as espoused by Wright, include the use of natural building materials in their unadorned state. The stone walls of the Interpretive Shelter and Comfort Station seem to grow naturally from the ground. The timber posts and beams supporting the roof are left unpainted, with the wood grain exposed (albeit stained with a wood preserver). The visitor enters a shelter of wood and stone, materials which imbue the space with an organic character (Photograph 9).

Photograph 9. View of the Interpretive Shelter and Comfort Station, facing southeast.

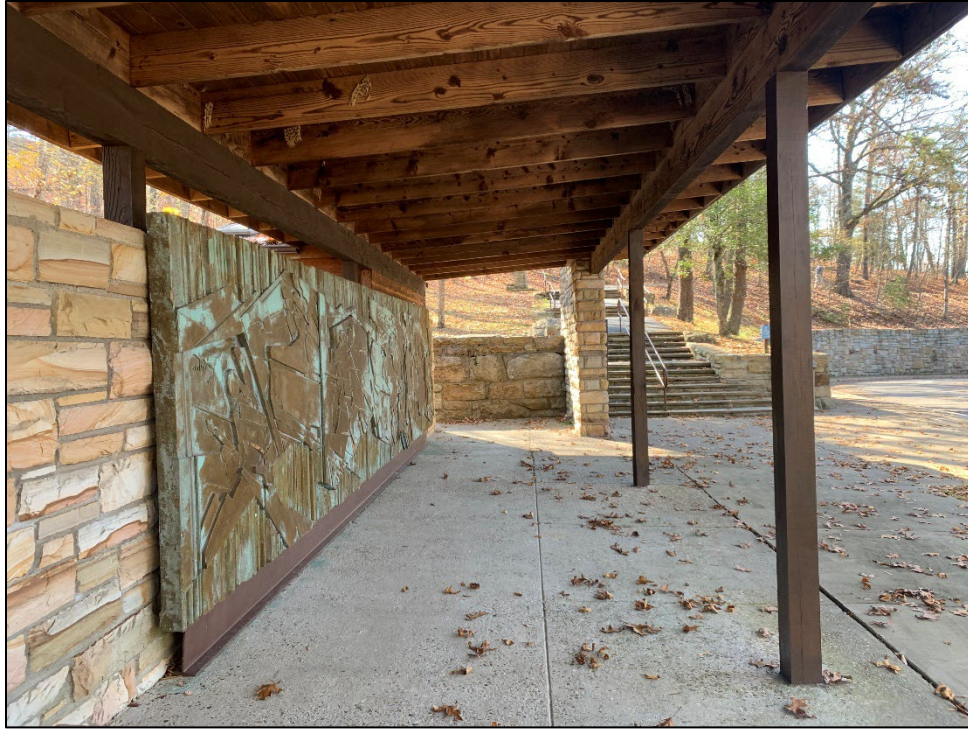
Photograph 10. Interpretive Shelter and Comfort Station, showing the gathering area, facing south.

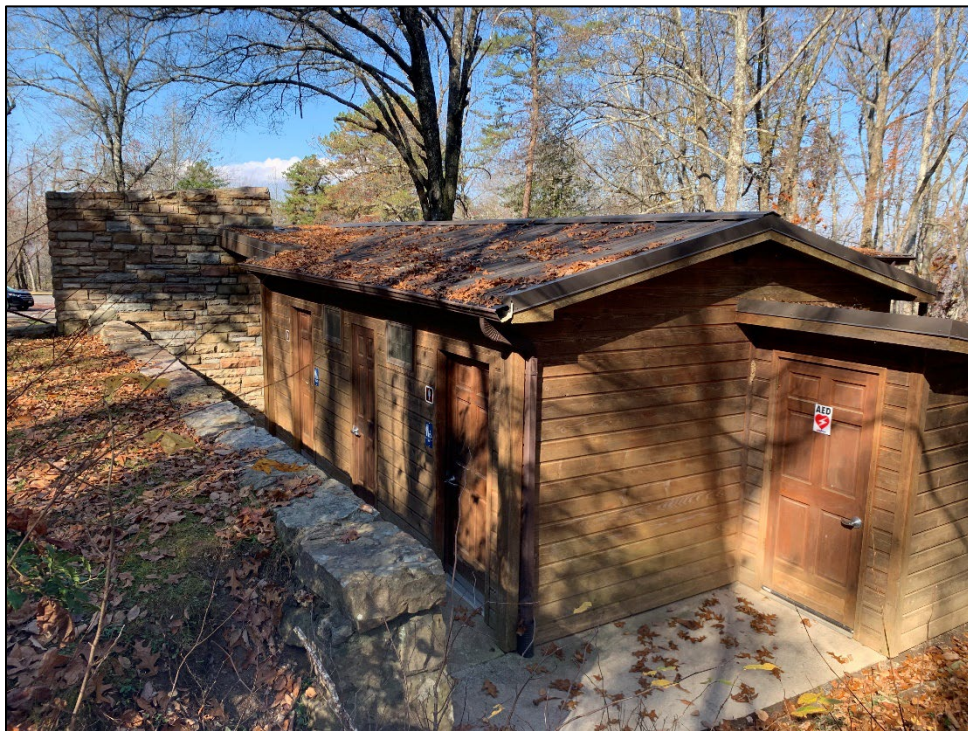
Photograph 11. View of the wood frame restrooms on the rear of the Information Shelter and Comfort Station building, facing west.

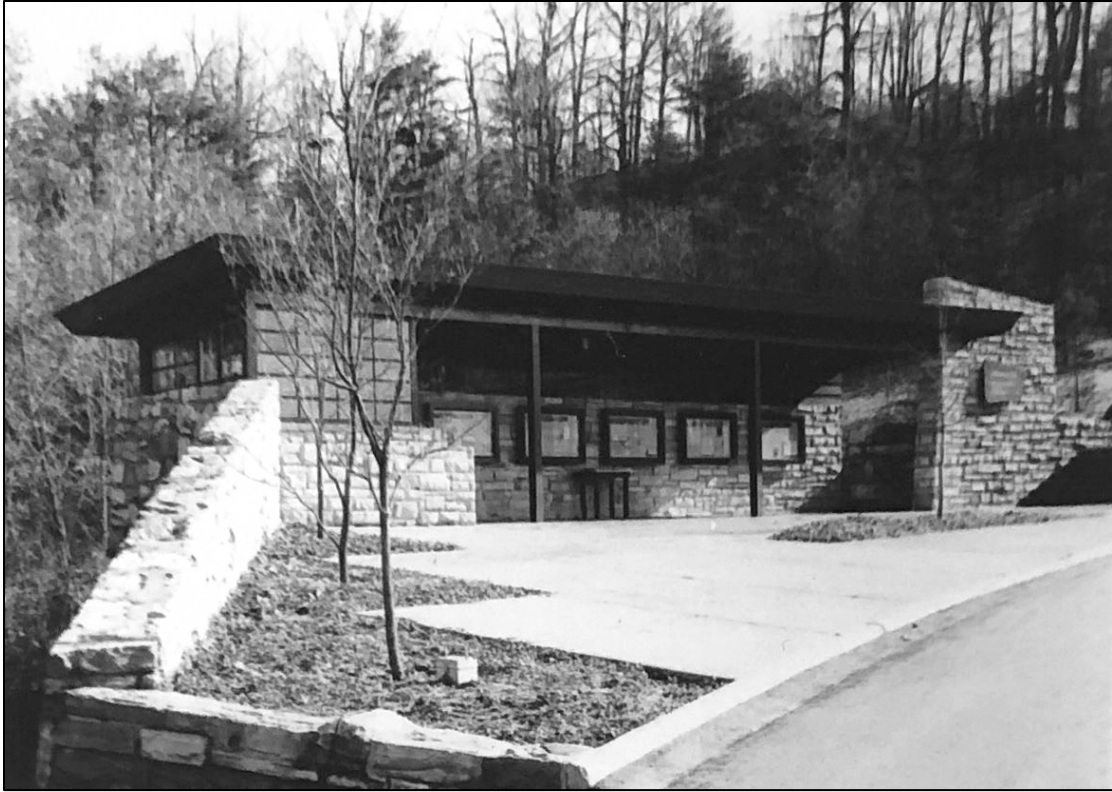
Figure 16. Photograph of the Interpretive Shelter and Comfort Station shortly after its completion, ca. 1958 (Image reprinted from National Park Service 1958).

The Interpretive Shelter and Comfort Station was designed in-house by National Park Service architects of the EODC in Philadelphia, Pennsylvania. The drawings are dated August 10, 1956. Construction was completed in 1957 (Figure 16). The building functions both as a place for visitor orientation, with a covered exterior gathering area for Ranger presentations and a set of park maps and display panels mounted on the walls; and as a

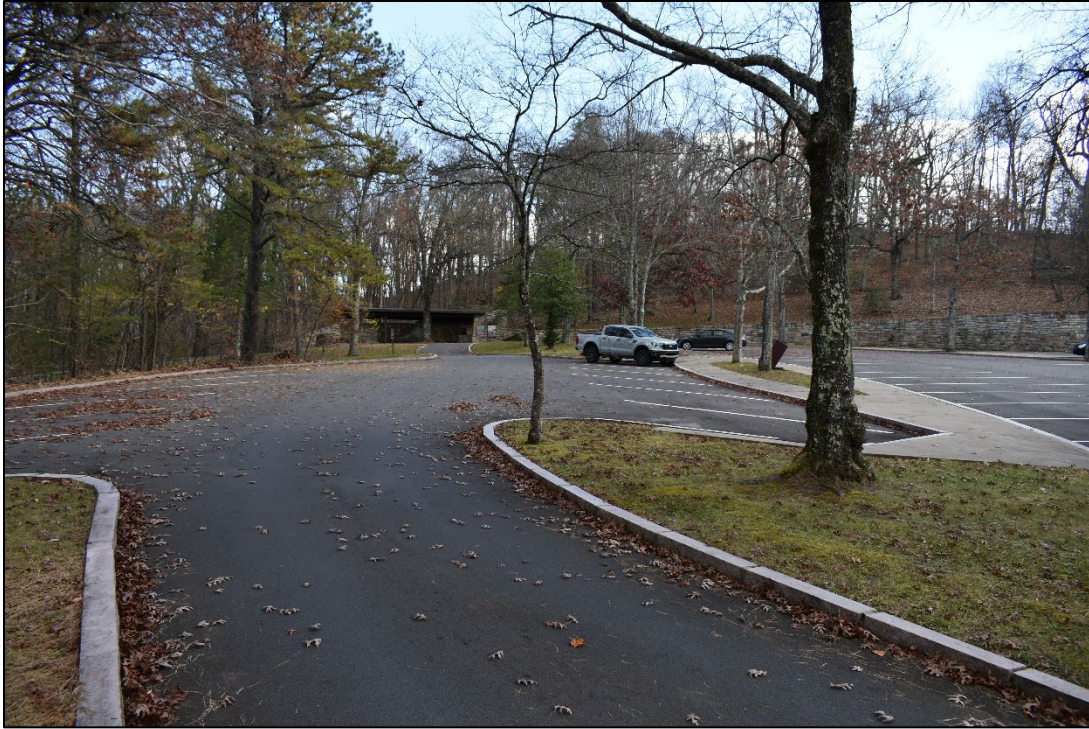
The Pinnacle Parking Area is an elliptical shaped parking lot located at the south end of Pinnacle View Road (formerly Skyland Road). It is situated to the west of the Interpretive Shelter and Comfort Station (Photograph 12). The area is paved with asphalt and contains two irregularly shaped landscaped medians situated between three drive aisles. The medians have a linear design, with an east-west orientation and are situated parallel to each other. The two medians are anchored at their east and west ends by a landscaped island. Each median is constructed of concrete with pink granite curbing. Landscaping throughout the parking area consists of grasses and a variety of mature trees, including Flowering Dogwood and Northern Red Oak trees. A coursed rubble sandstone masonry retaining wall runs along its south side.

Photograph 12. Overview of the Pinnacle Parking Area, facing east.

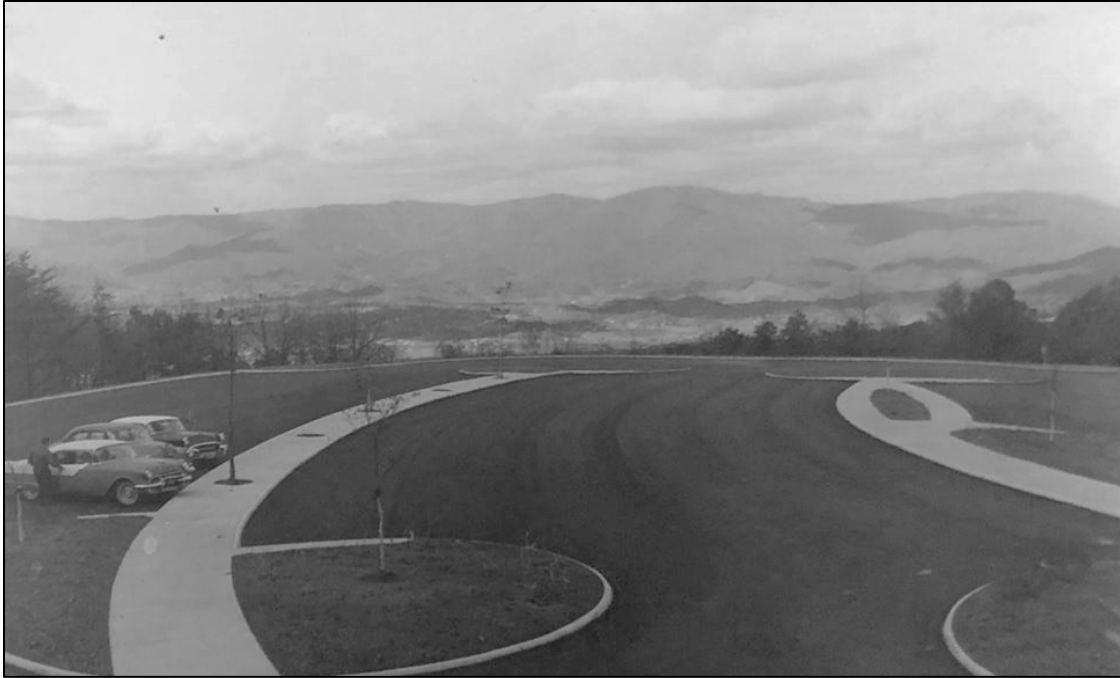
Figure 20. Overview of the Pinnacle Parking Area, shortly after its construction (Photograph on file at the Park Archives, Middlesboro, Kentucky [Classification No. 910, Negative No. 1576]).

A review of historic photographs and planting plans for the Pinnacle area indicate that the parking area has not undergone any major alterations since its initial construction in the mid-1950s (Figure 20). For this reason, the Pinnacle Parking Area is considered to be a contributing resource to the district.

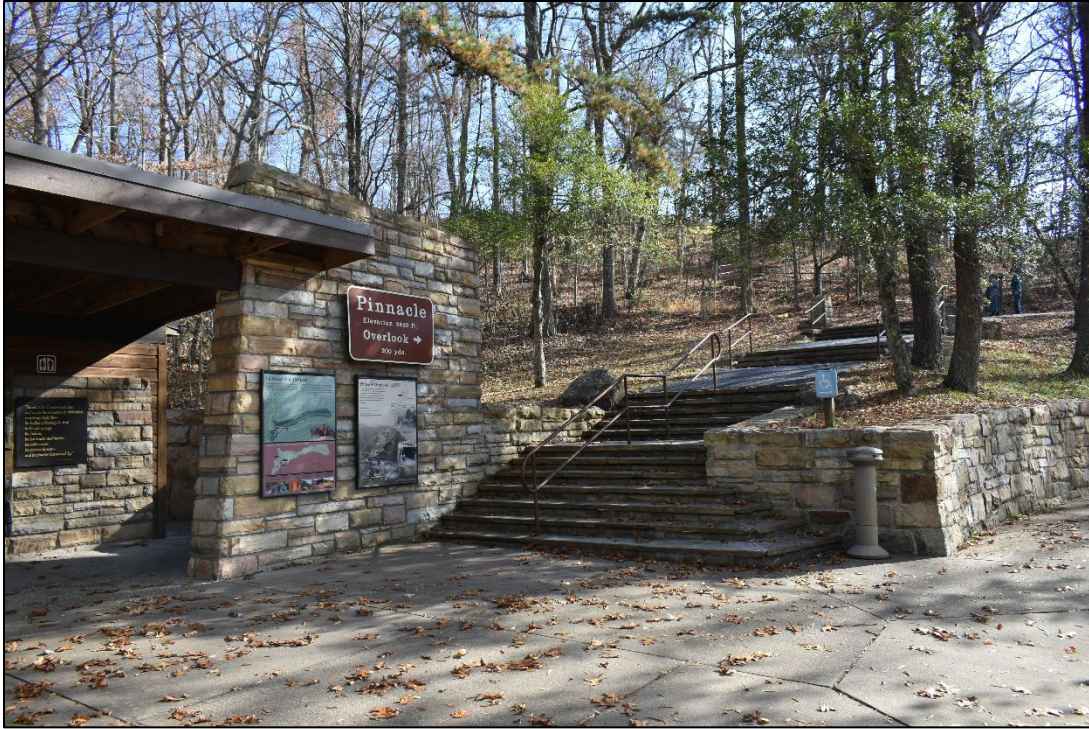
Photograph 13. Overview of the Information Terrace, facing southeast.

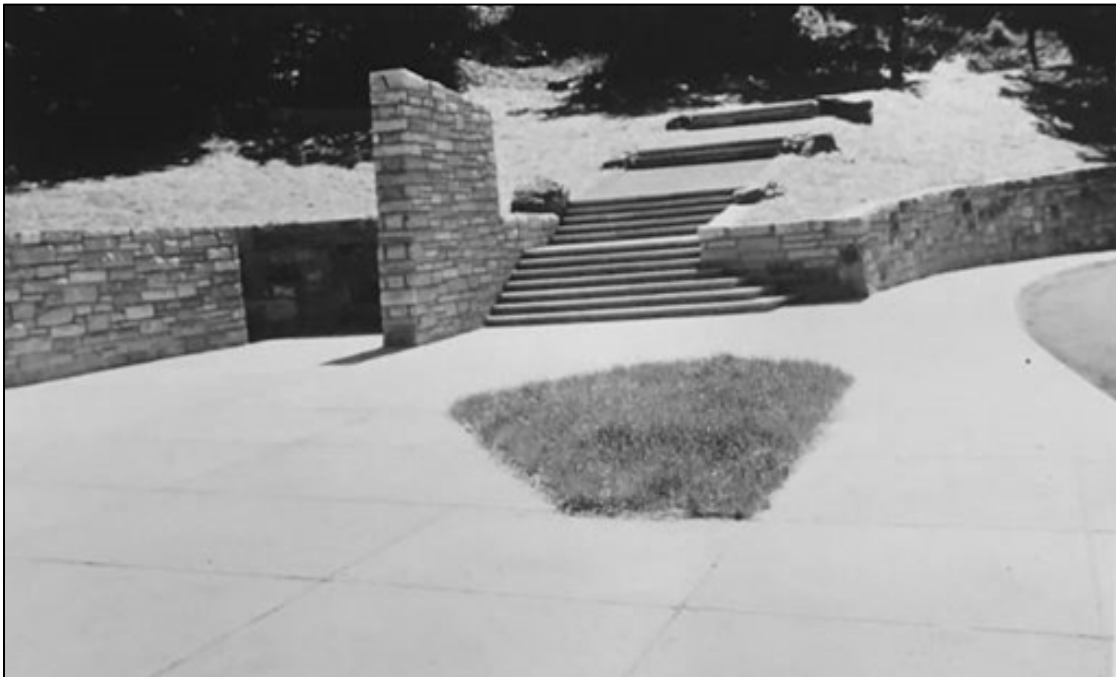
Figure 21. Information Terrace as it appeared shortly after its construction in 1958 (Image reprinted from National Park Service 1958).

The Information Terrace was completed by the Southern Landscape Co. in 1956 and was constructed as part of the initial Mission 66 era redevelopment of the Pinnacle Overlook Area. A review of historic photographs and planting plans indicate that the terrace has undergone only minor changes since its initial construction (Figure 21). According to the original planting plan for the Pinnacle Area, the north side of the concrete terrace originally featured a stepped design which contained three Flowering Dogwood trees (Figure 22). At an unknown date the trees were removed and replaced with trash receptacles. Other changes include the installation of metal handrails on the stairs to enhance visitor safety and the removal of a small grass island in front of the stairs. As the Information Terrace has not undergone any major exterior alterations and still retains its historic function, it is considered to be a contributing resource to the Pinnacle Overlook Developed Area Historic District.

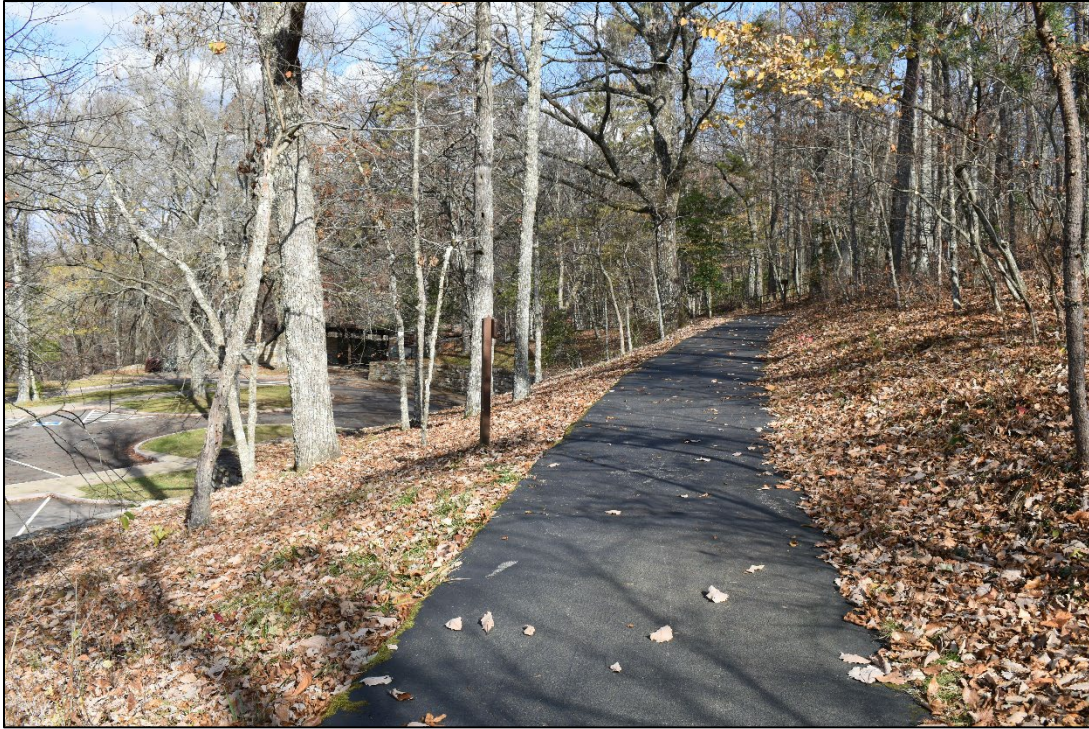
Photograph 14. Overview of the Pinnacle Loop Trail looking towards the Interpretive Shelter and Comfort Station, facing northeast.

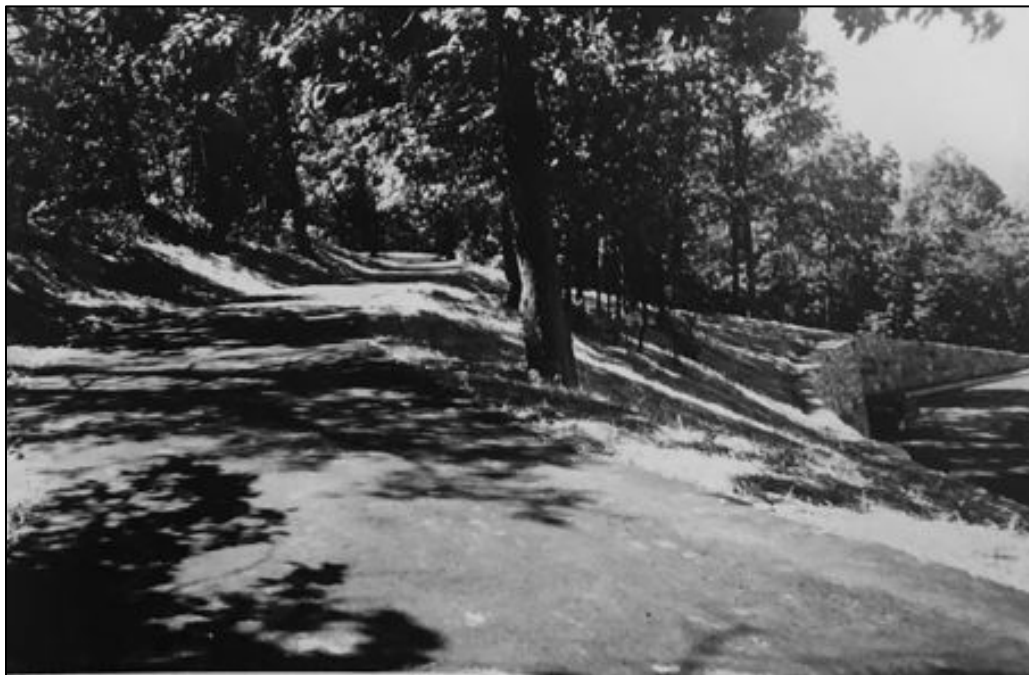
Figure 23. Pinnacle Loop Trail shortly after its completion, ca. 1956 (Image reprinted from National Park Service 1956).

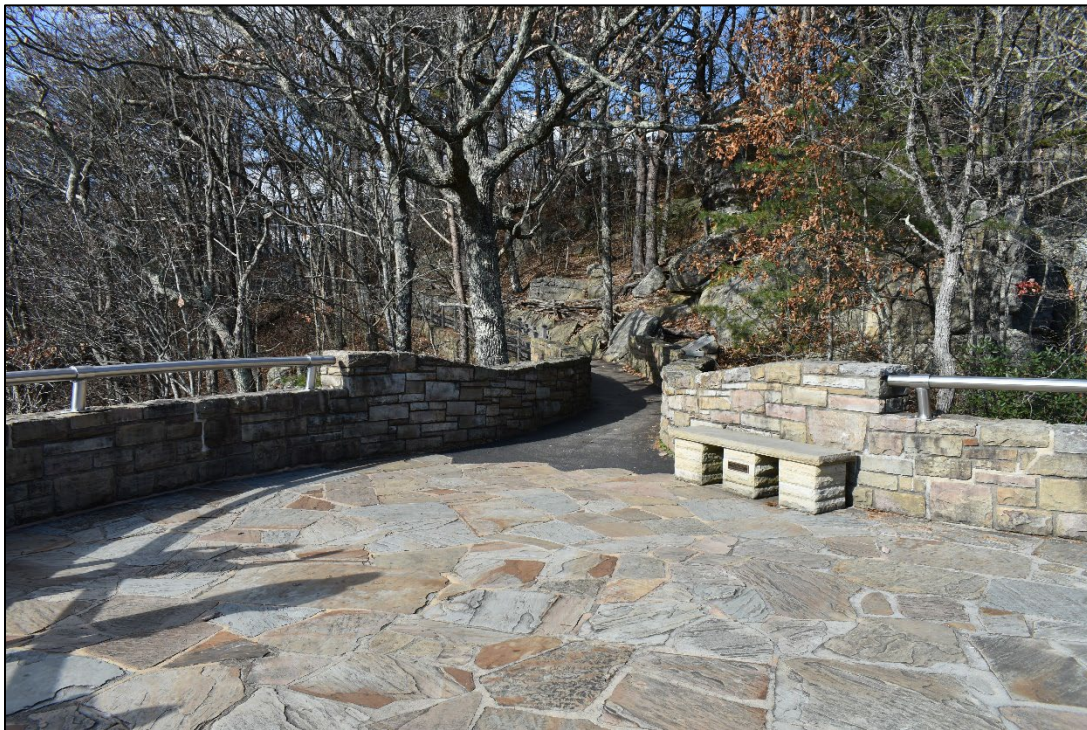
The Pinnacle Overlook Terrace consists of a masonry structure with an irregular shape that measures roughly 30 feet by 40 feet in size. The platform has a concrete slab foundation overlaid with a bed of mortar. The mortar used for the construction of the platform includes a combination of cement and sand. The south side of the platform has an undulating curved design. The platform is constructed of natural stone at the bottom, followed by walls of coursed rubble sandstone masonry with raked joints (Figure 25). The stone walls are 2 feet 8 inches tall and are capped by a steel railing. The deck of the platform is comprised of flagstone, which is set to avoid acute angles as much as possible (Photograph 15).

Photograph 15. Overview of the Pinnacle Overlook Terrace looking towards the Pinnacle Loop Trail, facing north. Note the stone memorial bench which was added in 2018.

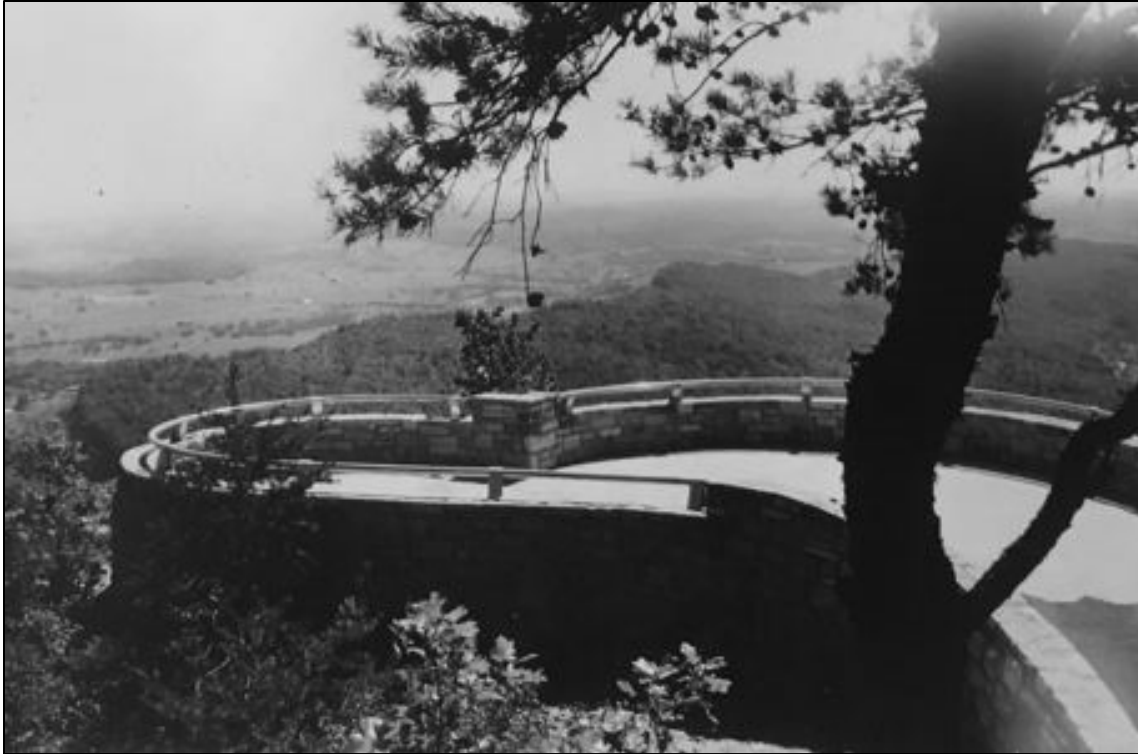
Figure 26. Pinnacle Overlook Terrace after its completion, ca. 1956 (Image reprinted from National Park Service 1956).

railing, and do not alter its essential form and character. A small stone memorial bench was added on the northeast corner of the platform in 2018 but is not a permanent part of the platform. Changes made to the Pinnacle Overlook Terrace are compatible with the original design and would meet the Secretary of the Interior's Standards for Rehabilitation. For this reason, the structure retains sufficient integrity to convey its association with the Mission 66 program and is considered a contributing resource to the Pinnacle Overlook Developed Area Historic District.

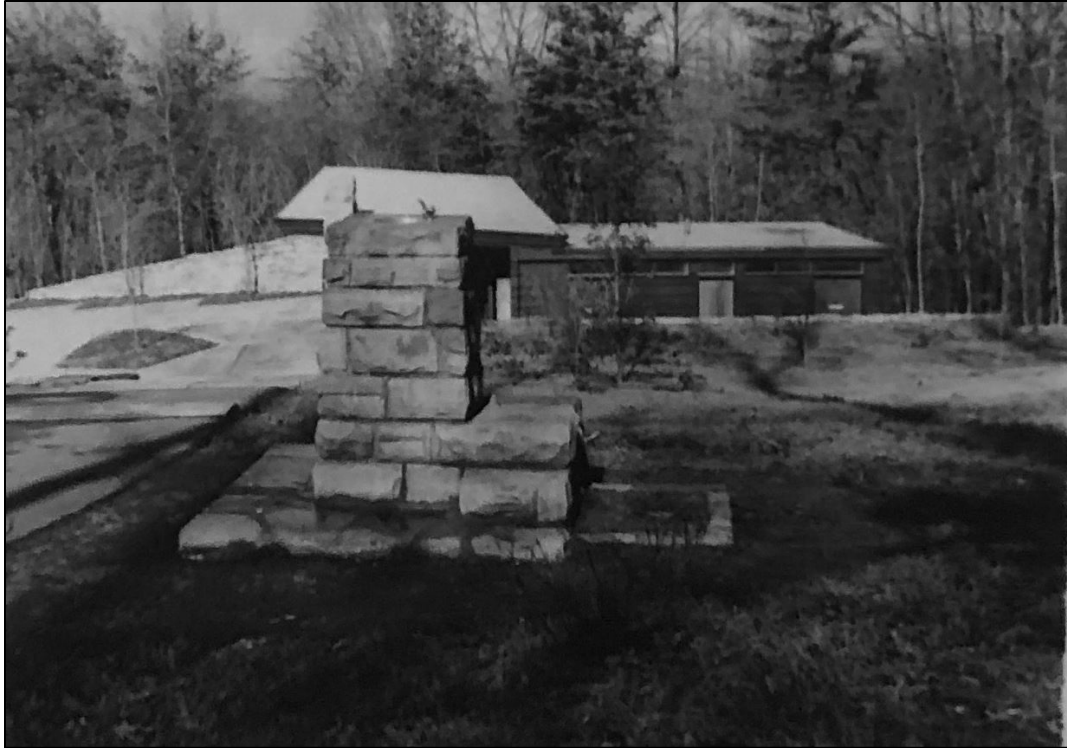
Figure 27. Drinking fountain, ca. 1957 (Image reprinted from NPS 1957).

A review of completion reports on file at the Cumberland Gap National Historical Park archives indicates that the drinking fountain was installed by Collingsworth and Tamer, Inc. of Middlesboro, Kentucky in 1957 (Figure 27) (National Park Service 1957). The fountain has a stone masonry base and cost \$480 to install. It originally had a Haws Model M Head, Model 7 W basin, and a Model 423 self-cleaning faucet with cast iron valve box (Photograph 16). Haws was originally formed by its namesake Luther Haws in Berkeley, California in 1909 following his patent for the first drinking fountain. The company was known as the Haws Sanitary Drinking Faucet Company until 1933, at which point the word "Sanitary" was dropped from its name. The company, which has been known as Haws

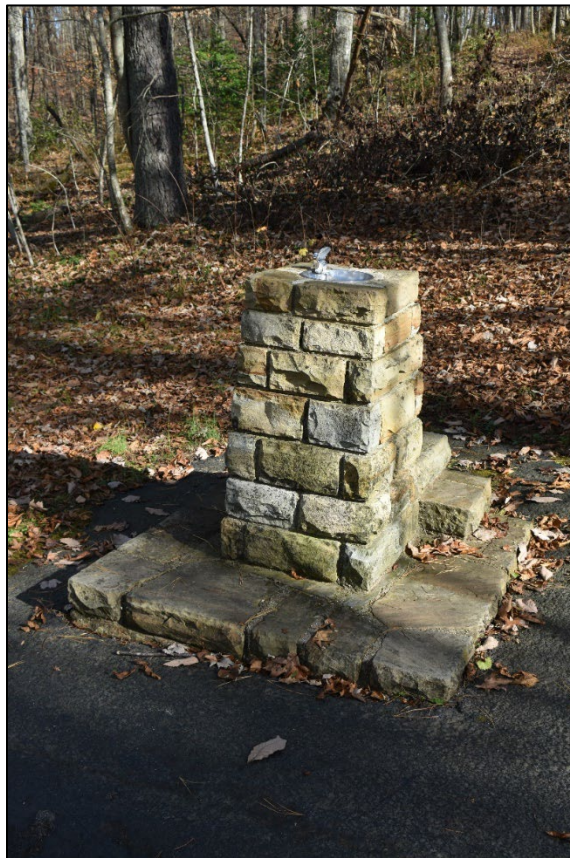
Photograph 16. Current view of the drinking fountain, facing north.
