# Coastal Hazards & Sea-Level Rise Asset Vulnerability Assessment for Redwood National Park

## *Summary of Results*

NPS 167/196687, January 2025

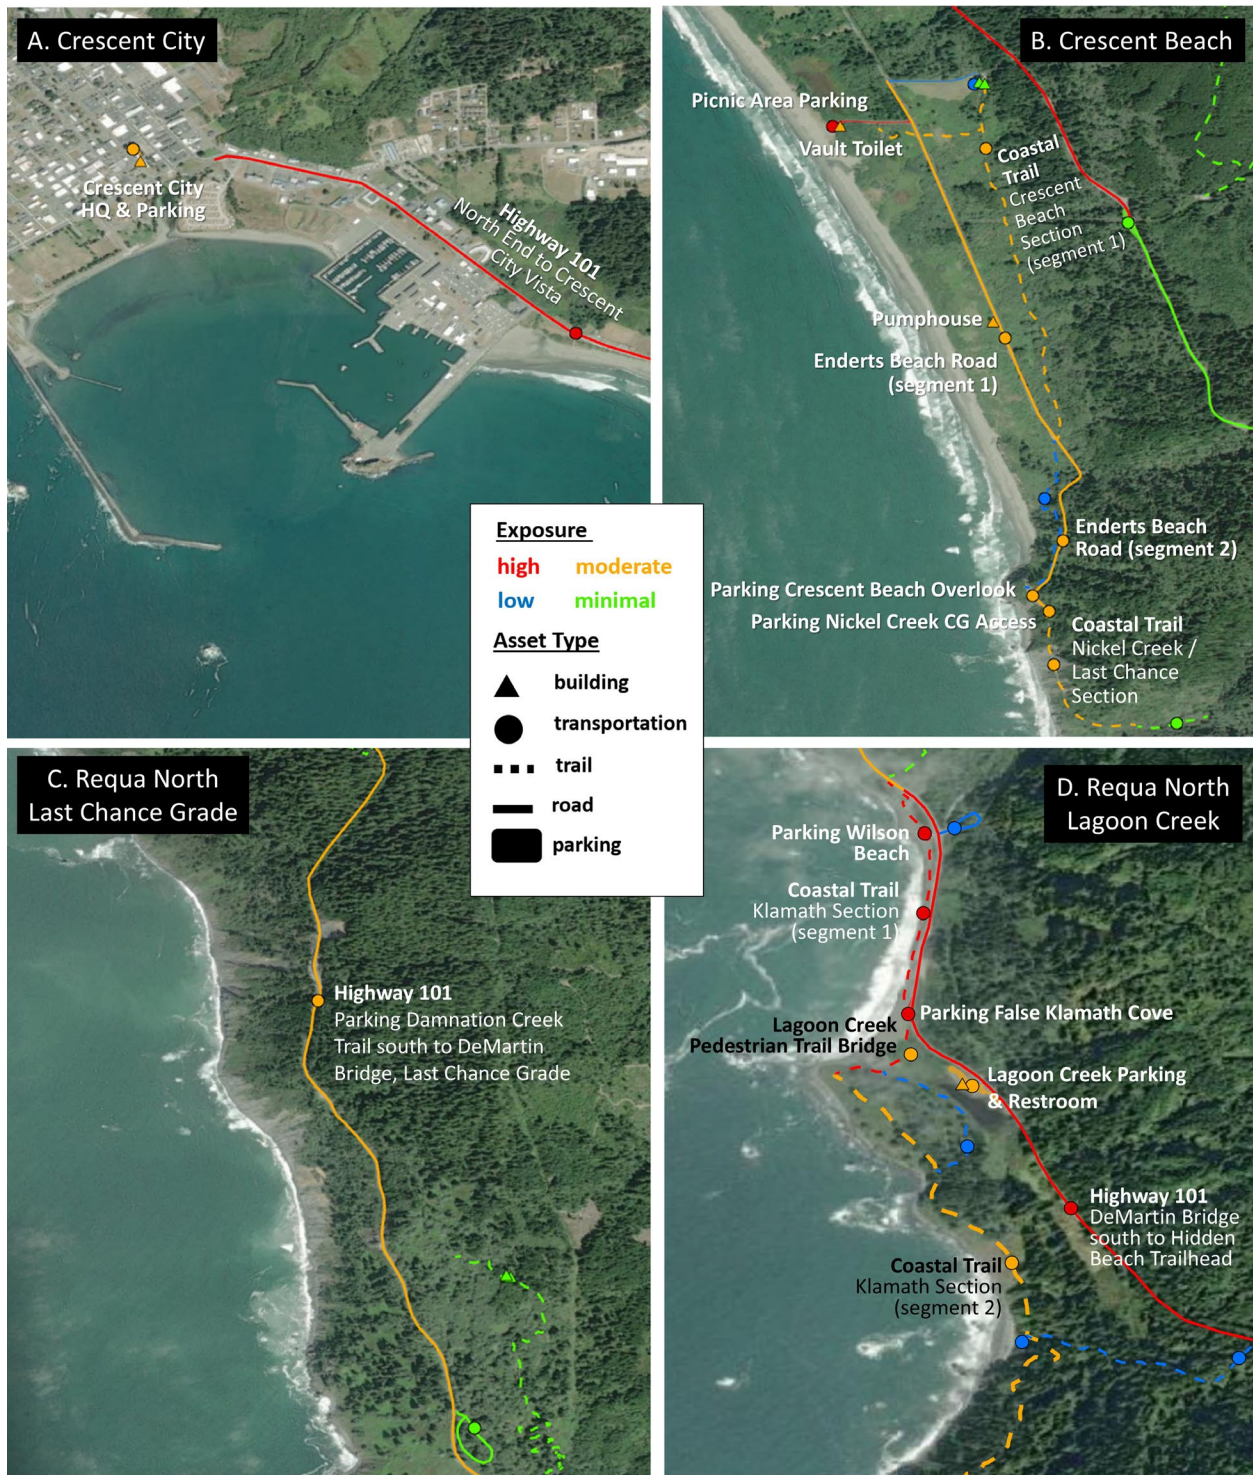
**Figure 1.** REDW exposure results summary for the A) Crescent City, B) Crescent Beach, C) Requa North-Last Chance Grade, and D) Requa North-Lagoon Creek areas. Only high and moderate exposure assets are labeled. Background is 2022 ESRI world imagery.

Ten assets (3%) analyzed at REDW have high exposure to the evaluated coastal hazards (Table 2), including the Brush Dance Area (Cultural Landscape) and three sections of Highway 101 (Figures 1-2). The Coastal Trail - Klamath Section (near Lagoon Creek, segment 1) is within all evaluated exposure zones (Figure 1D). Twenty-eight assets (9%) have moderate exposure, and 18 (6%) have low exposure. Over three-quarters (83%) of assets have minimal exposure, a result of the park's higher elevation leading to lower exposure overall to coastal flooding and SLR.

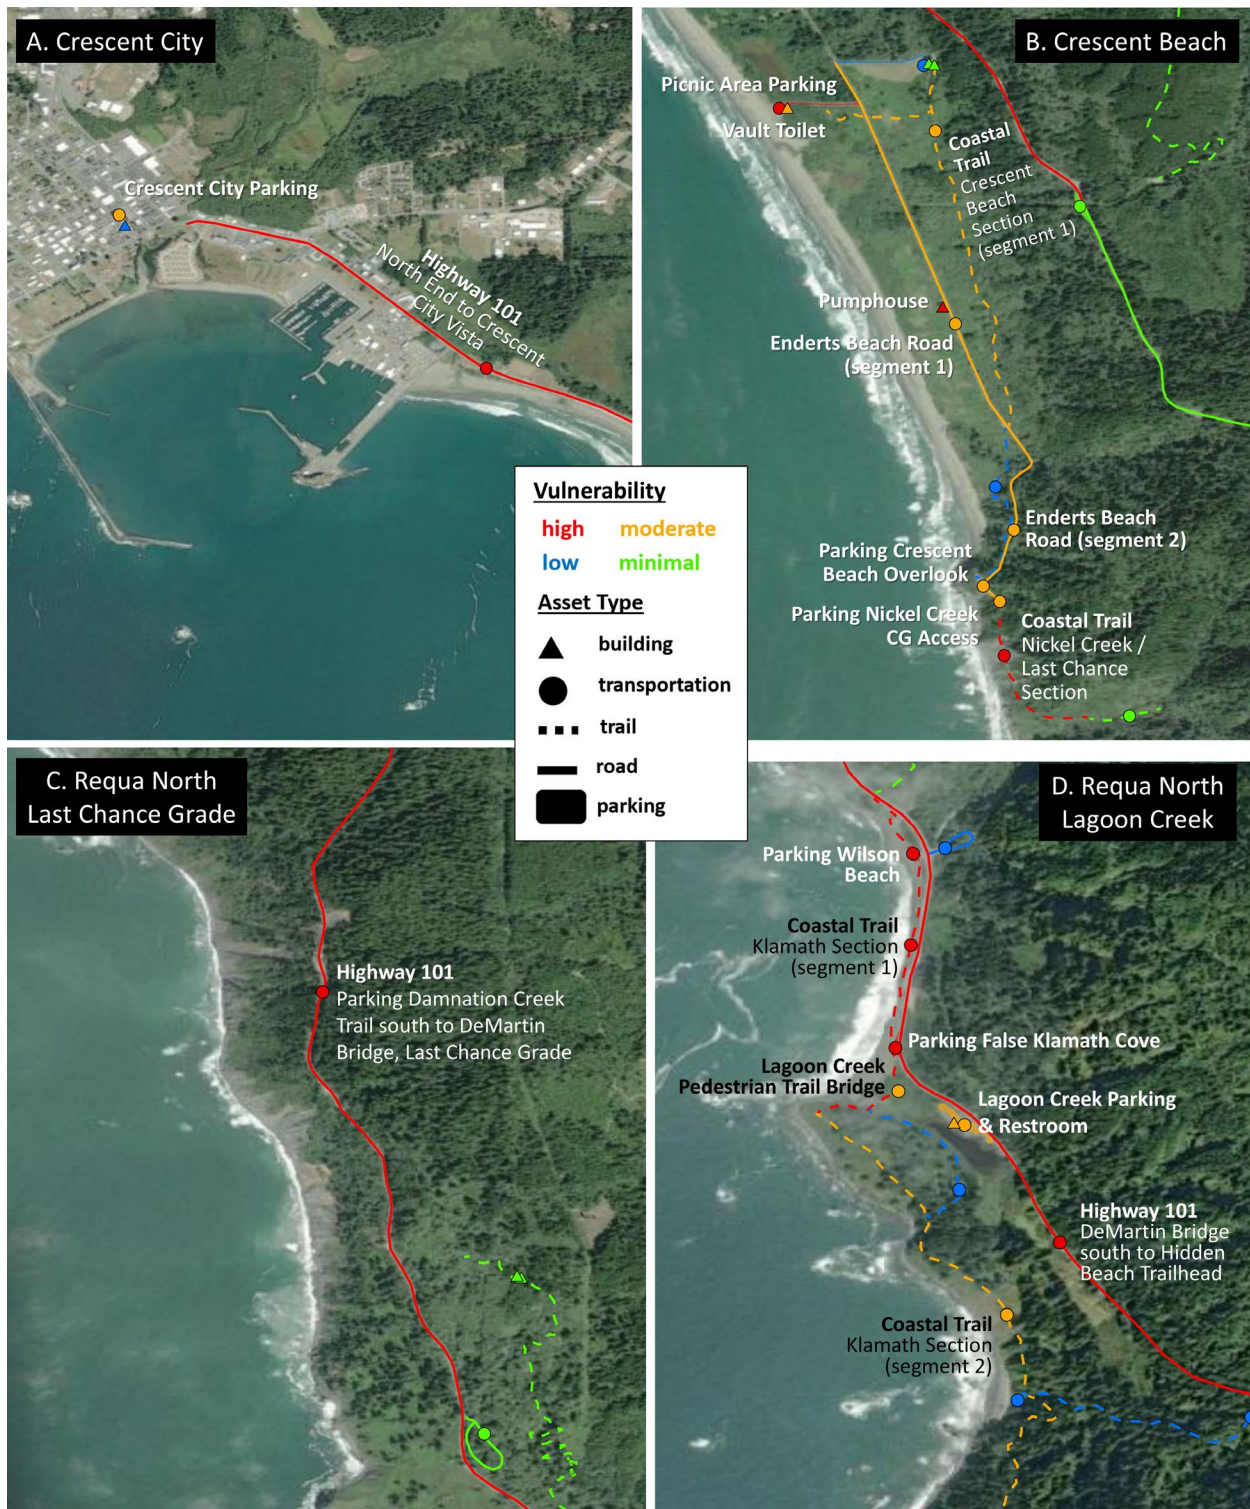
**Figure 3.** REDW vulnerability results summary for the A) Crescent City, B) Crescent Beach, C) Requa North - Last Chance Grade, and D) Requa North - Lagoon Creek areas. Only high and moderate vulnerability assets are labeled. Background is 2022 ESRI world imagery.

Thirteen assets (4%) analyzed at REDW have high vulnerability to the evaluated coastal hazards, 25 (8%) have moderate vulnerability, and 18 (6%) have low vulnerability (Table 4, and Figures 3-4). The majority (83%) of assets have minimal vulnerability. Brush Dance Area (Cultural Landscape), Brush Dance Road, and Coastal Trail - Klamath Section (near Lagoon Creek, segment 1) have both high exposure and high sensitivity. Four segments of Highway 101 (a primary route through and into the park) have high vulnerability: North End to Crescent City Vista, Parking Damnation Creek Trail south to DeMartin Bridge (Last Chance Grade), DeMartin Bridge south to Hidden Beach Trailhead, and Davison Road south to End. While no assets have both high vulnerability and a high asset priority index ( $API \geq 70$ , as reported in FMSS), four assets have moderate vulnerability and a high API: the Thomas Kuchel Visitor Center, Coastal Drive, and both segments of Enderts Road.
