# CROSSROADS IN SCIENCE

Fall 2016

# An Interdisciplinary Approach to Architectural Analysis at Montezuma Castle National Monument

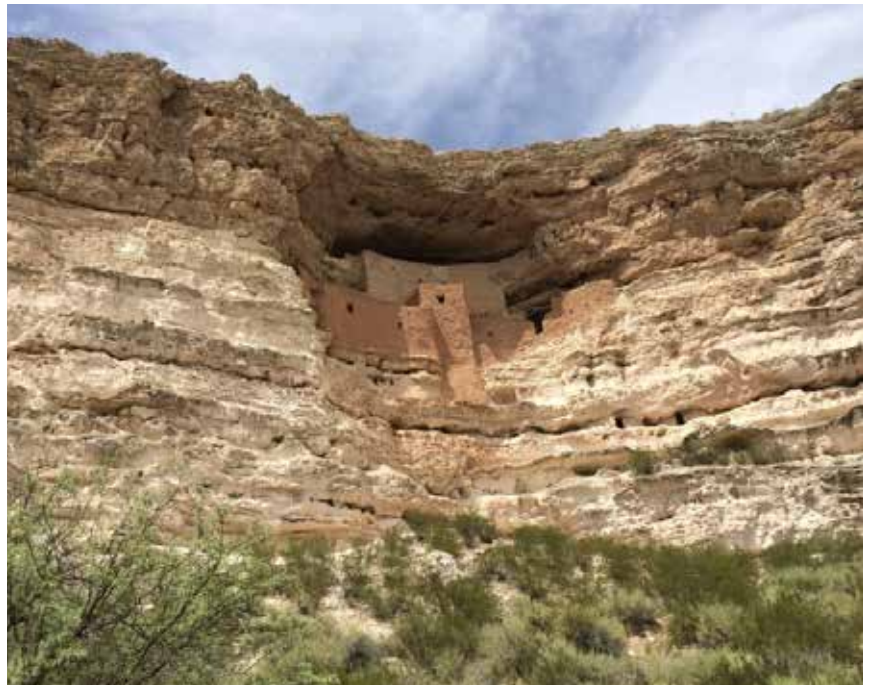
Figure 1. Montezuma Castle cliff dwelling (Source: Lucas Hoedl, 2016).

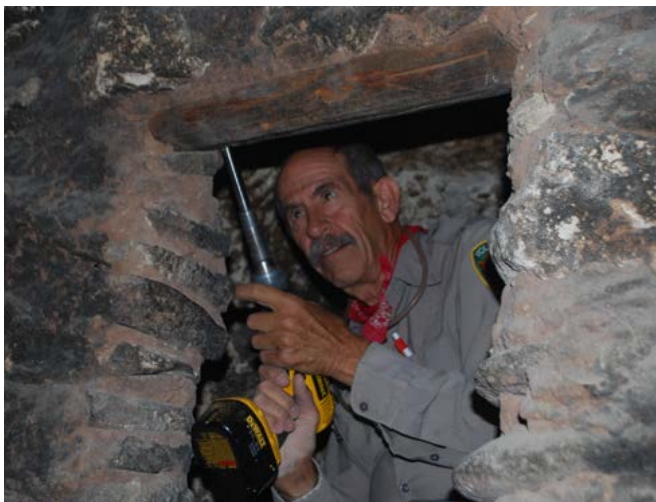
Figure 2. Tom Windes collects wood samples in Room 7, Montezuma Castle cliff dwelling (Source: Wendel Navenma, 2011).

Visitors to Montezuma Castle have long pondered the age of the ancient dwelling. Beginning in 2011, archeologists from the NPS and the University of New Mexico's Maxwell Museum of Anthropology initiated a study of wooden ceiling elements to understand the site's construction history. The cliff dwelling contains 11 rooms with complete ceilings comprised of over 150 individual wooden roof beams. Unfortunately, dendrochronology, an analytical method where a tree's annual growth rings are used to determine a cutting date, has proven unsuccessful at the site. This problem is caused by local conditions, which result in "complacent" growth rings that cannot be compared to master tree ring chronologies for the region. Conversely, Accelerator Mass Spectrometry (AMS), a form of radiocarbon dating, has been used with far greater success. AMS dating uses a Mass Spectrometer to quantify the amount of isotopic carbon in organic objects like wooden roof beams. The amount of remaining carbon isotopes is then used to determine a

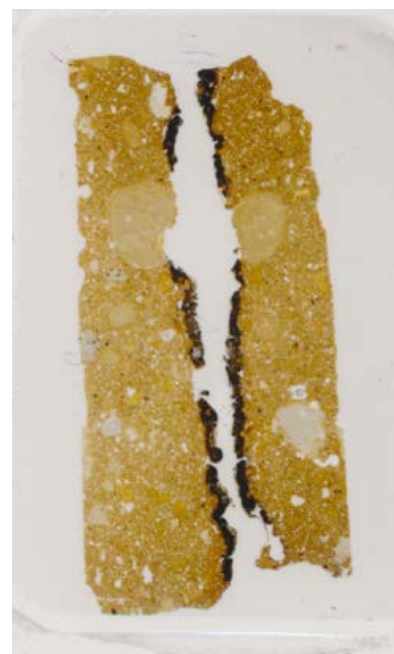
Figure 4. SEM thin section of plaster from the Room 21 exterior wall. The dark line is soot and dust that accumulated on the wall surface over time. (Source: Bass et al. 2015:8).

Angelyn Bass, an Architectural Conservator from the University of New Mexico, and a team of specialists including Doug Porter from the School of Engineering at the University of Vermont, also assessed earthen mortar and plaster used to build masonry walls and floors. Their study characterized different plaster types using Scanning Electron Microscopy (SEM) and X-ray Diffraction analysis. Technical examination yielded clues about the methods of plaster manufacture, application, and use. Preliminary results suggest that builders selected specific materials for leveling and finishing floors, exterior walls, and interior surfaces. For instance, "base coat" mortars typically incorporate coarse aggregates, possibly to control cracking associated with uneven drying of the thick leveling coats; finish plasters, on the other hand, have finer aggregates with mineral components that contribute colors for fine, polychrome finishes. The fine plaster finishes were installed in uniformly thin layers that vary within and between walls, suggesting, perhaps, that finishing was intended as a way to maintain the appearance and condition of the wall surface. Floor and exterior wall plasters combine well-graded aggregates with binder materials in proportions that yield dense, durable surfaces (Bass et al. 2015).

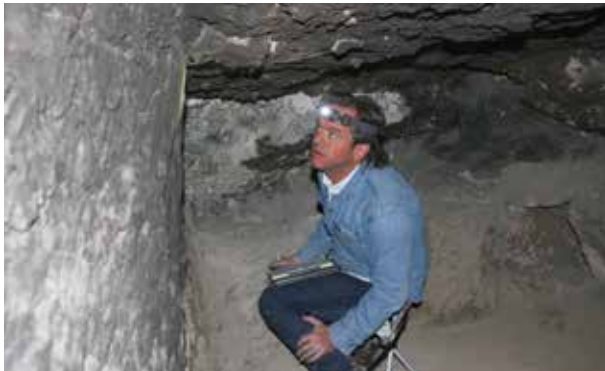
Figure 5. Doug Porter records the condition of walls at the Montezuma Castle cliff dwelling (Source: Lucas Hoedl, 2016).

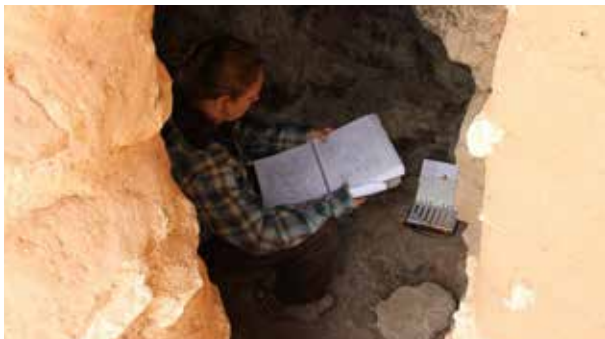
Figure 6. Angelyn Bass identifies plastered surfaces at Montezuma Castle (Source: Lucas Hoedl, 2016).

The project also assessed the condition of each ancient wall surface and wooden ceilings. In total, 233m<sup>2</sup> (2508 ft<sup>2</sup>) of original plaster survives on 53 walls at the Castle. This is approximately 77% of all wall faces at the site and proves that the interior of Montezuma Castle contains a remarkable amount of well-preserved architecture.

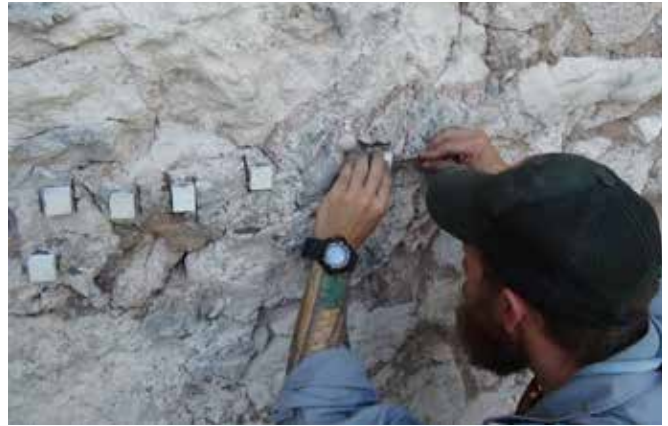
Figure 8: NPS Archeologist, Matt Guebard, taking samples for archaeomagnetic dating at Castle A (Source: Melissa Philibeck, 2013).

Using a scientific technique called archaeomagnetic dating as well as traditional knowledge provided by Native American participants, NPS and university scientists can hypothesize when and why the site was abandoned. Archaeomagnetic dating is a form of analysis that uses the earth's magnetic field to determine dates for fire events in the archeological record. In 1933, archeologists working at Castle A, part of the village that includes the Montezuma Castle cliff dwelling, noted evidence for a large and destructive fire (Jackson and Van Valkenburgh 1954). The fire completely destroyed Castle A and produced very hot temperatures, causing iron particles within earthen walls to realign with the direction of magnetic north. In 2011 and 2013, NPS and University of New Mexico scientists collected twenty small samples of burned plaster from one wall at Castle A. These samples were analyzed in the Archaeomagnetic Laboratory at the New Mexico Office of Archaeological Studies. In the laboratory, scientists compared the orientation of iron particles in burned plaster with a known record of changing magnetic orientations through time. Results from archaeomagnetic analysis strongly suggest the fire at Castle A occurred in the interval from A.D. 1375-1395 (Guebard 2015).
