## Determination of Eligibility

### Barnes Point Water & Wastewater Treatment System

Olympic National Park

January 2025

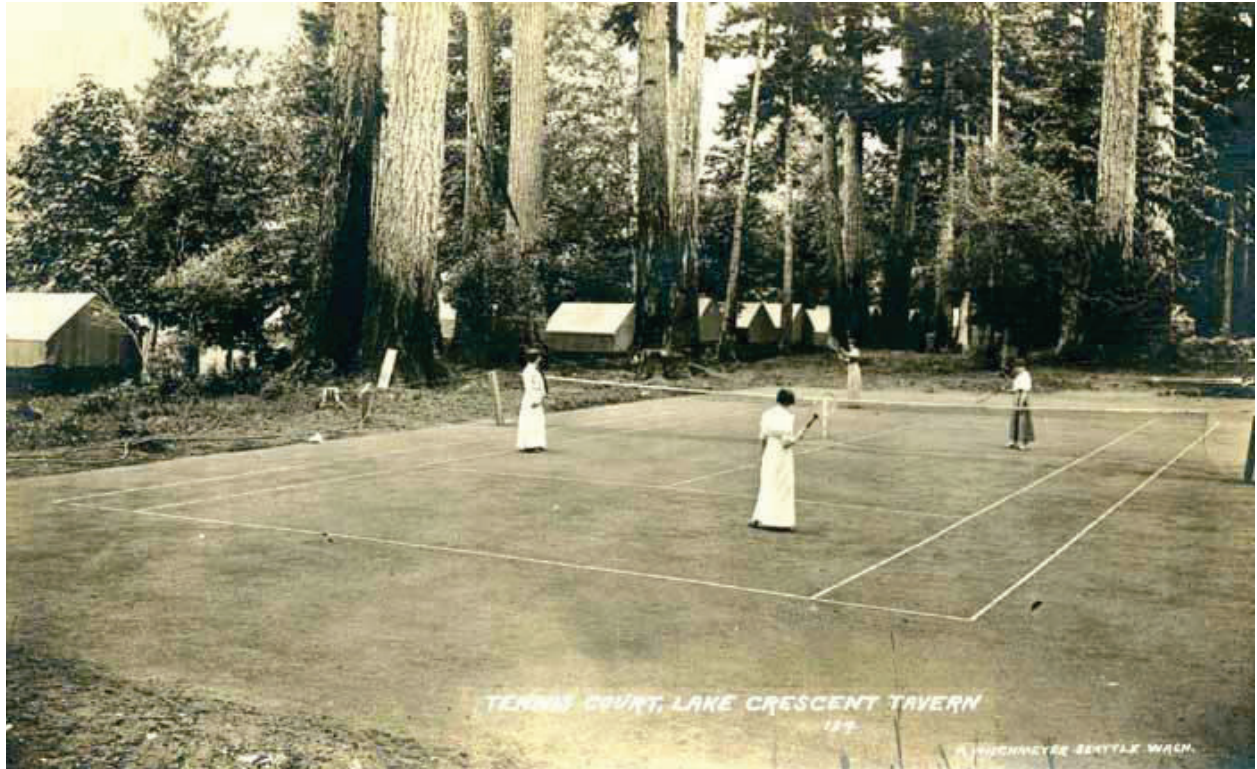
Figure 1: Lake Crescent Lodge tennis in the recreational lawn. Today, the absorption beds run north-south under the recreational lawn. A poured concrete tennis court is extant and contributes to the cultural landscape. (Clallam County Historical Society, 999.118.3)

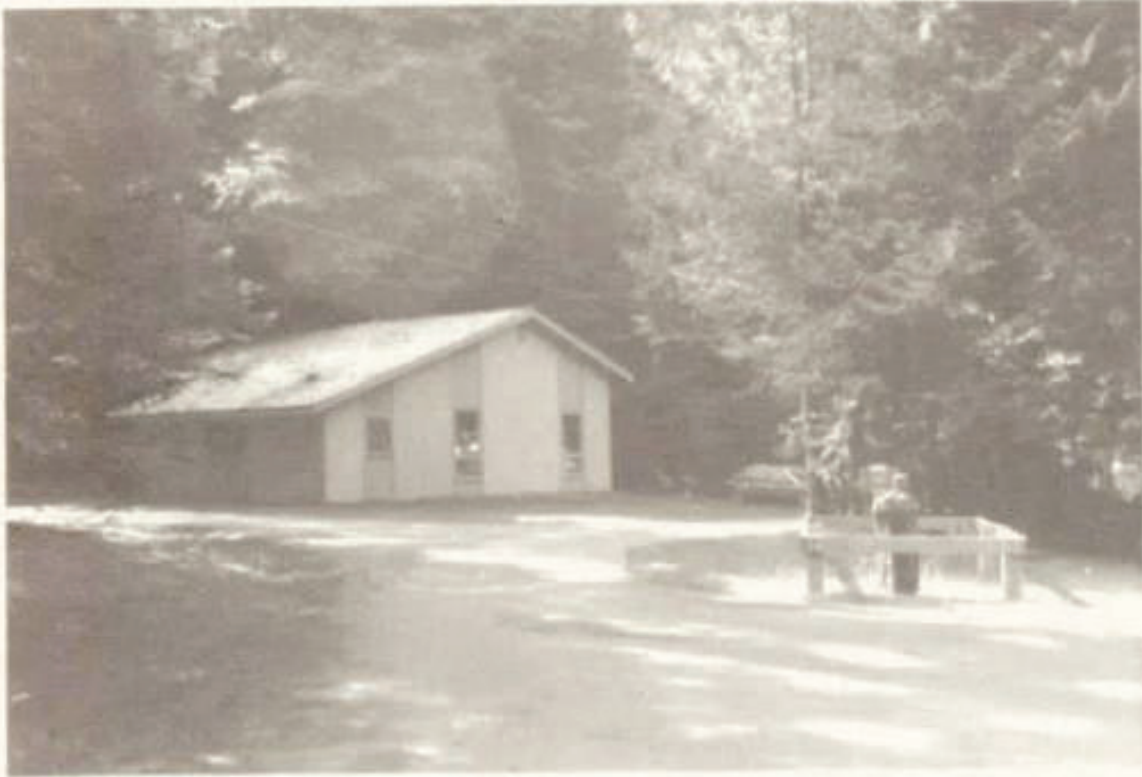
Fig. 40  
Water treatment plant and one of two wells outside  
the gate. Drew Rocker, National Park Service, 1985.

Figure 10: Water Treatment Building and Well No.1 at Rosemary Inn. (NPS photograph, Excerpt from 1985 *Rosemary Inn Historic Structure Report*)

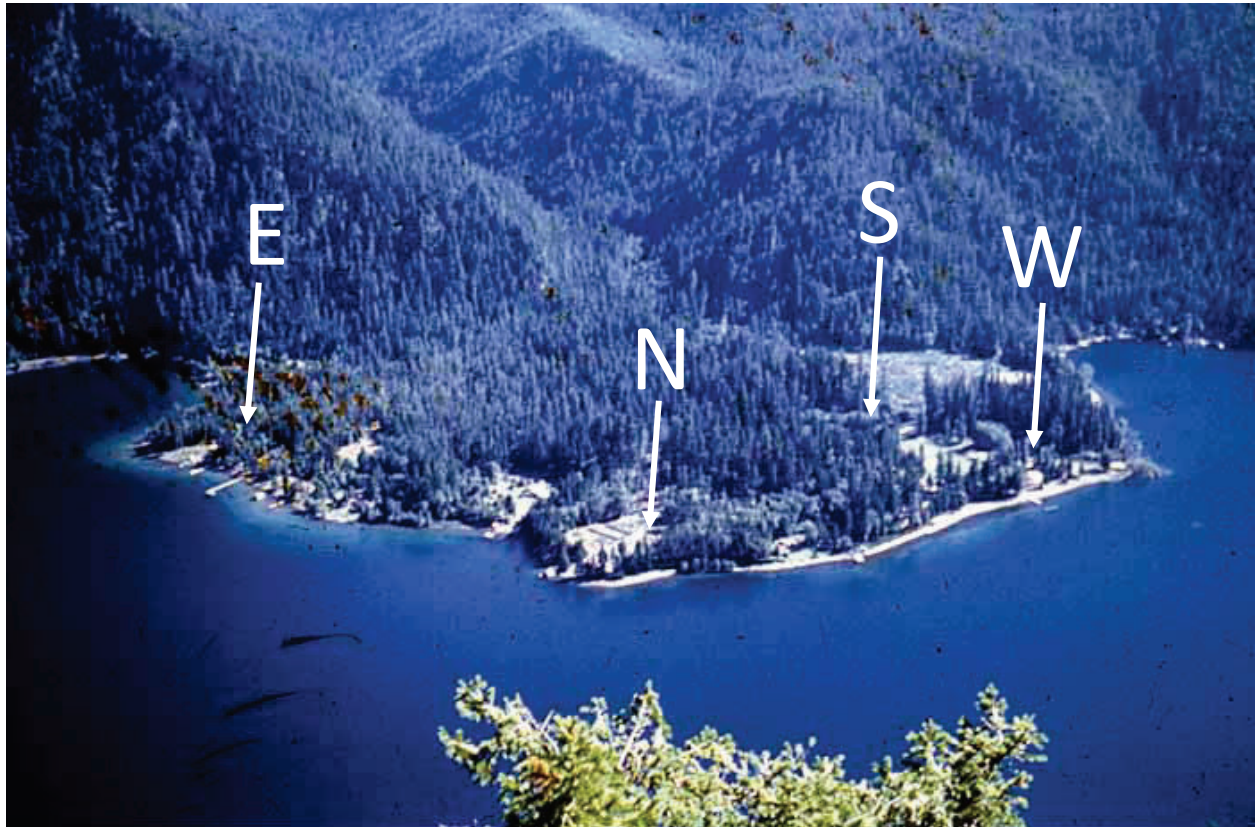
Figure 11: Barnes Point, looking south, with water and wastewater treatment key points located. (NPS 1991)

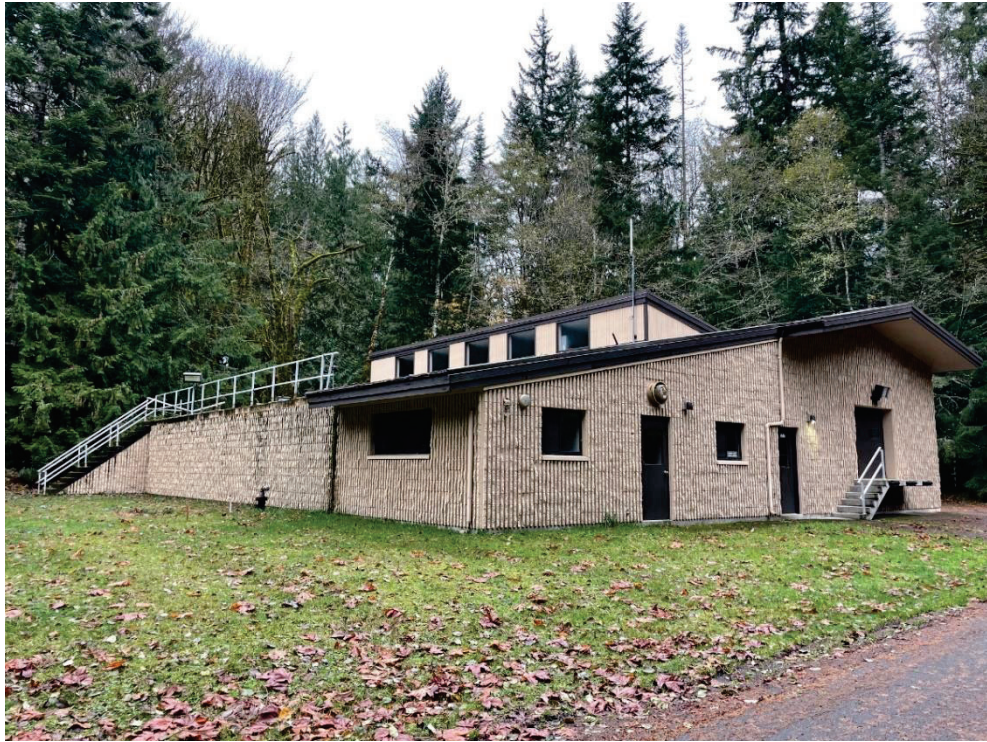
Photograph 1: East and South walls of Barnes Point Wastewater Treatment Plant (NPS/2024).

The Wastewater Treatment Plant is one-story, has a clerestory roof sheathed in standing-seam metal roofing with a 2-1/2:12 slope, is rectangular in plan (76'-0" x 62'-8"), and constructed of 8" reinforced, split-face concrete blocks. The foundation consists of 12" wide footers and 4'-0" stem walls of continual poured concrete. The roof structural members vary between open web joists, glulam beams, and rafters. The building is divided into 6 interior rooms plus 2 tanks and was purpose-built to house the wastewater treatment system.

The front (east) façade contains two metal entrance doors, measuring 3'-4" x 7'-4", and one 8'-0" x 7'-0" four-paneled overhead door. The doors have metal frames, are painted brown, and have inset fixed glass lites. Two metal-sash, double-lite 3'-0" x 4'-0" sliding windows align at door height. A 30" diameter mechanical exhaust fan sits above the door to south. Six continual-pour concrete steps with an aluminum handrail access the loading dock on its south side. The overhead door opens from an 8'-0" x 3'-0" elevated, poured concrete loading dock with rubber bumpers. A flood light is centered above the overhead door. The roof gable extends 4'-0" over the loading dock.

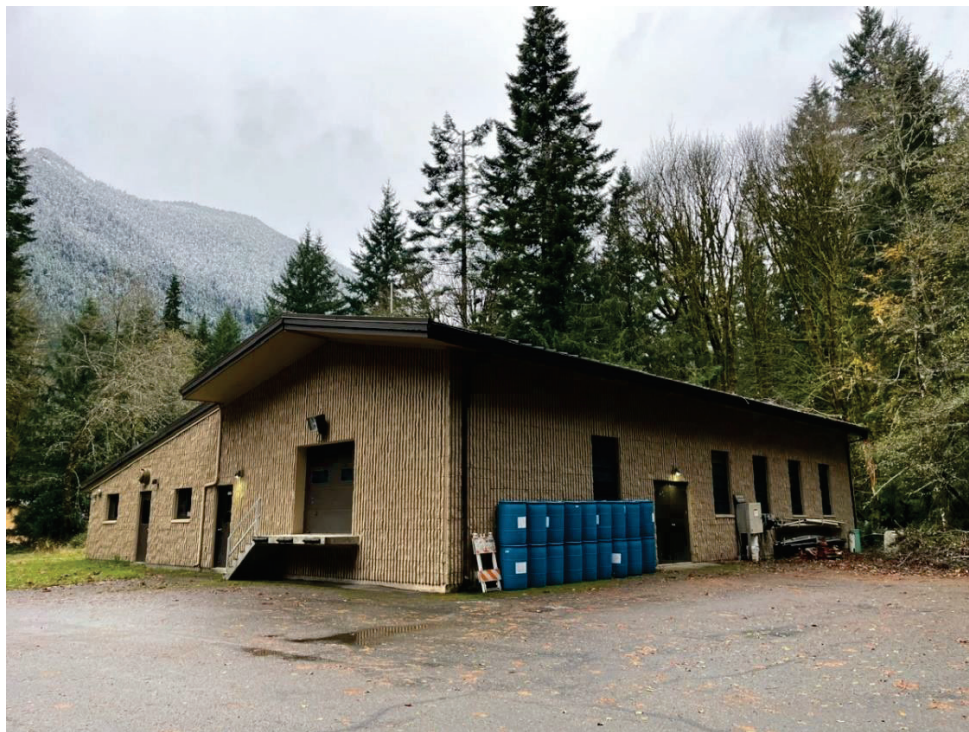
Photograph 2: East and North walls of Barnes Point Wastewater Treatment Plant (NPS/2024).

The north wall has a metal double door opening measuring 6'-0" x 7'-4" with a metal frame. The doors and frame are painted brown. The wall has five industrial window openings measuring 4'-0" x 7'-0" and containing multi-lite metal sashes. Each sash has four stacked lites: fixed, awning, fixed, and hopper (from top to bottom).

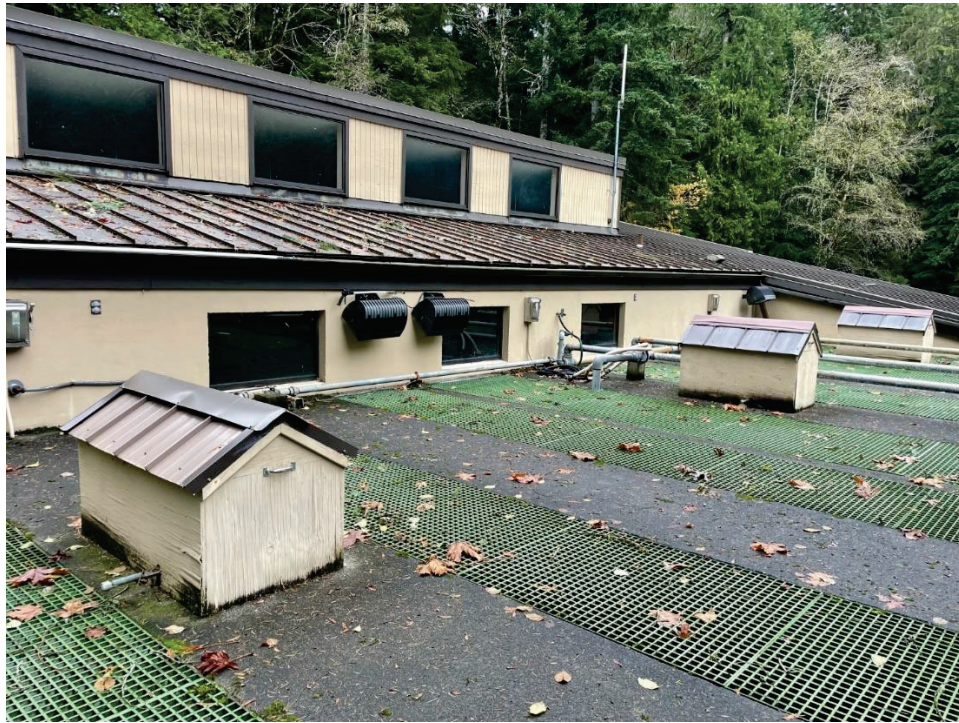
Photograph 3: Flat roof over tanks and clerestory windows of Barnes Point Wastewater Treatment Plant, looking northeast (NPS/2024).

The flat-roofed section of the building has 3 flood lights mounted to the north wall and one to the west. They are metal and directed down onto walking surfaces and into the grated tank openings. An identical flood light is mounted on the south wall and is directed to the ground to light the pedestrian route to the stairs. A comminutor, which shreds the large solids as they enter the system, is mounted over the northwest corner of the equalization tank and housed in a box sided on four sides with T1-11 with a shed roof sheathed in asphalt siding. Three mechanical aerators are individually mounted onto the flat

roof (one over the equalization tank and two over the sludge tank) and housed in small structures with plywood sides and standing-seam metal roofing of their gable roofs. 2-1/2" galvanized pipes run parallel to the roof surface between the sludge tank mechanical aerators and transport air from the blower (interior) to the base of the sludge tank.

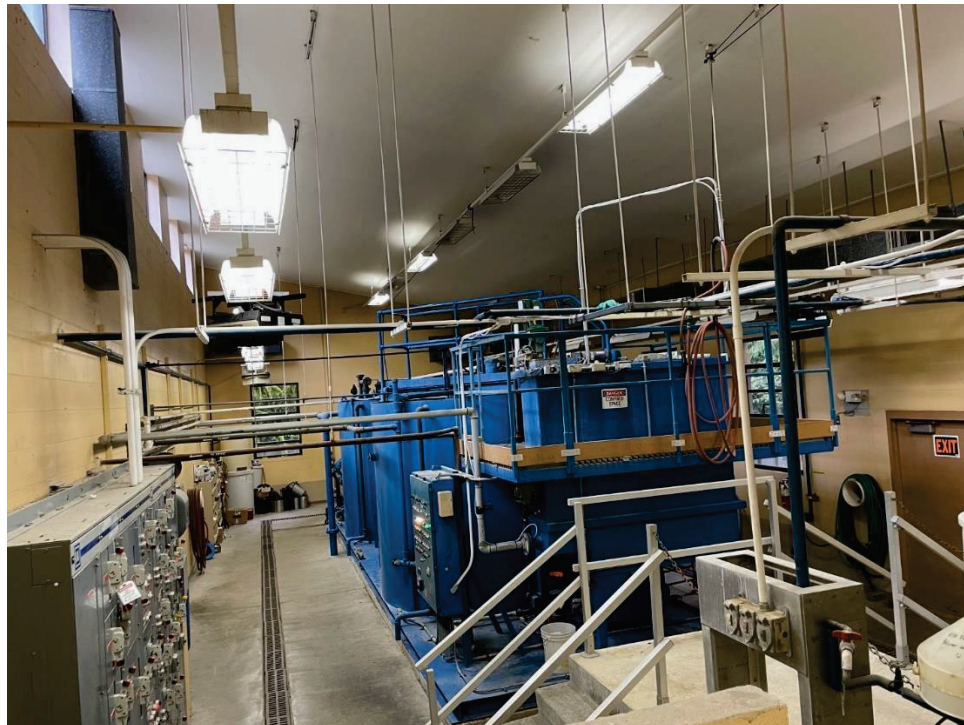
Photograph 4: Interior of Treatment Room of Barnes Point Wastewater Treatment Plant, looking west (NPS/2024).

The 56'-0" x 26'-8" treatment room runs the full length of the building's north end. The room is divided into two spaces with an elevated chemical storage to the east and the treatment area to the west. The chemical storage area is elevated 3'-0" above floor height and accessed by 4-step concrete stairs from the north and the south. The stairs have square aluminum handrails on either side and lead to a 6'-0" wide landing that is flanked by chemical storage bays on either side: 3 to the north and 3 to the south. The bays are divided by 4" wide and 4'-0" high concrete block pony walls. At the end of the chemical storage area is the overhead door that leads to the exterior loading dock. The floor is unpainted poured concrete, the walls are constructed of concrete block painted cream, and the ceiling is 5/8" water resistant gypsum board painted white. The area includes an eye wash station, overhead hanging florescent lights and a fan, and surface-mounted electrical conduit.

To the west, the treatment area has poured concrete floors, concrete block walls, and a 5/8" water resistant gypsum board ceiling. At the center of the space, a 10'-0" x 35'-0" concrete pad elevated 3-1/2" above floor height holds the treatment system. An 8" wide floor drain trench covered by metal grate panels runs along the floor on three sides of the elevated concrete pad. On the concrete pad sits a Met-Pro Systems, Inc. brand skid-mounted physical-chemical wastewater treatment system painted bright blue. The system includes a control panel, a flocculator tank with a dedicated flash-mix chamber, a clarifier tank with sludge rake, 2 carbon adsorber tanks, a mixed-media pressure filter with automatic backwash, and a chlorine contact tank. The motor control center for the entire treatment process, a 7-unit grey metal cabinet, sits along the south wall. The treatment area has overhead hanging florescent lights and fans, surface-mounted electrical conduit, and overhead pipes that move effluent between the tanks and feed chemicals into the system.

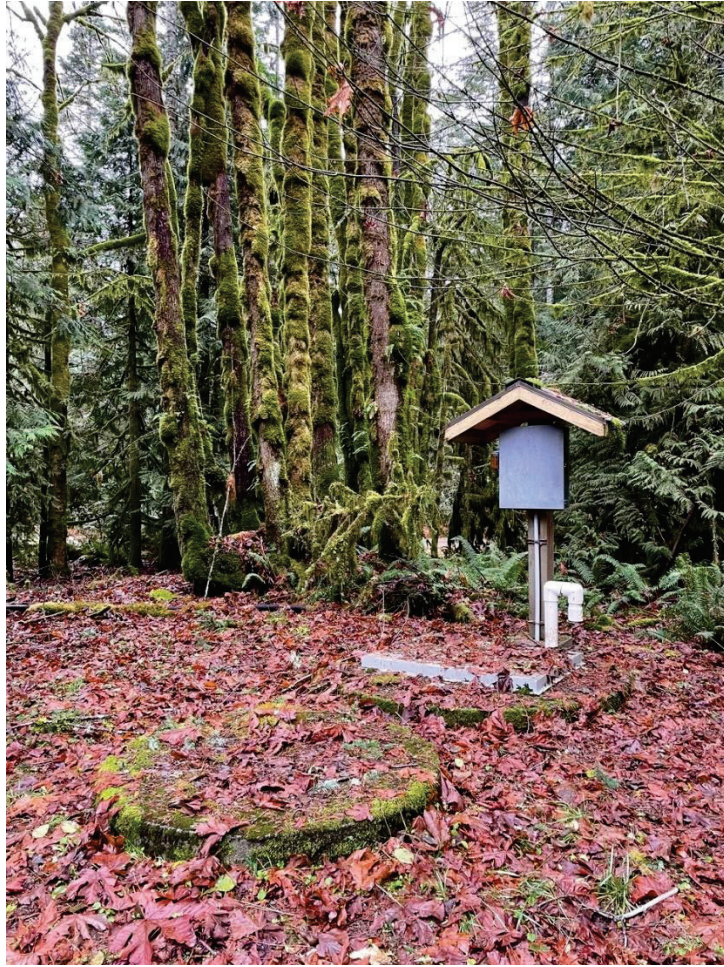
Photograph 5: Lift Station and valve vault west of Wastewater Treatment Plant, looking west (NPS/2024).

West of the building is a lift station that pumps sewage to the equalization tank at the start of the treatment process. A separate dosing tank pumps processed wastewater at the end of the treatment

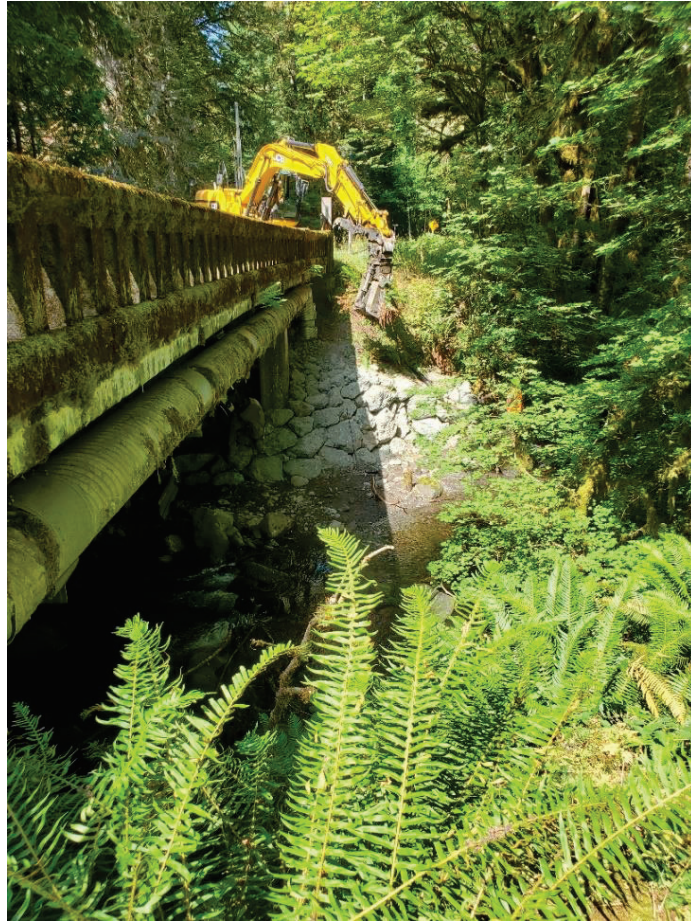
Photograph 6: Insulated pipe running along the west bridge beam as it crosses Barnes Creek, looking south (NPS/2020).

At Barnes Creek, three 4" PVC (polyvinyl chloride) pipes that run between the Wastewater Treatment Plant building and absorption beds span the creek attached to the underside of the 1945 bridge along Lake Crescent Road. One pipe flows south, toward the Wastewater Treatment Plant, and serves as the primary sewage pressurized force main transporting raw influent from the collection system to the lift station west of the building. (In the winter, flow in this pipe is reversed by adjusting valves and raw influent from the concession housing area gravity flows back to the winter septic tank and into the smallest absorption bed.) The other two pipes flow north, from the treatment plant to the two primary absorption beds. Each dosing pump in the effluent wet well has its own discharge line that feeds its own absorption bed, and they are set to automatically alternate with each dose. All three pipes reach the bridge in the southeast corner, run along the south abutment, cross the creek bolted to the west bridge beam, and return underground north of the creek. An 18" insulated pipe with an aluminum sleeve houses the PVC pipes. The insulated pipe is mounted to the bridge by 5/8" welded, steel, webbed brackets.

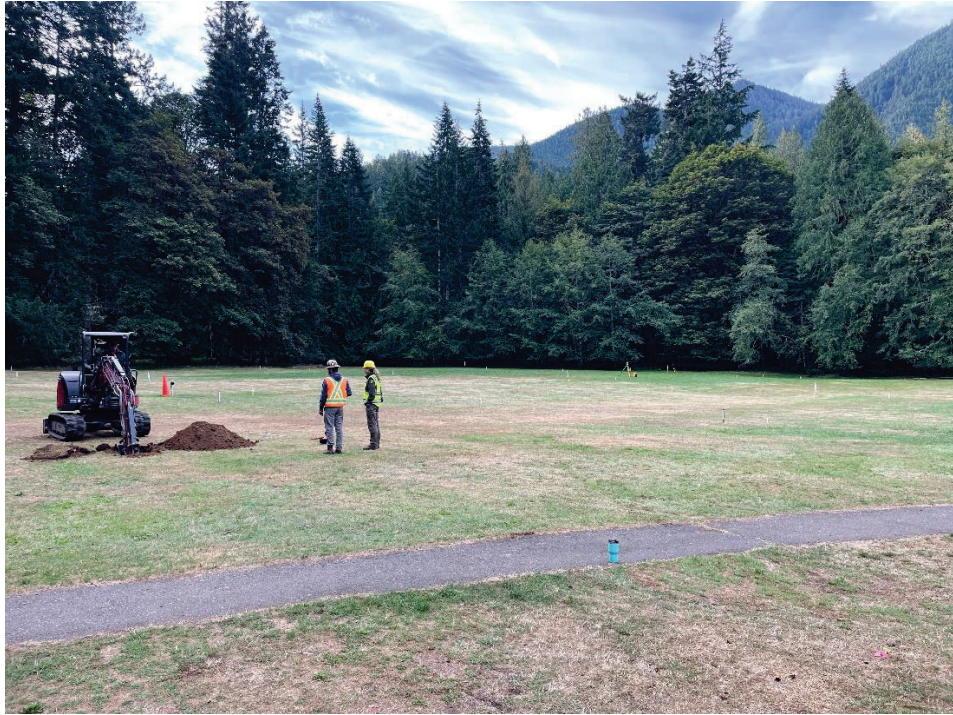
Photograph 7: Recreational field at Lake Crescent Lodge, looking east. The absorption beds are installed under the lawn, within the Lake Crescent Lodge cultural landscape (NPS/2024).

Under the recreation field are the wastewater treatment system's absorption beds that distribute the treated wastewater from perforated vitrified clay pipes set in washed aggregate beds at a minimum depth of 30" below grade. The 3 absorption beds are made up of north-south parallel pipe runs, two that are 200'-0" long fed from the wastewater treatment plant and the third, to their west, that is half that

length and fed from the winter septic tank and dosing siphon. Each of the two large absorption beds has eight 4" perforated pipes spaced 6'-0" on center. The small absorption bed has eight 6" perforated pipes spaced 6'-0" on center. All piping is laid at a level plane within the top half of a 13" thick gravel bed, to allow for even distribution of treated wastewater across the system. The gravel bed is covered with filter fabric and topped with at least 30" of fill. The gravel bed extends 3'-0" on all sides away from the outermost pipes. The 8 pipes for the small absorption bed are fed from the north by a 6" ductile iron pipe header. The two large absorption beds are fed from the south by 4" ductile iron pipe headers. Within each bed, all absorption bed pipes are connected to each other at the downstream end by a perforated vitrified clay pipe header of the same size pipe as their laterals at the opposite header.

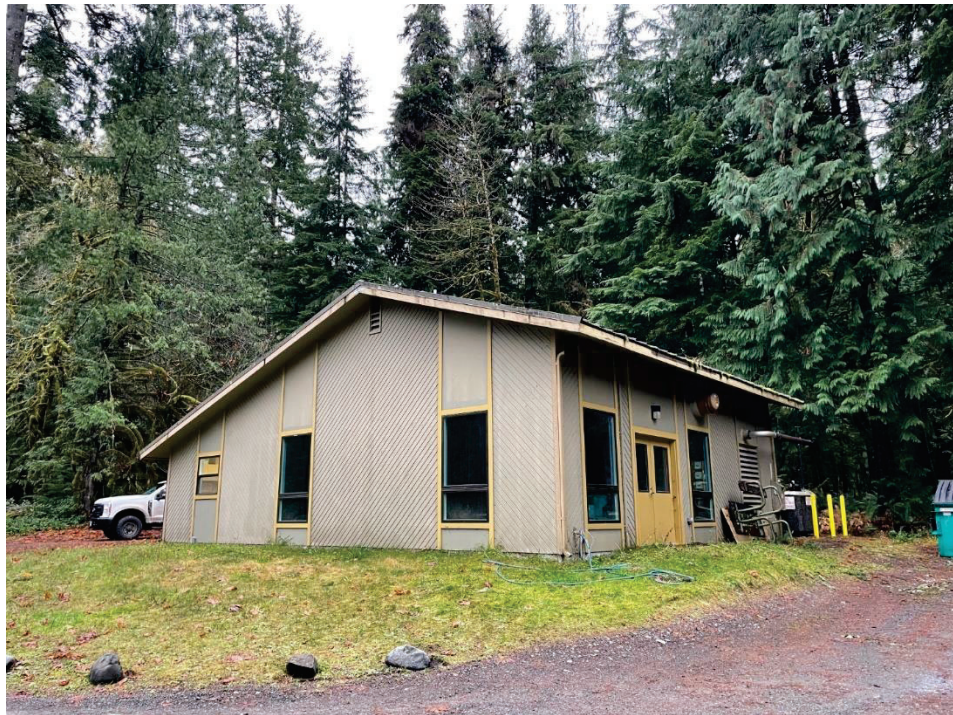
Photograph 8: North and West walls of the Barnes Point Water Treatment Plant at Rosemary Inn Campus, looking south (NPS/2024).

The north wall of the structure has three window openings that were replaced in 2019 to match the originals on the structure. The opening to the east has a 3'-6" x 3'-4" double-hung, one-over-one fiberglass with vinyl finish sash window with a wood sill and trim. The other two window openings have 3'-9" x 6'-4" multi-lite, fiberglass with vinyl finish sash windows with 5'-0" fixed lites over 2'-0" operable awning lites. These window openings also have wood sills and trim. Above and below all the window openings, the wall is clad in high density overlay plywood with flat stock 1x4 wood trim running vertically to the roofline. The rest of the wall is clad in 5/8" T1-11 plywood laid at a 45-degree angle with 1x4 flat stock corner boards. At the gable end, a 1'-0" x 1'-4" galvanized louver with inset screen provides airflow from the attic crawlspace.

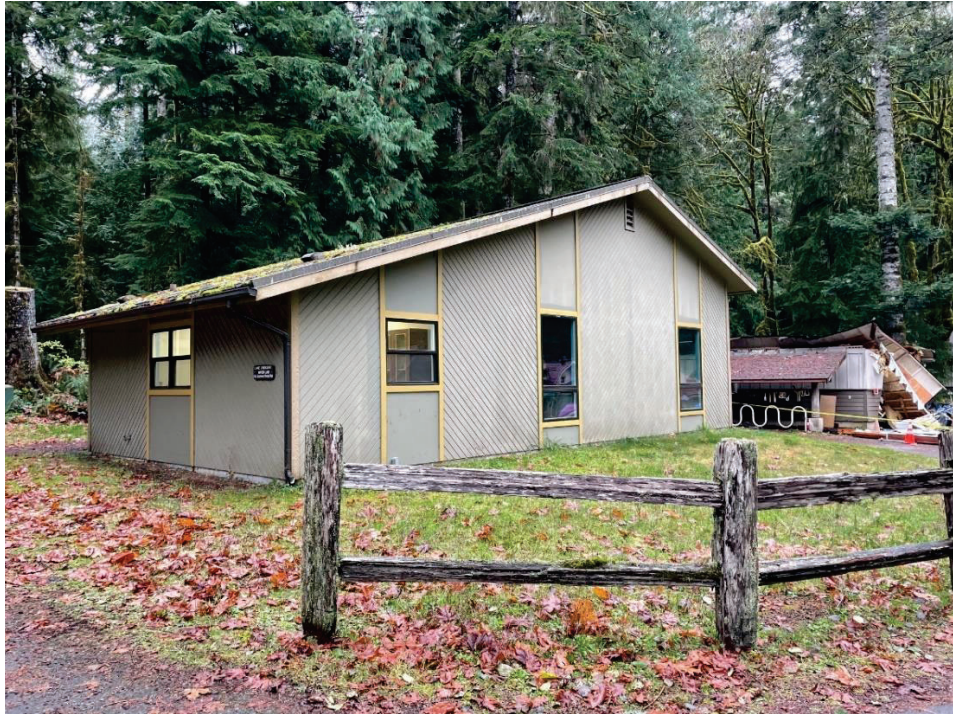
Photograph 9: North and East walls with fence line at Barnes Point Water Treatment Plant at Rosemary Inn Campus, looking south (NPS/2024).

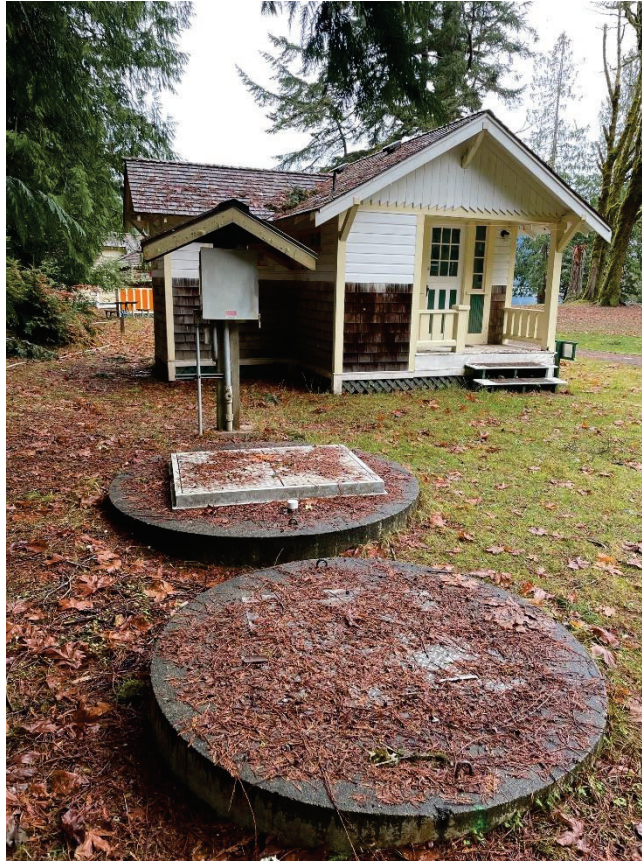
Photograph 11: Lift Station No.2 and valve vault near Dardanella Cabin at Rosemary Inn Campus, looking north (NPS/2024).

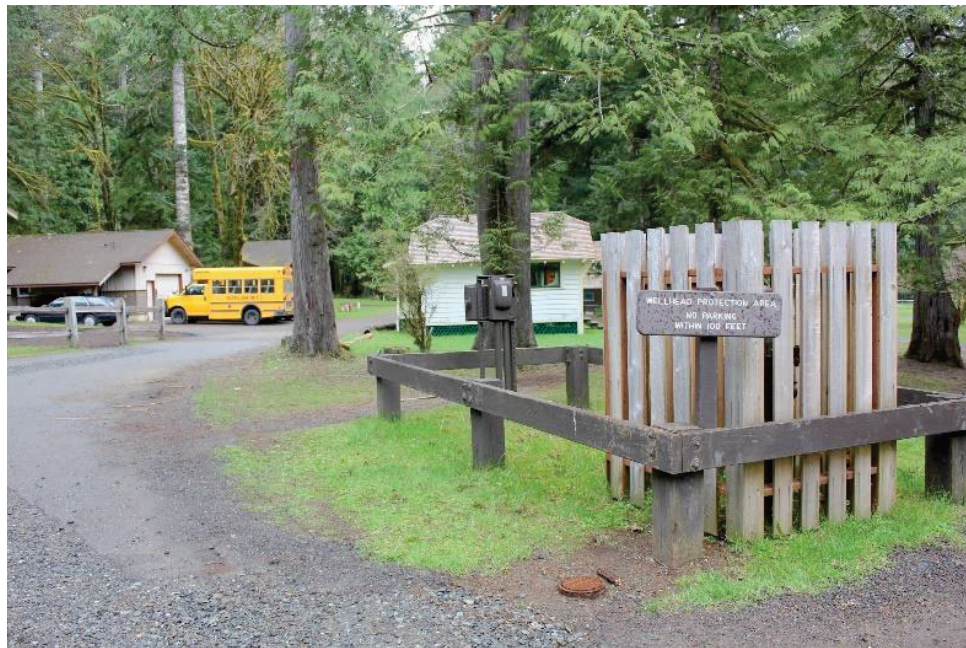
Photograph 12: Well #1 (behind fence) located at Rosemary Inn campus, north of the Water Treatment Plant, looking west. (NPS/2019).

Well #1, a domestic water well, was rotary drilled to a total depth of 78'-8" and includes an 8" diameter welded steel casing that extends down to 70'-11" below grade. Well #1 has a 7" diameter liner that extends from 68'-11" to 73'-6" and a stainless steel screen extending from 73'-6" to 78'-8" below grade.

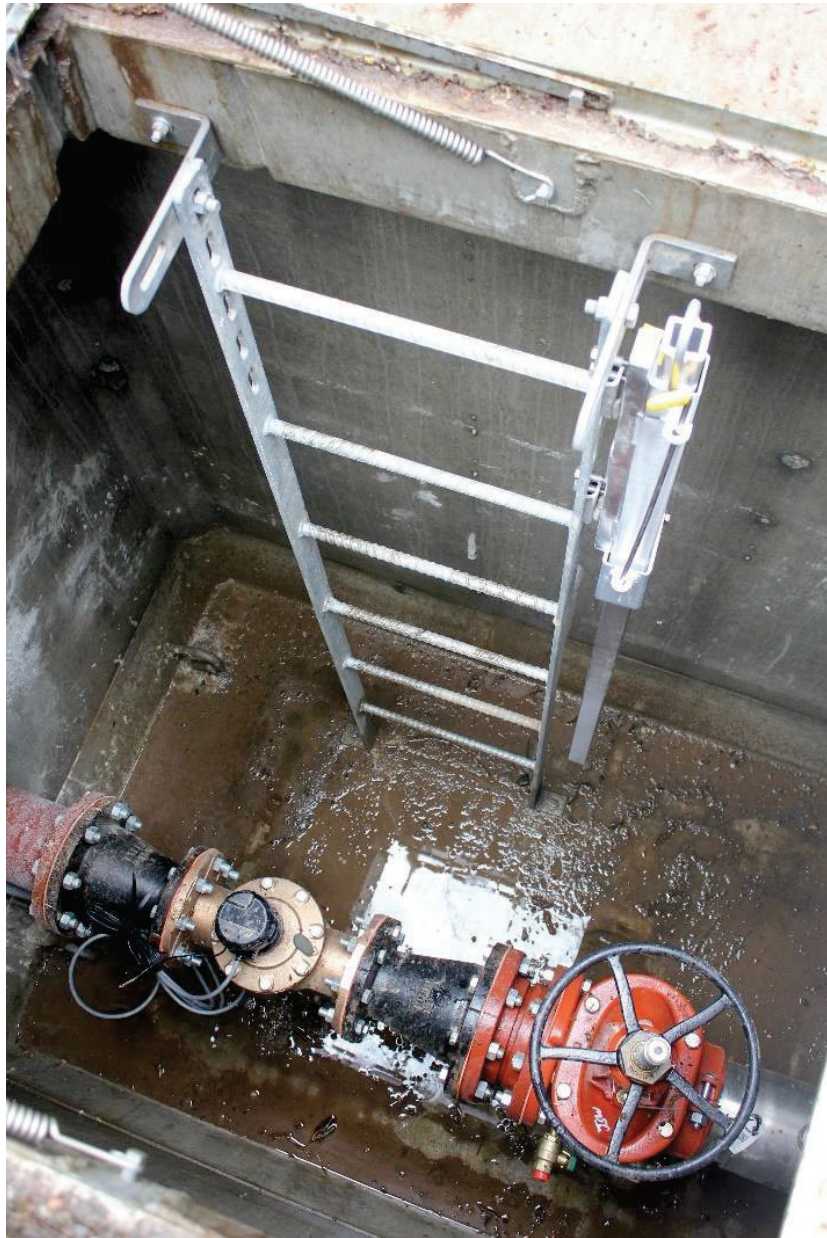
Photograph 13: Looking down into meter and valve vault for Well #3 (fire well) (NPS/2019).

Well #3, a fire well, was rotary drilled to a total depth of 72'-0" and includes a 10" diameter welded steel casing that extends down to 60'-2" below grade. The fire well has an 8" diameter liner that extends from 58'-2" to 61'-4" and a stainless steel screen extending from 61'-0" to 72'-0" below grade.

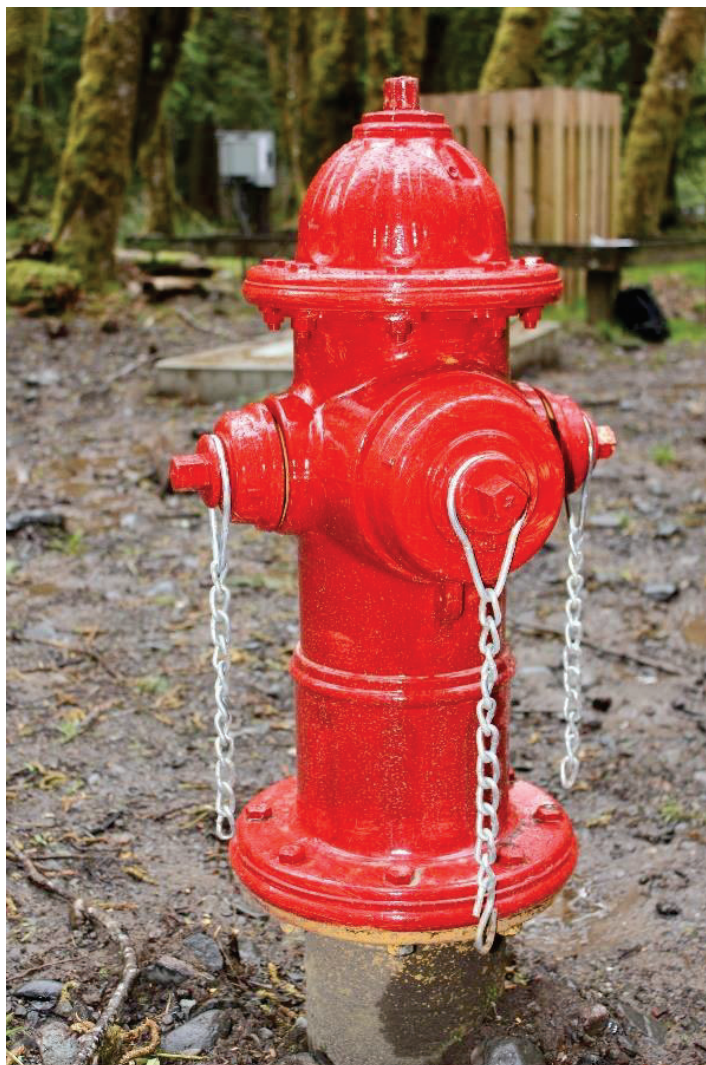
Photograph 14: Typical fire hydrant along water system, Well #3 seen in background, looking northwest. (NPS/2019).

Typical water system appurtenances including fire hydrants, valves, valve makers, meters, and meter boxes can also be found throughout the Barnes Point water distribution system. Underground linear features of the wastewater collection system include pressurized force mains, gravity sewer pipes, and cleanouts.
