# United States Department of the Interior

## NATIONAL PARK SERVICE

### Memorandum

Subject: Technical assistance evaluation of three culvert crossings in the vicinity of Salt Wash along Delicate Arch road.

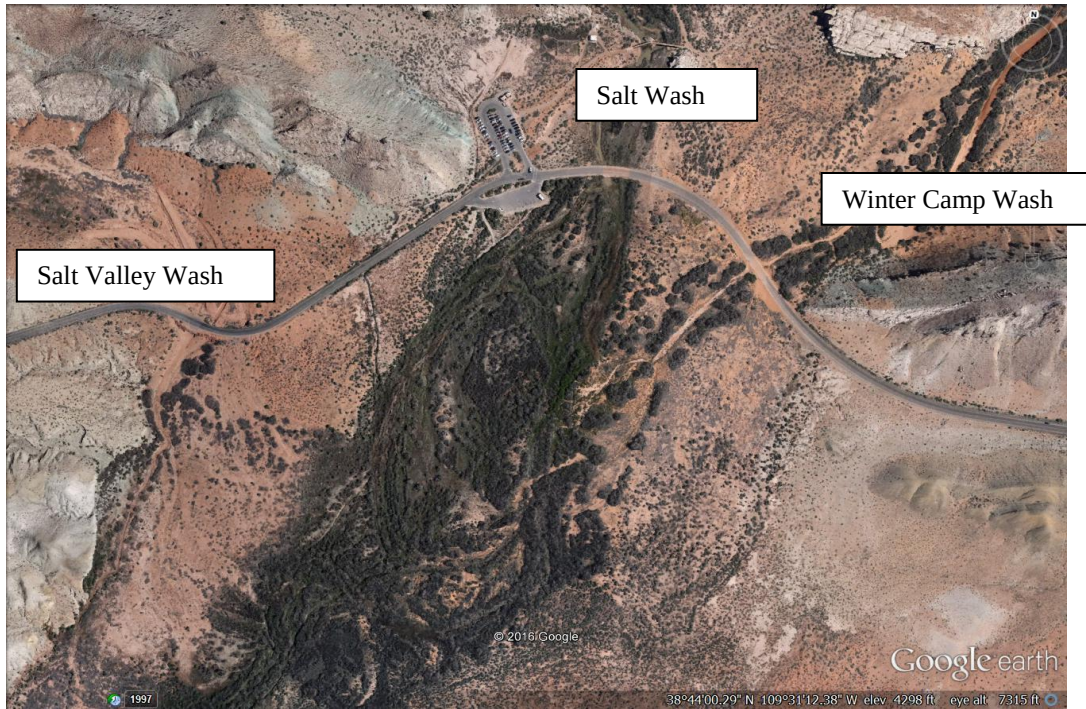
**Figure 1.** Google Earth Image showing the Delicate Arch road where it crosses Salt Valley Wash, Salt Wash, and Winter Camp Wash.

Delicate Arch road crosses the three drainages over a distance of about one km (3300 feet) with Salt Valley Wash to the west, Salt Wash in the center, and Winter Camp Wash to the east (Figure 1). All three washes may be subject to floodflows and sediment transport. Both Salt Valley Wash and Winter Camp Wash are ephemeral drainages, flowing only in response to rainfall, while Salt Wash, the largest of the three drainages, is perennial. When the road was last upgraded in the 1990's, all three crossings were fitted with culverts and all of the crossings responded differently with respect to sediment transport and flow hydraulics. Currently, channel and floodplain aggradation has rendered all of the culverts completely buried or non-functional.

The confluence of these three drainages forms an elongated, aggradational valley that resembles a coalescing alluvial fan. Areal imagery indicates that as recently as the 1970's, Salt Wash maintained a single-thread channel with a meandering planform through the area of the road crossings and on through the downstream valley. Currently, Salt Wash and its immediate tributaries form a braided system with shifting channels downstream from the crossing area. This braided reach is sub-irrigated by the perennial flow of Salt Wash, which has allowed an extensive riparian forest, much of which is *Tamarix*, to become established. The channel appears to regain a single-thread, meandering form about 600 m (2000ft) downstream from the crossing area (Figure 1).

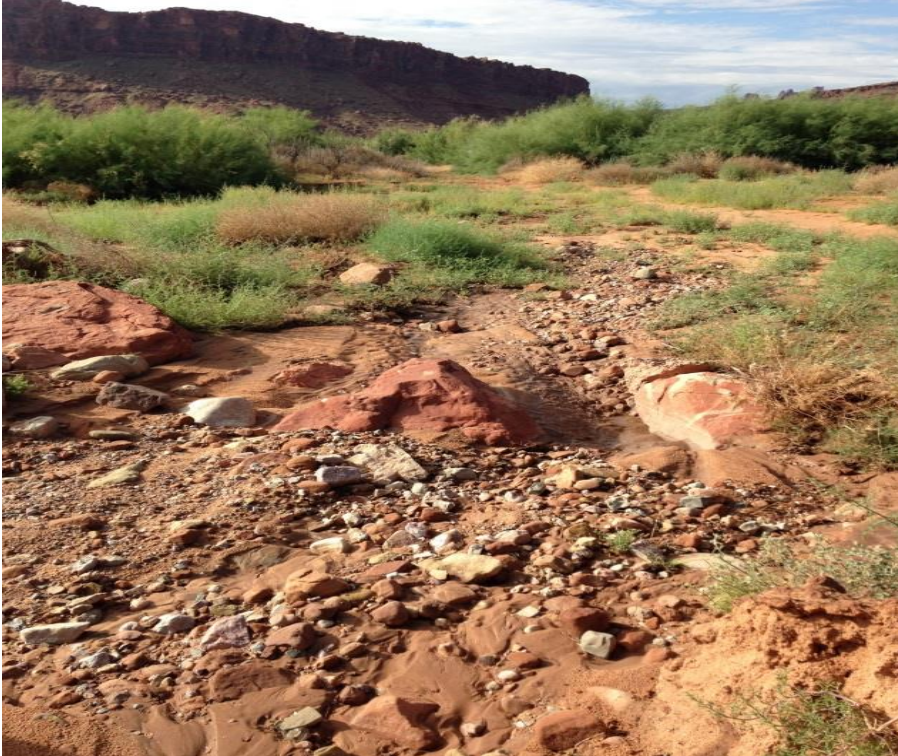
**Figure 2.** Salt Valley Wash looking downstream from the road crossing. Note the floodplain is relatively free of aggraded sediment. NPS -2016.

At the time of the site visit, the western-most ephemeral drainage, Salt Valley Wash (Figure 2), was functioning the best of the three crossings and appeared to be capable of passing incoming water and sediment, at least under the prevailing conditions. However, the crossing does not perform as designed and is suffering structurally as a result. The culverts that were installed in the 1990's have completely filled in with alluvium and the asphalt surface, which serves as a low-water-crossing during times of discharge, has experienced undercutting and erosion on the downstream side (Figure 3). Even though Salt Valley Wash is passing sediment and water, runoff events will continue to erode away the road surface and likely compromise the crossing at some time.

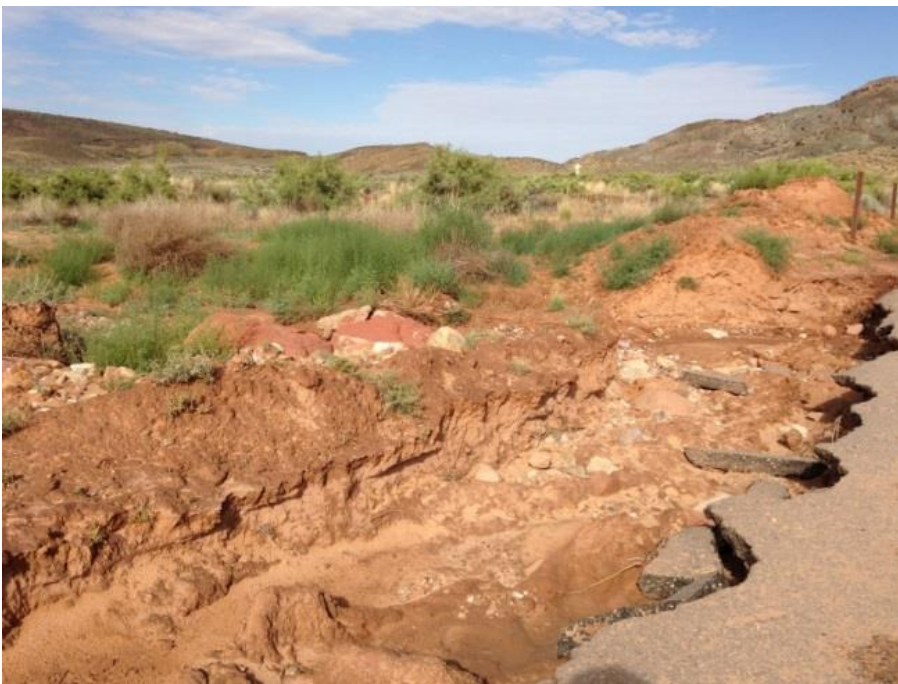
**Figure 3.** Salt Valley Wash, looking west across the channel from the road crossing. Note the failed asphalt where discharge periodically pours off the road surface. NPS-2016.

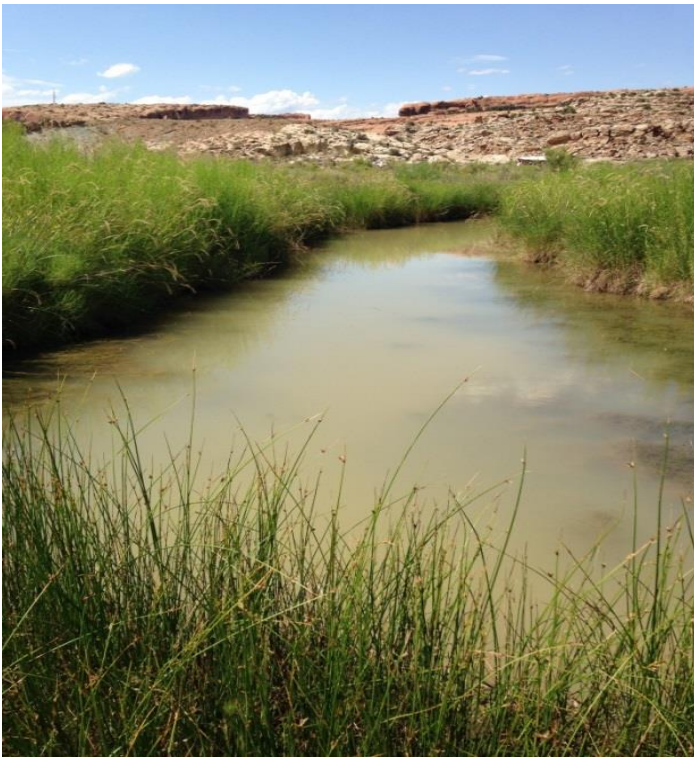
**Figure 4.** Salt Valley Wash looking upstream from the road crossing. Note that the culvert intake is completely submerged. This channel width may be somewhat representative of historic channel geometry. NPS – 2016.

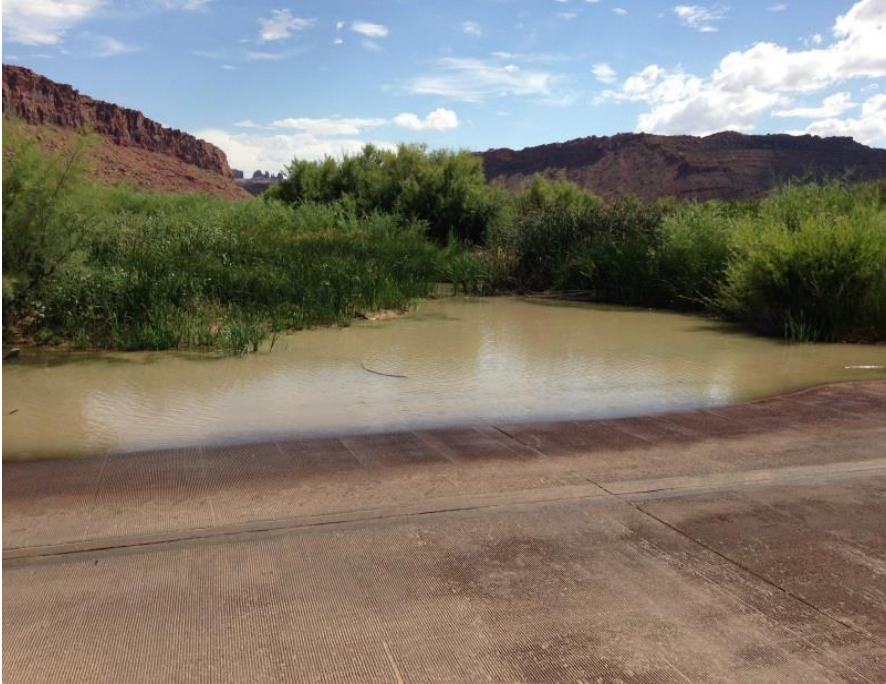
**Figure 5.** Salt Valley Wash looking downstream from the road crossing. Note that the culvert outlet is completely submerged due to downstream aggradation and vegetation establishment. NPS – 2016.

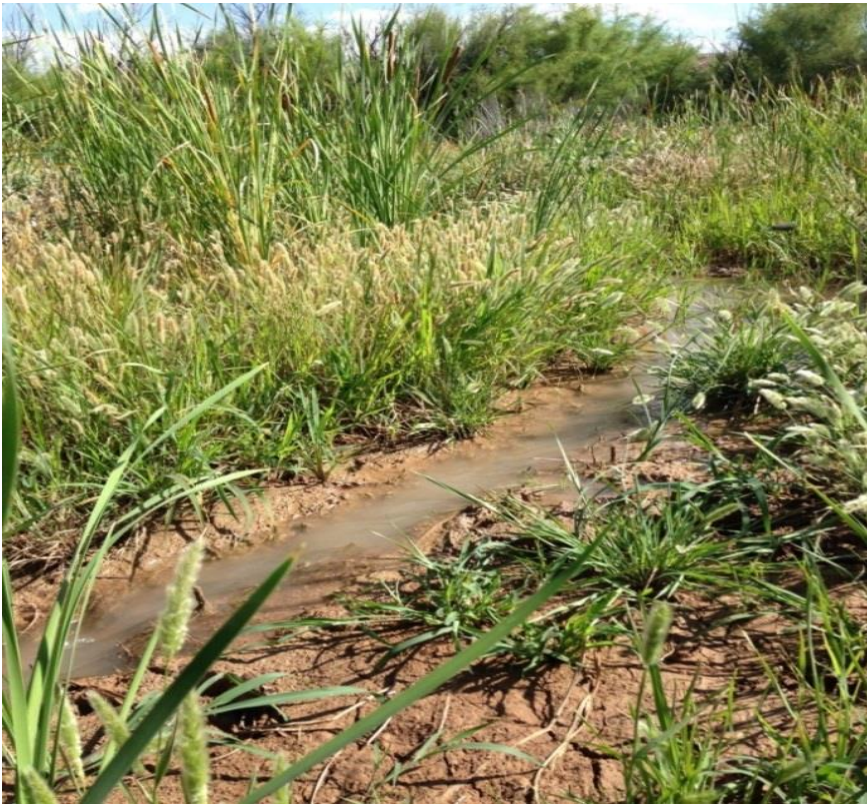
**Figure 6.** Salt Valley Wash about 200 m (650 ft) downstream of the road crossing. Note the small channel (about 0.3-0.5 m wide) that has formed through the alluvium, the only area obviously conveying flow downstream of the crossing. NPS – 2016.

Salt Wash, the middle crossing, is the largest drainage of the three and the only one with perennial flow (Figure 1). This catchment drains over 240 sq. km (150 sq. miles) and has formed a prominent valley both up and downstream of the crossing. Aerial imagery from the middle of last Century indicates that the historical Salt Wash channel was a well-developed meandering stream with a relatively constant channel width of between 10 and 20 m. (33-66 ft). Under the current aggraded conditions, Salt Wash and the other two drainages essentially form an elongated alluvial fan through a braided channel system. The perennial flow has supported sub-irrigation and an extensive woody and herbaceous riparian community, much of it composed of *Tamarix*. The combination of the aggradation and vegetation establishment has led to extremely poor flow conveyance conditions and there was practically no downstream flow at the time of the site visit even though there was substantial backwater at the crossing (Figures 4 and 5). Reconnaissance of the area immediately downstream of the crossing found only one small channel conveying flow (Figure 6).

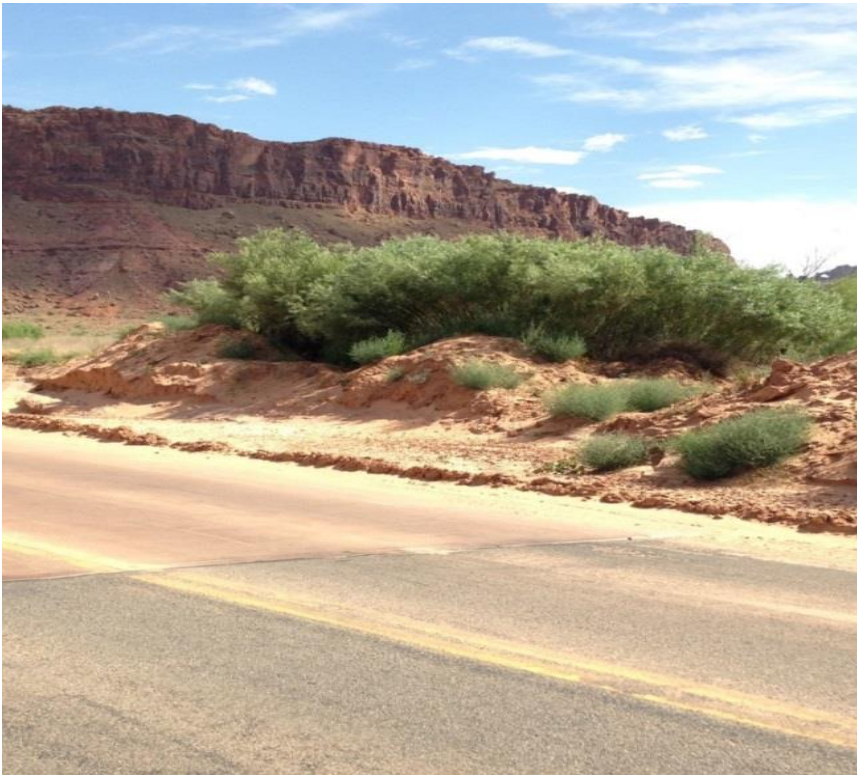
**Figure 7.** Winter Camp Wash looking down-valley just west of the road crossing. The accumulated sediment is from previous clearing operations and blocks part of a former channel. Note the well-established tamarisk on the mounds of sediment, which are spoil material. The culverts are below grade and completely buried. NPS – 2016.

Winter Camp Wash is the eastern most of the three drainages (Figure 1). The primary issue with this crossing is extreme sediment aggradation that has resulted in a sediment management issues and frequent road closures. The culvert passage has completely filled and currently functions as a low water crossing. This crossing however, does not pass sediment and the downstream channel and floodplain have aggraded substantially, currently providing little to no hydraulic passage. Reconnaissance level evaluation suggests that there is sufficient downstream gradient to provide both flow and sediment conveyance. However, the adverse grade in the accumulation area has to be completely reworked or removed.
