Re: Determination of Eligibility/Contributing Status for Lockhart Bridge (24CB2769) in Carbon County, Montana

**Subject:** Initiation of consultation of project on Lockhart Bridge and Retaining Wall, Carbon County (24CB2769).

## Lockhart Bridge (24CB2769)

Lockhart Bridge and Retaining Wall project with APE

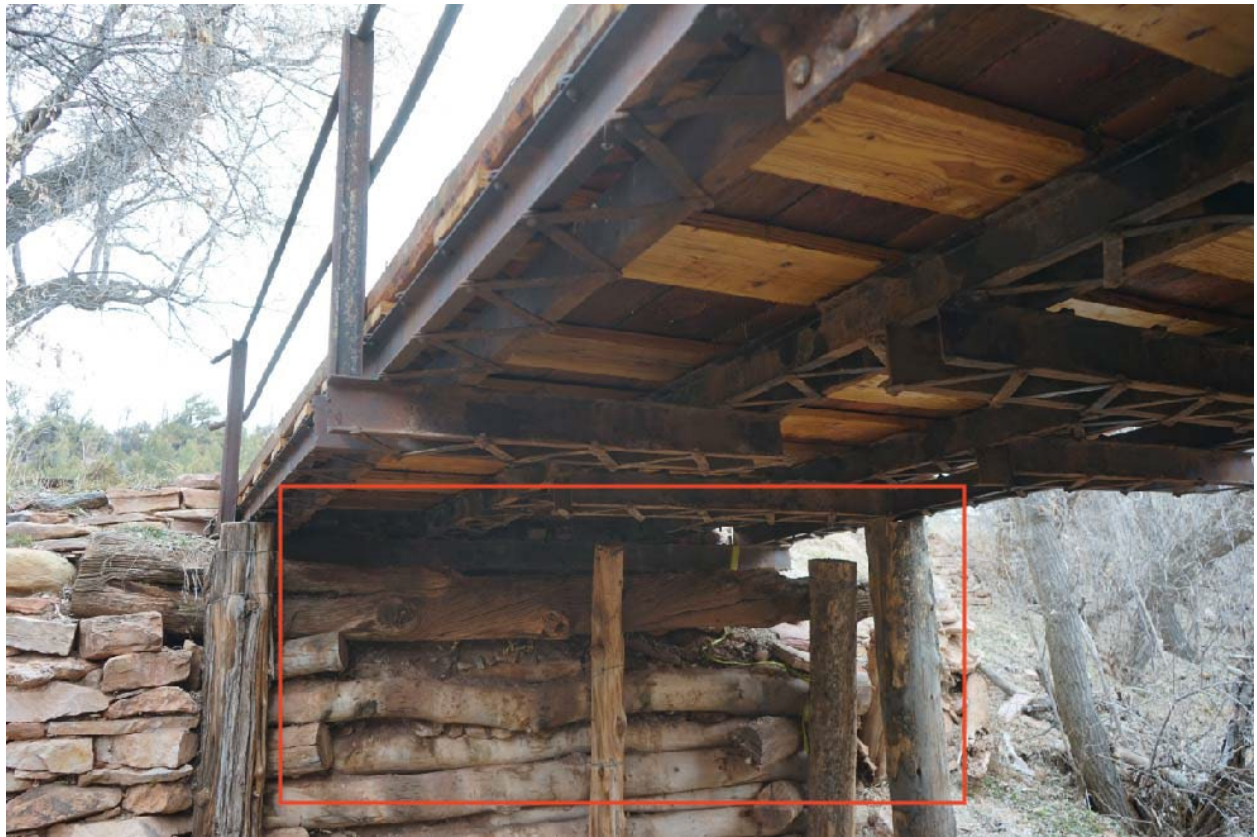
Figure 1 - North side of bridge showing failing logs and wash out behind the logs that is compromising bridge stability.

This rock retaining wall will need to be restored providing support for the northeast side of the bridge using the materials that are present to keep it historically accurate. The cottonwood log footer, 10 logs, will also need restoration to preserve the abutment. Any outside materials used will be in-kind and workmanship will meet the Secretary of Interior Standards for the Treatment of Historic Properties. The work will be completed by BICA's historic preservation crew under the supervision of the Cultural Resource Lead. The Lockhart Bridge and Retaining Walls will be stabilized and reconditioned for the safety and integrity of the visiting public and employees, ADA accessibility will be continued. The project will take this National Register asset from poor to good condition and will meet Bighorn Canyon's goals of compliance and preservation.

Due to the loss of the retaining wall and lack of soil integrity, 2-3 deadman devices will be required to stop sluffing of the embankment and alleviate pressure on the retaining wall itself. This will consist of 8" masonry block and ½" rebar fully grouted, tying into the back of the structure. Cottonwood log footers will then be placed on packed soil with the use of heavy gauge wire and cedar posts. A water-resistant treatment will be applied to the logs and the utilization of a vapor barrier between the logs and the soil will be installed to reduce the speed with which deterioration will occur in the future. A concrete footer, 6" deep by 8" wide and 12' long is placed behind the logs to carry the weight of the retaining wall and allow for masonry foundation. This will provide needed support for the Northeast corner of the bridges steel undercarriage. Using the existing stones, a dry stack veneer will cover all masonry and add the stability required to support the abutment.

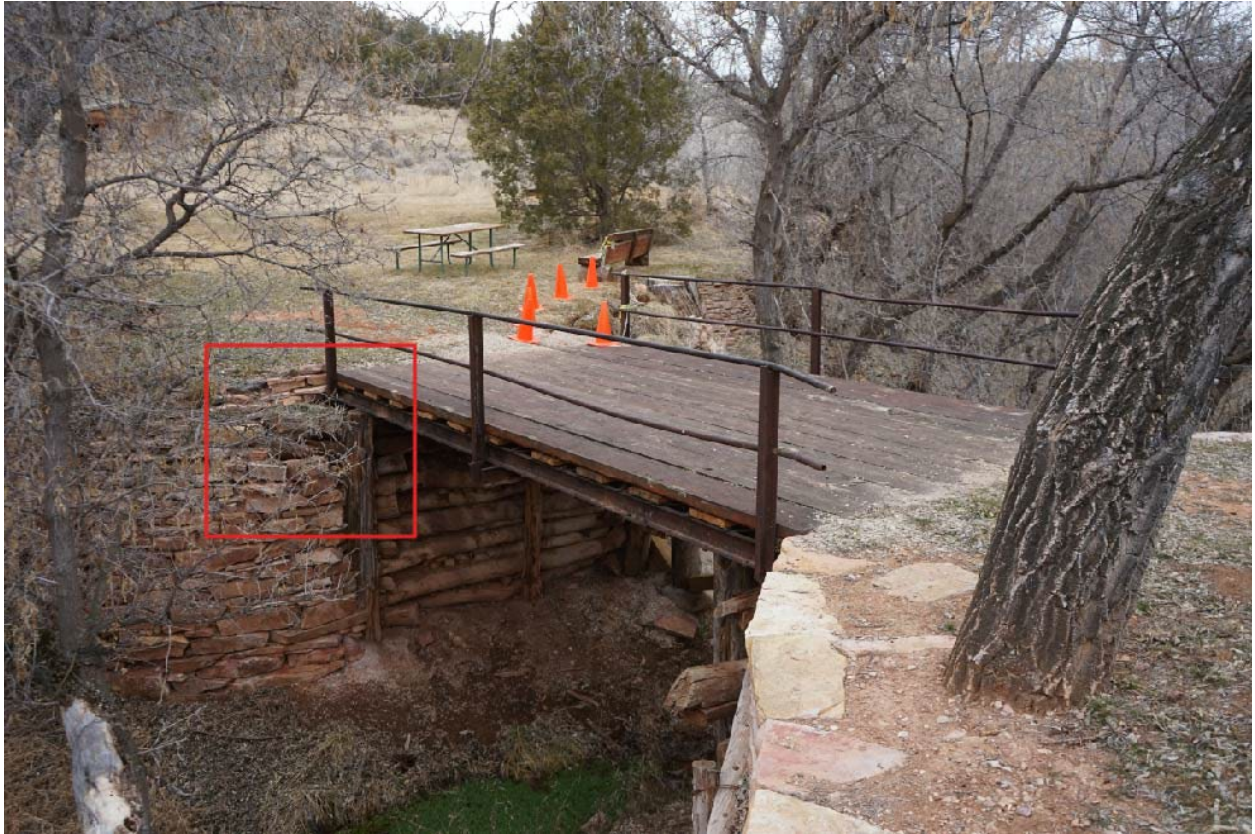
Figure 2 - Dry stack starting to fail on west side of bridge. Locations will be restacked before damage gets worse.

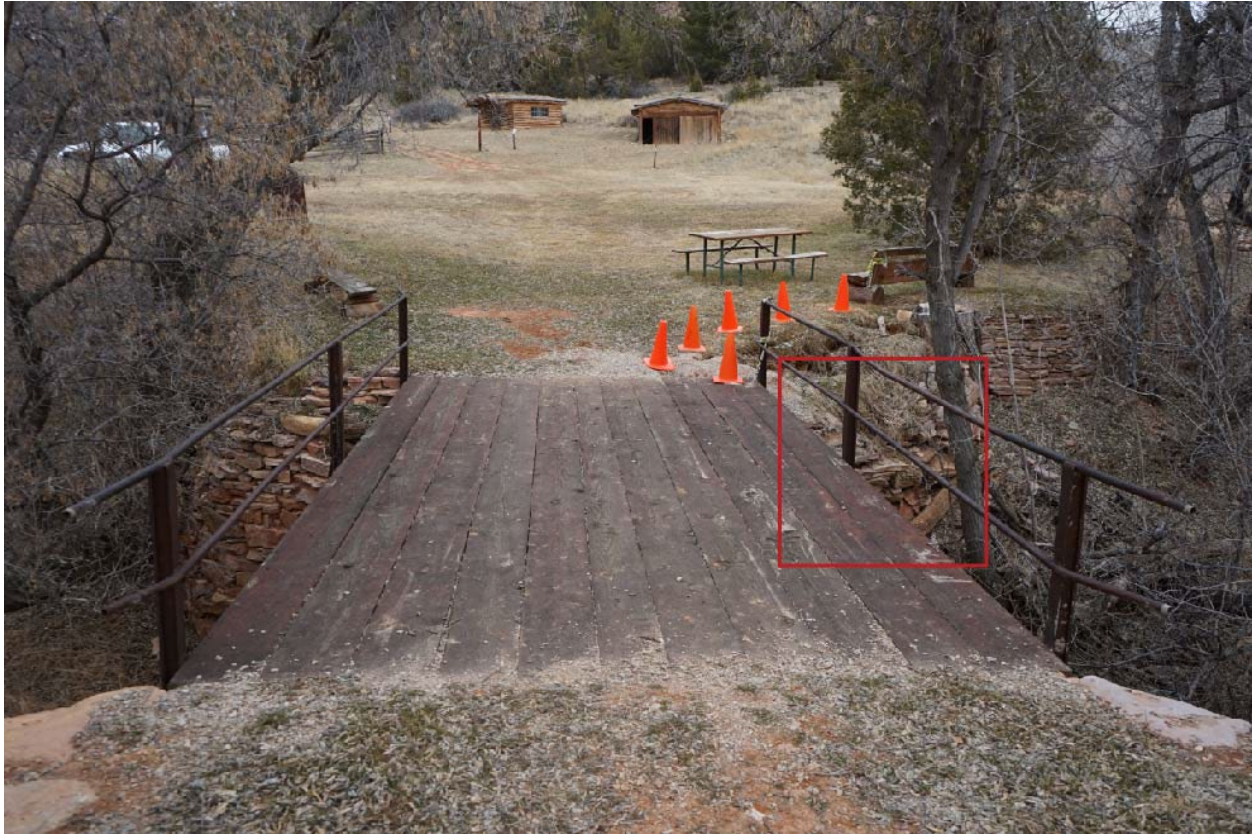
the Lockhart bridge. The compromised section of retaining wall is located on the northeast side of the bridge and consists of dry stack rock measuring 12' in length and 7' in height, 72 square feet in total. Under this dry stack is a retaining footer comprised of 10 cottonwood logs 14' in length and 12" to 16" in diameter which have also deteriorated. This log retaining footer was built using a heavy gauge wire and cedar posts to hold it in place. The deterioration of the log footer is a result of lack of funds and staffing which has further resulted in maintenance delays that were not addressed prior to the collapse of the rock dry stack section.

Figure 3 - East side of bridge where the dry stack and logs have almost completely failed.
