## **Determination of Eligibility**

### **Eielson Visitor Center, Denali National Park and Preserve**

- Original Design: 1956
- Designer: National Park Service (NPS), Western Office of Design and Construction (W.O.D.C.)
- Date of Construction: 1958-1960
- Alteration: 1974-1976<sup>1</sup>

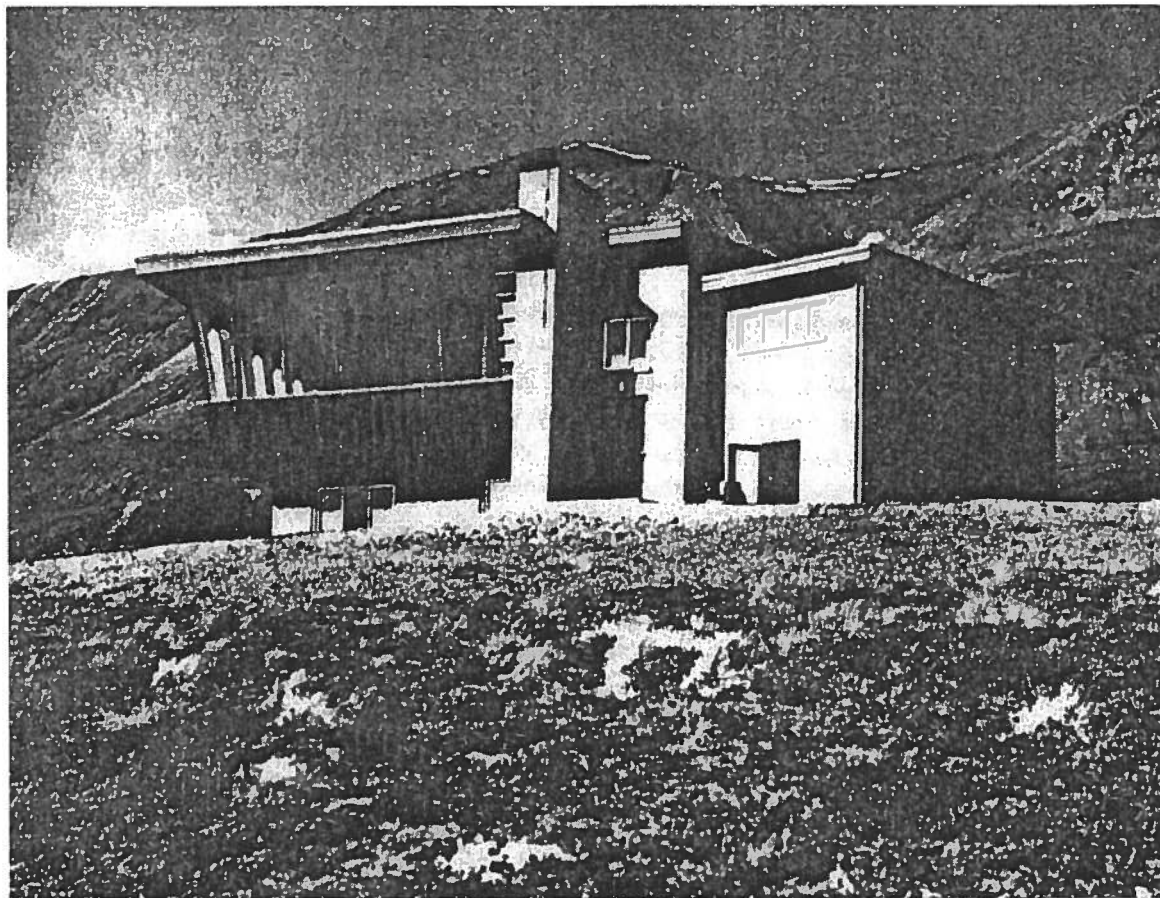
South Elevation  
Eielson Visitor Center  
Denali National Park and Preserve  
1963

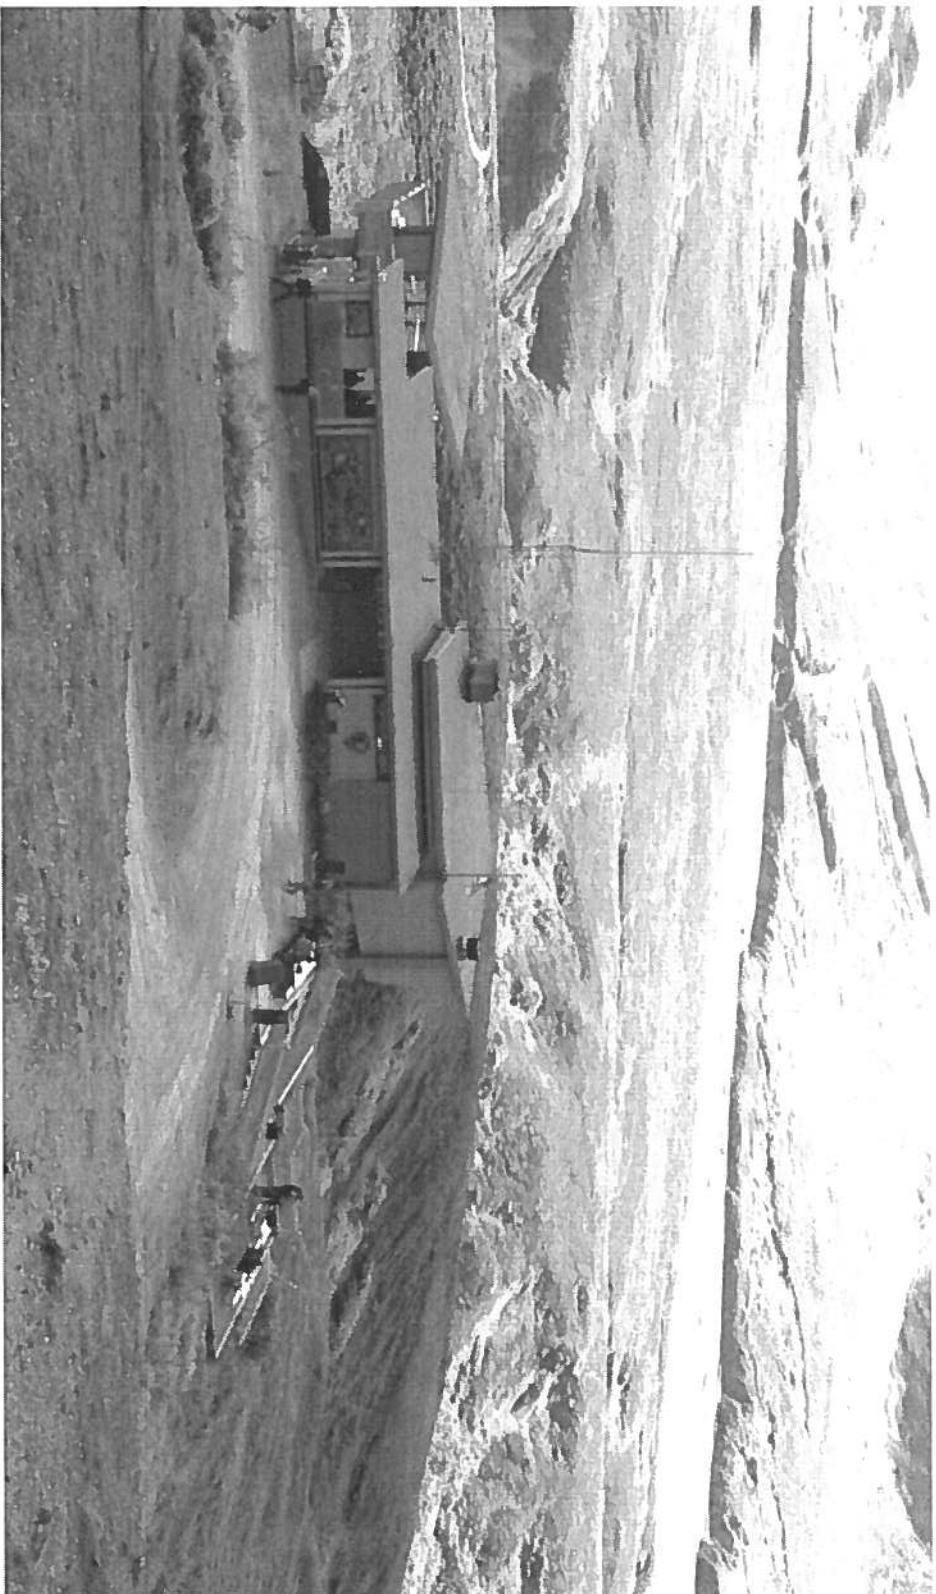
North Elevation  
Eielson Visitor Center  
Denali National Park and Preserve  
2001

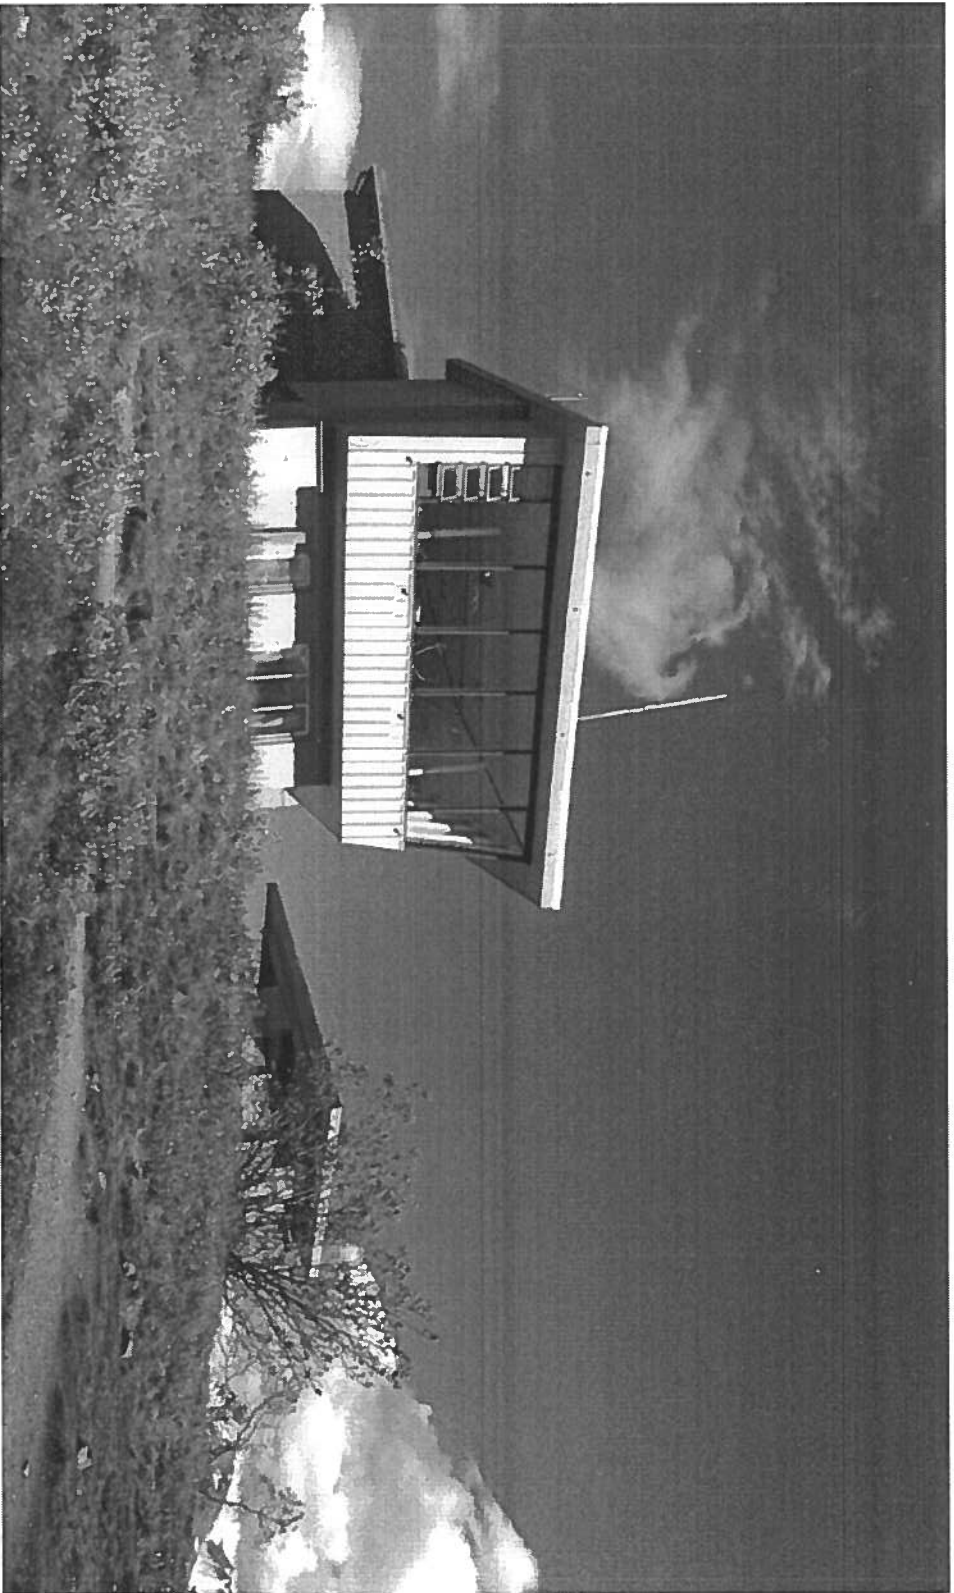
West Elevation  
Eielson Visitor Center  
Denali National Park and Preserve  
2001

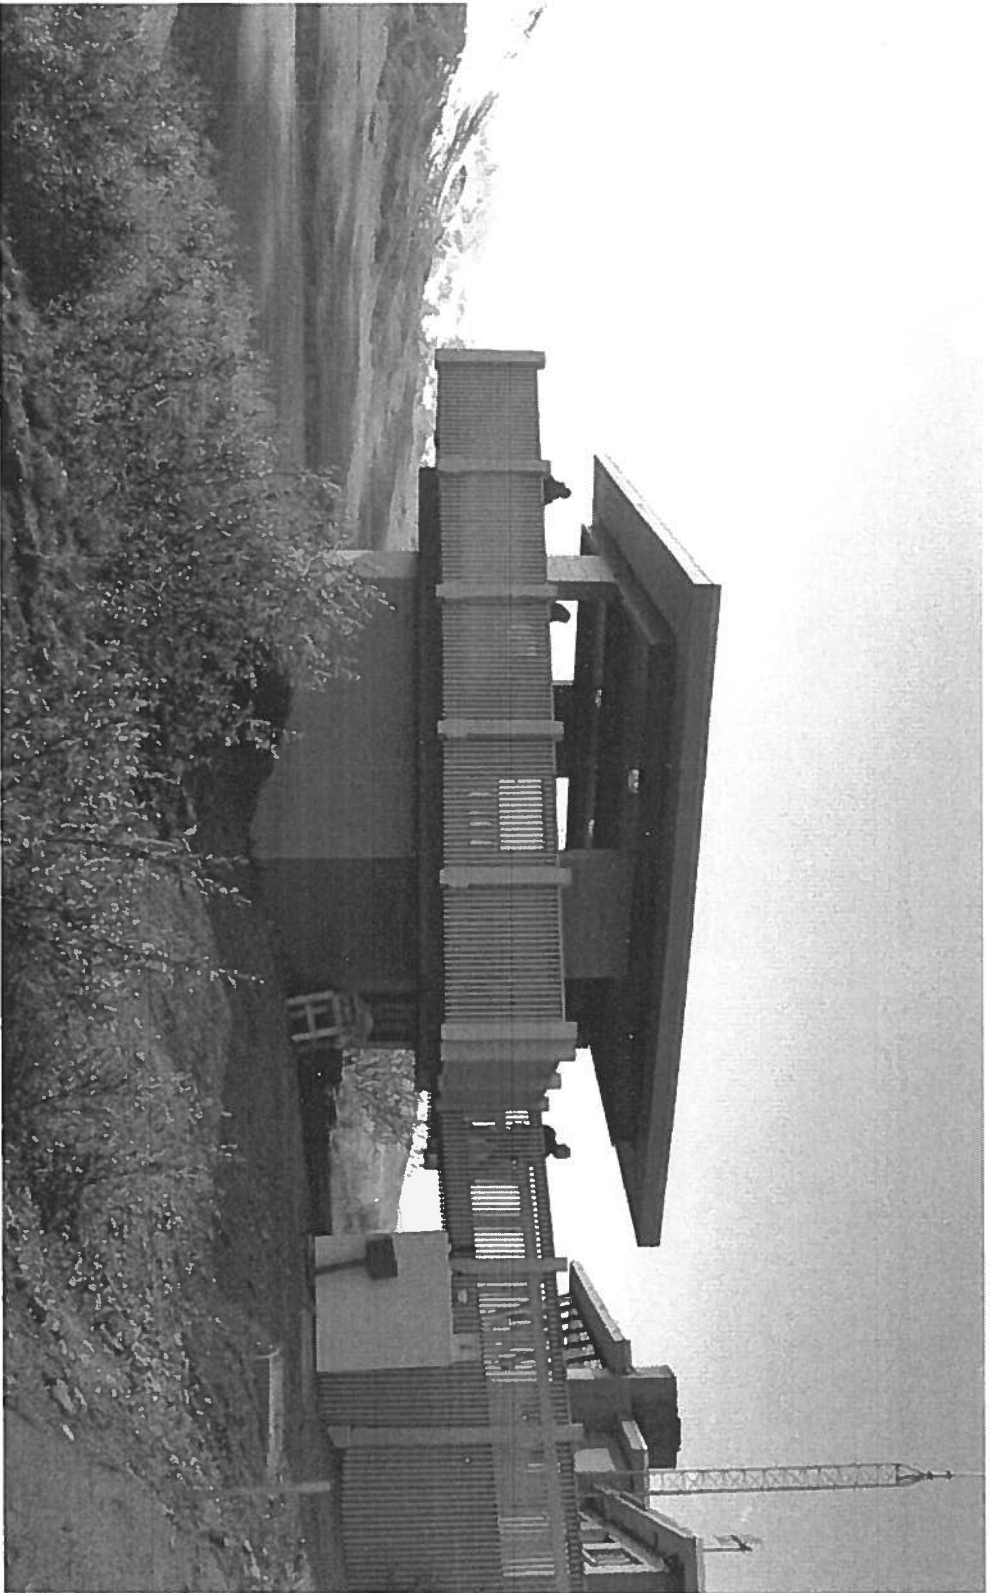
East Elevation  
Eielson Visitor Center  
Denali National Park and Preserve  
2001
