**2022 Avon and Buxton  
Beach Renourishment Projects**

**2024**  
**MONITORING REPORT**

**2022 BEACH RENOURISHMENT PROJECTS  
AVON and BUXTON  
DARE COUNTY (NC)**

**Year 2 Post-Project Monitoring Report**

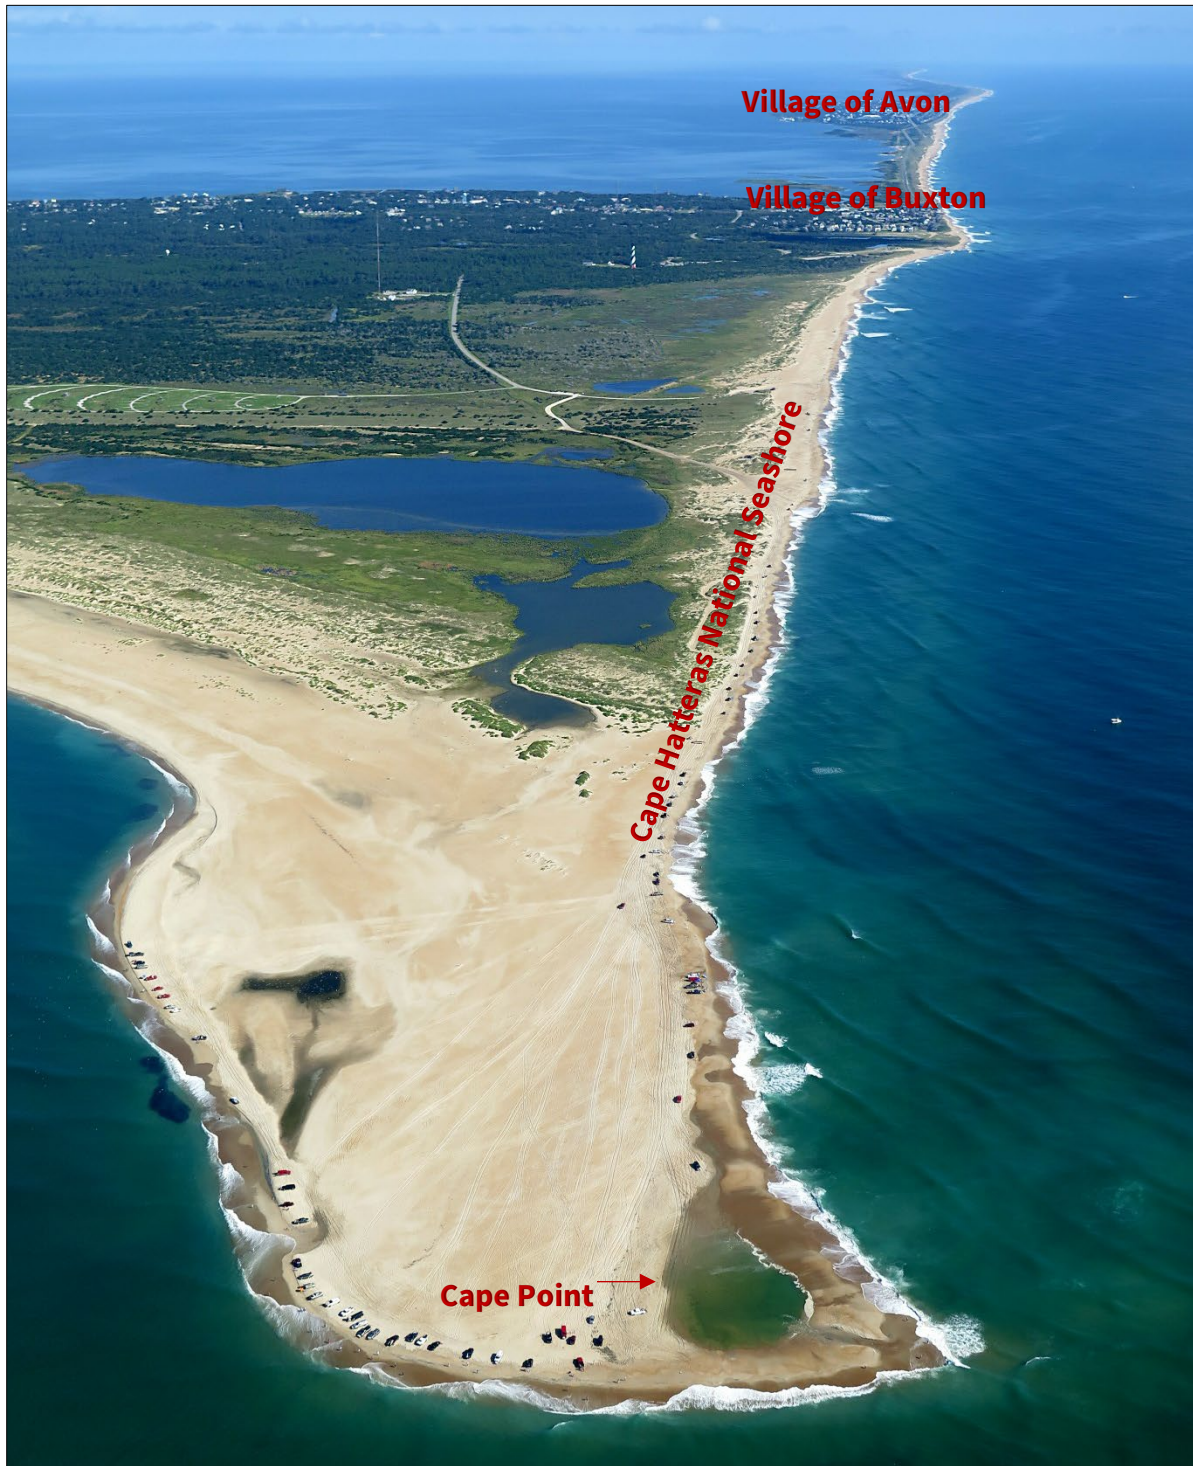
**FIGURE 2.1.** Aerial photo taken on 10 September 2014 showing sand movement from north to south and a sand deposit at Cape Point. Sand also accumulates from the west at Cape Point under prevailing winds and waves from the southwest. [Source: CSE]

Erosional hot spots near Buxton Village are related to the long-term migration of Cape Hatteras in a southwestward direction, which is driven by large-scale atmospheric and oceanic processes (Fig 2.4, cf – Inman and Dolan 1989). Three groins were built at the old Cape Hatteras Lighthouse in 1969 to help reduce the shoreline recession and provide some degree of protection for the lighthouse itself. Unsuccessful efforts to mitigate erosion on the beachfront at the lighthouse site resulted in NPS moving the structure landward in 1999 (Dallas et al 2013). Although the groins have deteriorated over time, they retain some sand-trapping capacity, and there is an offset in the shoreline between Cape Point and the groins, and between the groins and Buxton Village (Fig 2.1 and Fig 2.5).

The cause of elevated erosion from 2018 to 2020 at Buxton is due to several interacting dynamics related to nearshore bathymetry, the Salient (a bulge in the shoreline) created around the Hatteras groins, and the position of Cape Point. A deep trough with minimum elevations below –25 ft NAVD persists along much of Buxton Village and runs the length of the project area. Once nourishment material is deposited in this trough, wave and current conditions generally do not allow the material to migrate back onshore. Instead, sand spreads away from the salient at the groins with much of it shifting to the segment of beach on the east side of Cape Point (see Fig 2.1).

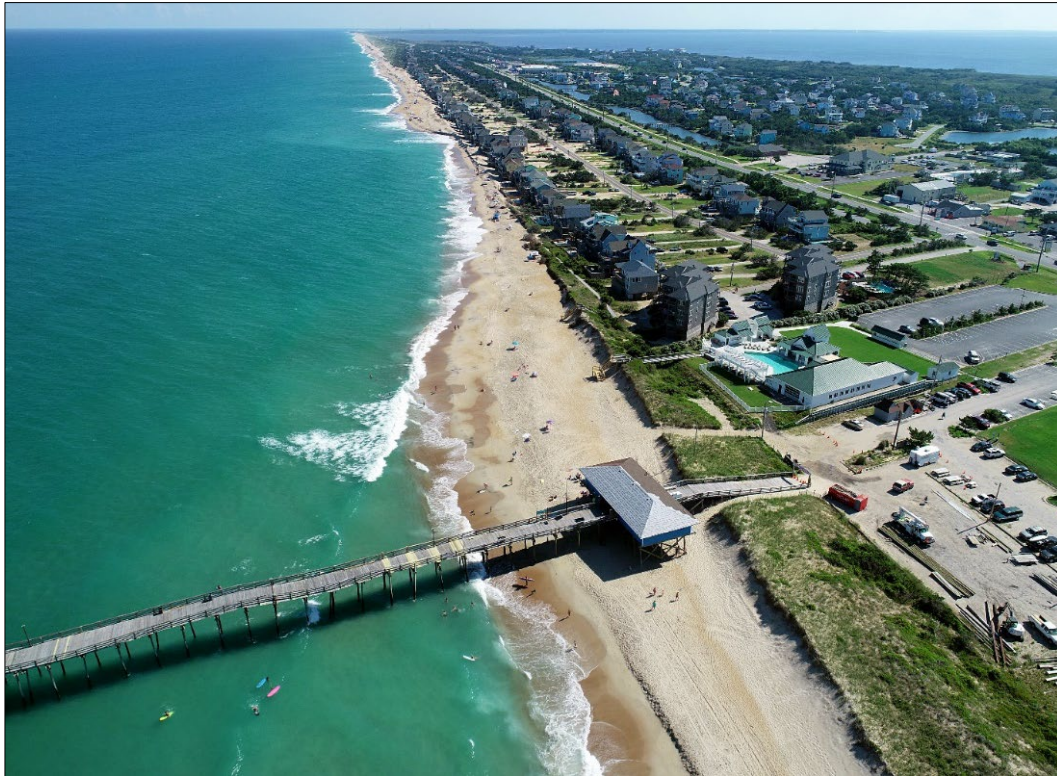
**FIGURE 2.3.** Until the past ~10 to 15 years, erosion rates along south Avon were not dramatically higher than many locations along Hatteras Island. The state-adopted erosion rates along south Avon measured ~4 to 6 ft/yr as recently as 2000, but by 2020 were higher than 15 ft/yr in many locations.

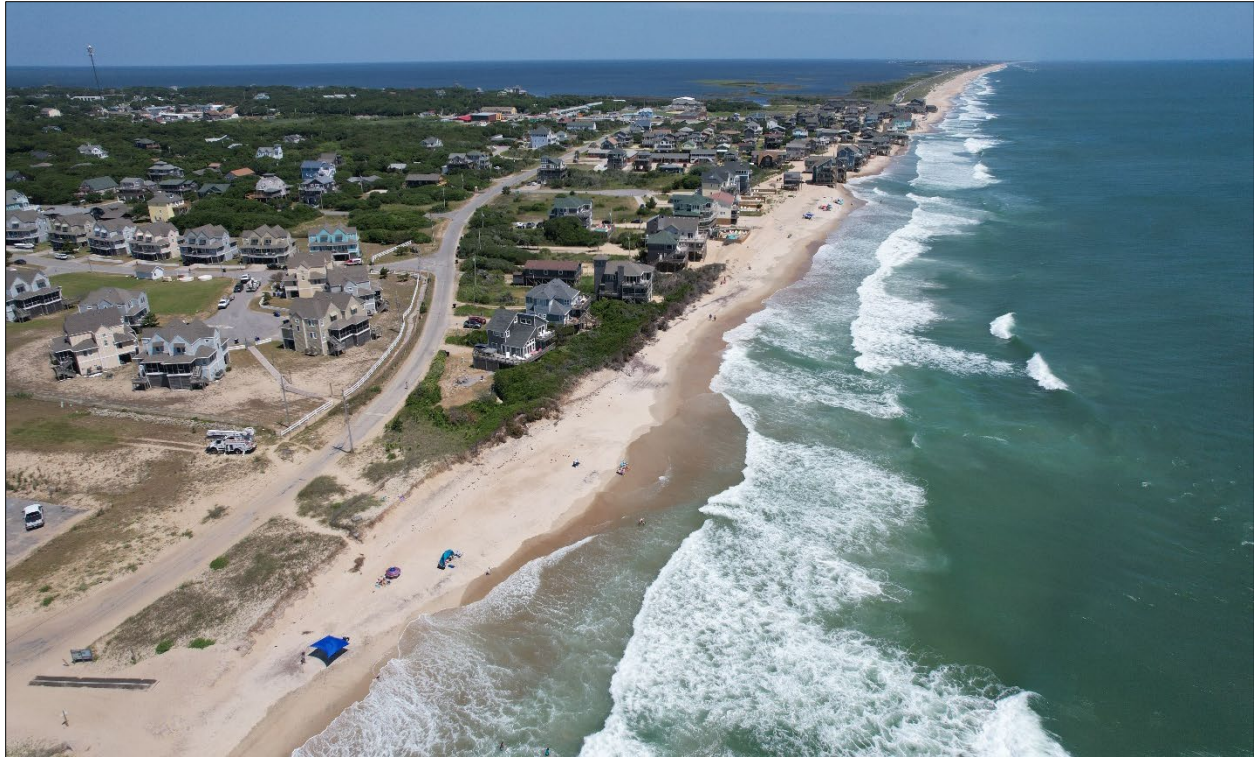
**FIGURE 2.5.** Oblique aerial image of Buxton Village taken from the former lighthouse site on 17 June 2022, just weeks before pumping began.

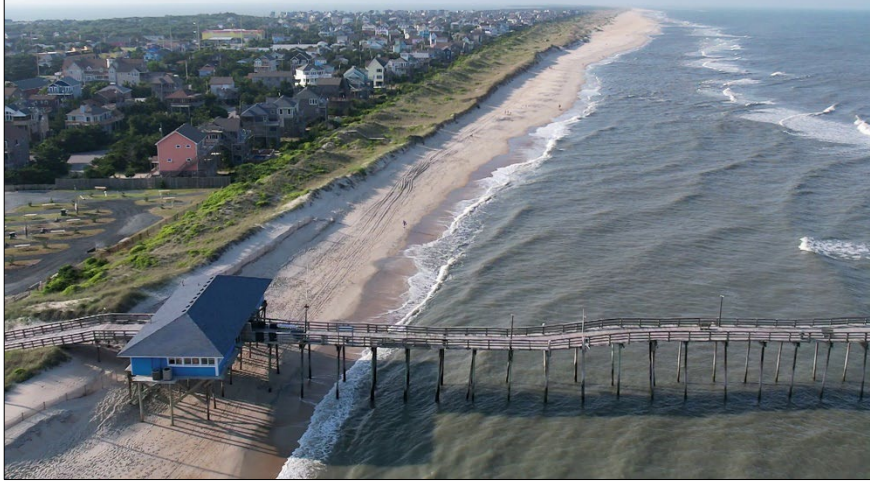
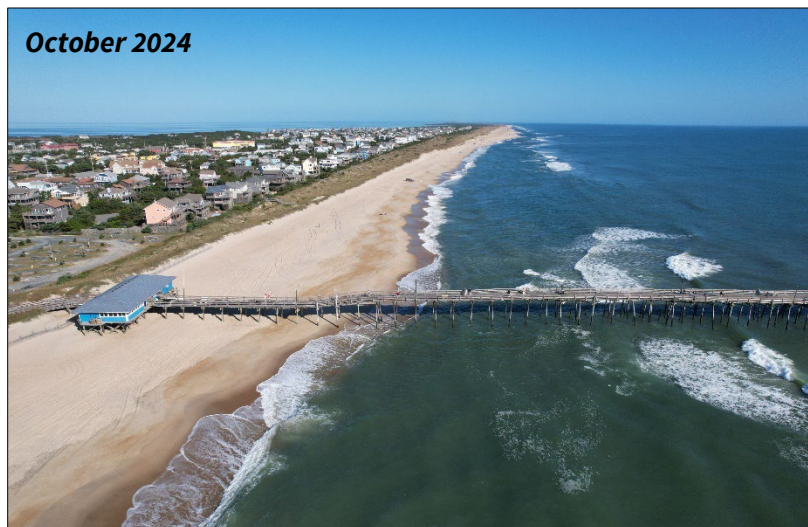
**FIGURE 4.8 (page 1 of 6).** Before, 27 Sep 2022 [**UPPER**], after, 26 Oct 2022 [**MIDDLE**], and 2-year post-project, 29 Oct 2024 [**LOWER**] images of Reach 1 for the beach nourishment project at Avon (NC). [all images taken by D. Giles]

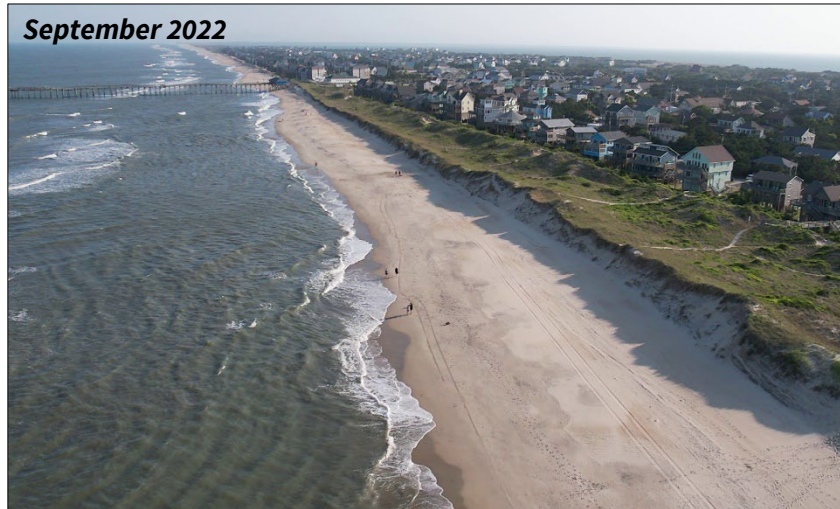
**FIGURE 4.8 (page 2 of 6).** Before [UPPER], after [MIDDLE], and 2-year post-project [LOWER] images of Reach 2 for the beach nourishment project at Avon (NC).

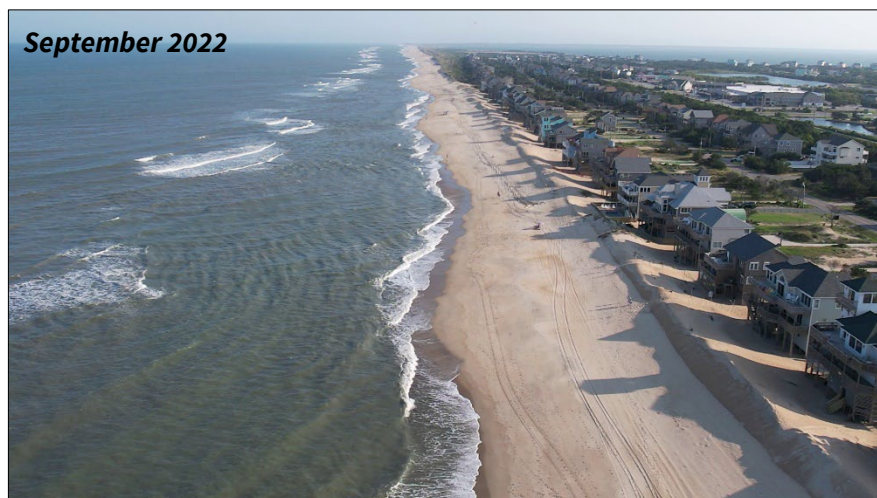
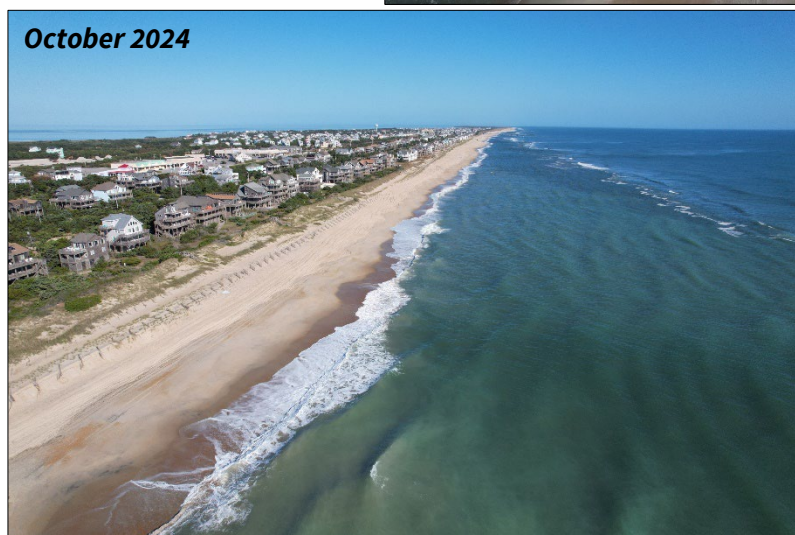
**FIGURE 4.8 (page 4 of 6).** Before [UPPER], after [MIDDLE], and 2-year post-project [LOWER] images of Reach 3 for the beach nourishment project at Avon (NC).

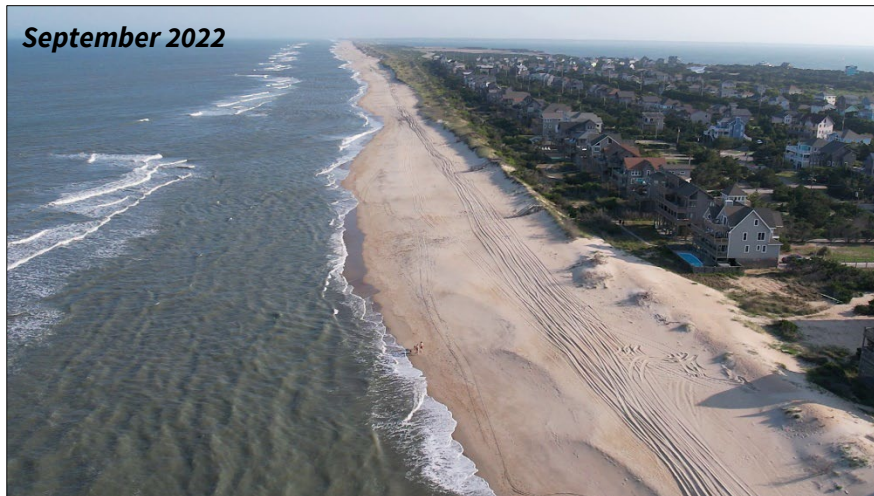
**FIGURE 4.8 (page 5 of 6).** Before [UPPER], after [MIDDLE], and 2-year post-project [LOWER] images of Reach 4 for the beach nourishment project at Avon (NC).

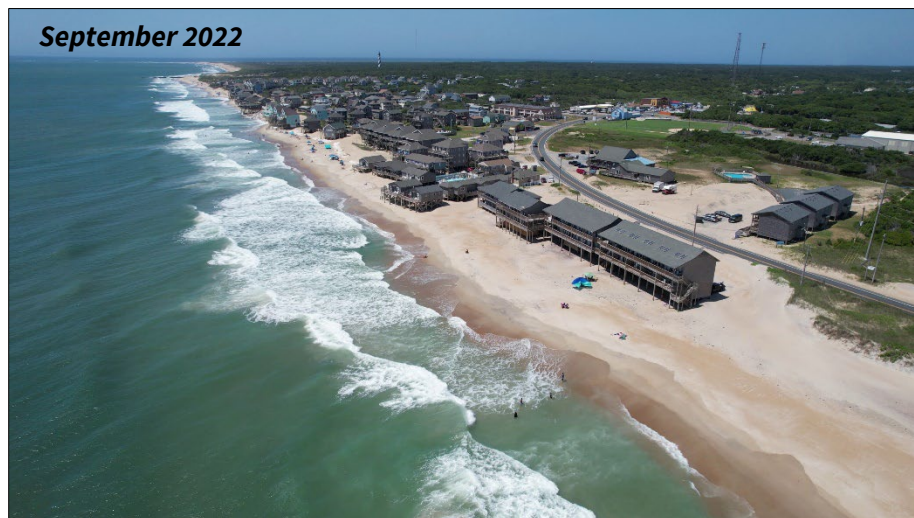
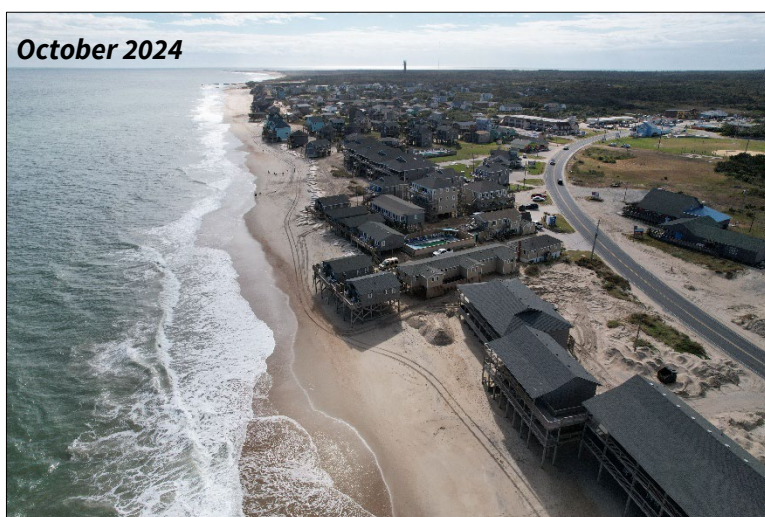
**FIGURE 4.8 (page 6 of 6).** Before [UPPER], after [MIDDLE], and 2-year post-project [LOWER] images of Reach 5 for the beach nourishment project at Avon (NC).

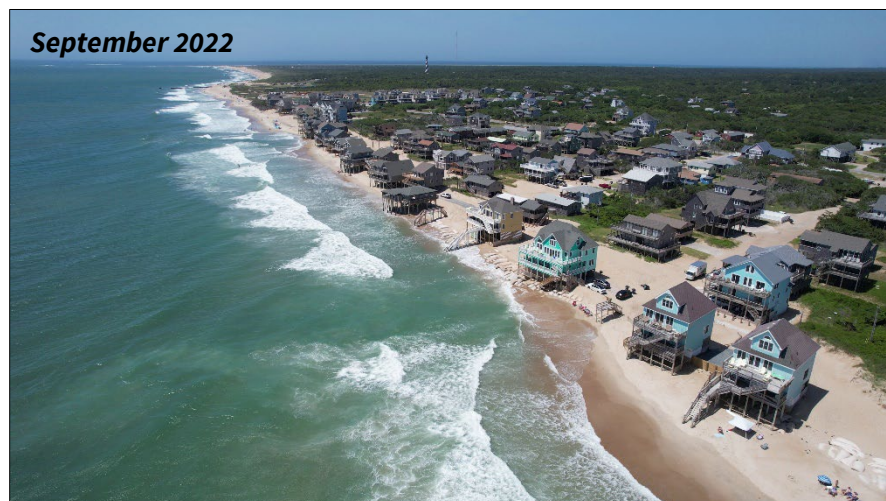
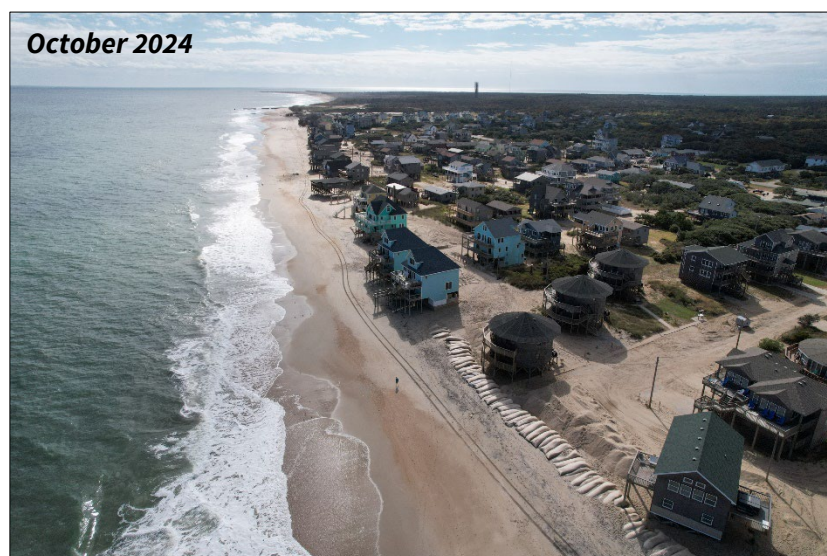
**FIGURE 4.9 (page 1 of 6).** Before [UPPER], after [MIDDLE], and 2-year post-project [LOWER] images of Reach 1 for the beach nourishment project at Buxton (NC).

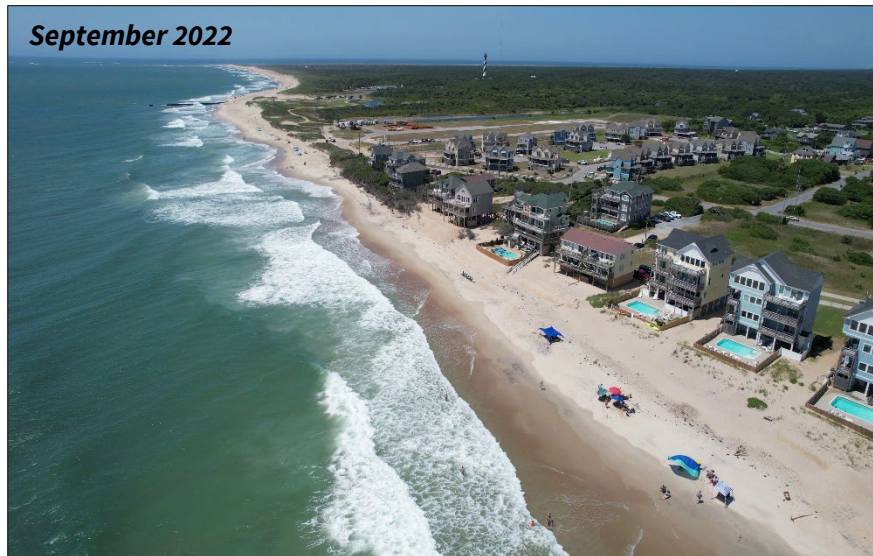
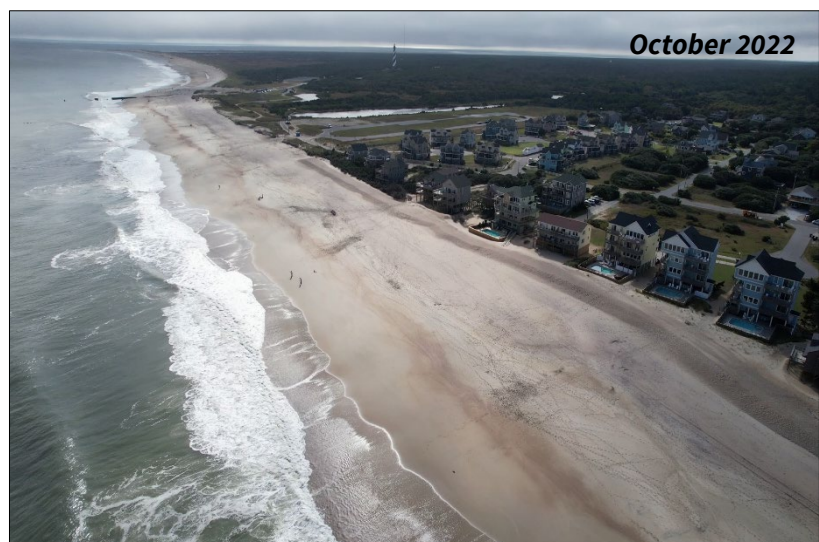
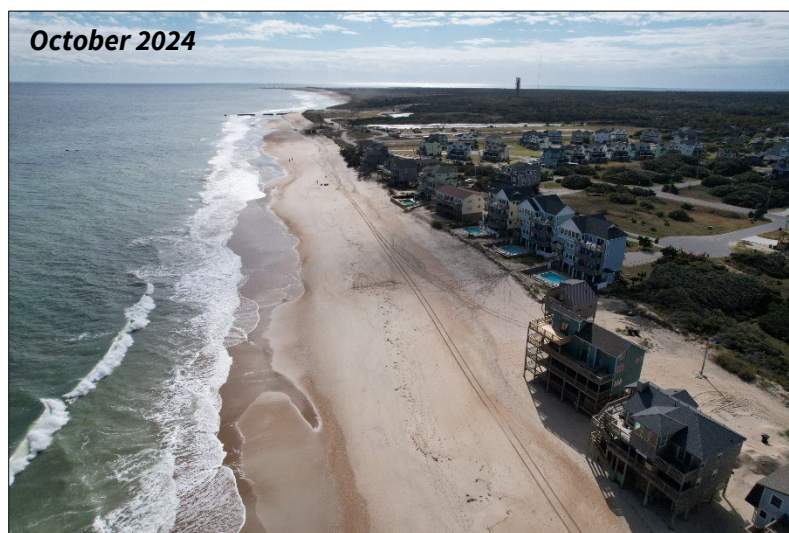
**FIGURE 4.9 (page 2 of 6).** Before [UPPER], after [MIDDLE], and 2-year post-project [LOWER] images of Reach 1 for the beach nourishment project at Buxton (NC).

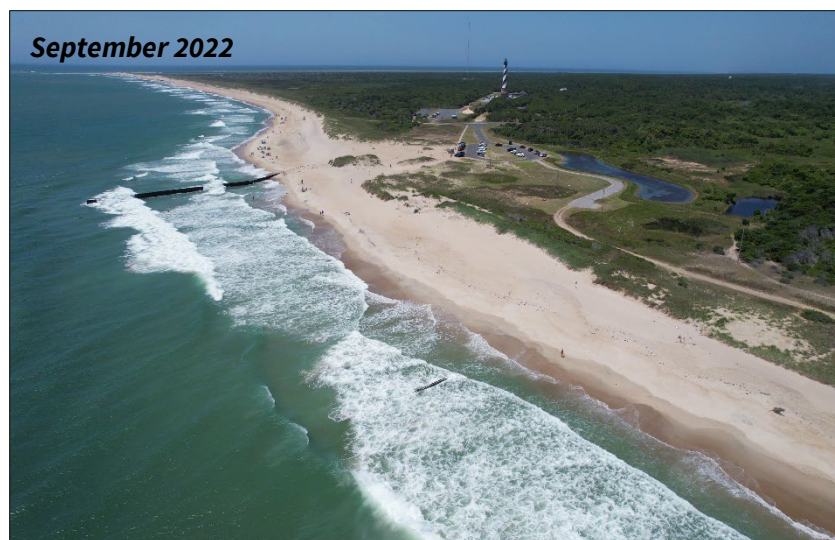
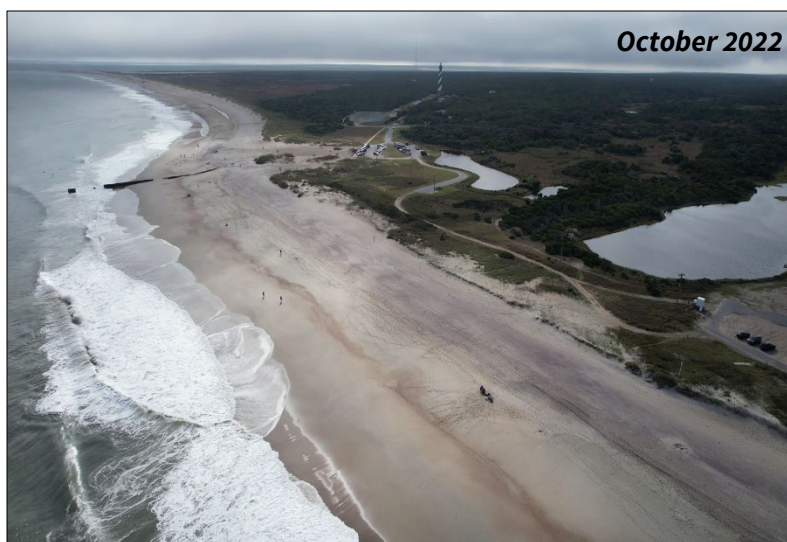
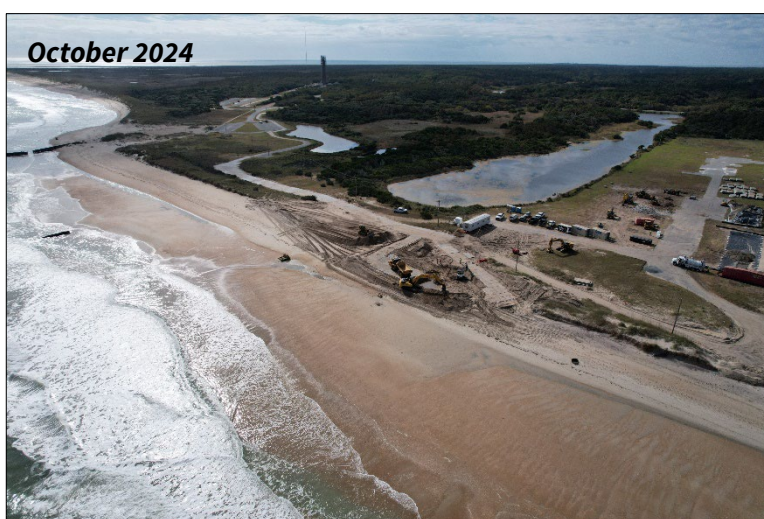
**FIGURE 4.9 (page 3 of 6).** Before [UPPER], after [MIDDLE], and 2-year post-project [LOWER] images of Reach 1 for the beach nourishment project at Buxton (NC).

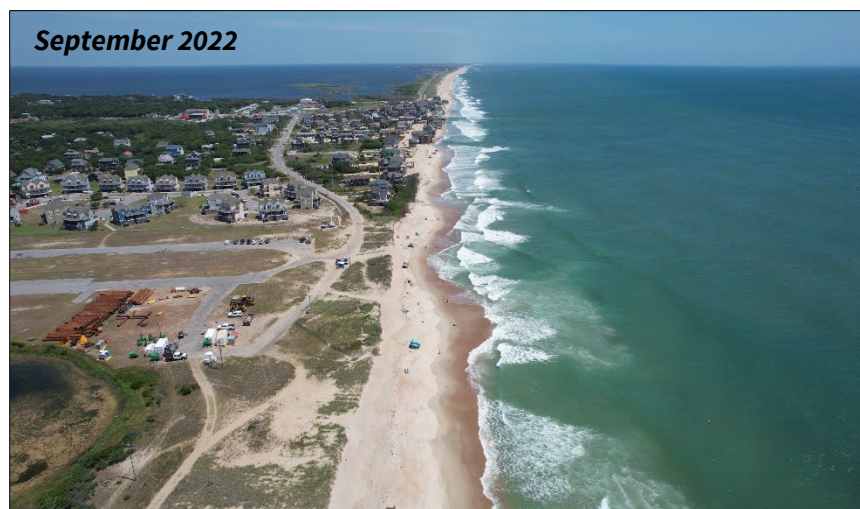
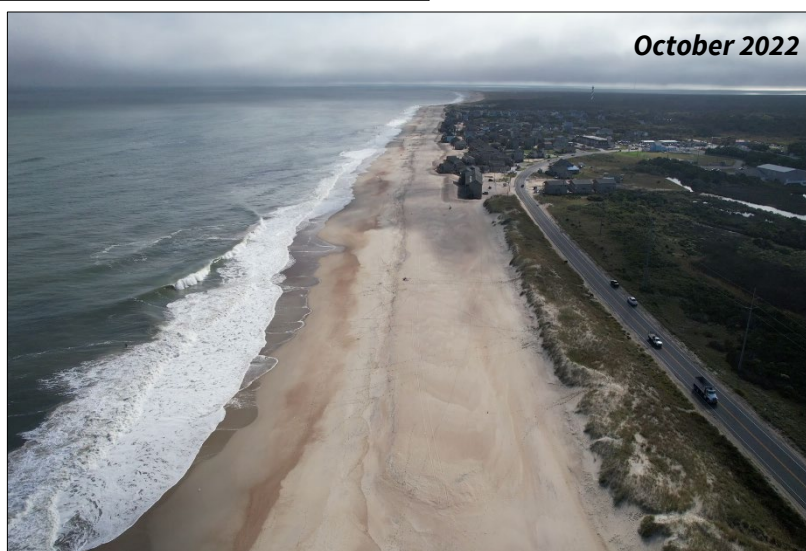
**FIGURE 4.9 (page 4 of 6).** Before [UPPER], after [MIDDLE], and 2-year post-project [LOWER] images of Reach 1 for the beach nourishment project at Buxton (NC).

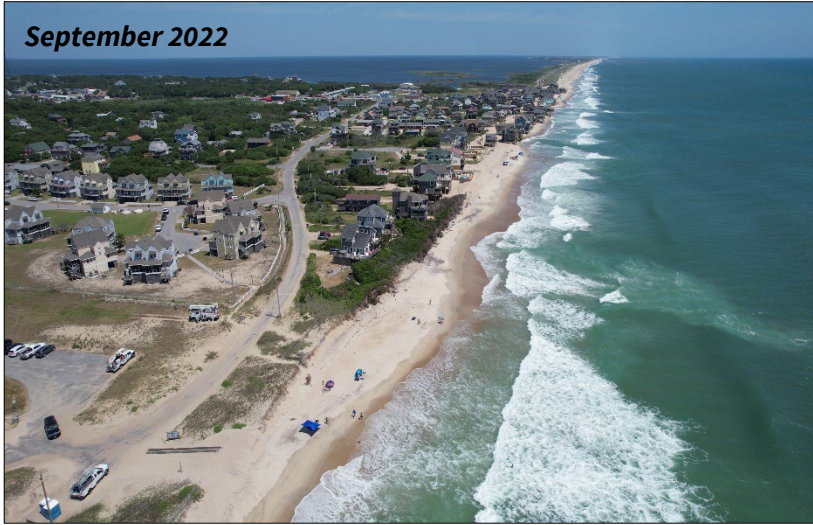
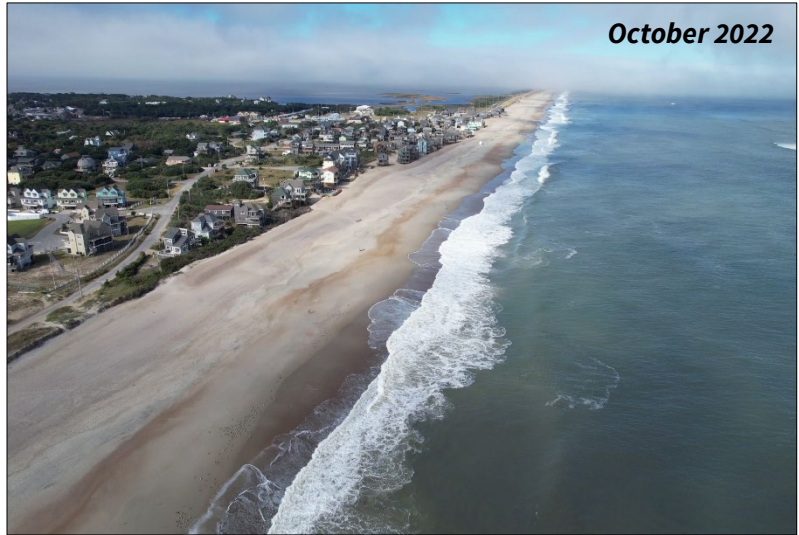
**FIGURE 4.9 (page 5 of 6).** Before [UPPER], after [MIDDLE], and 2-year post-project [LOWER] images of Reach 1 for the beach nourishment project at Buxton (NC).
