# **2005 Spring Inventory**

## **Pakoon Demo Area**

## **2005 Pakoon Basin Spring Inventory**

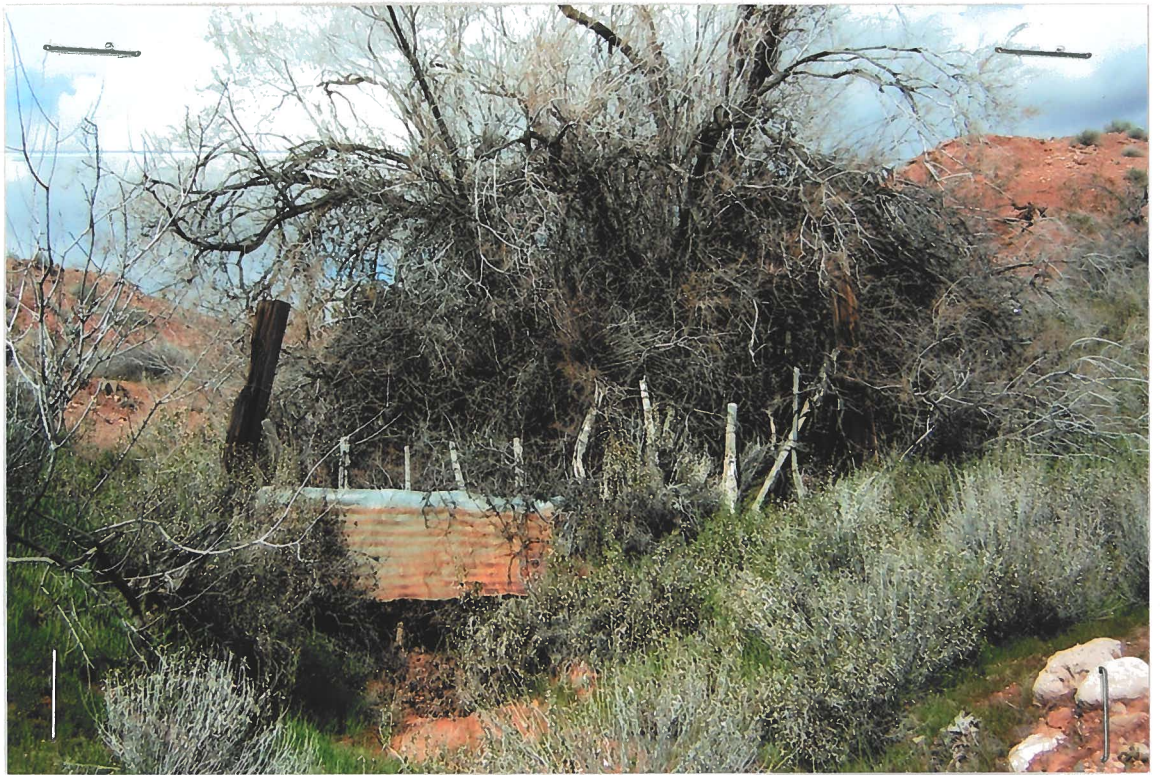
Ed Spring Feb 14 2005

Repairs needed: fence partially down, Spring is dry

Notes: Spring dry, tree in 'spring' dead, located in wash, lots of grass around → recent wet weather  
middle of area  
✓ Take photo 2x  
✓ Sketch on back

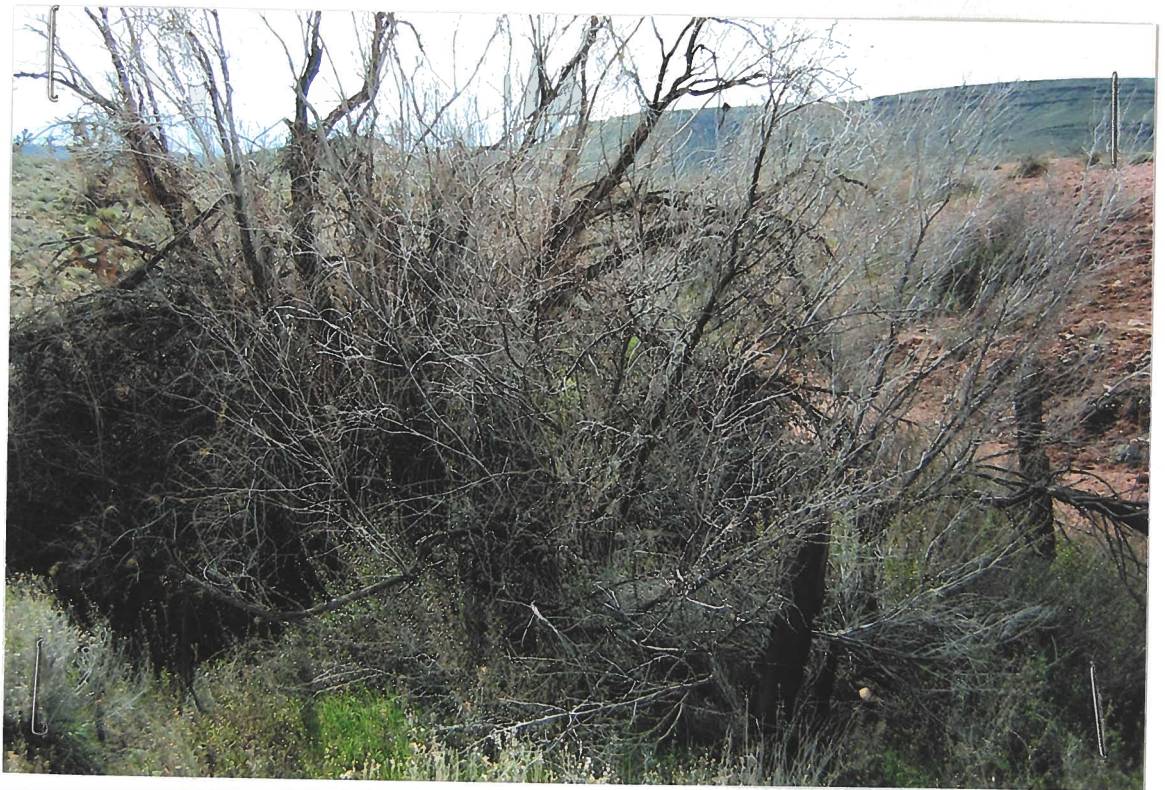
#2

Repairs needed: Needs to be cleaned out

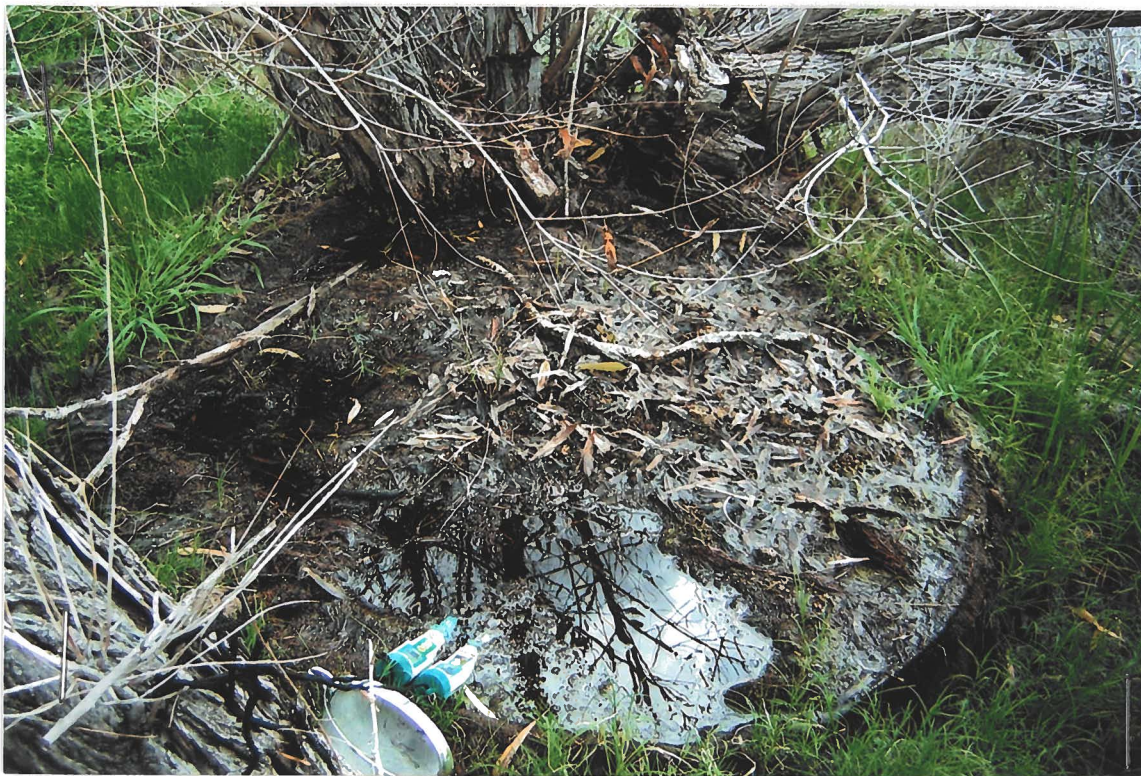
PAKOON SPRING  
FEB 14 2005

Notes: All water from spring sits in tank, piped/pooled from ground.

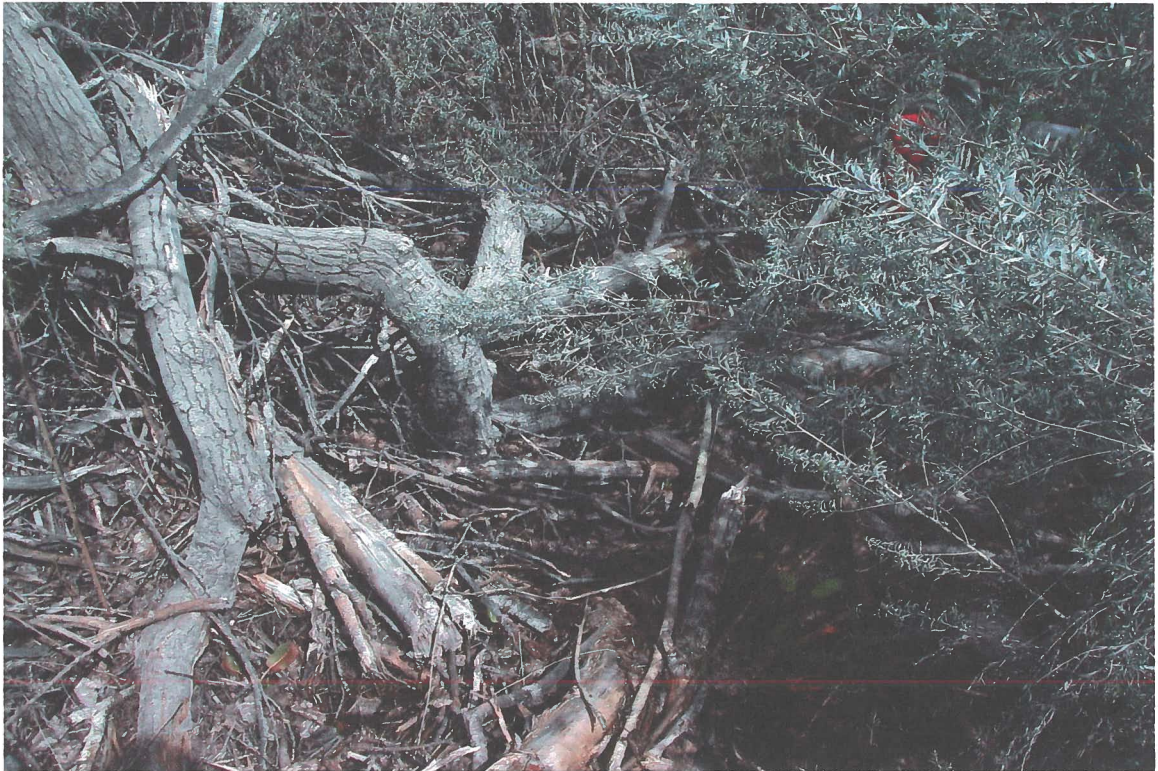
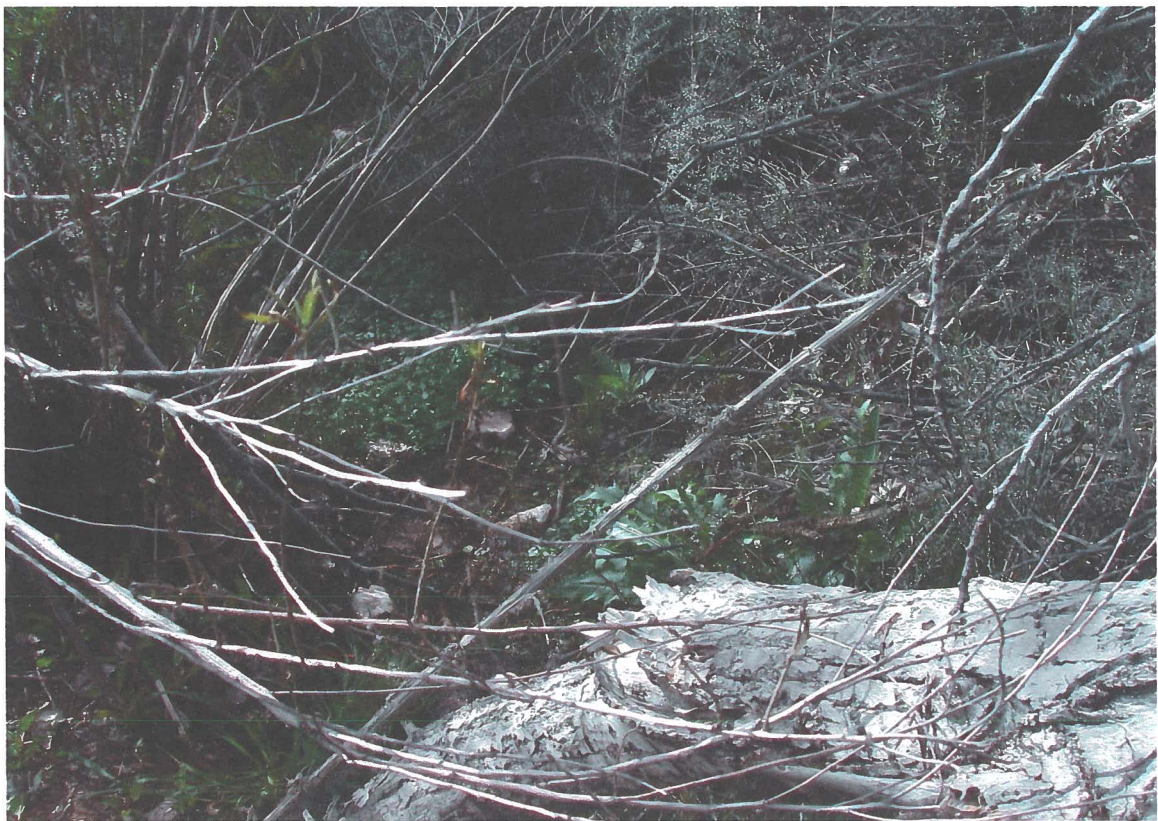
TASSI March 4 2005

Russian Olive Salt Cedar Scotch Thistle Silverleaf Nightshade Spotted Knapweed Squarros Knapweed Tall Whitetop OtherSpring Snails: Absent Rare Common AbundantOther invertebrates: Absent Rare Common Abundant Fish: Absent Rare Common AbundantAmphibians: Absent Rare Common Abundant Reptiles: Absent Rare Common AbundantBirds: Absent Rare Common Abundant Mammals: Absent Rare Common AbundantSite condition: Undisturbed Slightly disturbed Moderately disturbed Highly disturbedPrimary disturbance cause: Non-native animals Diversion Recreation Residence Drying Fire  
Flooding Dredging N/ANotes: Not sure if this is correct → actual Spring may beTake photo ✓  
Sketch on backelsewhere. We may have been measuring a broken pipe

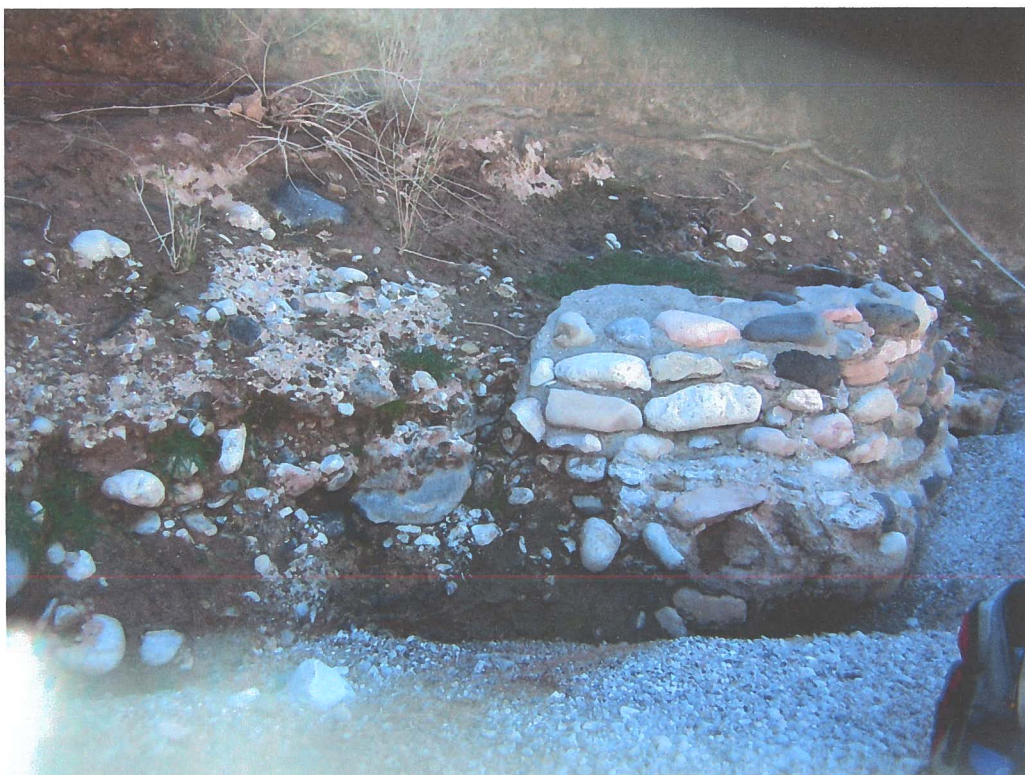
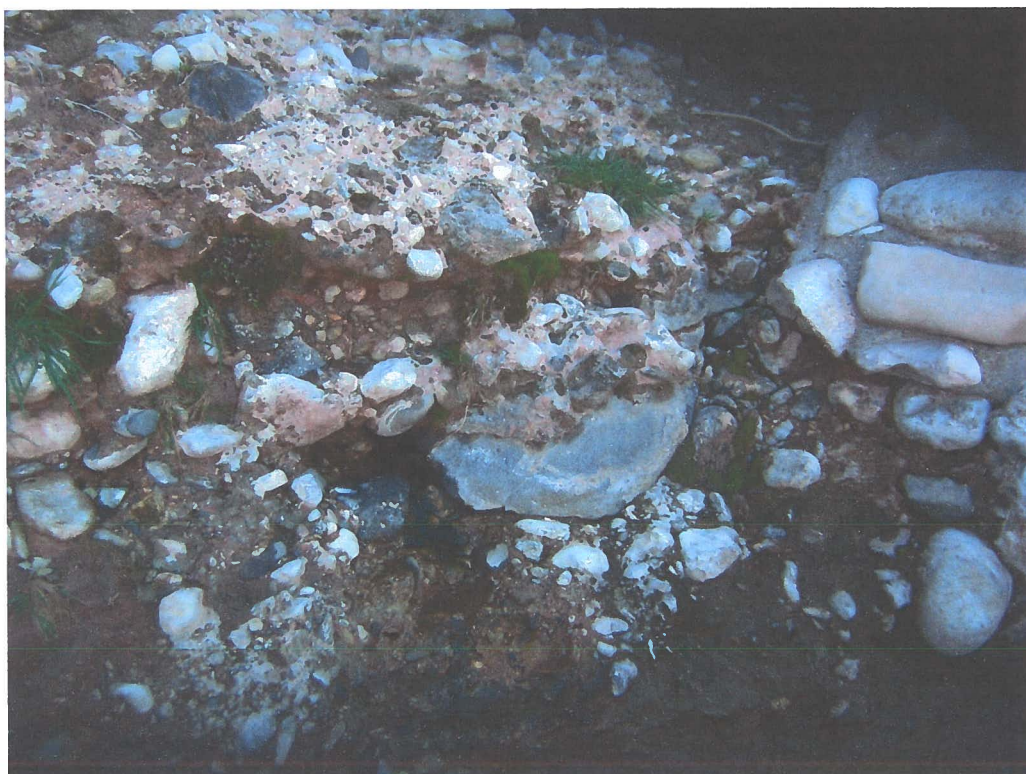
Black Willow  
March 11 2005

Russian Olive Salt Cedar Scotch Thistle Silverleaf Nightshade Spotted Knapweed Squarros Knapweed Tall Whitetop OtherNon-native species 2: Camelthorn Halogeton Hoary Cress Malta Star Thistle Morning Glory Russian Knapweed  
Russian Olive Salt Cedar Scotch Thistle Silverleaf Nightshade Spotted Knapweed Squarros Knapweed Tall Whitetop OtherSpring Snails: Absent Rare Common AbundantOther invertebrates: Absent Rare Common Abundant Fish: Absent Rare Common AbundantAmphibians: Absent Rare Common Abundant Reptiles: Absent Rare Common AbundantBirds: Absent Rare Common Abundant Mammals: Absent Rare Common AbundantSite condition: Undisturbed Slightly disturbed Moderately disturbed Highly disturbedPrimary disturbance cause: Non-native animals Diversion Recreation Residence Drying Fire  
Flooding Dredging N/ANotes: V. small seep - development no longer functioning, needs to be rebuilt & pumped outTake photo ☒

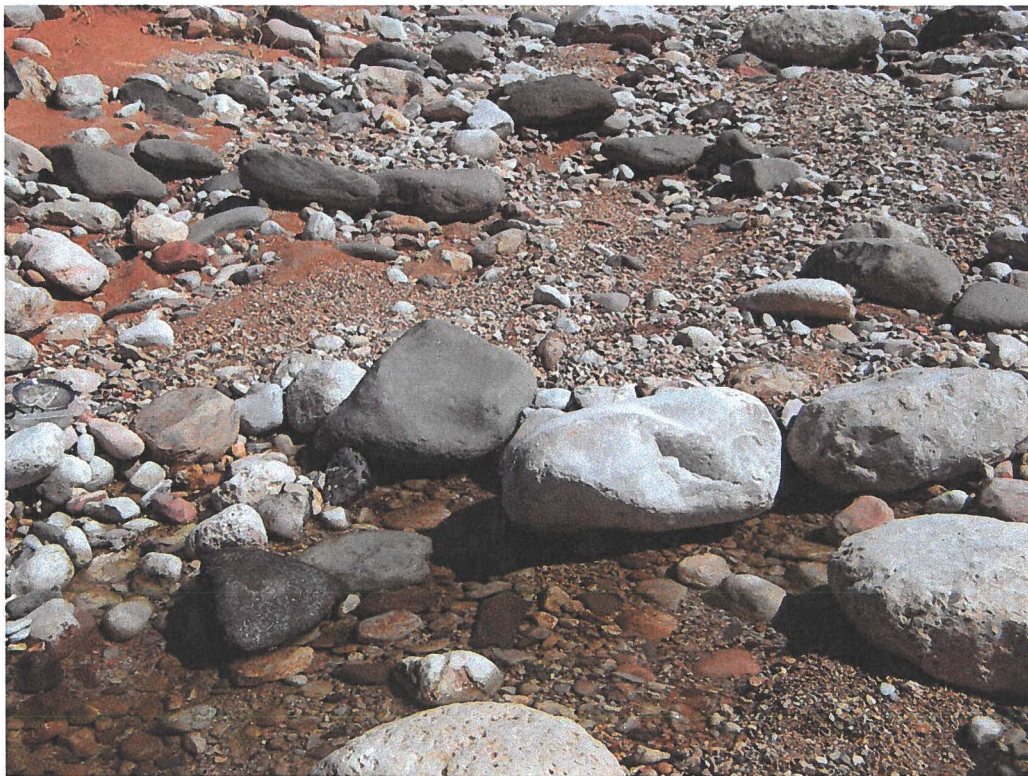
grand gulch spring  
March 11 2005

Discharge: 12 l/min Spring brook length: .25 mileDepth: Depth 1 11cm Depth 2 8 Depth 3 18 Width: Width 1 39 inches Width 2 60 inches Width 3 14 inchesWater temperature: 21 °C Water pH: 6.5 Conductivity: \_\_\_\_\_ μmhosDissolved oxygen concentration: \_\_\_\_\_ mg/L Public accessibility: Category: 1 2 3 4 5Substrate composition (%): Fines 10 Sand 10 Gravel 40 Cobble 30 Boulder 10 Bedrock 0Percent cover of emergent vegetation: 0 Percent cover of vegetative bank cover: 0Tree/Woody vegetation 1: Willow Cottonwood Mesquite Acacia Other NoneTree/Woody vegetation 2: Willow Cottonwood Mesquite Acacia Other NoneNon-native species 1: Camelthorn Halogeton Hoary Cress Malta Star Thistle Morning Glory Russian Knapweed  
Russian Olive Salt Cedar Scotch Thistle Silverleaf Nightshade Spotted Knapweed Squarros Knapweed Tall Whitetop OtherNon-native species 2: Camelthorn Halogeton Hoary Cress Malta Star Thistle Morning Glory Russian Knapweed

Russian Olive Salt Cedar Scotch Thistle Silverleaf Nightshade Spotted Knapweed Squarros Knapweed Tall Whitetop OtherSpring Snails: Absent Rare Common AbundantOther invertebrates: Absent Rare Common Abundant Fish: Absent Rare Common AbundantAmphibians: Absent Rare Common Abundant Reptiles: Absent Rare Common AbundantBirds: Absent Rare Common Abundant Mammals: Absent Rare Common AbundantSite condition: Undisturbed Slightly disturbed Moderately disturbed Highly disturbedPrimary disturbance cause: Non-native animals Diversion Recreation Residence Drying Fire  
Flooding Dredging N/ANotes: Comes out of Wash, may not be permanentTake photo ☒  
Sketch on back

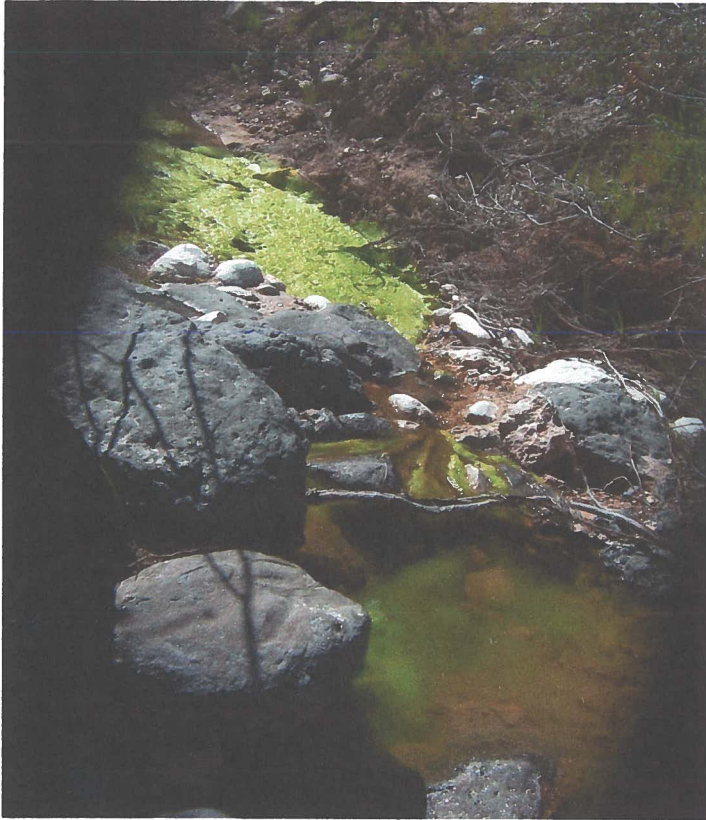
Little Arizona  
March 11 2005

Russian Olive Salt Cedar Scotch Thistle Silverleaf Nightshade Spotted Knapweed Squarros Knapweed Tall Whitetop OtherNon-native species 2: Camelthorn Halogeton Hoary Cress Malta Star Thistle Morning Glory Russian Knapweed  
Russian Olive Salt Cedar Scotch Thistle Silverleaf Nightshade Spotted Knapweed Squarros Knapweed Tall Whitetop OtherSpring Snails: Absent Rare Common AbundantOther invertebrates: Absent Rare Common Abundant Fish: Absent Rare Common AbundantAmphibians: Absent Rare Common Abundant Reptiles: Absent Rare Common AbundantBirds: Absent Rare Common Abundant Mammals: Absent Rare Common AbundantSite condition: Undisturbed Slightly disturbed Moderately disturbed Highly disturbedPrimary disturbance cause: Non-native animals Diversion Recreation Residence Drying Fire  
Flooding Dredging N/A mesquiteNotes: Couldn't get to head of Spring as it was too overg  
water covered w/ green algaeTake photo ☒

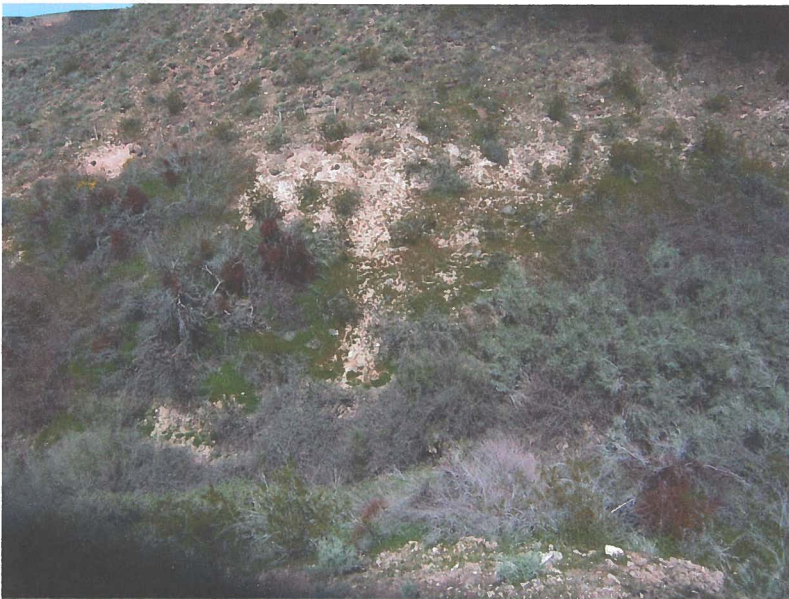
Side views  
of enclosure

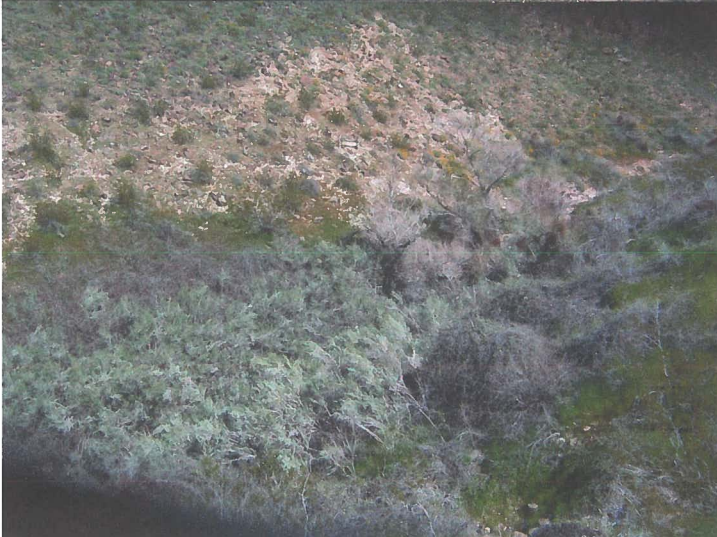
Russian Olive Salt Cedar Scotch Thistle Silverleaf Nightshade Spotted Knapweed Squarros Knapweed Tall Whitetop OtherNon-native species 2: Camelthorn Halogeton Hoary Cress Malta Star Thistle Morning Glory Russian Knapweed  
Russian Olive Salt Cedar Scotch Thistle Silverleaf Nightshade Spotted Knapweed Squarros Knapweed Tall Whitetop OtherSpring Snails: Absent Rare Common AbundantOther invertebrates: Absent Rare Common Abundant Fish: Absent Rare Common AbundantAmphibians: Absent Rare Common Abundant Reptiles: Absent Rare Common AbundantBirds: Absent Rare Common Abundant Mammals: Absent Rare Common AbundantSite condition: Undisturbed Slightly disturbed Moderately disturbed Highly disturbedPrimary disturbance cause: Non-native animals Diversion Recreation Residence Drying Fire  
Flooding Dredging N/ANotes: Spring dry, next to wash, fence in good shapeTake photo  
Sketch on back

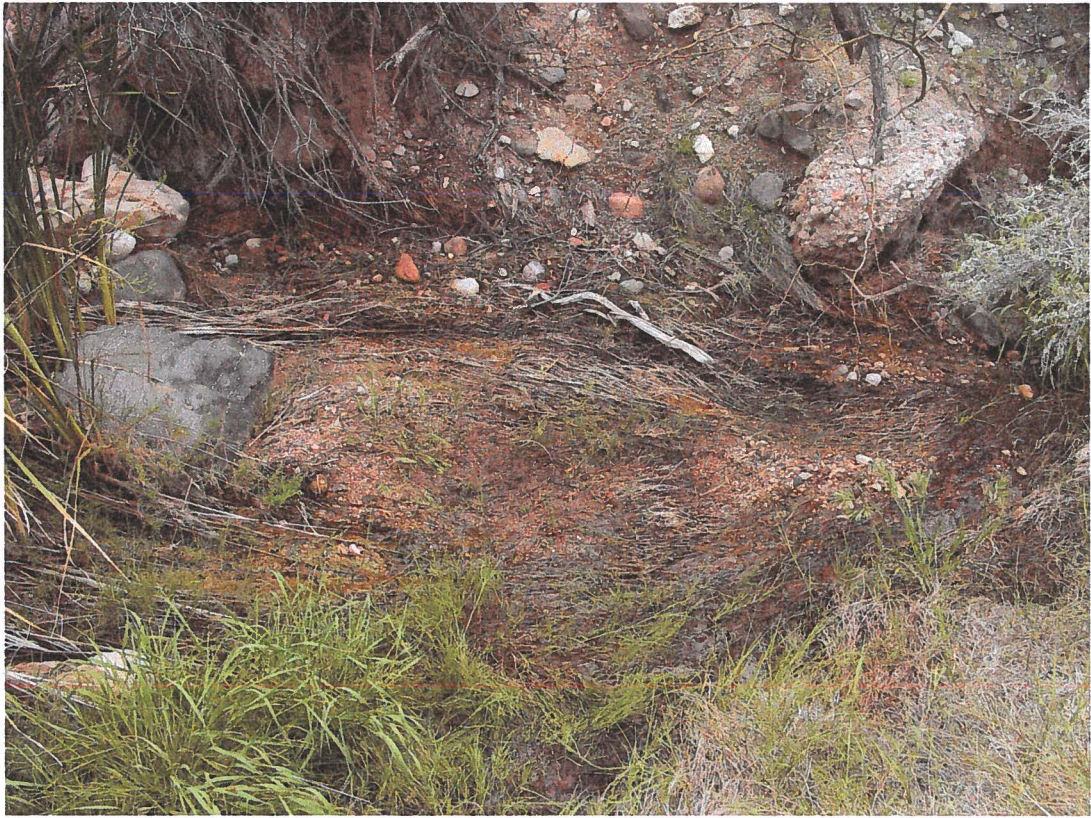
Buho  
NPS

Notes: lots of grass

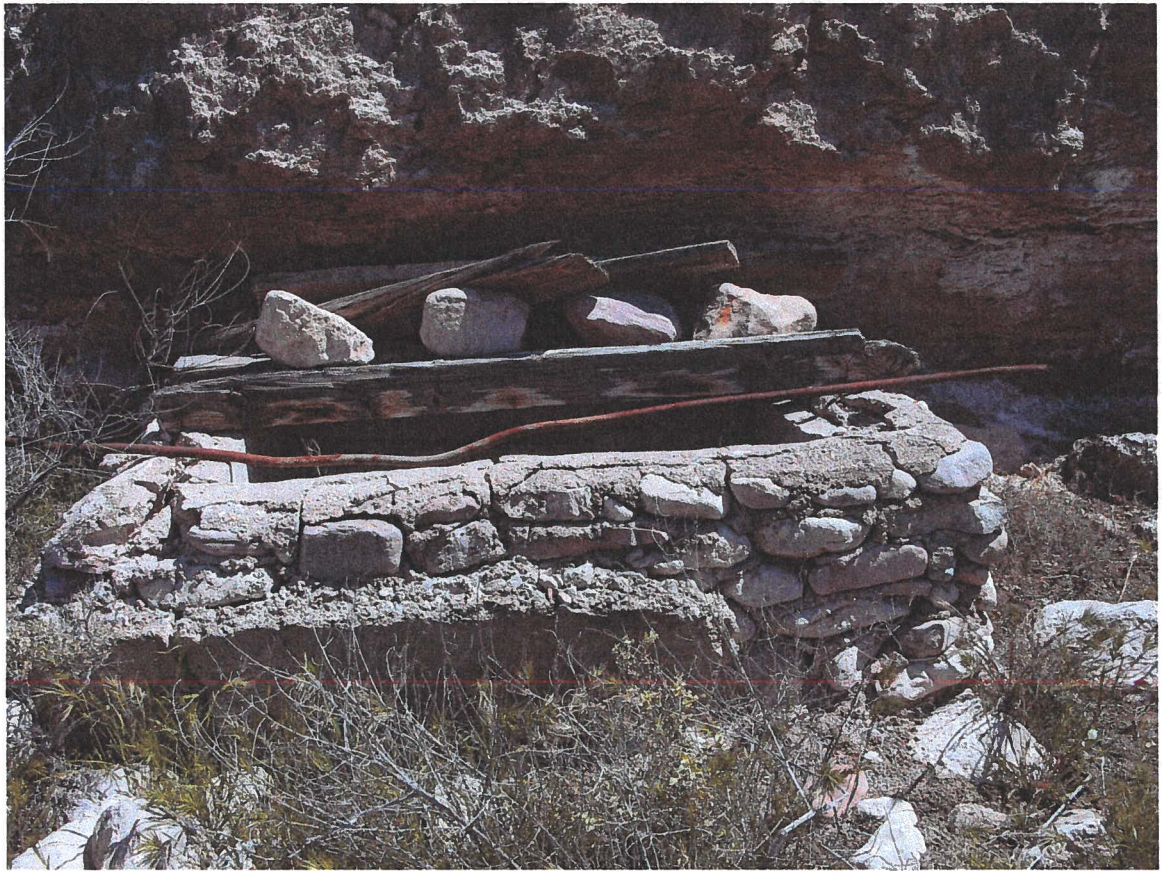
Non-native species 1: Camelthorn Halogeton Hoary Cress Malta Star Thistle Morning Glory Russian Knapweed  
Russian Olive Salt Cedar Scotch Thistle Silverleaf Nightshade Spotted Knapweed Squarros Knapweed Tall Whitetop OtherNon-native species 2: Camelthorn Halogeton Hoary Cress Malta Star Thistle Morning Glory Russian Knapweed  
Russian Olive Salt Cedar Scotch Thistle Silverleaf Nightshade Spotted Knapweed Squarros Knapweed Tall Whitetop OtherSpring Snails: Absent Rare Common AbundantOther invertebrates: Absent Rare Common Abundant Fish: Absent Rare Common AbundantAmphibians: Absent Rare Common Abundant Reptiles: Absent Rare Common AbundantBirds: Absent Rare Common Abundant Mammals: Absent Rare Common AbundantSite condition: Undisturbed Slightly disturbed Moderately disturbed Highly disturbedPrimary disturbance cause: Non-native animals Diversion Recreation Residence Drying Fire  
Flooding Dredging N/A RangeNotes: Spring dry - all that is left is a filled in troughTake photo

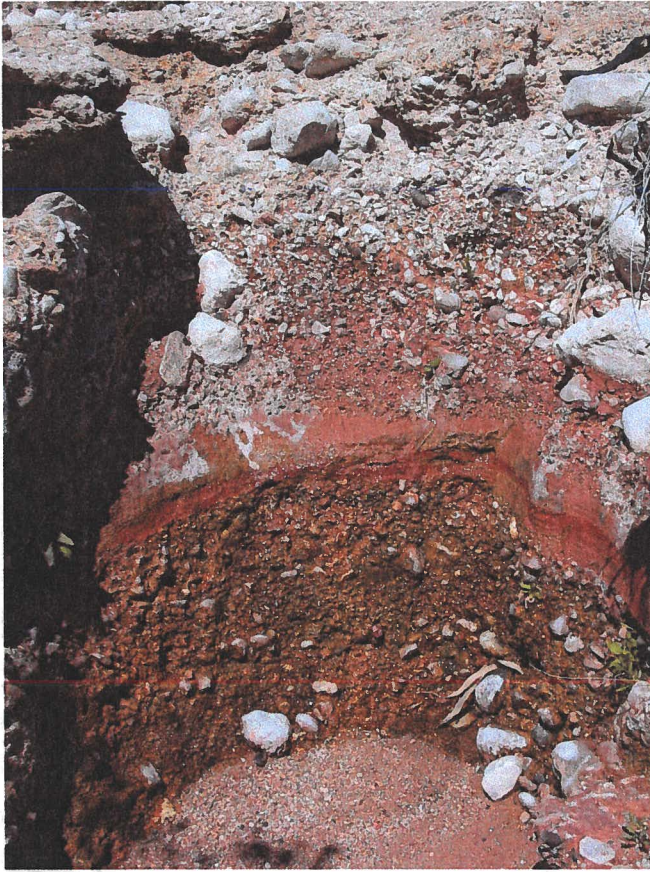
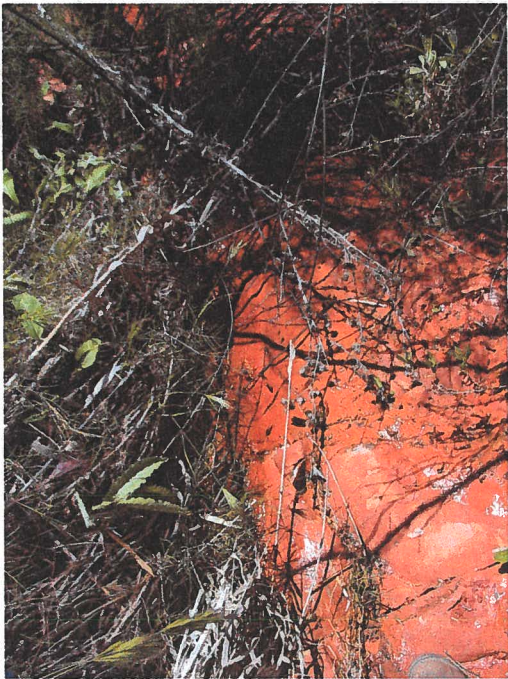
Non-native species 1: Camelthorn Halogeton Hoary Cress Malta Star Thistle Morning Glory Russian Knapweed  
Russian Olive Salt Cedar Scotch Thistle Silverleaf Nightshade Spotted Knapweed Squarros Knapweed Tall Whitetop OtherNon-native species 2: Camelthorn Halogeton Hoary Cress Malta Star Thistle Morning Glory Russian Knapweed  
Russian Olive Salt Cedar Scotch Thistle Silverleaf Nightshade Spotted Knapweed Squarros Knapweed Tall Whitetop OtherSpring Snails: Absent Rare Common AbundantOther invertebrates: Absent Rare Common Abundant Fish: Absent Rare Common AbundantAmphibians: Absent Rare Common Abundant Reptiles: Absent Rare Common AbundantBirds: Absent Rare Common Abundant Mammals: Absent Rare Common AbundantSite condition: Undisturbed Slightly disturbed Moderately disturbed Highly disturbedPrimary disturbance cause: Non-native animals Diversion Recreation Residence Drying Fire  
Flooding Dredging N/ANotes: long w/ several startsTake photo 2

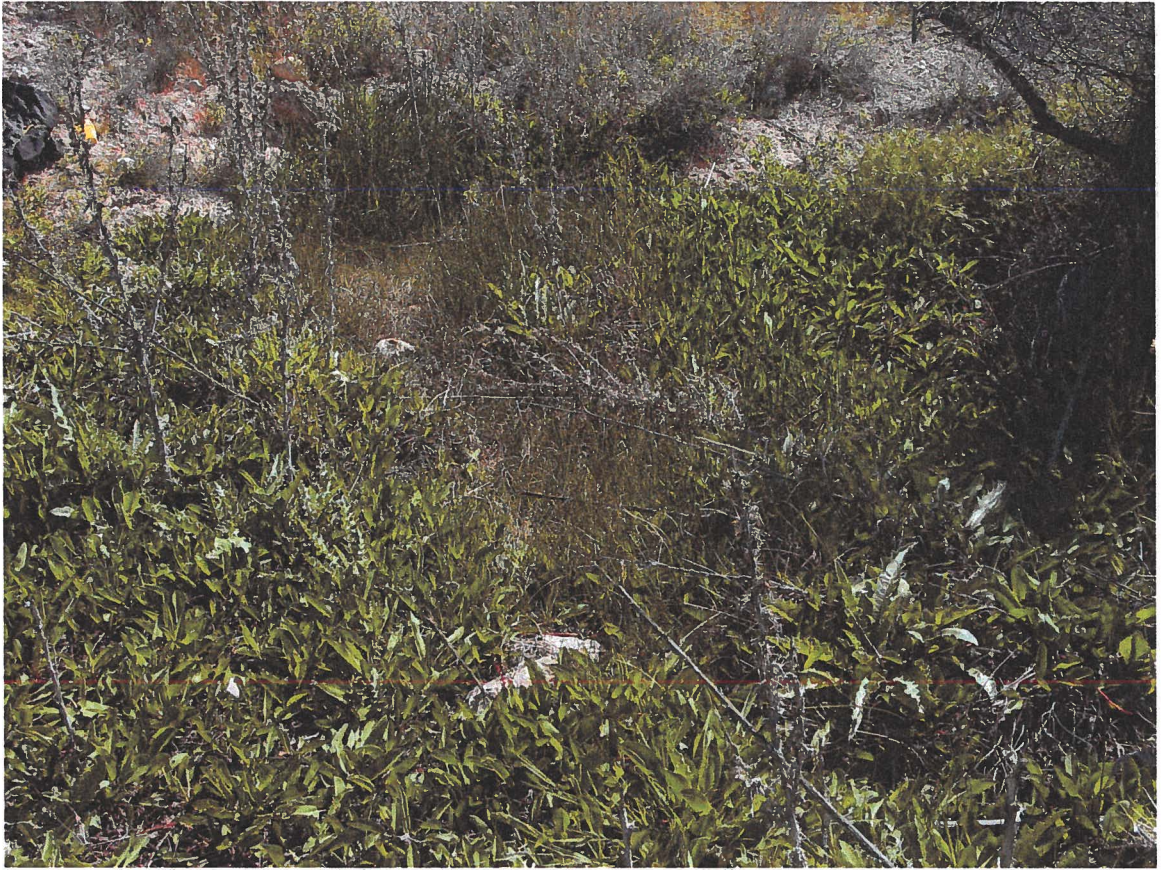
Flooding Dredging N/ANotes: Marshy - seep area, NO flowing waterTake photo 0124Sketch on back X
