# Cultural Landscape Inventory

## Hartwell Area

Battle Road Unit

Minute Man National Historical Park

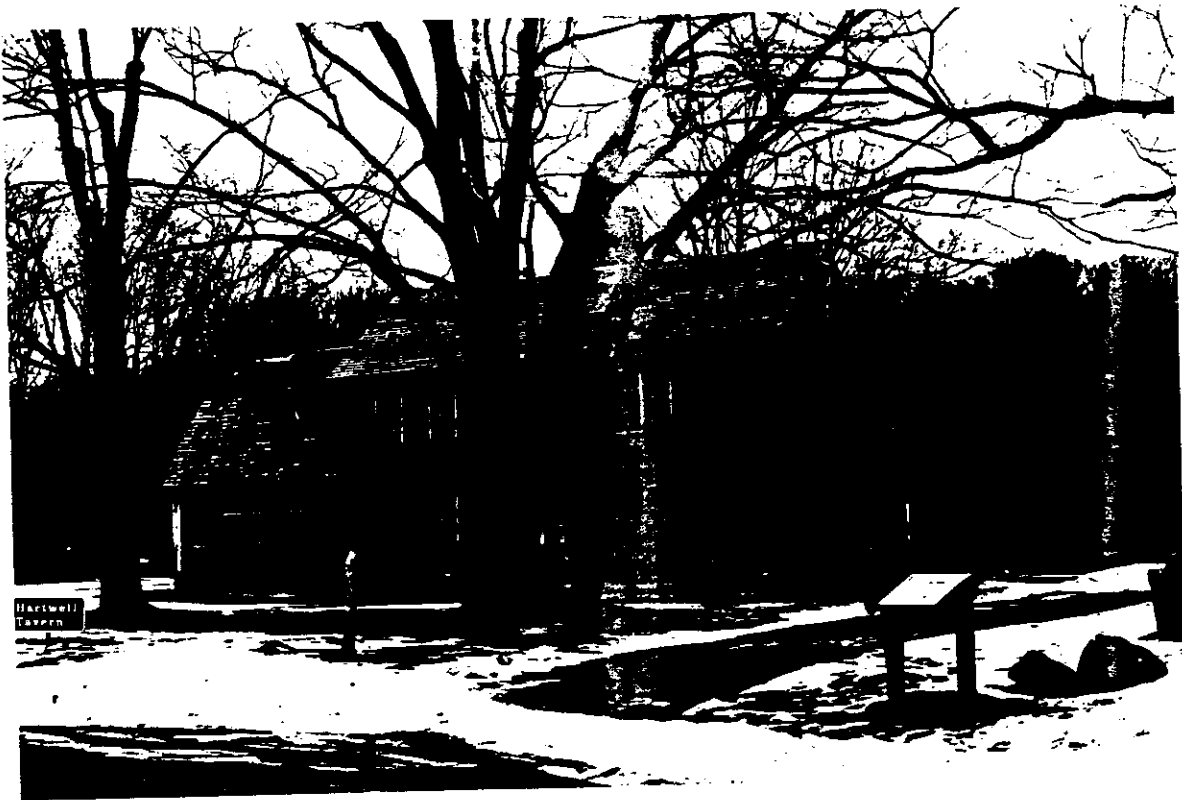
Figure 4: Ephriam Hartwell Tavern (OCLP, 1996).

East of Bloody Angles on Virginia Road is the Ephriam Hartwell Tavern. The Ephriam Hartwell Tavern, constructed in 1732, has been restored by the NPS and is open to the public for interpretation to the public (see fig. 4). A wayside with an interpretive plaque is at the front of the site. The area immediately surrounding the Tavern is open grass lawn. A row of

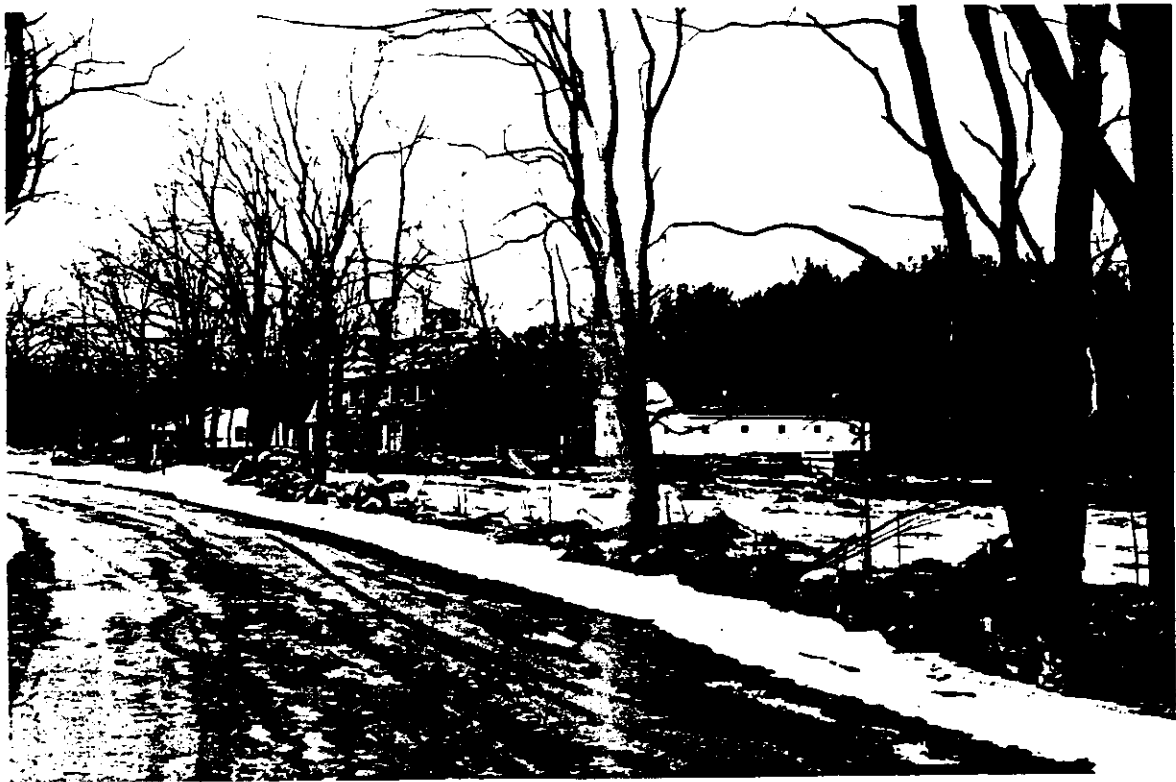
Figure 5: Pasture adjacent to Hartwell Tavern (OCLP, 1996).

large maples stands in front of the Tavern and stone walls border the sides and rear. A small pasture enclosed by stone walls and split-rail fencing stands on the Tavern's east side. The pasture holds livestock as part of the NPS interpretive program for the park (see fig. 5). The McHugh Barn is located at the rear of the Tavern. The barn is a 1939 structure constructed on an 1820 foundation (see fig. 6).

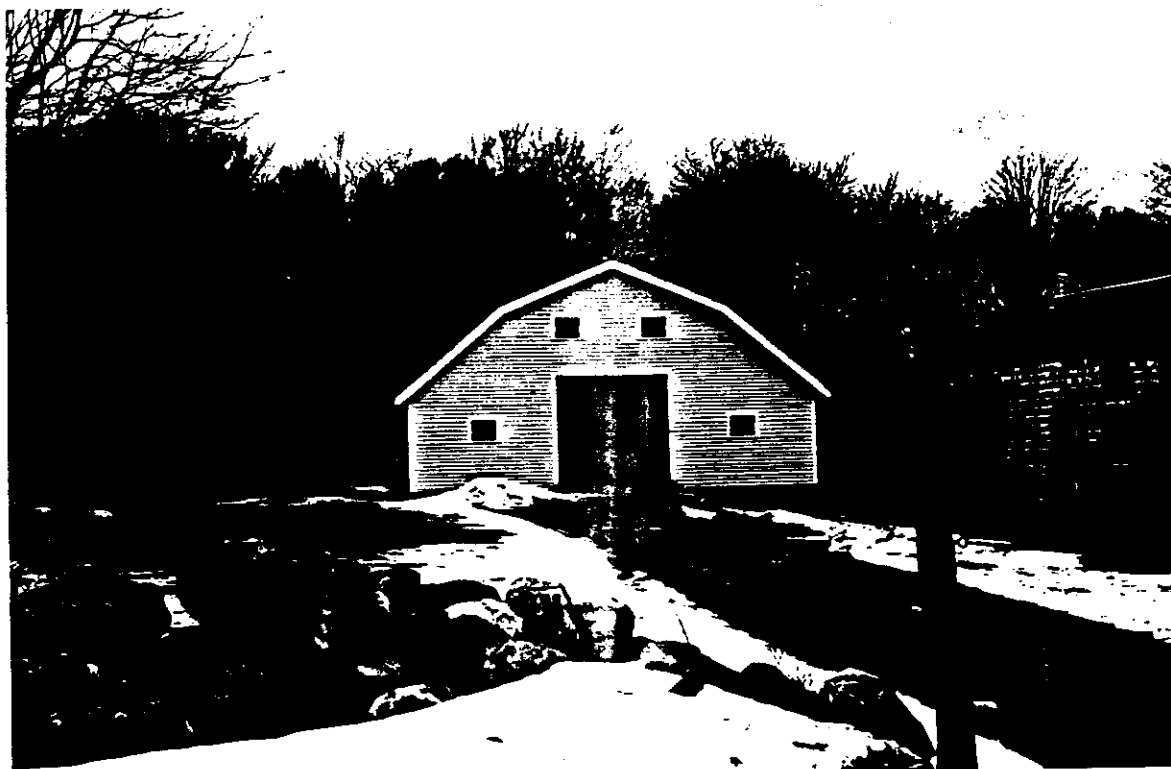
Figure 6: McHugh Barn (OCLP, 1996).

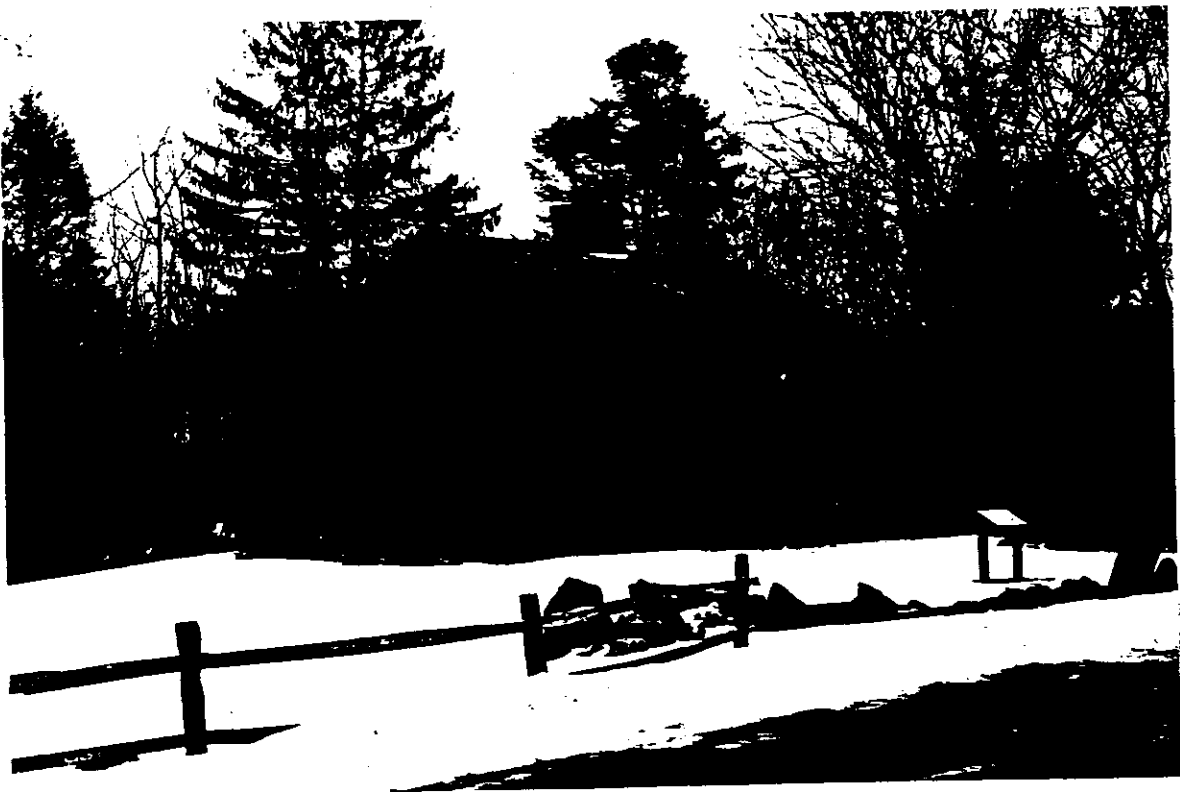
Figure 7: Samuel Hartwell house shelter (OCLP, 1996).

The Samuel Hartwell site, historically the houselot of the Samuel Hartwell farm, is the site of the foundation and chimney of the farmhouse. The house was constructed around 1693 and destroyed by a fire in 1968. A shelter constructed by the NPS now protects the remains of the house and mimics its original size and shape (see fig. 7). The shelter is surrounded by an area of maintained grass lawn fronting Virginia Road. The sides and rear of the lawn area are bordered by successional forest. A combination of stone wall and split-rail fence stands along the front of the site. A wayside with an interpretive plaque is at the front of the site.

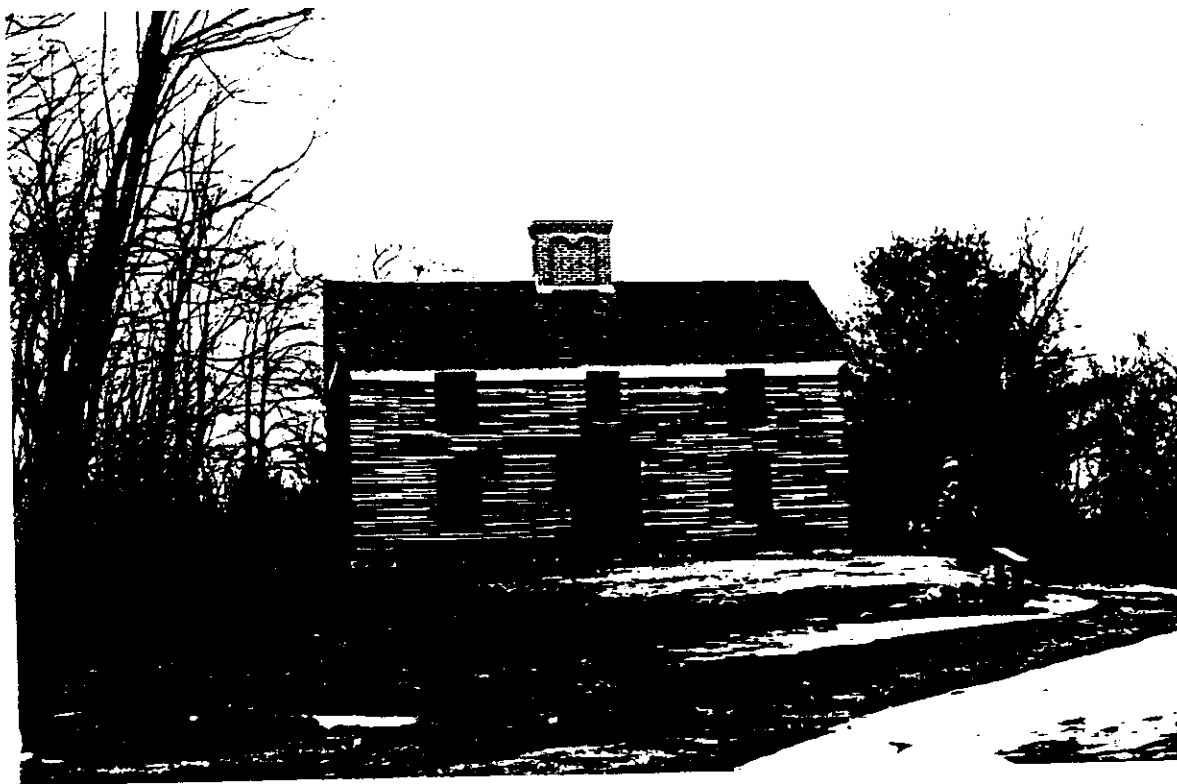
Figure 8: William Smith House (OCLP, 1996).

The William Smith House, a post-1693 construction, is located at the east end of the area where Virginia Road meets Route 2A. The house has been restored by the NPS and is set on the top of a small knoll in an area maintained as open grass lawn. A retaining wall within the lawn approximately one foot high and thirty feet long curves around the north corner of the house (see fig. 8). The lawn area extends to Virginia Road and has a picnic area by the road. A dirt drive connects Route 2A with the house and a row of Norway Spruce border the west side of the drive (see fig. 9). An interpretive plaque stands at the front of the house.

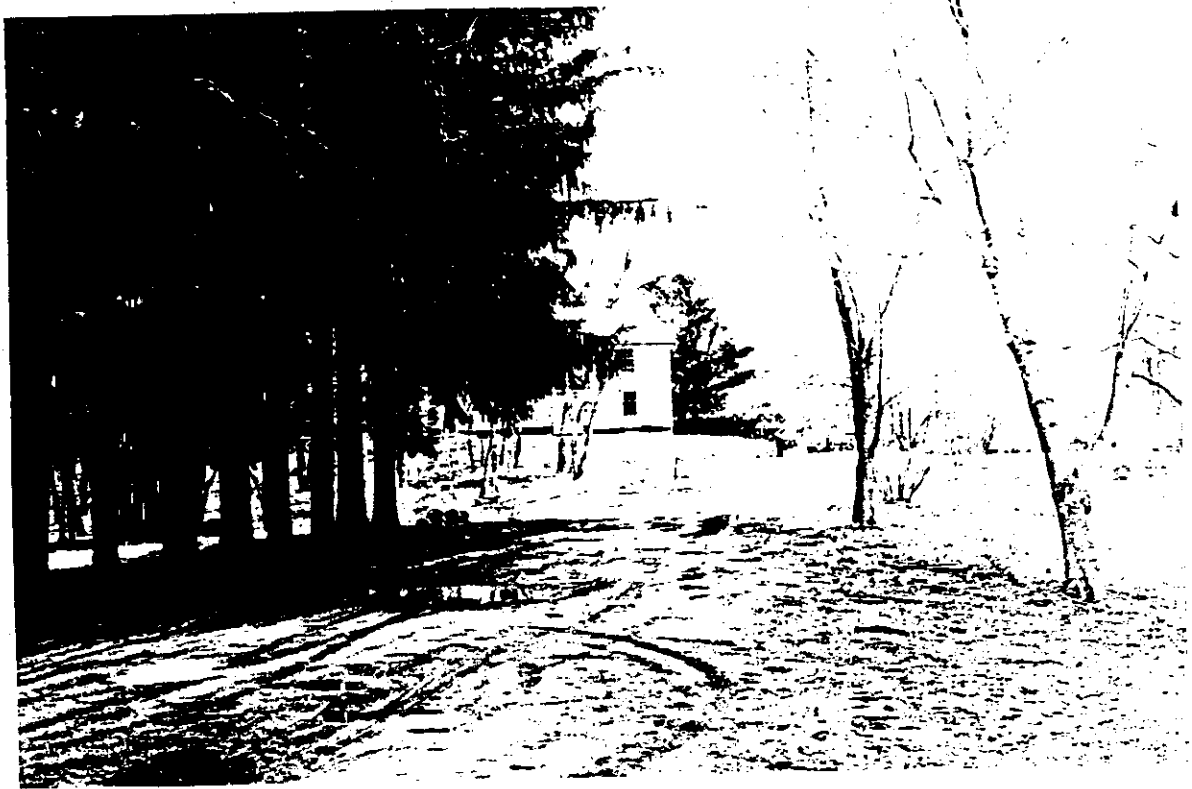
Figure 9: William Smith House (OCLP, 1996).

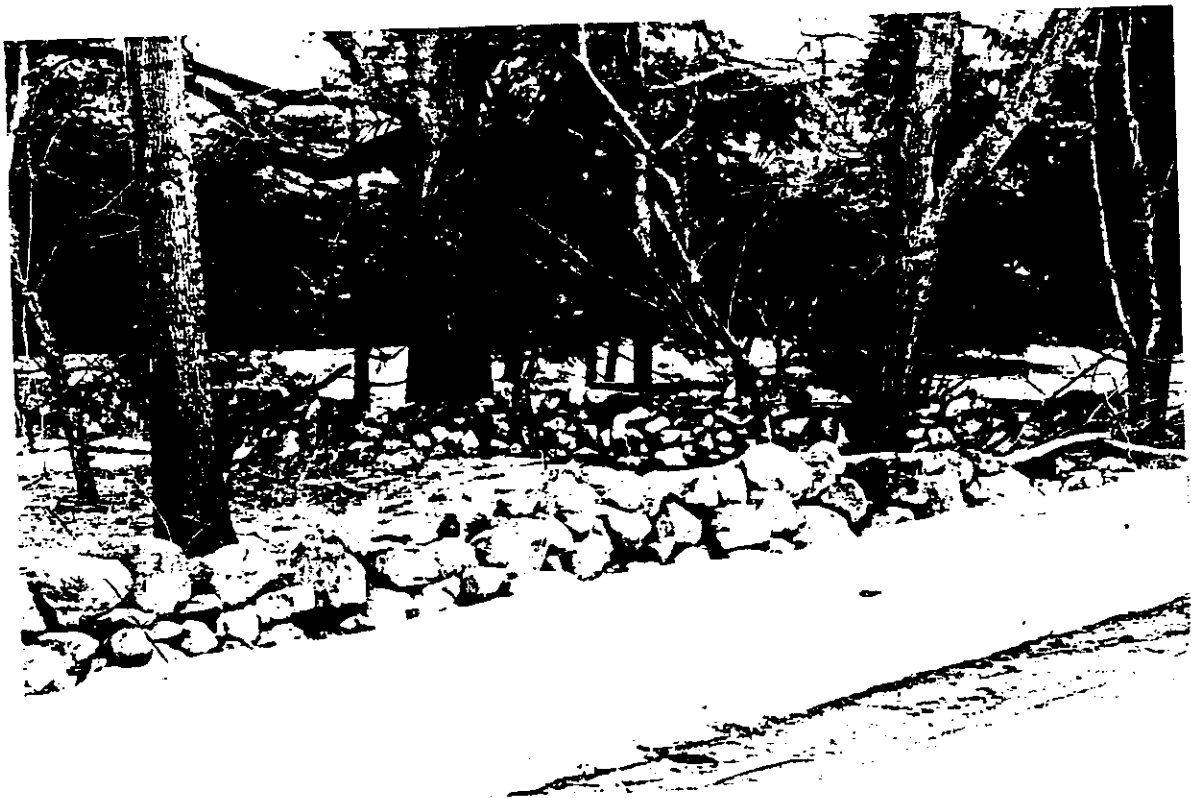
Figure 10: Hartwell Area stone walls (OCLP, 1996).

In addition to the historic structures the Hartwell Area has a high concentration of stone walls. The walls surround the houselots, line the roads and extend through the woods in areas historically planted as agricultural fields.

In general the Hartwell Area is a rural residential area within a successional forest. The area contains several historic and contemporary structures, a vast network of stone walls and is traversed by several secondary roads and a major highway (see fig. 10).

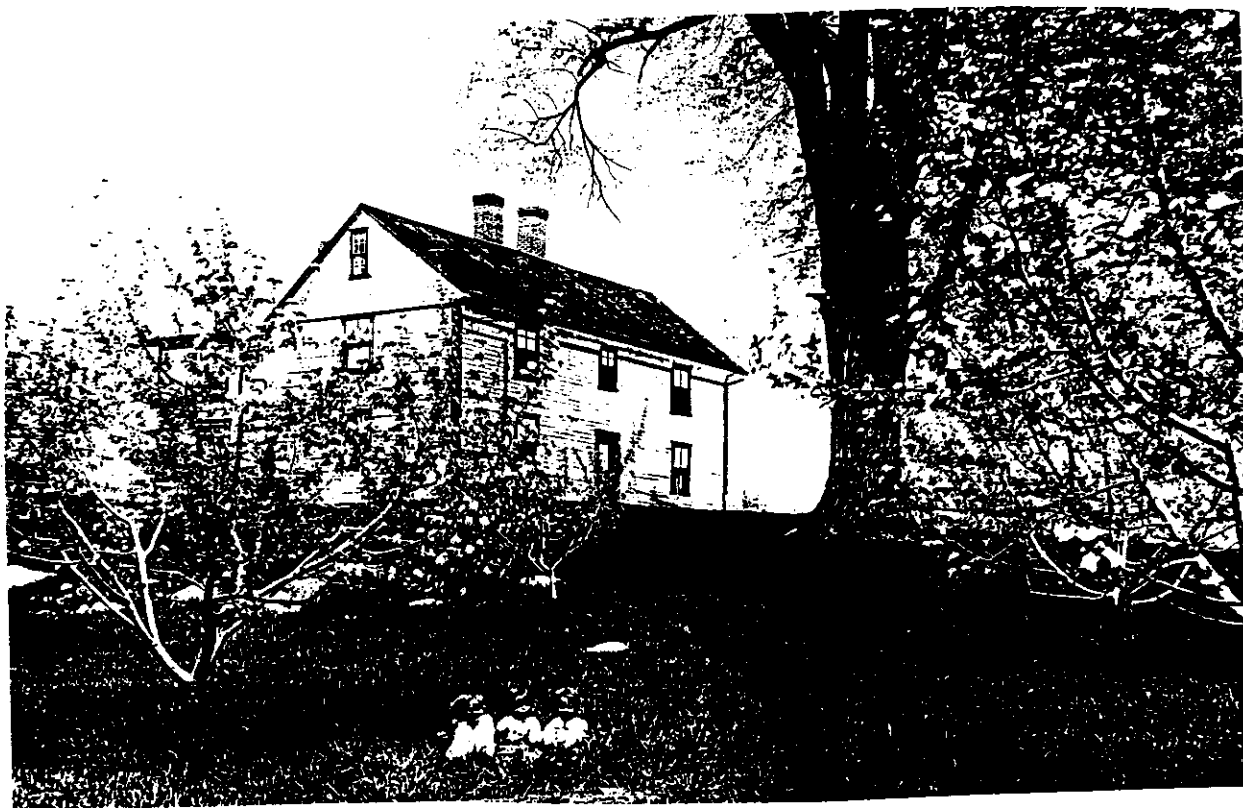
Figure 11: William Smith House, ca.1936 (SPNEA).

At some point soon after 1693 William Smith, a Captain of the Lincoln company of minute men, constructed a house and established a 120-acre farm at the east end of the Hartwell Area. This farm has been documented to have contained a house (extant), two barns, plowland, mowing, pasture, woodland, and an orchard (see fig. 11). The area between the Smith house and the Samuel Hartwell site was pasture and the area to the east of the Smith house was part pasture and part orchard. Another orchard stood behind the house. A network of stone walls served to separate and enclose the fields and orchards. One of the barns seems to have been located east of the house.<sup>2</sup>

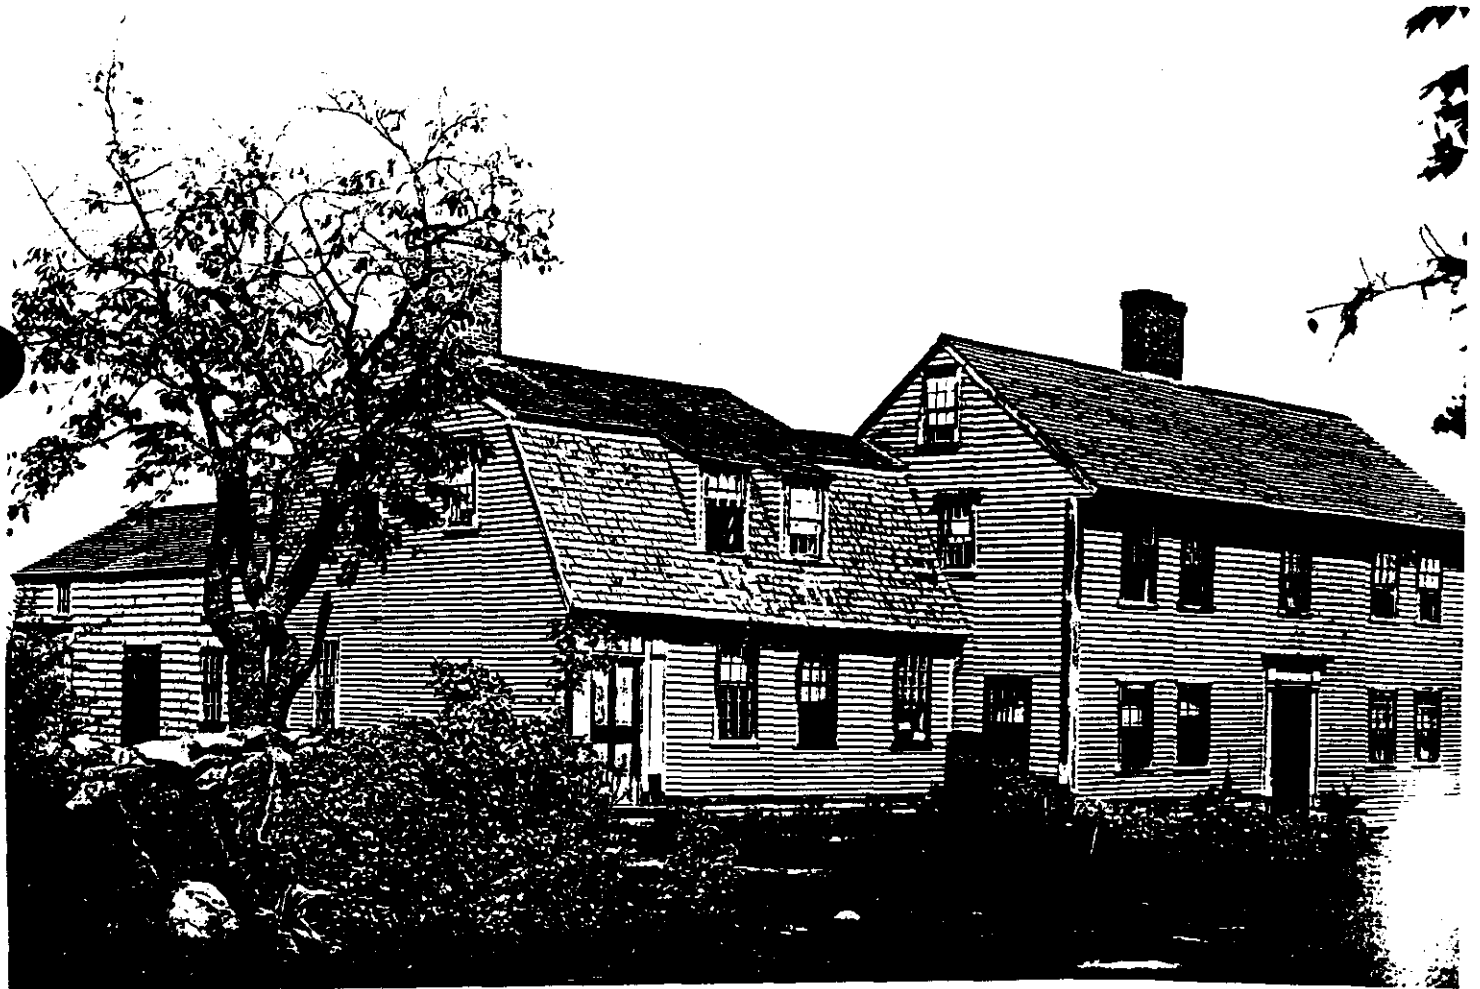
Figure 12: Ephriam Hartwell Tavern, date unknown, pre1959 (SPNEA).

Ephriam Hartwell, Samuel Sr.'s youngest son, was given 18 acres of Samuel's land, on which he built a house in 1733. Samuel Sr. died in 1774, leaving the remainder of his land to Ephriam upon his widow's death. Ephriam obtained an innkeeper's license in 1756 and began operating his house as an inn (see fig. 12).<sup>3</sup>

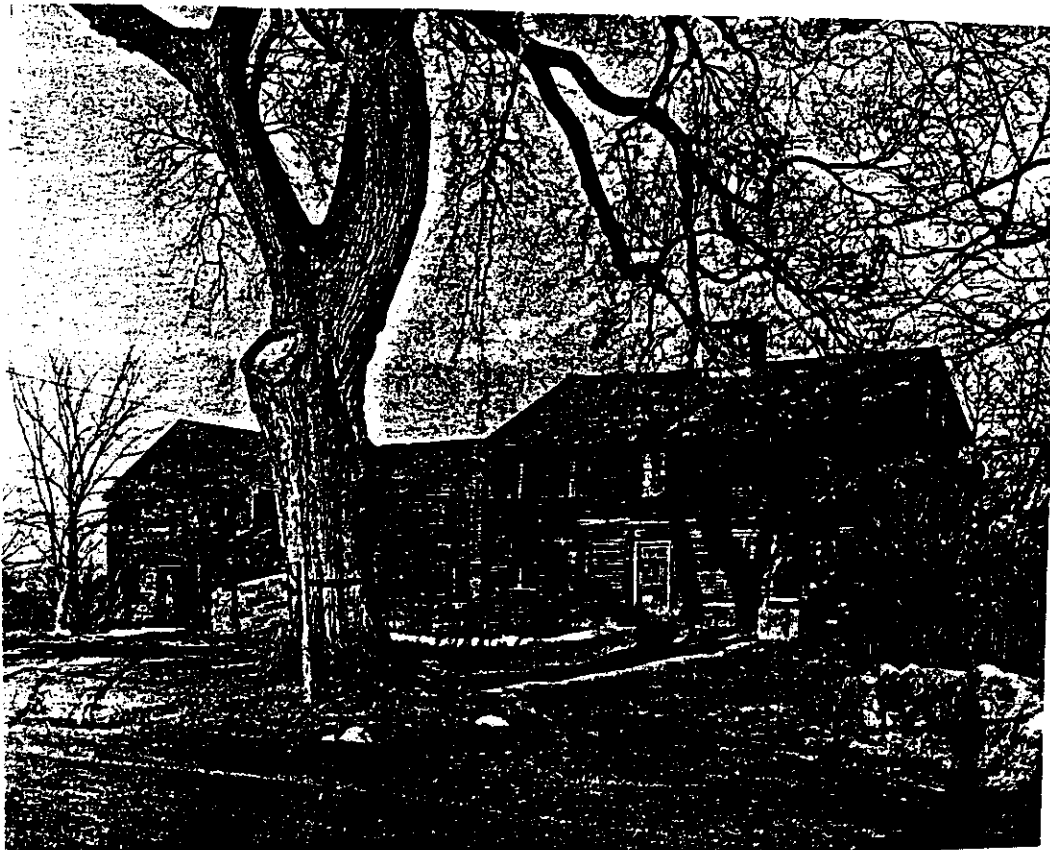
Figure 13: Samuel Hartwell house (Hartwell Inn), ca.1935 (SPNEA).

After the Hartwell family tenure the property passed through many ownerships. In 1938 the McHugh barn was destroyed by a hurricane and rebuilt on the original foundation later that year. The Samuel Hartwell house was used as a restaurant during the beginning of the 20th century. Referred to as the Hartwell Inn (as was Ephriam's 18th-century establishment) the house had a large addition on its west end at this time (see fig. 13). Minute Man National Historical Park was established in 1959 incorporating much of the Hartwell area. The NPS acquired a portion of the Hartwell property in 1968. The Samuel Hartwell house burned that same year. In 1985 the NPS restored the William Smith house and in 1986 constructed the Samuel Hartwell shelter.
