# DAVISON RANCH FLOODPLAIN DELINEATION PRAIRIE CREEK, HUMBOLDT COUNTY, CALIFORNIA

REDWOOD NATIONAL AND STATE PARKS  
Resource Management and Science Division

January, 1998

**Randy D. Klein  
Hydrologist**

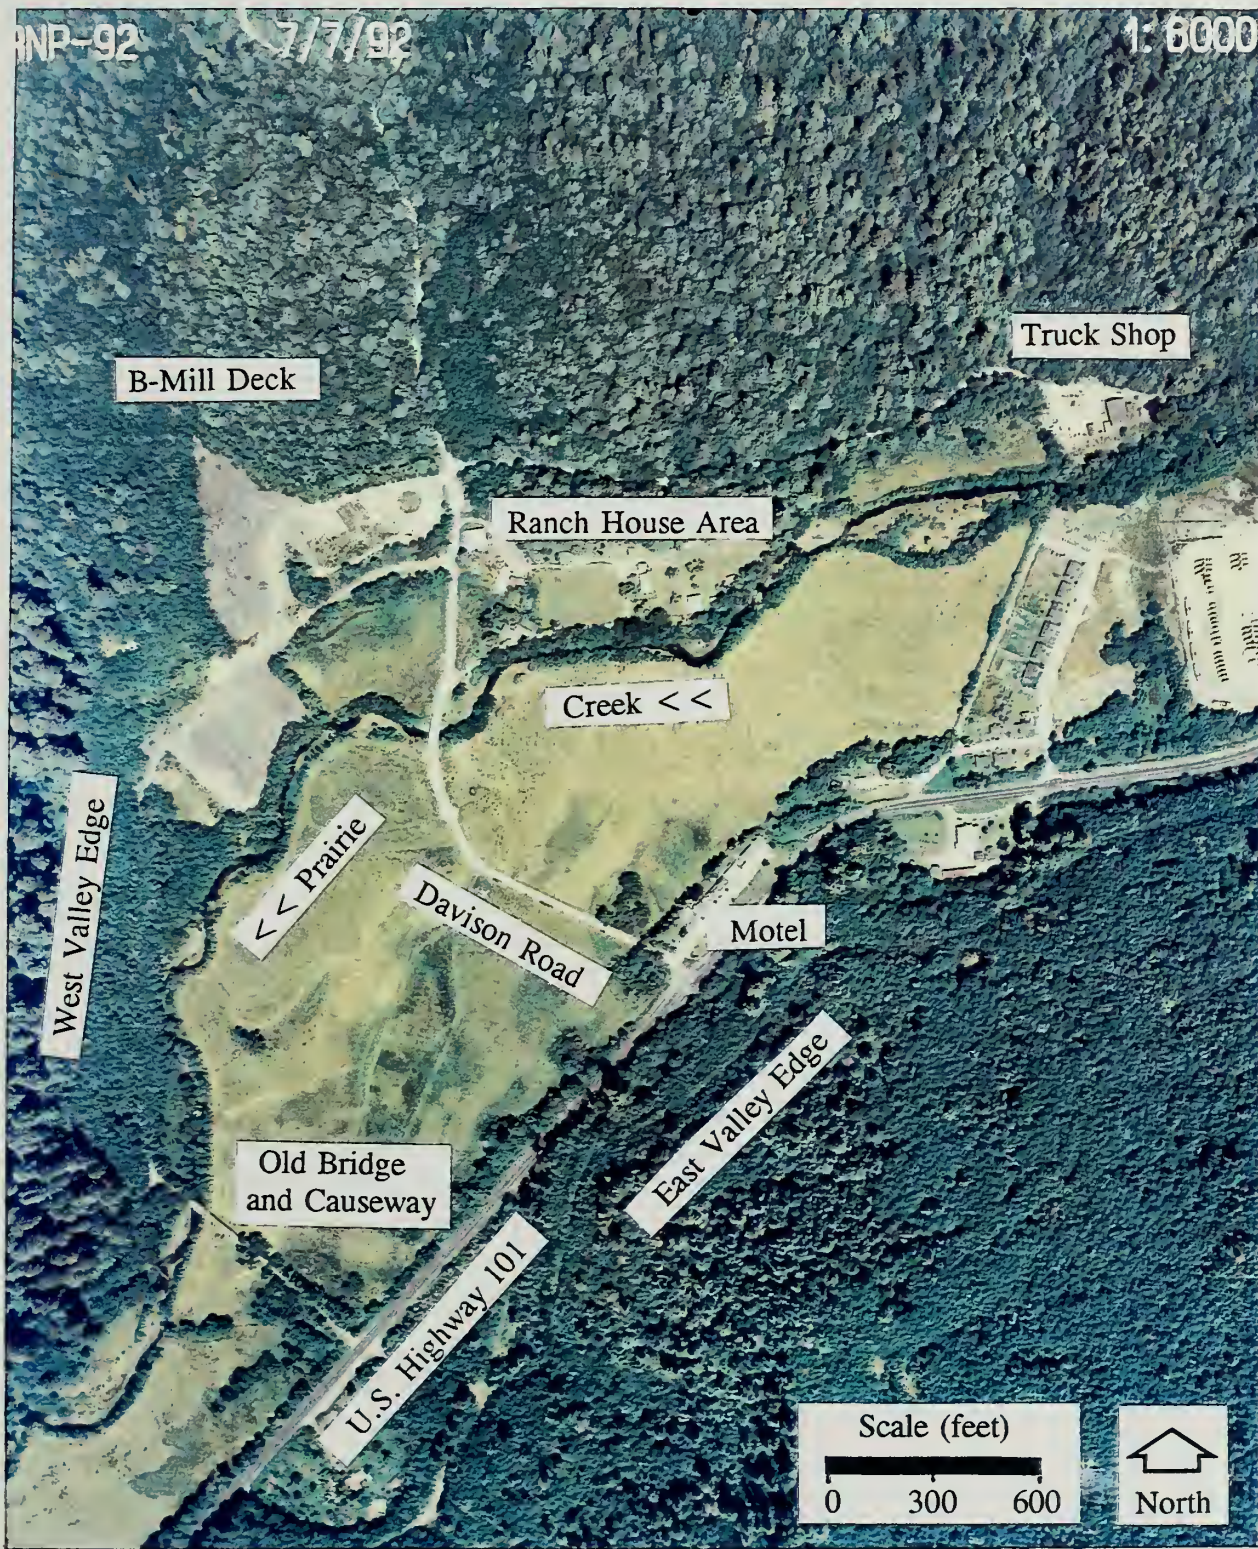
Figure 2. Pertinent natural and cultural features at the Davison ranch, Redwood National and State Parks.

Figure 2 shows the study area and several pertinent natural and cultural features. The area covered in this analysis includes approximately 104 acres of valley bottom land on either side of Prairie Creek.

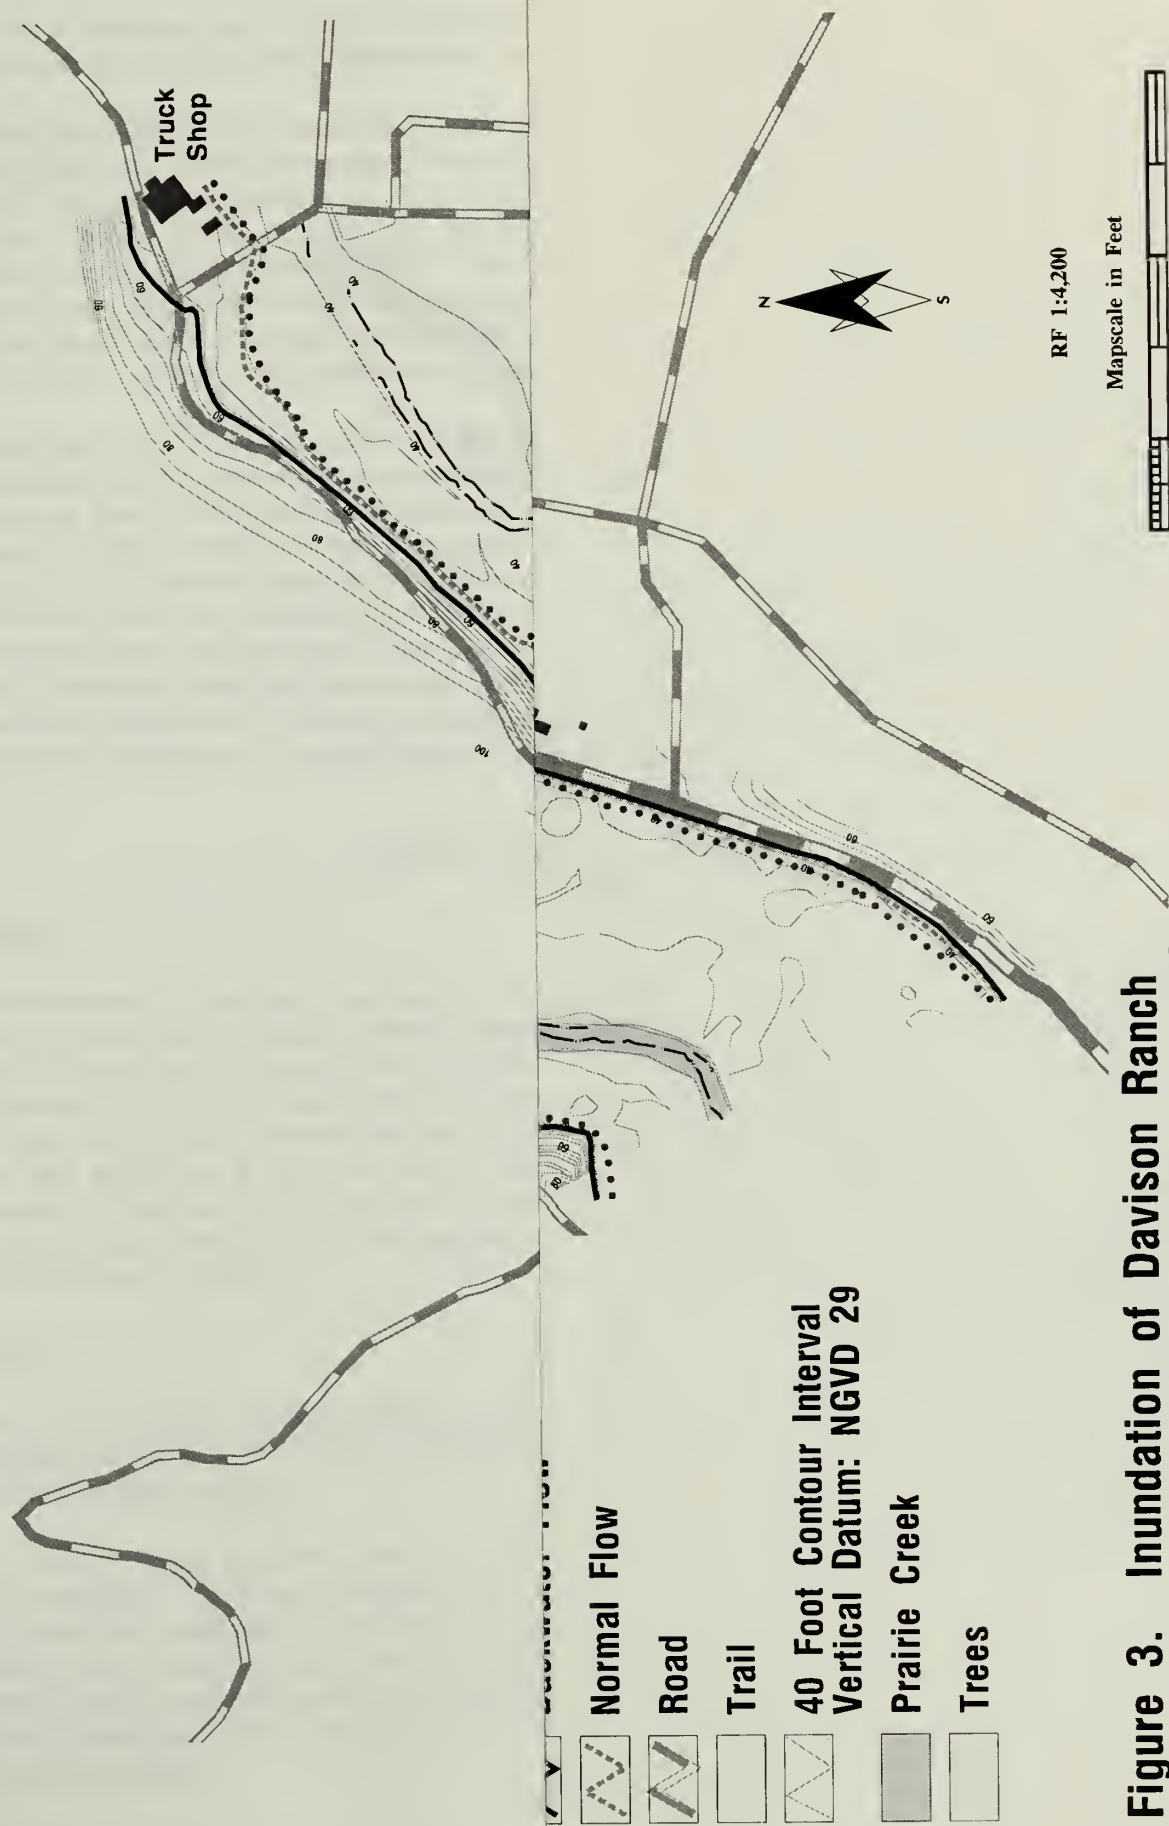
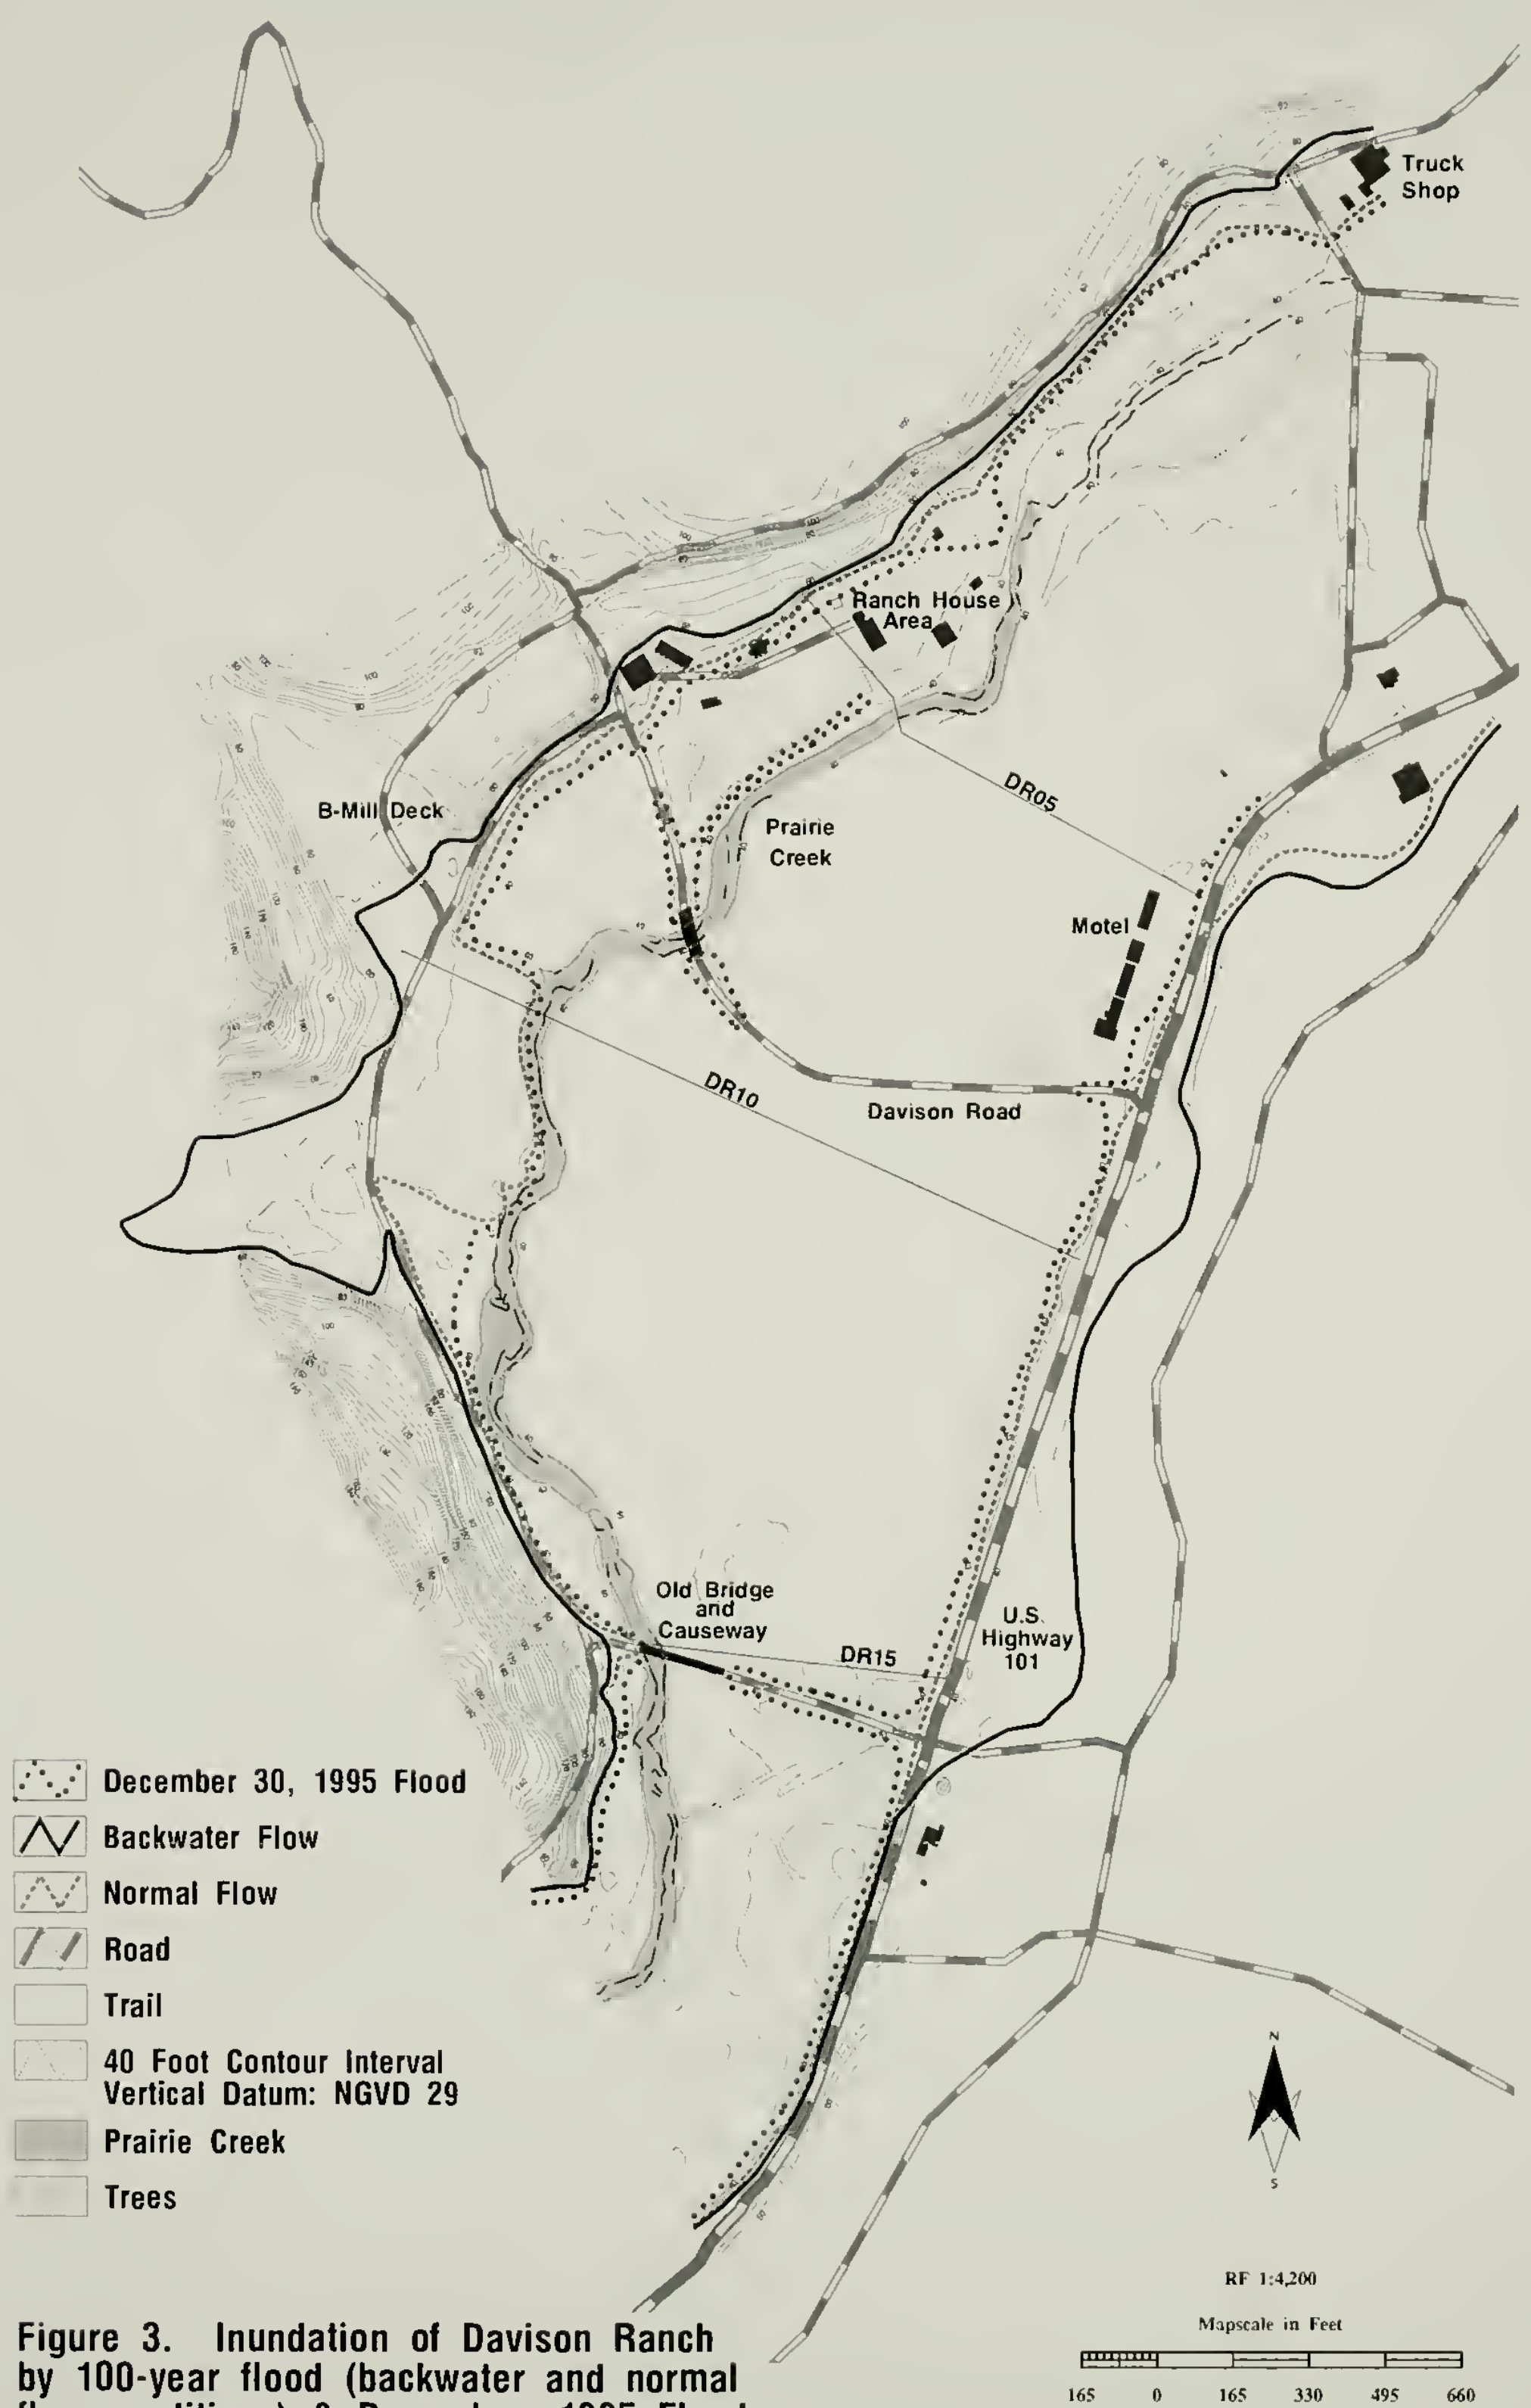
**Figure 3. Inundation of Davison Ranch by 100-year flood (backwater and normal flow conditions) & December, 1995 Flood.**

Using the  $Q_{100}$  water surface elevations (WSELs) computed for the three cross sections for the three high flow scenarios, the regulatory floodplain was outlined on a topographic map of the Davison Ranch (Fig. 3). Under normal flow conditions, the 100-year floodplain would be only slightly larger than that observed during a 10-year flood in December, 1995. As mentioned earlier, and as shown on Figure 3, the effect of the elevated roadway would cause expansion of the floodplain to include a significant portion of the B-Mill deck as well as U.S. Highway 101 and lowlands to the east.

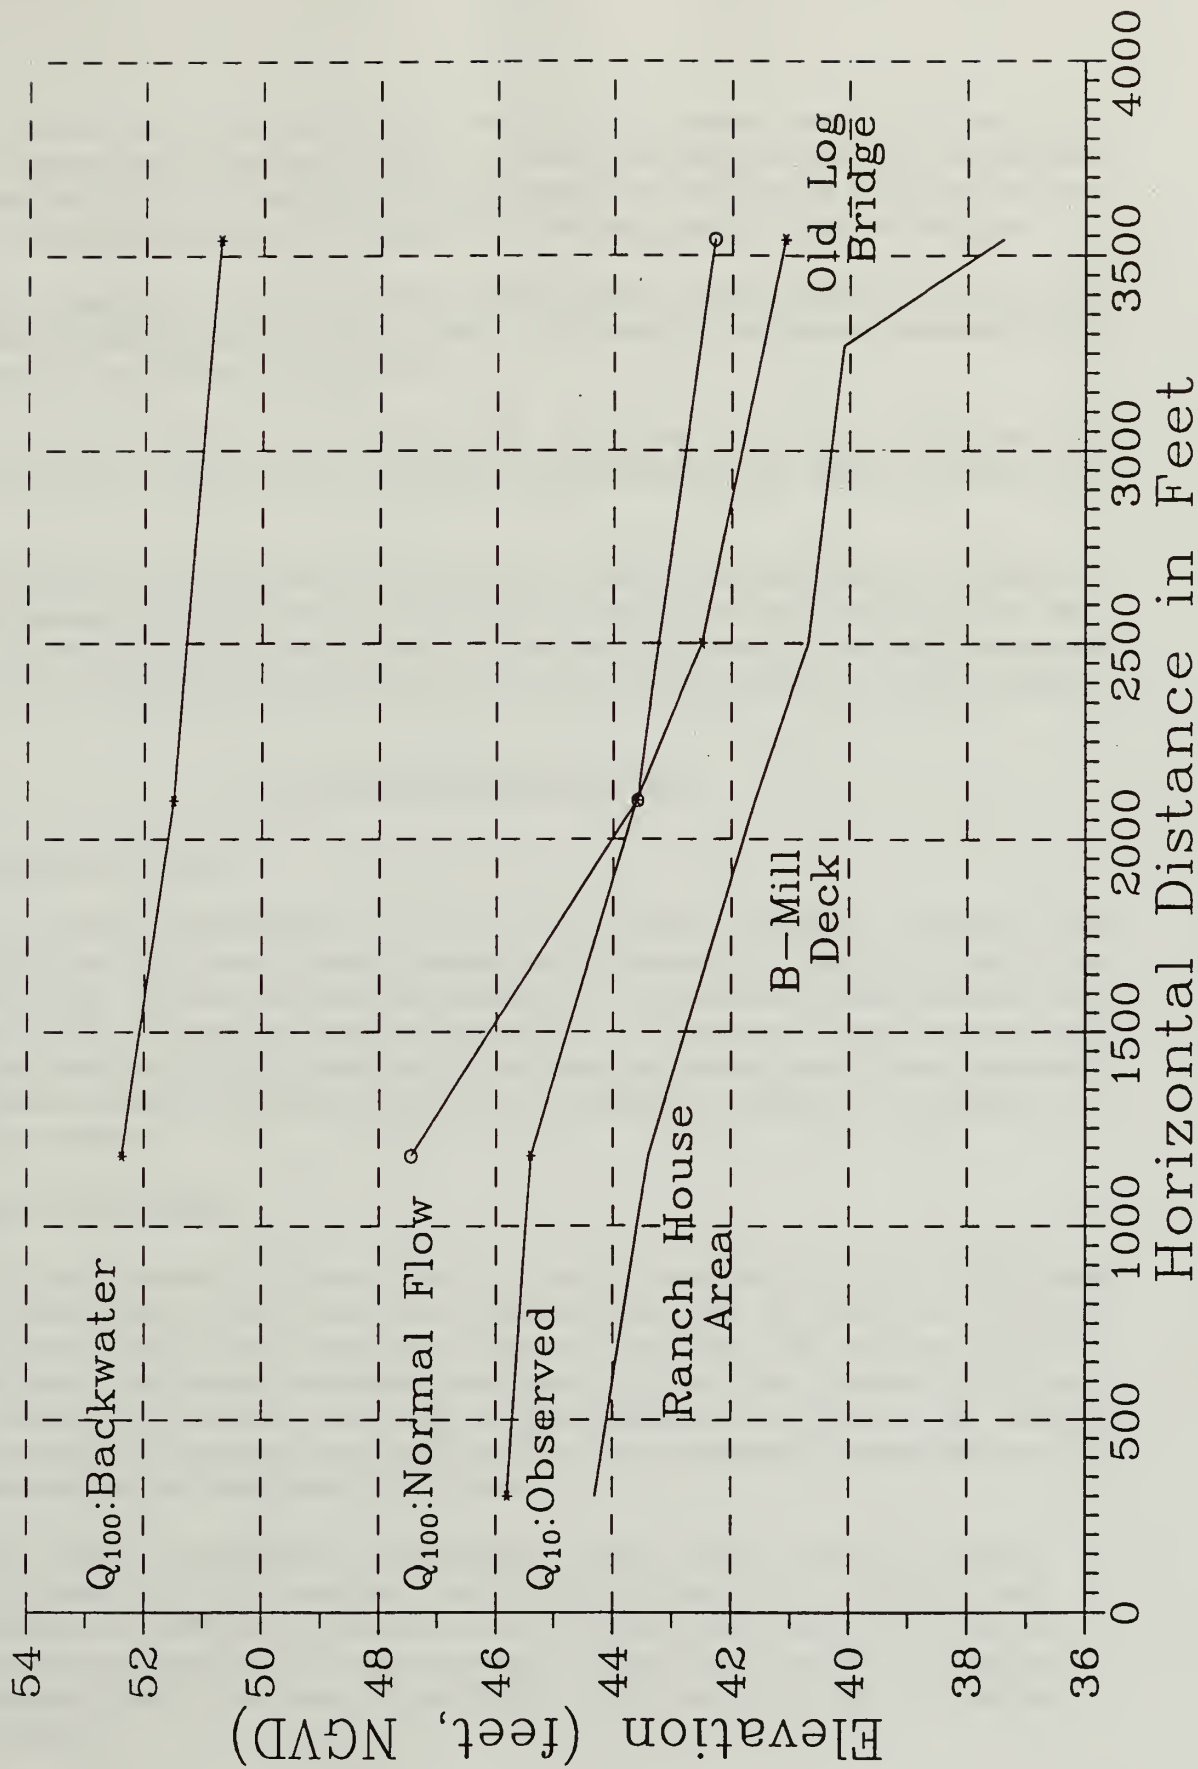
Figure 4. Longitudinal profile of Prairie Creek showing the ground surface at the top at the left bank and water surface profiles at the  $Q_{10}$  (5,860 cfs) and the  $Q_{100}$  (14,164 cfs).

The data from the December, 1995, storm is denoted in Table 1 and elsewhere in this report as the "observed" hydraulic condition. As indicated, the water surface profile derived by surveying high water marks ("observed", Fig. 4) varied considerably from that of the channel bed profile within the study reach. Some of the variability may be due to error in precisely locating HWMs or in not being able to find and survey a greater number so that a trend line could be fitted through them on the longitudinal profile. It may also be due to backwater effects which may have occurred during this storm.

As shown in Figure 4, the  $Q_{100}$ , normal flow WSEL dips in the vicinity of the B-Mill deck (at cross section DR10). This is due to a greater floodplain width and steeper slope at this location.

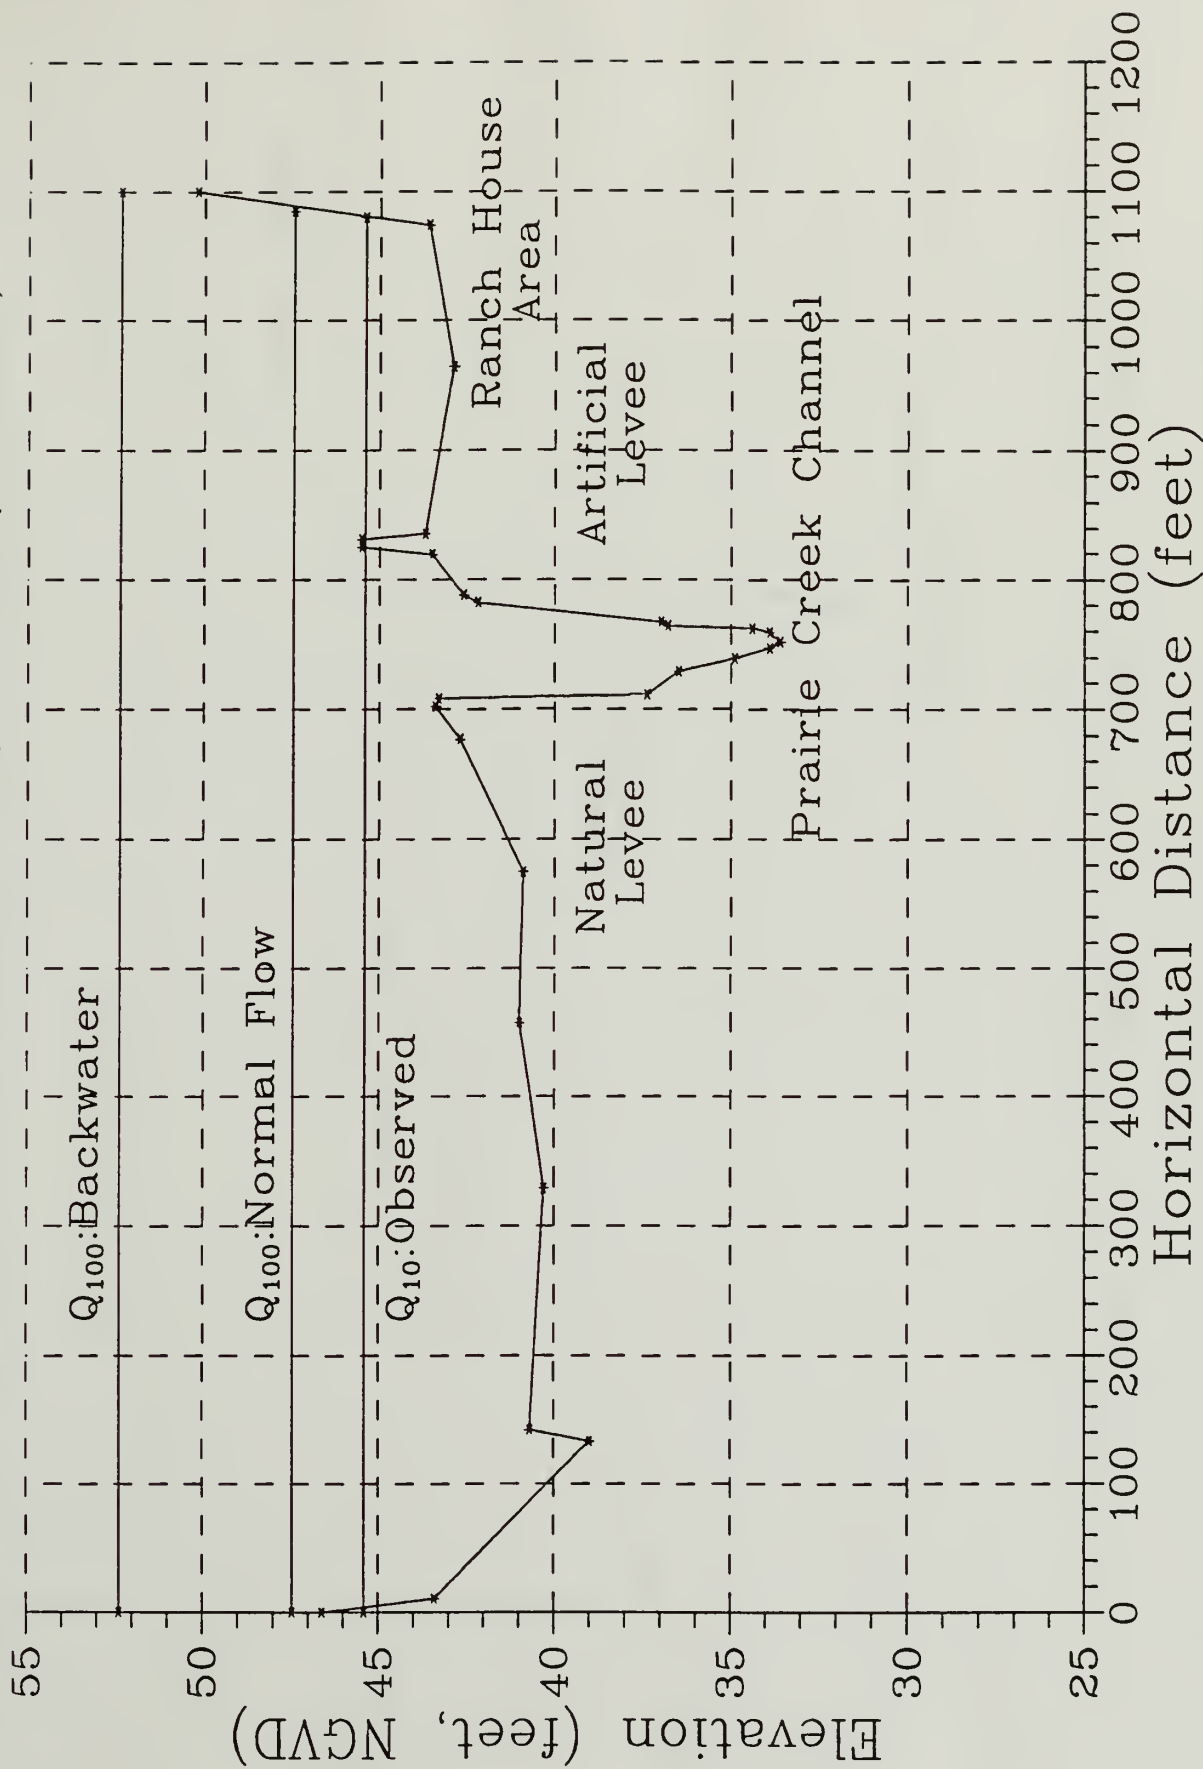
Figure 5. Davison Ranch cross section DR05 on Prairie Creek showing water surface elevations at the  $Q_{10}$  (5,860 cfs) and  $Q_{100}$  (14,164 cfs).

Water Surface Elevations: Cross section plots showing water surface elevations (WSELs) for the  $Q_{10}$ , the  $Q_{100}$  under both normal flow conditions and under the backwater condition for the three cross sections are shown in Figures 5-7.

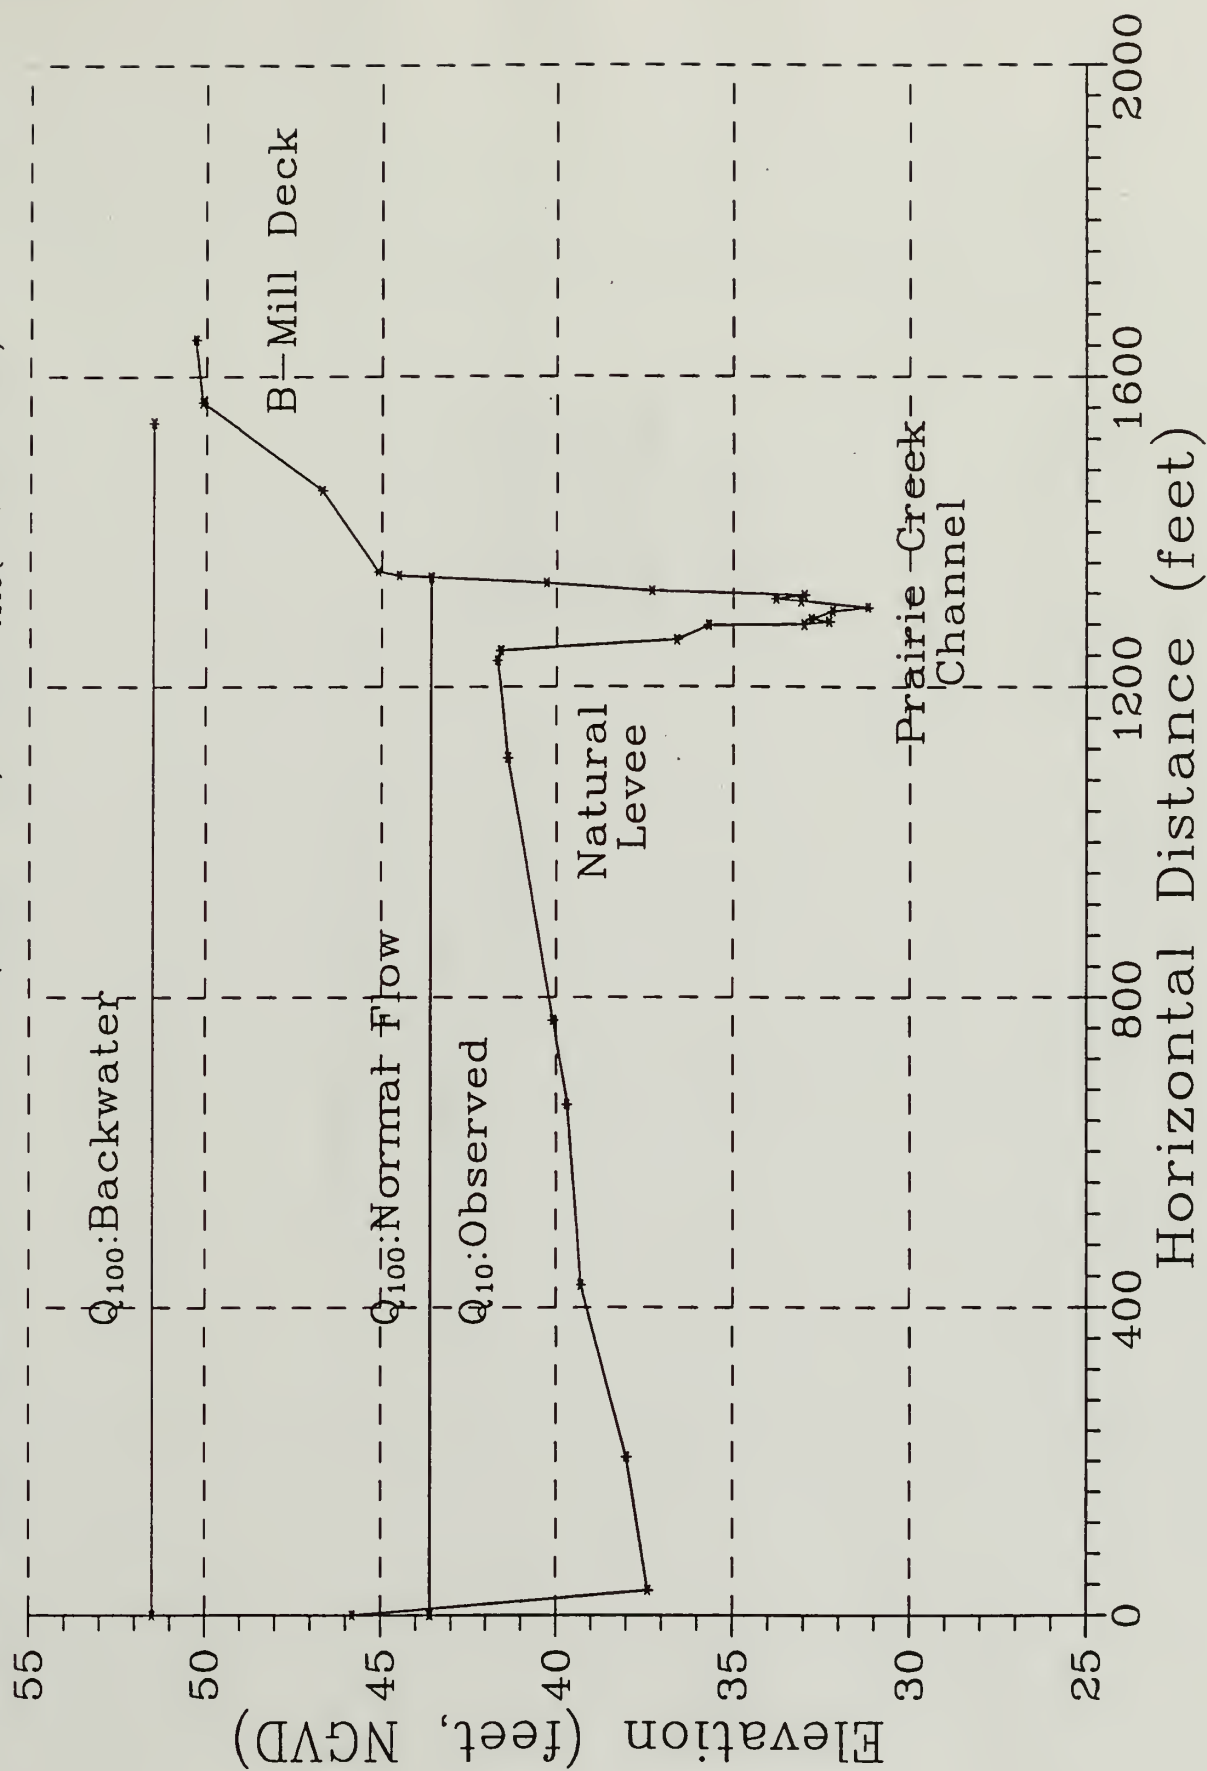
Figure 6. Davison Ranch cross section DR10 on Prairie Creek showing water surface elevations at the  $Q_{10}$ (5,860 cfs) and  $Q_{100}$ (14,164 cfs).

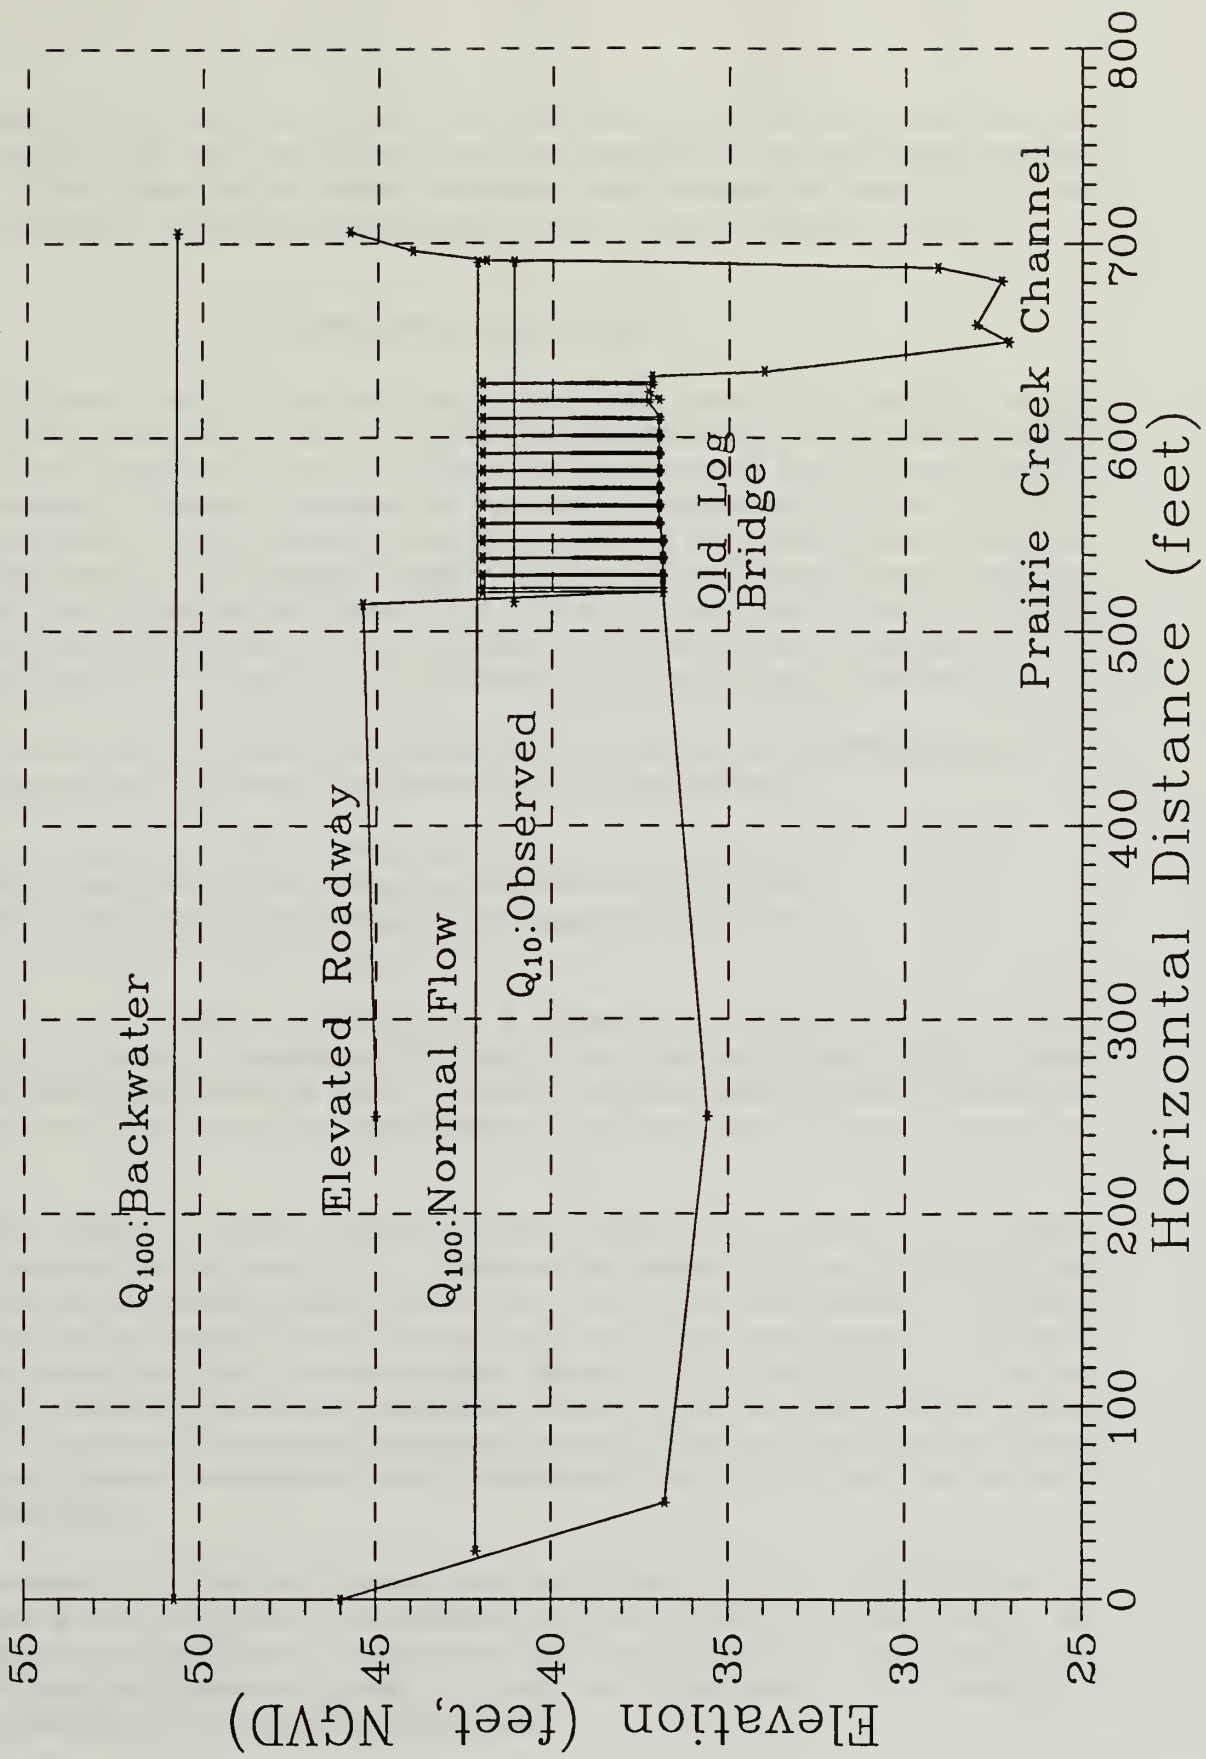
Figure 7. Davison Ranch cross section DR15 on Prairie Creek showing water surface elevations at the  $Q_{10}$ (5,860 cfs) and  $Q_{100}$ (14,164 cfs).
