EROSION AT REDOUBT #10

Janette Hansen  
and  
Kim Blankenbaker

May 8, 1979

### I. Introduction

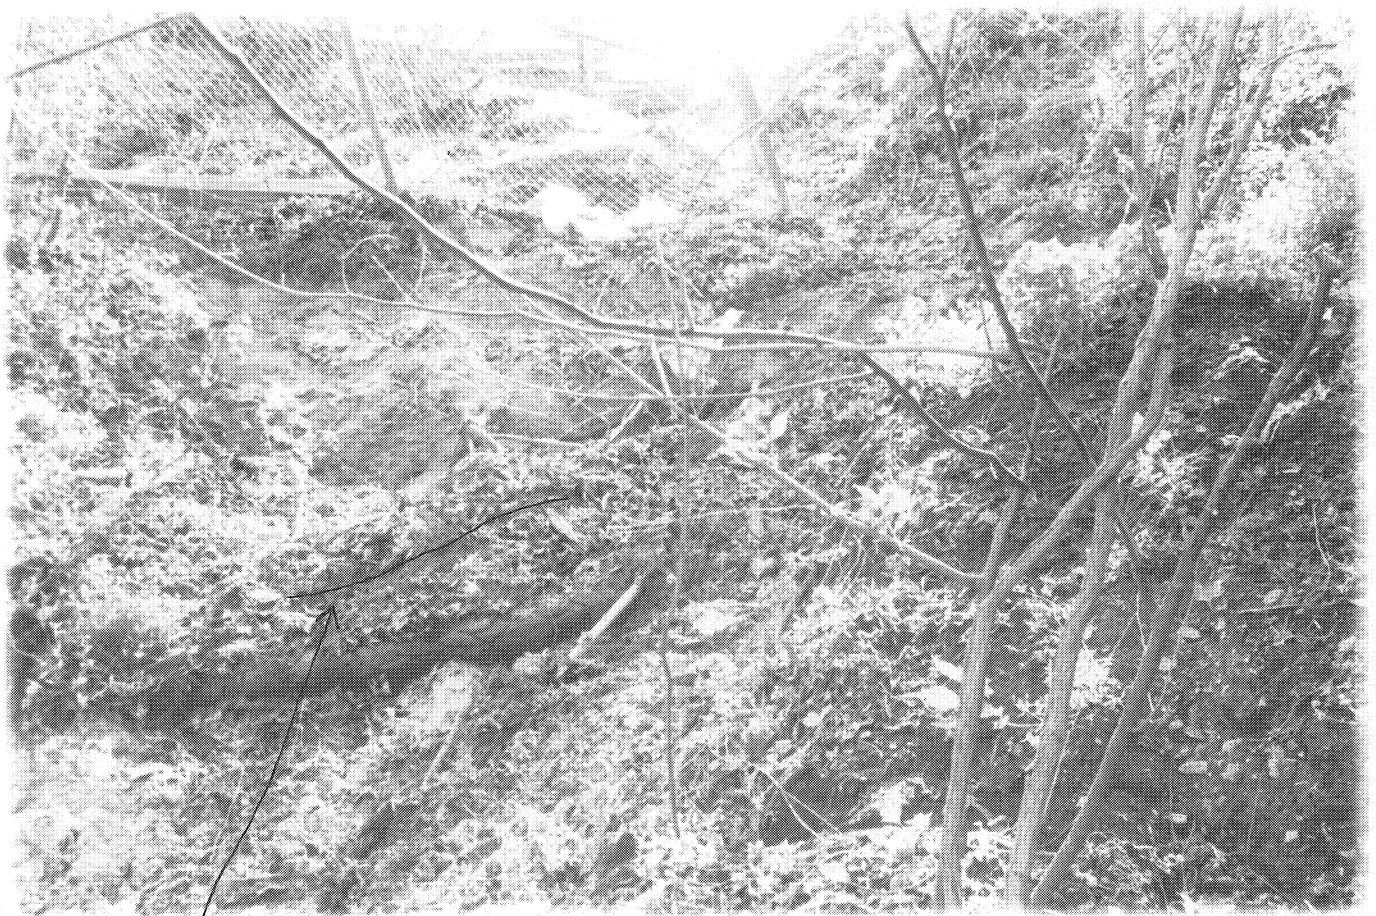
Fig. 5. Slope C. Immediately west of Redoubt #10.

line shows intersection with water table

In the area of Slope C, right below the redoubt, the soil is so waterlogged from the water table that vegetating the slope

may be difficult. A drainage pipe that takes the water directly from the water table intersection to the river might be helpful. If a pipe that has holes along the sides were used, then some of the water would seep out and keep the soil moist without making it soggy.

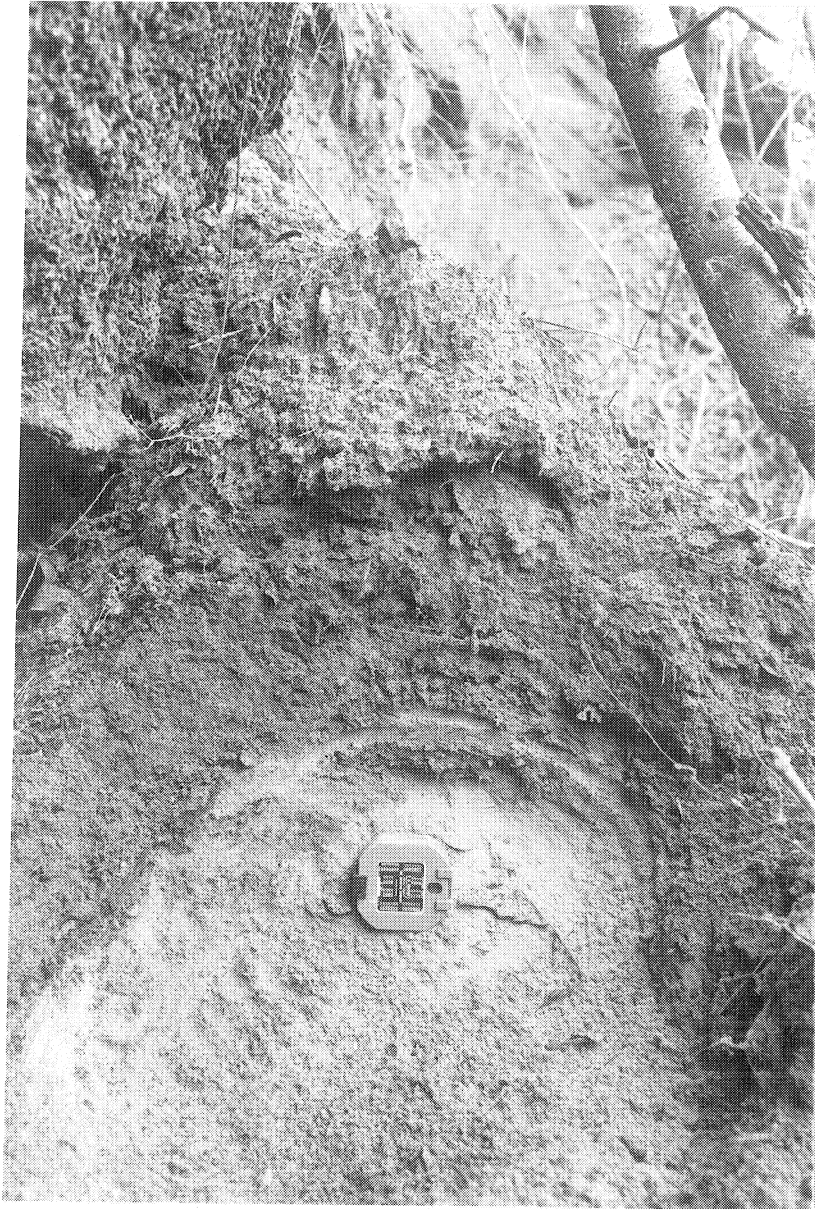
Fig. 19. Talus cut in half to show dark, outer layer, leaf layer, and light, inner layer. The dark layer shows one winter's erosion.

In other areas not specifically on the profile lines, talus cones were found in steep areas, close to footpaths. We were able to cut the cones in half and distinguish a darker layer, a thin leaf layer, and a lighter layer in the core. (Fig. 19). We understood the dark outside layer to be material that had accumulated during winter. In one case, this was estimated to be  $.64 \text{ m}^3$  of material, which was gathered from a very small area, about  $1\text{m} \times 2\text{m}$ . The cones were results of footpaths, <sup>erosion</sup> since these destroy vegetation, thereby leading to slump and sheet wash.

The next aspect of the problem concerns human traffic. We suggest that the Park Service either ban the slopes to visitors or have one terraced walkway down to the beach. In several areas, the formation of talus cones was due entirely to human traffic.
