G-6 Road  
Watershed Rehabilitation Project Summary Report

Michael Kenning

February 1989

**G-6 ROAD CONTRACT 87-2  
Redwood Creek Area**

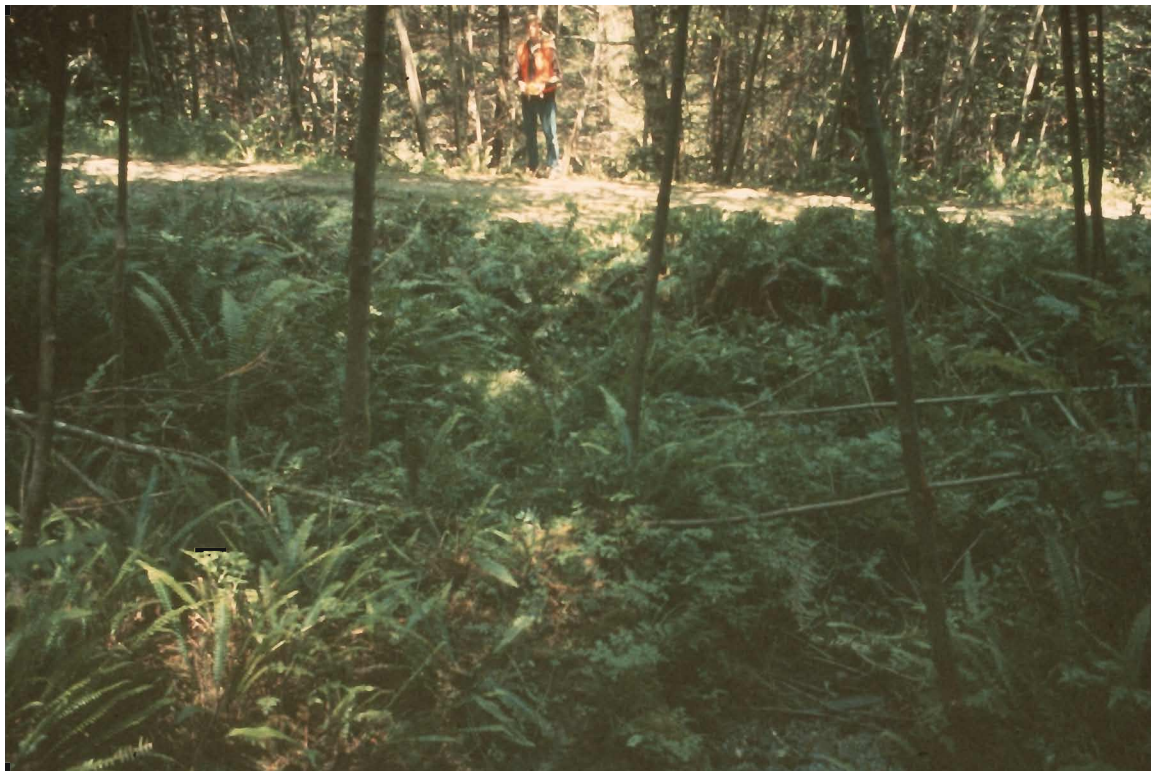
Unit: 87-2 Date: 5-18-1987, PP8 G-6 STA 32+85

Some culverts along the G-6 were placed without consideration of the upslope drainage. For example, the ephemeral drainage at RX-2 shows channel definition above the road, but is not as well defined below the road. The 18 inch culvert was placed almost 100 feet away and the stream flow was carried along the inboard ditch to the culvert. This resulted in a minor fill failure and

gully, but the potential for greater erosion existed, and could have resulted in much more erosion if a larger storm event (25 yr. return interval or greater) had occurred.
