Fish And Flow Measurements And General  
Observations For Lobos Creek, San Francisco,  
California, Spring 1998

Darren Fong  
Aquatic Ecologist  
Golden Gate National Recreation Area

June 1998

Division of Resource Management and Planning  
Golden Gate National Recreation Area

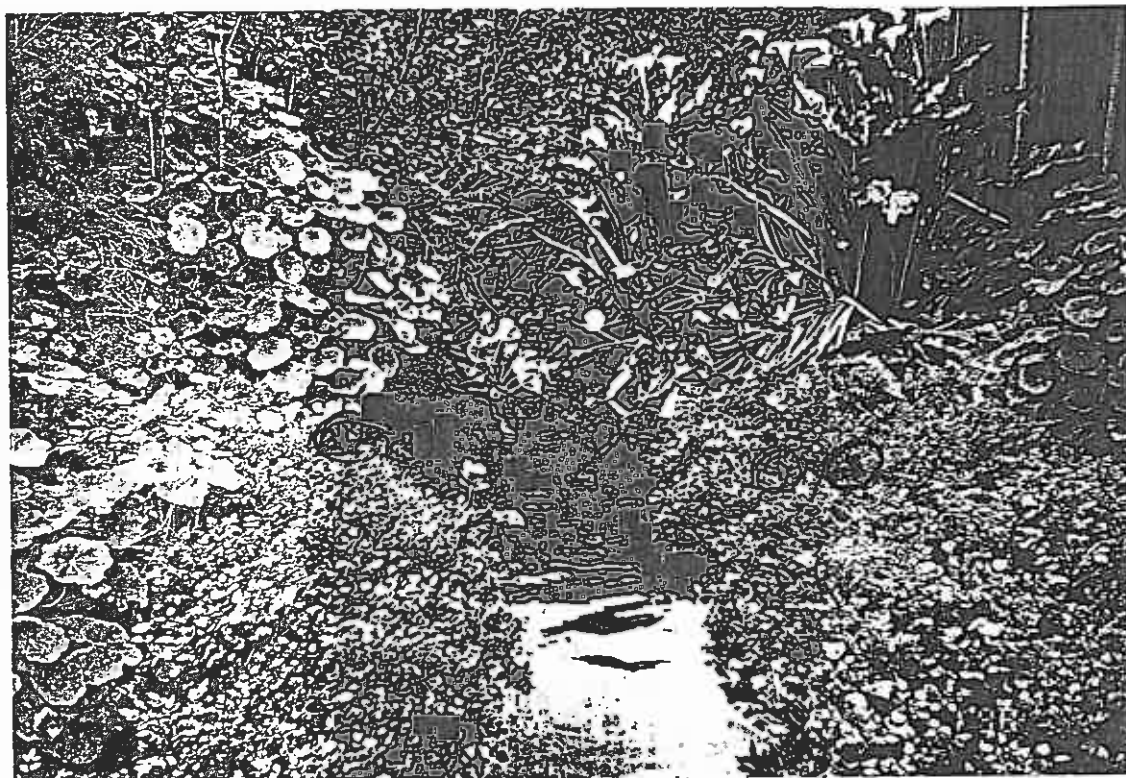
Figure 2: Lobos Creek channel : wire flags marking (circled) wetted perimeter under different flow regimes on May 7, 1998.

Changes in flow rates resulted in changes in the cross-sectional area. Because of time limitations, no transects were established at sites other than the discharge measurement locations. We followed the decrease in channel width as pumping rates increased through placement of wire flags and photographs (Figure 2).

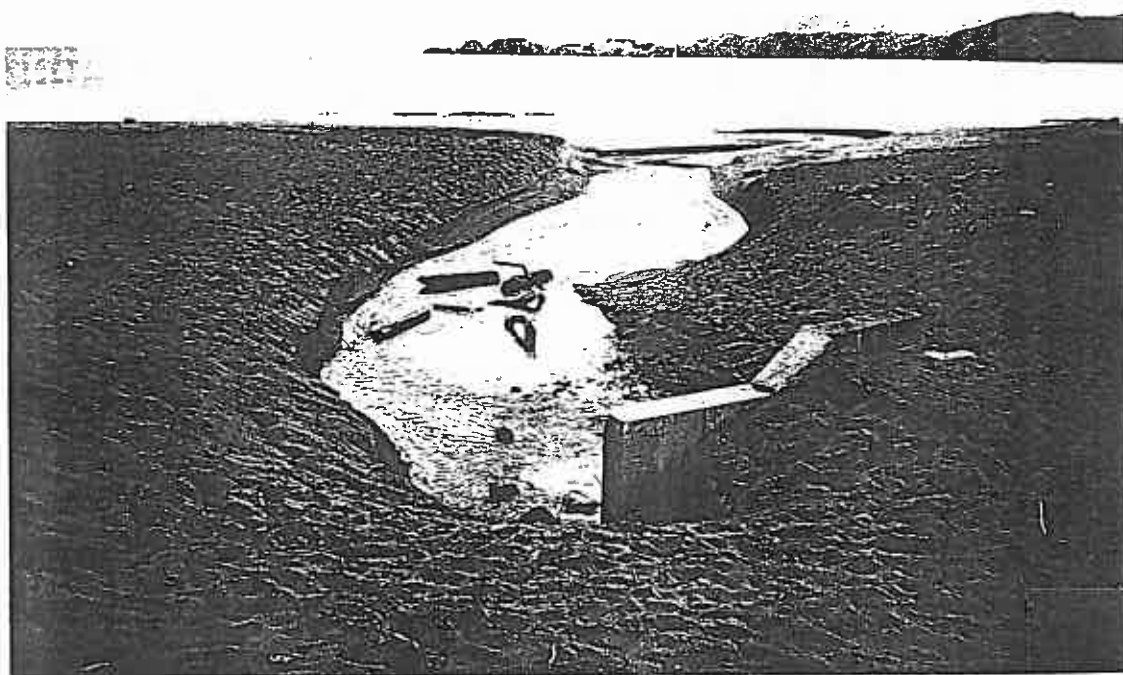
Figure 4: Lobos Creek at Baker Beach outfall in absence of pumping on May 12, 1998

A well-defined channel between the Ocean and Lobos Creek Outfall was present (Figure 4). It is likely that the channel banks and bottom elevation are maintained by the higher flows occurring at night when pumps are inoperative. On May 12<sup>th</sup>, when no pumping was occurring, the wetted channel was at the edge of the defined banks. On May 7<sup>th</sup>, under the various pumping rates, the wetted channel was well within the defined banks.

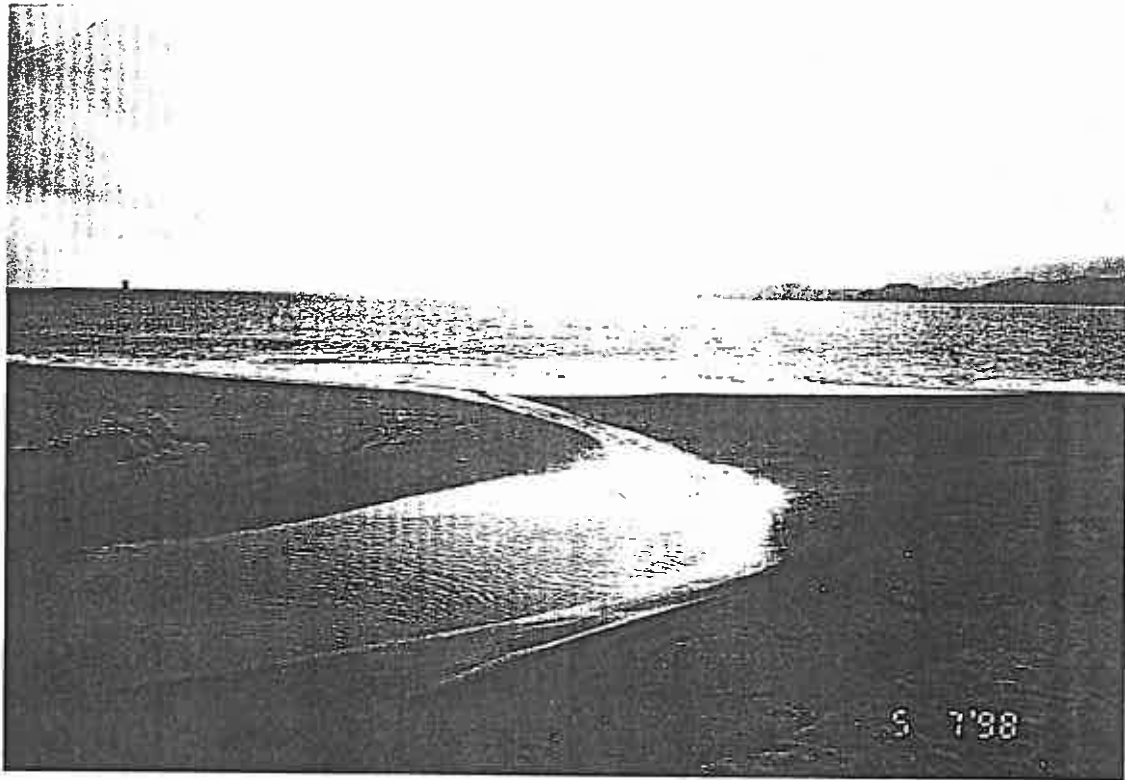
Figure 5: Lobos Creek Confluence with  
Pacific Ocean at approx 0.1 cfs flows  
on May 7, 1998,

Under the range of short-term discharges observed at Baker Beach, the stream was connected to the ocean. Under the lowest discharge (0.09 cfs), flows were confined to a shallow channel about 0.9 m wide at its confluence with the Ocean (Figure 5). When no pumping was occurring, flows (1.64 MGD) were spread across a shallow, but wide channel of 8.5 m wide.
